EA11-012

HONDA

4/20/2012

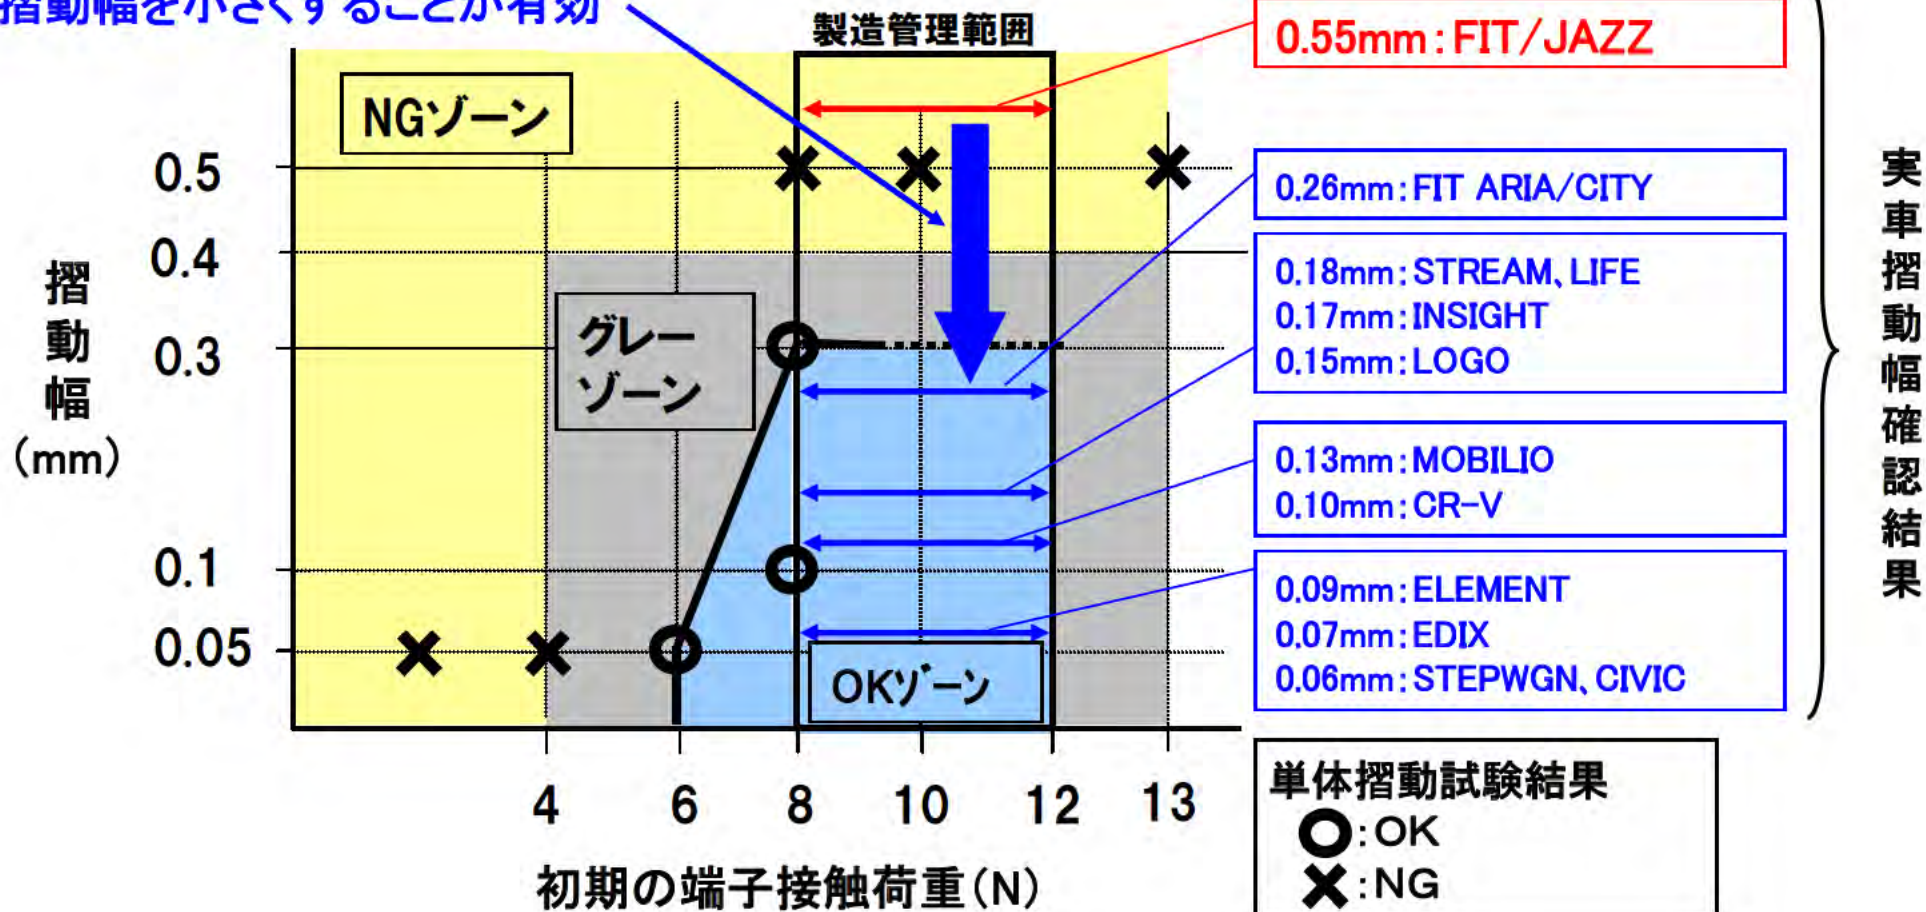
摺動幅を小さくすることが有効

FIT/JAZZの実車摺動幅のみが、抵抗値増大が認められるNGゾーンにいたることが判明  
また、摺動幅を抑えることが最も有効な対策である

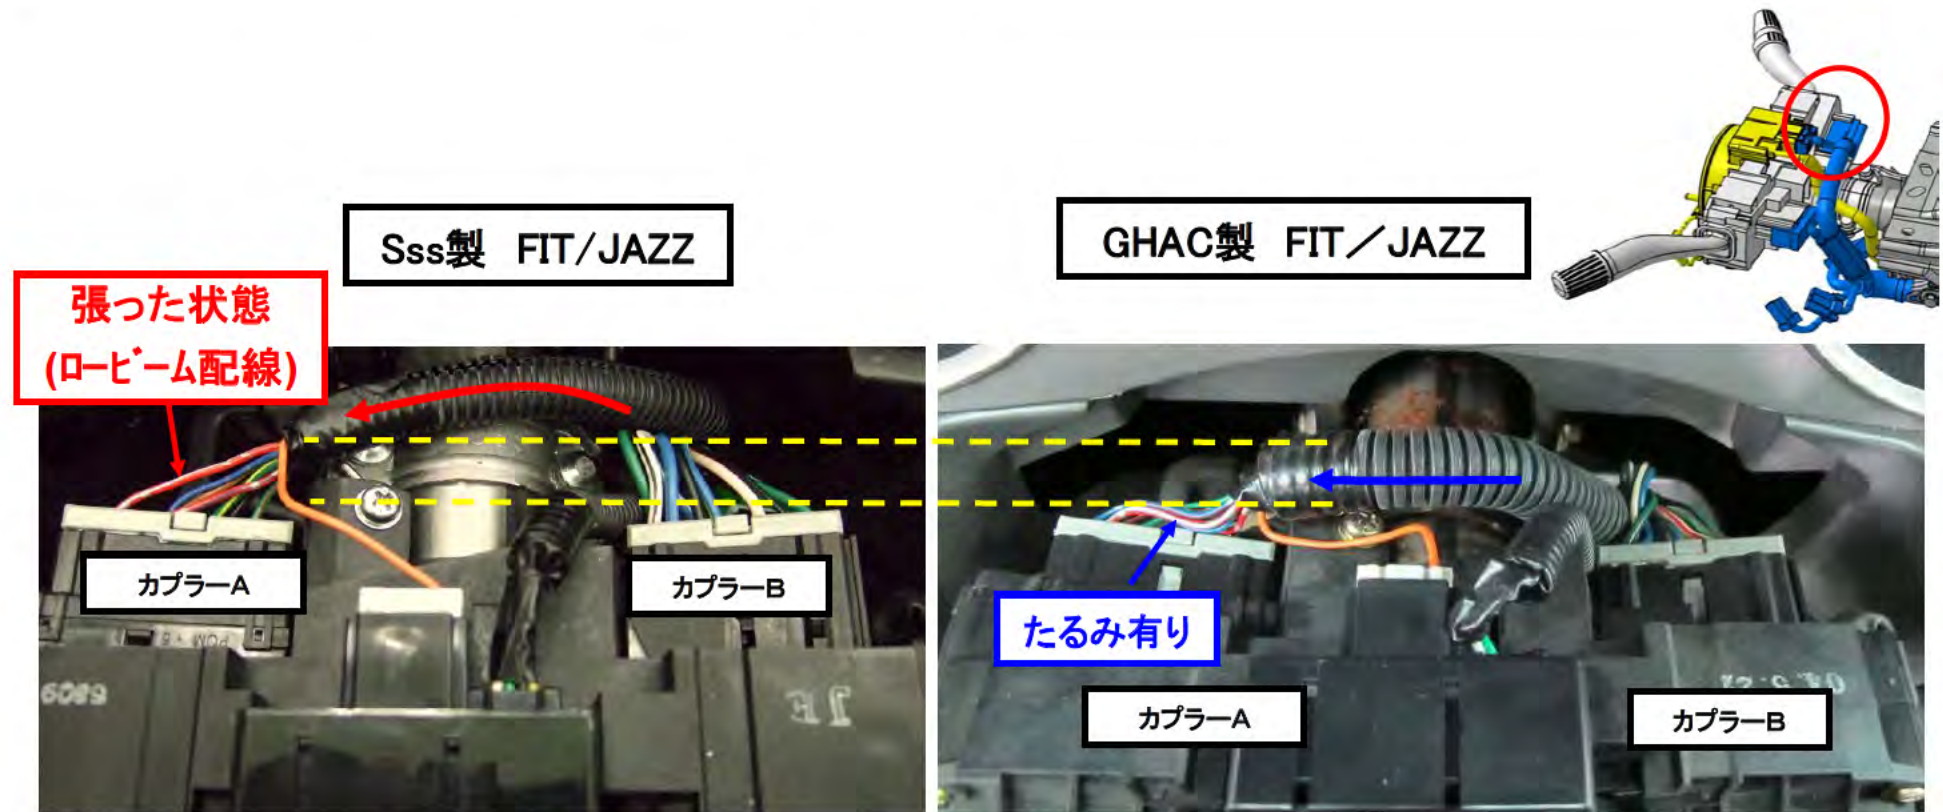
たるみ量が大きいと摺動幅も小さくなることを確認

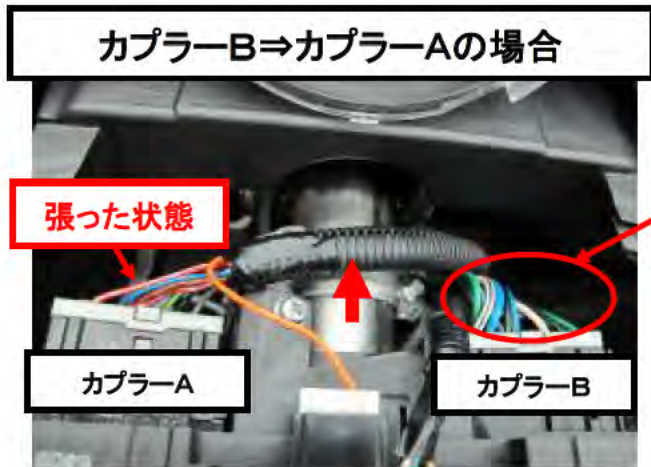
①コンビSW側組付でカプラーB ⇒ カプラーAの順で組付を行うとハーネスがカプラーから離れ、ロービーム配線が張る傾向になる

この部分の取り合いでカプラーから離れる

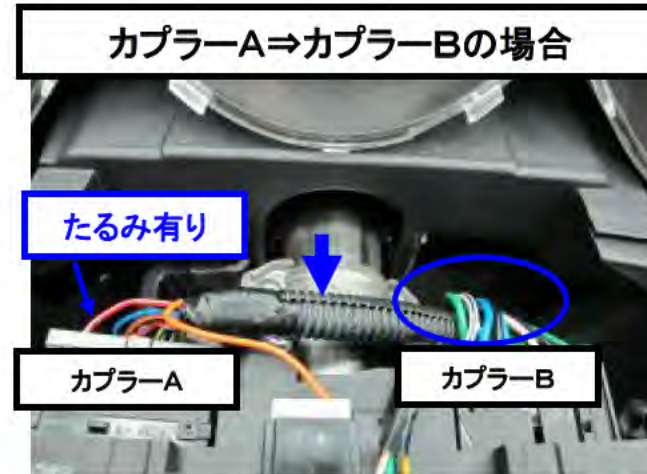
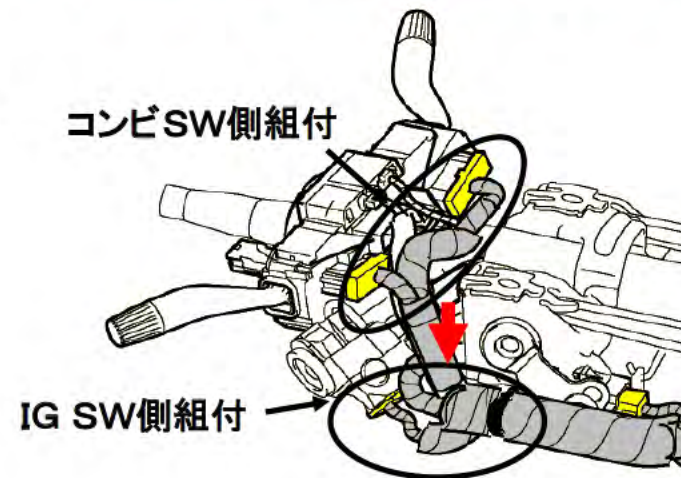
②コンビSW側組付 ⇒ IG SW側組付の順で行うとコンビSWの配線が引き下げられ、ロービーム配線が張る傾向になる

Sss製 FIT/JAZZの組付手順のカプラーB ⇒ カプラーA ⇒ IG SW側組付で行うとロービーム配線が張った状態になる。

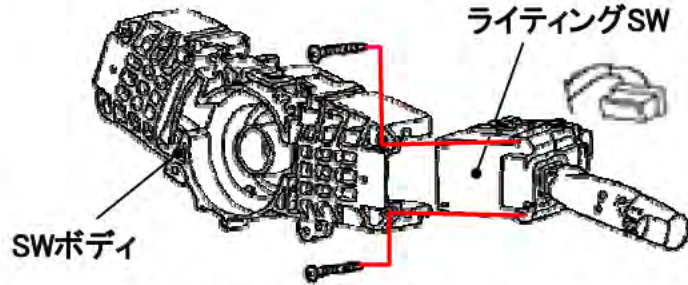
ライティングSWの締め付けネジを支点として、レバー操作(Hi-Lo切替や手前に引きながらのターン操作)を行うとSWが微かに動く

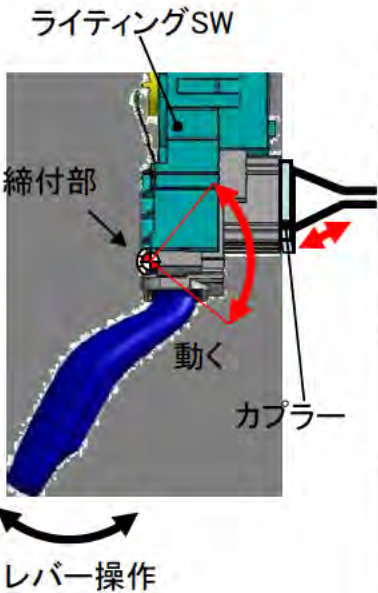
組立て性と部品の公差のためカプラーとメス端子に遊びがある

たるみ量 = 配線長(A) - レイアウト直距離(B)

配線が張っている場合	配線にたるみがある場合
<ul style="list-style-type: none"> <li>Hi⇒Lo切替</li> <li>パッシング</li> <li>引きながらターン</li> </ul> 操作方向 力	カプラー、メス端子、オス端子、前照灯操作SW	ハーネスのたわみが変位を吸収する
操作前後		
<ul style="list-style-type: none"> <li>Lo⇒Hi切替</li> <li>押しながらターン</li> </ul> 操作方向 力	(反作用)	ハーネスのたわみが変位を吸収する

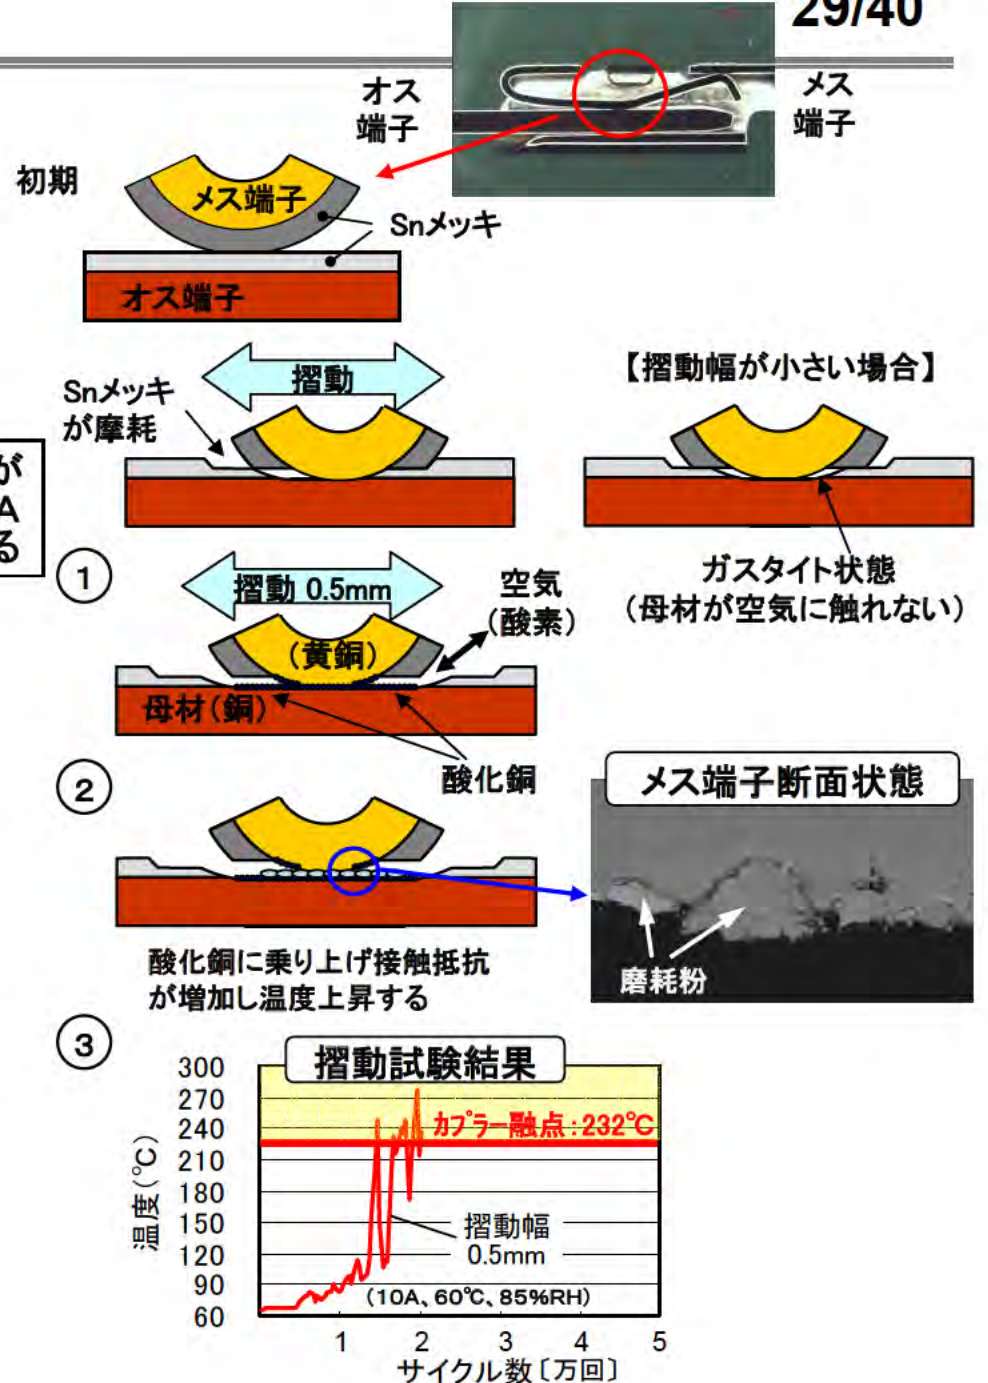
# 7. 解析結果 7-13 発生メカニズム②

※カプラー樹脂が溶けて流れ込むと導通不良となり、電流が流れないため類焼はしない。

電流が約10A流れる

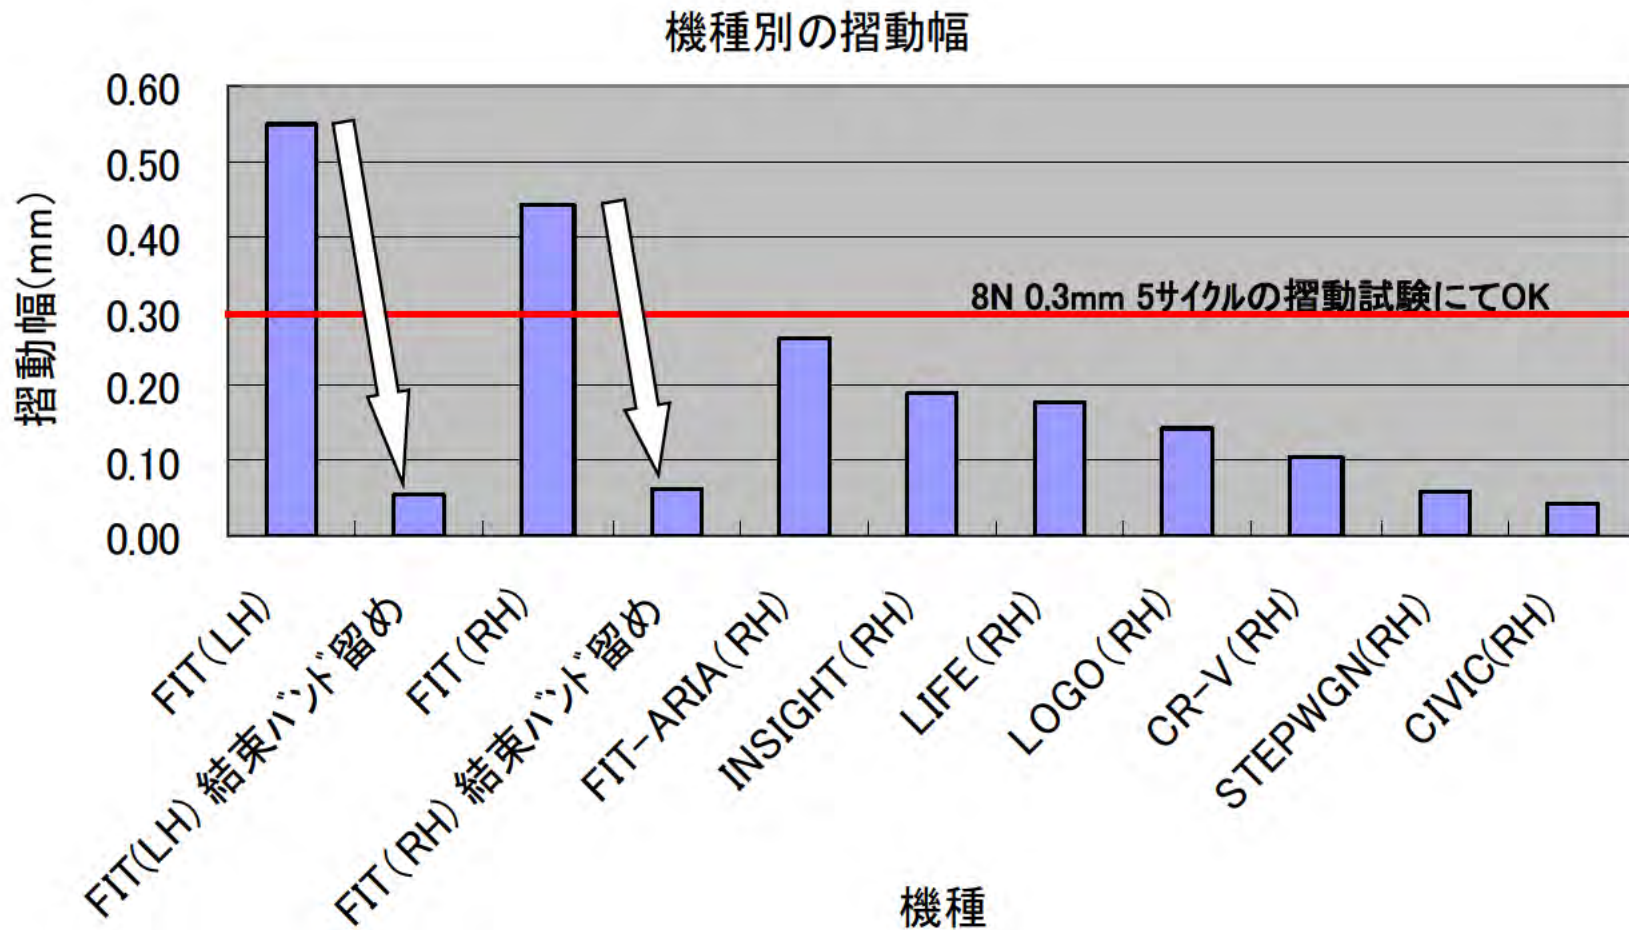
結束バンド留めによりで摺動幅が約1/10に減少

オス端子のSnメッキが磨耗により剥離したとしても、結束バンドによるハーネス固定とメス端子耐熱銅合金に変更すれば、今後の使用過程において不具合が発生しないことを確認した。

- ・実車にてライティングスイッチ操作1万サイクルによる対策効果を確認する  
(1サイクル:Rターン→中立→Lターン→中立→パッシング→中立 のSW操作)

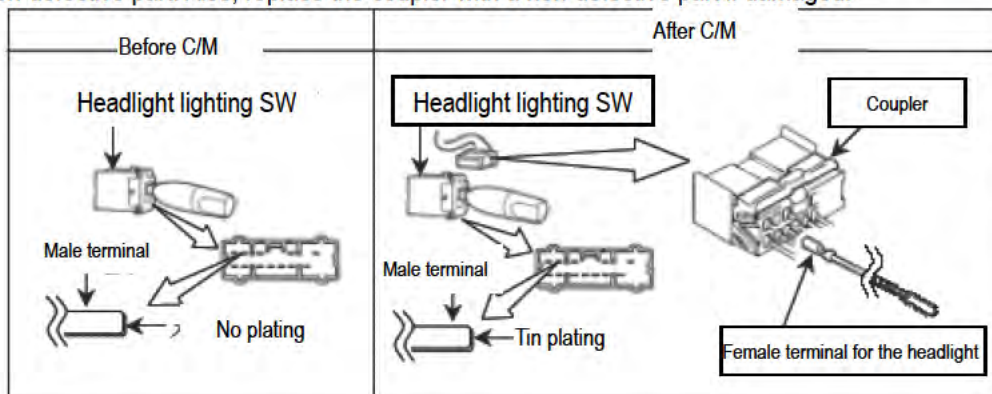
Due to inappropriate surface treatment for a headlight SW terminal of the lighting system, the coupler joint moves and increases contact resistance when switching operation of the headlight is performed. As a top event, the coupler joint melts and leads to a continuity failure, possibly causing the headlight failure.

In all units, replace the combination SW to a C/M part and replace the headlight female terminal to a non-defective part. Also, replace the coupler with a non-defective part if damaged.

Note: Replacement parts are surrounded with a box.

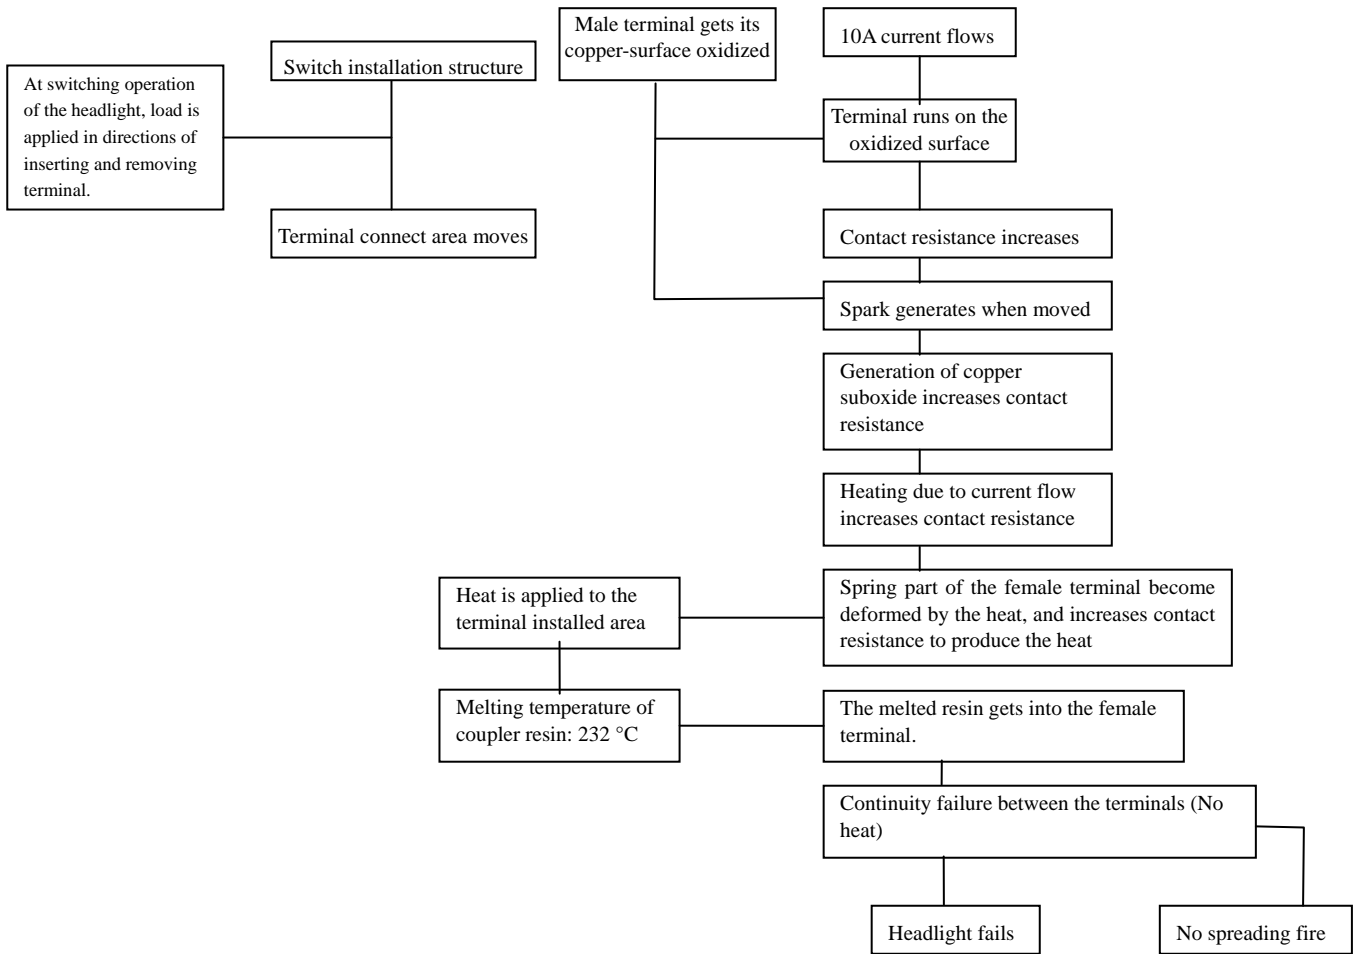
Occurrence mechanism

As a result, we assumed rubbing due to movement between the male and female terminals caused the heat.

4. The result of the heat generation test shows that the rubbing mark similar to ones we saw on the returned units and heat could be generated by repeated switching operation. The mechanism of the heat occurrence is as follows. The change of contact surface due to terminal movement causes a spark to occur and generates copper suboxide to increase the contact resistance. Depending on time of lighting the headlight as is, the contact resistance increases more and spring part of the female terminal become deformed by the heat. This reduces contact pressure of the bend area to the male terminal, causing contact resistance and heating temperature to increase even more.

5. If the heat reaches 232°C, the melting temperature of the coupler resin, from repeated switching operation of the headlight, melted coupler resin enters between the terminals and leads to a continuity failure.

From the above, the mechanism of the headlight failure was identified. The contact resistance increases and the heat generates when the male and female terminal joint of the headlight moves by repeated switching operation of the headlight, and melted coupler joint goes into terminals to cause the continuity failure. This leads to the headlight failure. Global Quality Committee has decided to take proactive market action since the symptom may occur from the combination of the frequent switching operation and the lighting time.

In all units, replace the combination SW to a C/M part and replace the headlight female terminal to a non-defective part. Also, replace the coupler with a non-defective part if damaged.

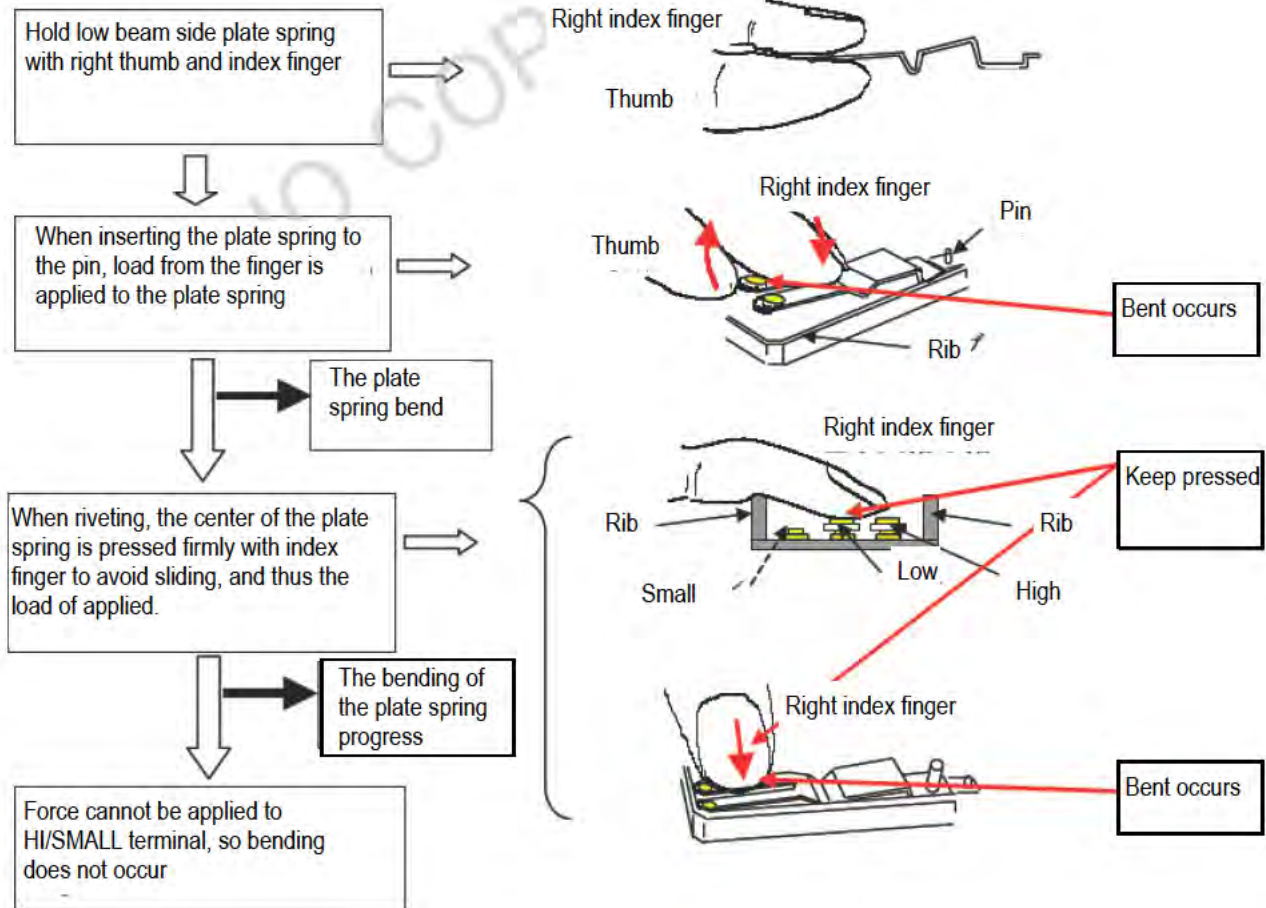
A mechanism of the problem occurrence which is limited to low beam plate spring terminal  
(Installation procedure difference by operator)

In all units, replace the lighting switch with a non-defective part.

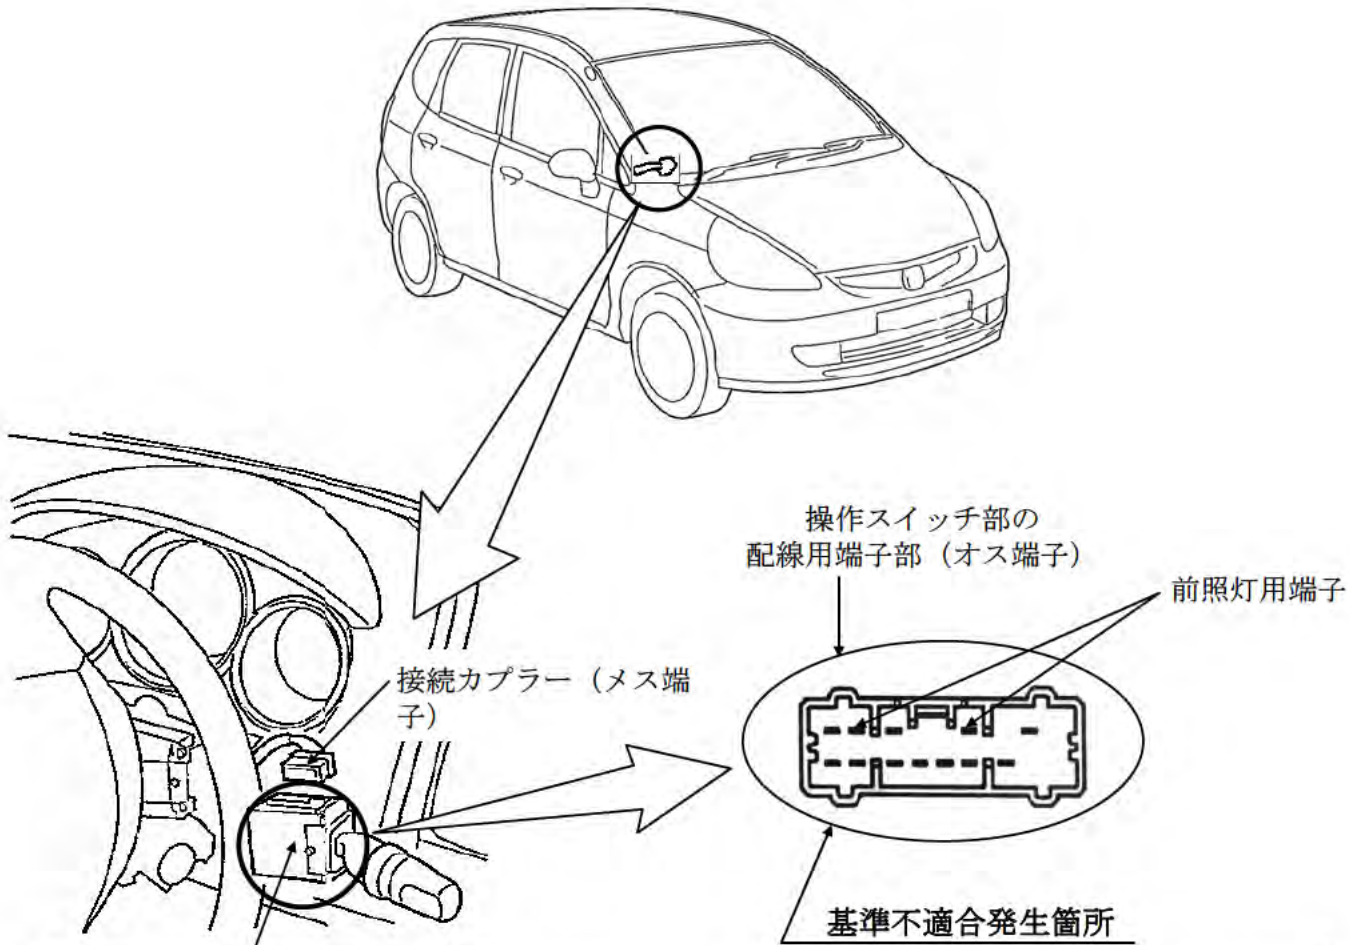
# 改善箇所説明図

灯火装置において、前照灯操作スイッチ部の配線用端子の表面処理が不適切なため、前照灯の切り替え操作を行うと当該端子の嵌合部が動くことにより接触抵抗が増大するものがあり、最悪の場合、接続カプラーが溶けて導通不良となり、前照灯が不灯となるおそれがある。

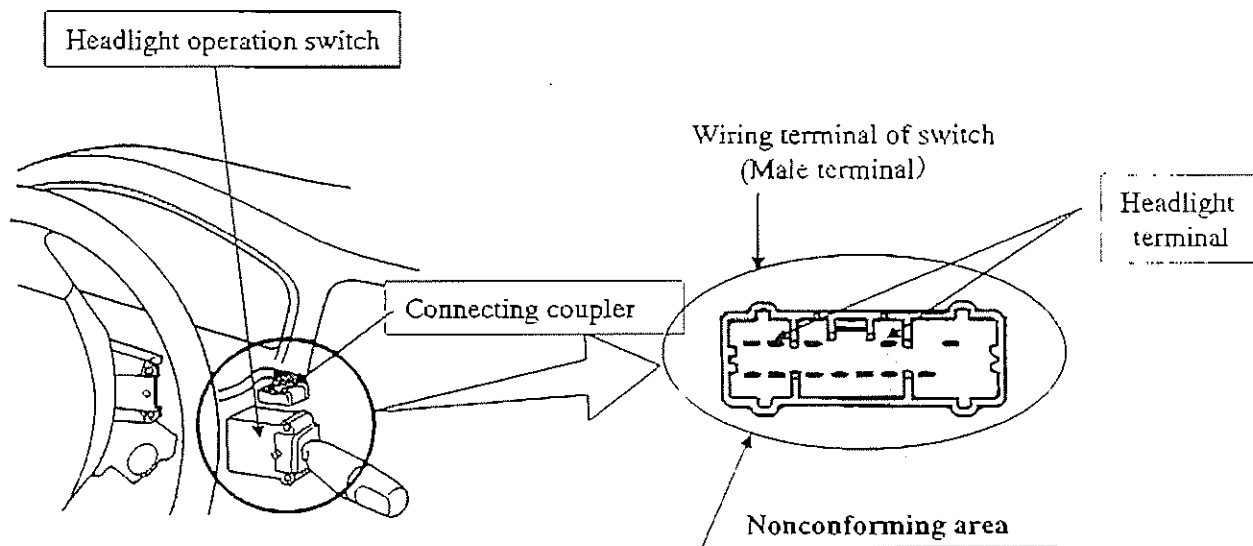
During headlight switch operation, the terminal contact point shifts or slides. If the non-plated copper terminal is oxidized, the sliding movement increases resistance and generates heat. Over time, oxidation builds up and resistance increases at the terminal joint, eventually melting the switch coupler. Switch failure results in a loss of headlight low beam function.

Call in affected vehicles and operation switch is replaced with a countermeasure part and female terminal of headlamp wirings is with a non-defective part. In addition, if damaged, the coupler is replaced with a non-defective.

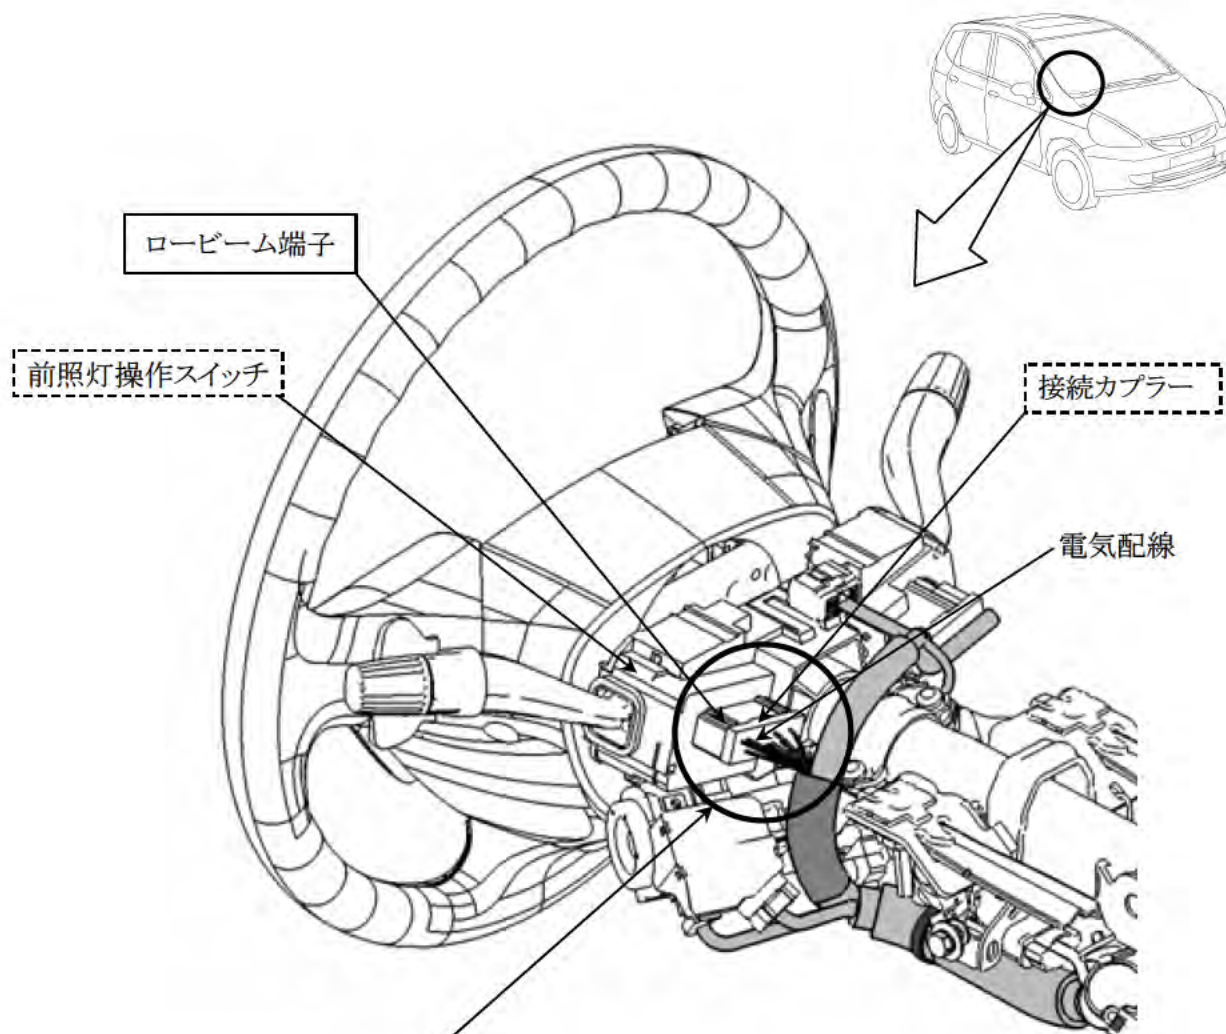
## 改善箇所説明図

前照灯操作スイッチに接続する電気配線の配線長さに余裕が少ない設定のため、配線作業で配線を張り過ぎたものがある。そのため、前照灯の切替えスイッチを操作した際に、端子結合部が追従できずに動いて接触抵抗が増え、端子が発熱してカプラーが溶け、最悪の場合、ロービームが不灯となるおそれがある。
