Title: Horton VMaster Ultra (Stratis) Viscous Fan Hub Diagnostics and Troubleshooting Guide

Applies To: ProStars, LoneStars, WorkStar, TranStar, IBB

This article is a Troubleshooting Guide for the Horton VMaster Ultra (Stratis) Viscous Fan Drive.

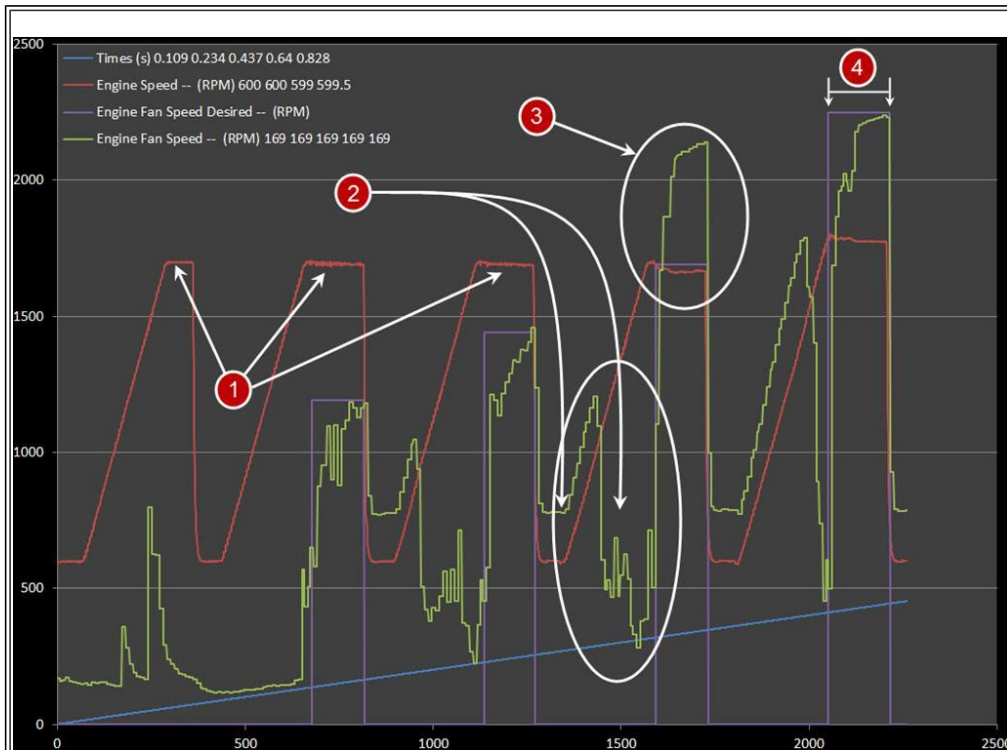
**Figure 8 - Properly Working Fan Hub Assembly**

- The engine ramps to the same speed for each section of the test.
- When the ECM is no longer requesting a set fan speed, the fan disengages. However, as the engine ramps to start the next section of the test, the fan speed increases. This is normal due to the viscous characteristics of the fan hub. As the fan hub stabilizes you see the fan speed then continues to decrease.

- This section of the test shows the fan speed higher than the desired fan speed. This is due to engine speed and desired speed being very similar values. The fan is then commanded ON, and the fan speed is 125% of desired. This is normal.

- This is showing the duration of the fan on command. Notice in each section the fan does not match up and perfectly align. This is due to the PWM (Pulse Width Modulated) signal that is being sent to the fan hub.

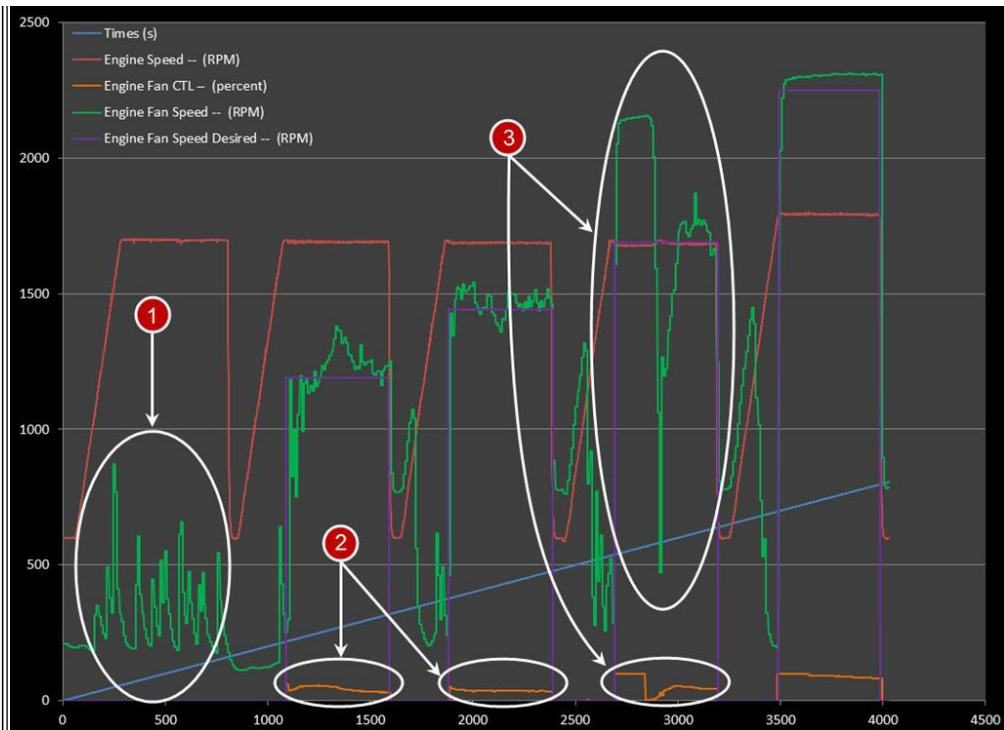
Figure 9 - Properly Working Fan Hub Assembly (Example 2)

- Again, notice the fan speed varies when the engine ramps for the first time and desired fan speed is zero. This is normal due to the viscous properties of the fan hub, and is normal operation.
- The Fan Control % has been added to this chart.
- As stated in the chart above, due to the engine speed and desired fan speed being very similar values, the ECM commands the fan on at 98.04%. However, in this test the ECM tries to change the fan speed by changing the fan control percent. The fan control percent drops near zero to attempt to achieve this. While this is a different reaction for this portion of the test then the chart above, it is still normal operation.
 - You can review your fan test in ServiceMaxx to see a chart view of the signals shown in this chart.
 - If you have any questions of the results, attach your fan test snapshot to your case file for review.

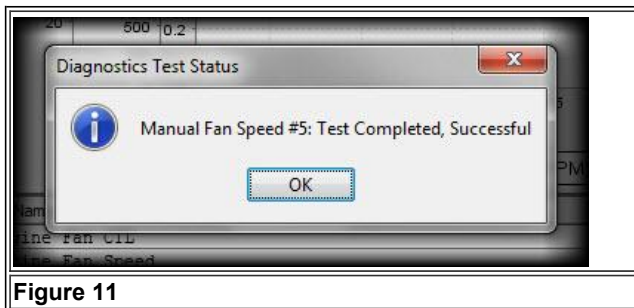
Figure 11

5. The "Test Completed, Successful" (*Figure 11*) window at the conclusion of the test does not indicate the fan has passed. It only indicates the test has been completed successfully. You will need to determine if the fan has passed or failed.

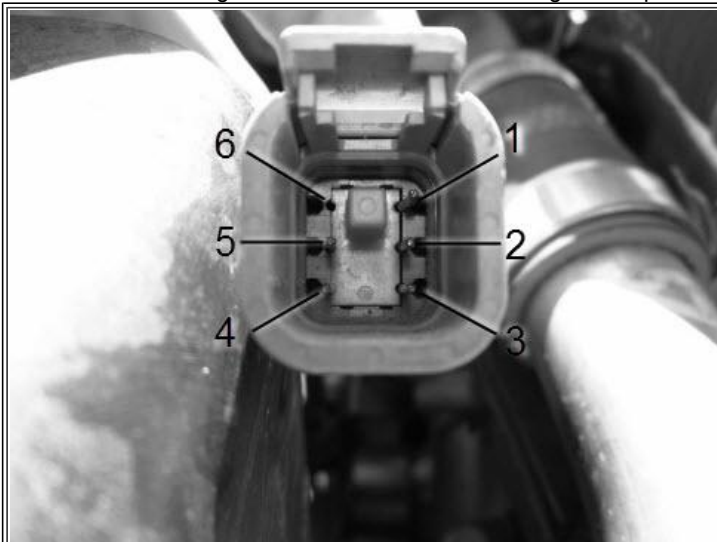
Figure 18 - Pin Location Map (Front View)

- 1. Brown Wire
- 2. Red Wire
- 3. Grey Wire
- 4. Blue Wire
- 5. Green Wire
- 6. Empty

13. Install wires into terminals in fan clutch harness connector following pin location map (*Figure 18*).
