Campaign code:
L636-A.08.19.

Campaign Name:
Gateway ECU connectivity configuration.

Model:
Urus.

Network information notice.

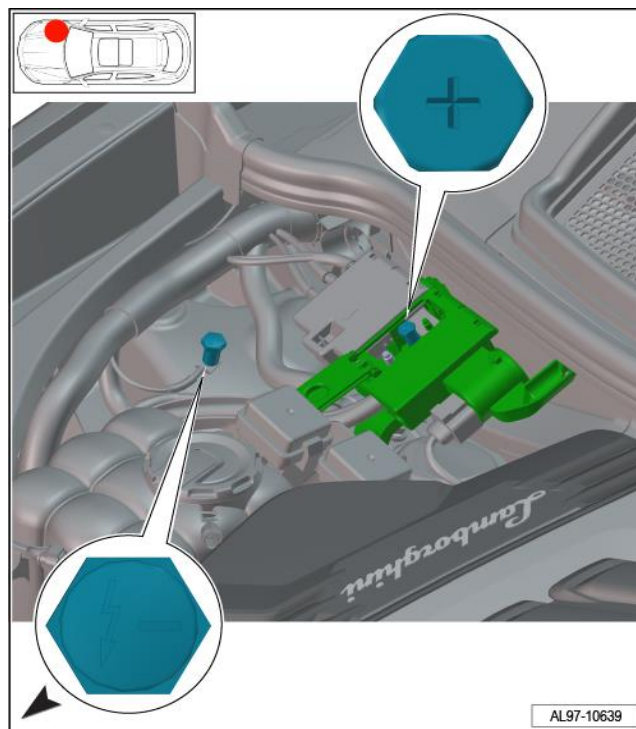
2. It is essential that you connect an appropriate battery charger to the charge points available in the engine hood (left side of the vehicle). Please refer to the following figure.

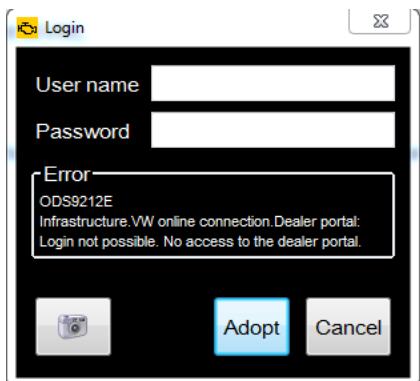
vi. If the infrastructure error as shown in the following screenshot is displayed (error code: ODS9212E):

- Ensure you have a valid GeKO user account
- Ensure that the “Geko” label is printed on the token you are using
- Check that the Internet is set in ODIS settings and not CPN (see document “Set-up_Iniziale_ODIS_2.0” (*))
- Click on “Cancel” and run the application test (see document “ODIS_ControlloConnessione_Server_SVM_2.0” (*)).

vii. If the same error type should reoccur during the application test, try the following procedure:

- Exit ODIS
- Browse to the folder C:\Program Files (x86)\Offboard_Diagnostic_Information_System_Service\automatic_sessions on your diagnostic laptop
- Delete the only file which will be in the folder
- Restart ODIS Service, ensuring that:
 1. You have a network connection
 2. The ODIS connection is set to Internet
- Run the connection test again, and perform the SVM again with your GeKO Token.
