24-18-01 - MIL ON DTCs P2004, P2014 and or P2015 Stored in Engine/Motor Control Module -J623-

Release date: 8/25/2022

Condition

DTC	Description
P2004	Intake Manifold Flap for Air Flow Control Bank 1 Stuck Closed
P2014	Intake Manifold Runner Position Sensor/Switch Circuit
P2015	Sender for Intake Manifold Flap Position/Air Flow Control, Implausible Signal

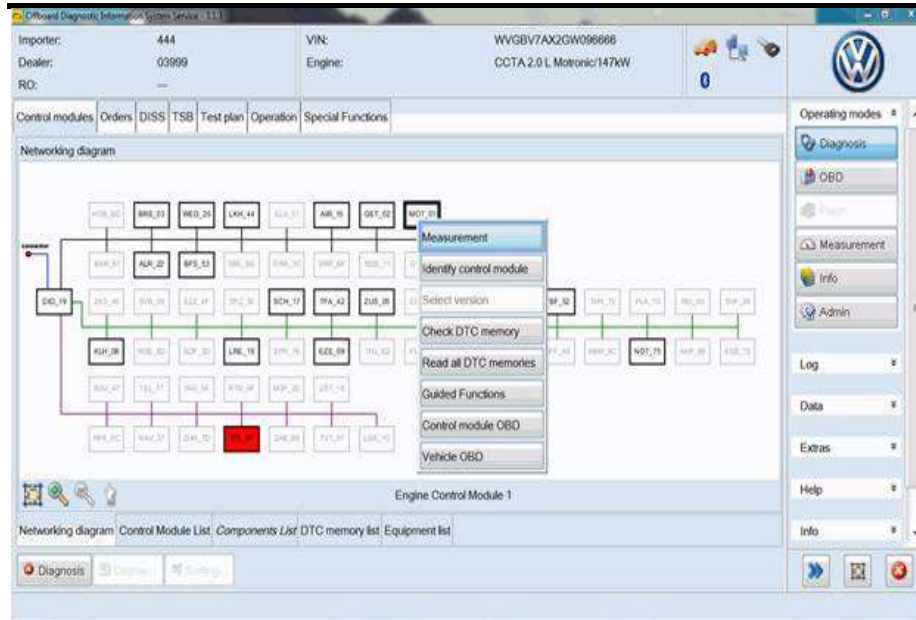
Figure 4

- Check the diagnostic limits of the flap with the ODIS tester.
- Under Motor, select Guided Functions (Figure 4).

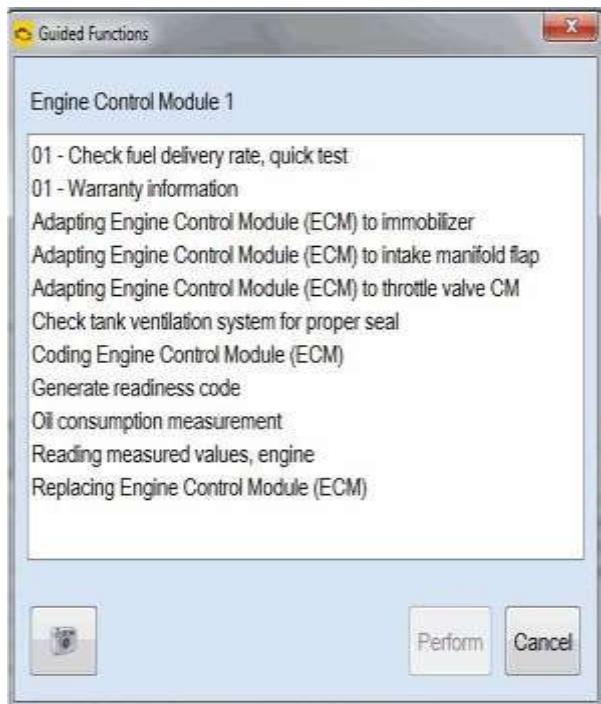
Figure 5

- Select Adapting Engine Control Module (ECM) to intake manifold flap (Figure 5).

If the adaptation is not successful, the flap stop is worn internally, the intake manifold also has to be replaced. See Repair Group 24 Multiport Fuel Injection in Elsa.
