Post Mortem Failure Assessment of MODUs During Hurricane Ivan

September 2004

Minerals Management Service

Hurricane Ivan: MODU Investigation & Recommendations Sept 2004

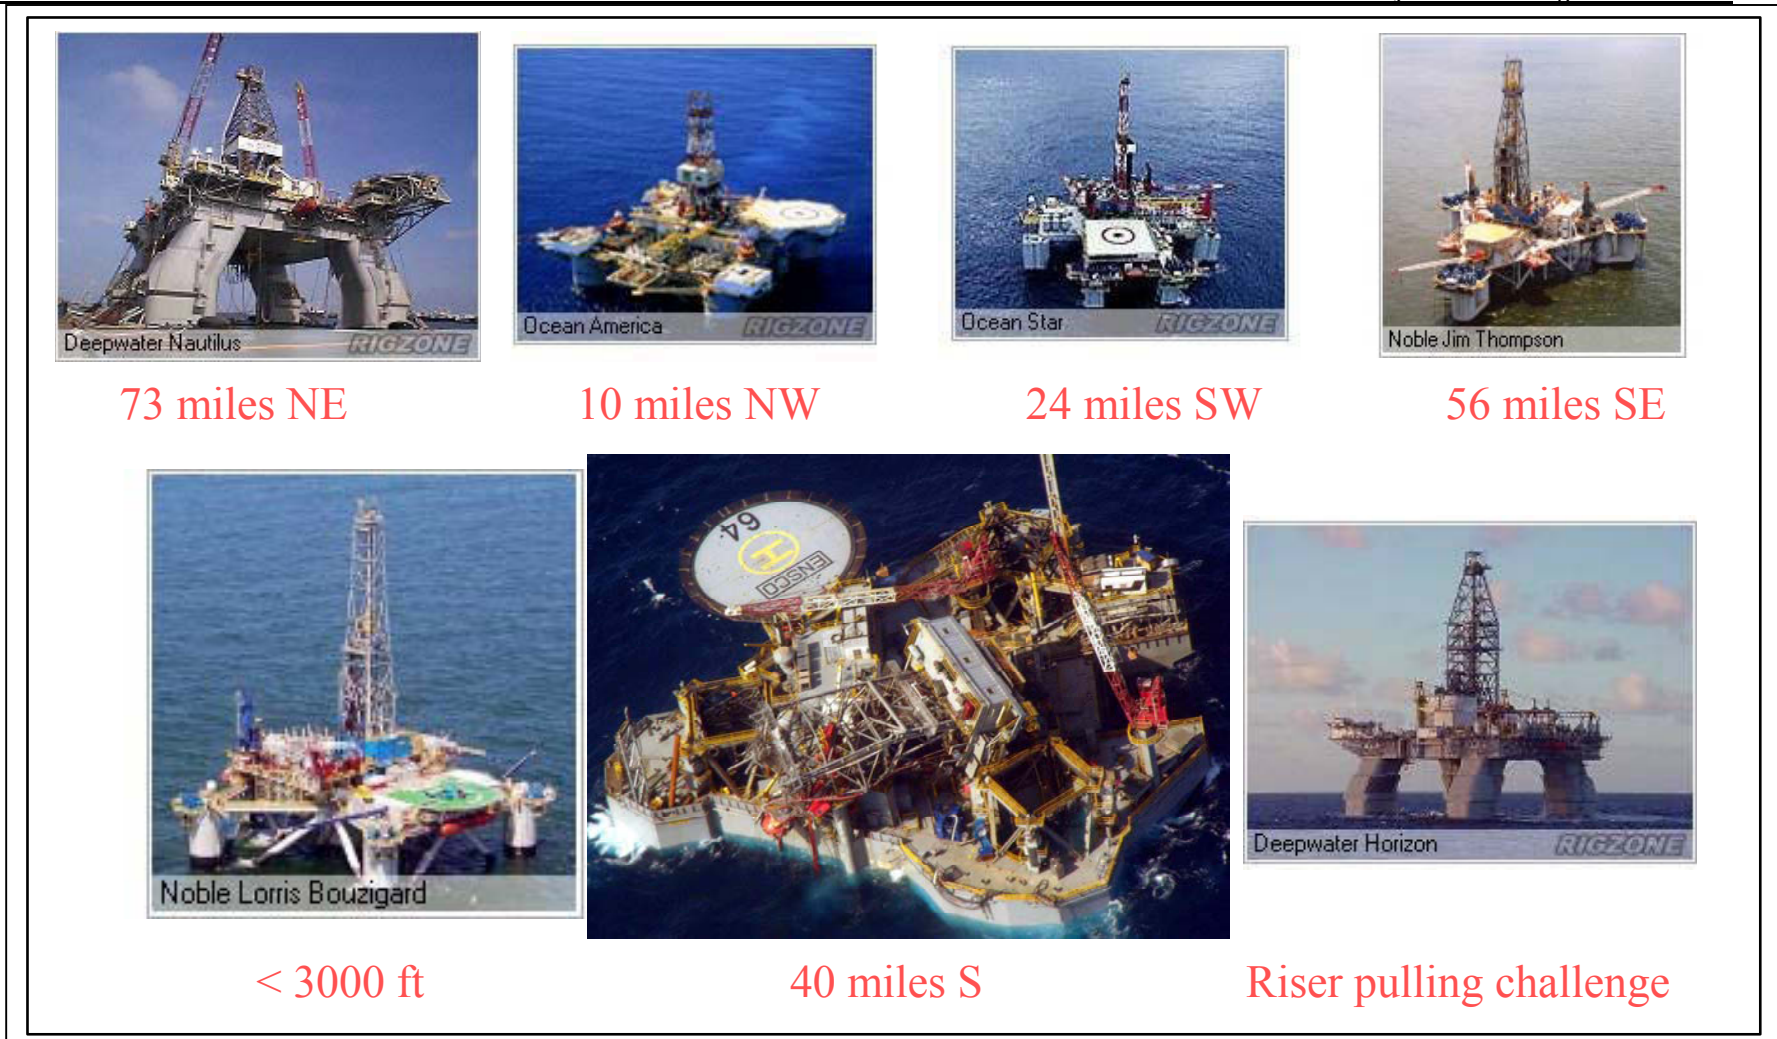
Figure 9: Hurricane Ivan MODU Mooring Issues

Figure 9 shows each of the MODUs that had stationkeeping issues. Note the Deepwater Horizon is self-propelled, and the Ensc 64 is a jackup. The other vessels depicted are semisubmersibles that are moored to their respective locations and where the moorings broke in Hurricane Ivan.

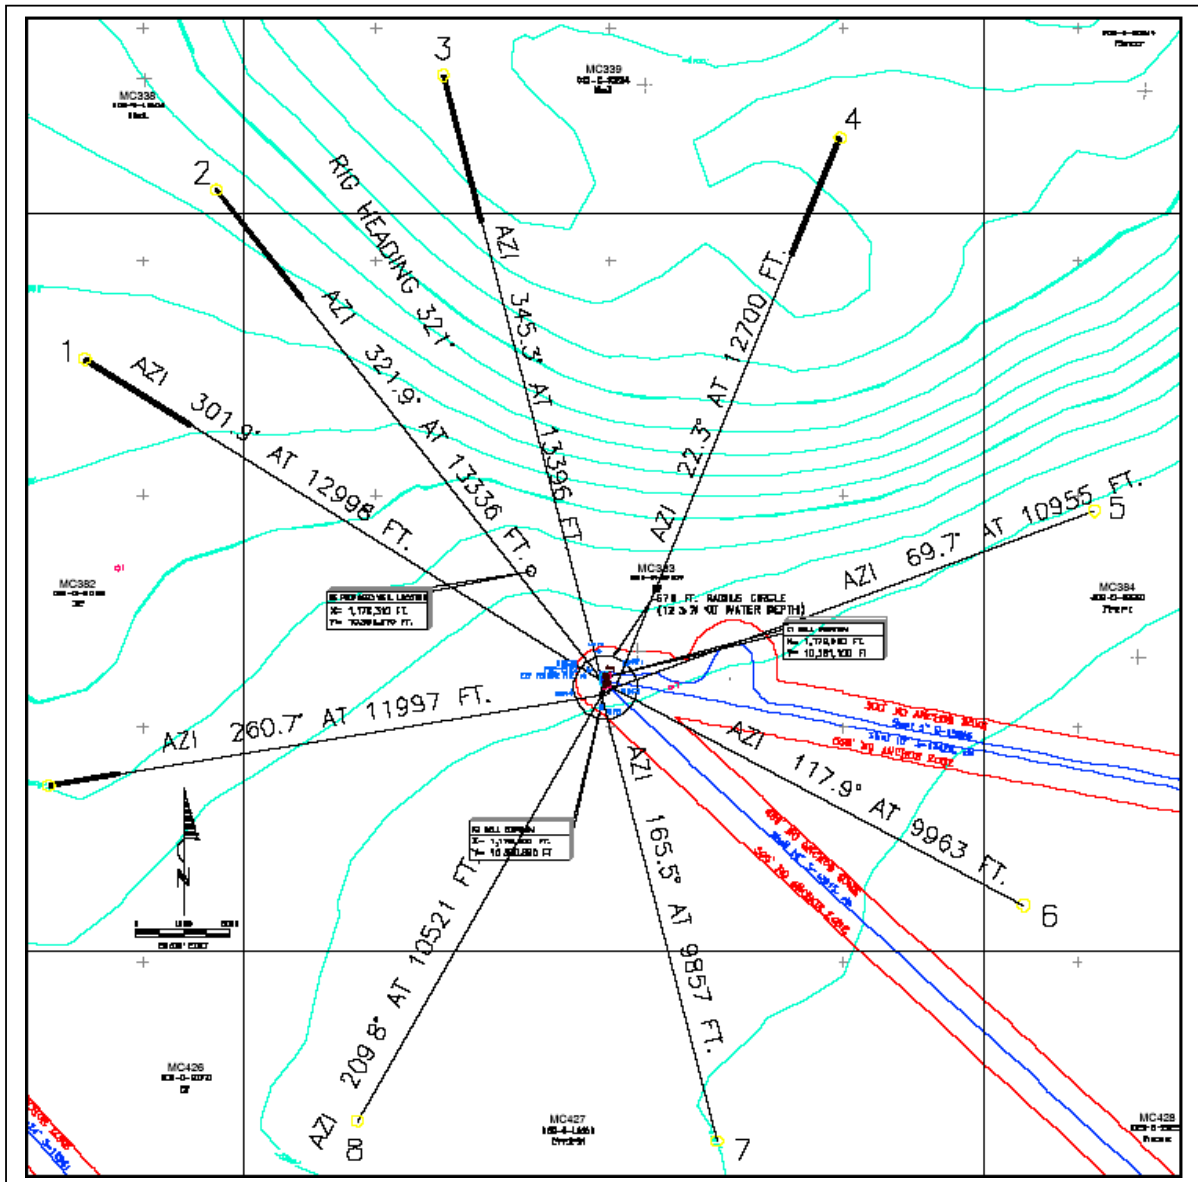
Figure 11: Noble Jim Thompson mooring pattern at MC 383

Figure 11 shows the mooring pattern at MC 383. Points of note are the pipelines. Arrangements of moorings over existing pipelines ensured that #6 would not impact if the hurricane winds came from the south. Different elevations to the north increases the complexity of the mooring design.

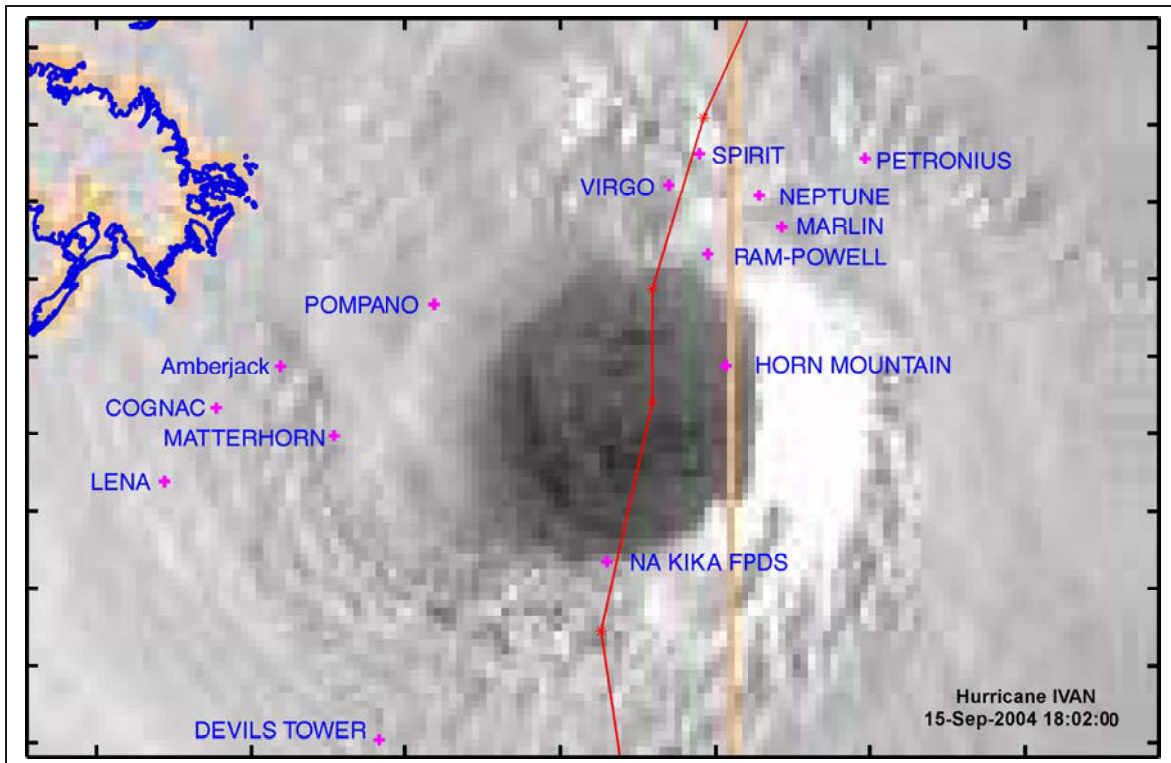
Figure 13 shows the eye of the Hurricane Ivan in relation to the Noble Jim Thompson which was working very close by to the Nakika position.

Once the 3 initial lines #5, #4 and #3 had broken the rig would have moved off location and then put a significant load out-of-plane on the padeyes of the suction piles, for which they are not traditionally designed. This would also be consistent with reported tangling of moorings around the rig after the event (Ref 22).

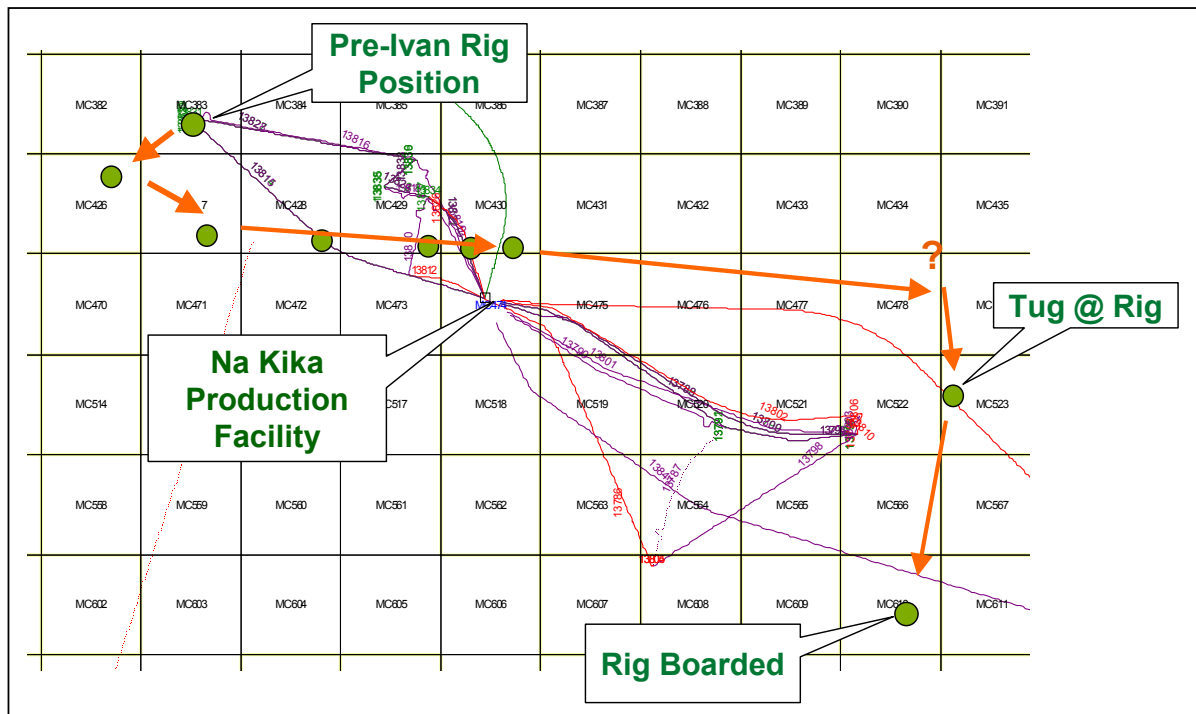
Figure 20: Possible Route of the Noble Jim Thompson after the Hurricane Broke the Moorings.

Figure 20 illustrates a possible route to that the vessel may have followed. The path was based on where mooring components were found, marks in the seafloor or from an indication where wire was drug across pipelines.

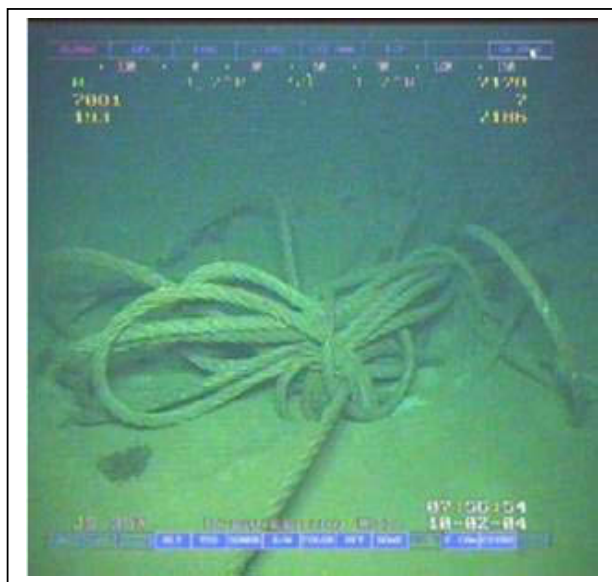
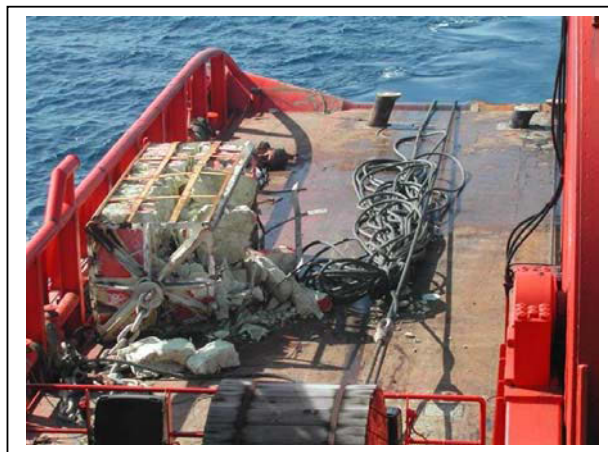
Figure 21: Photos taken during the recovery process of the wire.

All mooring lines, mooring equipment and suction piles were located with the exception of one Kenter link.

- With mooring lines tangled around the rig it is difficult to get the towline hooked up and get under tow. Hooking up towlines is more difficult if the cranes are damaged. Consideration should be given to a pre-rigged towing bridle easily deployable when necessary.
- Finding, locating and retrieving mooring lines after the incident turned out to be a chore that had to have careful planning and executing. Issues included handling knotted wires, and potential damage to ROVs and equipment, attempting to find the lines. There was also limited availability of this equipment.
- While not determined to be in any way an issue, some of the breakages remind us of how important it is to get the quality of the moorings right to ensure that when the moorings are strained, they can take their full component design load.

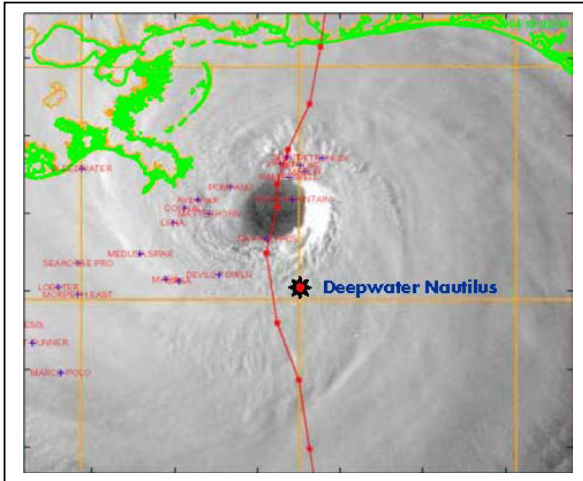
During the storm the eyewall of the hurricane passed directly over the Deepwater Nautilus with

1-min. sustained windspeeds of 111 kts gusting to 130 kts. and generating a maximum wave height of about 87 ft.

Figure 23: Deepwater Nautilus in relation to the eye of the storm and to the other significant production platforms in the area. The Nautilus was 17 miles to the east of the track in the most ferocious part of the storm.

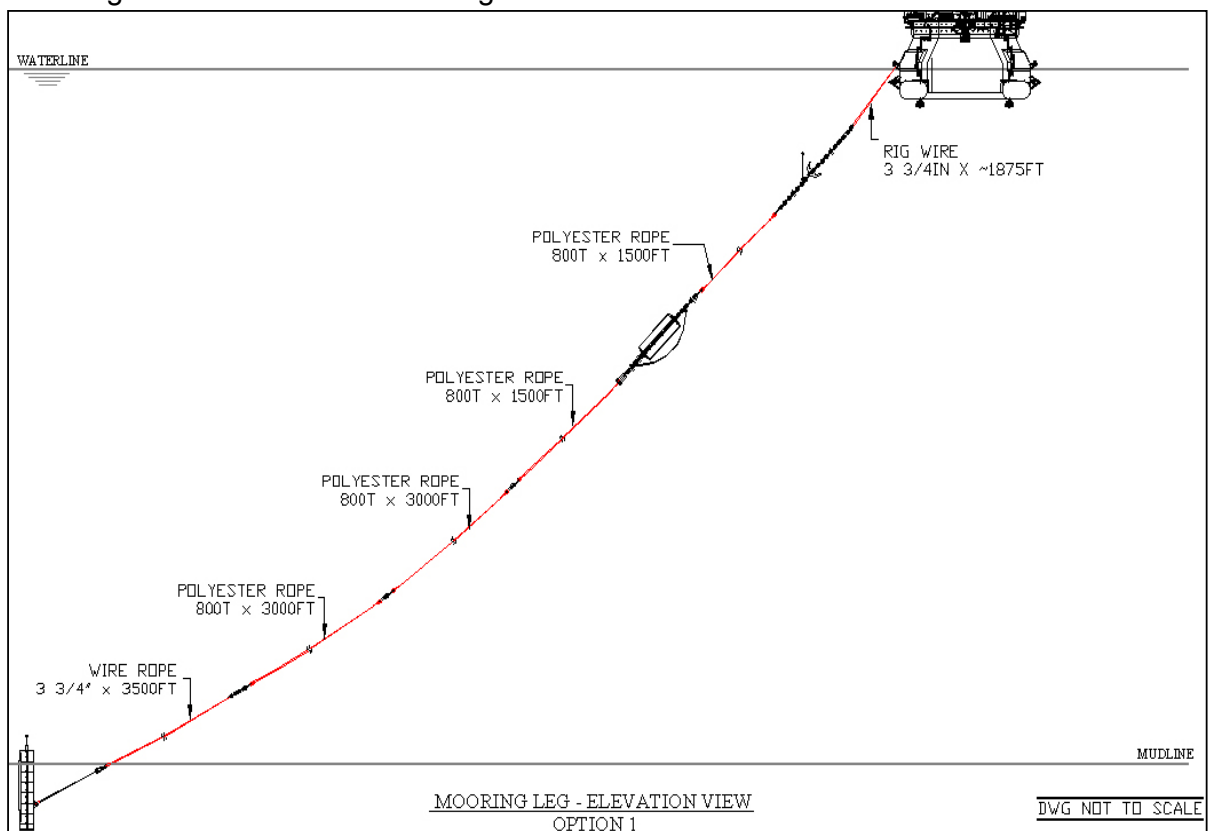
Figure 25: Mooring Line Elevation

Based on the sequence of the breaks and the direction determined by the lines on the seafloor after the incident the break must have occurred close to the time the storm center was on the same latitude as the Nautilus. A break at this time would allow the unit to move north propelled by the northerly winds on the east side of the storm.

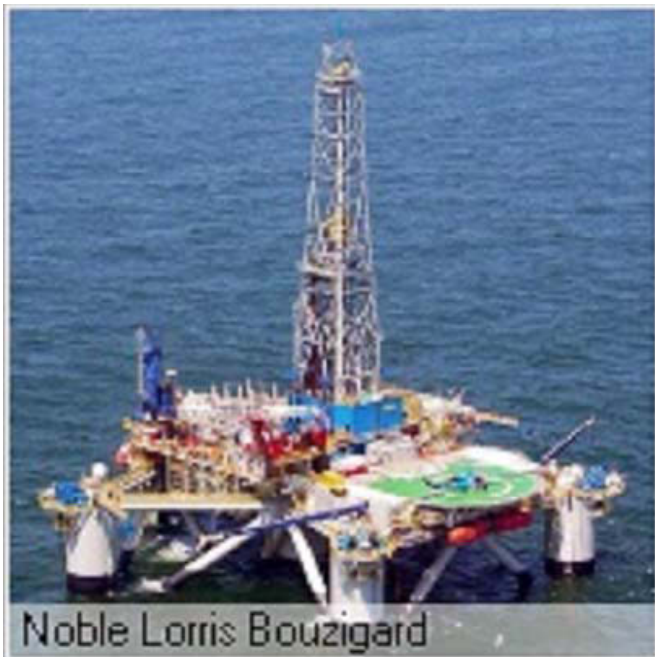
8.5 NOBLE LORRIS BOUZIGARD

It was approximately 26 miles west of the storm, however, it experienced winds, waves and currents equal to almost a 100-year event rather than the 10-year event the moorings were designed to. While the forces on the unit were substantial, it is not obvious without significant calculations, soils data and further investigation as to whether it would be expected to fail. With a wind force equal to 1.7 times that for which it was designed one would expect trouble.

Trouble came from the hurricane in the way of 6 broken mooring lines and a movement of the rig

Table 4 gives the maximum wind, waves and currents and corresponding 10-year API criteria values. The wave crest reached up to do some damage to the BOP garage, which needed extensive repairs. Other than this the unit weathered the storm well and was back at work within about 10 days after the anchors were recovered and re-deployed.

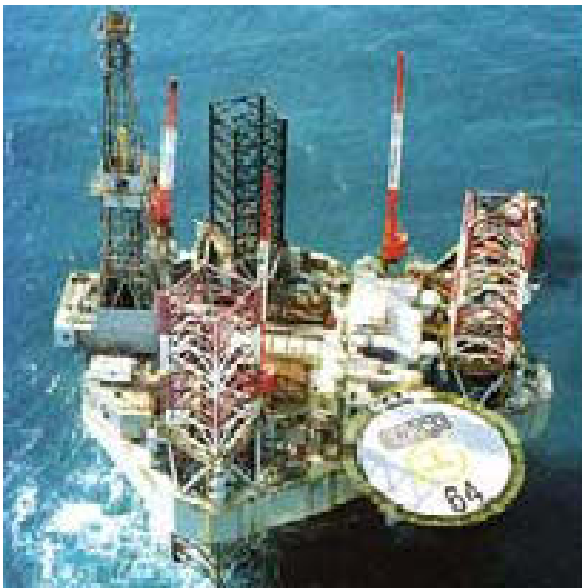
Figure 28: Ensco 64 jacked up on location

London, Sep 20 -- A press release from Ensco International Corp, dated Dallas Sep 16, states: Ensco International Inc announced today that one of the Company's jackup drilling platforms, Ensco 64 (5451 gt, built 1973, upgraded 2002) was directly in the path of hurricane "Ivan" and has sustained damage. The platform is now afloat in the U.S. Gulf of Mexico approximately 80 miles southeast of Venice, Louisiana. The platform was operating in Main Pass Block 280 for Dominion Exploration and Production Inc, and all personnel had been safely evacuated ahead of the storm. Appropriate regulatory agencies have been notified. A report of visual inspection from a fixed-wing aircraft has indicated Ensco 64 is floating approximately 40 miles south of its drilling location. Company personnel will be deployed to assess the extent of damage and determine appropriate remedial action to secure the platform as soon as practicable. The platform is insured for \$65 million. Unless the rig is declared a total loss, Ensco anticipates the cost of repairs will be recoverable in excess of policy deductibles which are limited to \$5.5 million. The Company also has received a preliminary report from a third-party of damage to the helideck on one of the Company's platform Ensco 25, which was adjacent to the path of the storm. The Company has commenced inspection and re-boarding operations of its Gulf of Mexico rig fleet and is unaware of any further damage at this time.

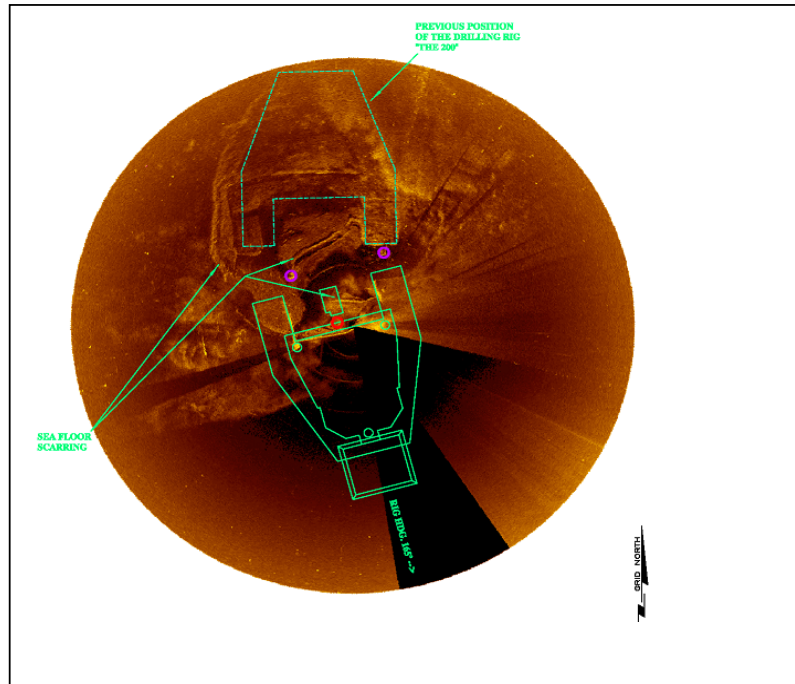
Figure 41: Fugro Chance Inc. Sonar Data on THE 200

THE 200 had no failures, and no issues resulting from a detailed structural inspection. Scour at the forward end of the mat of 6-8 ft and at the stern end of approximately 4 ft was the result of the passage of the storm causing the rig to be relocated for continuation of its work. Figure 41 shows the sonar scan of the area after the passage of the storm and lays out the position that the rig was to be moved to after the storm because of the unevenness of the soil, which had scoured under the mat. Figure 42 shows THE 200 after the storm. Note the effect of the high current on the legs of the unit.

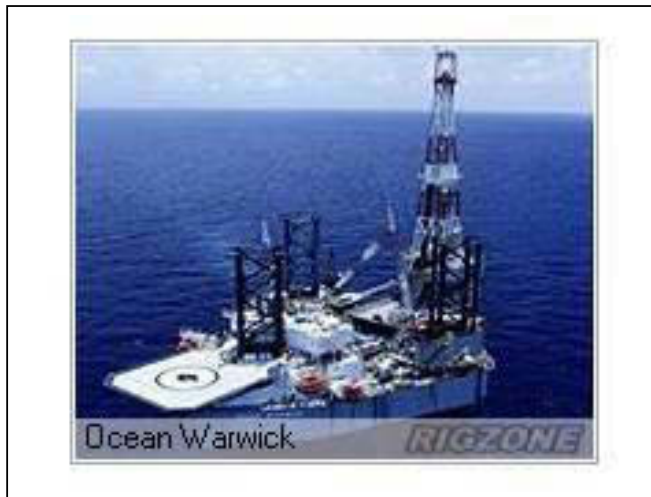
There were multimode cracks in all three legs from levels 248 ft to 296 ft. The starboard preload tank bulkhead buckled. The wellhead impaled on the hull. All three jackhouses were damaged. It would not be unusual to expect some damage to the jackhouses since this had been a chronic issue with Livingston 111 units, and thus would not be of major concern, except to say the cracks would need repairing.
