**Technical Service
Information Bulletin**

Title:
SHIFT LOCK ASSEMBLY
Models:
'01 – '02 LS 430 & '02 SC 430

ELECTRICAL
EL011-02

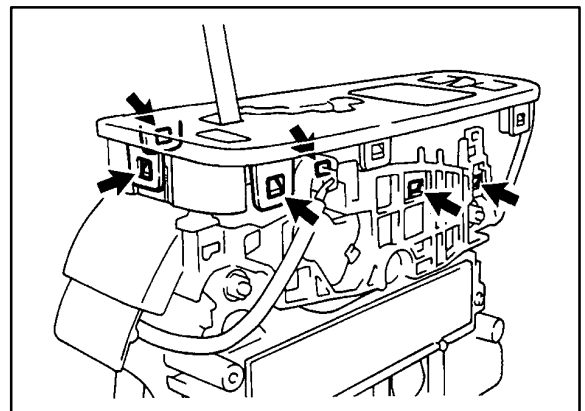
The clear plastic tabs on the front are very fragile.

3. Remove shift position indicator.
 - A. Remove shift lever knob.
 - B. Remove shift position indicator.
