**METALLURGICAL AND FAILURE ANALYSIS OF  
SWS PUMP P-7C COUPLING #6**

**Report No. F11358-R-001  
Revision 1**

**ENTERGY NUCLEAR OPERATIONS, INC.  
PALISADES NUCLEAR PLANT**

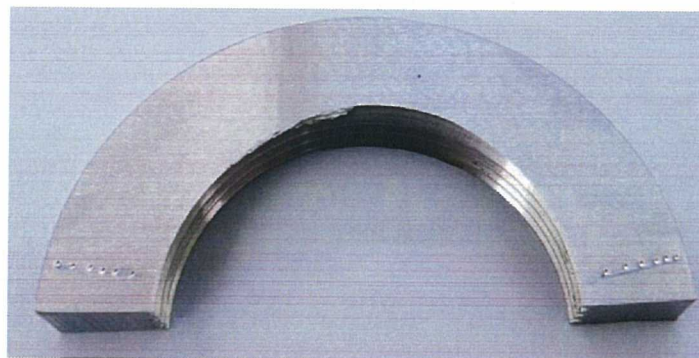
Coupling	Location	Measurements from OD to ID (R <sub>c</sub> )
11-P7C-5	1	27.2, 28.0, 28.0, 27.7, 28.0, 27.1
	2	31.5, 30.9, 30.4, 30.2, 30.2, 30.7
11-P7C-6F	1	31.5, 32.7, 32.0, 32.1, 32.2, 32.0
	2	31.5, 32.2, 31.9, 32.1, 31.5
11-P7C-7K	1	31.2, 32.0, 31.7, 31.9, 31.3, 31.8
	2	32.0, 32.0, 32.0, 31.9, 32.6, 32.0
11-P7A-5	1	33.0, 29.9, 33.2, 33.0, 33.6, 32.2
	2	32.9, 32.9, 33.0, 32.6, 32.8, 33.1
11-P7A-6	1	24.0, 24.0, 24.0, 24.0, 24.0, 24.0
	2	24.5, 24.0, 24.0, 24.0, 24.5, 24.0
11-P7A-7	1	31.0, 31.5, 31.0, 31.5, 31.0, 31.0
	2	32.0, 31.5, 32.0, 31.0, 31.0, 31.0
11-P7B-5K	1	27.0, 27.5, 27.5, 28.0, 27.9, 27.5
	2	28.5, 28.0, 28.6, 28.0, 27.7, 28.1
11-P7B-6K	1	28.8, 29.0, 29.1, 29.4, 29.8, 29.8
	2	29.2, 29.9, 30.0, 30.0, 30.1, 30.2
11-P7B-7K	1	28.2, 28.0, 27.9, 27.9, 28.0, 28.5
	2	28.1, 28.8, 28.7, 28.5, 28.4, 28.6
09-P7C-6F	(a)	34.8, 35.9, 35.2, 36.0, 36.3, 36.8, 37.1

Notes: (a) Hardness measurements on 09-P7C-6F were taken at the mid-wall along the length of the coupling from the center to the end of the coupling.

Sample through thickness hardness test specimen.

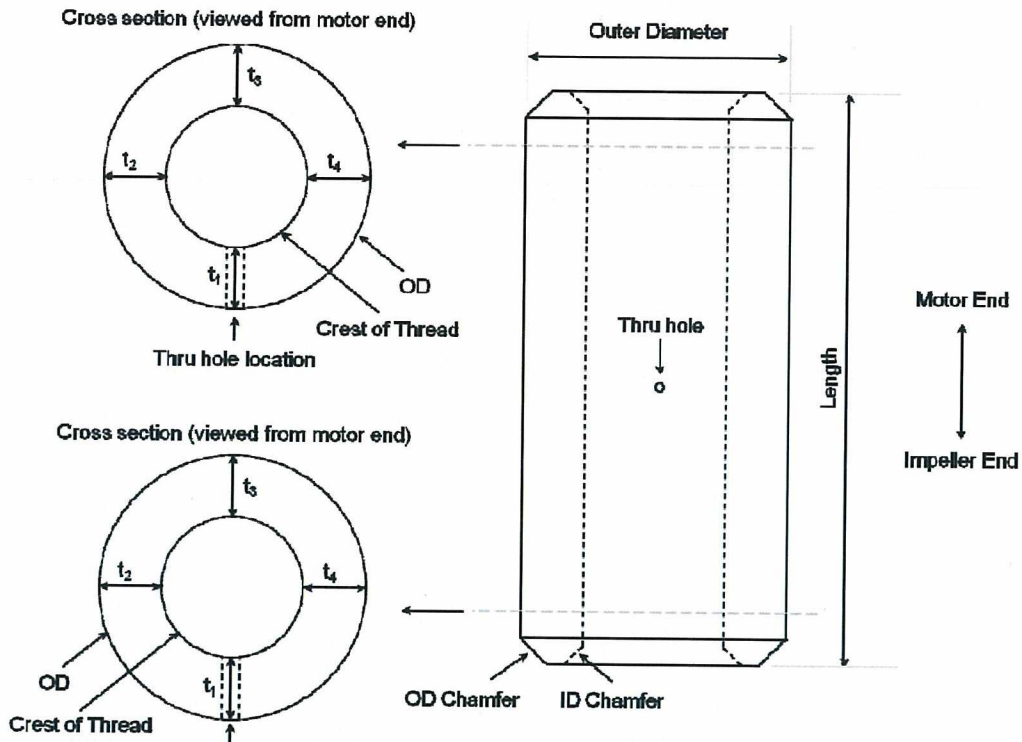
Figure 3-4: Coupling Dimensioning Scheme

The dimensioning scheme is shown in Figure 3-4. All intact couplings (i.e. those that did not fail) were found to have outside dimensions within the specified dimensions and tolerances of HydroAire drawing 1047237 [20].
