NINE MILE POINT NUCLEAR STATION UNIT 2

PROCEDURE NO. N2-RAP-6

POST REACTOR SCRAM ANALYSIS AND EVALUATION

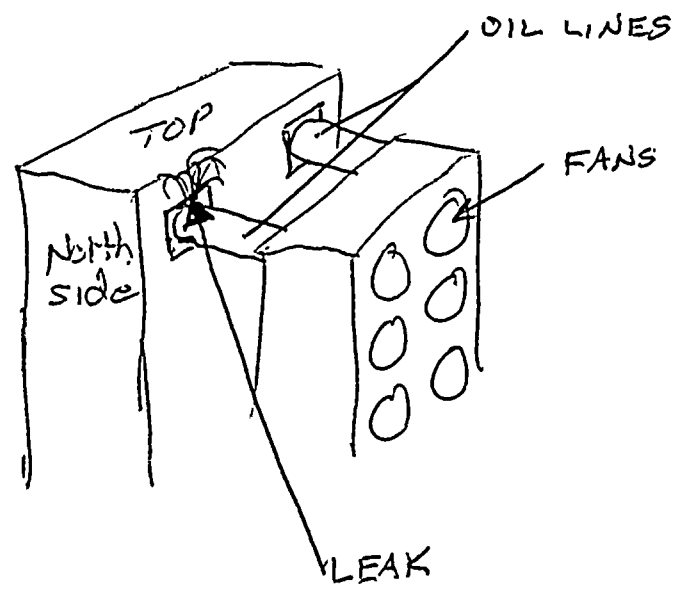
Mr Xfmr 1B noticed oil on wall, verified leak on Xfmr, placed fan/pumps switches in off.

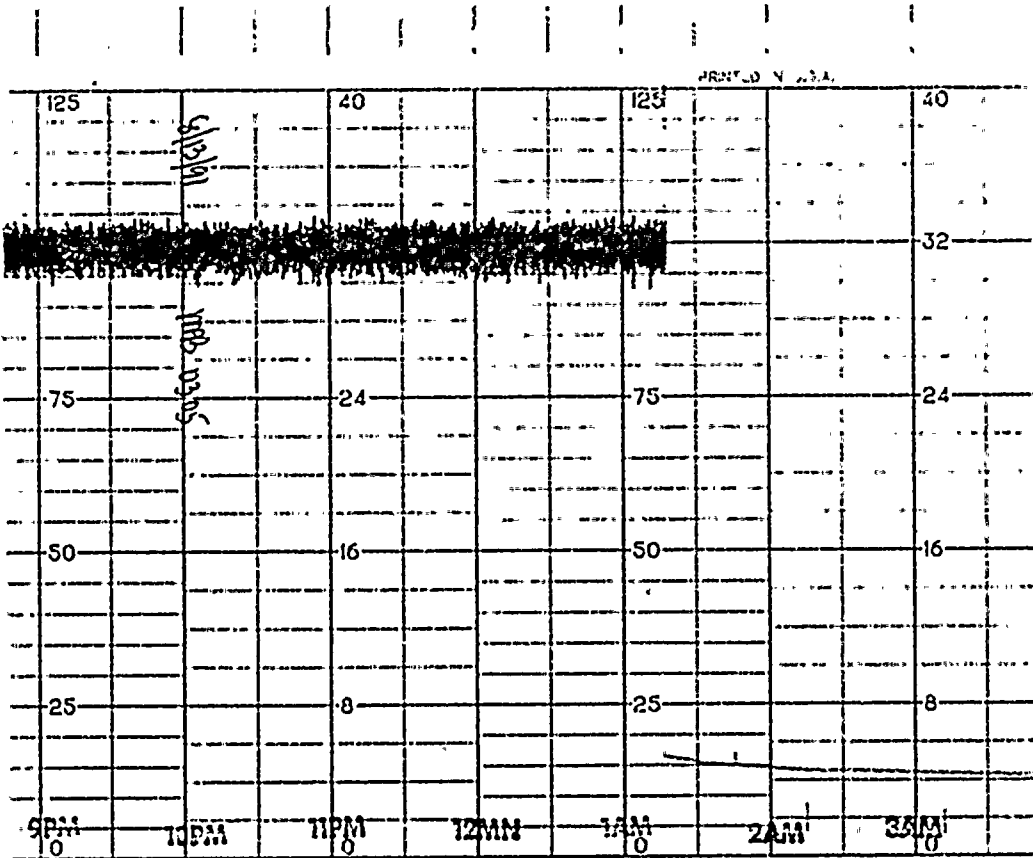
APRM CHANNEL 'E'
 RCR CSI-R603C

• Highest Power level attained:
* (NSS Post Trip Log) 125%[±] APRM Recorder (PNL 603)
* GETARS (Channel E)
± APRM recorders failed as-is, spike due to repowering recorder
Explain if highest reading wasn't from APRM's.

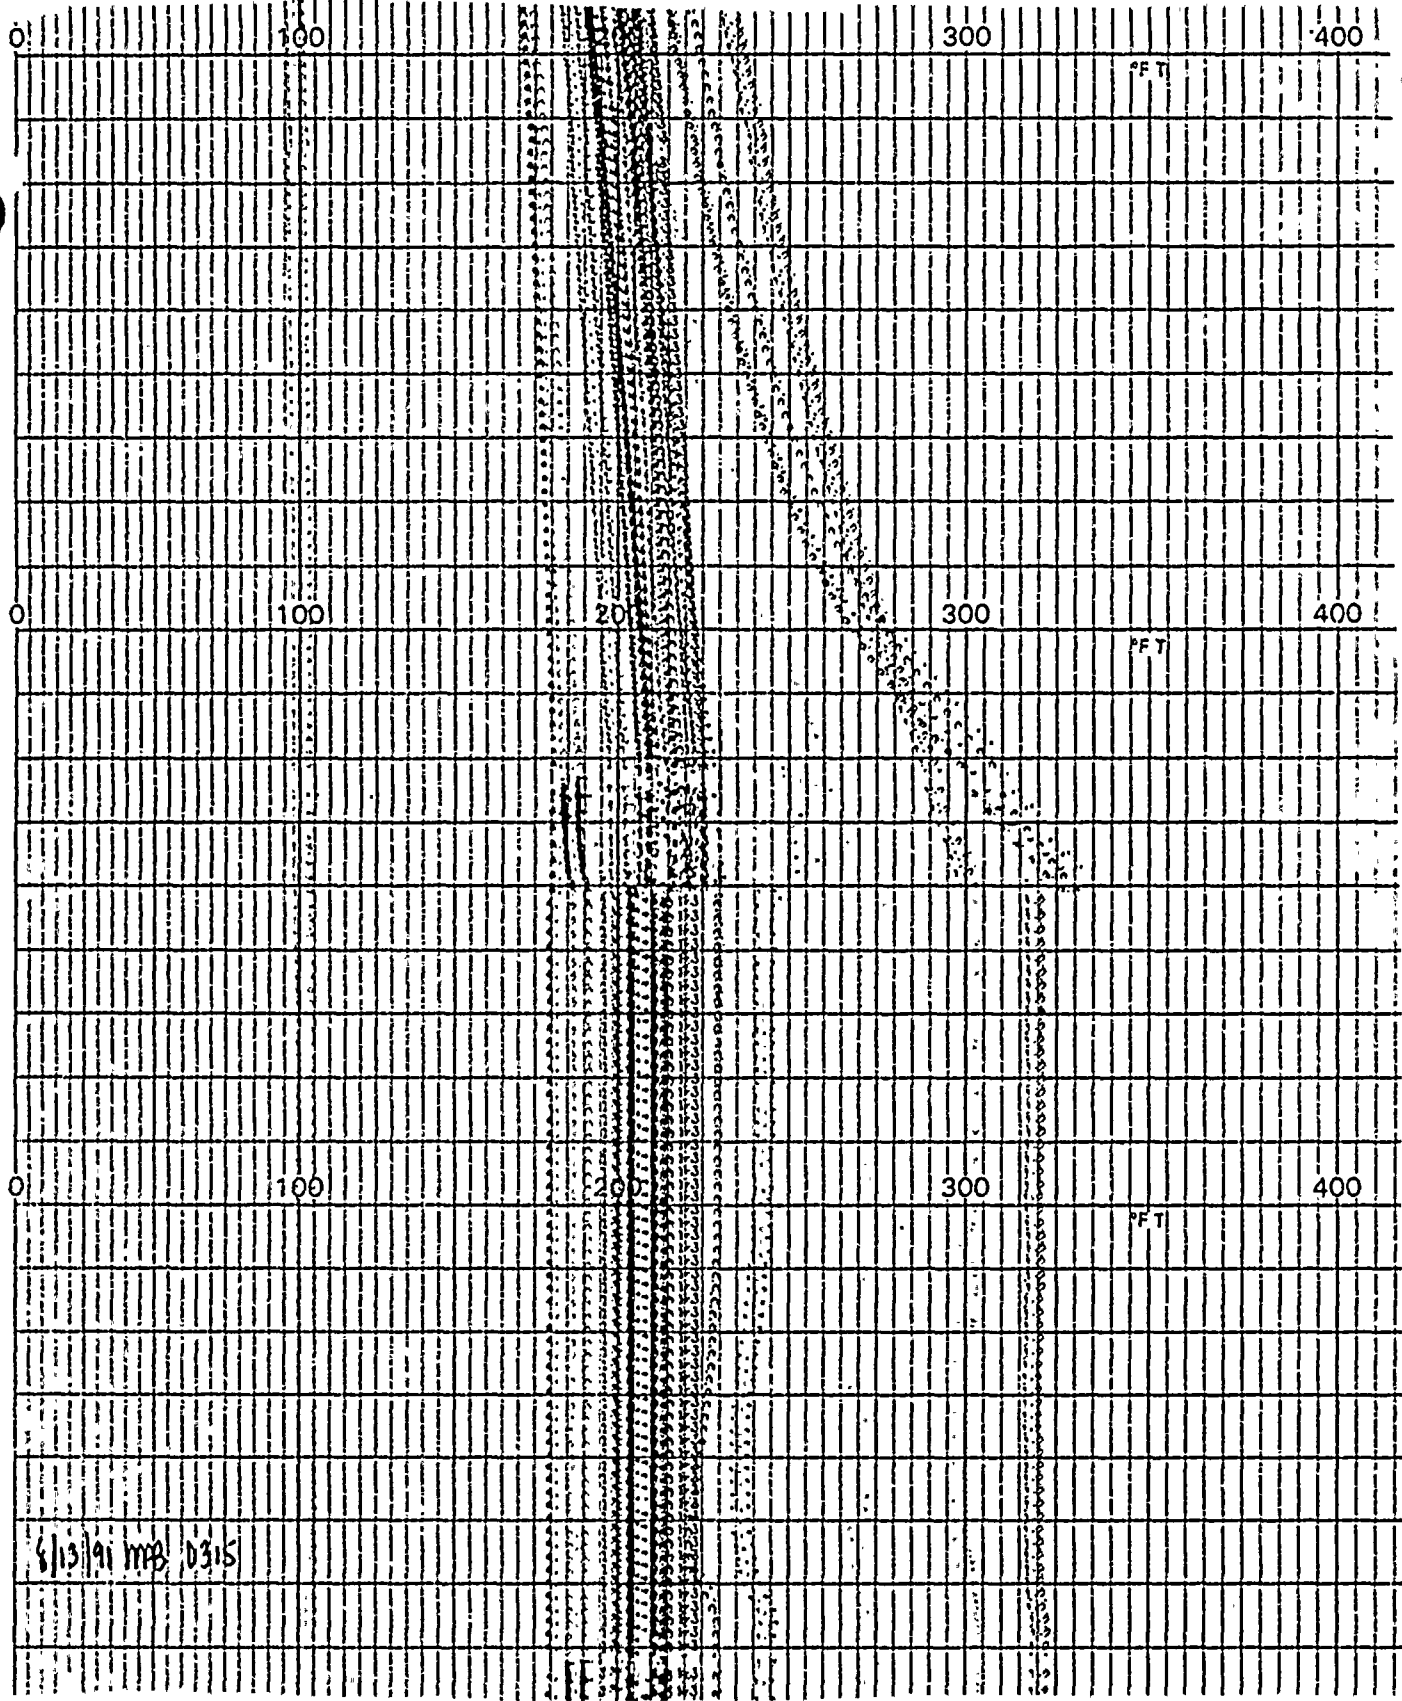
STEAM RELIEF VALVES

TRACE 8 → PSV 133
 TRACE 9 → PSV 128 } SET POINT 1076 PSIG

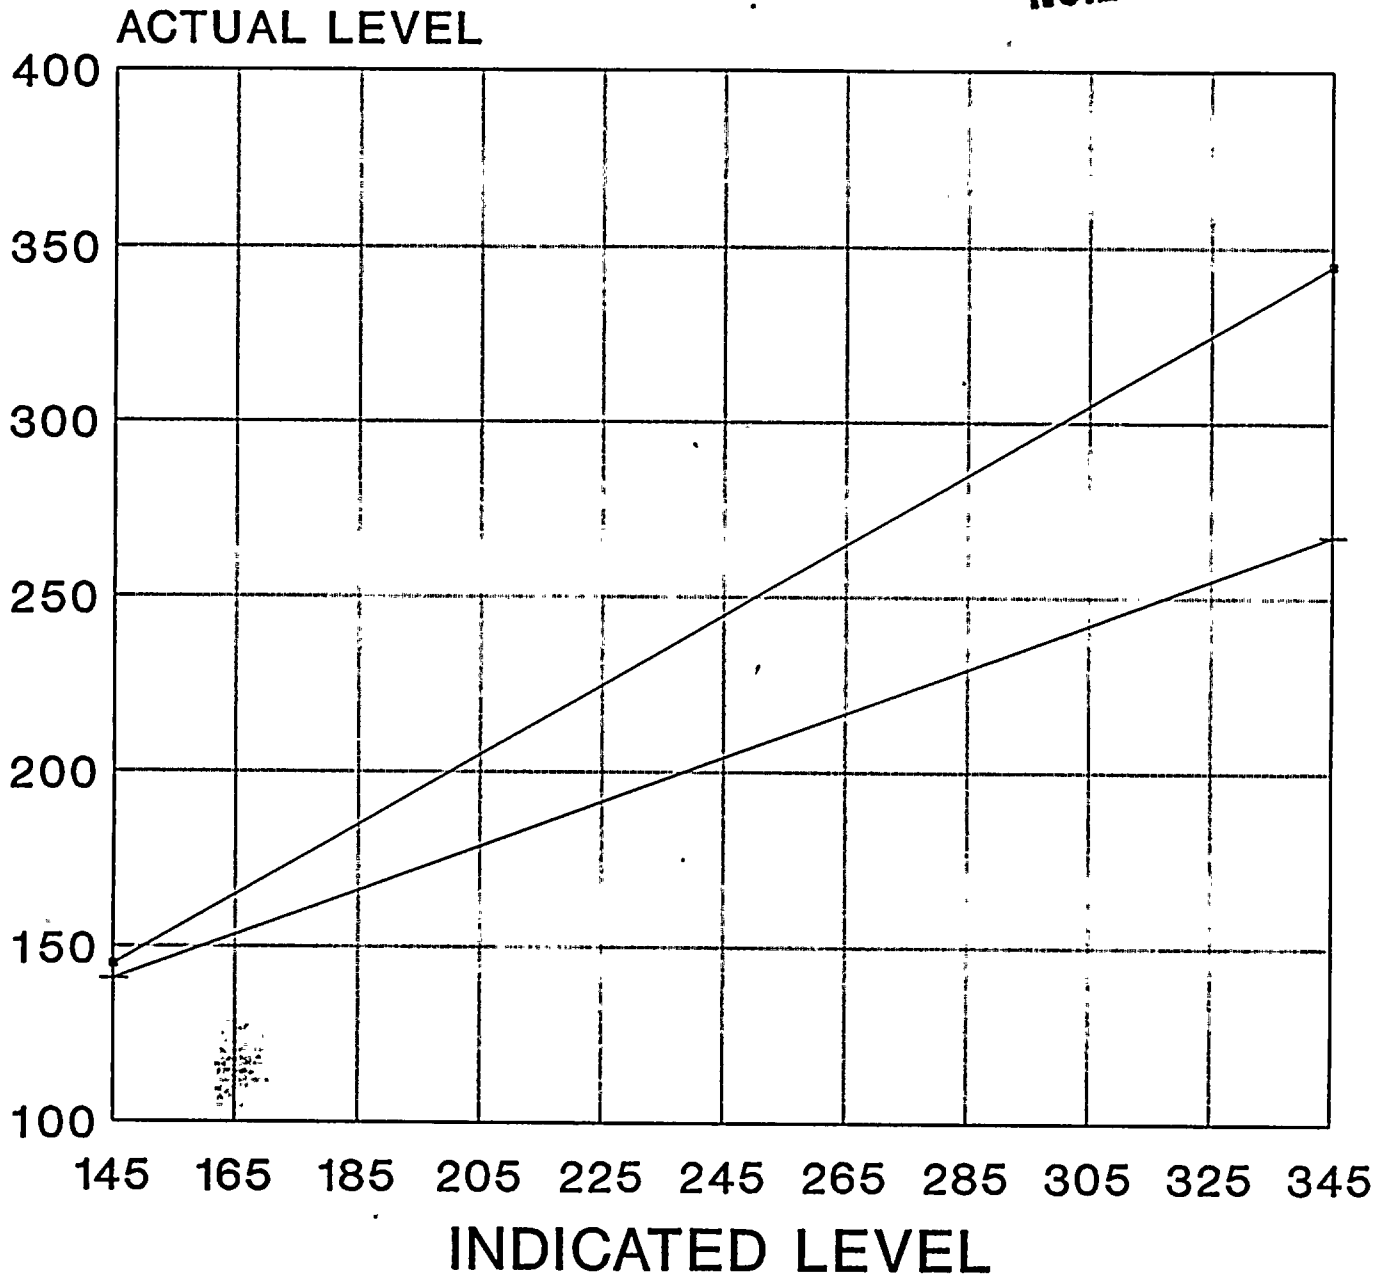
Indication error based upon Rx Vessel WTR Temp

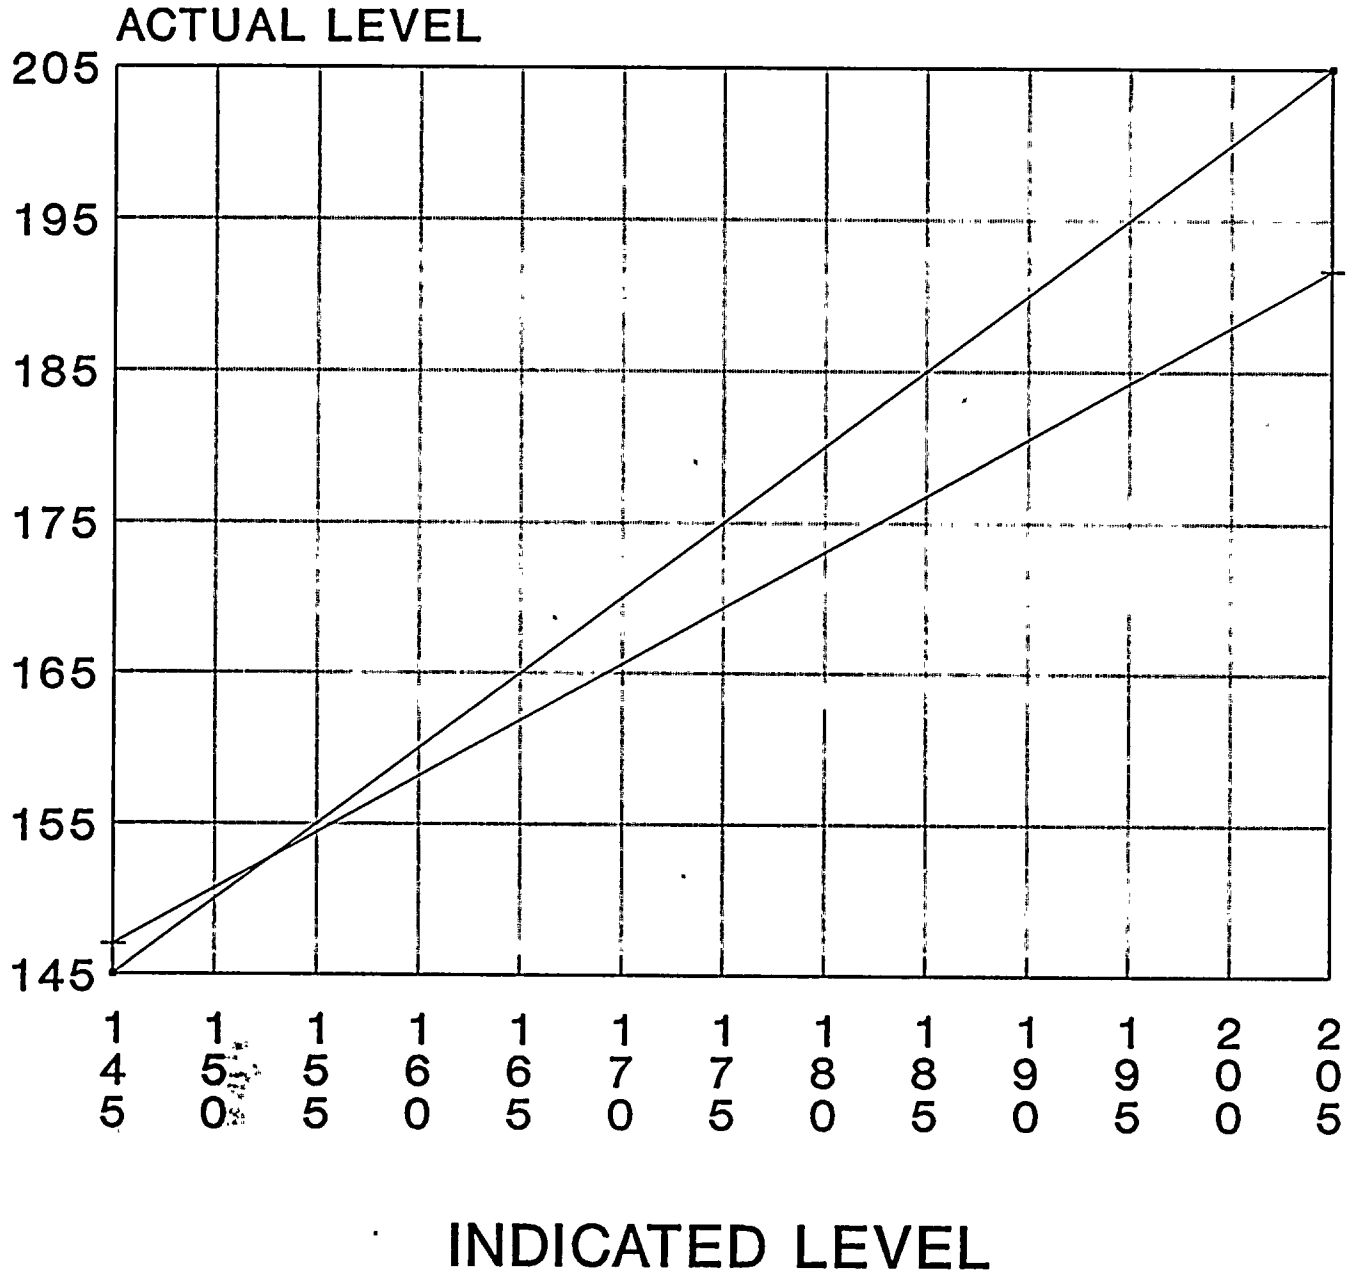
Rx WATER LEVEL NARROW RANGE

Indicator error based upon Rx Vessel Water Temp

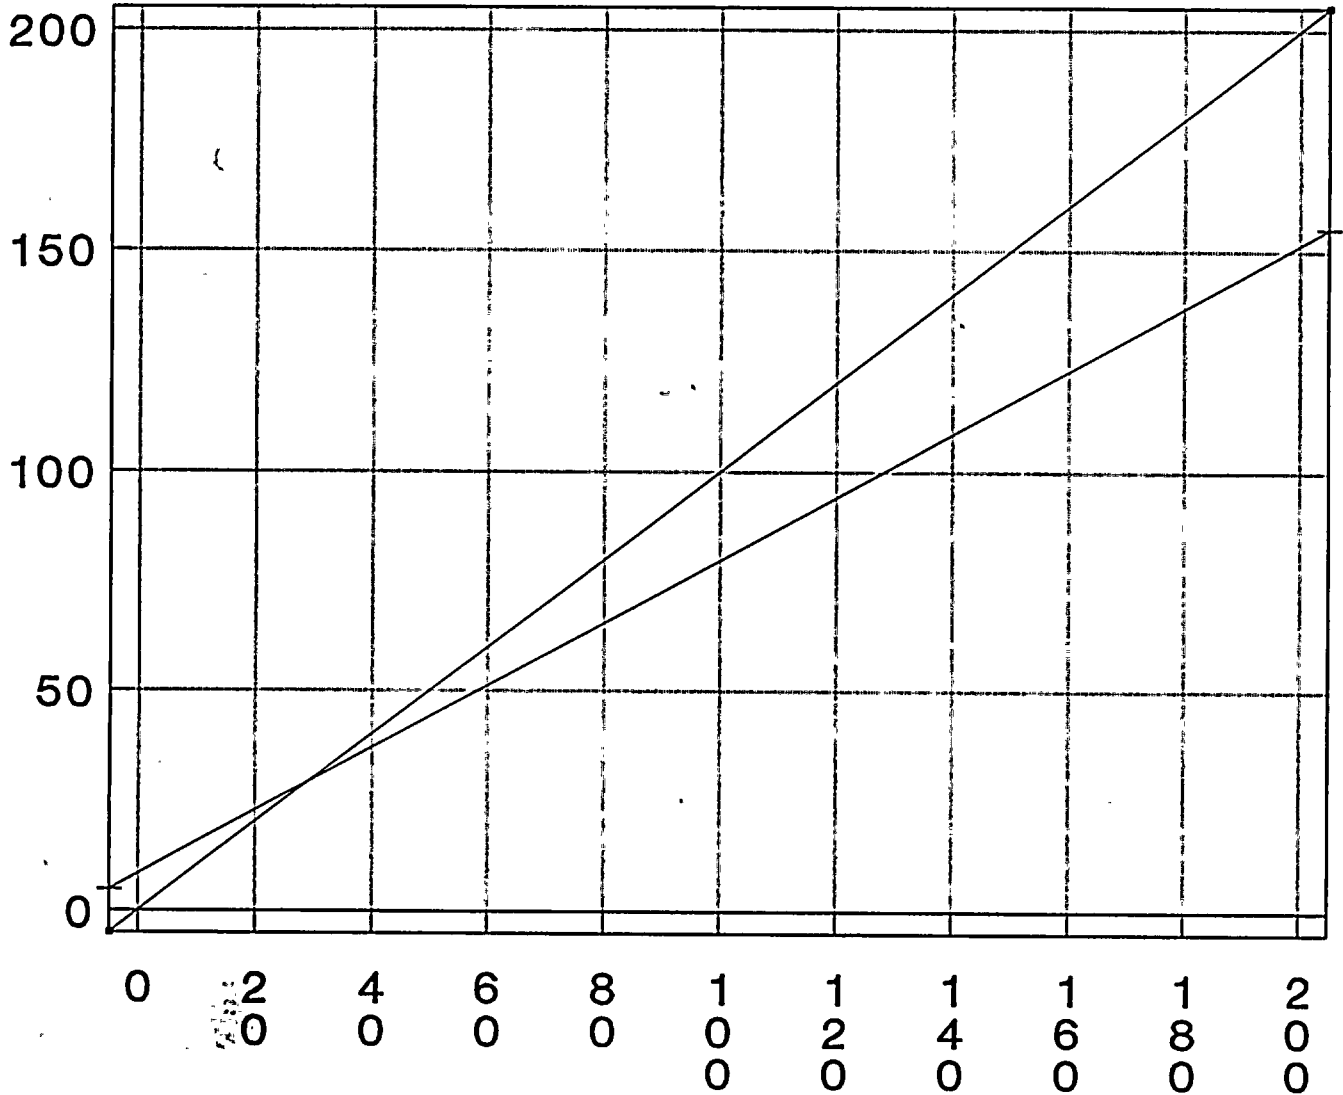
Indication error based upon Rx Vessel Water Temp

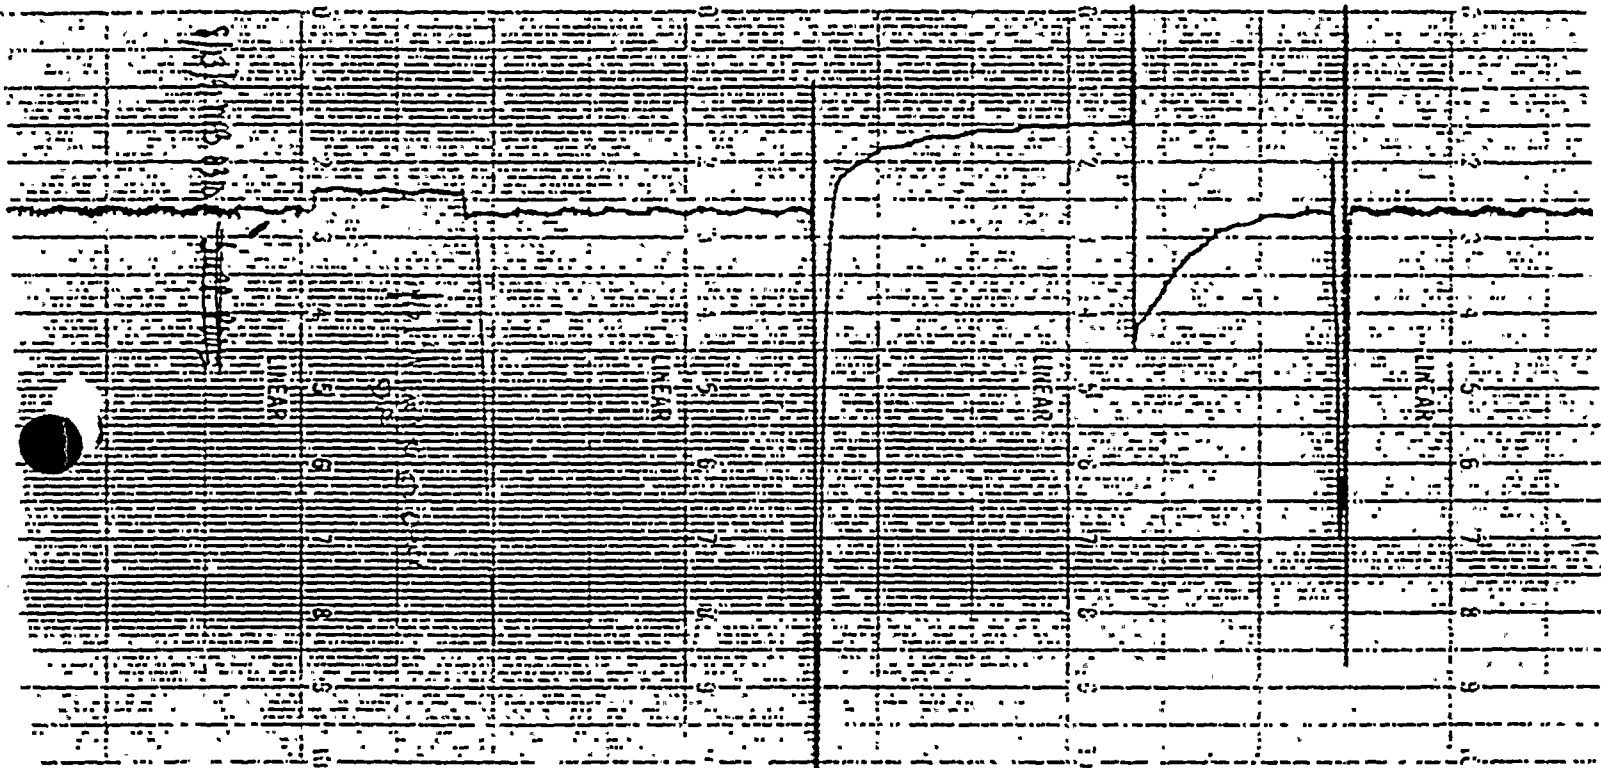
ZCMS*ART1B CONTAINMENT OXYGEN CONCENTRA

DURING PLANT TRANSIENT ON 8/13/91 DIV II PUMP TRIPPED (2CMS*P2B) FOR NO OBVIOUS REASON. ALL OTHER DIV II SOV'S WERE FOUND IN THEIR NORMAL POSITIONS. DETERMINE CAUSE OF PUMP TRIP AND CORRECT IF REQUIRED.

05:48
TRANSIENT
PUMP TRIPS

~ 07:30
PUMP
MANUALLY
RESTARTED
(ZCMS*P2B)

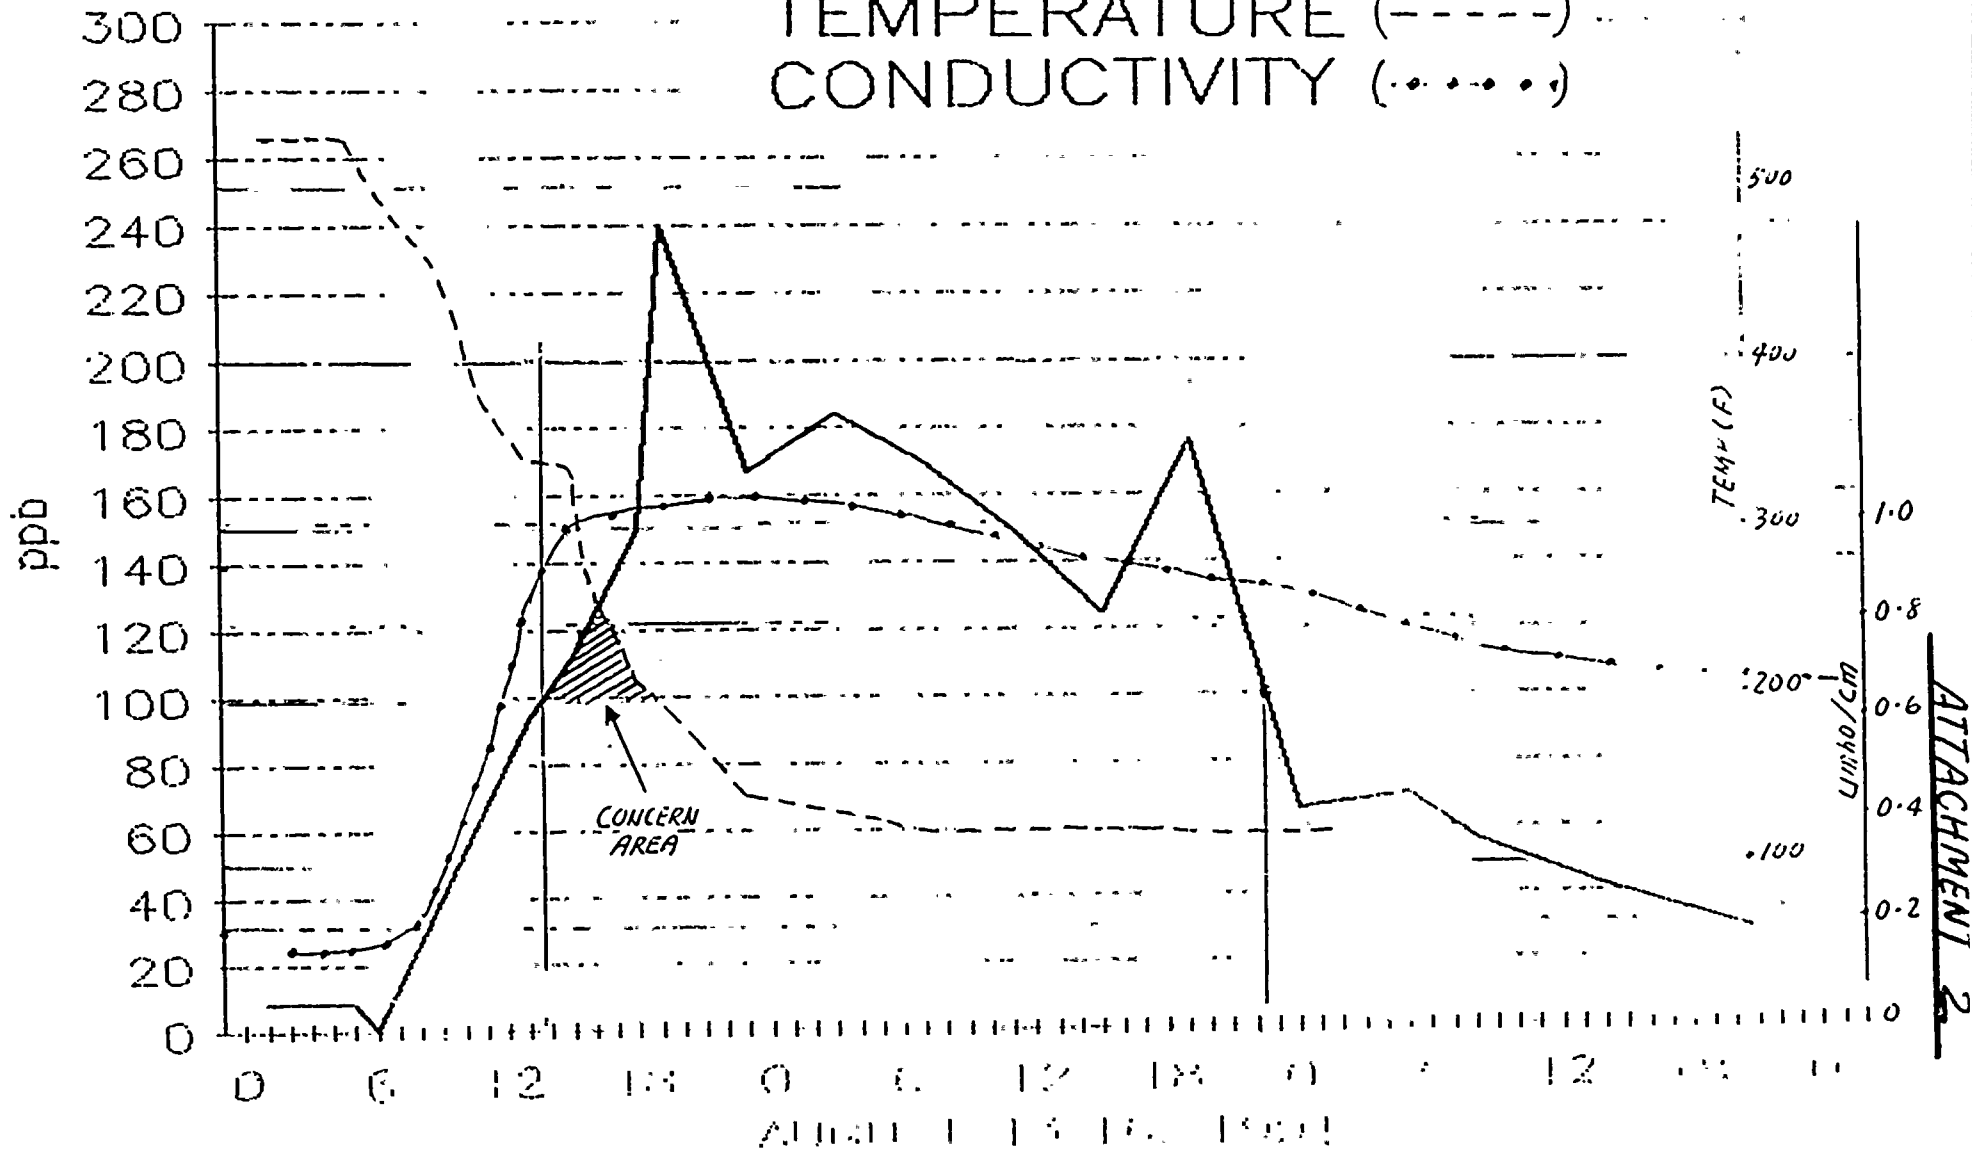
NMP-2 REACTOR WATER

3. According to technical specification, the temperature of reactor coolant below 200°F is defined as cold shutdown mode. Review of those plots of pertinent plant parameters reveals that the majority of the transient duration of sulfate (see Attachment 2) occurred while the plant was in cold shutdown (ie., over 90%). In EPRI's Water Chemistry Guideline, no action level is available for sulfate during cold shutdown; however, sulfate must be below 100 ppb before proceeding to startup.

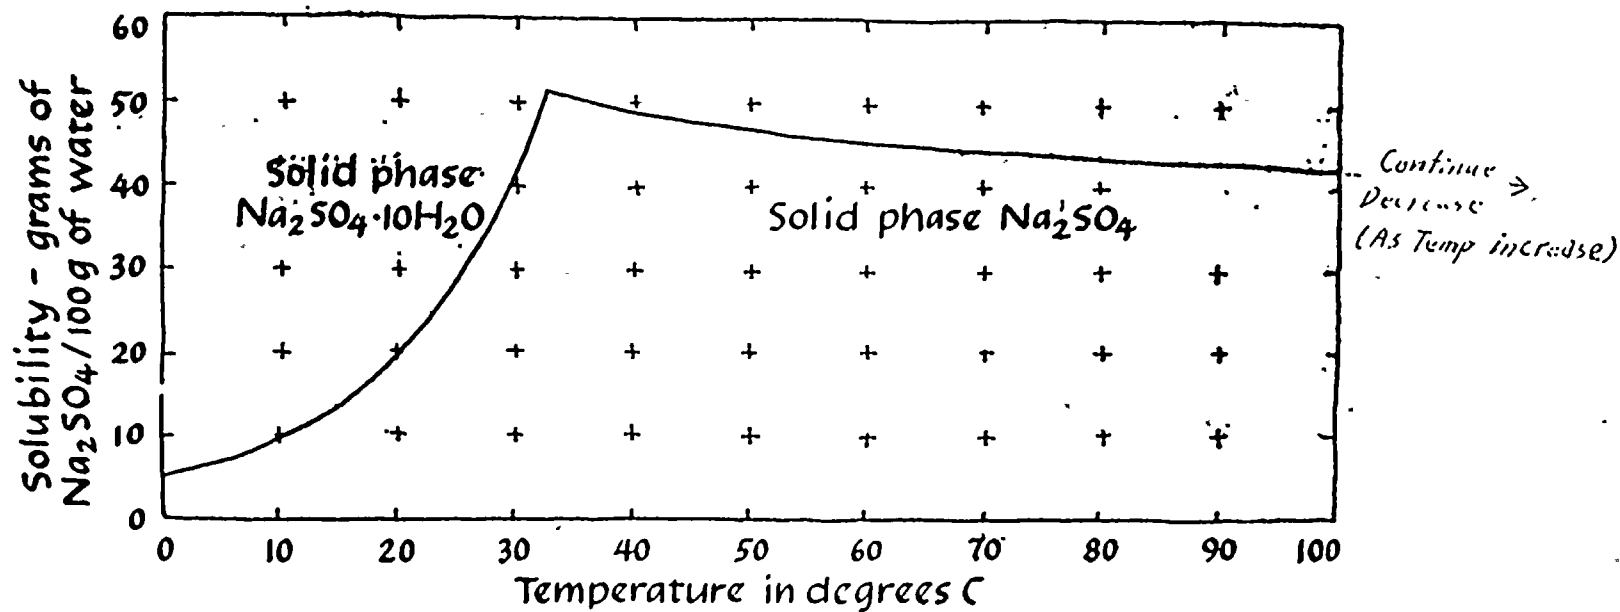
Solubility of sodium sulfate in water.

3. A plausible explanation for the source of sulfate is that during operation resin fines get into reactor water and decompose to form sodium sulfate (the sodium may come from demineralizer leakage or corrosion products). The solubility of hydrated sodium sulfate increases very rapidly with increasing temperature. When the temperature reaches around 80°F, the stable solid phase becomes Na_2SO_4 , the interesting case is that the solubility of this phase turns to decrease with increasing temperature (see Attachment 4). The concentration of sulfate in the water during operation is small (10-20 ppb), but due to the heat flux and boiling on the fuel rods, the sodium sulfate may become concentrated on the fuel rods and stays on the fuel surface until shutdown operation, and is then released to the water, showing up as a spike in conductivity because the solubility increases as temperature decreases.

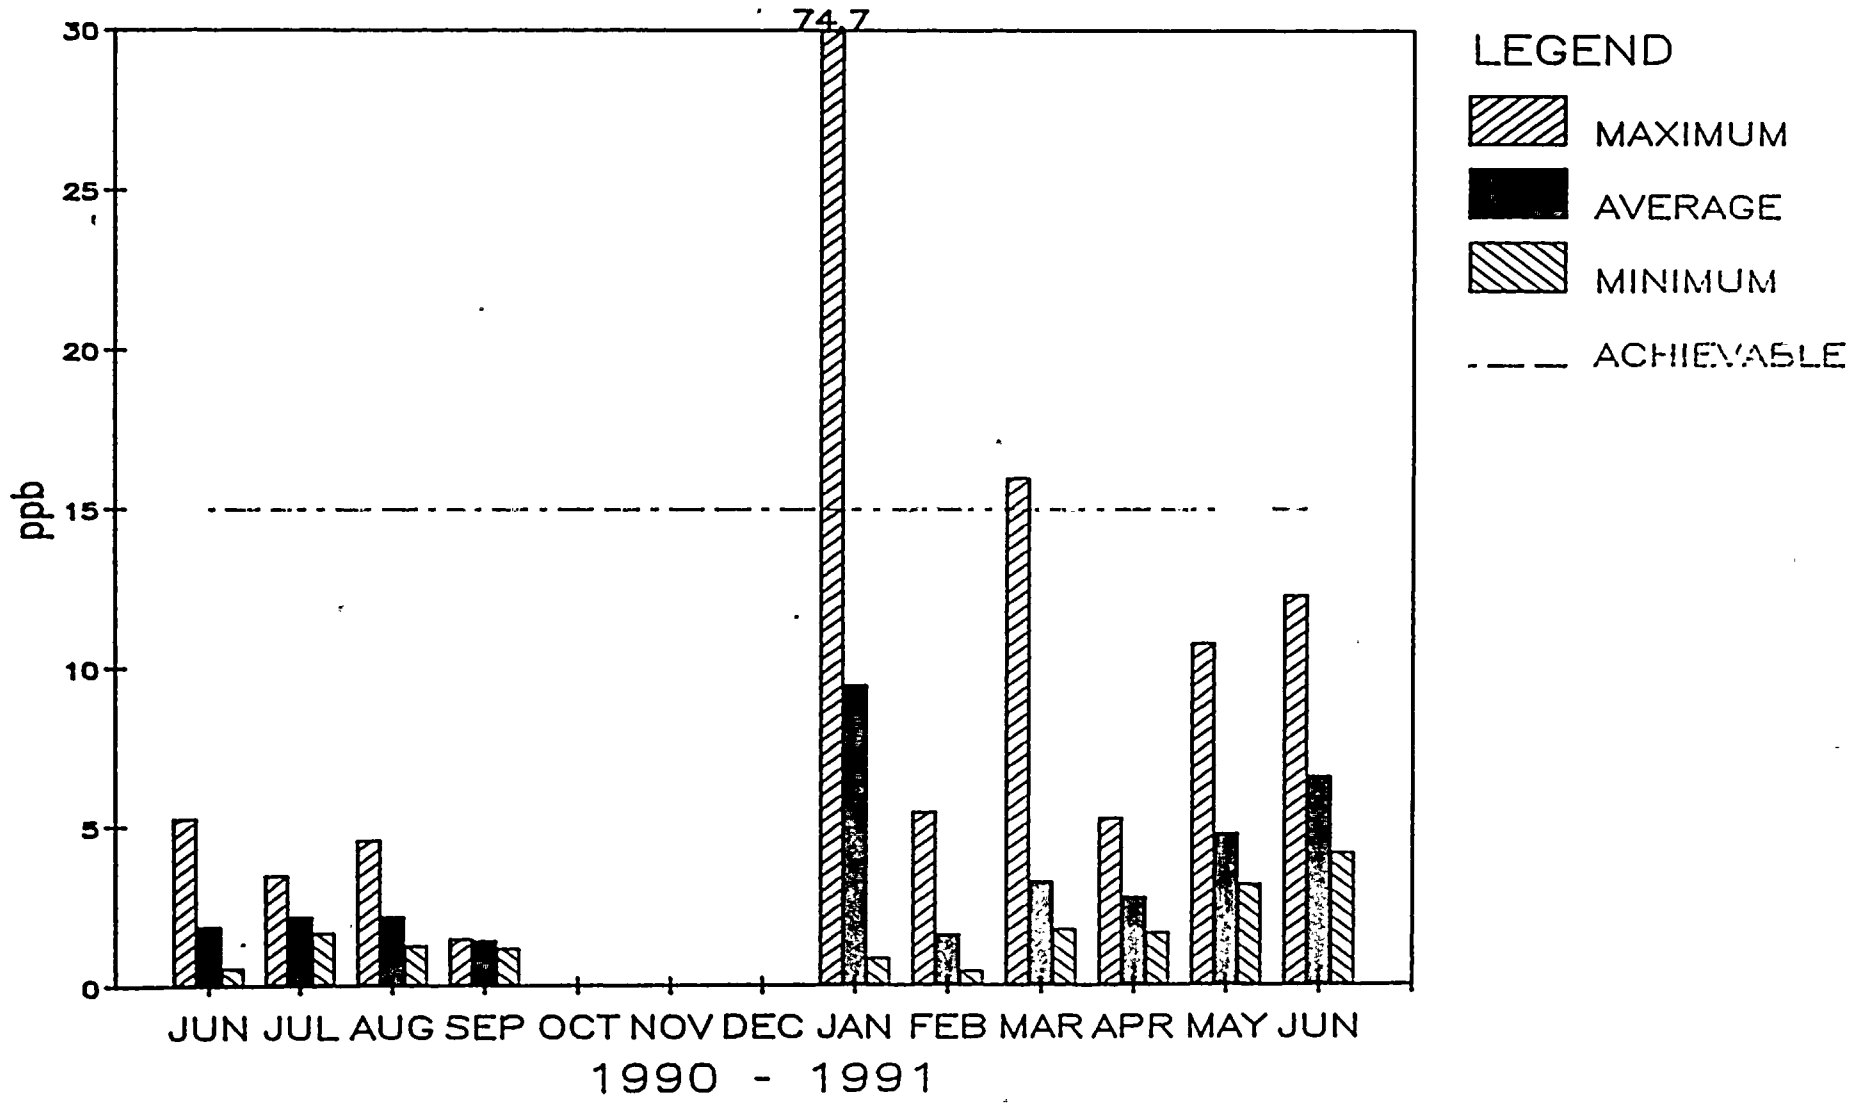
UNIT 2 REACTOR WATER SULFATE

Additionally, past resin intrusions and reactor coolant sulfate excursions have occurred and resin breakdown has been implicated as a source of sulfate (see Internal Correspondence File Code SM-HP91-0033). Following the NMP-2 return to service on April 12, 1991, and to present, the reactor coolant sulfate concentration was higher than that found in previous operational periods (see Attachment 1).

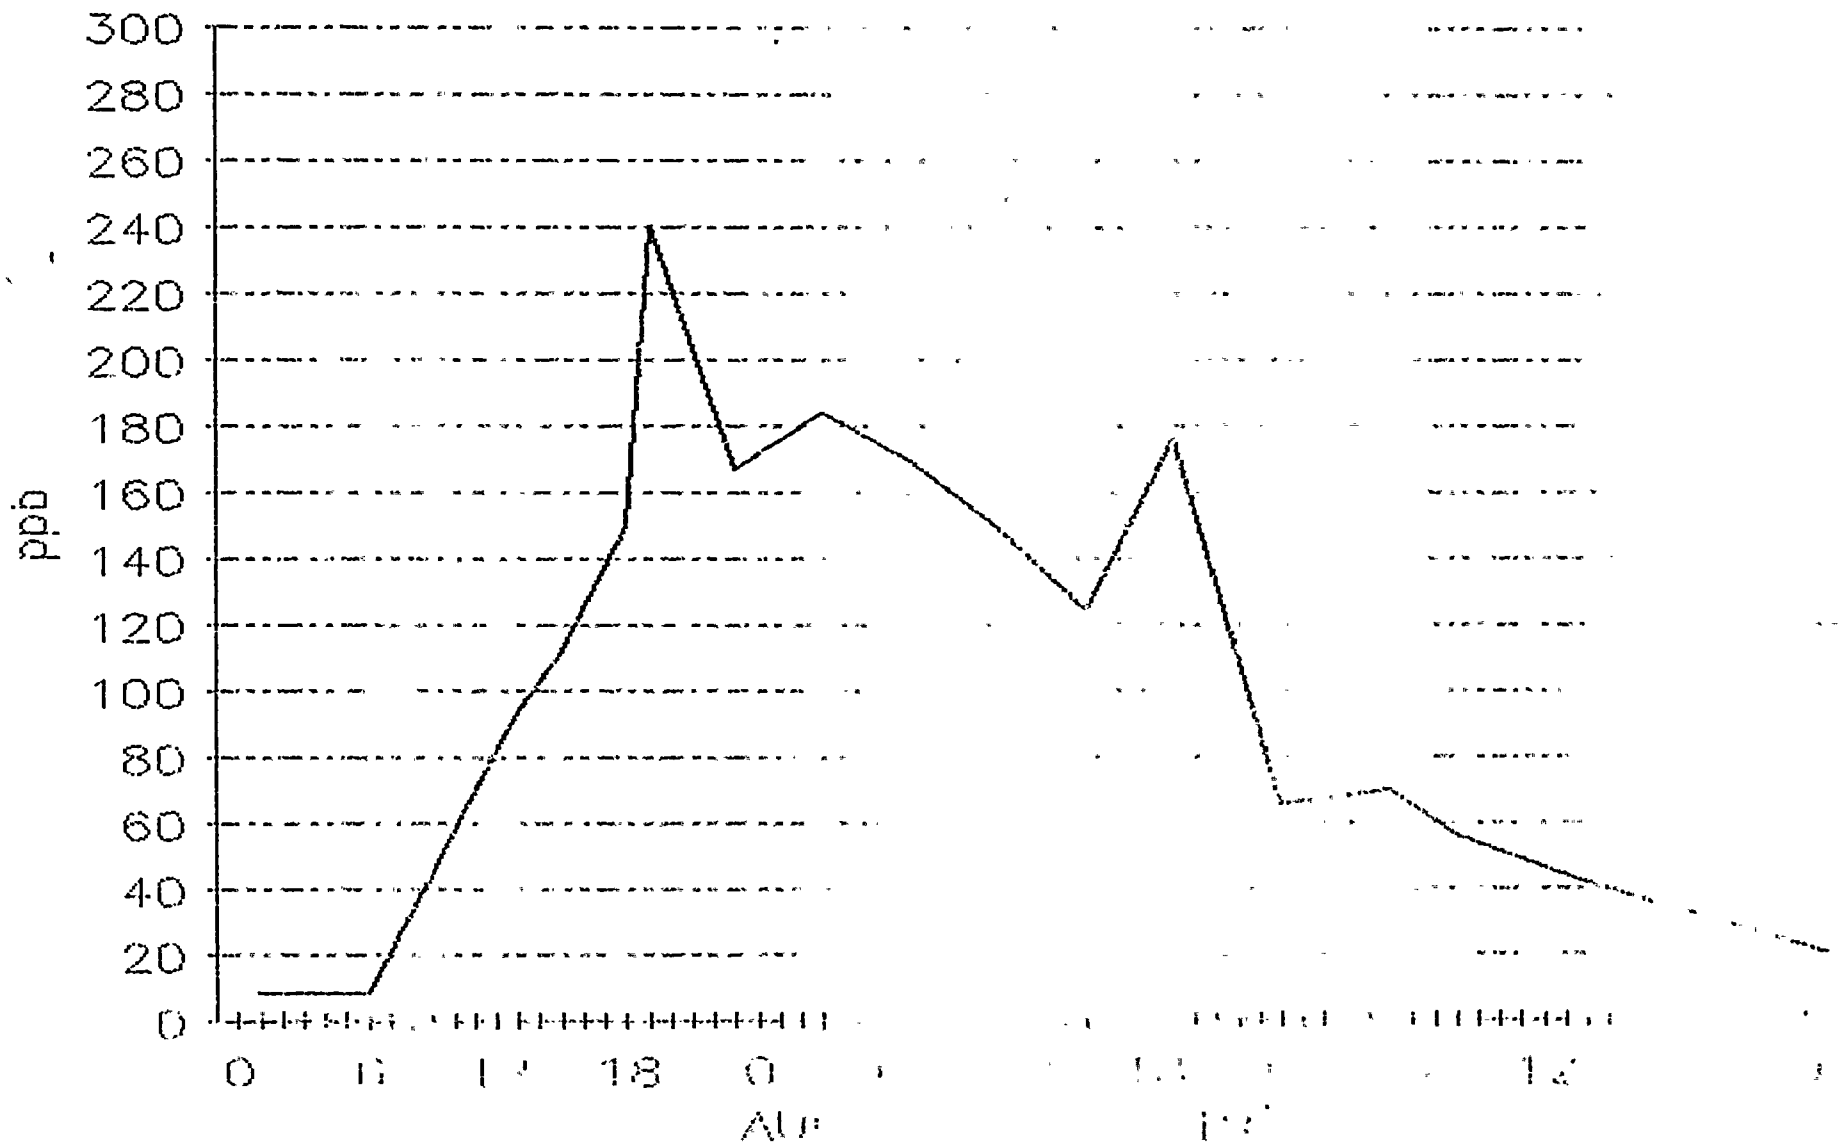
NMP-2 REACTOR WATER SULFATE

One would expect the sulfate to be reduced to 20.6 ppb. The measured sulfate concentration in reactor coolant was 19.8 ppb. This measurement was made 54.5 hours after the peak sulfate concentration of 240 ppb. was measured. The conclusion is that a source of sulfate or the conditions needed to break down cation resin rapidly (i.e., > 200°F) have been eliminated from the system during this period of the excursion. Certainly trapped resin and hideout of impurities like sodium sulfate are possible in this vein of thought.
