# A/T - NO START AFTER HEAT SOAK: WIRE LENGTH INCREASED CAT. G, NO. 001/93

1993 Mazda RX7

TECHNICAL SERVICE BULLETIN

Model(s): 1993 Mazda RX-7 (A/T) with a VIN of JM1FD3\*\*\*P0200001  
through JM1FD3\*\*\*P0210498  
Category: "G" Engine Electrical  
Bulletin No.: 001/93  
Date: 7/2/93

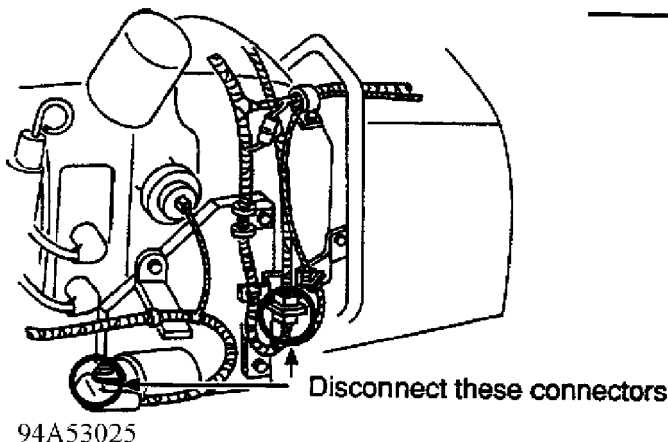
Fig. 1: Disconnecting Starter Solenoid Connectors

Hard restart after running the vehicle at high speeds on hot days. Vehicle restarts easily after engine compartment cools down. This hard start condition is caused when heat from the engine increases the electrical resistance in the starter wire. This decreases the amount current received at the "S" terminal on the starter. To correct this problem, the starter harness length has been changed and the amount of current applied to the "S" terminal during starting increased.

If the condition exists, install the countermeasure starter wire harness.

1. Disconnect the vehicle battery.
2. Raise the vehicle on a hoist or raise the front end with ramps.
3. Disconnect the connectors at the starter.

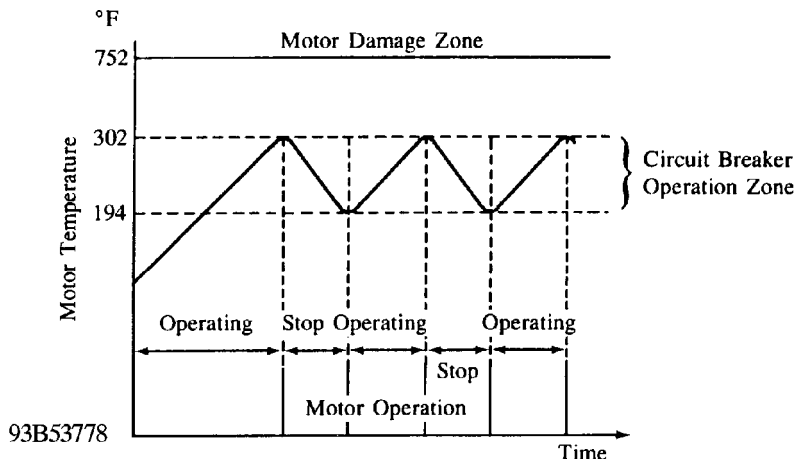
Fig. 1: Motor Temperature & Motor Damage Zone Chart

NOTE: Circuit automatically resets when motor temperature decreases below 90 degrees C, 194 degrees F.

The information in this bulletin is provided to answer customer questions regarding occasional wiper motor perceived problems and prevent unnecessary wiper motor replacement.

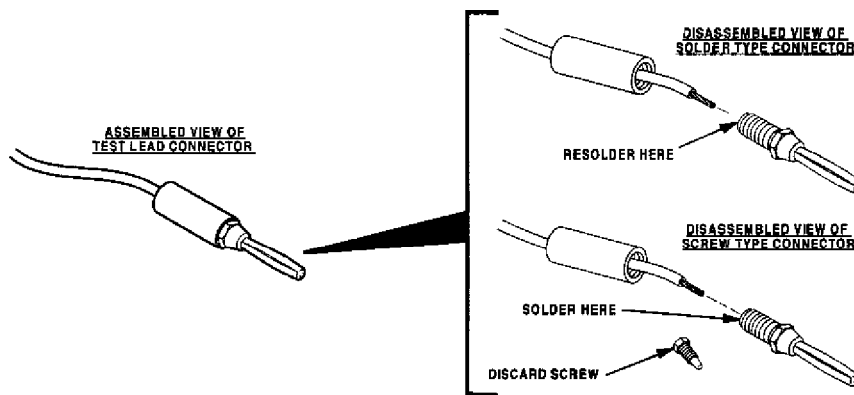
Fig. 2: Assembled\Disassembled Connectors

The NGS test lead connectors may become loose or corroded causing incorrect readings. Before using the ohm meter function of the NGS tester for diagnosing electrical circuits, check for excessive resistance in the test leads and connectors and repair them if necessary.

3) Disassemble the connectors and check for corrosion, solder breakage, or looseness. Resolder connections to repair as necessary. See Fig. 2.

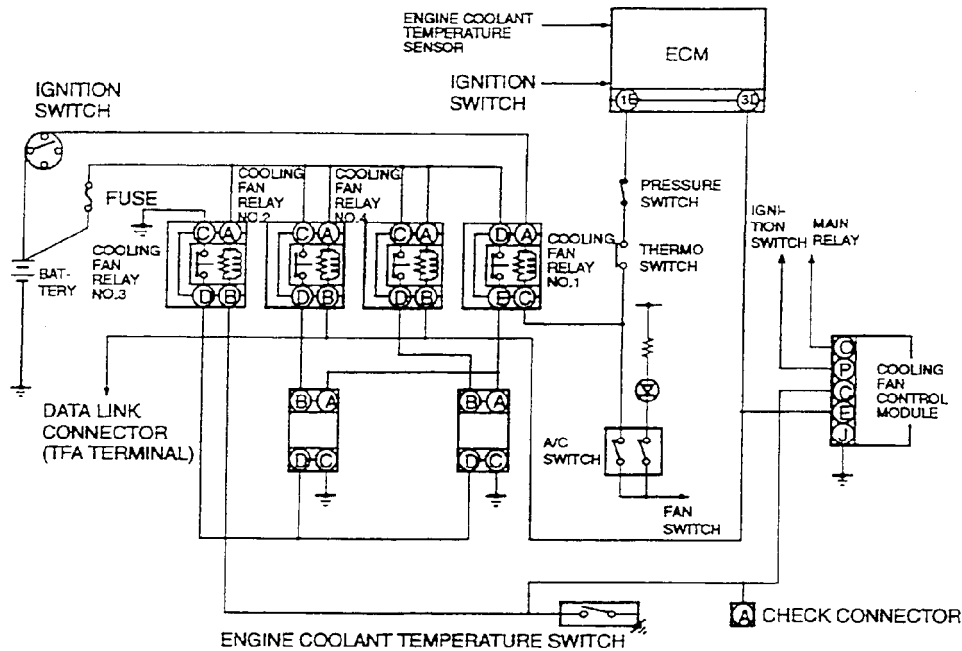
98E51619  
 Fig. 3: Cooling Fan Control System Components

To improve idle smoothness and engine reliability, the cooling fan control system controls the electrical fan speed by ECM. This system consists of the cooling fan, cooling fan relays, cooling fan control module, ECM, and input devices. See Figs. 3 and 4.

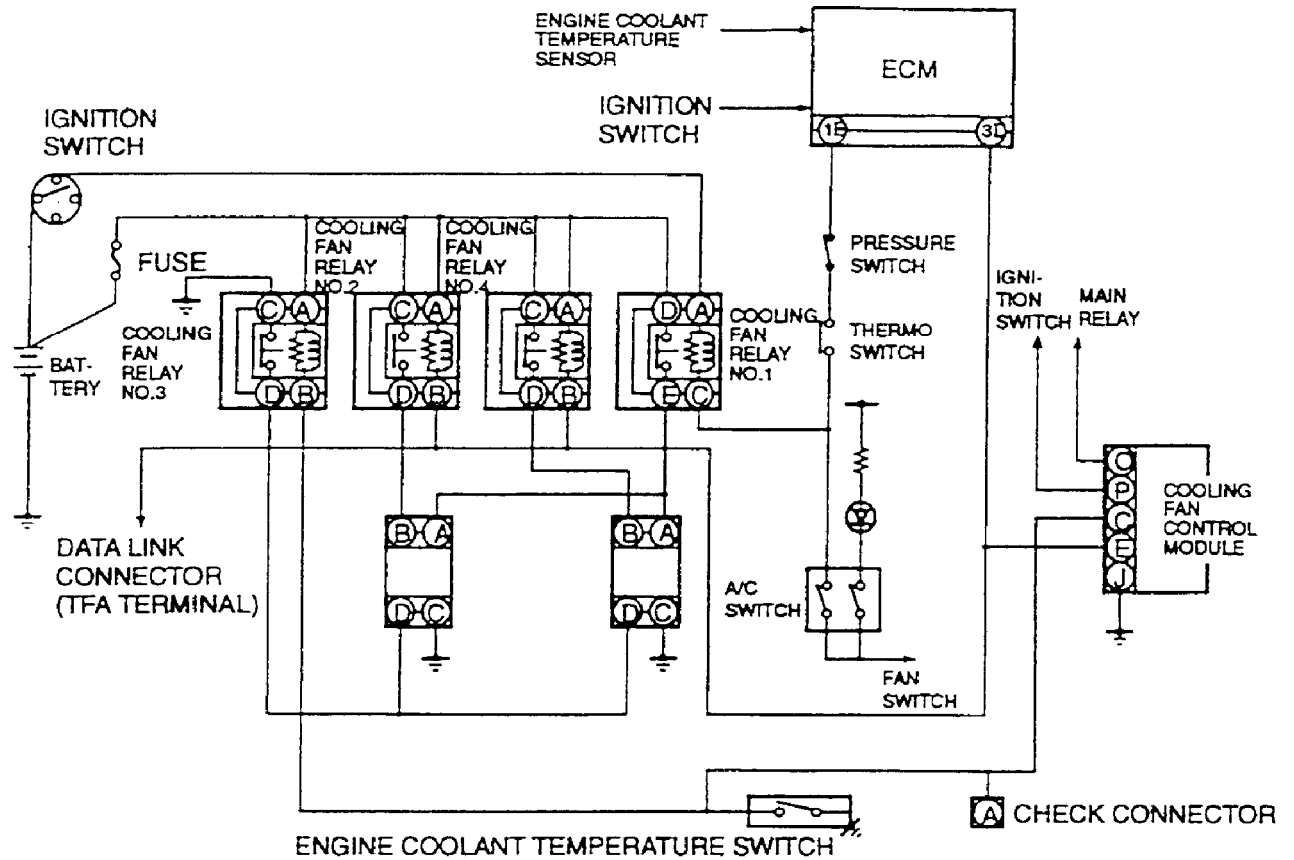
98E51627  
Fig. 14: Cooling Fan Control System Components

To improve idle smoothness and engine reliability, the cooling fan control system controls the electrical fan speed by ECM. This system consists of the cooling fan, cooling fan relays, cooling fan control module, ECM, and input devices. See Figs. 14 and 15.

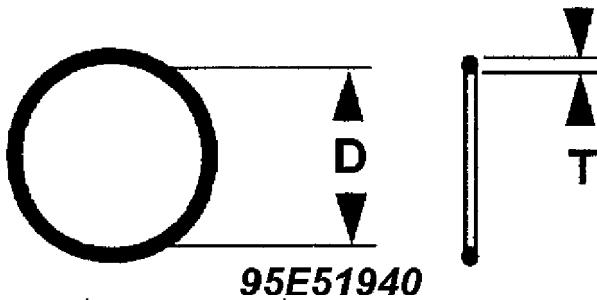
Fig. 1: Measuring New O-Rings

Fig. 1 indicates where a new O-ring is measured to determine diameter and thickness. Use this information and the chart above to identify the proper part if the O-rings are accidentally mixed.

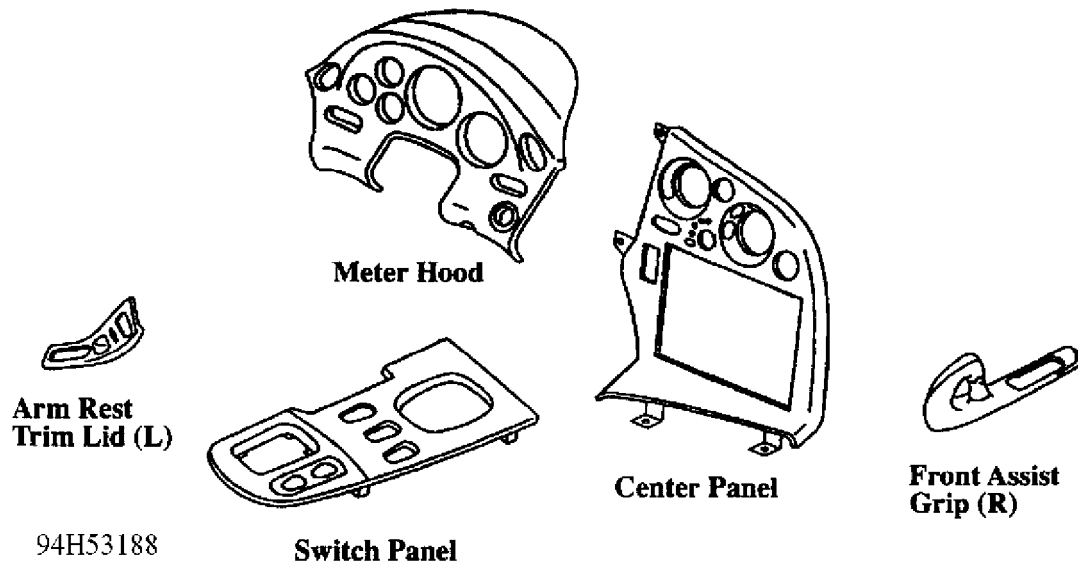
Fig. 1: Affected Parts

Some vehicles may experience the black finish peeling from certain interior trim parts. Fig. 1 illustrates the affected parts.

This condition is caused by poor adhesion of the black finish to the trim parts.

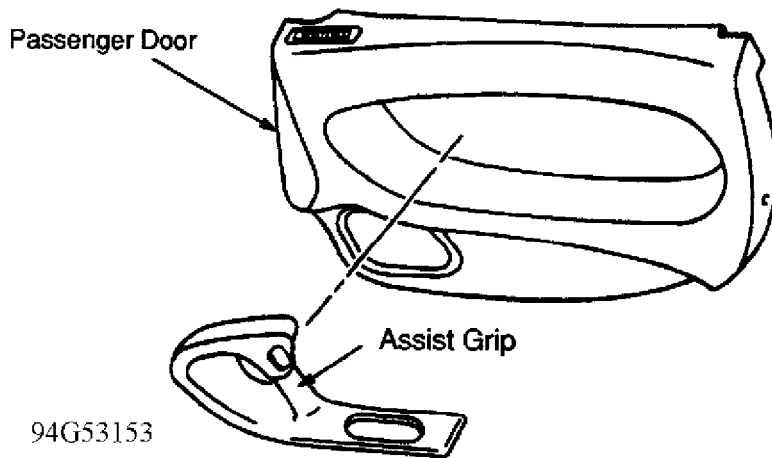
Fig. 1: Door Grip

On some vehicles, the passenger door grip may break or become loose. This is due to the constant pulling force when closing the door. The material used to manufacture the door grip has been improved to reduce the possibility of breakage

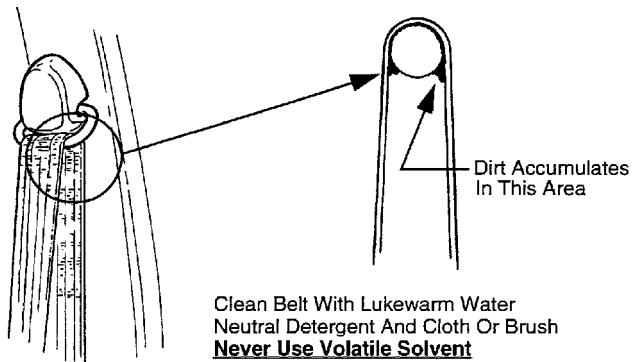
Fig. 1: Dirt Accumulates In This Area

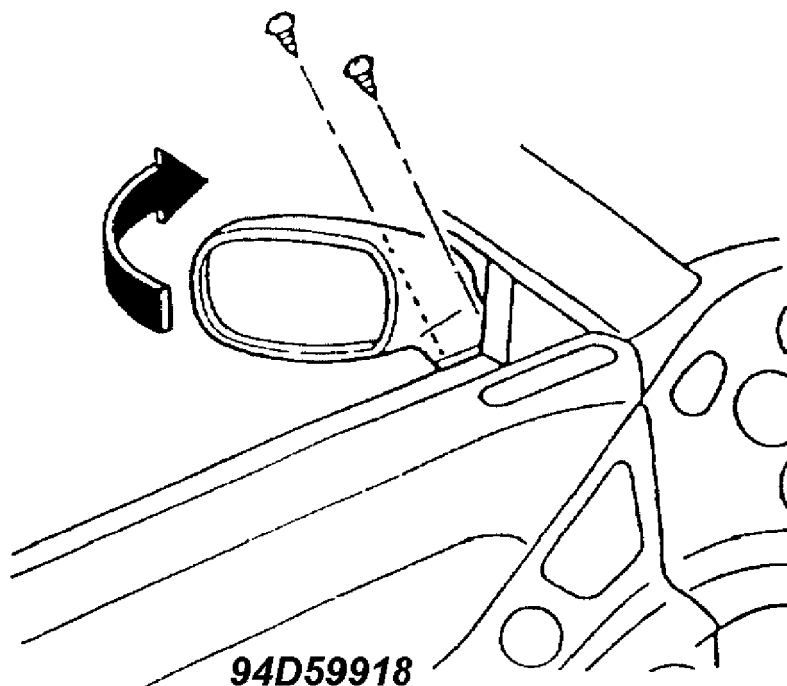
Fig. 1: Location of Mounting Screws

If the left or right door mirrors shake or vibrate under normal driving conditions, or on rough roads, do not replace the door mirror.

Twist the mirror downward to expose the two (2) mounting screws that attach the mirror to the body. See Fig. 1. Remove the mounting screws and apply loctite (blue type) to the threads and reinstall the screws very firmly to ensure the vibration has been eliminated.

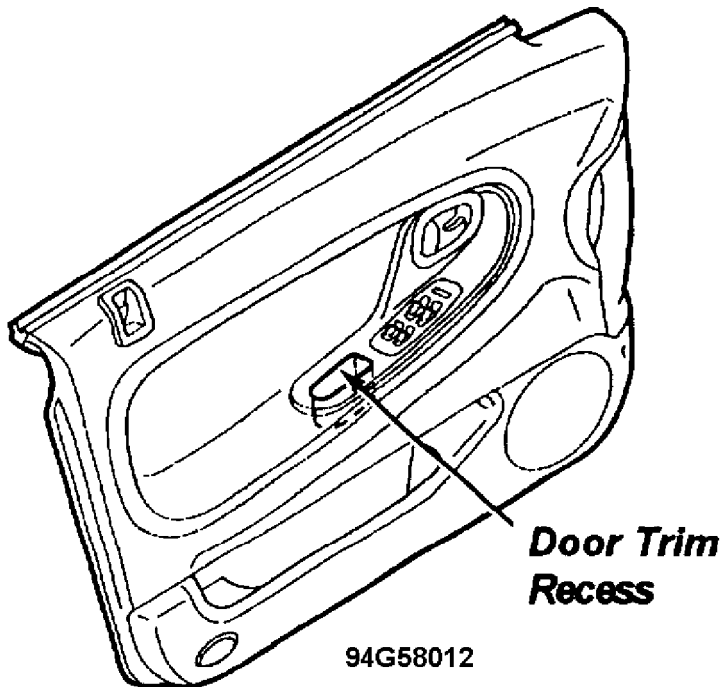
Fig. 1: Door Trim Recess

If the door trim recess is broken, do not replace the entire door trim. The recess is available separately as a service part for all models. The complete door trim is not warrantable if it was replaced to repair a broken recess. See Fig. 1.

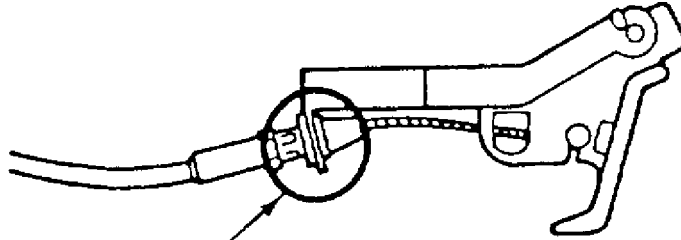
**Check angle here  
(Incorrect angle shown)**

2. Correct the angle of the hood release knob bracket. Adjust the bracket angle to 90 degrees. If this angle is not at 90 degrees, the release cable may not pull out fully and therefore may not release the lock. See Fig. 2.

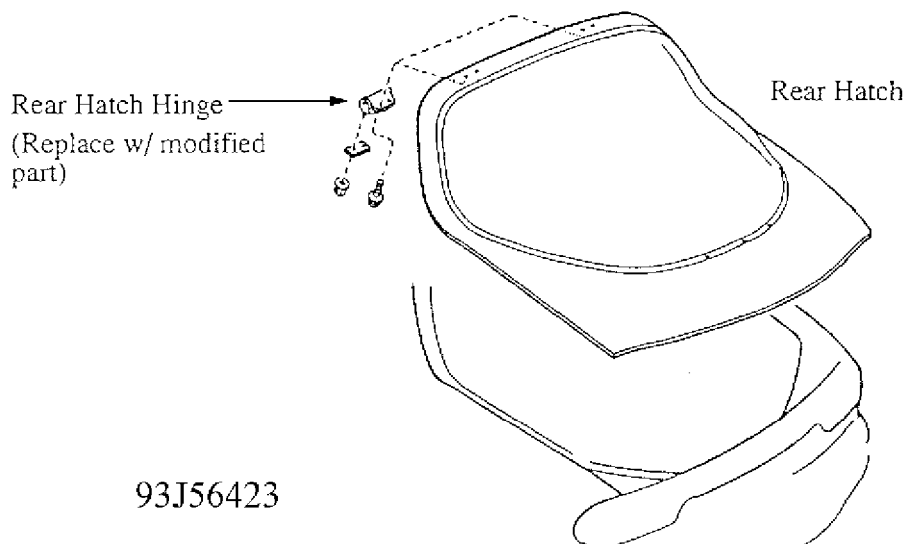
Fig. 1: Modified Rear Hatch Hinge

On some vehicles, noise may be heard from the rear hatch hinges. This noise is most evident when driving on rough roads or going over bumps.

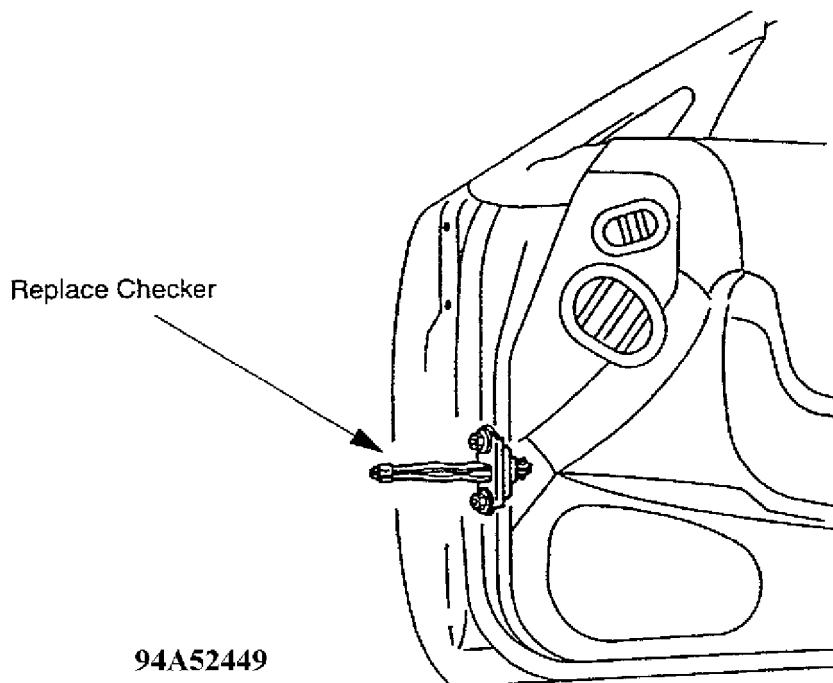
Fig. 1: View of Door Checker

When opening or closing the door a squeaking sound may be heard. This is caused by the door checker. To correct this problem, the checker has been modified.

Follow the procedures listed in section S of the workshop manual to replace the door checker for customers complaining of this noise.

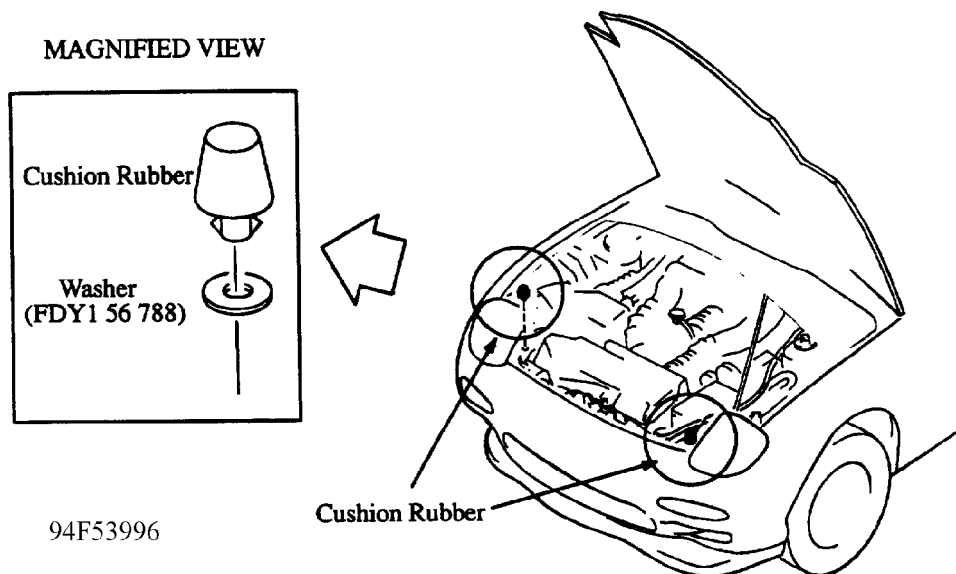
Fig. 1: Rubber Hood Cushion

Some vehicles may experience a squealing sound from the hood when driving on normal road surfaces. After July 2, 1992, the hood was modified to eliminate this condition.

If the above condition occurs, install a washer between the two cushion rubbers under the hood. See Fig. 1.

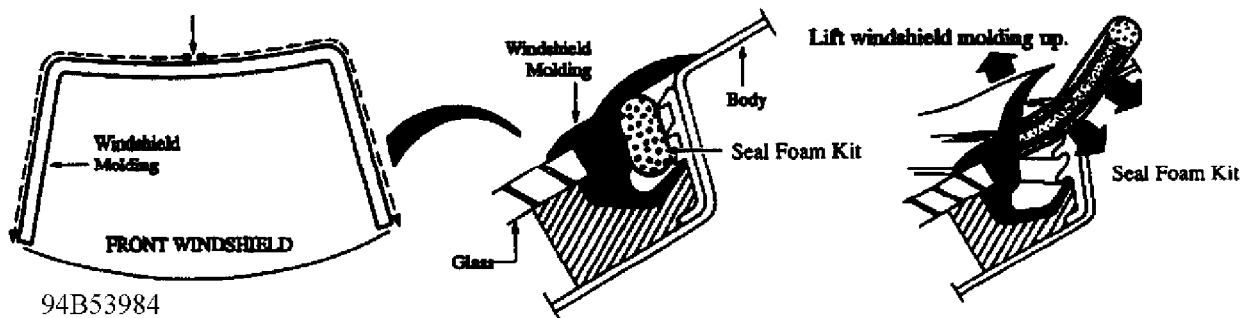
Fig. 1: Seal Foam Kit Installation

Some 1993 RX-7s may emit a whistling noise around the windshield area when being driven at high speeds. This whistling noise is caused by air being pulled through the space between the molding and the windshield.

A repair seal foam kit has been established as a countermeasure. If a whistling noise is encountered on a vehicle(s) produced on or before May 31, 1992, install a repair seal foam kit into the vehicle's front windshield molding. Lift the windshield molding and slide the sealing foam into the space between the molding and the windshield. See Fig. 1.

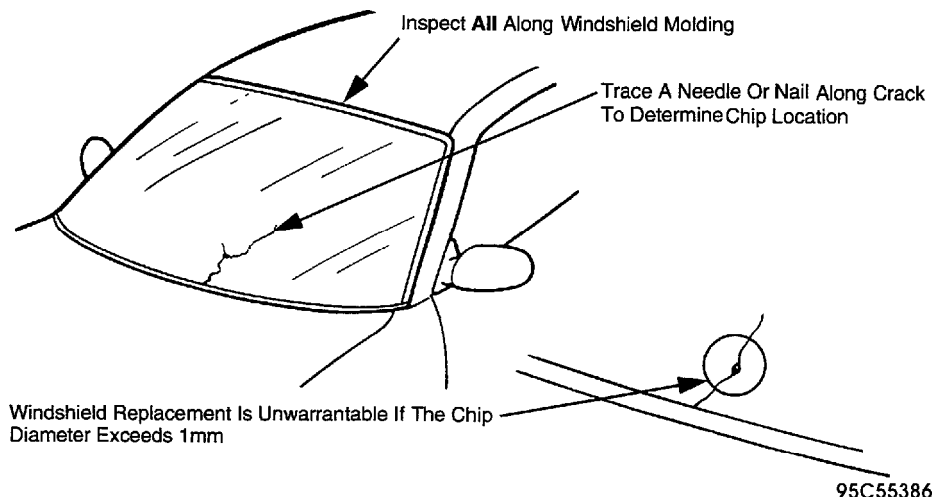
Fig. 1: Windshield Inspection

Windshield replacement is not warrantable if a chip larger than 1 mm in diameter exists along the length of the crack.

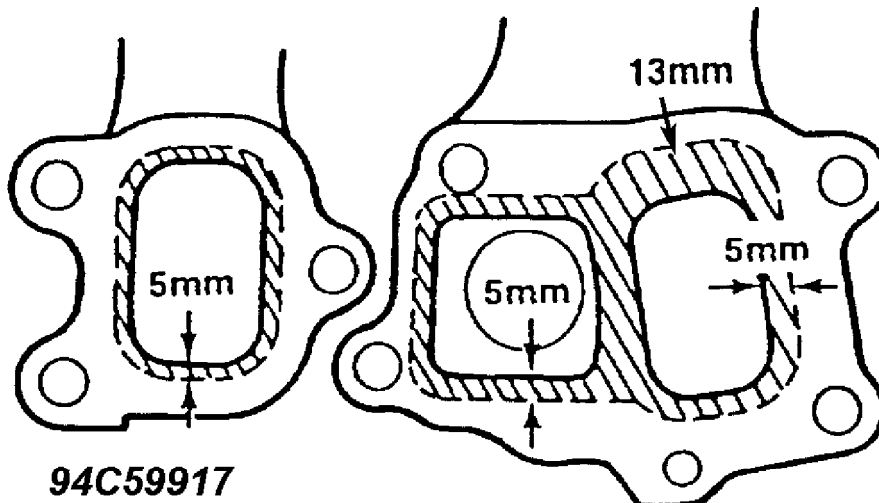
Fig. 1: Location Of Cracks On The Turbocharger

1) Cracks of 5mm or less in length that do not pierce the housing, EXCEPT:

2) At the top of the secondary turbo flange, next to the turbo pre-control valve, cracks of 13mm or less are acceptable. See Fig. 1.

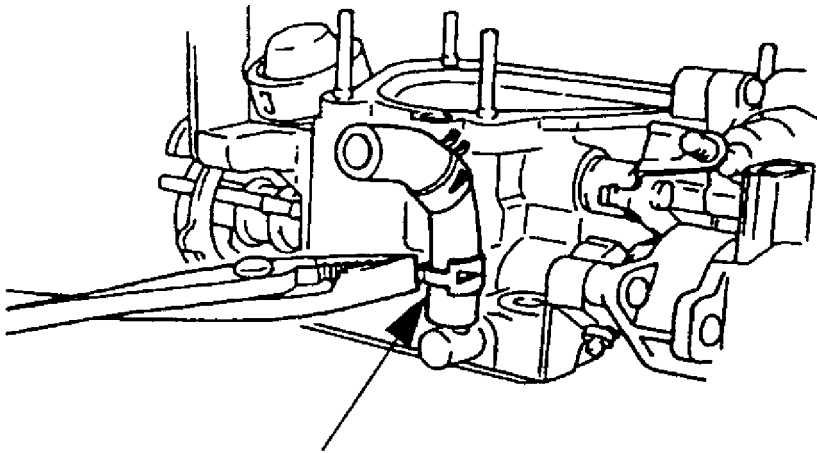
Fig. 21: Installing Throttle Body Water Hose

**Install New Throttle Body Water  
Hose Using Two (2) New Clamps**

27) Replace the throttle body water hose with a new one using two new clamps. See Fig. 21.

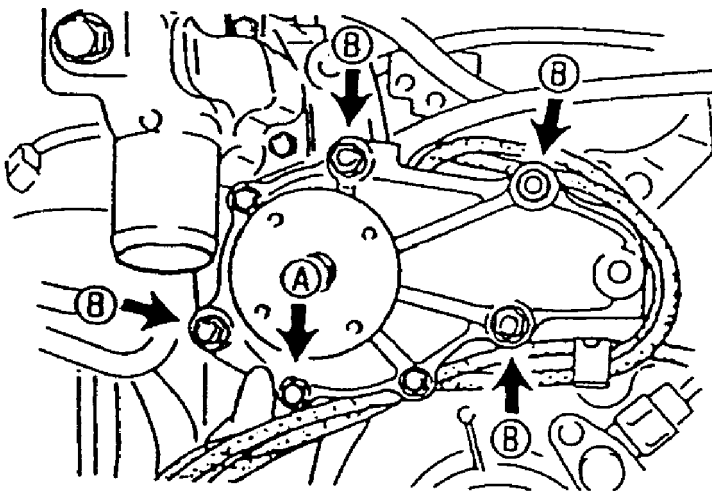
Fig. 28: Oil Metering Line Routing

**Route Oil Metering Line Properly**

Note: Be sure that oil metering line retaining clip is installed correctly on the outside of the water pump at bolt "A". See Fig. 28.

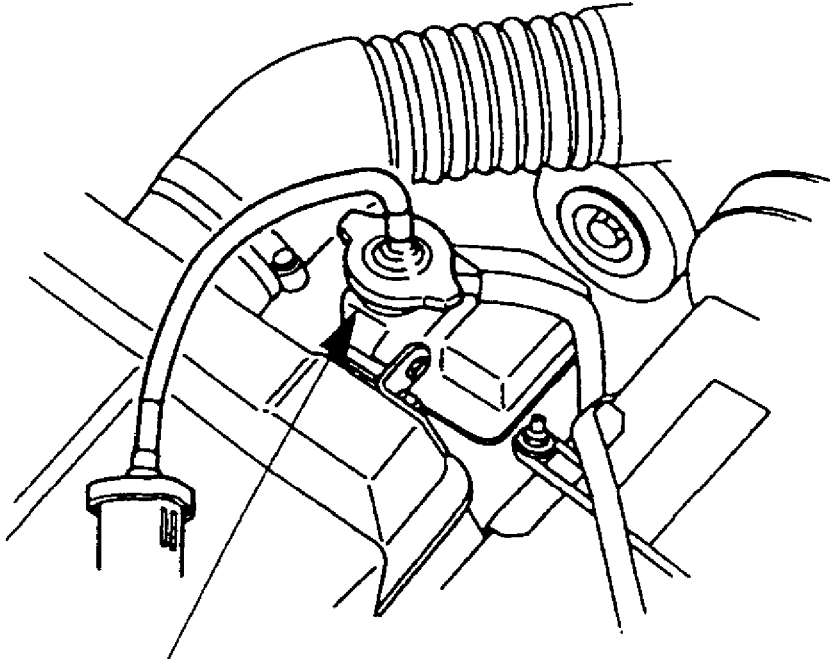
Fig. 31: Radiator Pressure Tester

### Install Radiator Tester And Apply 15psi Verify That Pressure Holds

**NOTE:** If the radiator coolant pressure has dropped, locate the leak and repair as necessary. Retest after repair following the above procedures. After confirmation that no leaks are present, remove the tape from the overflow hole and install the pressure cap.

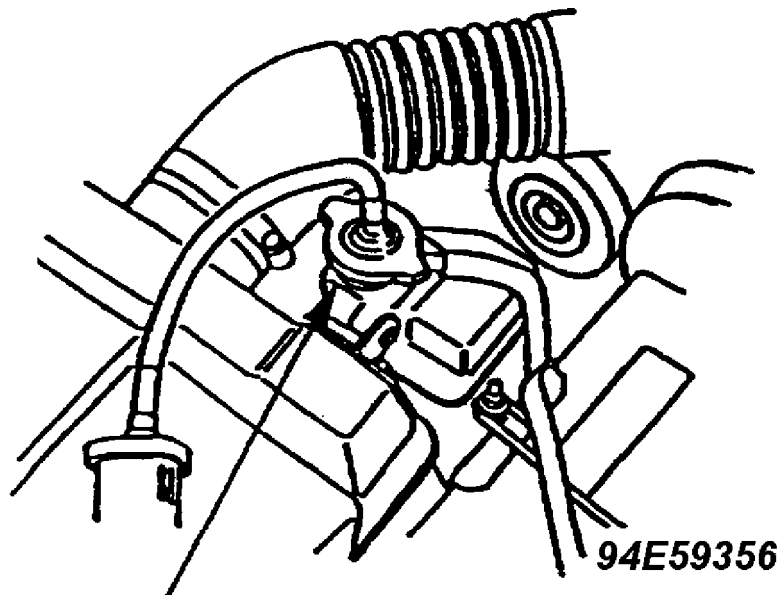
Fig. 73: Radiator Pressure Tester Application

**Install radiator tester and apply 15psi.  
Verify that pressure holds.**

58. Apply 15 psi. See Fig. 73.

NOTE: If the radiator coolant pressure has dropped, locate the leak and repair as necessary. Retest after repair following the above procedures. After confirmation that no leaks are present, remove the tape from the overflow hole and install the pressure cap.

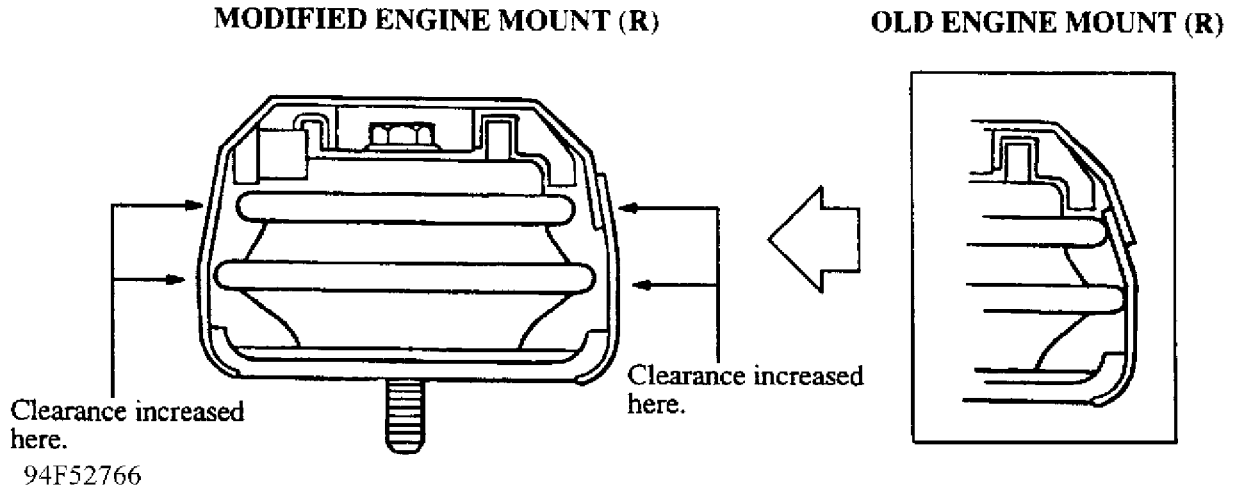
Fig. 2: Modified Engine Mount Illustration

Vehicles produced after the May 31, 1992 production date come with the modified right engine mount. Removal and installation procedures are outlined in appropriate service information

If the above condition occurs, replace the right engine mount with a modified part. The clearance between the rubber mount and mount housing has been increased to eliminate the noise. See Fig. 2.
