Number	A.1.
Section	General Information
Sheet	1 (of 1)
Date	January, 1960

PRELIMINARY INFORMATION

(Mark 2 Models)

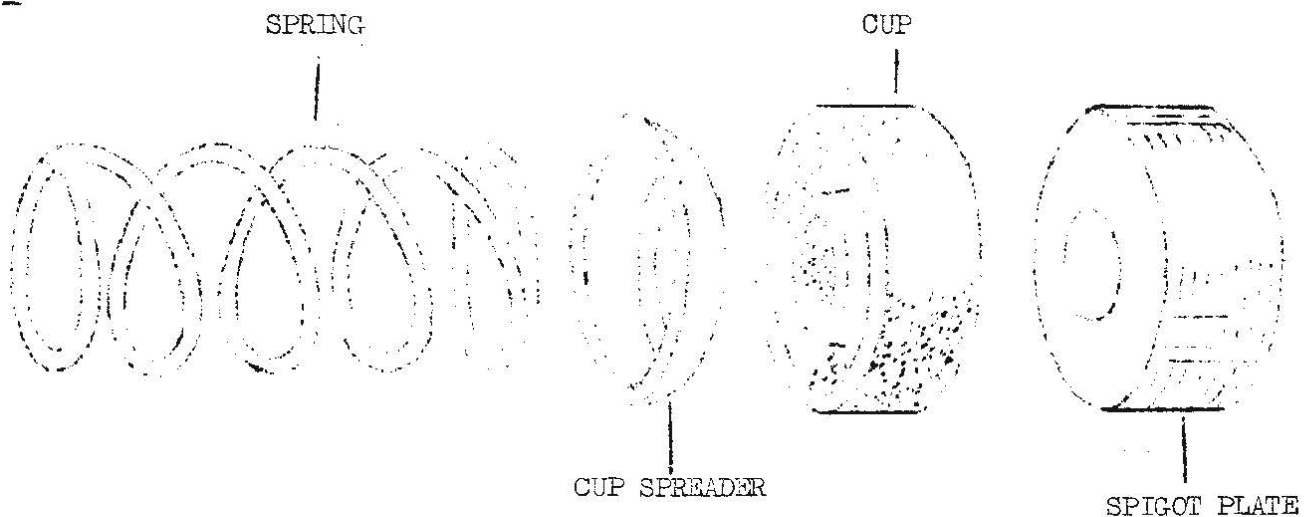
This cup spreader (Part No. 7896) will be included in future repair kits and should be incorporated in all servo units undergoing overhaul.

The spreader is fitted between the cup and spring (Items 60 and 49 in Fig.41 of Section L, 2.4/3.4 litre Service Manual) with the concave side towards the spring. (See sketch).
