# Network OS 7.4.1g for Extreme VDX

## Release Notes

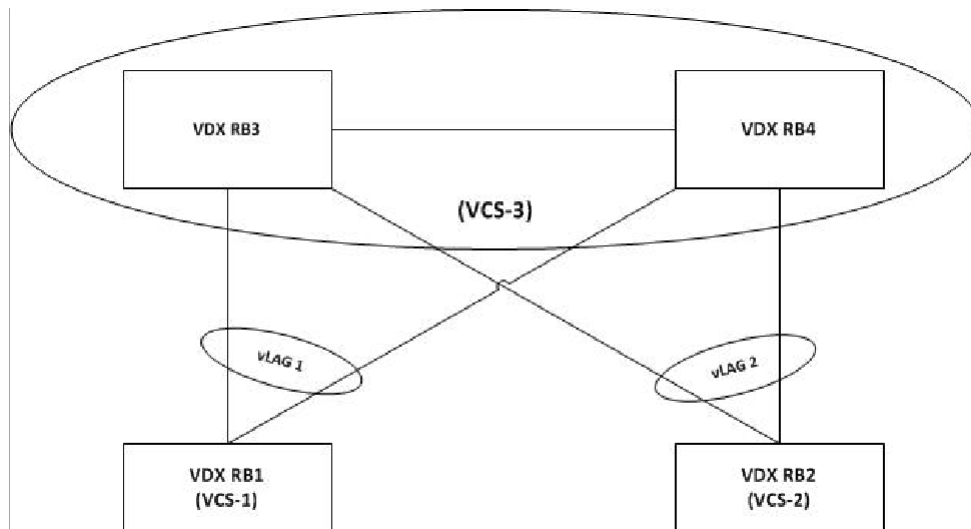
### vLAG deployment upgrade illustration

- **Approach 1:** Graceful shutdown of vLAG ports on one node at a time.
- **Approach 2:** Static vLAGs and Dynamic vLAGs without configuration changes.

**Approach 1:** Graceful shutdown of vLAG ports on one node at a time.

**Step 1:** With LC mode, shutting down port-channel takes down entire port-channel including port-channel interfaces on remote RBs. Therefore, if in LC mode, shut all the member ports of the vLAG 1 on RB3.
