APOLLO OPTICAL SUBSYSTEM AND LM ALIGNMENT OPTICAL TELESCOPE

FINAL REPORT

VOLUME II
(2 of 2)

Kollsman Instrument Corporation
Syosset, New York

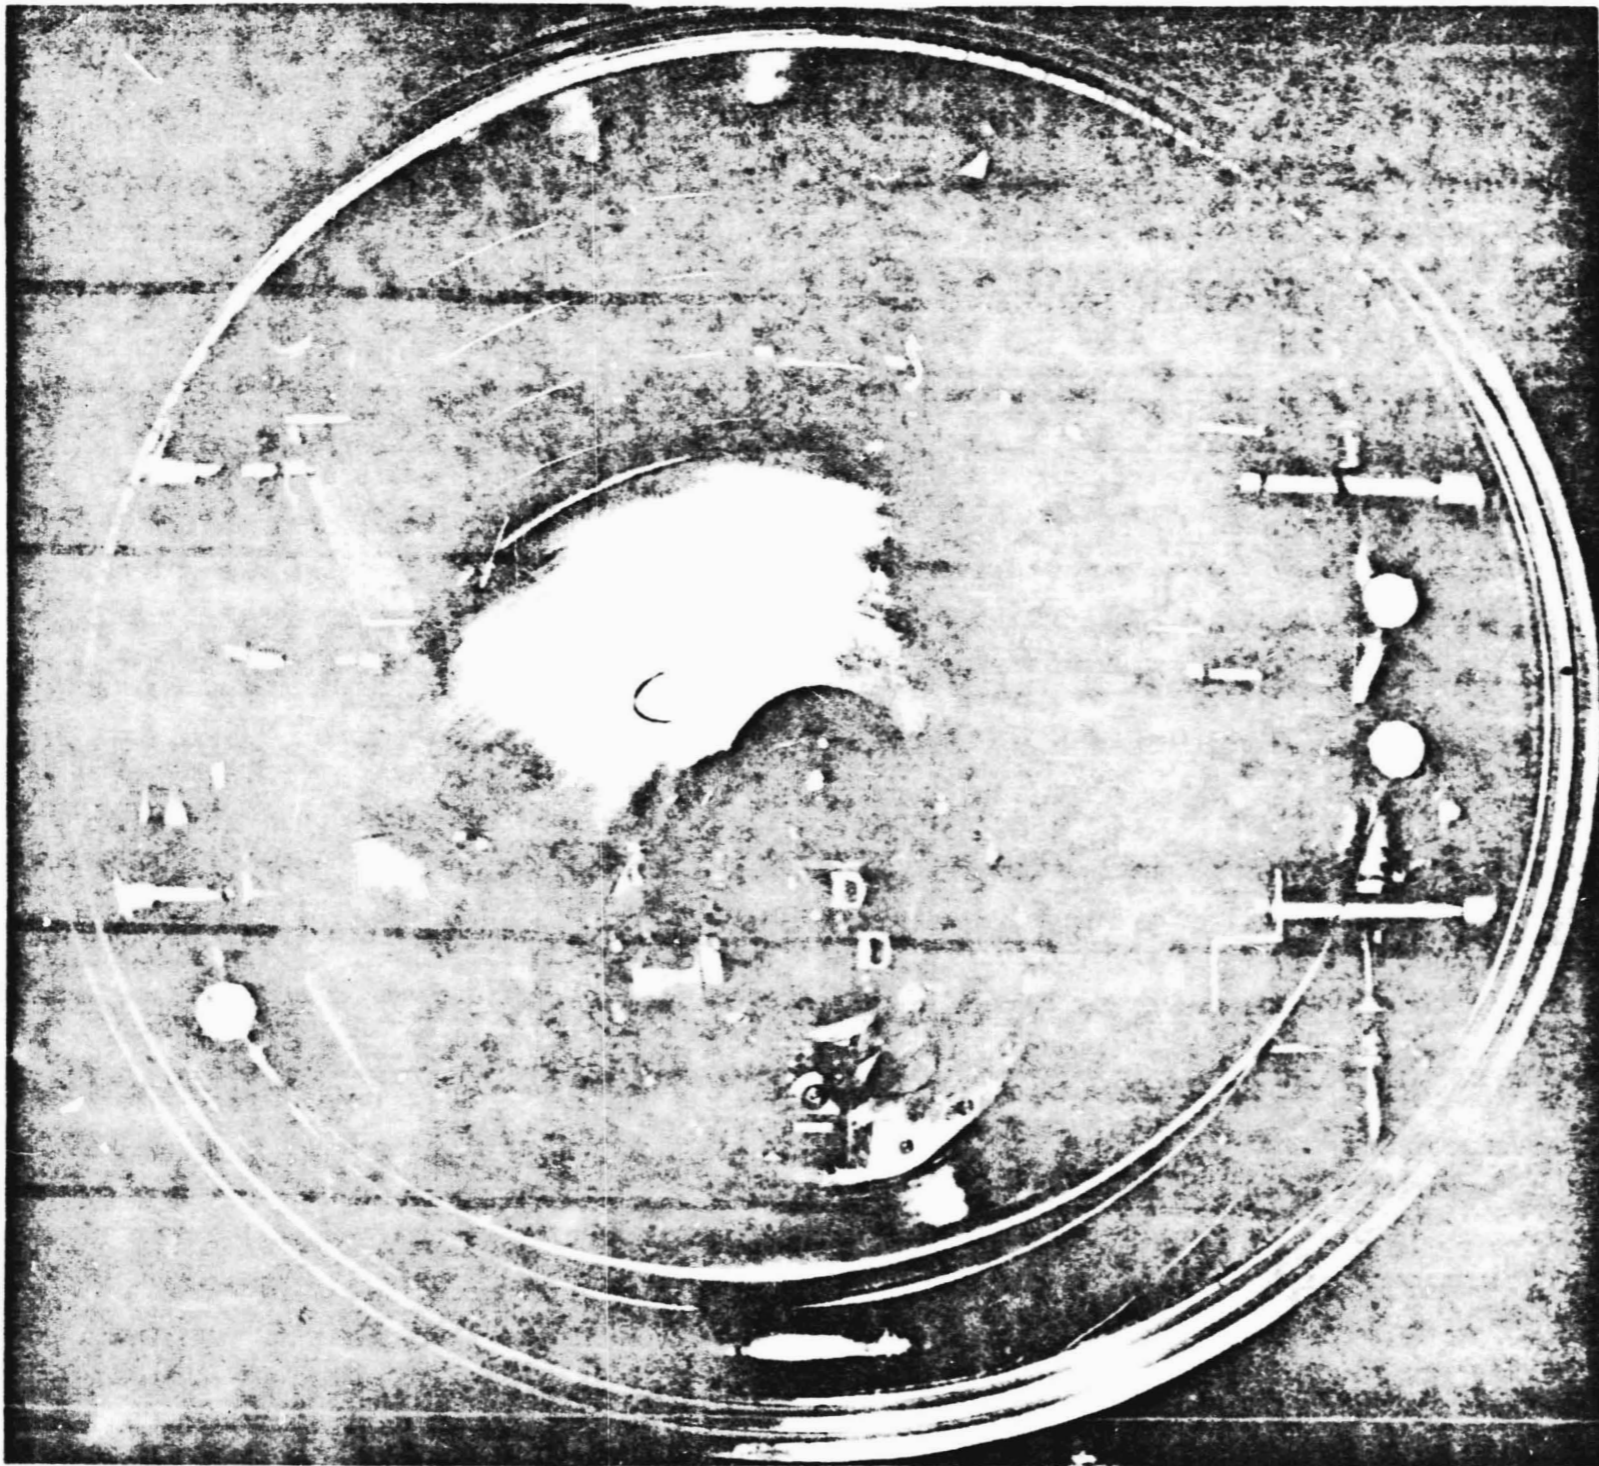
Figure 5-7. Dual Space Chamber

The chamber was installed in the Kollsman test area under Kollsman and vendor supervision to assure conformance to all design specifications, see photograph in Figure 5-7.

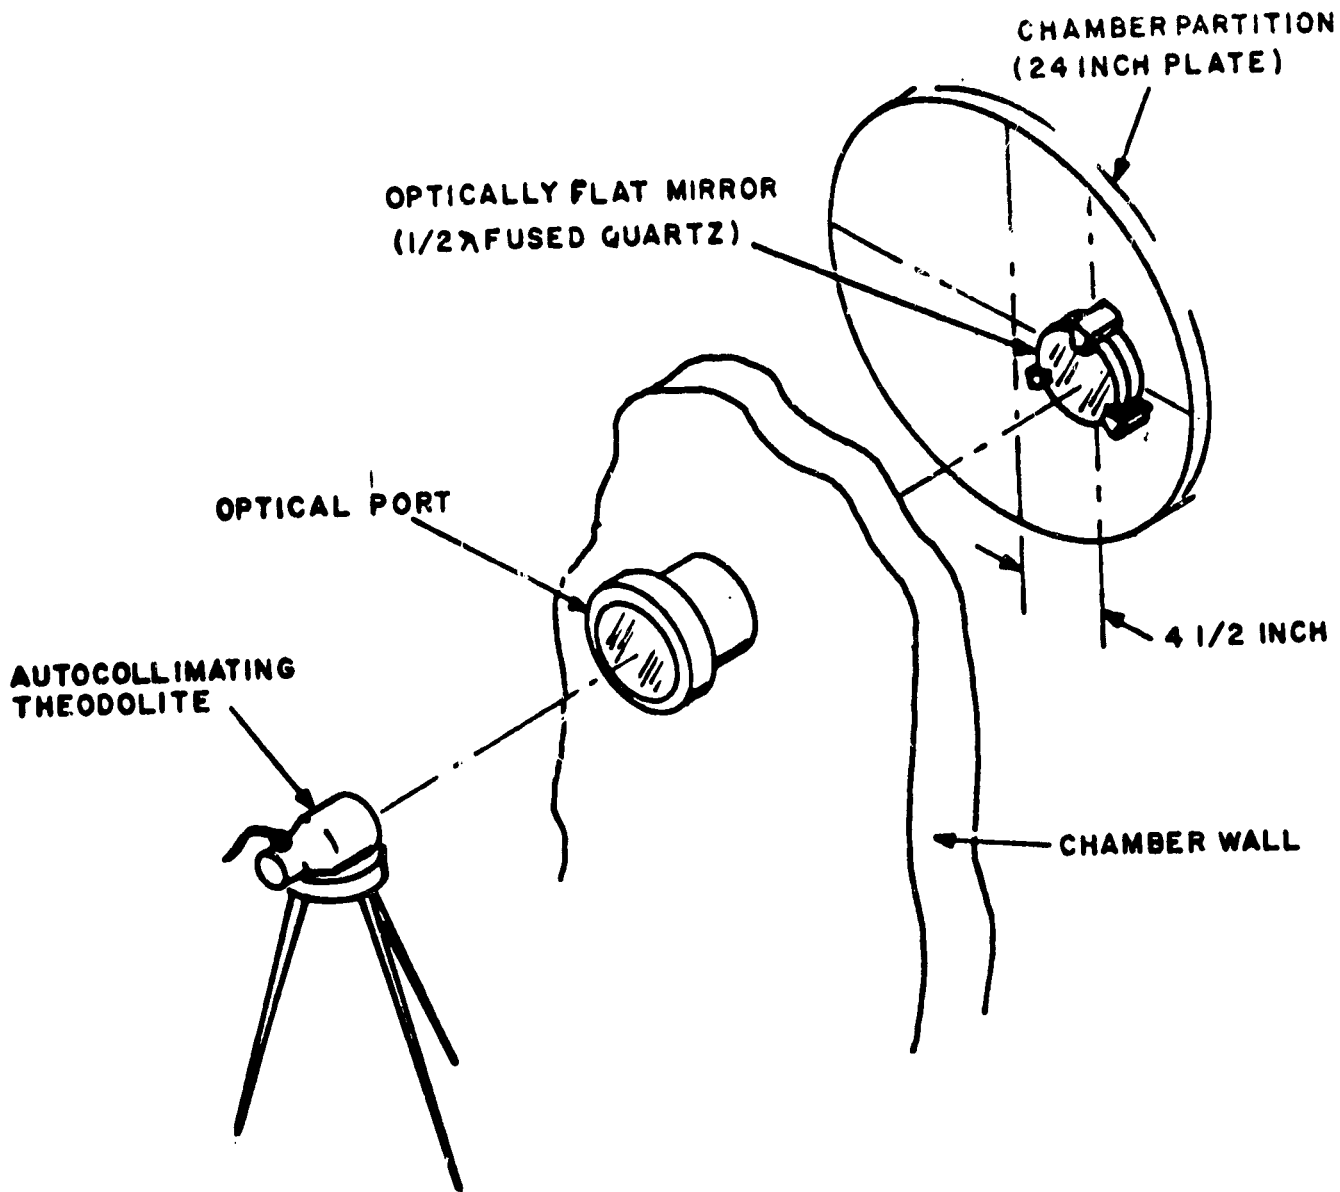
Figure 5-13. Test Set-up for Chamber Partition Movement Evaluation

The optical evaluation studies of the Space Chamber were completed. The equipment used was an optically flat mirror (1/4) and an autocollimating theodolite to establish the movement of the partition between the chamber section under the extreme environmental conditions to which the Optical Unit was exposed. A sketch of the test set-up is shown in Figure 5-13. The conditions applied were as follows (see Figure 5-14, "Chamber Schematic"). Chamber B was varied in temperature, from 0° to 160°F and, in pressure, from one atmosphere (approximately 14.7 psi) down to 1×10^{-4} mm Hg. Chamber A was varied in temperature from +200° to -250°F and the pressure was brought to and maintained at 1×10^{-7} mm Hg. The results of the test indicated that the greatest change in angular displacement of the optical axis of the mirror will never exceed 1 minute of arc with the maximum stress differentials applied across the partition. The maximum stress conditions applied were as follows:

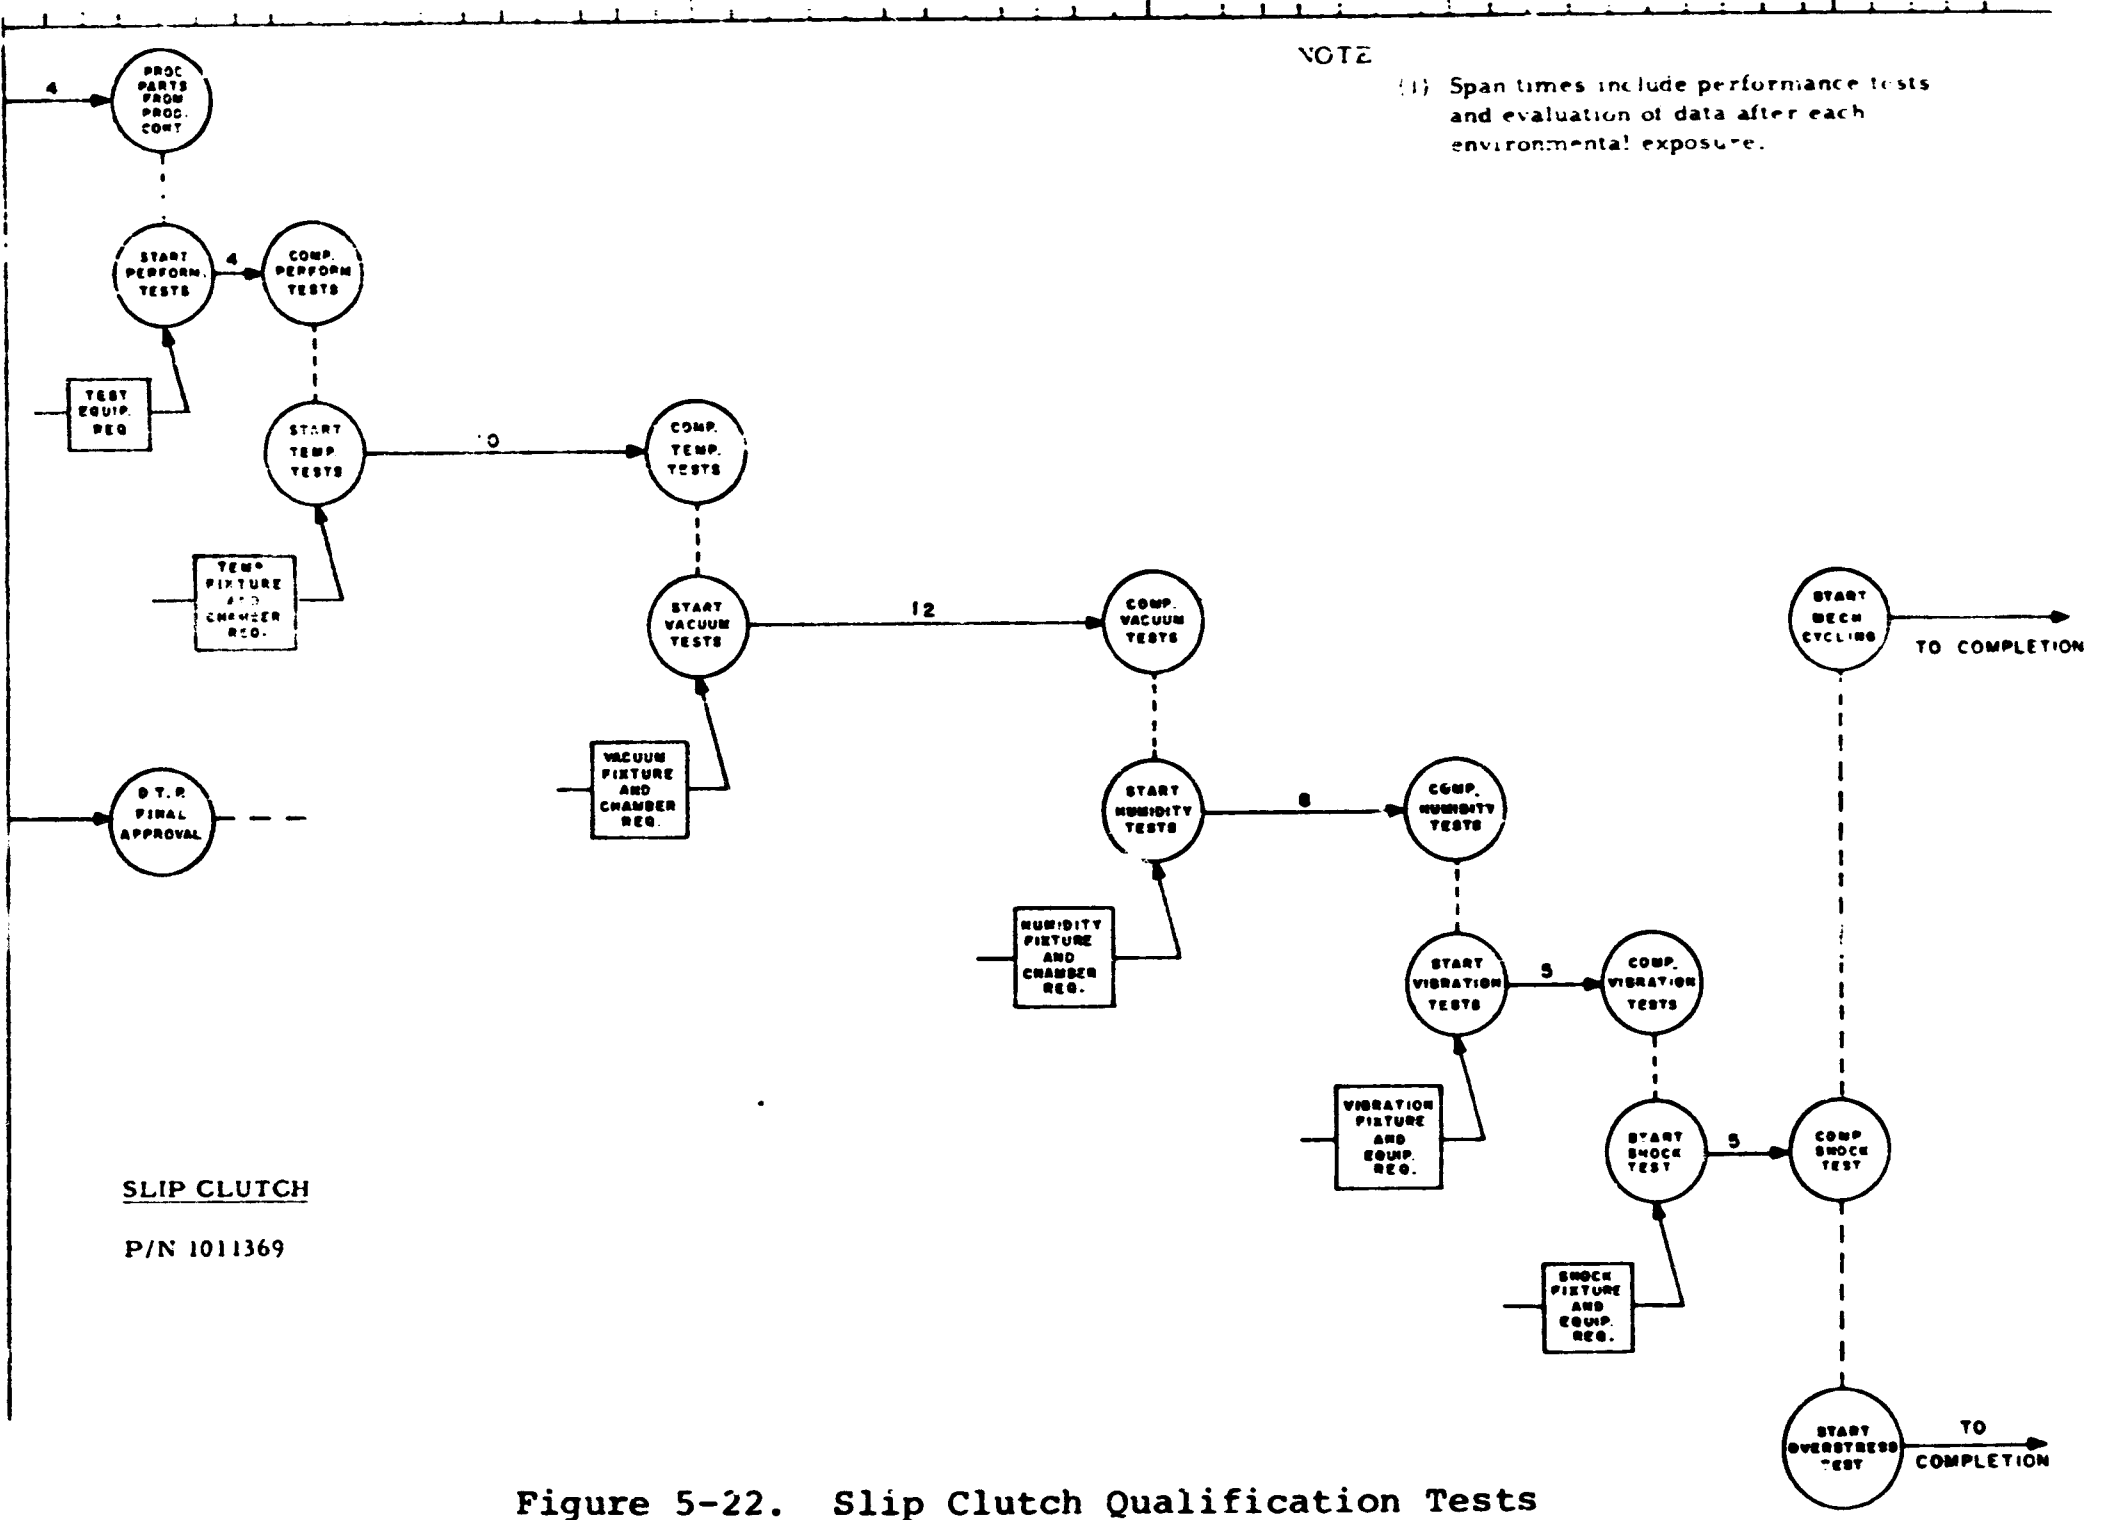
SLIP CLUTCH
P/N 1011369

Figure 5-22. Slip Clutch Qualification Tests

(8) Flow charts, Figures 5-22 through 5-24 indicate how three typical parts were processed through qualification tests. These charts indicate when various environmental and test equipments were needed and show the span time for each individual test. Thus, a complete control on the part from the start of testing to the completion of testing was maintained.

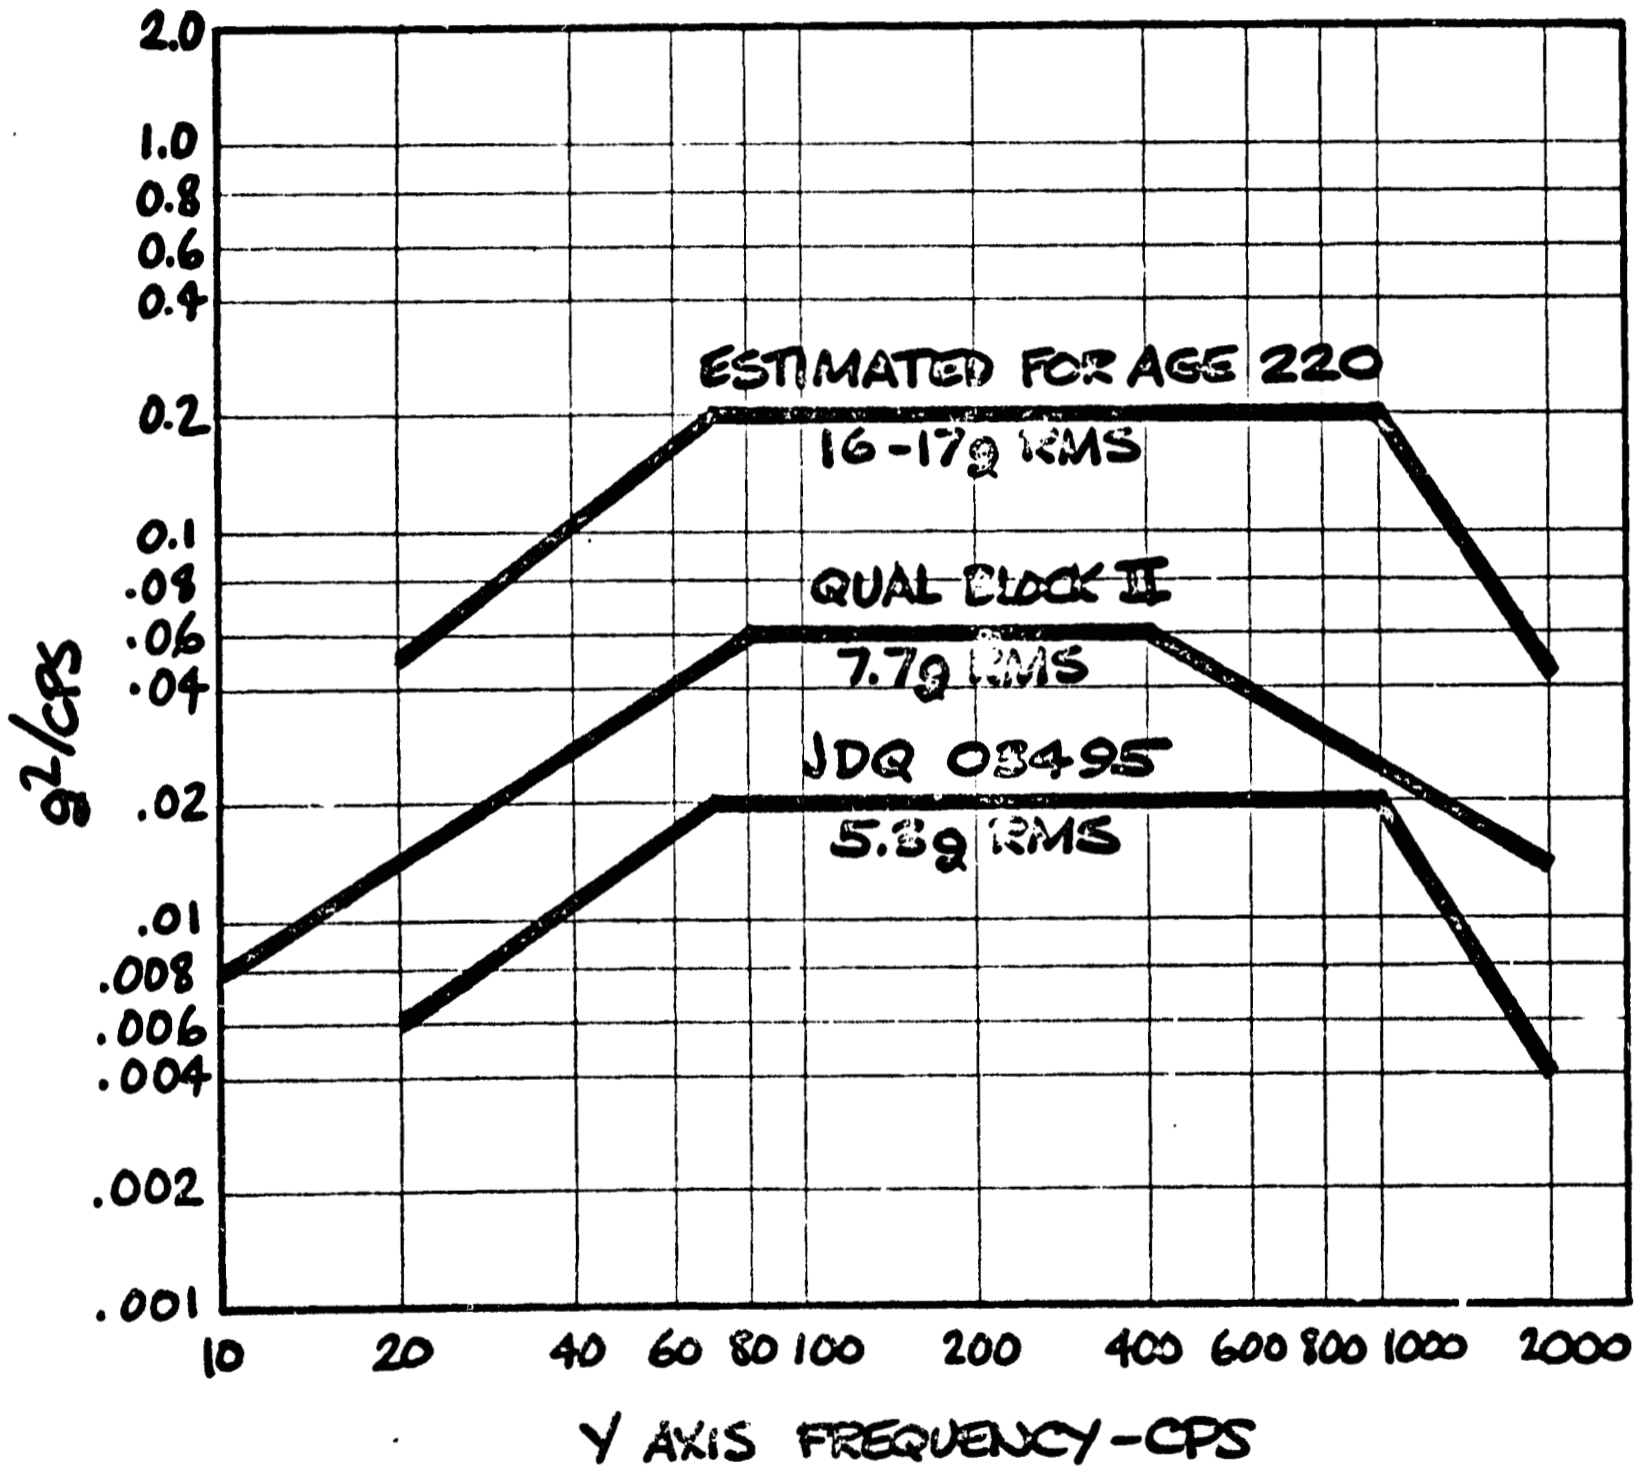
Figure 5-32. Power Spectral Density, Comparison of Levels

On July 8, 1968, while proceeding through normal sell-off tests, OUA AGE 220 was inadvertently exposed to a random vibration level three times (Figures 5-31 and 5-32) greater than nominal. An extensive evaluation covering visual examination, stress analysis and functional performances was conducted and finalized. (See Tables 5-16, 5-17; Figures 5-33, 5-34, and 5-35)
