# Incident Investigation Report

CAR #: 10808359  
Claimant: [REDACTED]  
VIN: 5N1AR2MM9DC [REDACTED]

Model year & model name: 2013 Pathfinder Mfg. date: 09/29/12 VIN: 5N1AR2MM9DC [REDACTED]  
 Mileage: 1,542 License #: [REDACTED] State: PA

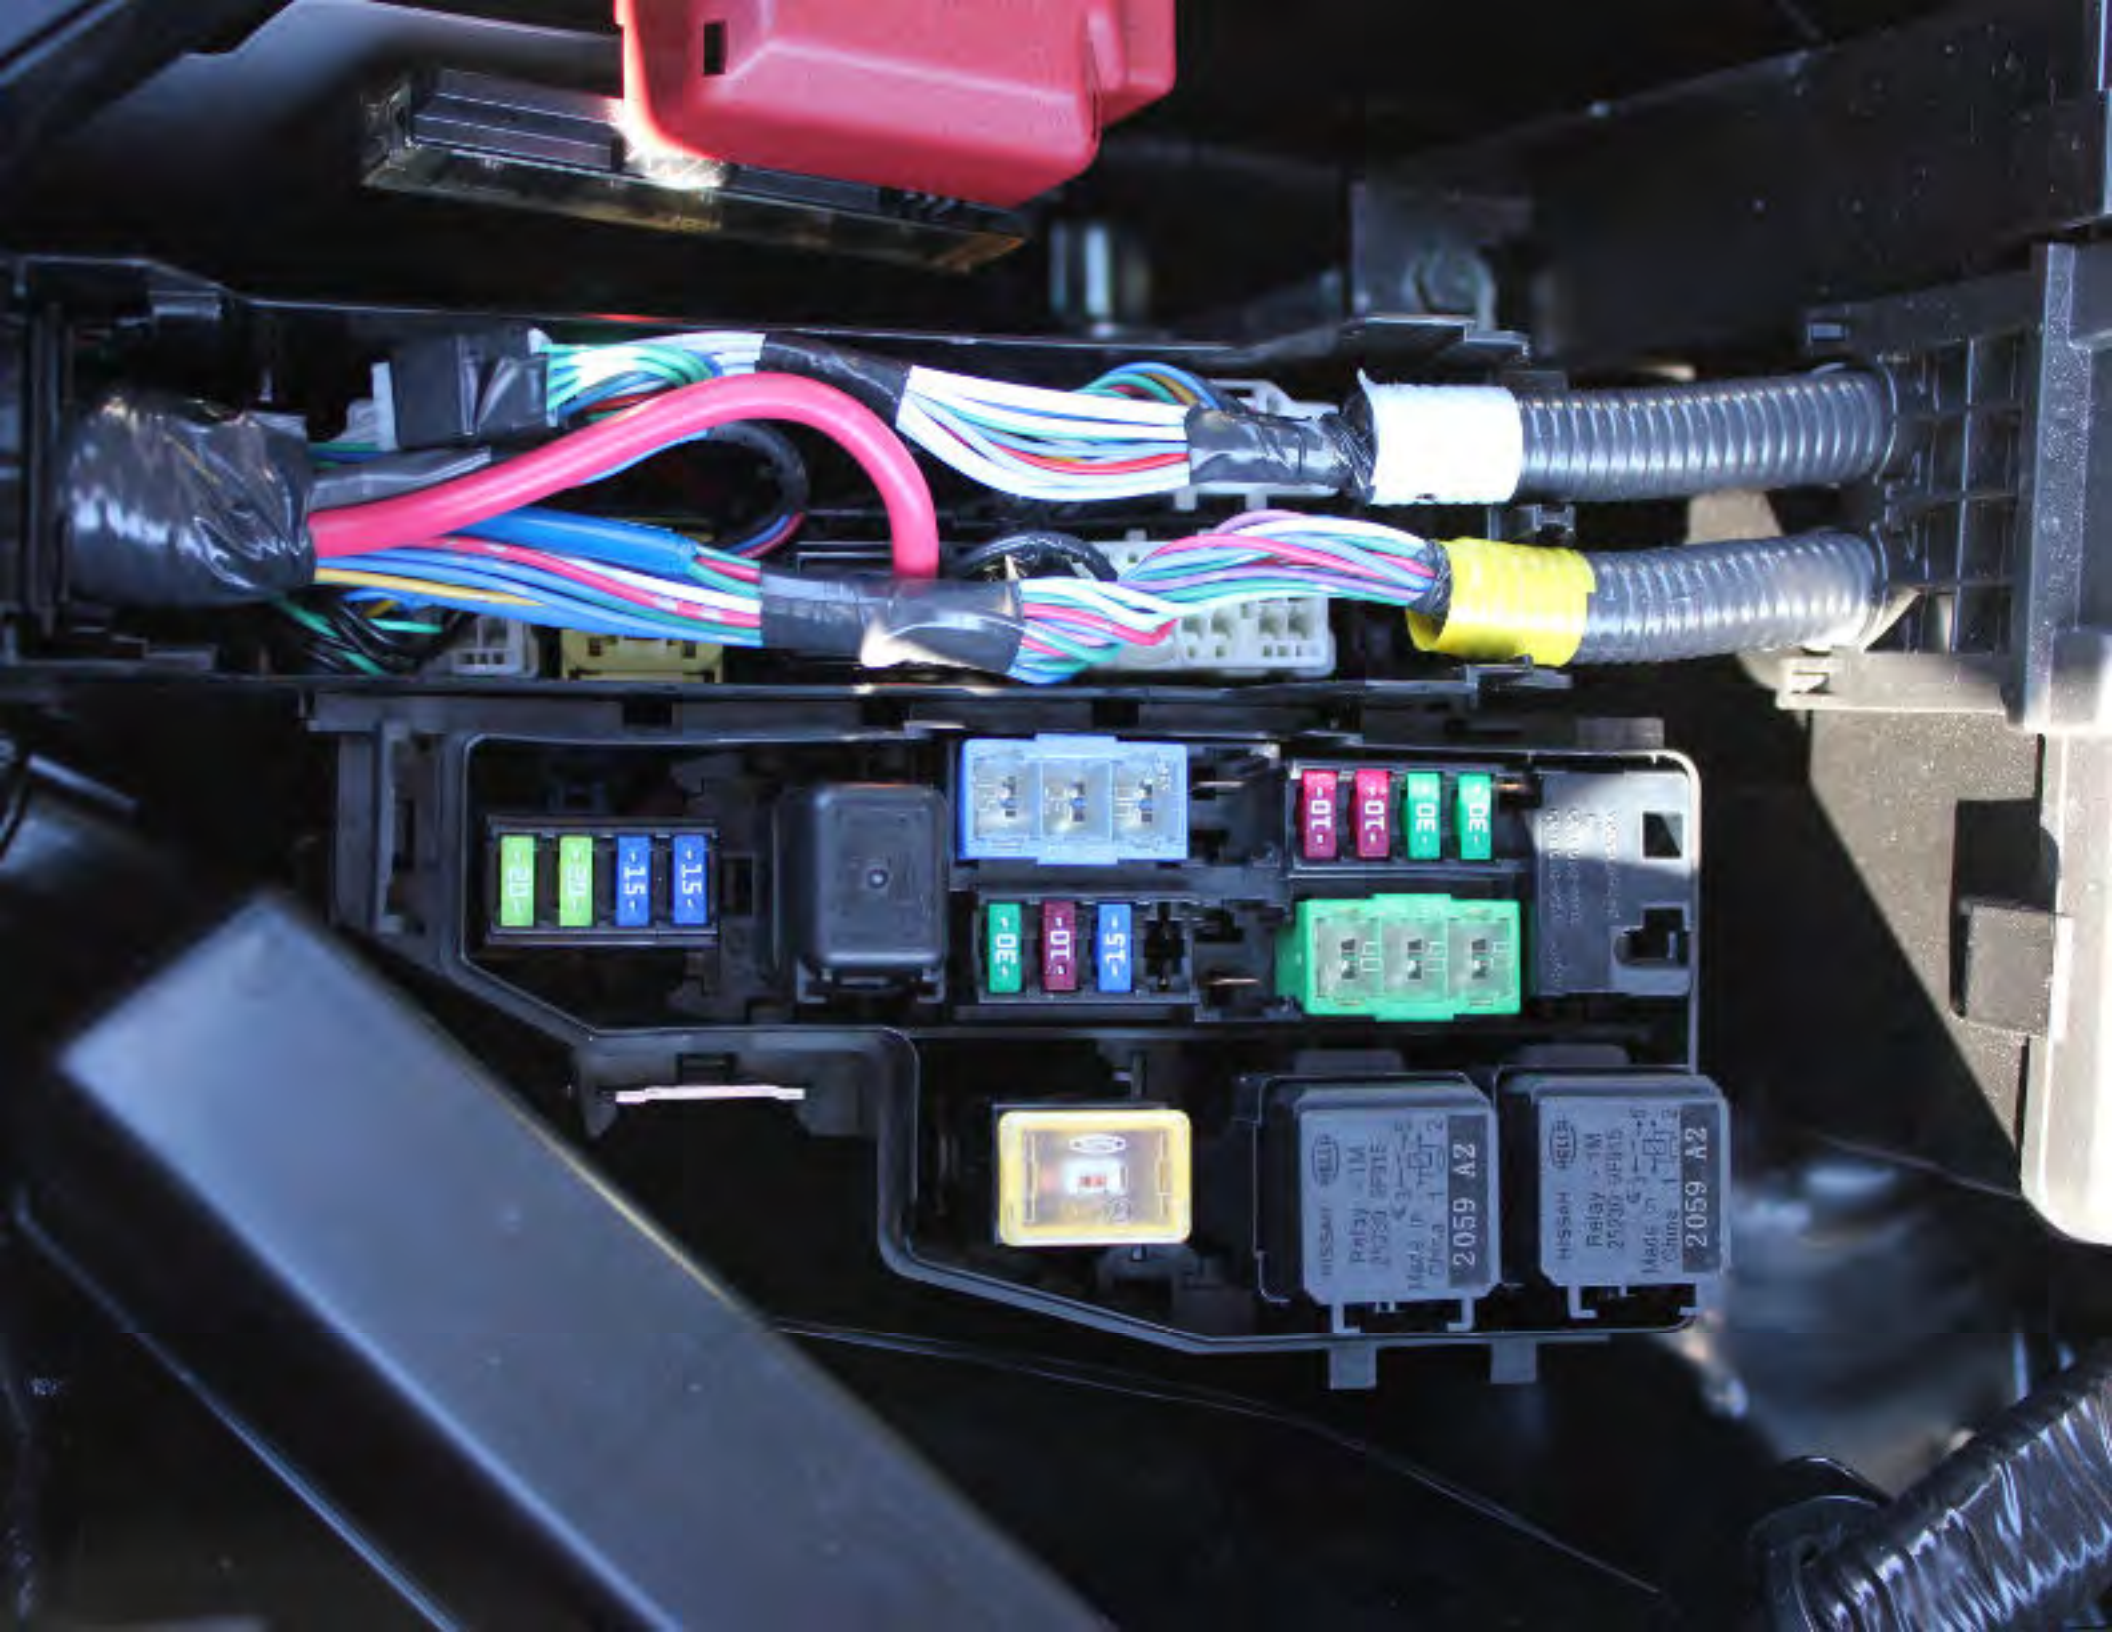
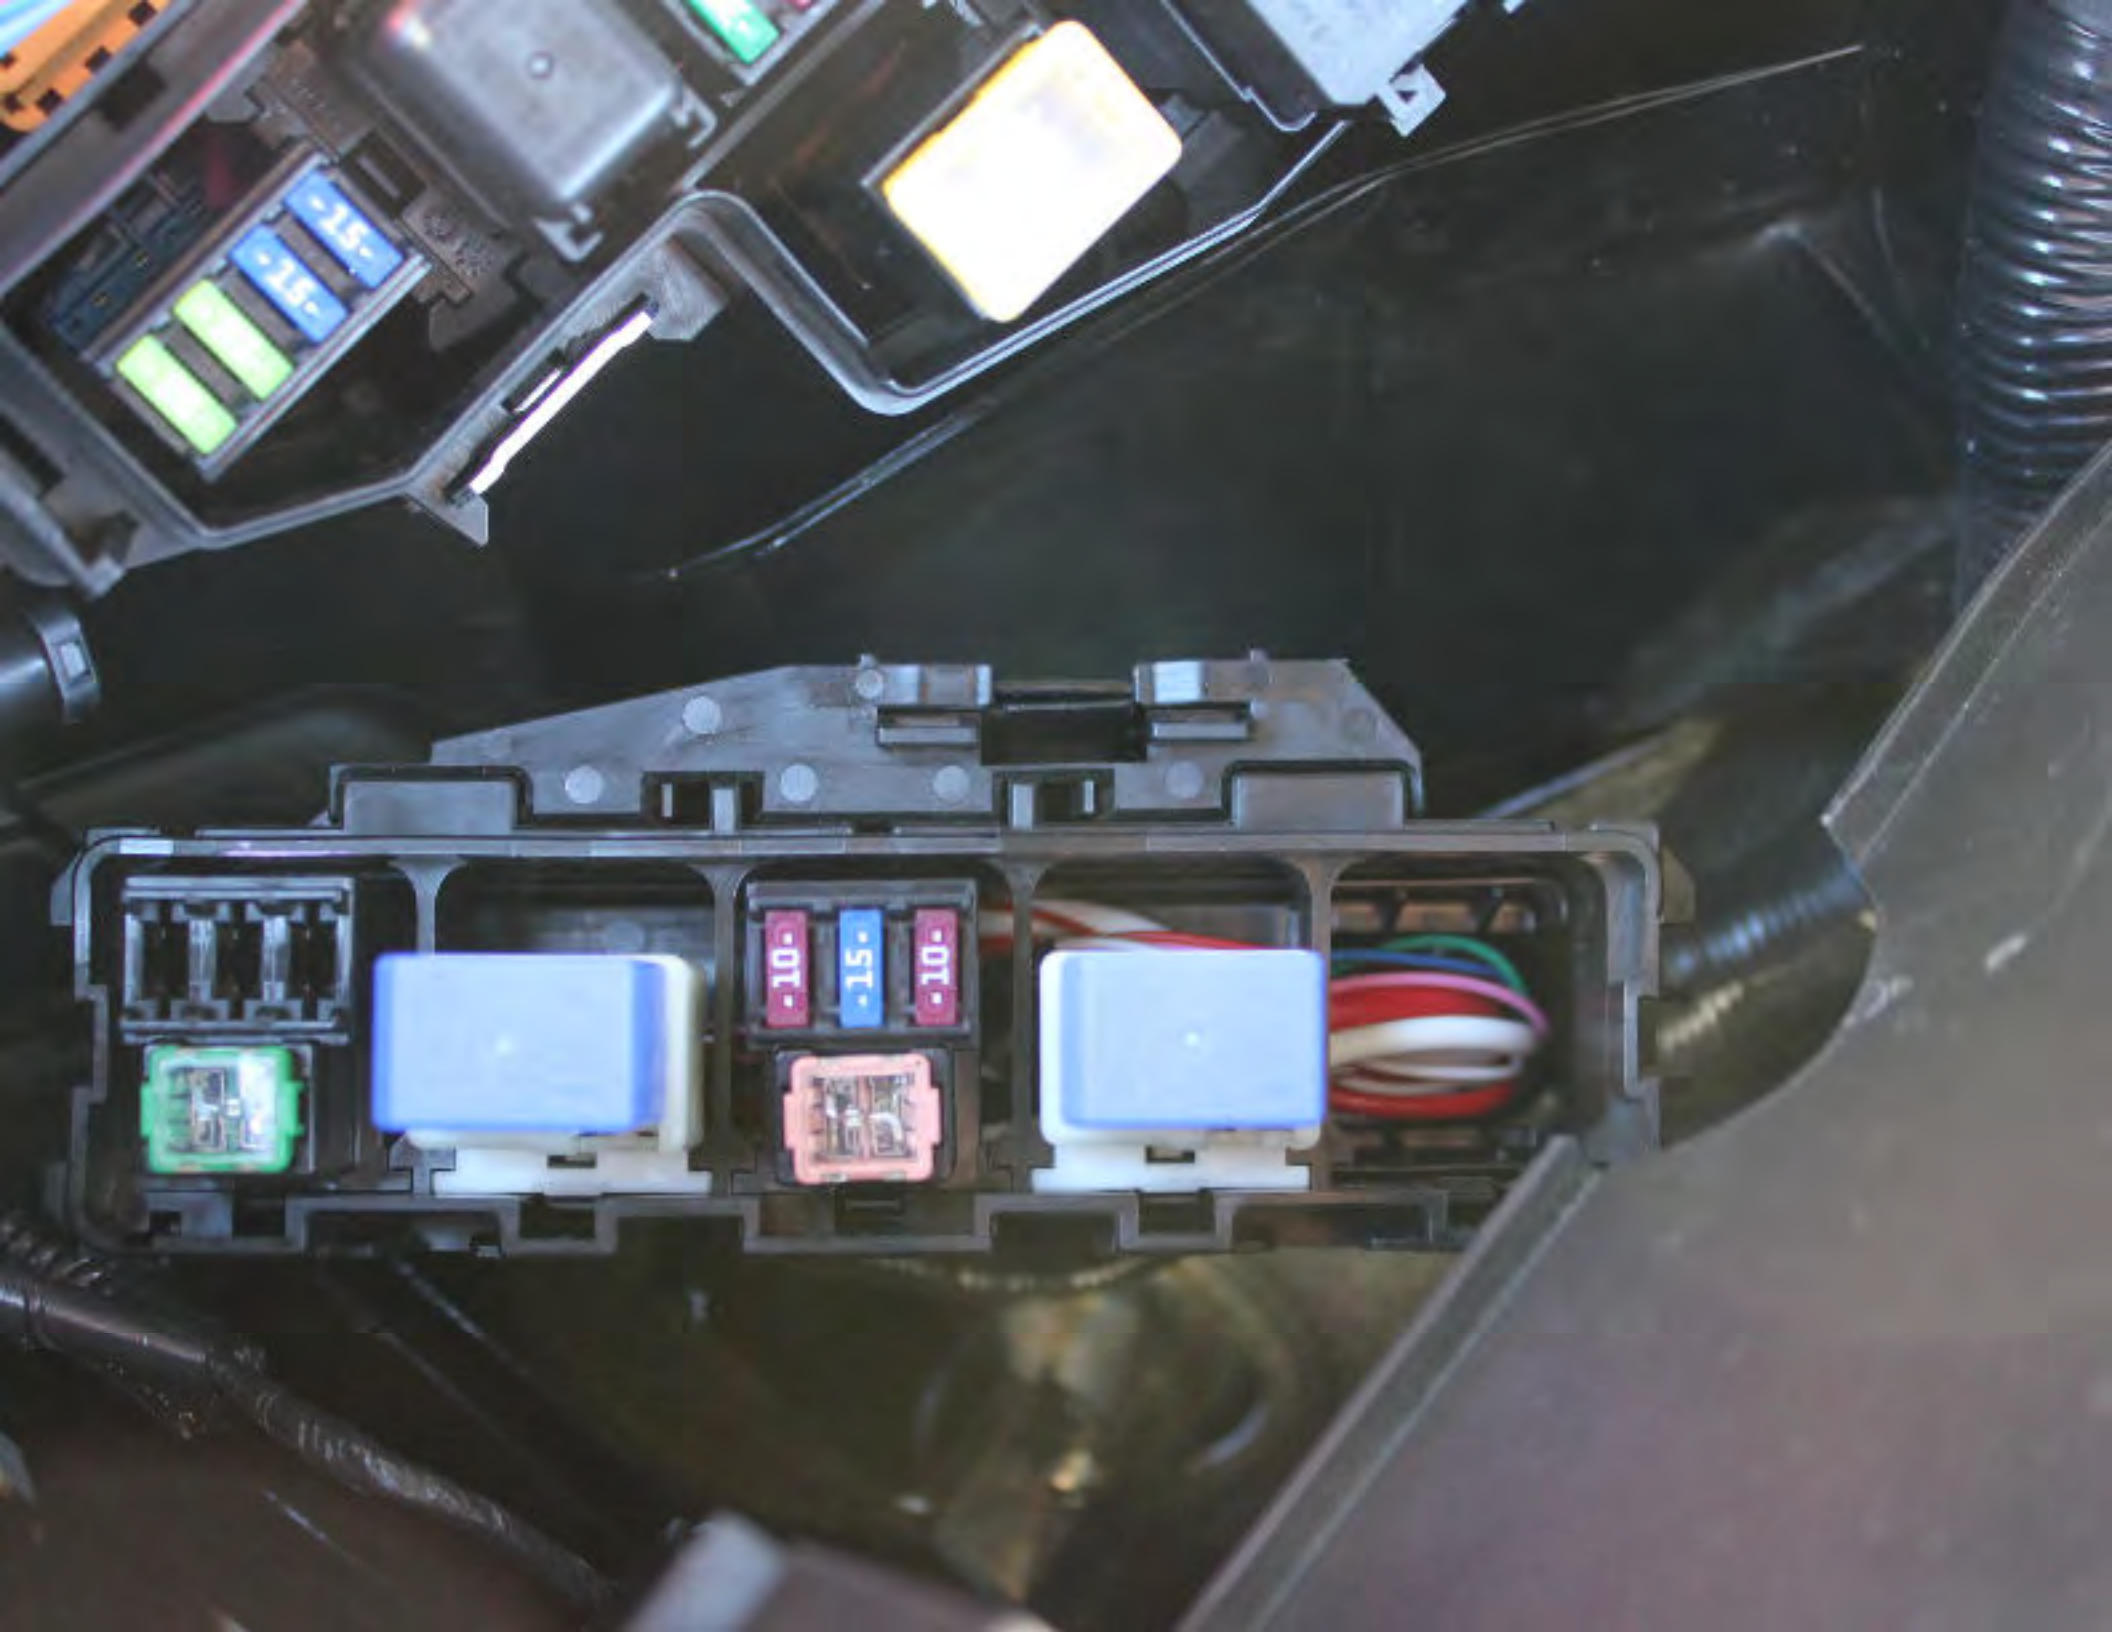
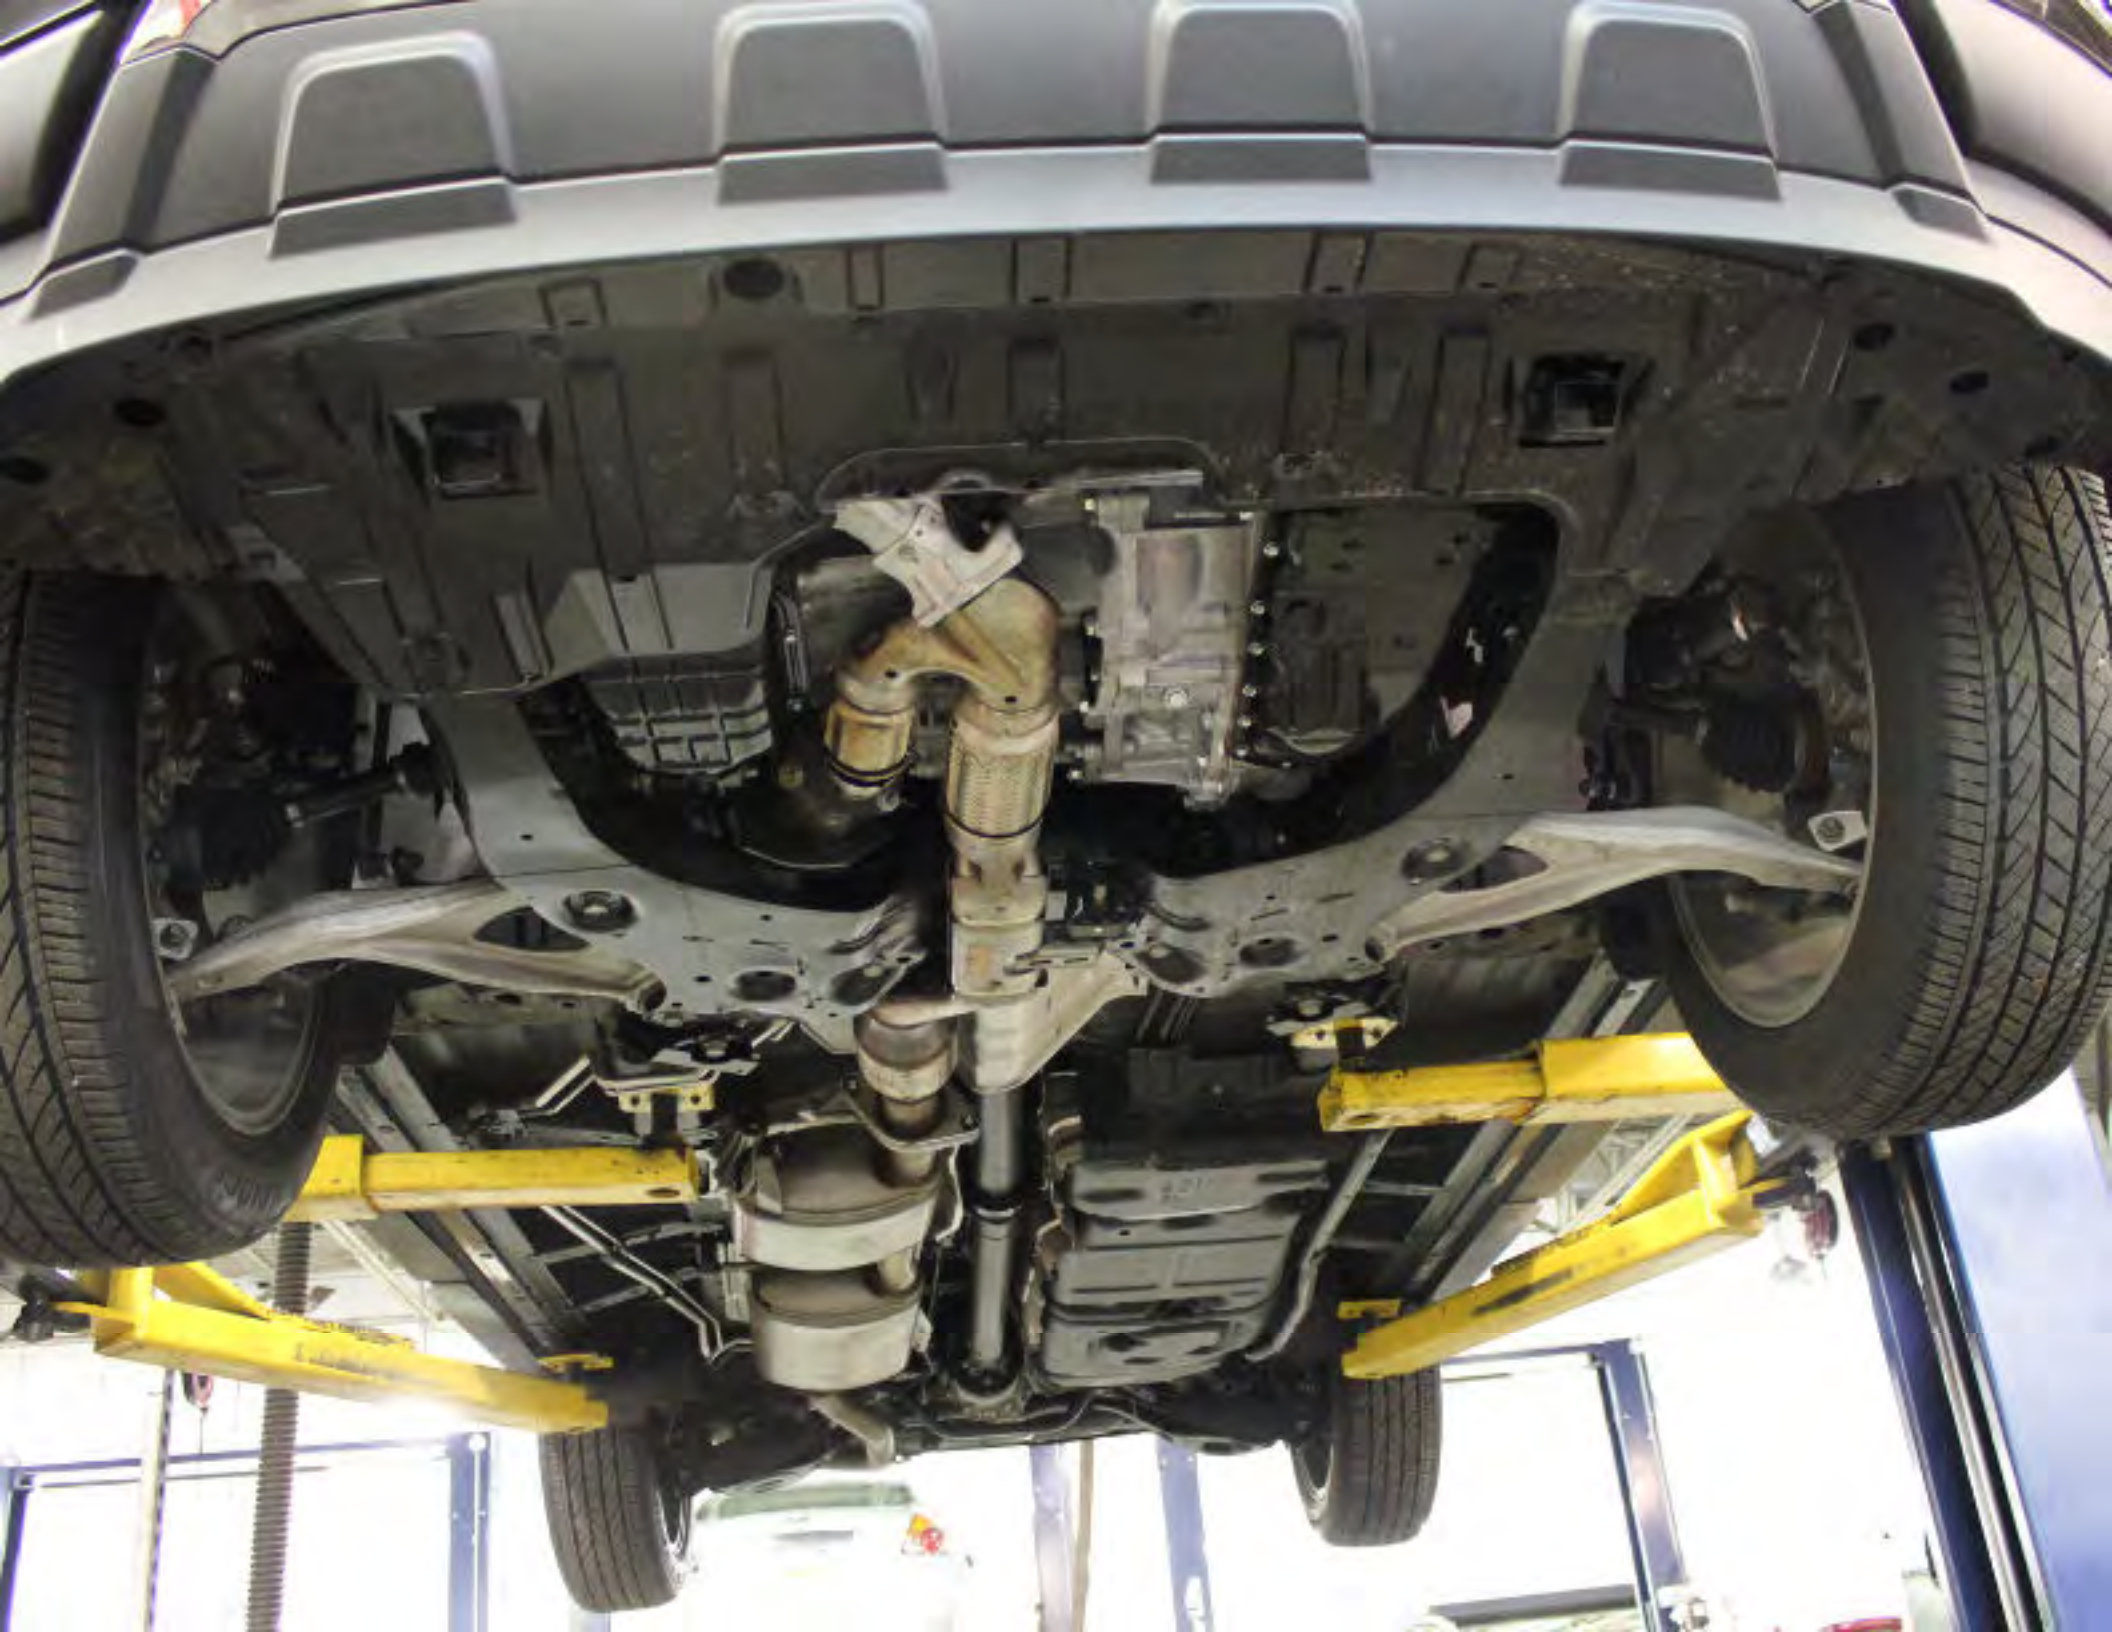
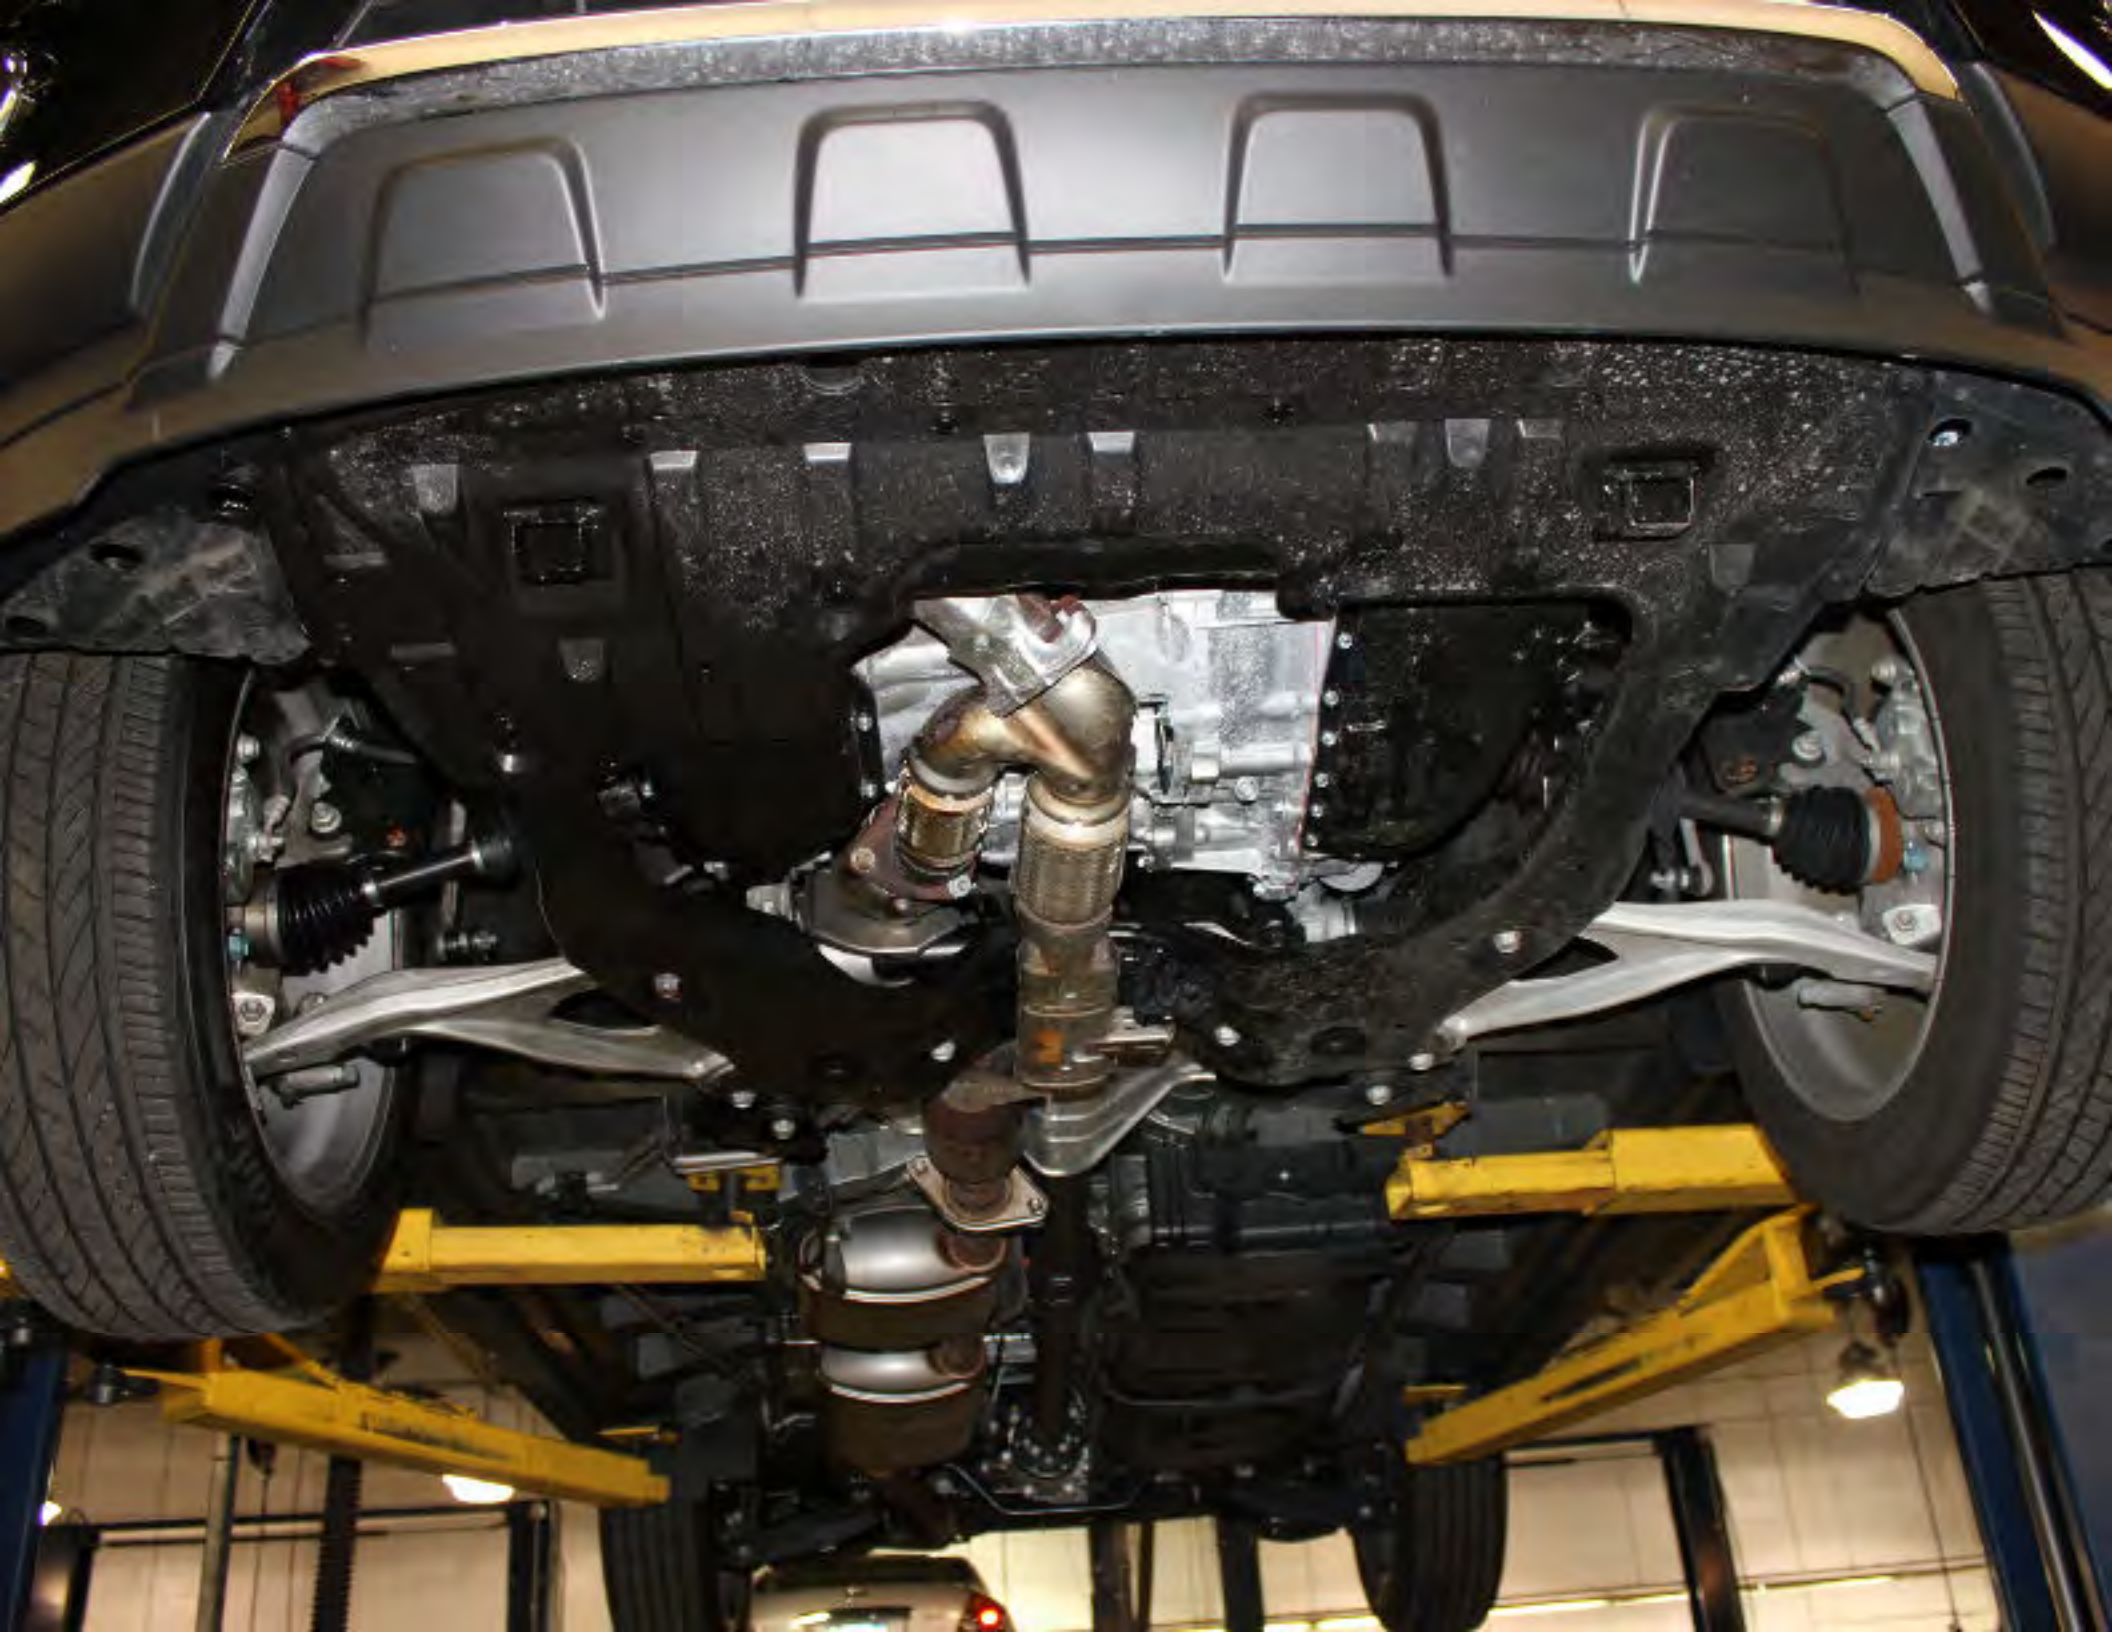
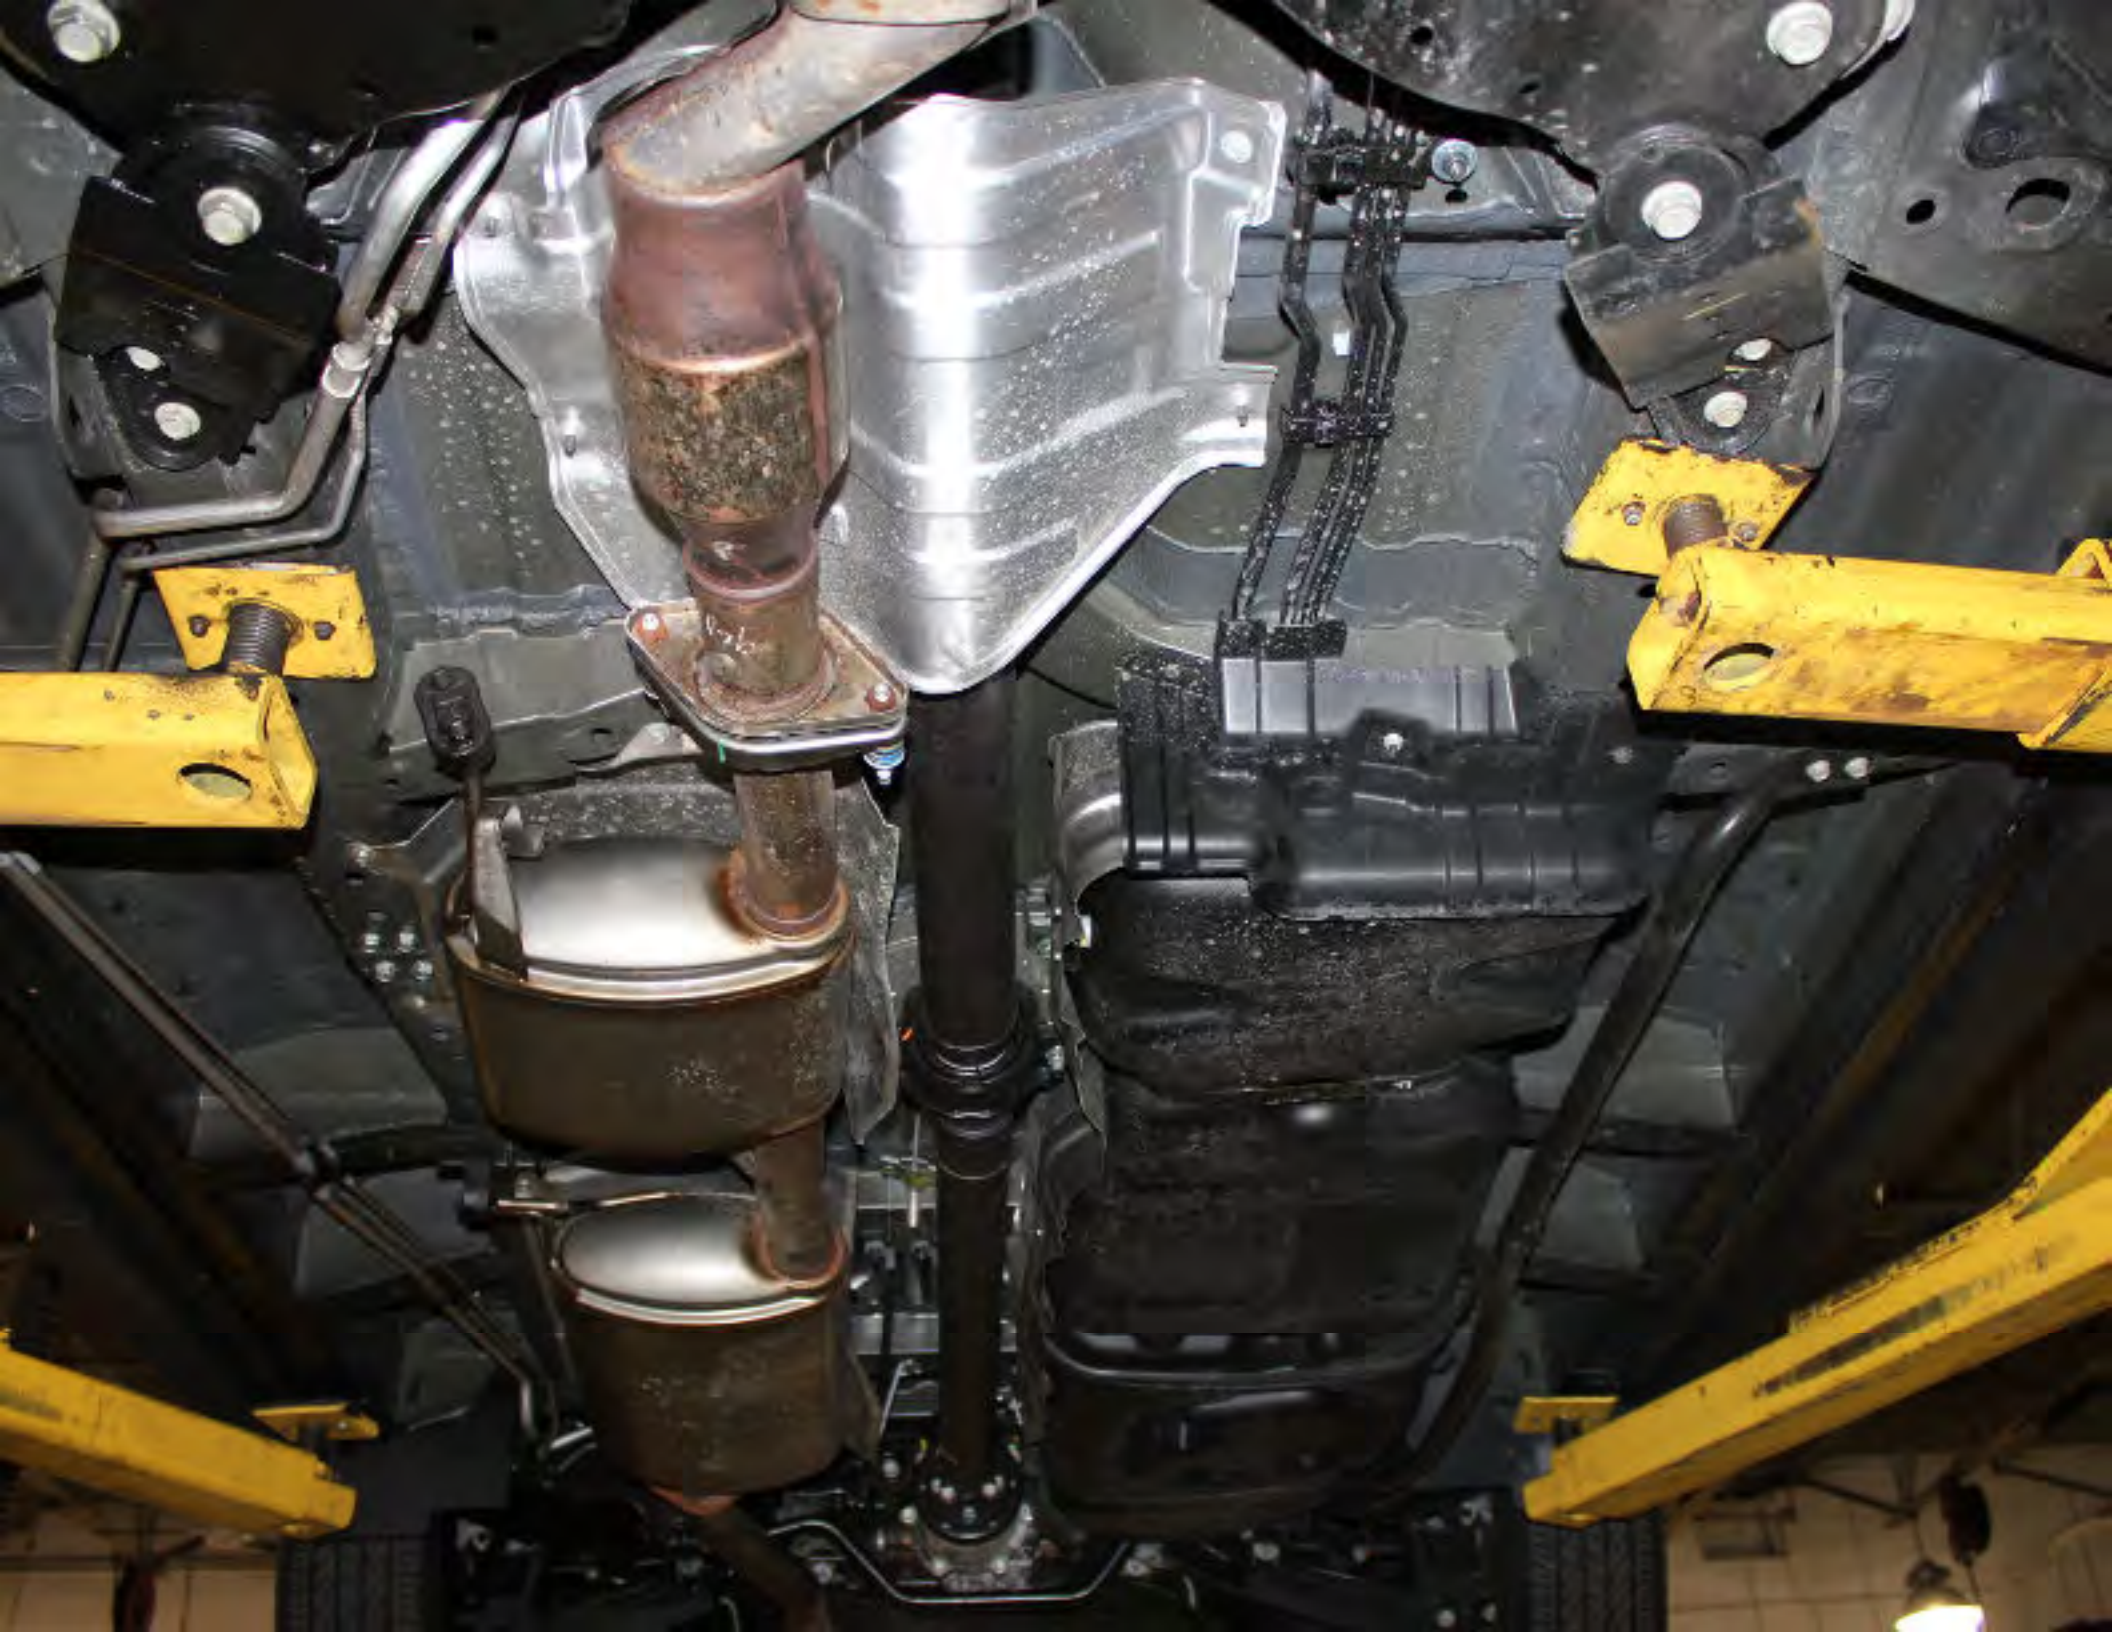
- No thermal damage noted.
  - Note: oily liquid film on right front underside. See photo 36 to 45.
  - Note: stains on exhaust flex pipe. See photos 40 & 44.

#	Allegation	Factual Findings
1	Loss of Power and Smoke in Cabin	See repair order 184360 attached. Oily liquid on underside of vehicle. Stains on exhaust flex pipe. See observations and findings.
2	N/A	N/A
3	N/A	N/A
4	N/A	N/A
5	N/A	N/A
