| | GROUP TRA | MODEL 2015MY K900 (KH) |
| | NUMBER 054 (REV 1, 11/04/2014) | DATE September 2014 |
| TECHNICAL SERVICE BULLETIN | | |
| SUBJECT: COMBINED TSB/SERVICE ACTION: K900 (KH) SHIFT LOGIC IMPROVEMENT - TCM UPGRADE (SA174) | | |

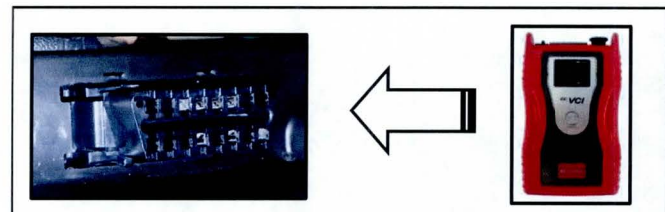
3. Connect the Main 16-pin DLC cable (GHDM – 241000) to the VCI.

4. Connect the Main 16-pin DLC cable (GHDM – 241000) to the OBD-II connector, located under the driver's side of the instrument panel.

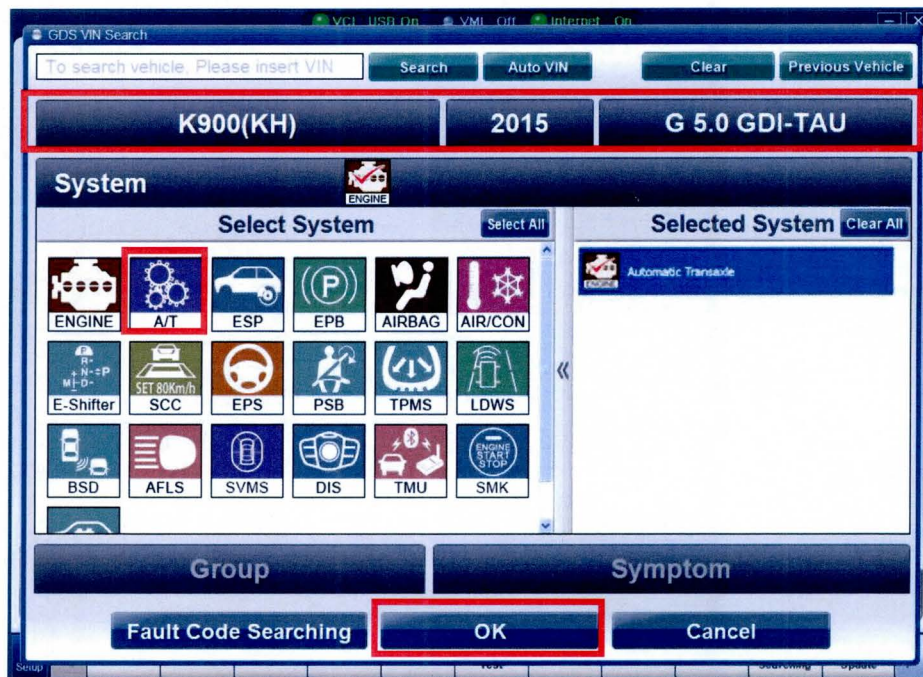
5. With the ignition key ON, turn ON the VCI and GDS. Access the GDS vehicle identification number (VIN) screen and configure the vehicle using the **VIN AUTO DETECT** Function.
6. Select **A/T** system and click **OK**.
