# Technical Service Bulletin

SUBJECT: <b>CHECK ENGINE LIGHT ILLUMINATES WITH DTC RELATED TO PARKING SENSOR SYSTEM FAULT</b>			No: <b>TSB-23-54-006</b>
			DATE: <b>September 2023</b>
			MODEL: <b>See below</b>
<b>CIRCULATE TO:</b>	<input type="checkbox"/> GENERAL MANAGER	<input checked="" type="checkbox"/> PARTS MANAGER	<input checked="" type="checkbox"/> TECHNICIAN
<input checked="" type="checkbox"/> SERVICE ADVISOR	<input checked="" type="checkbox"/> SERVICE MANAGER	<input checked="" type="checkbox"/> WARRANTY PROCESSOR	<input checked="" type="checkbox"/> SALES MANAGER

This reflash is to correct the SONAR Control Unit (CU) software when the check engine illuminates while driving at low speed or upon deceleration before stopping. One of the following DTC codes may be present: B2729-97, B272A-97, B272B-97, B272C-97, B2720-97, B2721-97, B2722-97, OR B2723-97. When DTC(s) are detected, a warning light with the message "Parking Sensor System Fault See Owner's Manual" is displayed.

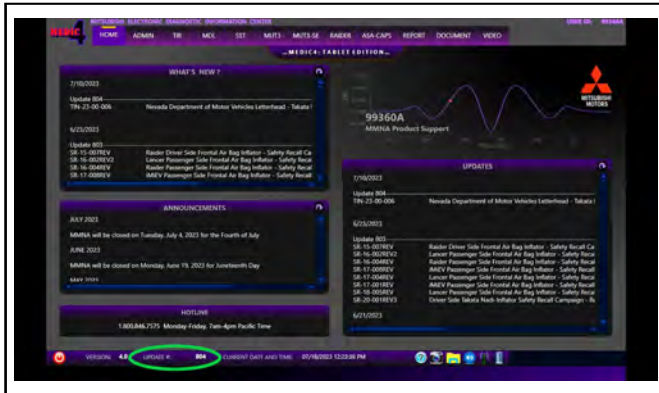
If your **MEDIC 3.5/4 update is at least 815**, continue with the Reprogramming Procedure. If your **MEDIC 3.5/4 update is below 815**, update your MEDIC as follows.

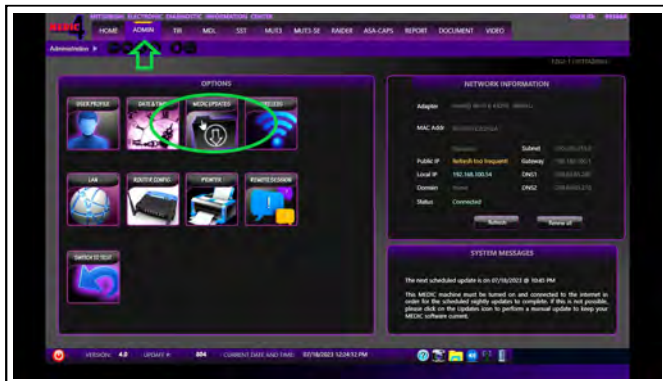
3. Select the MEDIC 3.5/4 Admin tab and click on "Updates".

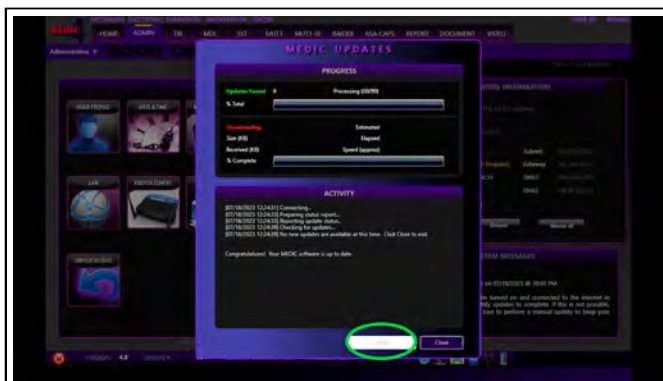
4. If the MEDIC update screen advises updates are available, click the "Begin" button. After all updates are complete, **GO TO THE REPROGRAMMING PROCEDURE**.

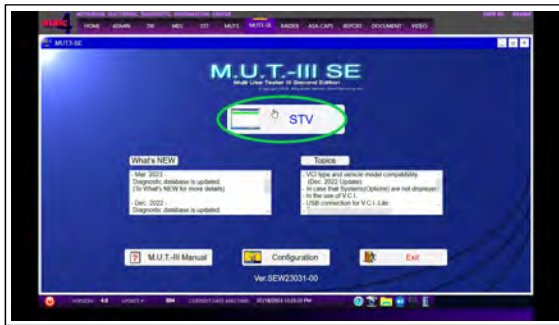
5. Click "STV".

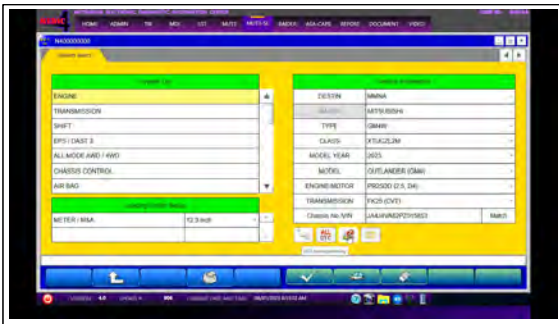
a. Confirm the vehicle information is accurate and click the ECU reprogramming button.

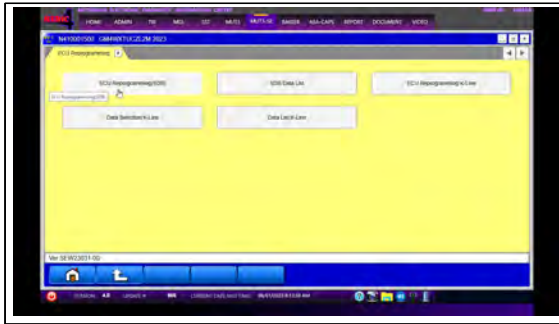
b. Click "ECU Reprogramming (SDB) and press the OK button".

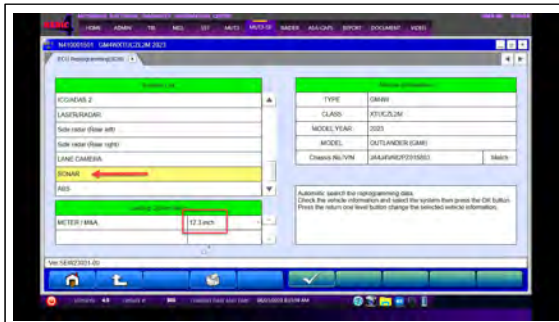
c. Select "SONAR" in the System List, choose the Loading Option Setup for METER/M&A from the drop down and press the OK button.

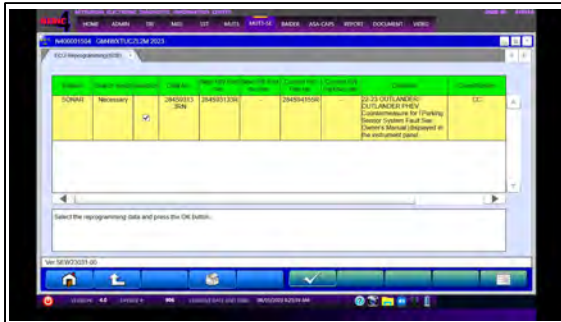
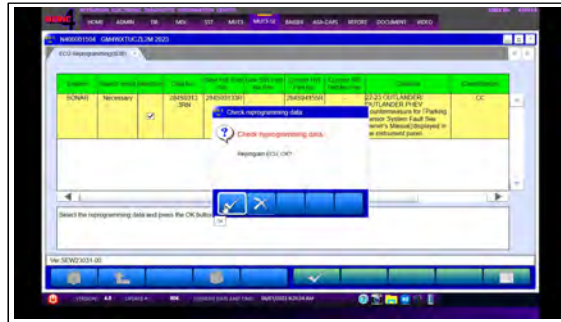
- d. Confirm that the database number displayed is **N230401NR** or higher.
- If the database number displayed on your MUT3-SE is **N230401NR** or greater, continue to the next section.
  - If the reprogramming database number displayed on your MUT3-SE is lower than **N230401NR**, then the MUT3-SE database needs to be updated.
- e. Confirm the New HW Part No., click in the selection box and press the OK button.

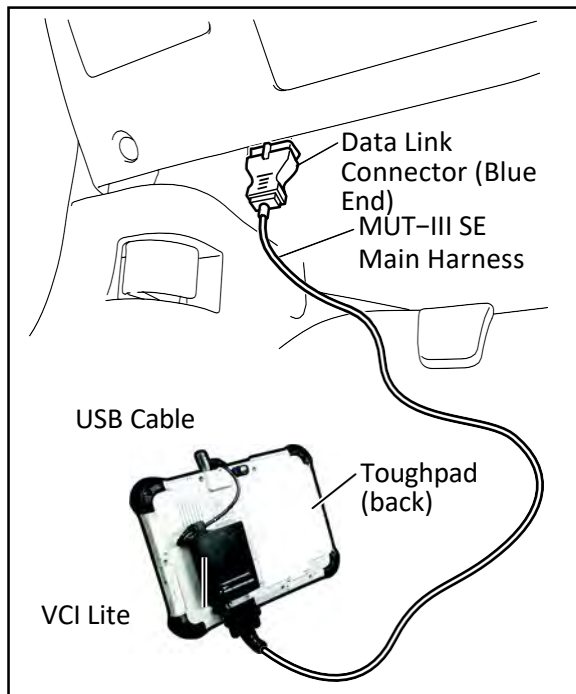
1. Connect the equipment as follows:

**NOTE:** VCI Lite and MEDIC 4.0 Toughpad shown for illustration purposes only.

- Turn the MEDIC PC/tablet on. If the battery indicator in the lower right hand corner of the screen does not show a full charge, it is recommended that either the battery be charged prior to beginning or be used with the A/C power adaptor connected.
- Connect the USB cable to the VCI/VCI Lite. When the laptop/tablet displays the MUT-III SE main screen, connect the USB cable to the device.
- Connect the MUT-III SE main harness with the blue DLC connection to the VCI/VCI Lite. Connect the blue connection of the MUT-III SE main harness to the vehicle's data link connector.
- For VCI only (p/n MB991824): Turn the VCI power switch ON. Verify that the indicator lamp in the upper right corner of the screen is green.

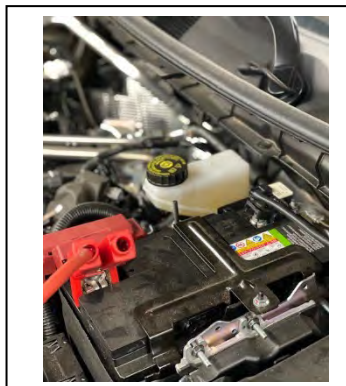
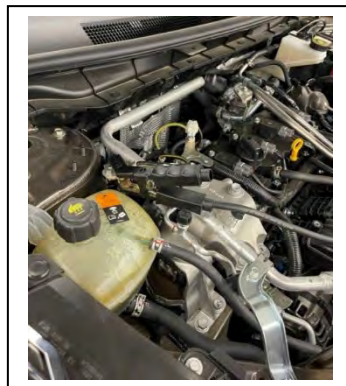
**NOTE:** Due to limited space it may be easiest to connect cable onto negative ground post and ground strap as shown below.

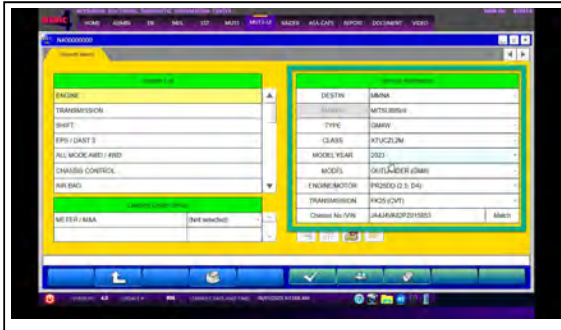
3. Using MEDIC, from the main page, click the "MUT3-SE" icon at the top center of the screen.

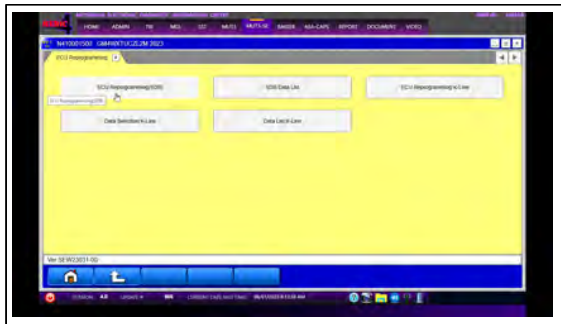
5. Verify that the ECU has not already been updated to the latest S/W number shown in the "ECU Reprogramming Chart" in this TSB. If the ECU is at the latest level, reprogramming is **not** necessary. If reprogramming is necessary, proceed with the following steps.

a. Select ECU Reprogramming (SDB).

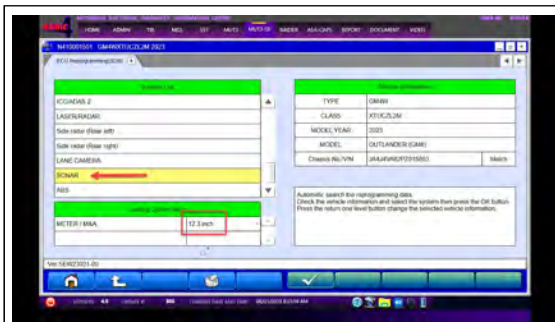
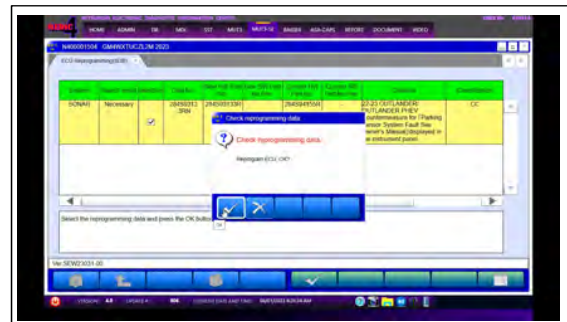
b. Select "SONAR" in the System List, choose the Loading Option Setup for METER/M&A from the drop down and press the OK button.

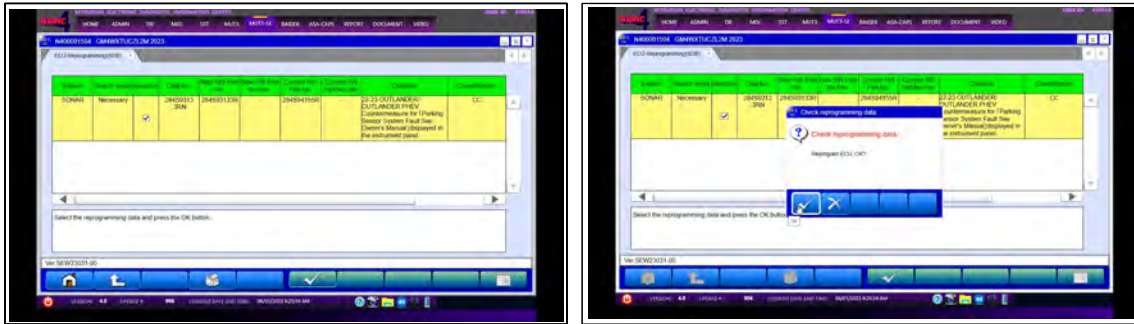
c. Click the selection box and press the OK button to begin reprogramming data.

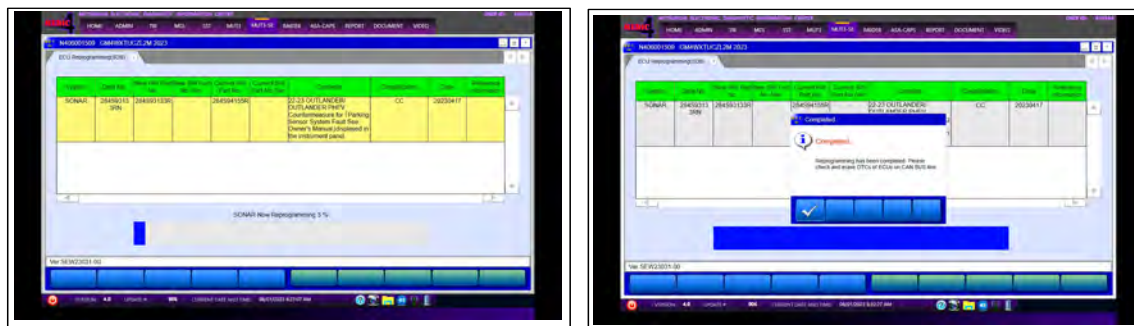
d. Reprogramming will begin and a progress bar will appear followed by a notification upon successful completion.

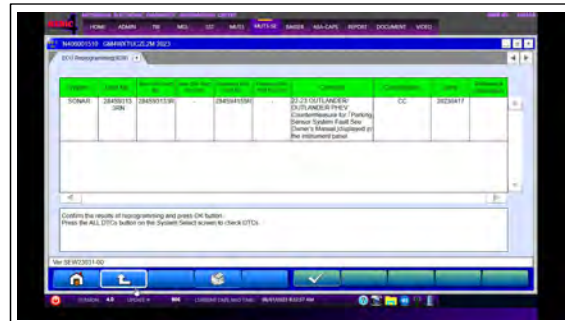
e. Confirm the reprogramming results and press the OK button.

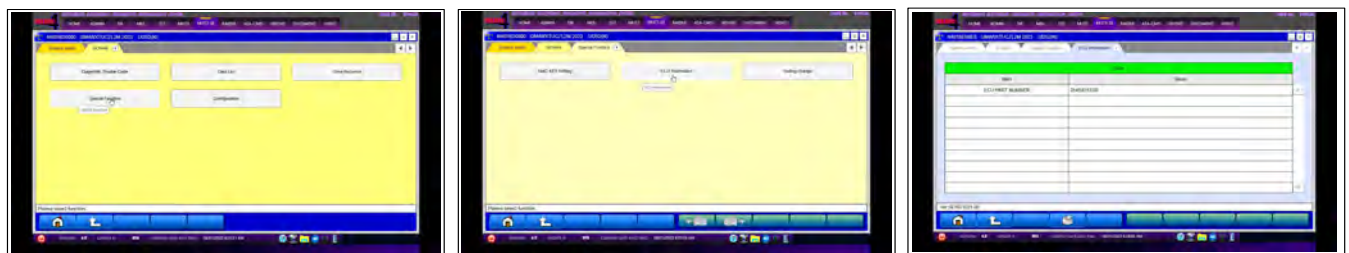
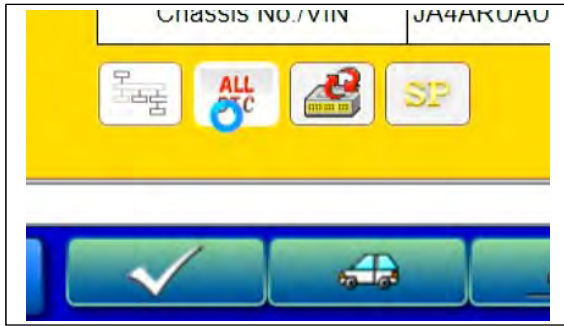
f. To verify the ECU information, click home, select the Special Function tab, then press the ECU Information button.

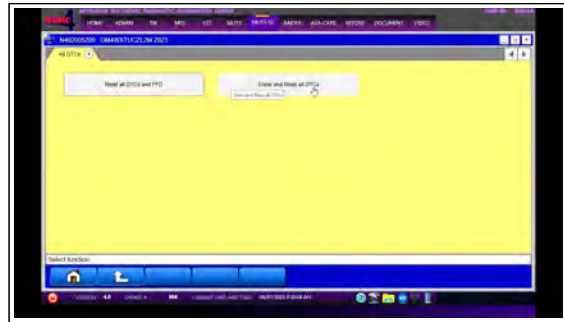
g. Select ALL DTCs.

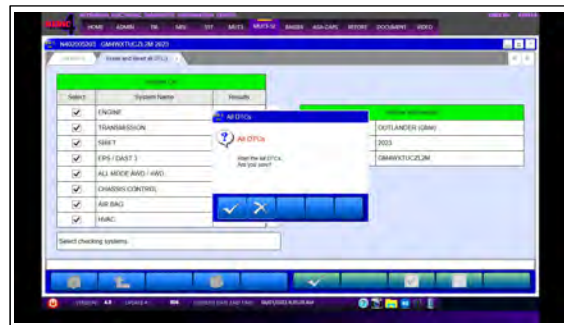
h. Select Erase and Read all DTCs.

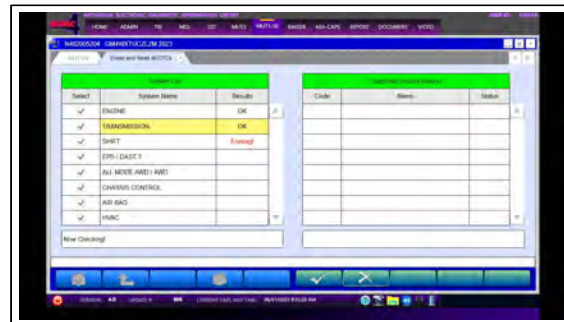
i. Click the OK button to begin.

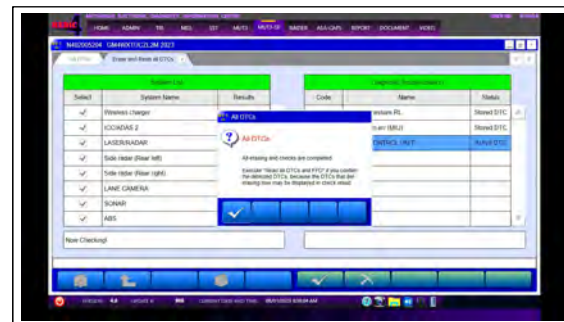
j. Results and a completion notification will be displayed.

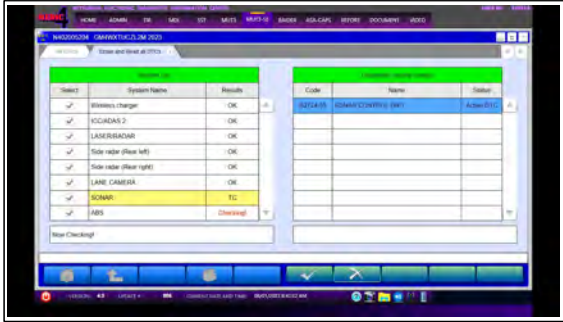
- k. If an active DTC is found after reprogramming, perform auto-configuration according to the Service Manual, confirm DTC is no longer active and erase DTC's in all systems.

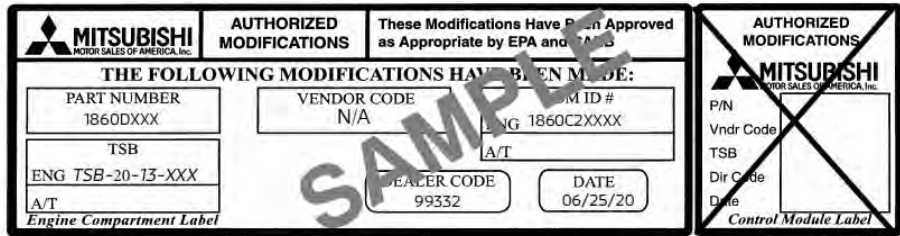
- 6. Using a ball-point pen, enter the appropriate ECU part number, Software Part Number (ROM ID#), this Technical Service Bulletin number, your dealer code, and the current date on the Engine Compartment/Control Module Label (p/n MSSF024G00). The Vendor Code is not applicable. The label is available from your facing PDC.
