# FACILITY CONDITION ASSESSMENT

Newark School District  
5715 Musick Avenue  
Newark, California 94560

FACILITY CONDITION ASSESSMENT  
OF  
BIRCH GROVE INTERMEDIATE  
37490 BIRCH STREET  
NEWARK, CALIFORNIA 94560

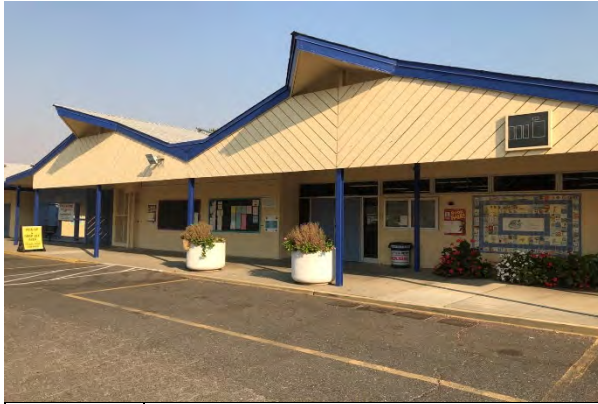
#1	FRONT ELEVATION, BUILDINGS 1, 2 AND 3
----	---------------------------------------

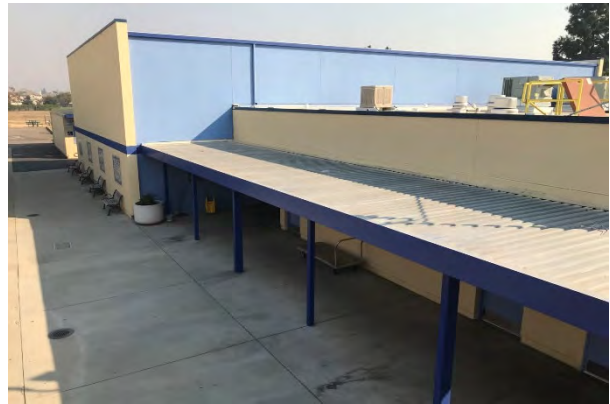
#4	FRONT ELEVATION, MULTIPURPOSE BUILDING
----	--

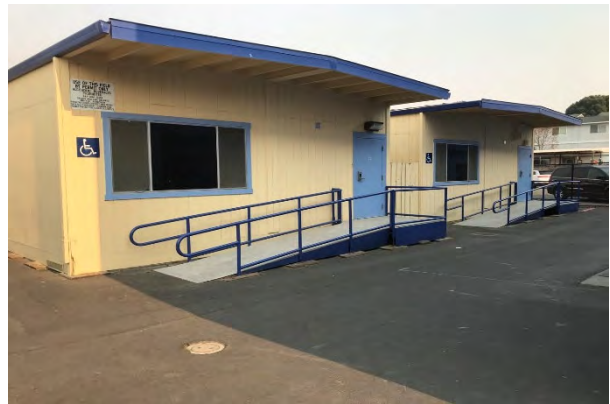
#6	FRONT ELEVATION, PORTABLES
----	----------------------------

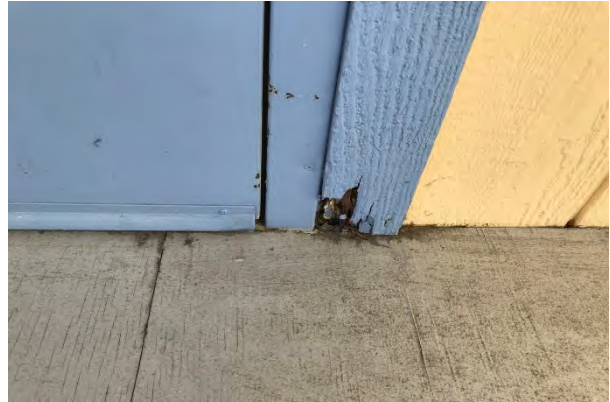
#8	ROT AT PORTABLES
----	------------------

<b>Plumbing</b>	Copper supply and cast iron waste and venting	Fair
<b>HVAC</b>	Individual package heat pump units	Fair
<b>Fire Suppression</b>	Fire extinguishers	Fair
<b>Electrical</b>	Source and Distribution: Main panel with copper wiring Interior Lighting: T-8, T-5 Emergency: None	Fair
<b>Fire Alarm</b>	smoke detectors, alarms, strobes, pull stations, and exit signs	Fair
<b>Equipment/Special</b>	None	--
<b>Accessibility</b>	Presently it does not appear an accessibility study is needed for this building. See Appendix C.	
<b>Key Issues and Findings</b>	Rotting and loose siding, outdated fire alarm system

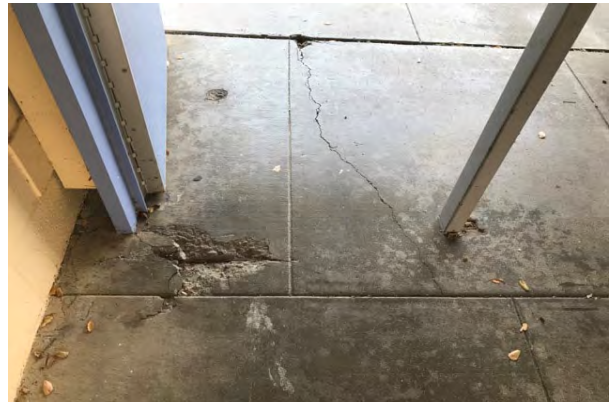
#16	CRACKING AND UPLIFT SEEN AT MUCH OF THE FLATWORK
-----	--

<b>Key Issues and Findings</b>	significant sidewalk trip hazards, damaged landscaping antiquated irrigation inadequate site lighting

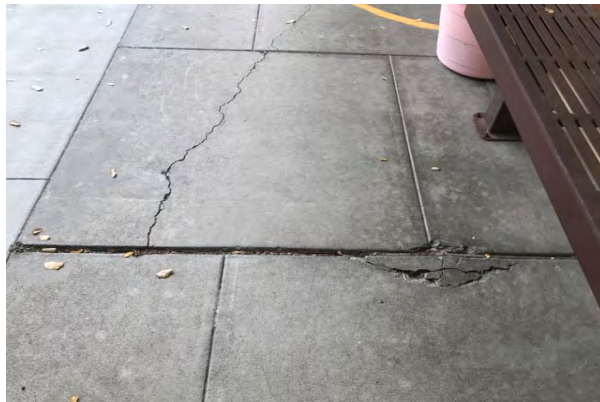
#17	CRACKING AND UPLIFT SEEN AT MUCH OF THE FLATWORK
-----	--

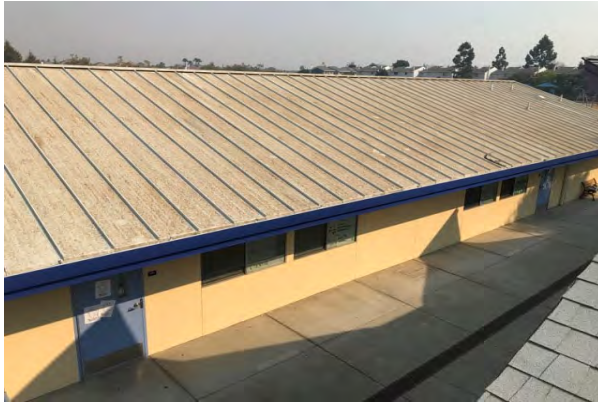
#19	METAL ROOF AT 3A AND 3B
-----	-------------------------

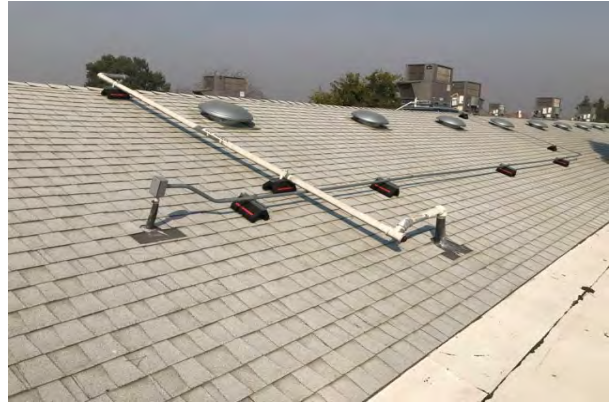
#20	ASPHALT SHINGLES AT BUILDINGS 1, 2 AND 3
-----	--

The classroom building exterior walls are exposed CMU or have a stucco finish. In 2016, the sloped roofs were re-roofed with asphalt shingles and new TPO was installed over the multipurpose building. Roofs over the walkways are metal or modified bitumen, these roofs are not new and replacement is anticipated. The exteriors have recently been upgraded. Replacing the full height single-glazed storefront assemblies with double-glazed windows and a knee wall is recommended and budgeted.

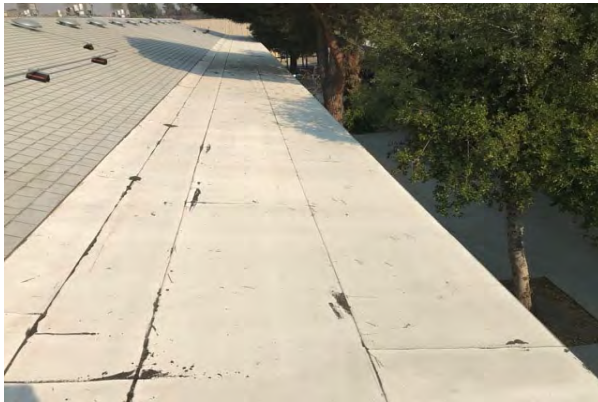
#21	MODIFIED BITUMEN AT BUILDINGS 1, 2 AND 3
-----	--

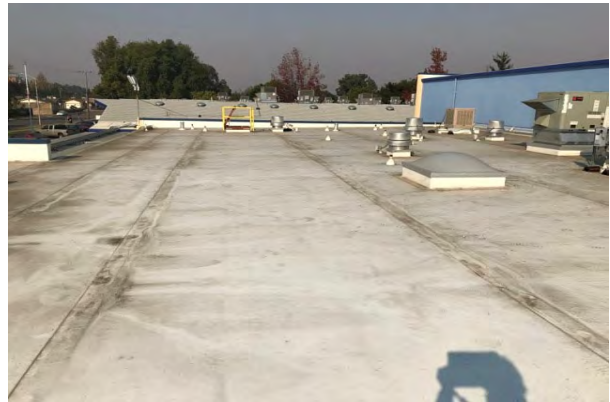
#22	TPO AT MULTIPURPOSE BUILDING
-----	------------------------------

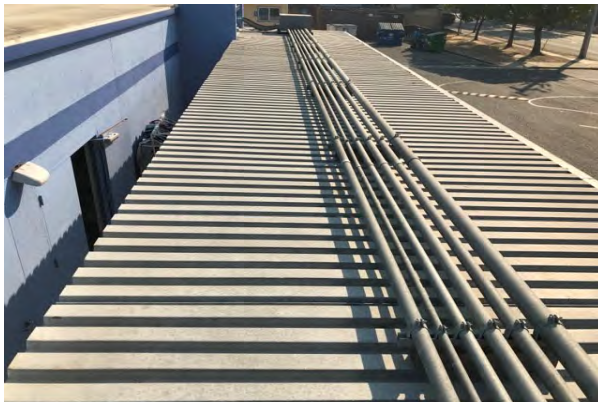
#23	METAL ROOF AT WALKWAYS
-----	------------------------

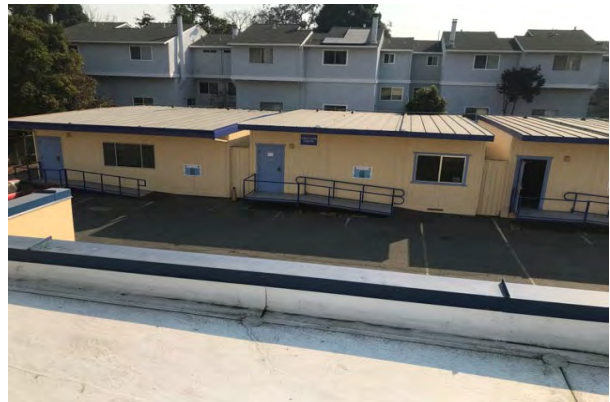
#24	METAL ROOFS AT THE PORTABLES
-----	------------------------------

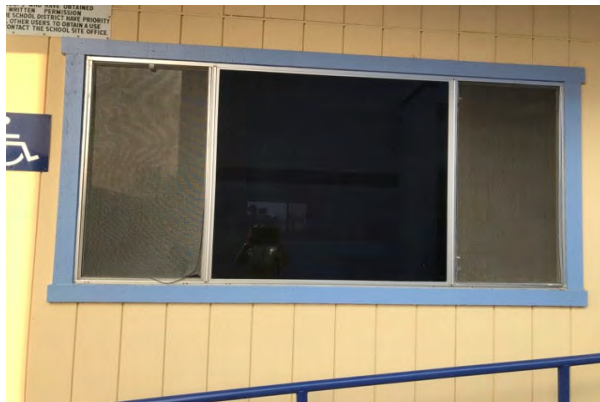
#26	WINDOW, ALUMINUM
-----	------------------

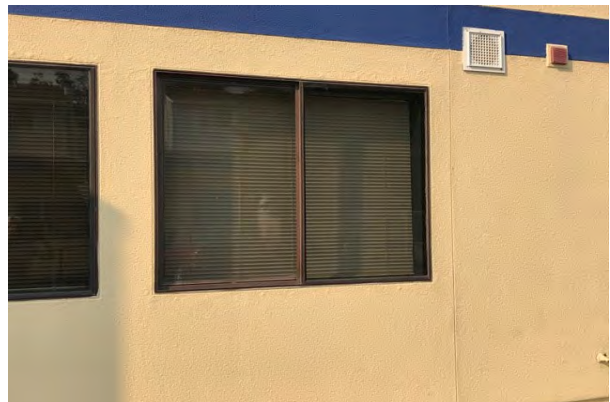
#27	WINDOW AT PORTABLE ALUMINUM DOUBLE-GLAZED
-----	---

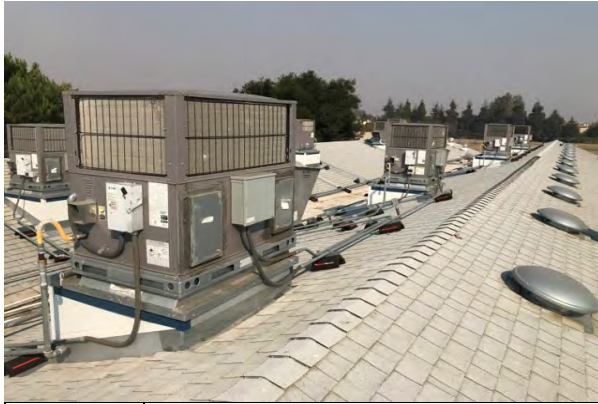
#30	HVAC AT THE MULTIPURPOSE BUILDING
-----	-----------------------------------

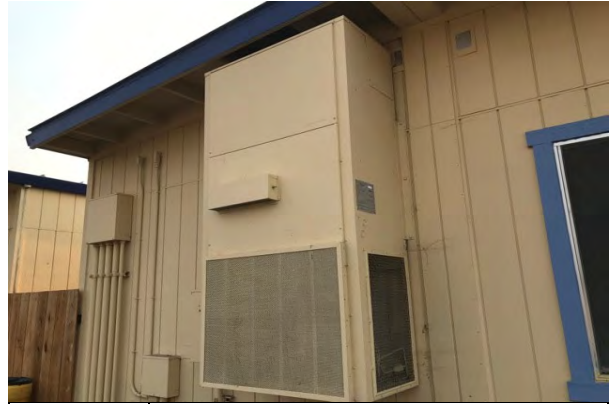
#31 HVAC AT BUILDINGS 1, 2 AND 3

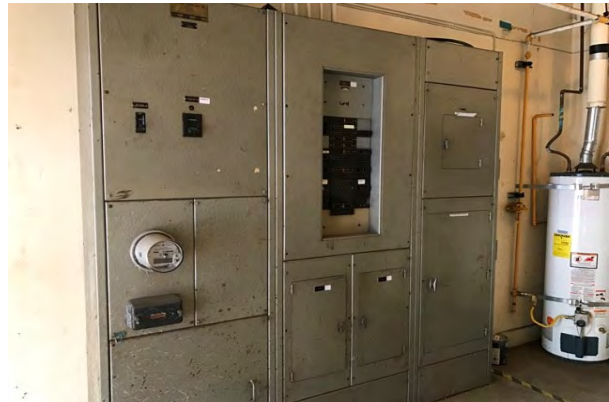
#33 BUILDING/MAIN SWITCHGEAR

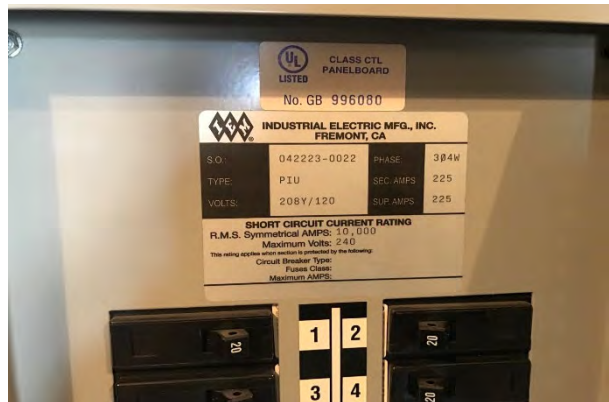
#35 DISTRIBUTION PANEL

11	1089863	D5012	<b>Distribution Panel [Panel D]</b>	225 AMP	Birch Grove Intermediate / Building 3, Classrooms 14 - 21	Electrical room	Zinsco	No tag/plate found	An 9408505	1990		
12	1090339	D5012	<b>Distribution Panel [Pnl A]</b>	225 AMP	Birch Grove Intermediate / Building 1, Classrooms 1 - 7	Classrooms	Industrial Electric	NDP	291698			
13	1090330	D5012	<b>Distribution Panel [PP1]</b>	225 AMP	Birch Grove Intermediate / Building 1, Classrooms 1 - 7	Room three	Industrial Electric	PIU	991219	2002		
14	1090329	D5012	<b>Distribution Panel [RP1]</b>	225 AMP	Birch Grove Intermediate / Building 1, Classrooms 1 - 7	Room three	Industrial Electric	PIU	996077	2002		
15	1086104	D5012	<b>Distribution Panel [RP1]</b>	225 AMP	Birch Grove Intermediate / Building 2, Office & Classrooms 8 - 13	Electrical room	Industrial Electric	CDP	042223-0019	2002		
16	1086110	D5012	<b>Distribution Panel [RP2]</b>	225 AMP	Birch Grove Intermediate / Building 2, Office & Classrooms 8 - 13	Electrical room	Industrial Electric	PIU	04223x0022	2002

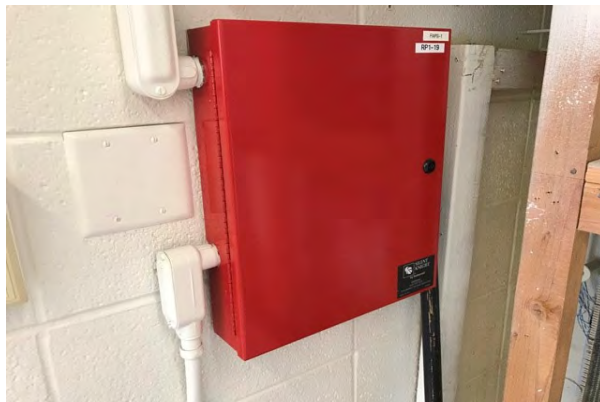
#44	FIRE ALARM
-----	------------

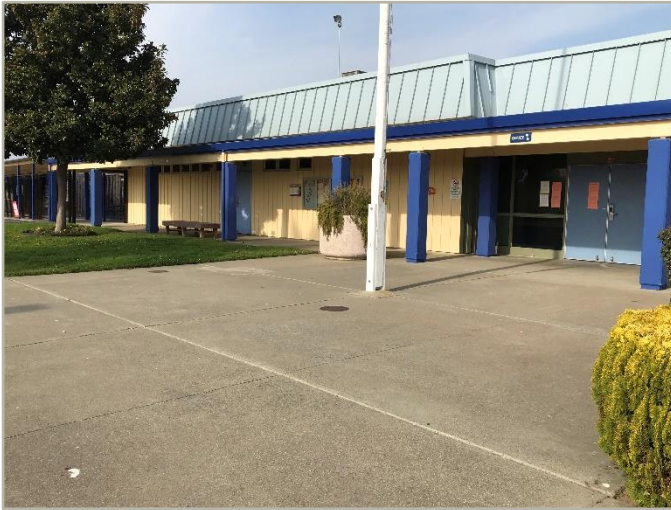
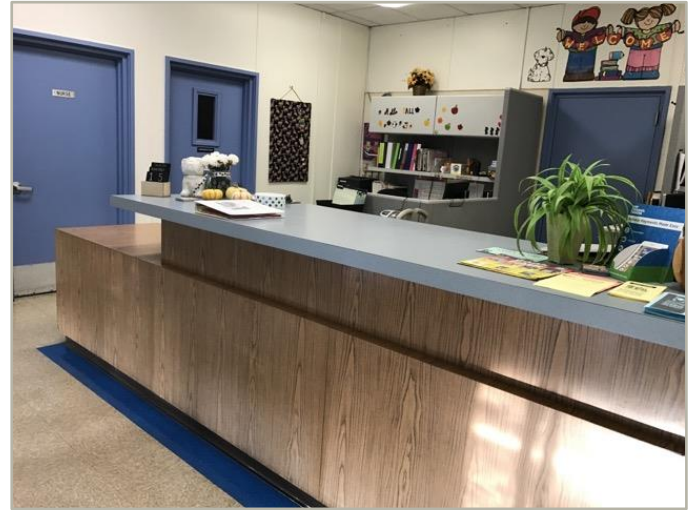
## 2. Unit 1

<b>Constructed/ Renovated</b>	1966/1991/2002	
<b>Building Size</b>	3,600 SF	
<b>Number of Stories</b>	1	
<i>System</i>	<i>Description</i>	<i>Condition</i>
<b>Structure</b>	Conventional wood frame structure on concrete slab	Fair
<b>Façade</b>	Wood siding with aluminum windows	Fair
<b>Roof</b>	Primary: Flat construction with single-ply TPO/PVC membrane Secondary: Mansard construction with metal finish	Good
<b>Interiors</b>	Walls: Painted gypsum board and vinyl Floors: Carpet, VCT Ceilings: ACT	Fair
<b>Elevators</b>	None	--
<b>Plumbing</b>	Copper and galvanized iron supply and cast-iron waste and venting Electric water heater	Fair
<b>HVAC</b>	Individual package units	Fair
<b>Fire Suppression</b>	Hydrants, fire extinguishers	Fair

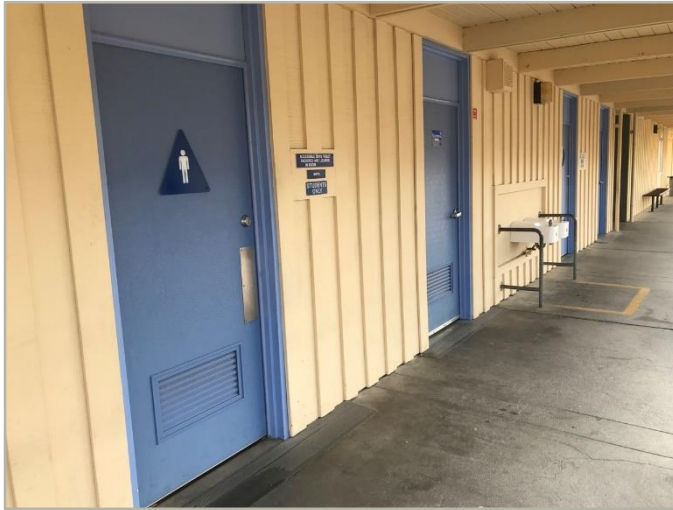
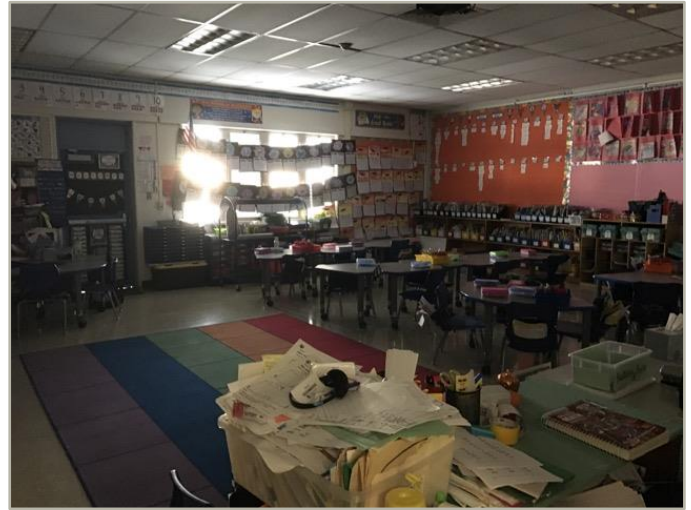
### 3. Unit 2

<b>Constructed/ Renovated</b>	1966/1991/2002	
<b>Building Size</b>	9,720 SF	
<b>Number of Stories</b>	1	
<i>System</i>	<i>Description</i>	<i>Condition</i>
<b>Structure</b>	Conventional wood frame structure on concrete slab	Fair
<b>Façade</b>	Wood siding with aluminum windows	Fair
<b>Roof</b>	Primary: Flat construction with single-ply TPO/PVC membrane Secondary: Mansard construction with metal finish	Good
<b>Interiors</b>	Walls: Painted gypsum board and vinyl Floors: VCT, ceramic tile Ceilings: ACT	Fair
<b>Elevators</b>	None	--
<b>Plumbing</b>	Copper and galvanized iron supply and cast-iron waste and venting No water heaters	Fair
<b>HVAC</b>	Individual package units	Fair
<b>Fire Suppression</b>	Hydrants, fire extinguishers	Fair

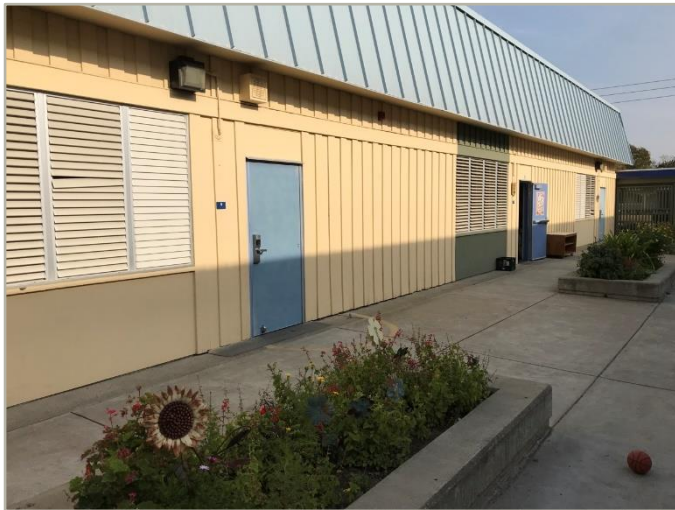
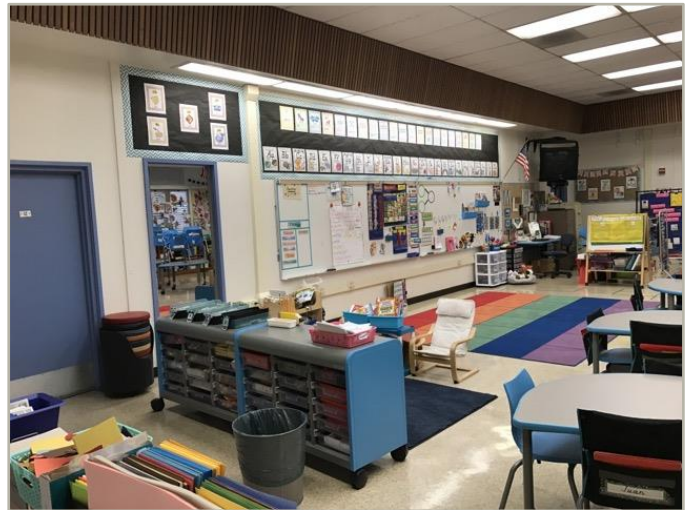
## 4. Unit 3

<b>Constructed/ Renovated</b>	1966/1991	
<b>Building Size</b>	8,100 SF	
<b>Number of Stories</b>	1	
<i>System</i>	<i>Description</i>	<i>Condition</i>
<b>Structure</b>	Conventional wood frame structure on concrete slab	Fair
<b>Façade</b>	Wood siding with aluminum windows	Fair
<b>Roof</b>	Primary: Flat construction with single-ply TPO/PVC membrane Secondary: Mansard construction with metal finish	Good
<b>Interiors</b>	Walls: Painted gypsum board and vinyl Floors: Epoxy, VCT Ceilings: ACT	Fair
<b>Elevators</b>	None	--
<b>Plumbing</b>	Copper and galvanized iron supply and cast-iron waste and venting Electric water heater	Fair
<b>HVAC</b>	Individual package units	Fair

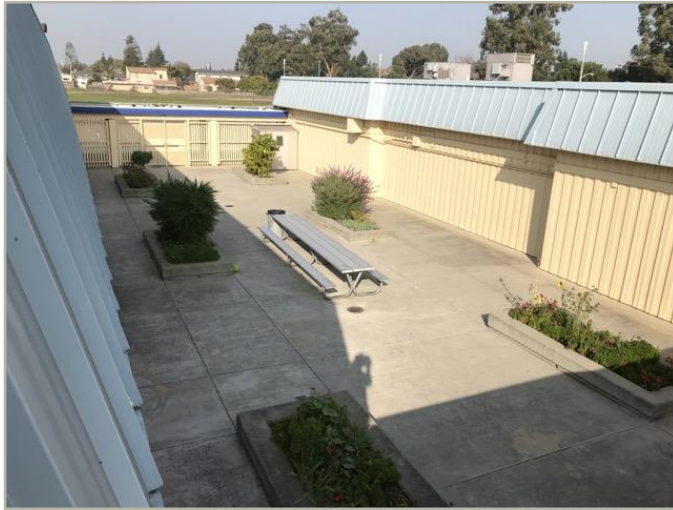
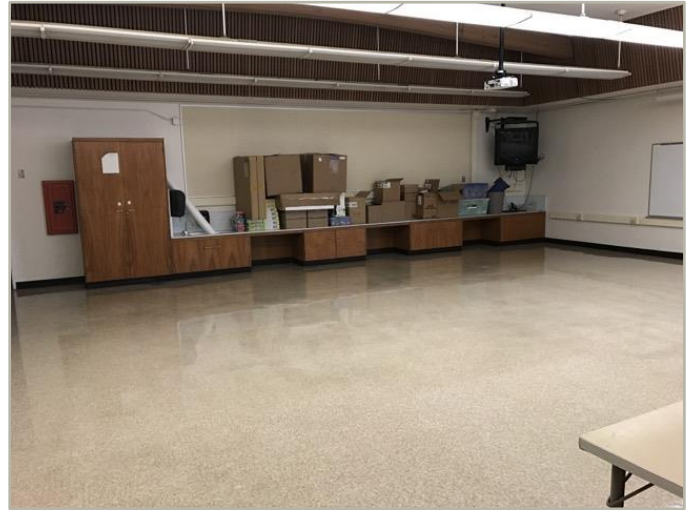
## 5. Unit 4

<b>Constructed/ Renovated</b>	1966/1991/2002	
<b>Building Size</b>	2,900 SF	
<b>Number of Stories</b>	1	
<i>System</i>	<i>Description</i>	<i>Condition</i>
<b>Structure</b>	Conventional wood frame structure on concrete slab	Fair
<b>Façade</b>	Wood siding with aluminum windows	Fair
<b>Roof</b>	Primary: Flat construction with single-ply TPO/PVC membrane Secondary: Mansard construction with metal finish	Good
<b>Interiors</b>	Walls: Painted gypsum board and vinyl Floors: VCT, Epoxy Ceilings: ACT	Fair
<b>Elevators</b>	None	--
<b>Plumbing</b>	Copper and galvanized iron supply and cast-iron waste and venting No water heaters	Fair
<b>HVAC</b>	Individual package units	Fair
<b>Fire Suppression</b>	Hydrants, fire extinguishers	Fair

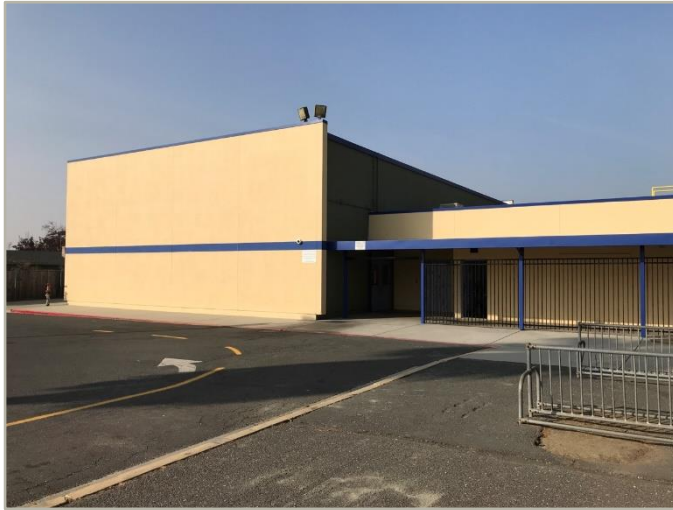
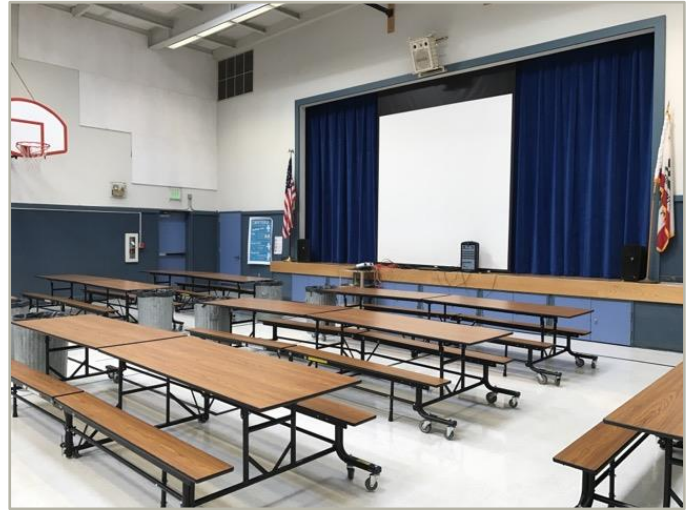
## 6. Unit 5, Multipurpose Room

<b>Constructed/ Renovated</b>	1991	
<b>Building Size</b>	8,700 SF	
<b>Number of Stories</b>	1	
<i>System</i>	<i>Description</i>	<i>Condition</i>
<b>Structure</b>	Conventional wood frame structure on concrete slab	Fair
<b>Façade</b>	Stucco with aluminum windows	Fair
<b>Roof</b>	Primary: Flat construction with single-ply TPO/PVC membrane	Good
<b>Interiors</b>	Walls: Painted gypsum board and vinyl Floors: VCT, quarry tile Ceilings: ACT	Fair
<b>Elevators</b>	Wheelchair lift	Fair
<b>Plumbing</b>	Copper supply and cast-iron waste and venting Gas water heater	Good
<b>HVAC</b>	Individual package units	Fair

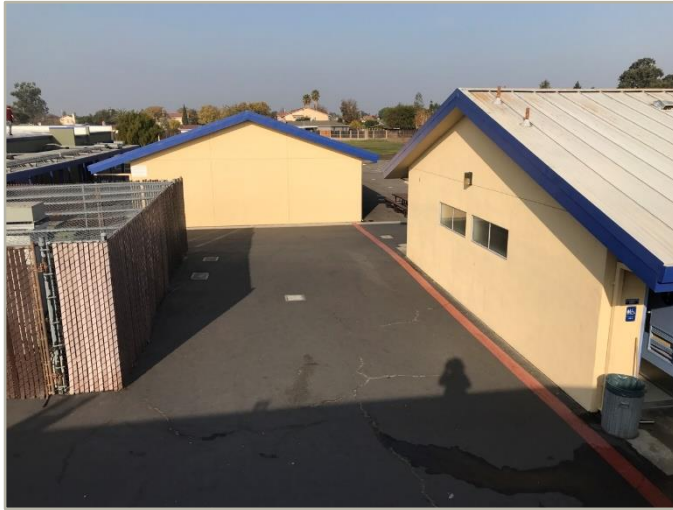
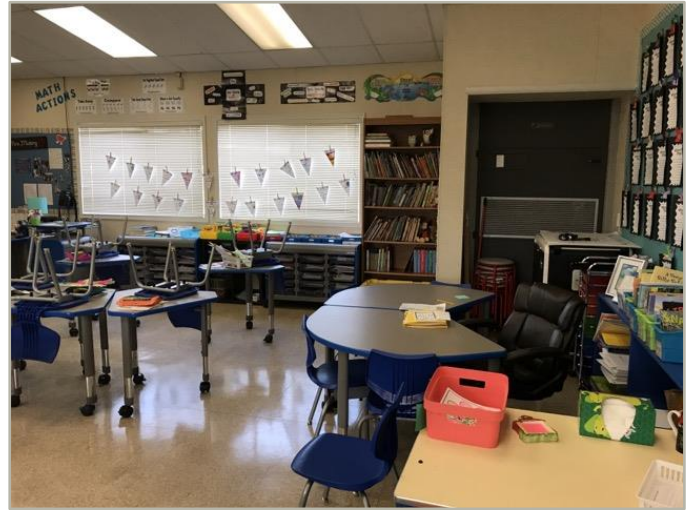
## 7. Unit 6, Portables

<b>Constructed/ Renovated</b>	2002	
<b>Building Size</b>	5,100 SF	
<b>Number of Stories</b>	1	
<i>System</i>	<i>Description</i>	<i>Condition</i>
<b>General</b>	There are two Portable buildings at Birch Grove Primary Elementary School. One is a classroom building and the second is a restroom building.	
<b>Structure</b>	Conventional lightweight metal frame structure on concrete slab	Fair
<b>Façade</b>	Stucco with aluminum windows	Fair
<b>Roof</b>	Primary: Gable construction with asphalt shingles	Good
<b>Interiors</b>	Walls: Painted gypsum board and vinyl Floors: Epoxy, VCT Ceilings: ACT	Fair
<b>Elevators</b>	None	--
<b>Plumbing</b>	Copper supply and cast-iron waste and venting Hot water supplied by the water heater in Unit 5	Good
<b>HVAC</b>	Individual PTAC units, no heat or cooling in the restroom building	Fair

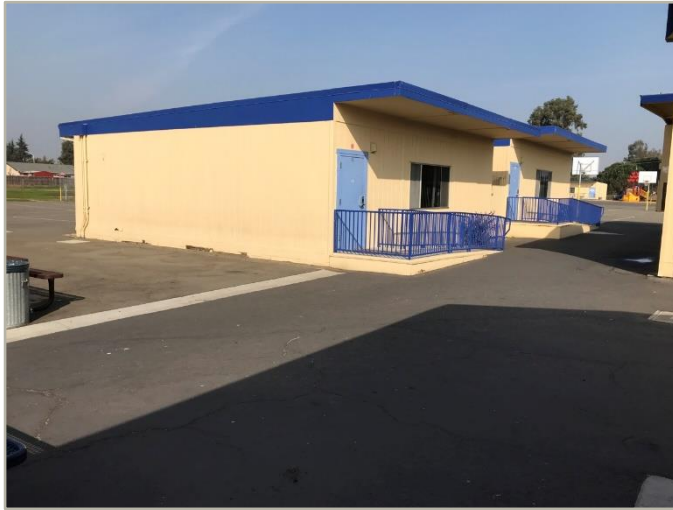
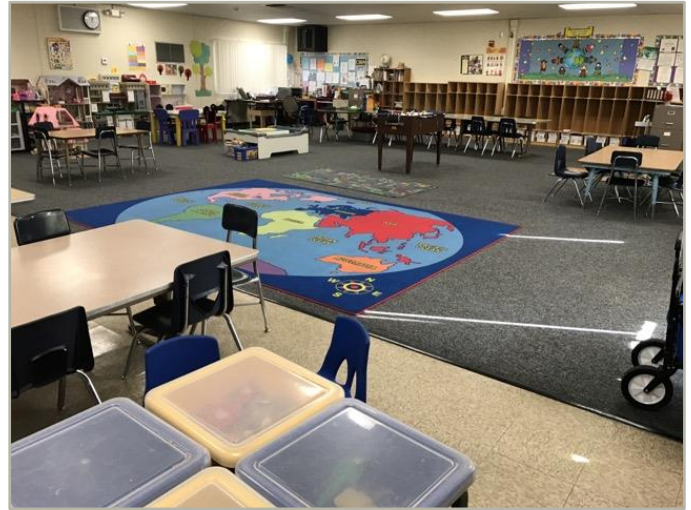
## 8. Portables

<b>Constructed/ Renovated</b>	Varies	
<b>Building Size</b>	6,700 SF	
<b>Number of Stories</b>	1	
<i>System</i>	<i>Description</i>	<i>Condition</i>
<b>Structure</b>	Light weight metal framing	Fair
<b>Façade</b>	Wood siding with aluminum windows	Fair
<b>Roof</b>	Primary: Flat construction with single-ply TPO/PVC membrane Secondary: Mansard construction with metal finish	Good
<b>Interiors</b>	Walls: Painted gypsum board and vinyl Floors: Carpet, VCT Ceilings: ACT	Fair
<b>Elevators</b>	None	--
<b>Plumbing</b>	Copper supply and cast-iron waste and venting No water heaters	Fair
<b>HVAC</b>	Individual heat pump units	Fair

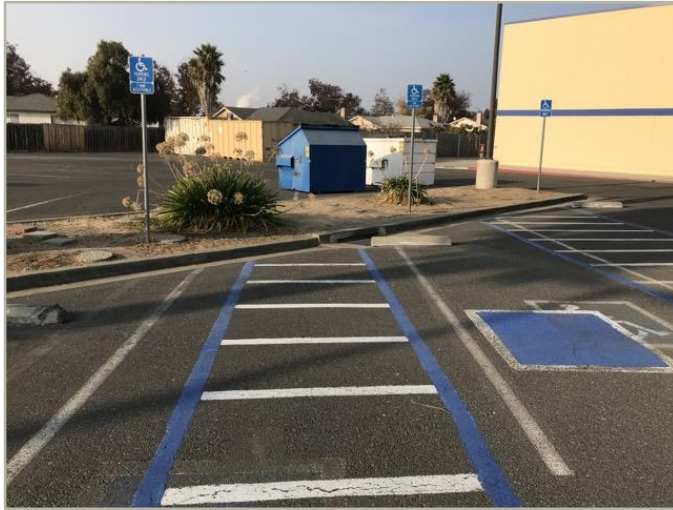
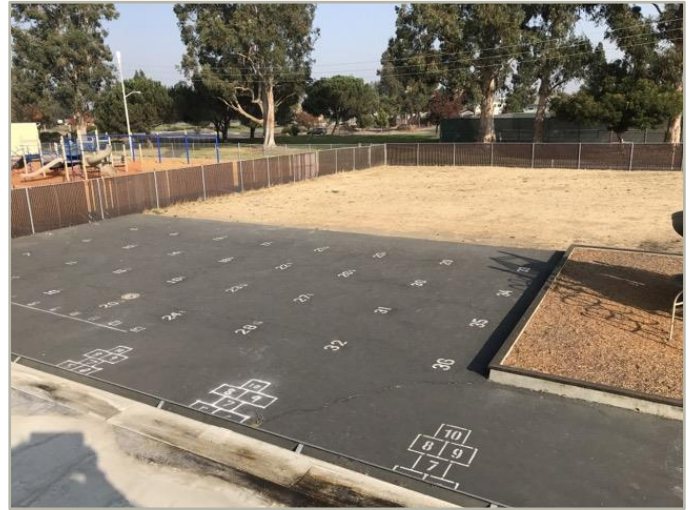
## 9. Site Summary

Site Information		
<b>Lot Size</b>	8.98 acres (estimated)	
<b>Parking Spaces</b>	62 total spaces all in open lots; 3 of which are accessible	
<i>System</i>	<i>Description</i>	<i>Condition</i>
<b>Pavement/Flatwork</b>	Asphalt lots with areas of concrete and concrete sidewalks, curbs, ramps, and stairs	Fair
<b>Site Development</b>	Property entrance signage, chain link fencing, Playgrounds with fencing Limited park benches, trash receptacles	Fair
<b>Landscaping and Topography</b>	Limited landscaping features Irrigation is present There are no retaining walls Low to moderate site slopes throughout	Fair
<b>Utilities</b>	Municipal water and sewer	Fair
<b>Site Lighting</b>	Building-mounted: HPS and incandescent light fixtures Pole Mounted: HID	Fair
<b>Ancillary Structures</b>	None	--
<b>Accessibility</b>	Potential moderate/major issues have been identified associated with the site areas and a detailed accessibility study is recommended. See Appendix C

<b>Key Issues and Findings</b>	Severe alligator cracking and potholes in the paved areas Significant sidewalk trip hazards

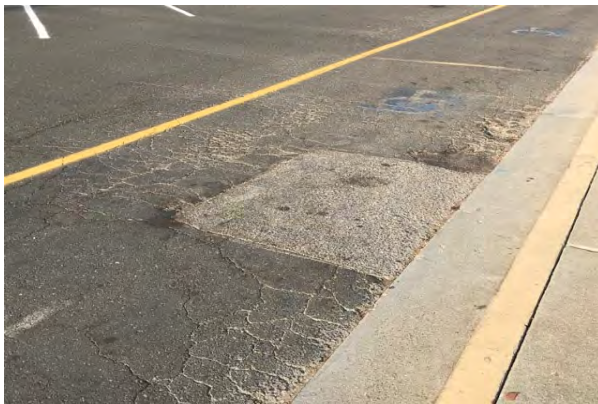
#9	PARKING LOT DAMAGE
----	--------------------

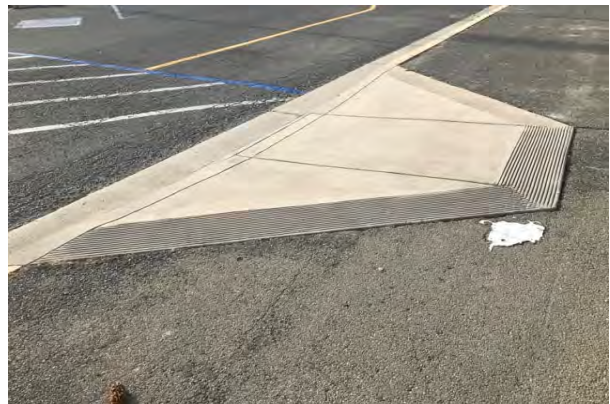
#10	ACCESSIBLE CURB CUT
-----	---------------------

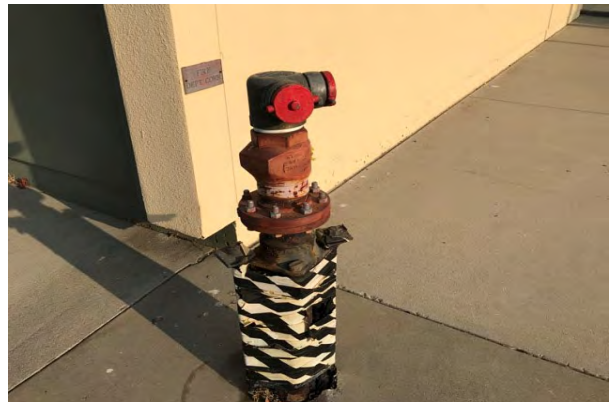
#18	SIAMESE CONNECTOR FOR FIRE SERVICE
-----	------------------------------------

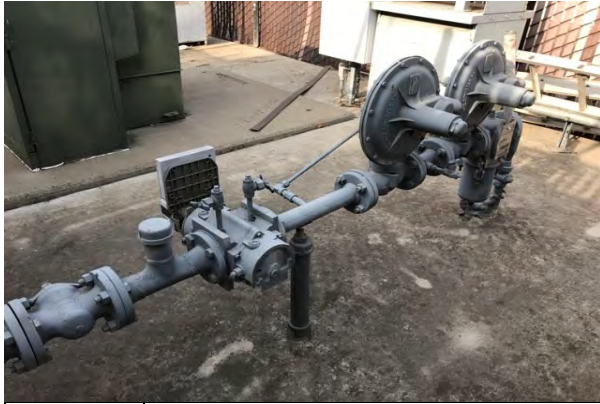
#19	GAS REGULATOR
-----	---------------

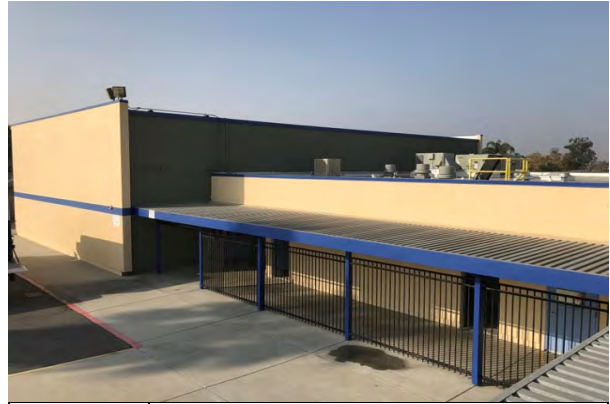
#20	STUCCO WALLS AT MULTIPURPOSE BUILDING
-----	---------------------------------------

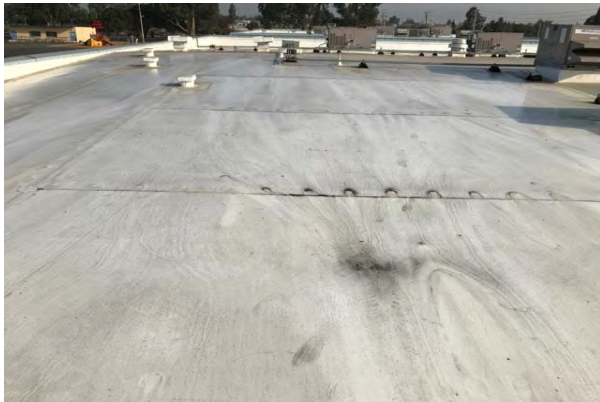
#21	TPO ROOFING
-----	-------------

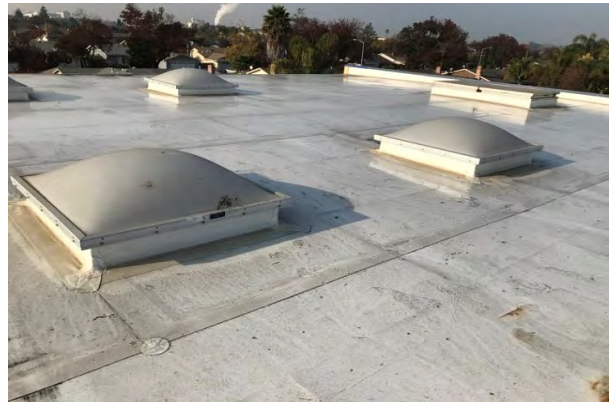
#22	SKYLIGHTS
-----	-----------

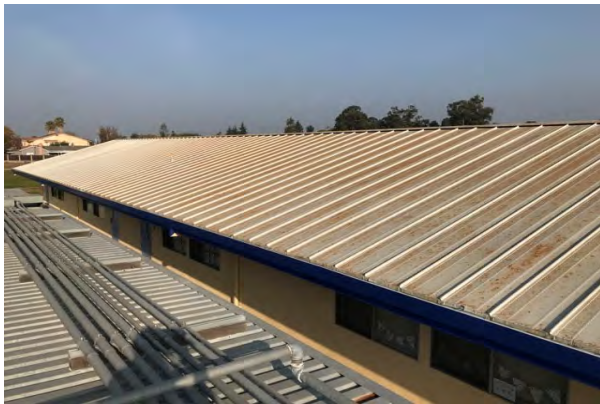
#23	METAL ROOFING AT MODULARS
-----	---------------------------

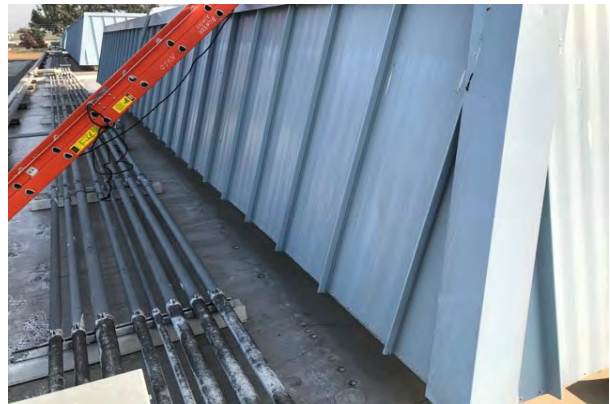
#24	MANSARD ROOFING
-----	-----------------

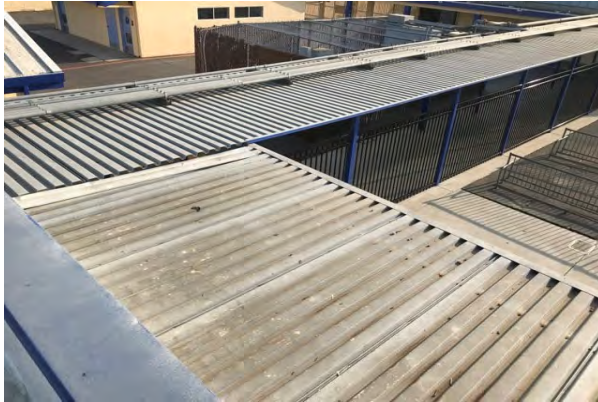
#25	METAL WALKWAY ROOFING
-----	-----------------------

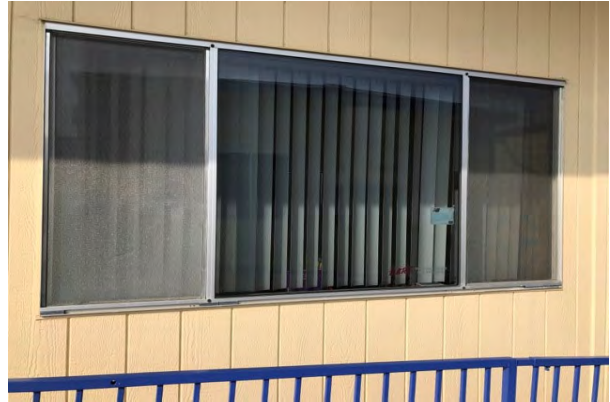
#26	ALUMINUM WINDOW AT PORTABLE
-----	-----------------------------

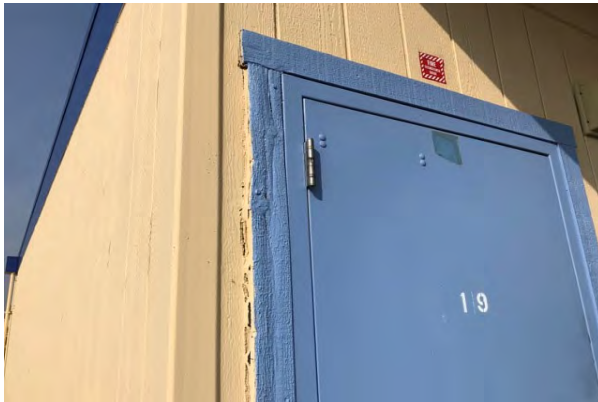
#27	ROTTING TRIM AND CAULKING CRACKS AT PORTABLE BUILDING DOOR
-----	--

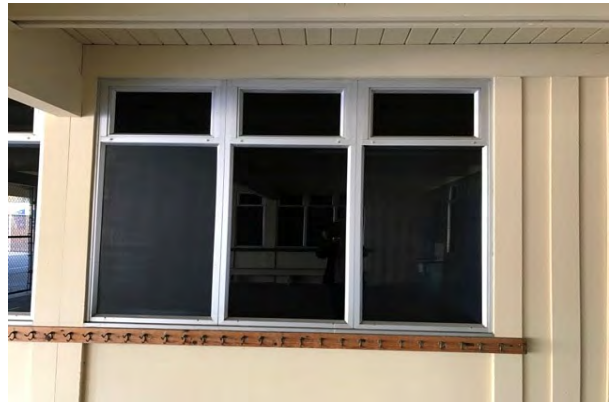
#28	TYPICAL ALUMINUM WINDOWS
-----	--------------------------

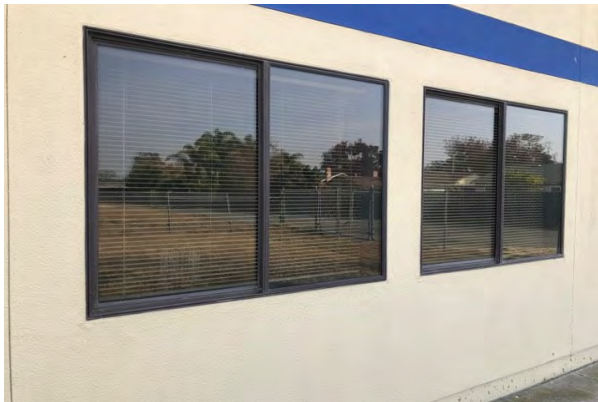
#29	WINDOWS AT MODULARS
-----	---------------------

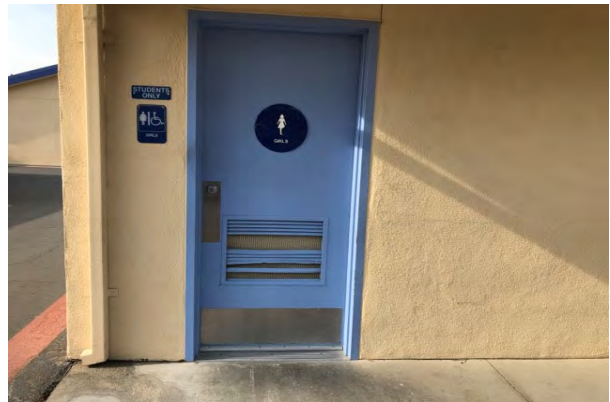
#30	EXTERIOR DOOR AT RESTROOM MODULAR
-----	-----------------------------------

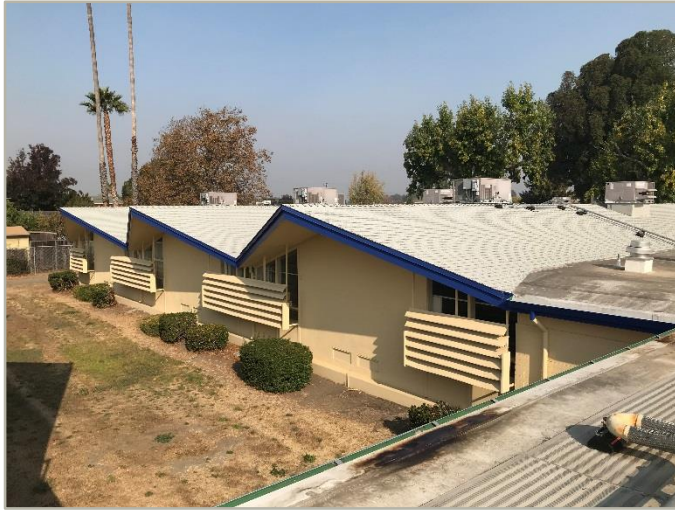
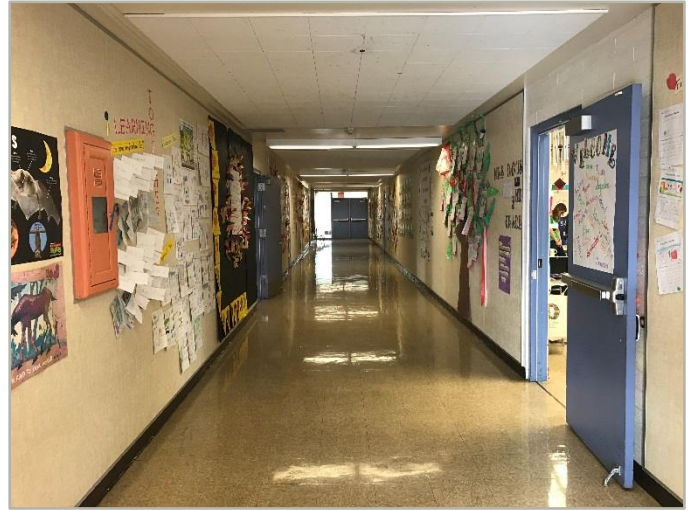
## 2. Original Graham ES Buildings 1,2,3,4,5 & 6

<b>Address</b>	36270 Cherry Street Newark, California	
<b>Constructed/ Renovated</b>	1964	
<b>Building Size</b>	Four at 7600 SQFT each, one at 3800 SQFT, one at 2400 SQFT	
<b>Number of Stories</b>	1	
<i>System</i>	<i>Description</i>	<i>Condition</i>
<b>Structure</b>	Masonry bearing walls and wood-framed roofs	Good
<b>Façade</b>	Painted brick with aluminum windows	Fair
<b>Roof</b>	Primary: Gable construction with asphalt shingles Secondary: Flat construction with single-ply TPO/PVC membrane	Fair
<b>Interiors</b>	Walls: Painted CMU, Fabric covered panels Floors: VCT, Epoxy Ceilings: Painted gypsum board, ACT	Fair
<b>Elevators</b>	None	--
<b>Plumbing</b>	Copper supply and cast-iron waste and venting Hot water from Building 2 and 3	Fair

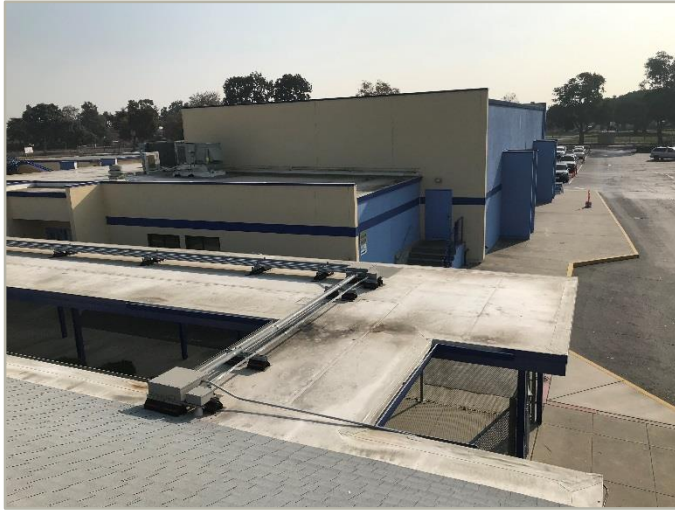
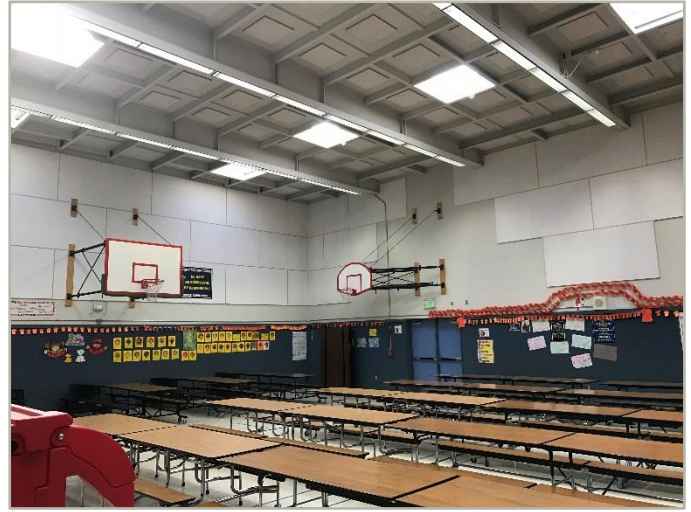
### 3. Building 7 - Multi-Purpose

<b>Address</b>	36270 Cherry Street Newark, California	
<b>Constructed/ Renovated</b>	1991	
<b>Building Size</b>	9600 SQFT	
<b>Number of Stories</b>	1	
<i>System</i>	<i>Description</i>	<i>Condition</i>
<b>Structure</b>	Steel frame with metal framed roof decks	Good
<b>Façade</b>	Stucco with aluminum windows	Fair
<b>Roof</b>	Primary: Flat construction with single-ply TPO/PVC membrane Secondary: Flat construction with metal finish	Fair
<b>Interiors</b>	Walls: Painted gypsum board Floors: Carpet, VCT, ceramic tile, Ceilings: Painted gypsum board, ACT, exposed structure	Fair
<b>Elevators</b>	Wheelchair lift serving stage	Fair

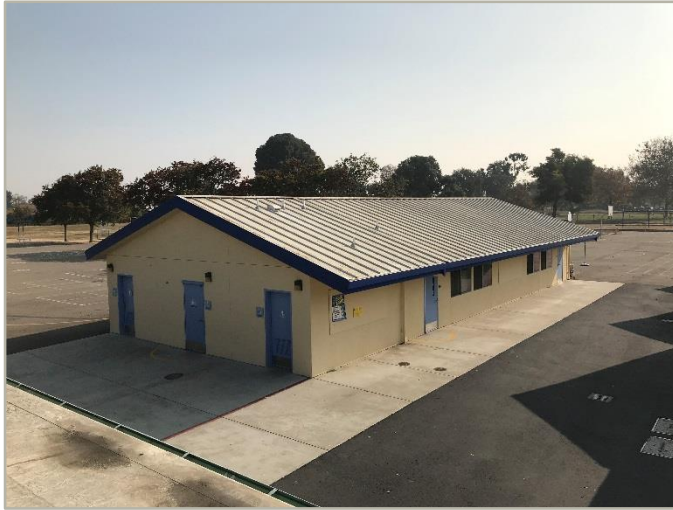
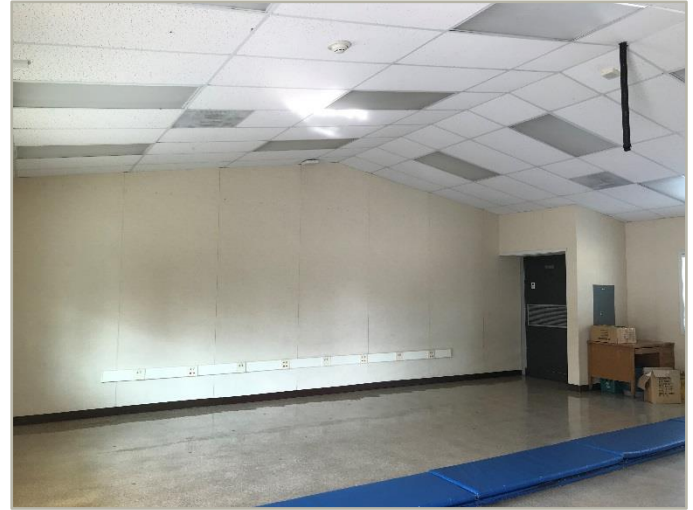
## 4. Building 8

<b>Address</b>	36270 Cherry Street Newark, California	
<b>Constructed/ Renovated</b>	2004	
<b>Building Size</b>	2600 SF	
<b>Number of Stories</b>	1	
<i>System</i>	<i>Description</i>	<i>Condition</i>
<b>Structure</b>	Conventional wood frame structure on concrete slab	Good
<b>Façade</b>	Stucco with aluminum windows	Fair
<b>Roof</b>	Primary: Gable construction with metal finish	Fair
<b>Interiors</b>	Walls: Fabric panels, Fiberglass reinforced panels at restroom Floors: VCT, epoxy Ceilings: Painted gypsum board, ACT	Fair
<b>Elevators</b>	None	--

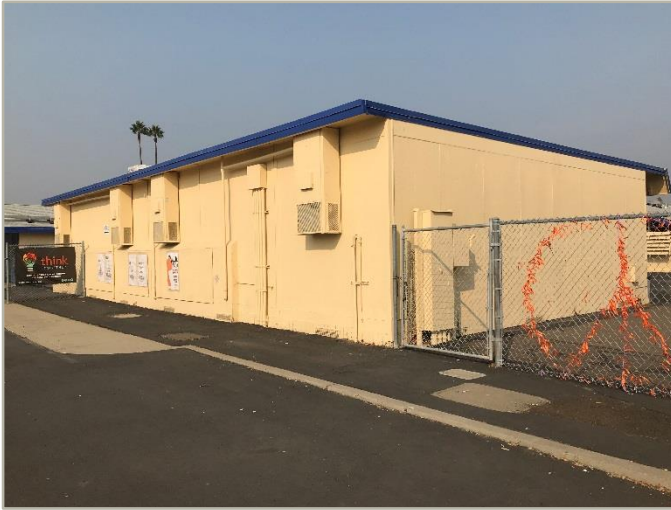
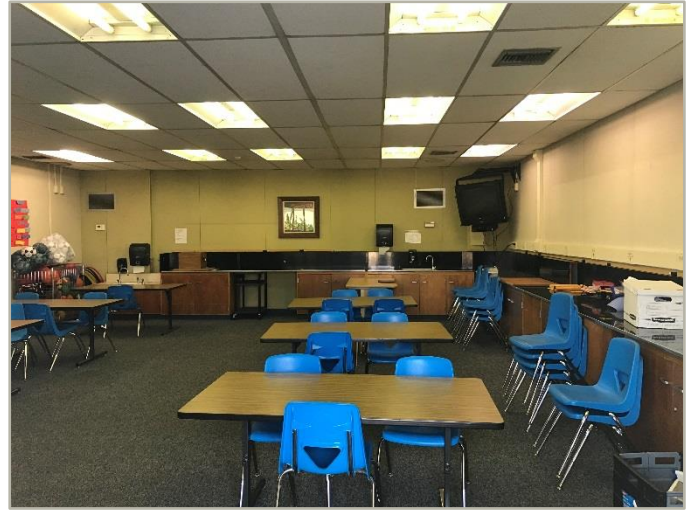
## 5. Portable Classroom Buildings A, B & C

<b>Address</b>	36270 Cherry Street Newark, California	
<b>Constructed/ Renovated</b>	1991, 1999	
<b>Building Size</b>	One at 840 SQFT each, One at 1700 SQFT, One at 2000 SQFT	
<b>Number of Stories</b>	1	
<i>System</i>	<i>Description</i>	<i>Condition</i>
<b>Structure</b>	Conventional wood frame structure with raised floor	Good
<b>Façade</b>	Wood siding with aluminum windows	Fair
<b>Roof</b>	Primary: Flat construction with metal finish	Fair
<b>Interiors</b>	Walls: Painted gypsum board, fabric panels Floors: Carpet, VCT Ceilings: ACT	Fair
<b>Elevators</b>	None	--

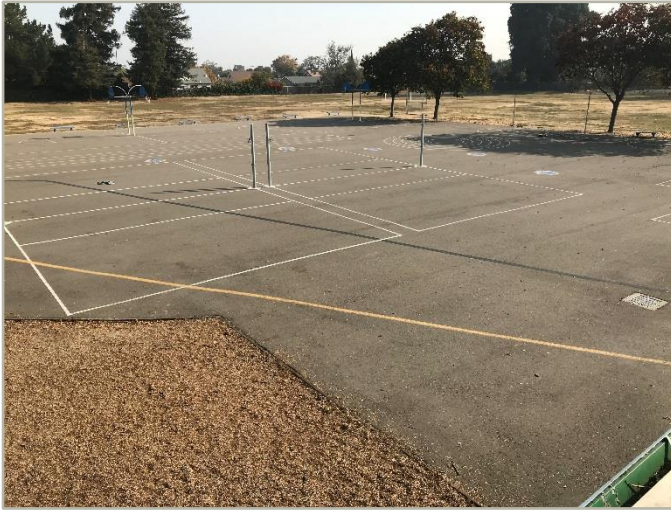
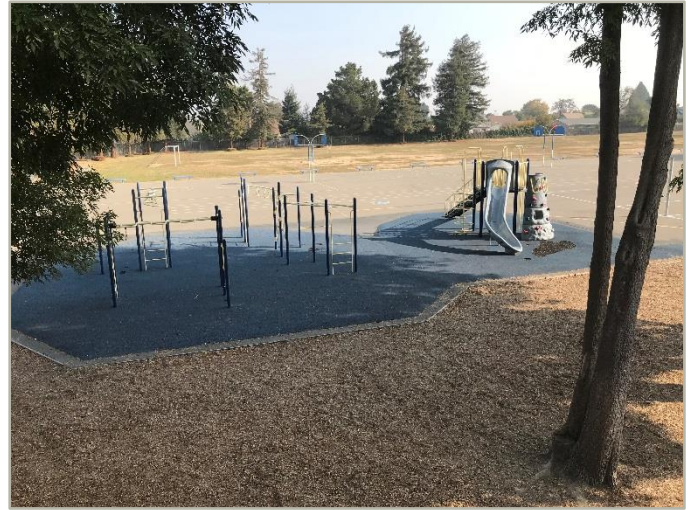
## 6. Site Summary

Site Information		
<b>Lot Size</b>	10 acres (estimated)	
<b>Parking Spaces</b>	67 total spaces all in open lots; 3 of which are accessible	
<i>System</i>	<i>Description</i>	<i>Condition</i>
<b>Pavement/Flatwork</b>	Asphalt lots with areas of concrete and concrete sidewalks, curbs, ramps, and stairs	Fair
<b>Site Development</b>	Property entrance signage, chain-link fencing Playgrounds and sports courts, fencing	Fair
<b>Landscaping and Topography</b>	No significant landscaping features Irrigation present Flat site	Fair
<b>Utilities</b>	Municipal water and sewer Local utility-provided electric and natural gas	Fair
<b>Site Lighting</b>	Building-mounted: LED, CFL	Fair
<b>Ancillary Structures</b>	Pre-fabricated storage/shipping container, shed	Fair
<b>Accessibility</b>	Presently it does not appear an accessibility study is needed for the exterior site areas. See Appendix C.	
<b>Key Issues and Findings</b>	Some of the site lighting was recently upgraded with LED exterior lighting but did not include all exterior lighting, we recommend replacing all exterior lighting with LED. There are areas of paving that should be repaired including asphalt and concrete. There is a tripping hazard at the concrete sidewalk adjacent to the street that should be ground down or replaced. We recommend sealing older playground asphalt to prolong its life.

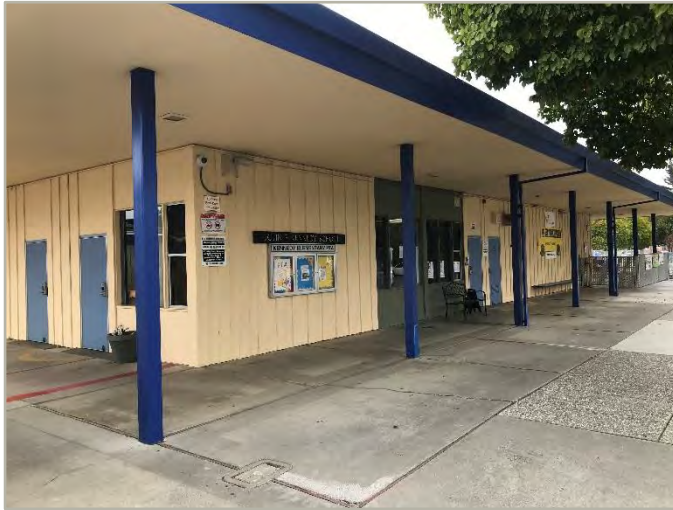
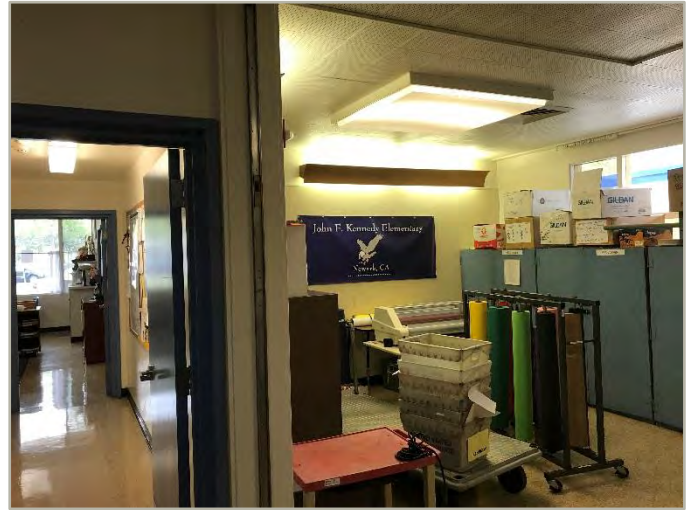
## 2. Original Kennedy Elementary School Buildings 1, 2 & 3

<b>Address</b>	35430 Blackburn Drive Newark, California	
<b>Constructed/ Renovated</b>	1964	
<b>Building Size</b>	Three at 8100 SQFT each	
<b>Number of Stories</b>	1	
<i>System</i>	<i>Description</i>	<i>Condition</i>
<b>Structure</b>	Conventional wood frame structure on concrete slab with wood framed roof	Good
<b>Façade</b>	Wood siding with aluminum windows	Fair
<b>Roof</b>	Primary: Hip construction with single-ply TPO/PVC membrane Secondary: Flat construction with single-ply TPO/PVC membrane	Fair
<b>Interiors</b>	Walls: Painted gypsum board Floors: VCT, Epoxy Ceilings: Painted gypsum board, ACT	Fair
<b>Elevators</b>	None	--
<b>Plumbing</b>	Copper supply and cast-iron waste and venting Hot water from Building 3	Fair
