# FACILITY CONDITION ASSESSMENT

Newark School District  
5715 Musick Avenue  
Newark, California 94560

FACILITY CONDITION ASSESSMENT  
OF  
BIRCH GROVE INTERMEDIATE  
37490 BIRCH STREET  
NEWARK, CALIFORNIA 94560

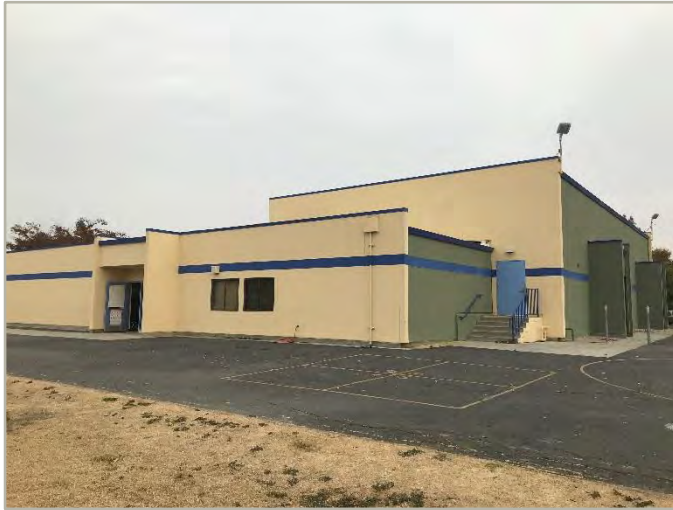
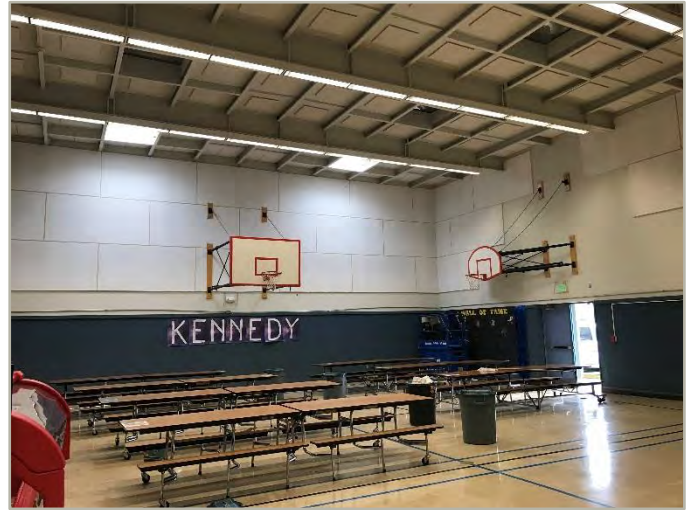
### 3. Building 4 - Multi-Purpose

<b>Address</b>	35430 Blackburn Drive Newark, California	
<b>Constructed/ Renovated</b>	1991	
<b>Building Size</b>	9600 SQFT	
<b>Number of Stories</b>	1	
<i>System</i>	<i>Description</i>	<i>Condition</i>
<b>Structure</b>	Steel frame with metal framed roof decks	Good
<b>Façade</b>	Stucco with aluminum windows	Fair
<b>Roof</b>	Primary: Flat construction with single-ply TPO/PVC membrane Secondary: Flat construction with metal finish	Fair
<b>Interiors</b>	Walls: Painted gypsum board, ceramic tile Floors: Carpet, VCT, ceramic tile, wood floor Ceilings: Painted gypsum board, ACT, exposed structure	Fair
<b>Elevators</b>	Wheelchair lift serving stage	Fair

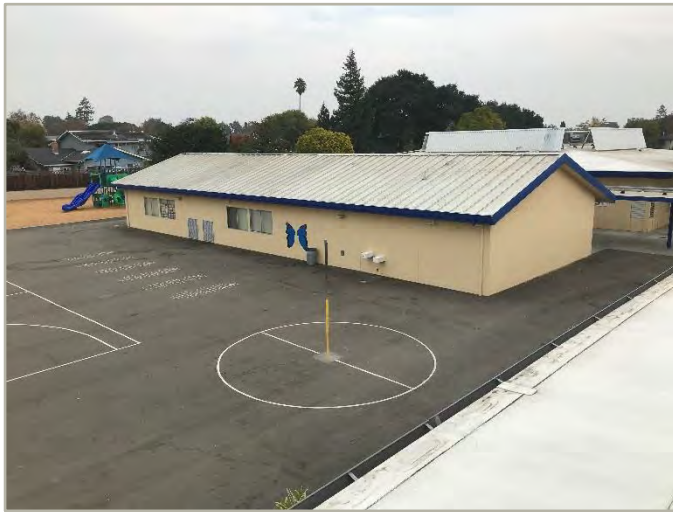
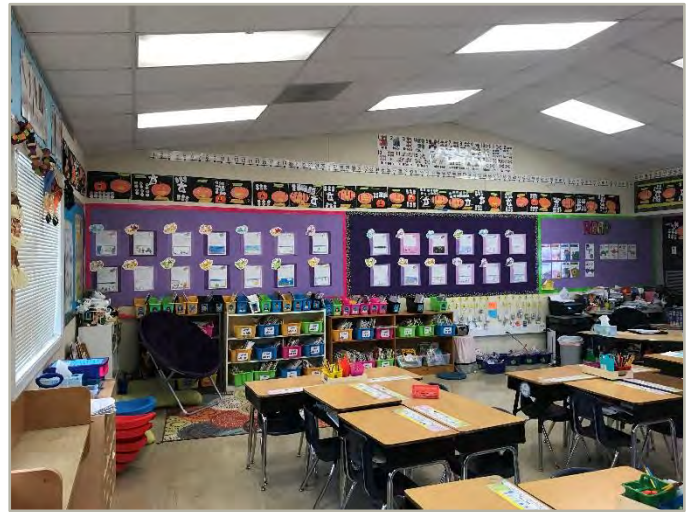
## 4. Building 5

<b>Address</b>	35430 Blackburn Drive Newark, California	
<b>Constructed/ Renovated</b>	2004	
<b>Building Size</b>	3600 SF	
<b>Number of Stories</b>	1	
<i>System</i>	<i>Description</i>	<i>Condition</i>
<b>Structure</b>	Conventional wood frame structure on concrete slab	Good
<b>Façade</b>	Stucco with aluminum windows	Fair
<b>Roof</b>	Primary: Gable construction with metal finish	Fair
<b>Interiors</b>	Walls: Fabric panels, Fiberglass reinforced panels at restroom Floors: Carpet, VCT, epoxy Ceilings: Painted gypsum board, ACT	Fair
<b>Elevators</b>	None	--

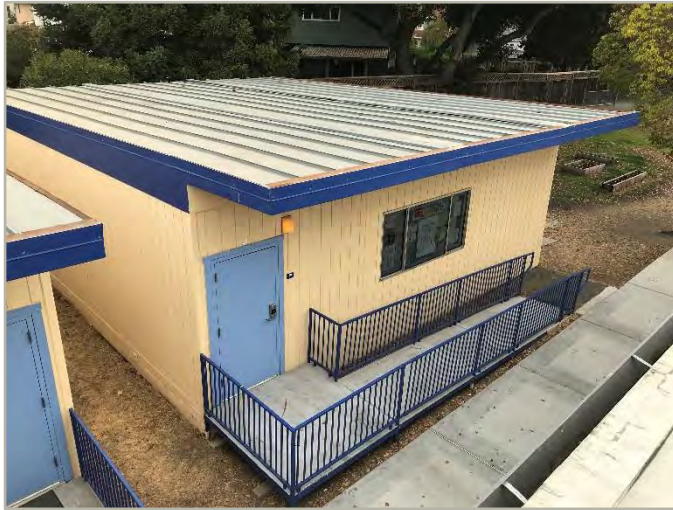
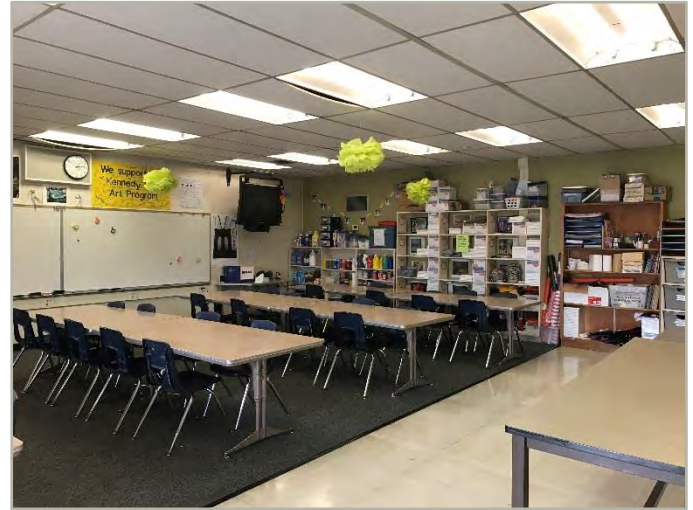
## 5. Portable Classroom Buildings A, B, C, D & E

<b>Address</b>	35430 Blackburn Drive Newark, California	
<b>Constructed/ Renovated</b>	1991	
<b>Building Size</b>	Four at 1200 SQFT each, one at 2000 SQFT	
<b>Number of Stories</b>	1	
<i>System</i>	<i>Description</i>	<i>Condition</i>
<b>Structure</b>	Conventional wood frame structure with raised floor	Good
<b>Façade</b>	Wood siding with aluminum windows	Fair
<b>Roof</b>	Primary: Flat construction with metal finish	Fair
<b>Interiors</b>	Walls: Painted gypsum board, fabric panels Floors: Carpet, VCT, vinyl sheeting Ceilings: ACT	Fair
<b>Elevators</b>	None	--

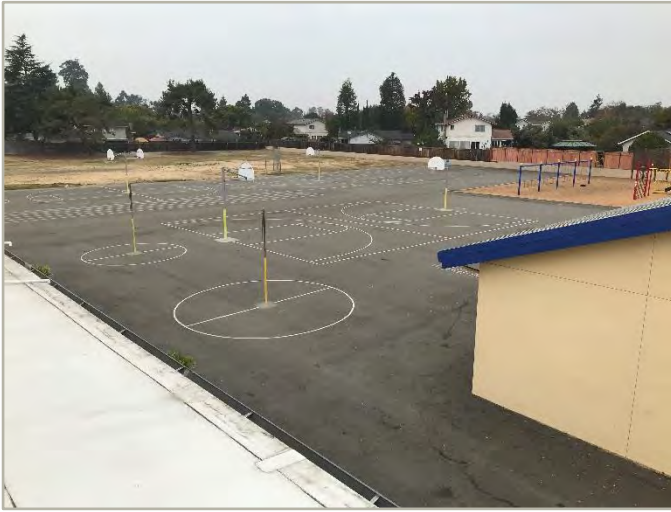
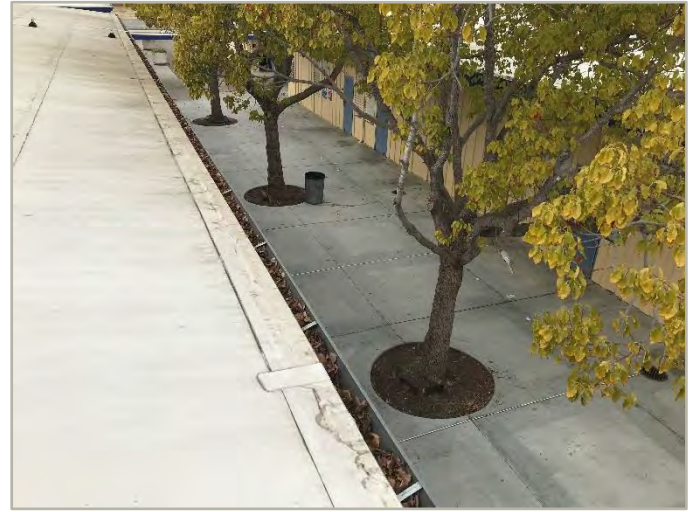
## 6. Site Summary

Site Information		
<b>Lot Size</b>	9 acres (estimated)	
<b>Parking Spaces</b>	55 total spaces all in open lots; 2 of which are accessible	
<i>System</i>	<i>Description</i>	<i>Condition</i>
<b>Pavement/Flatwork</b>	Asphalt lots with areas of concrete and concrete sidewalks, curbs, ramps, and stairs	Fair
<b>Site Development</b>	Property entrance signage, chain-link fencing Playgrounds and sports courts with bleachers, fencing	Fair
<b>Landscaping and Topography</b>	No significant landscaping features Irrigation present CMU retaining wall Flat site	Fair
<b>Utilities</b>	Municipal water and sewer Local utility-provided electric and natural gas	Fair
<b>Site Lighting</b>	Building-mounted: LED, CFL	Fair
<b>Ancillary Structures</b>	Pre-fabricated storage/shipping container	Fair
<b>Accessibility</b>	Presently it does not appear an accessibility study is needed for the exterior site areas. See Appendix C.	
<b>Key Issues and Findings</b>	Inefficient site lighting –not upgraded to LED with the rest, Significant sidewalk trip hazards- adjacent to the street and Building 4.

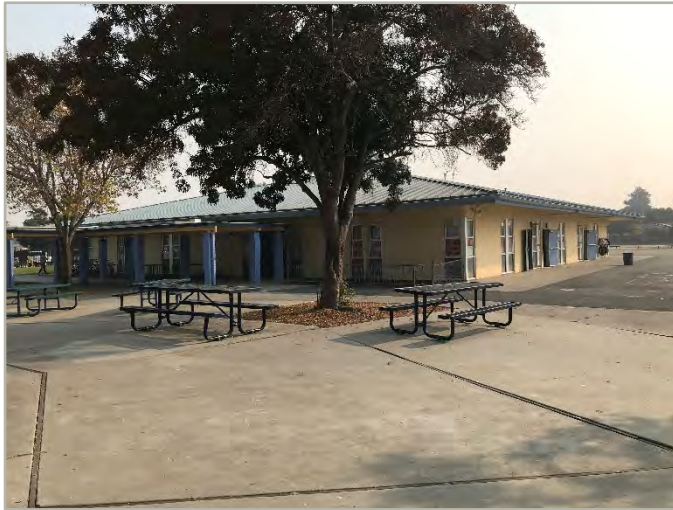
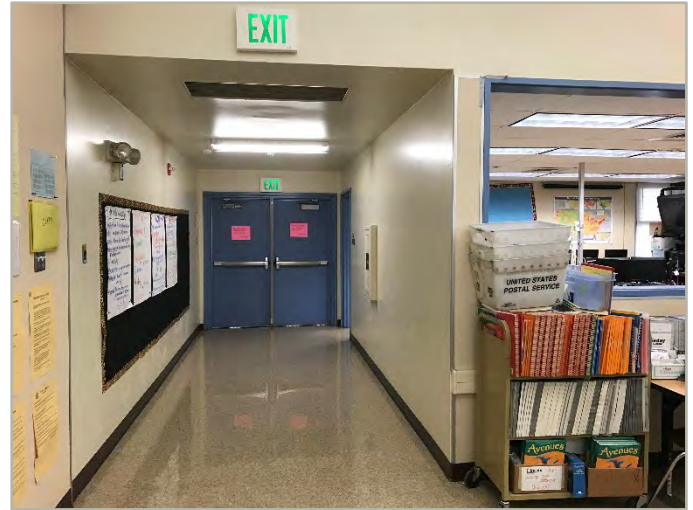
## 2. Original Lincoln ES Buildings 1,2 and 3

<b>Address</b>	36111 Bettencourt Street Newark, California	
<b>Constructed/ Renovated</b>	1965	
<b>Building Size</b>	Two at 8100 SQFT each, one at 5600 SQFT	
<b>Number of Stories</b>	1	
<i>System</i>	<i>Description</i>	<i>Condition</i>
<b>Structure</b>	Masonry bearing walls and wood-framed roofs	Good
<b>Façade</b>	Painted CMU with aluminum windows	Fair
<b>Roof</b>	Primary: Hip construction with metal finish Secondary: Flat construction with single-ply TPO/PVC membrane	Fair
<b>Interiors</b>	Walls: Painted gypsum board, Fabric finish, laminated panels Floors: VCT, Epoxy Ceilings: Painted gypsum board, ACT	Fair
<b>Elevators</b>	None	--
<b>Plumbing</b>	Copper supply and cast-iron waste & venting Hot water from Building 1 3	Fair

<b>HVAC</b>	Individual Split System units	Fair
<b>Fire Suppression</b>	Fire extinguishers	Fair
<b>Electrical</b>	Source & Distribution: Main panel with copper wiring Fed from Site switchboard with copper wiring Interior Lighting: T-8 Emergency: None	Fair
<b>Fire Alarm</b>	smoke detectors, alarms, strobes, and exit signs	Fair
<b>Equipment/Special</b>	None	--
<b>Accessibility</b>	Presently it does not appear an accessibility study is needed for this building. See Appendix C.	
<b>Key Issues &amp; Findings</b>	Aged plumbing infrastructure, missing fire suppression

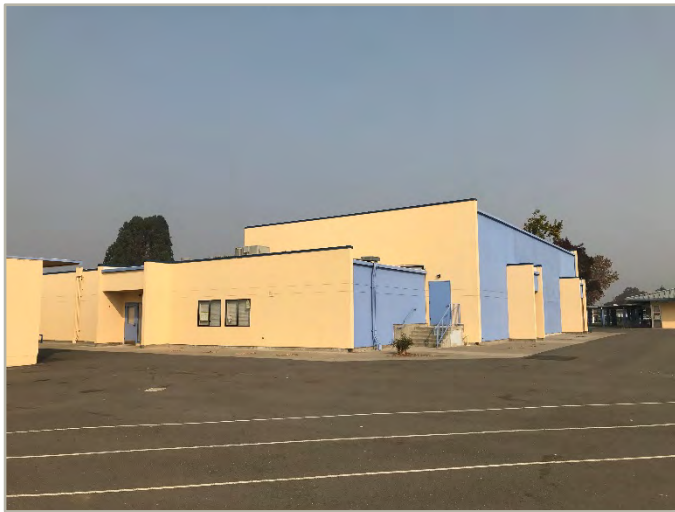
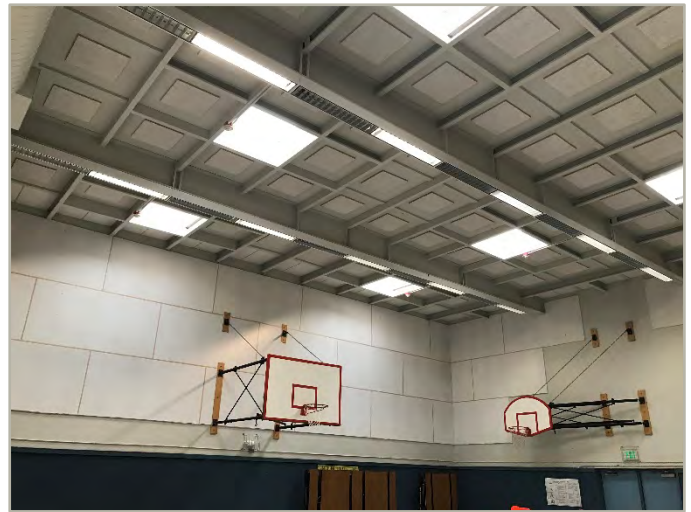
### 3. Building 4 - Multi-Purpose

<b>Address</b>	36111 Bettencourt Street Newark, California	
<b>Constructed/ Renovated</b>	1992	
<b>Building Size</b>	9600 SQFT	
<b>Number of Stories</b>	1	
<i>System</i>	<i>Description</i>	<i>Condition</i>
<b>Structure</b>	Steel frame with metal framed roof decks	Good
<b>Façade</b>	Stucco with aluminum windows	Fair
<b>Roof</b>	Primary: Flat construction with single-ply TPO/PVC membrane Secondary: Flat construction with metal finish	Fair
<b>Interiors</b>	Walls: Painted gypsum board, Fabric finish, laminated panels, wallpaper, ceramic tile Floors: Carpet, VCT, ceramic tile, wood Ceilings: Painted gypsum board, ACT, exposed structure	Fair
<b>Elevators</b>	Wheelchair lift serving stage	Fair

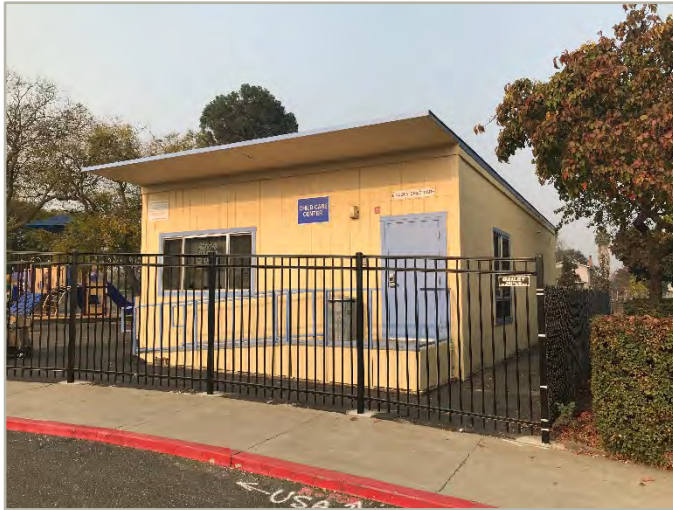
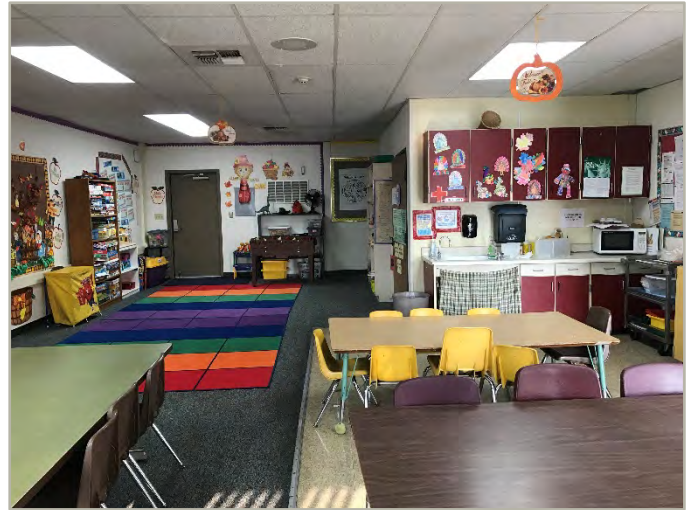
## 4. Portable Classroom Buildings A, B, C and E

<b>Address</b>	36111 Bettencourt Street Newark, California	
<b>Constructed/ Renovated</b>	One built 1992, three built 1998	
<b>Building Size</b>	Four at 840 SQFT each	
<b>Number of Stories</b>	1	
<i>System</i>	<i>Description</i>	<i>Condition</i>
<b>Structure</b>	Conventional wood frame structure with raised floor	Good
<b>Façade</b>	Wood siding with aluminum windows	Fair
<b>Roof</b>	Primary: Flat construction with metal finish	Fair
<b>Interiors</b>	Walls: Painted gypsum board, fabric panels Floors: Carpet, VCT Ceilings: ACT	Fair
<b>Elevators</b>	None	--

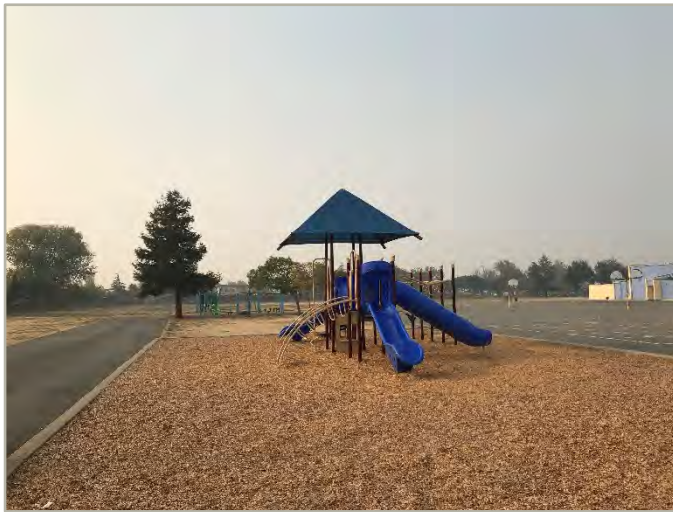
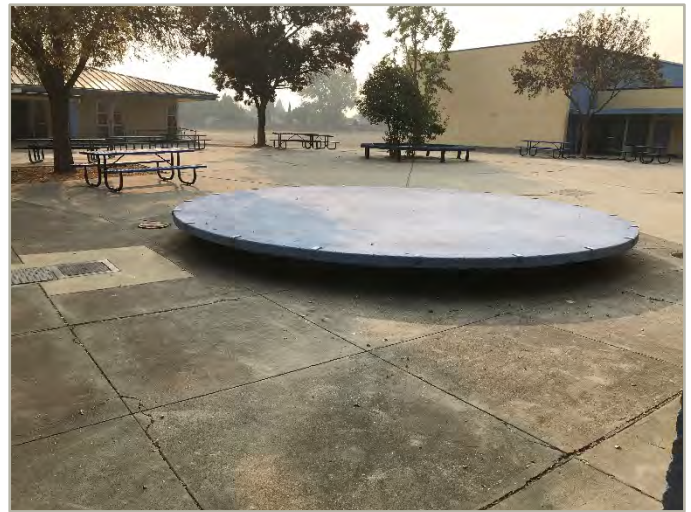
## 5. Site Summary

Site Information		
<b>Lot Size</b>	13 acres (estimated)	
<b>Parking Spaces</b>	65 total spaces all in open lots; 2 of which are accessible	
<i>System</i>	<i>Description</i>	<i>Condition</i>
<b>Pavement/Flatwork</b>	Asphalt lots with areas of concrete and concrete sidewalks, curbs, ramps, and stairs	Fair
<b>Site Development</b>	Property entrance signage, chain-link fencing Playgrounds and sports courts with bleachers, fencing	Fair
<b>Landscaping &amp; Topography</b>	No significant landscaping features Irrigation present Flat site	Failed
<b>Utilities</b>	Municipal water and sewer Local utility-provided electric and natural gas	Fair
<b>Site Lighting</b>	Building-mounted: LED, CFL	Fair
<b>Ancillary Structures</b>	Pre-fabricated storage/shipping container	Fair
<b>Accessibility</b>	Presently it does not appear an accessibility study is needed for the exterior site areas. See Appendix C.	
<b>Key Issues &amp; Findings</b>	Aged Pre-fabricated storage/shipping container, Failed Irrigation, tripping hazard

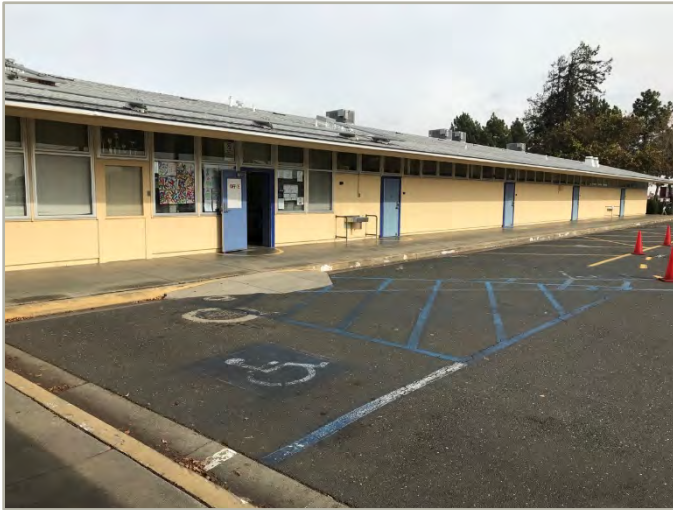
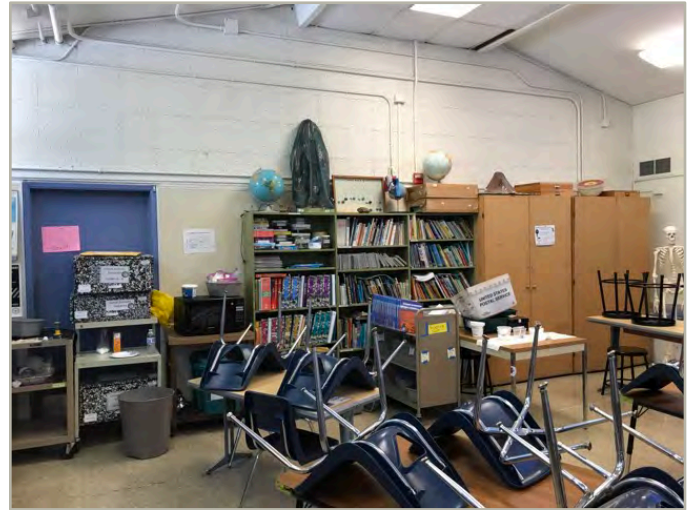
### Building 1, Administration & Classrooms 1 - 4: Systems Summary

<b>Address</b>	5735 Musick Avenue, Newark, California	
<b>Constructed/ Renovated</b>	1955	
<b>Building Size</b>	5,200 SF	
<b>Number of Stories</b>	1	
<i>System</i>	<i>Description</i>	<i>Condition</i>
<b>Structure</b>	Wood frame structure with steel columns on concrete slab	Fair
<b>Façade</b>	Stucco with aluminum windows. The lower glass panels have been replaced with aluminum	Fair
<b>Roof</b>	Primary: Gable construction with asphalt shingles	Good
<b>Interiors</b>	Walls: Painted gypsum board, laminated paneling & vinyl Floors: VCT, Ceilings: Painted gypsum board, ACT	Fair
<b>Elevators</b>	None	--
<b>Plumbing</b>	Copper/galvanized supply and cast iron waste & venting	Fair

<b>HVAC</b>	Individual package units	Good
<b>Fire Suppression</b>	Hydrants, fire extinguishers	Fair
<b>Electrical</b>	Source & Distribution: Main panel with copper wiring Interior Lighting: T-5, LED, Emergency: None	Fair
<b>Fire Alarm</b>	Smoke detectors, alarms, strobes, pull stations and exit signs	Fair
<b>Equipment/Special</b>	None	--
<b>Accessibility</b>	Presently it does not appear an accessibility study is needed for this building. See Appendix C.	
<b>Key Issues &amp; Findings</b>	Outdated supply piping, Missing fire suppression Environmental engineering survey due to possibility of termites

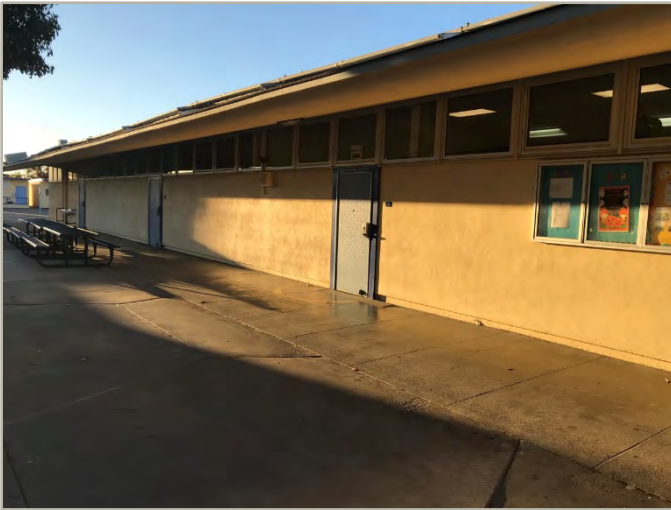
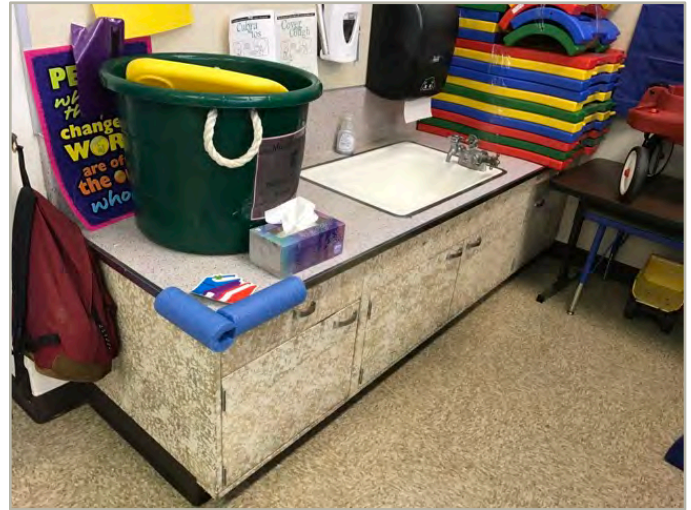
#### Building 1A, Classrooms 5 - 7: Systems Summary

<b>Address</b>	5735 Musick Avenue, Newark, California	
<b>Constructed/ Renovated</b>	1955	
<b>Building Size</b>	3,700 SF	
<b>Number of Stories</b>	1	
<i>System</i>	<i>Description</i>	<i>Condition</i>
<b>Structure</b>	Wood frame structure with steel columns on concrete slab	Fair
<b>Façade</b>	Stucco with aluminum windows. The lower glass panels have been replaced with aluminum	Fair
<b>Roof</b>	Primary: Gable construction with asphalt shingles	Good
<b>Interiors</b>	Walls: Painted gypsum board & vinyl Floors: VCT, epoxy coating Ceilings: Painted gypsum board, ACT	Fair
<b>Elevators</b>	None	--

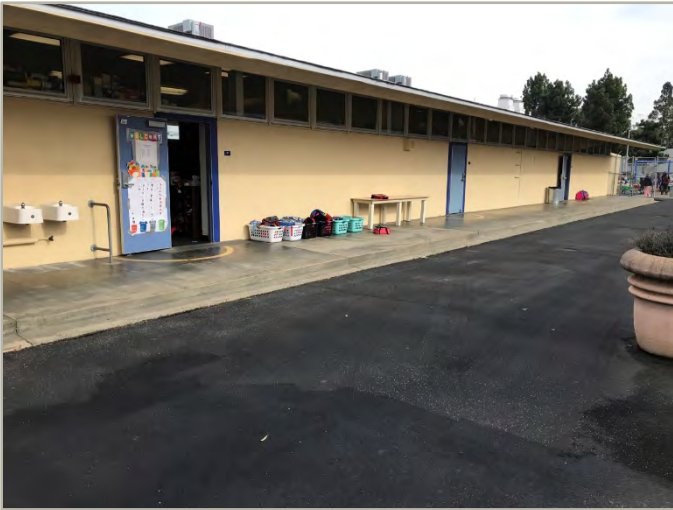
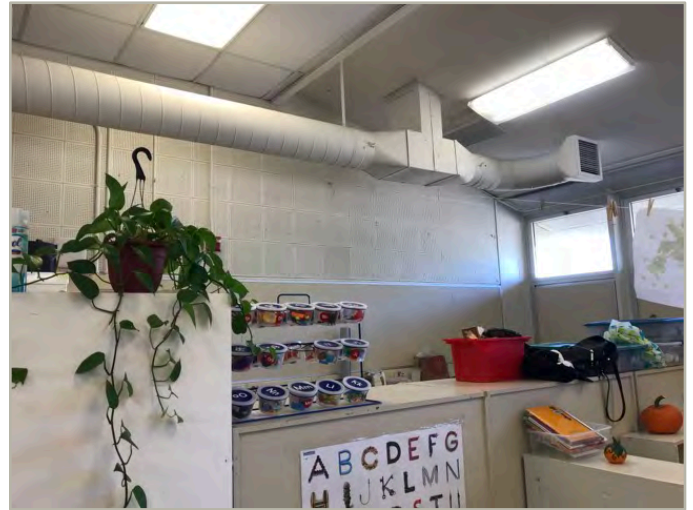
### Building 2, Classrooms 12 - 14: Systems Summary

<b>Address</b>	5735 Musick Avenue, Newark, California	
<b>Constructed/ Renovated</b>	1955	
<b>Building Size</b>	3,600 SF	
<b>Number of Stories</b>	1	
<i>System</i>	<i>Description</i>	<i>Condition</i>
<b>Structure</b>	Wood frame structure with steel columns on concrete slab	Fair
<b>Façade</b>	Stucco with aluminum windows. The lower glass panel has been replaced with aluminum	Good
<b>Roof</b>	Primary: Gable construction with asphalt shingles	Good
<b>Interiors</b>	Walls: Painted gypsum board, acoustical tile, cultured marble, & vinyl Floors: VCT, Ceilings: Painted gypsum board, ACT	Fair
<b>Elevators</b>	None	--

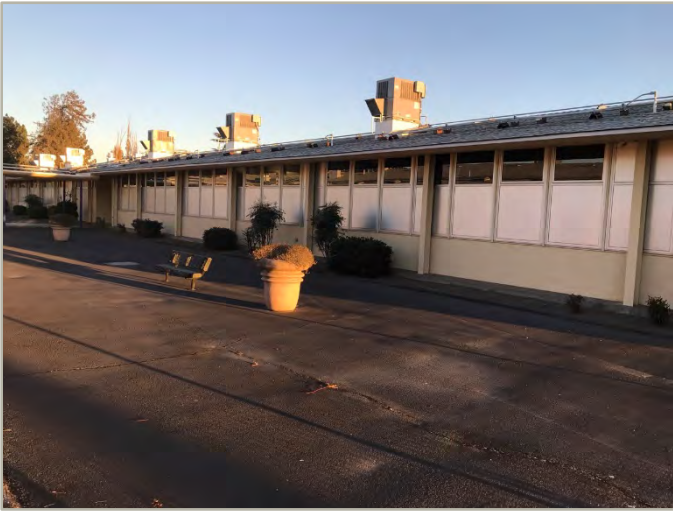
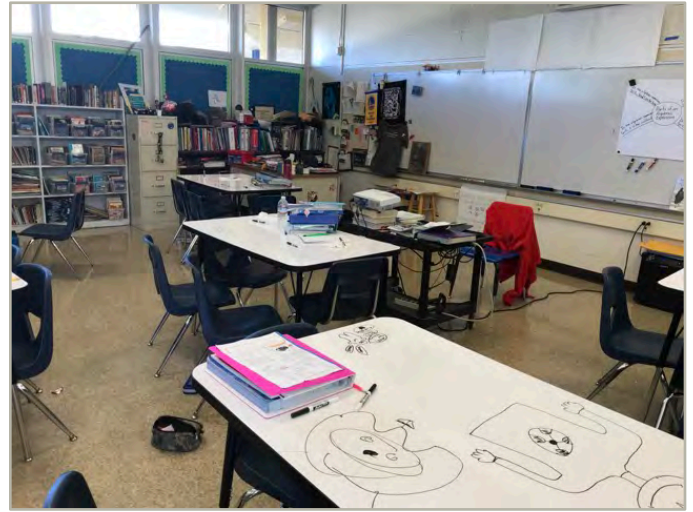
### Building 2A, Classrooms 8-11: Systems Summary

<b>Address</b>	5735 Musick Avenue, Newark, California	
<b>Constructed/ Renovated</b>	1955	
<b>Building Size</b>	3,900 SF	
<b>Number of Stories</b>	1	
<i>System</i>	<i>Description</i>	<i>Condition</i>
<b>Structure</b>	Wood frame structure with steel columns on concrete slab	Fair
<b>Façade</b>	Stucco with aluminum windows. The lower glass panels have been replaced with aluminum	Fair
<b>Roof</b>	Primary: Gable construction with asphalt shingles	Good
<b>Interiors</b>	Walls: Painted gypsum board ,acoustical tile, & vinyl Floors: VCT, Ceilings: Painted gypsum board, ACT	Fair
<b>Elevators</b>	None	--

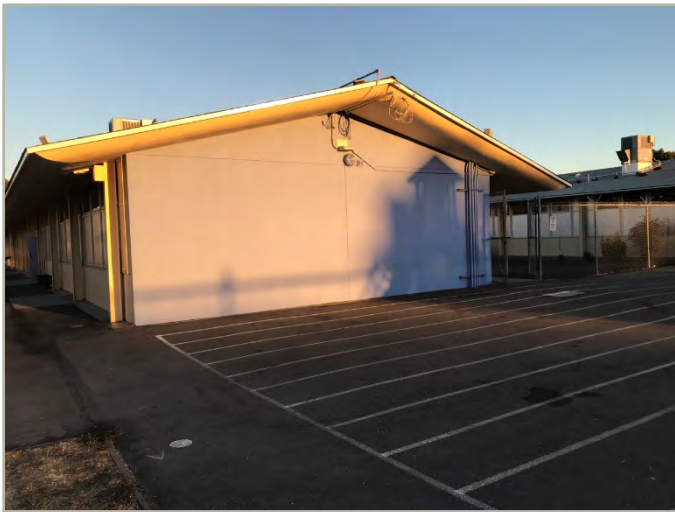
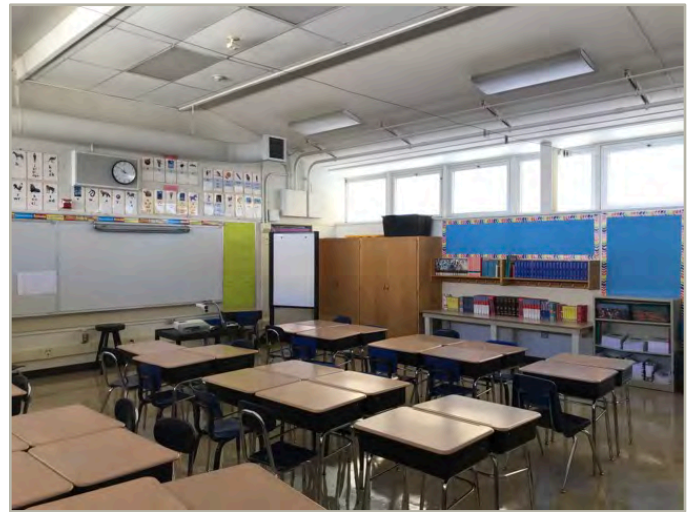
### Building 3, Classrooms 18 - 20: Systems Summary

<b>Address</b>	5735 Musick Avenue, Newark, California	
<b>Constructed/ Renovated</b>	1955	
<b>Building Size</b>	3,400 SF	
<b>Number of Stories</b>	1	
<i>System</i>	<i>Description</i>	<i>Condition</i>
<b>Structure</b>	Wood frame structure with steel columns on concrete slab	Fair
<b>Façade</b>	Stucco with aluminum windows. The lower glass panels have been replaced with aluminum	Fair
<b>Roof</b>	Primary: Gable construction with asphalt shingles	Good
<b>Interiors</b>	Walls: Painted gypsum board, acoustical tile, cultured marble, & vinyl Floors: VCT, epoxy coating Ceilings: Painted gypsum board, ACT	Fair
<b>Elevators</b>	None	--

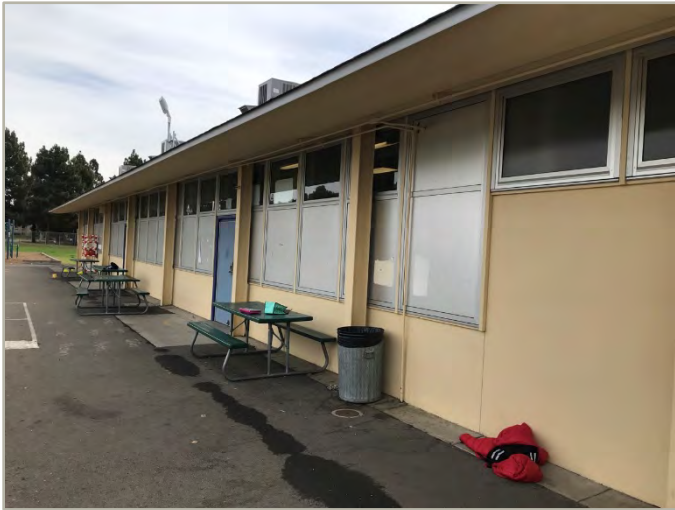
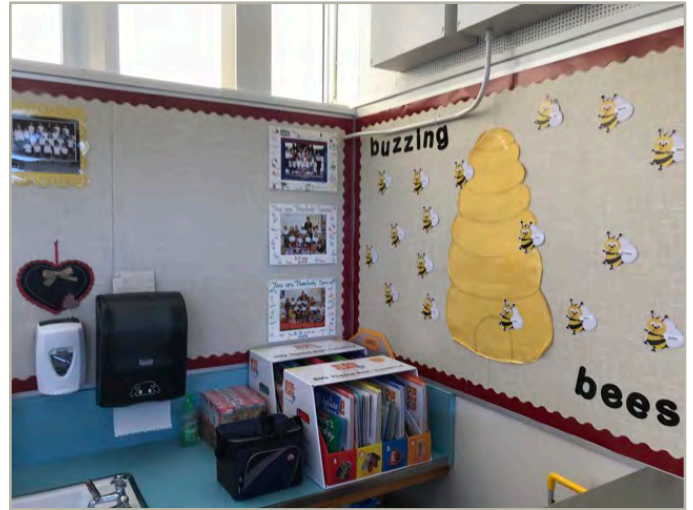
### Building 3A, Classrooms 15 – 17: Systems Summary

<b>Address</b>	5735 Musick Avenue, Newark, California	
<b>Constructed/ Renovated</b>	1955	
<b>Building Size</b>	3,200 SF	
<b>Number of Stories</b>	1	
<i>System</i>	<i>Description</i>	<i>Condition</i>
<b>Structure</b>	Wood frame structure with steel columns on concrete slab	Fair
<b>Façade</b>	Stucco with aluminum windows. The lower glass panels have been replaced with aluminum	Fair
<b>Roof</b>	Primary: Gable construction with asphalt shingles	Good
<b>Interiors</b>	Walls: Painted gypsum board & vinyl Floors: VCT, ceramic tile Ceilings: Painted gypsum board, ACT	Fair
<b>Elevators</b>	None	--

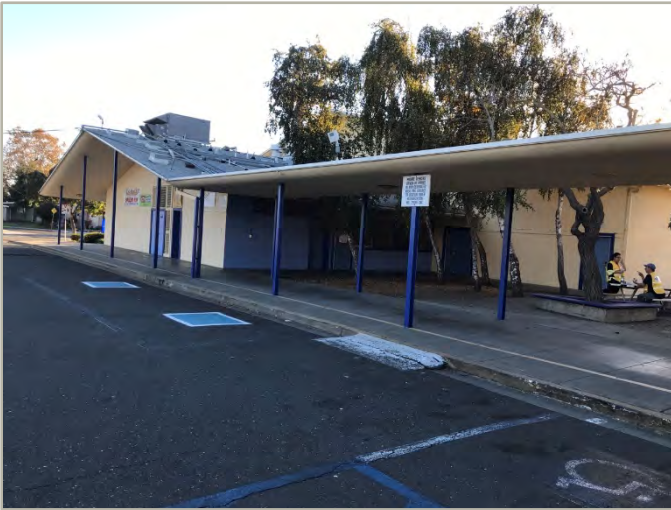
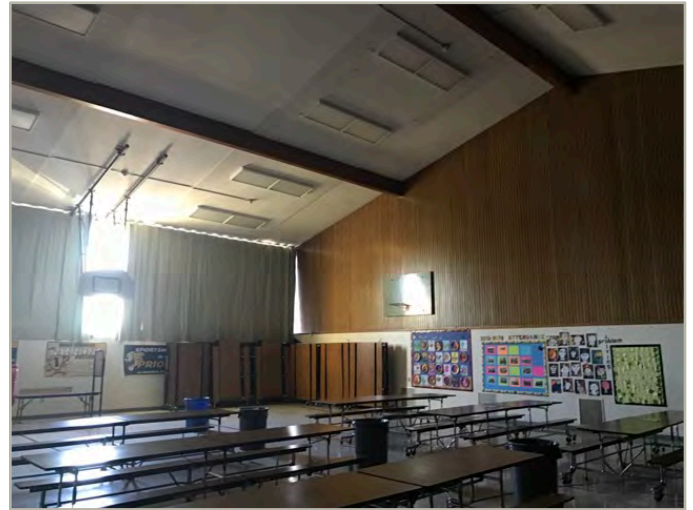
### Building 4, Multipurpose: Systems Summary

<b>Address</b>	5735 Musick Avenue, Newark, California	
<b>Constructed/ Renovated</b>	1991	
<b>Building Size</b>	7,700 SF	
<b>Number of Stories</b>	1	
<i>System</i>	<i>Description</i>	<i>Condition</i>
<b>Structure</b>	Concrete cast in place, on a concrete slab, wood framed roof	Fair
<b>Façade</b>	Painted concrete with steel windows	Fair
<b>Roof</b>	Primary: Gable construction with asphalt shingles	Fair
<b>Interiors</b>	Walls: Painted concrete, wood, painted gypsum board Floors: VCT, ceramic tile, Ceilings: Painted gypsum board, ACT	Fair
<b>Elevators</b>	Wheelchair lift	Fair

Evidence of termite activity was noted in two buildings, Building 2 and Building 4 Multipurpose.

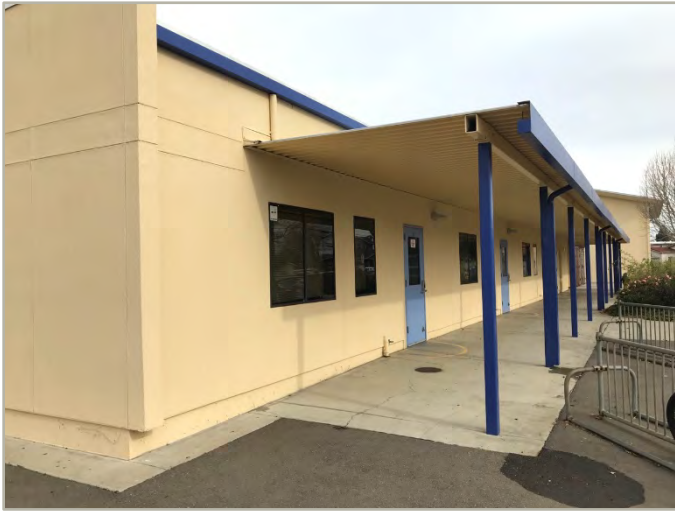
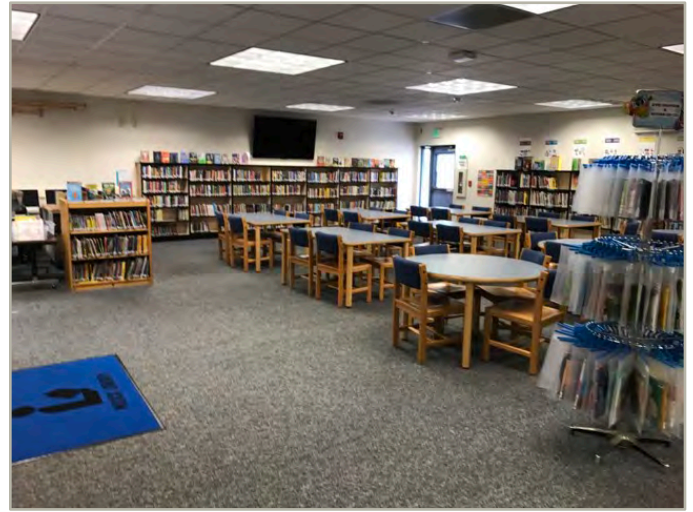
### Building 5, Library/ Classrooms 21 - 23: Systems Summary

<b>Address</b>	5735 Musick Avenue, Newark, California	
<b>Constructed/ Renovated</b>	2000	
<b>Building Size</b>	7,000 SF	
<b>Number of Stories</b>	1	
<i>System</i>	<i>Description</i>	<i>Condition</i>
<b>Structure</b>	Conventional wood frame structure on concrete slab/ with raised floor	Good
<b>Façade</b>	Stucco with aluminum windows	Fair
<b>Roof</b>	Primary: Flat construction with single-ply TPO/PVC membrane	Good
<b>Interiors</b>	Walls: Painted gypsum board, ceramic tile & vinyl Floors: Carpet, VCT Ceilings: Painted gypsum board, ACT	Fair
<b>Elevators</b>	None	--

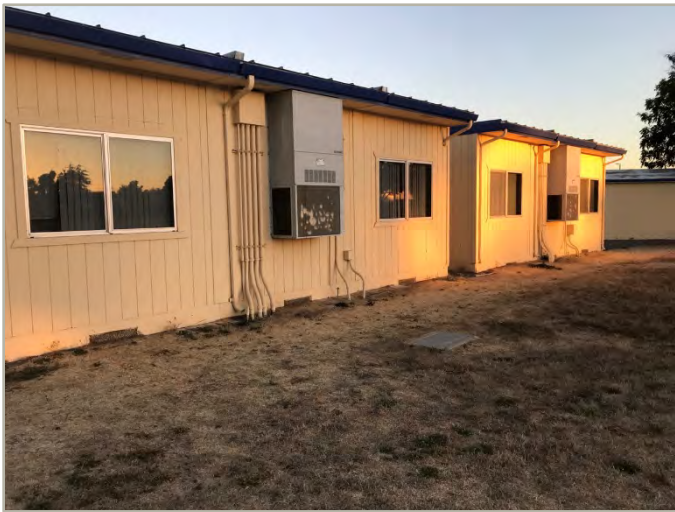
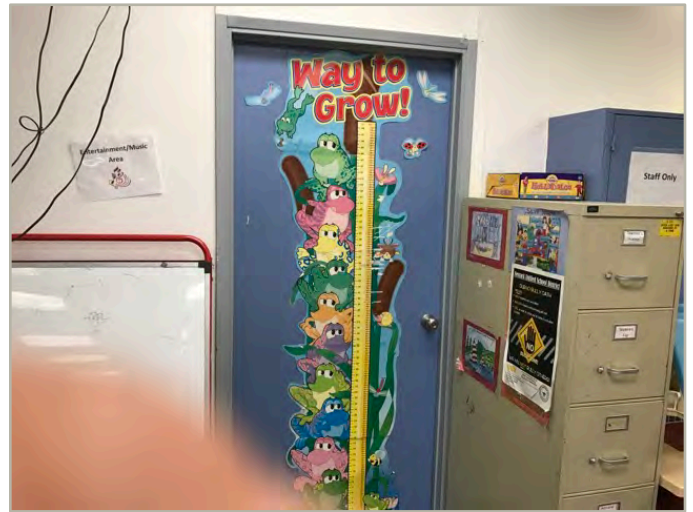
### Building 6, Portables: Systems Summary

<b>Address</b>	5735 Musick Avenue, Newark, California	
<b>Constructed/ Renovated</b>	1990 - 2006	
<b>Building Size</b>	4,800 SF	
<b>Number of Stories</b>	1	
<i>System</i>	<i>Description</i>	<i>Condition</i>
<b>Structure</b>	Lightweight metal framing	Fair
<b>Façade</b>	Painted T-111 with aluminum windows	Poor
<b>Roof</b>	Primary: Flat construction with metal finish	Fair
<b>Interiors</b>	Walls: painted surfaces Floors: Carpet, VCT Ceilings: ACT	Fair
<b>Elevators</b>	None	Fair

<b>Plumbing</b>	Copper supply and cast iron waste & venting No hot water	Fair
<b>HVAC</b>	Individual heat pump units	Fair
<b>Fire Suppression</b>	hydrants, fire extinguishers	Fair
<b>Electrical</b>	Source & Distribution: Main panel with copper wiring Interior Lighting: T-8, Emergency: None	--
<b>Fire Alarm</b>	smoke detectors, alarms, strobes, pull stations and exit signs	--
<b>Equipment/Special</b>	None	--
<b>Accessibility</b>	Presently it does not appear an accessibility study is needed for this building. See Appendix C.	
<b>Key Issues &amp; Findings</b>	Missing fire suppression T-111 rot and deterioration

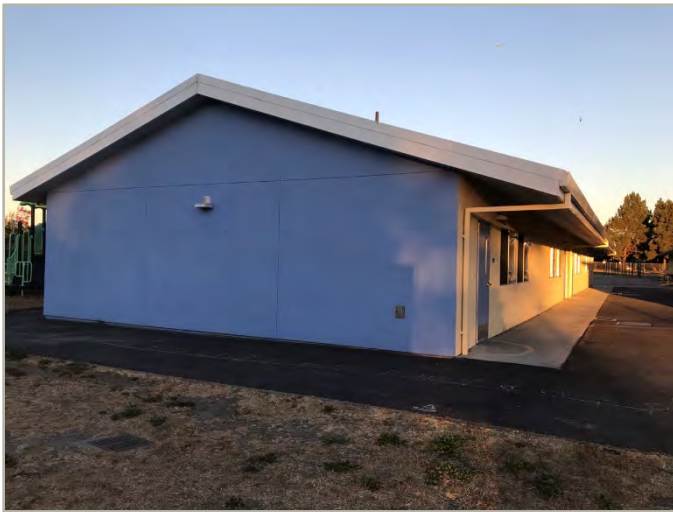
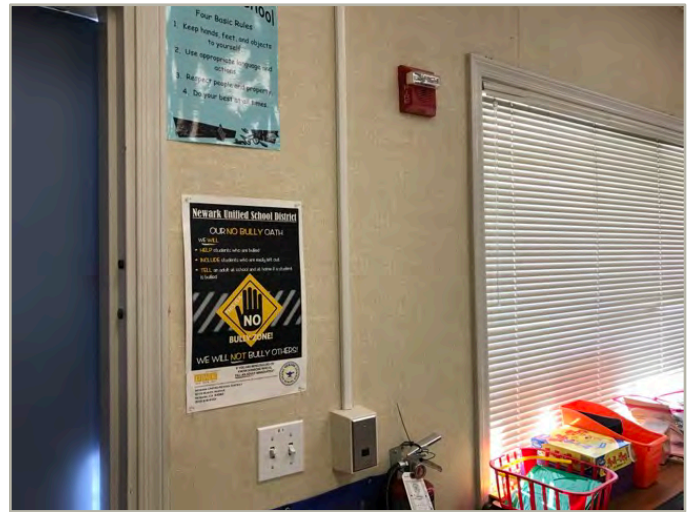
## Building 7, Portable Classrooms 27 - 30: Systems Summary

<b>Address</b>	5735 Musick Avenue, Newark, California	
<b>Constructed/ Renovated</b>	2002	
<b>Building Size</b>	3,800 SF	
<b>Number of Stories</b>	1	
<i>System</i>	<i>Description</i>	<i>Condition</i>
<b>Structure</b>	Conventional metal stud frame structure on concrete slab	Good
<b>Façade</b>	Stucco with aluminum windows	Fair
<b>Roof</b>	Gable construction with metal finish	Fair
<b>Interiors</b>	Walls: vinyl Floors: VCT Ceilings: ACT	Fair
<b>Elevators</b>	None	--

<b>Building 7, Portable Classrooms 27 - 30: Systems Summary</b>		
<b>Plumbing</b>	None	--
<b>HVAC</b>	Individual heat pump units	Fair
<b>Fire Suppression</b>	fire extinguishers	Fair
<b>Electrical</b>	Source & Distribution: Main panel with copper wiring Interior Lighting: T-8, CFL Emergency: None	Fair
<b>Fire Alarm</b>	smoke detectors, alarms, strobes	Fair
<b>Equipment/Special</b>	None	--
<b>Accessibility</b>	Presently it does not appear an accessibility study is needed for this building. See Appendix C.	
<b>Key Issues &amp; Findings</b>	Missing fire suppression

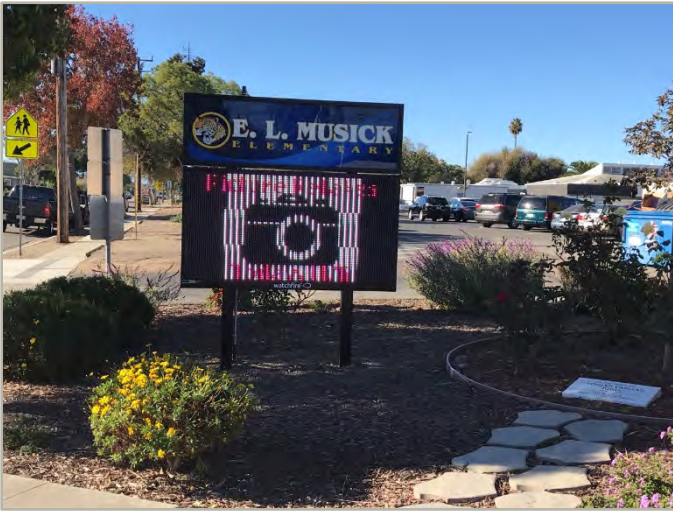
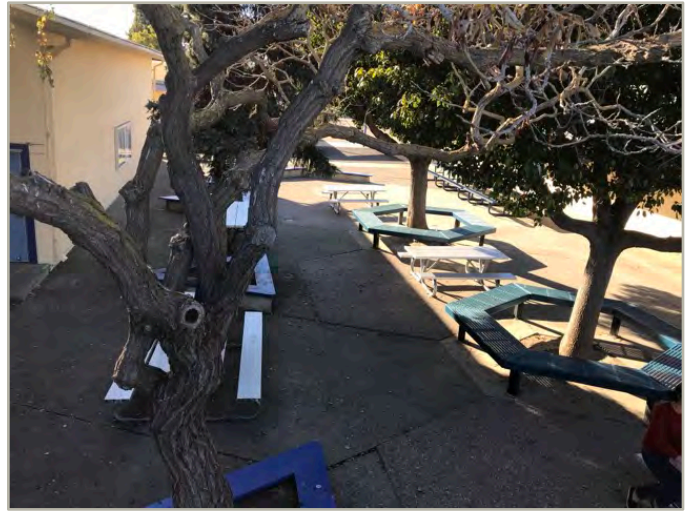
## 12 Site Summary

Site Information		
<b>Lot Size</b>	7.4 acres (estimated)	
<b>Parking Spaces</b>	27 total spaces all in open lots; one of which are accessible	
<i>System</i>	<i>Description</i>	<i>Condition</i>
<b>Pavement/Flatwork</b>	Asphalt lots with areas of concrete and concrete sidewalks, curbs, ramps, and stairs	Fair
<b>Site Development</b>	Property entrance signage, chain link fencing, no dumpster enclosures Asphalt and wood chip playgrounds Limited park benches, trash receptacles	Fair
<b>Landscaping &amp; Topography</b>	Limited landscaping features Irrigation not present No retaining walls Low to flat site slopes throughout	Fair
<b>Utilities</b>	Municipal water and sewer Local utility-provided electric and natural gas	Good
<b>Site Lighting</b>	Pole-mounted: LED Building-mounted: LED, HPS, CFL	Fair
<b>Ancillary Structures</b>	None	--

<b>Accessibility</b>	Potential moderate/major issues have been identified associated with the site areas and a detailed accessibility study is recommended. See Appendix C.
<b>Key Issues &amp; Findings</b>	Alligator cracking and potholes, significant sidewalk trip hazards,

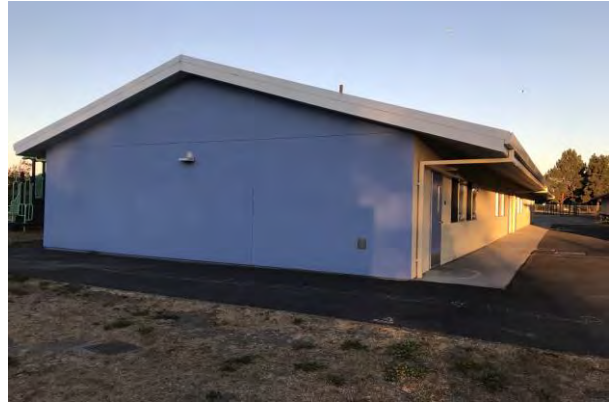
#8	END ELEVATION OF MODULAR CLASSROOM BUILDING
----	---

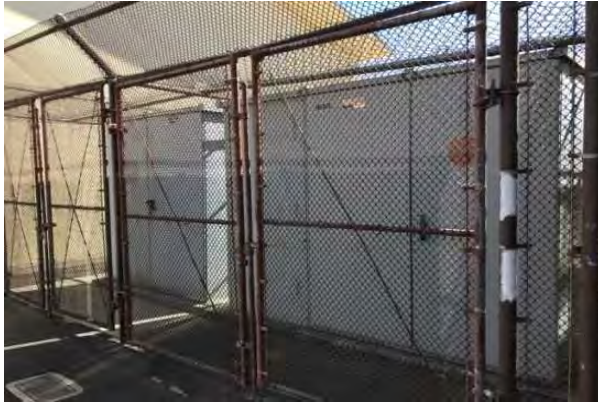
#13	SWITCHGEAR
-----	------------

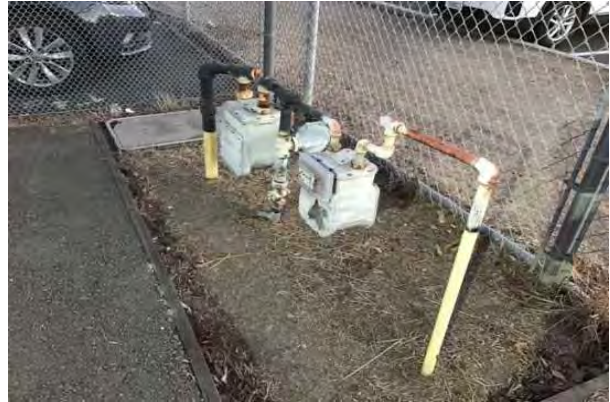
#14	GAS METERS
-----	------------

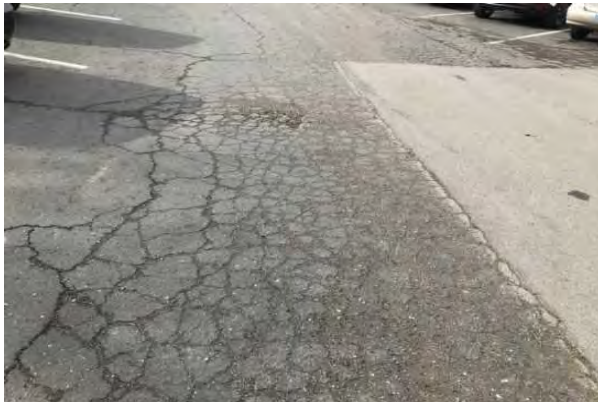
#15	ASPHALT PAVING
-----	----------------

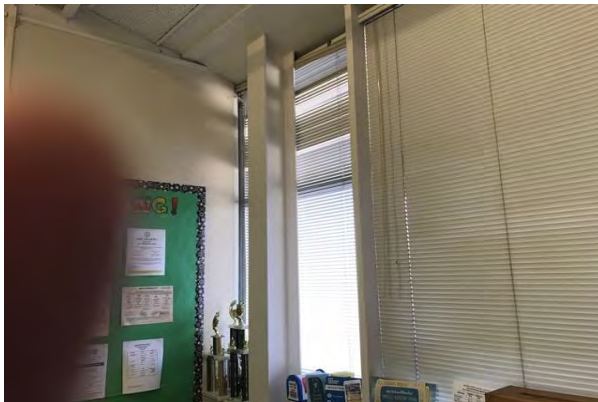
#17	STRUCTURE, STEEL COLUMNS
-----	--------------------------

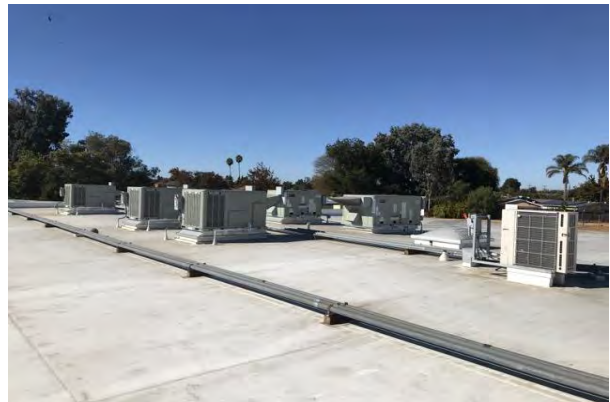
#18	TPO ROOFING
-----	-------------

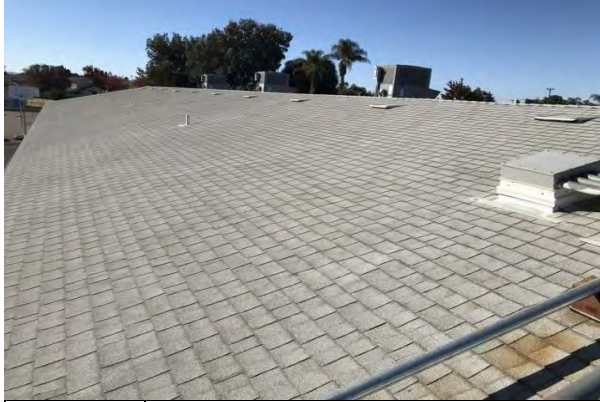
#19	ASPHALT SHINGLES
-----	------------------

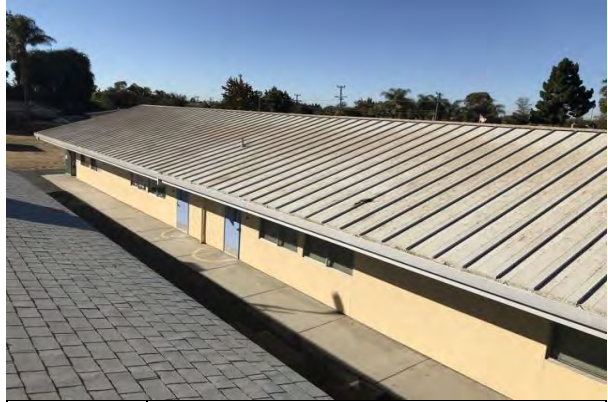
#20	METAL ROOF AT MODULAR BUILDING
-----	--------------------------------

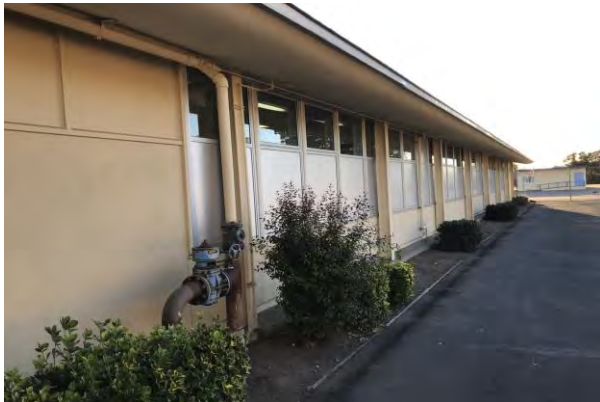
#21	STUCCO WALL
-----	-------------

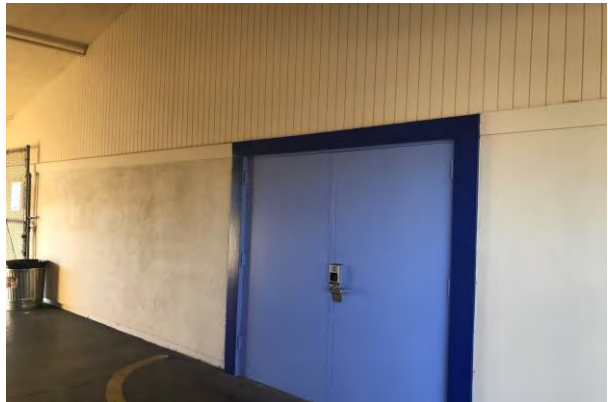
#22	STUCCO & WOOD SIDING, FIBERGLASS DOORS
-----	---

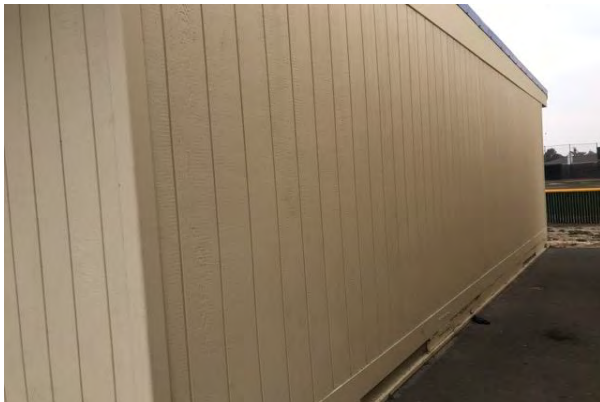
#23	T-111 WALLS
-----	-------------

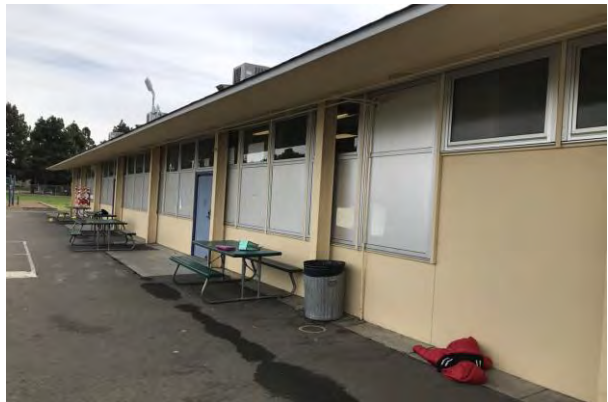
#24	ALUMINUM WINDOWS
-----	------------------

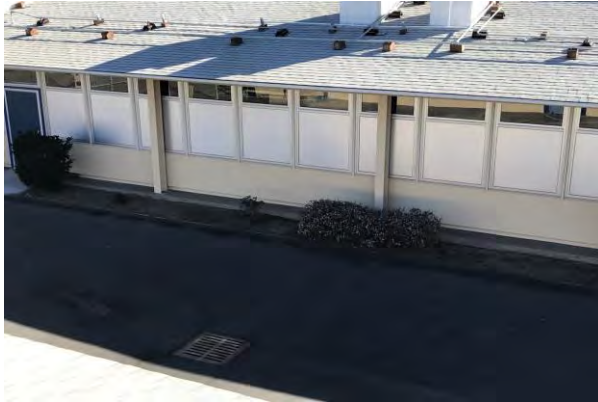
#25	ALUMINUM WINDOWS
-----	------------------

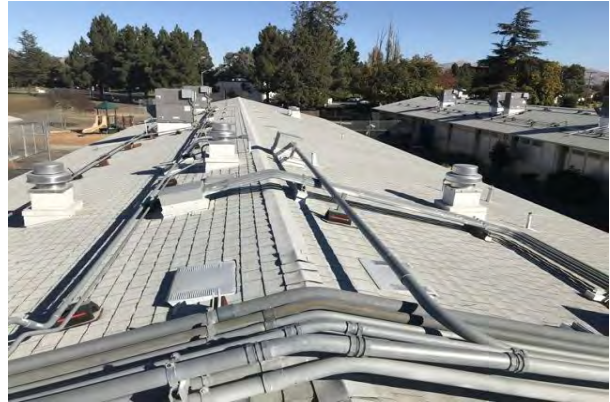
#26	HVAC AND VENTILATION
-----	----------------------

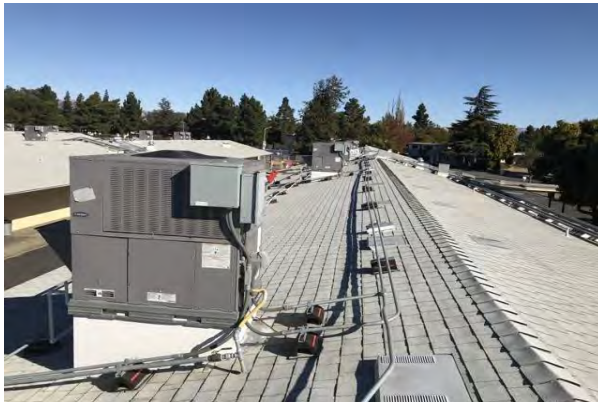
#27	HVAC
-----	------

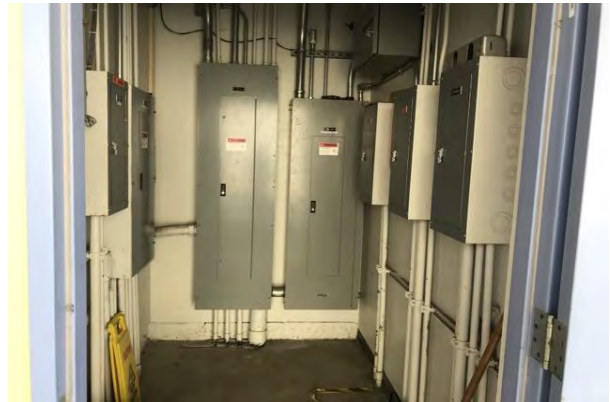
#28	ELECTRICAL DISTRIBUTION
-----	-------------------------

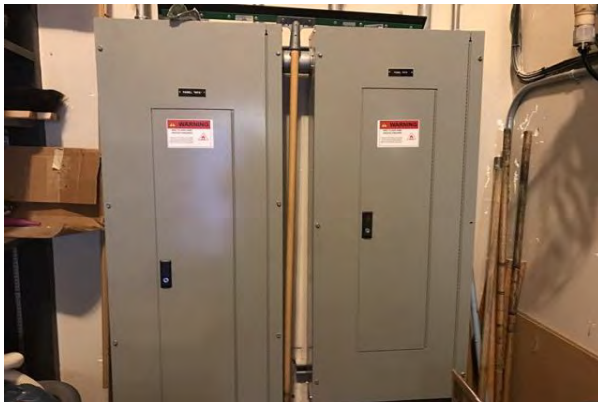
#29	ELECTRICAL DISTRIBUTION
-----	-------------------------

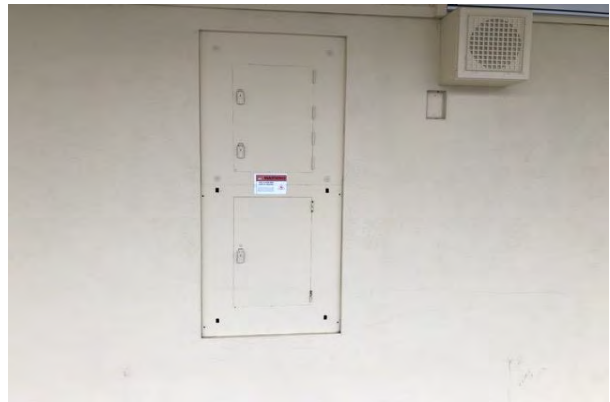
#30	OLD DISTRIBUTION PANEL
-----	------------------------

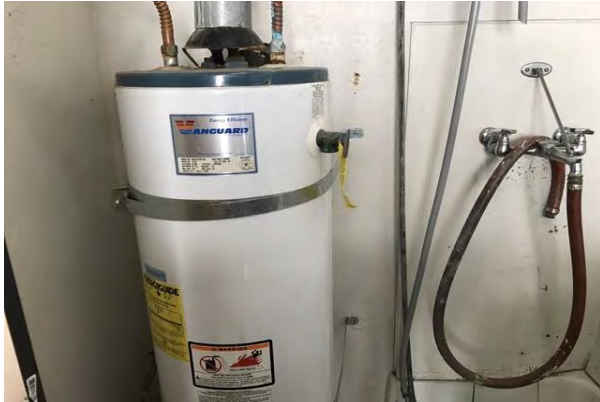
#37	WATER HEATER, GAS
-----	-------------------
