# FACILITY CONDITION ASSESSMENT

Newark School District  
5715 Musick Avenue  
Newark, California 94560

FACILITY CONDITION ASSESSMENT  
OF  
BIRCH GROVE INTERMEDIATE  
37490 BIRCH STREET  
NEWARK, CALIFORNIA 94560

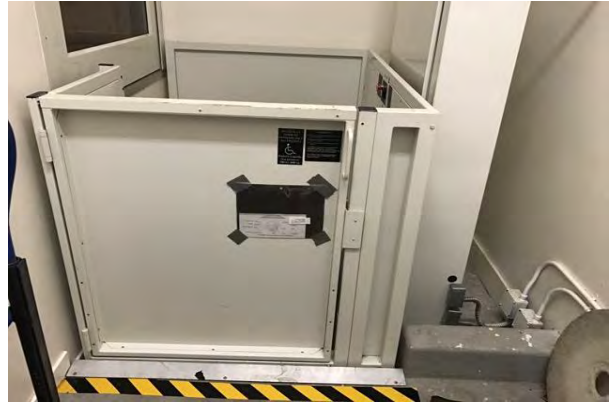
#38	WHEELCHAIR LIFT
-----	-----------------

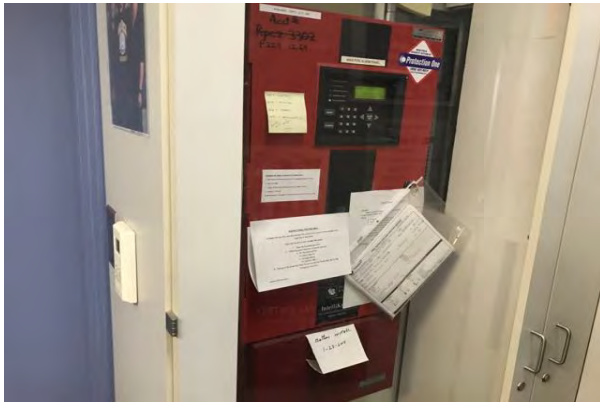
#39	FIRE ALARM CONTROL PANEL
-----	--------------------------

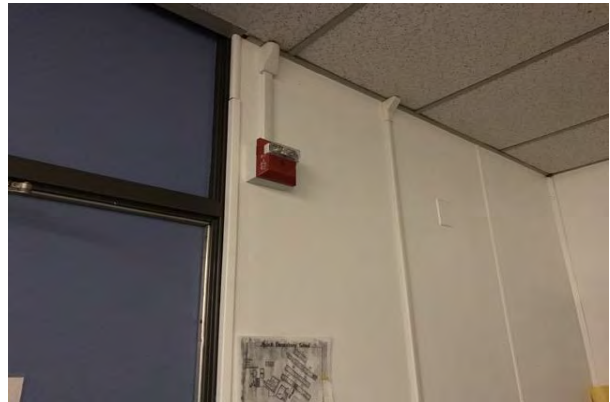
#40	FIRE ALARM SYSTEM
-----	-------------------

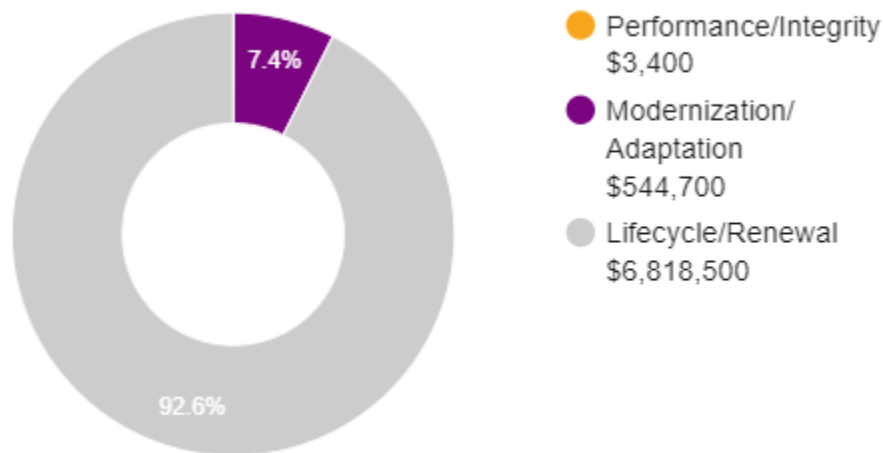
### Plan Type Distribution (by Cost)

Ten year total: \$7,366,600

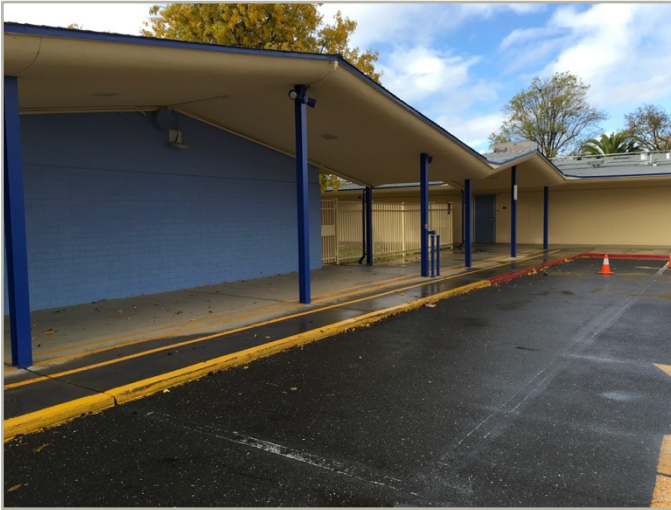
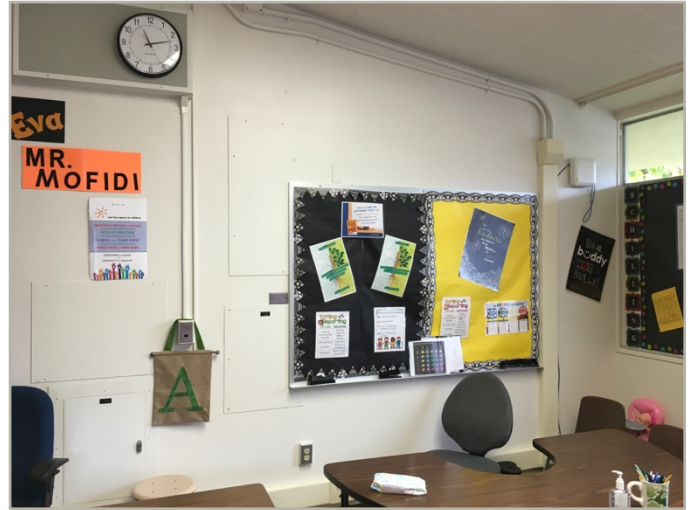
## 2. Unit 1 Classrooms

<b>Address</b>	36901 Spruce Street Newark, California 94560	
<b>Constructed/ Renovated</b>	1960	
<b>Building Size</b>	6,620 SF	
<b>Number of Stories</b>	1	
<i>System</i>	<i>Description</i>	<i>Condition</i>
<b>Structure</b>	Masonry bearing walls and wood-framed roofs	Good
<b>Façade</b>	Painted CMU with aluminum windows	Fair
<b>Roof</b>	Primary: Gable construction with asphalt shingles	Good
<b>Interiors</b>	Walls: Painted gypsum board and CMU Floors: VCT, Epoxy coating Ceilings: Glued acoustical tile	Good
<b>Elevators</b>	None	--
<b>Plumbing</b>	Copper supply and cast iron waste and venting No hot water	Fair

<b>HVAC</b>	Individual Package Units roof mounted	Fair
<b>Fire Suppression</b>	No sprinkler system; fire extinguishers,	Fair
<b>Electrical</b>	Source and Distribution: Main switchboard, distribution panel with copper wiring Fed from 600 Amp building main with copper wiring Interior Lighting: T-8 Emergency: None	Fair
<b>Fire Alarm</b>	Smoke detectors, alarms, strobes, pull stations, back-up emergency lights, and exit signs	Fair
<b>Equipment/Special</b>	None	--
<b>Accessibility</b>	Potential moderate issues have been identified at this building and a detailed accessibility study is recommended. See Appendix C.	
<b>Key Issues and Findings</b>	Single glazed aluminum windows, aged electrical infrastructure, outdated fire alarm system no fire sprinkler system

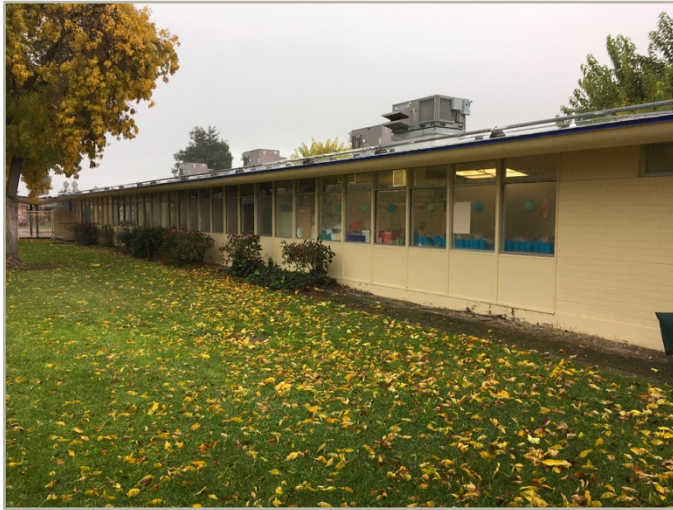
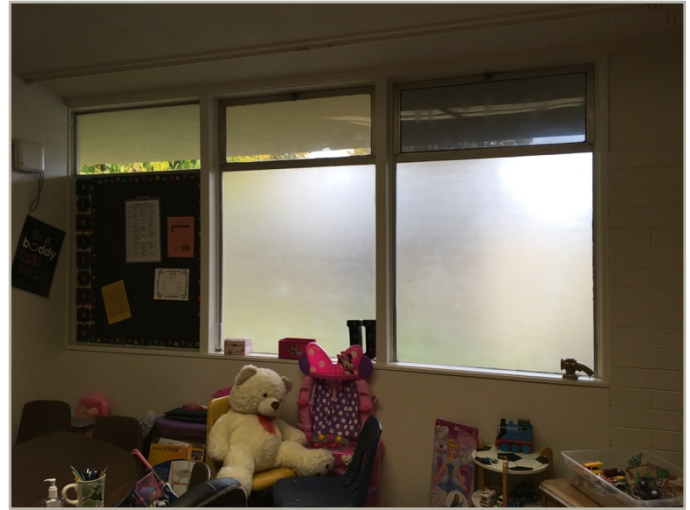
### 3. Unit 2 Classrooms

<b>Address</b>	36901 Spruce Street Newark, California 94560	
<b>Constructed/ Renovated</b>	1960	
<b>Building Size</b>	5,319 SF	
<b>Number of Stories</b>	1	
<i>System</i>	<i>Description</i>	<i>Condition</i>
<b>Structure</b>	Masonry bearing walls and wood-framed roofs	Good
<b>Façade</b>	Painted CMU with aluminum windows	Fair
<b>Roof</b>	Primary: Gable construction with asphalt shingles	Good
<b>Interiors</b>	Walls: Painted gypsum board and CMU Floors: VCT, Epoxy coating, Ceramic tile Ceilings: Glued acoustical tile	Good
<b>Elevators</b>	None	--
<b>Plumbing</b>	Copper supply and cast-iron waste and venting No hot water	Fair

<b>HVAC</b>	Individual Package Units roof mounted	Fair
<b>Fire Suppression</b>	No sprinkler system; fire extinguishers,	Fair
<b>Electrical</b>	Source and Distribution: Main switchboard, distribution panel with copper wiring Fed from 600 Amp building main with copper wiring Interior Lighting: T-8 Emergency: None	Fair
<b>Fire Alarm</b>	Smoke detectors, alarms, strobes, pull stations, back-up emergency lights, and exit signs	Fair
<b>Equipment/Special</b>	None	--
<b>Accessibility</b>	Potential moderate issues have been identified at this building and a detailed accessibility study is recommended. See Appendix C.	
<b>Key Issues and Findings</b>	Single glazed aluminum windows, aged electrical infrastructure, outdated fire alarm system no fire sprinkler system

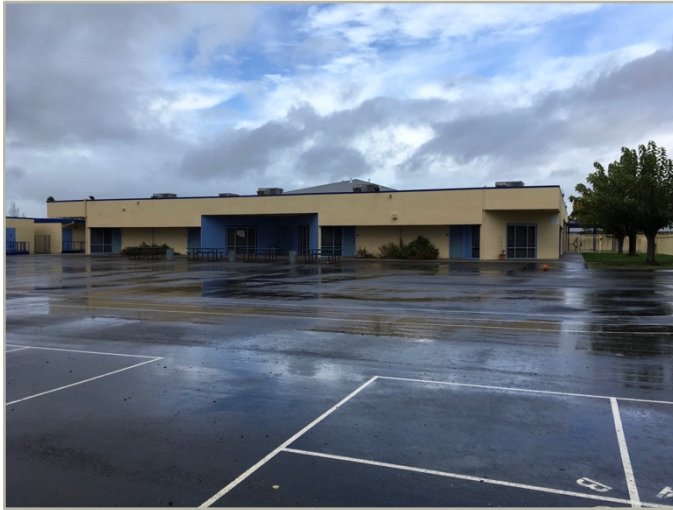
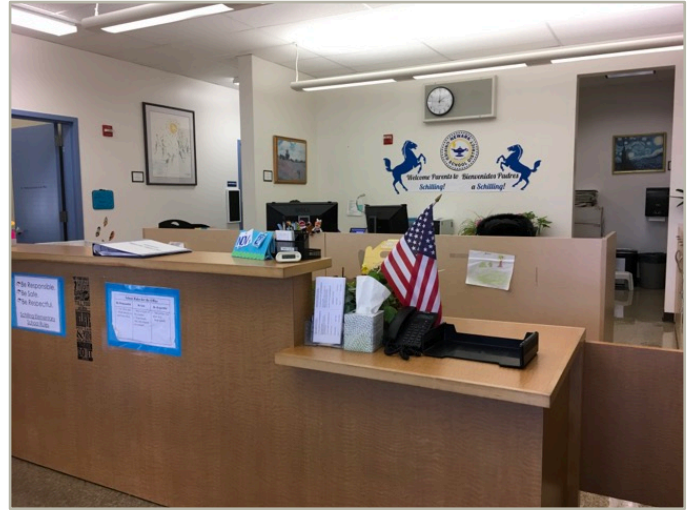
## 5. Unit 4 Office / Classrooms

<b>Address</b>	36901 Spruce Street Newark, California 94560	
<b>Constructed/ Renovated</b>	1960	
<b>Building Size</b>	13,701 SF	
<b>Number of Stories</b>	1	
<i>System</i>	<i>Description</i>	<i>Condition</i>
<b>Structure</b>	Masonry bearing walls with stucco and wood-framed roofs	Good
<b>Façade</b>	Painted CMU and Stucco with store front windows	Good
<b>Roof</b>	Primary: Pyramid construction with asphalt shingles Secondary: Flat construction with single-ply TPO/PVC membrane Secondary: Flat construction with metal finish	Fair
<b>Interiors</b>	Walls: Painted gypsum board and CMU Floors: Carpet, VCT, Epoxy coating Ceilings: Glued acoustical tile	Fair
<b>Elevators</b>	None	--

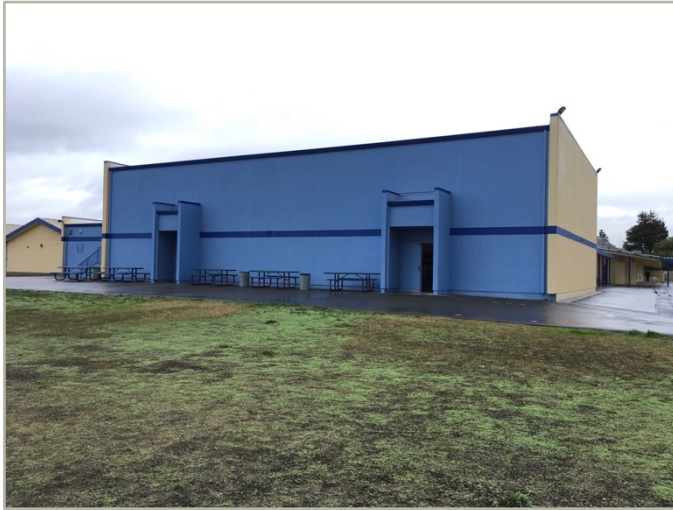
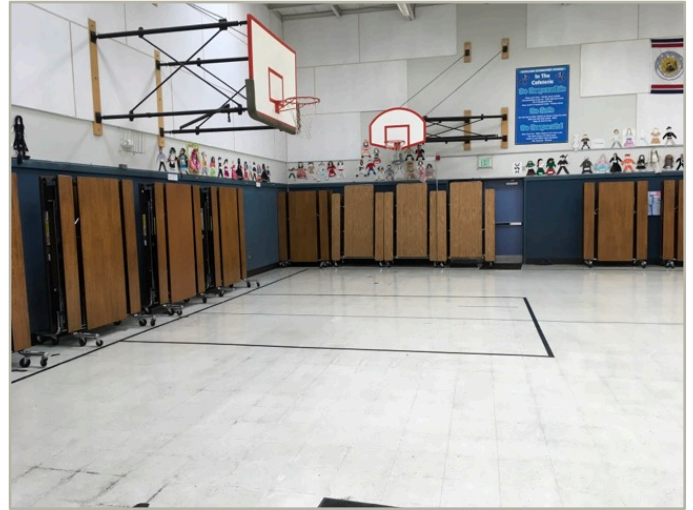
## 6. Unit 5 Multi-purpose / Office

<b>Address</b>	36901 Spruce Street Newark, California 94560	
<b>Constructed/ Renovated</b>	1960	
<b>Building Size</b>	9,378 SF	
<b>Number of Stories</b>	1	
<i>System</i>	<i>Description</i>	<i>Condition</i>
<b>Structure</b>	Masonry bearing walls with stucco and wood-framed roofs	Good
<b>Façade</b>	Painted CMU and Stucco with store front windows	Good
<b>Roof</b>	Primary: Flat construction with single-ply TPO/PVC membrane Secondary: Shed construction with metal finish	Fair
<b>Interiors</b>	Walls: Painted gypsum board and CMU Floors: VCT, carpet, wood flooring, ceramic tile, quarry tile Ceilings: ACT	Fair
<b>Elevators</b>	Wheelchair lift for the stage.	Fair
<b>Plumbing</b>	Copper supply and cast-iron waste and venting Gas water heater	Fair

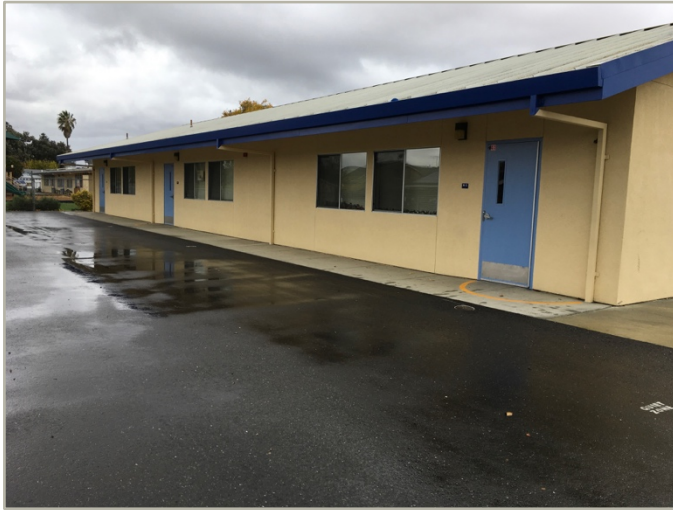
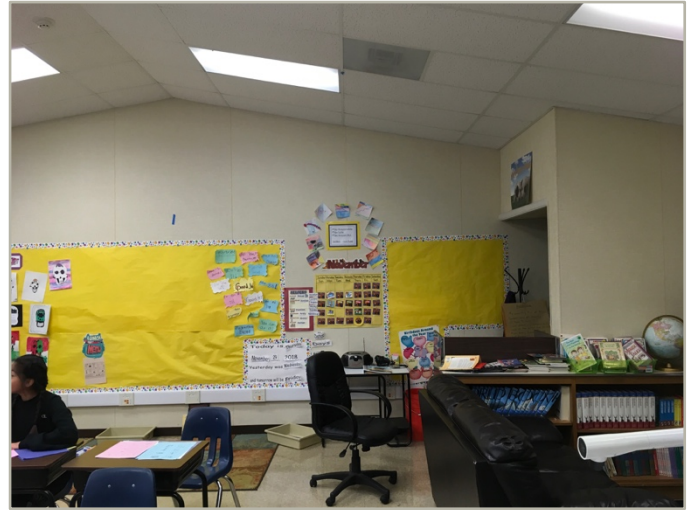
## 7. Unit 6 Classrooms

<b>Address</b>	36901 Spruce Street Newark, California 94560	
<b>Constructed/ Renovated</b>	1960	
<b>Building Size</b>	6940 SF	
<b>Number of Stories</b>	1	
<i>System</i>	<i>Description</i>	<i>Condition</i>
<b>Structure</b>	Conventional wood frame structure on concrete slab and wood-framed roofs	Good
<b>Façade</b>	Painted Stucco with aluminum windows	Fair
<b>Roof</b>	Primary: Gable construction with metal finish	Good
<b>Interiors</b>	Walls: Painted gypsum board, laminated paneling, vinyl wallcovering Floors: VCT, Epoxy coating Ceilings: ACT	Good
<b>Elevators</b>	None	--
<b>Plumbing</b>	Copper supply and cast-iron waste and venting No water heater	Fair

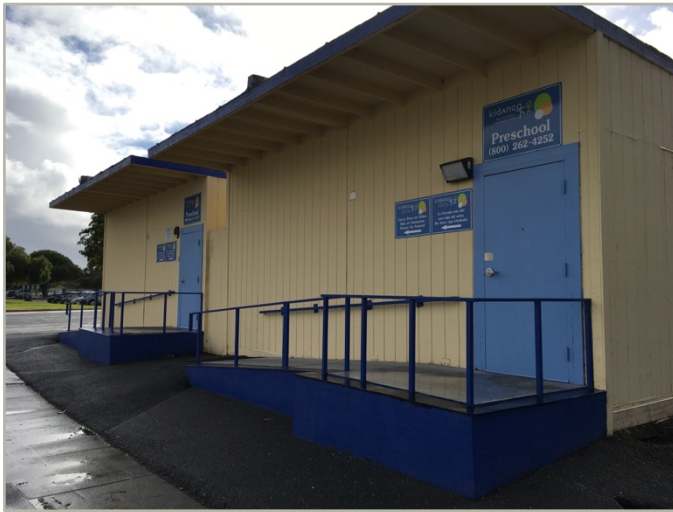
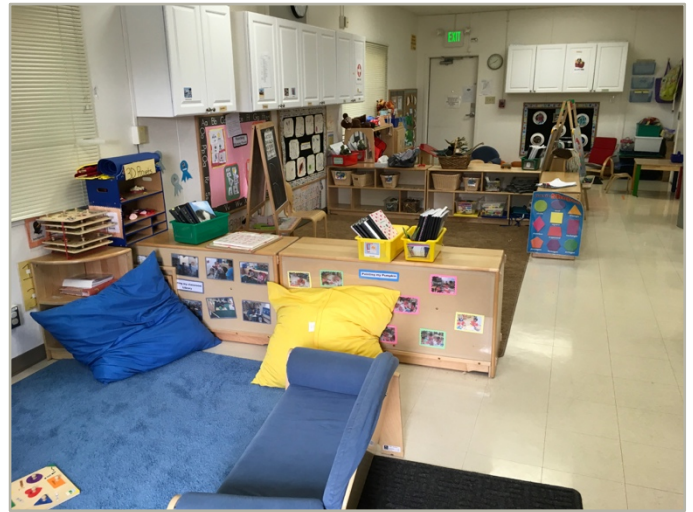
## 8. Portable 1A 1B Preschool

<b>Address</b>	36901 Spruce Street Newark, California 94560	
<b>Constructed/ Renovated</b>	1993	
<b>Building Size</b>	900 SF each x 2 = 1,800	
<b>Number of Stories</b>	1	
<i>System</i>	<i>Description</i>	<i>Condition</i>
<b>Structure</b>	Conventional wood frame structure on steel floor frame, wood roof structure	Good
<b>Façade</b>	Painted wood siding with aluminum windows	Fair
<b>Roof</b>	Primary: Flat construction with metal finish	Fair
<b>Interiors</b>	Walls: Vinyl covered gypsum board Floors: VCT Ceilings: ACT	Fair
<b>Elevators</b>	None	--
<b>Plumbing</b>	Copper supply and cast-iron waste and venting Electric hot water heater	Fair

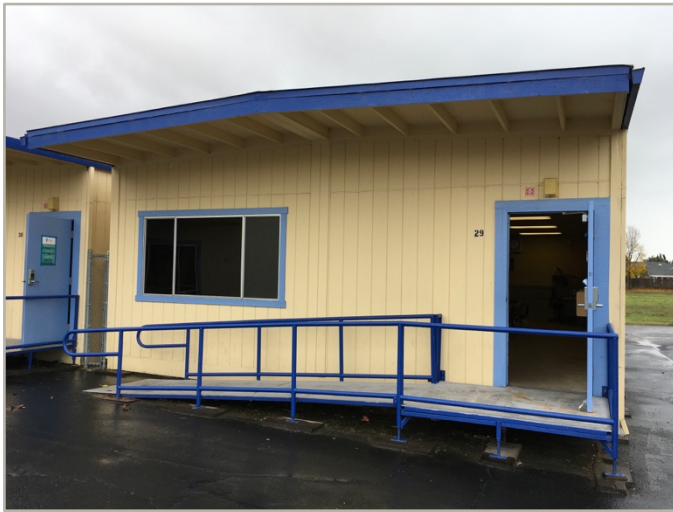
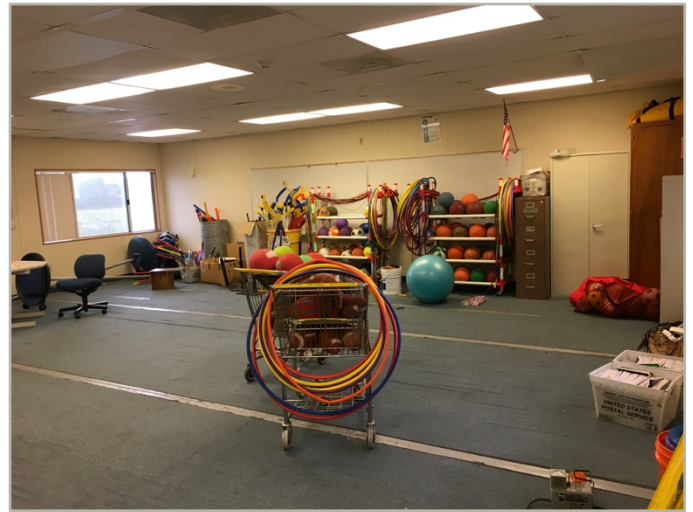
## 9. Portable 29, 30 Classrooms

<b>Address</b>	36901 Spruce Street Newark, California 94560	
<b>Constructed/ Renovated</b>	1993	
<b>Building Size</b>	900 SF each x 2 = 1,800	
<b>Number of Stories</b>	1	
<i>System</i>	<i>Description</i>	<i>Condition</i>
<b>Structure</b>	Conventional wood frame structure on steel floor frame, wood roof structure	Good
<b>Façade</b>	Painted wood siding with aluminum windows	Fair
<b>Roof</b>	Primary: Flat construction with metal finish	Fair
<b>Interiors</b>	Walls: Vinyl covered gypsum board Floors: Carpet Ceilings: ACT	Fair
<b>Elevators</b>	None	--
<b>Plumbing</b>	No supply or waste and venting No water heater	--

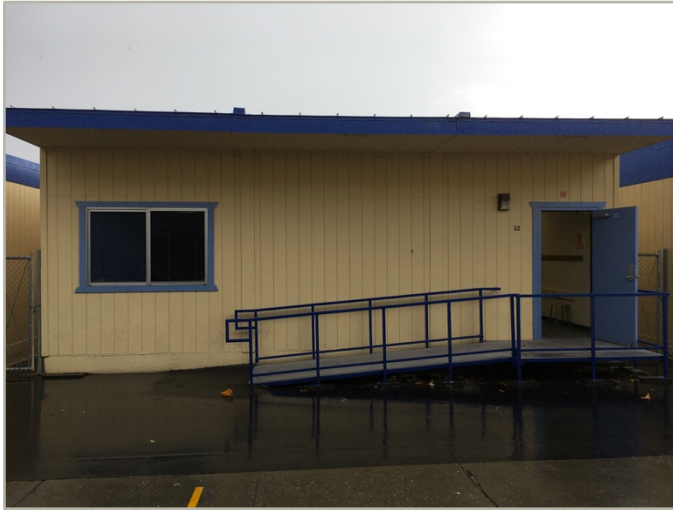
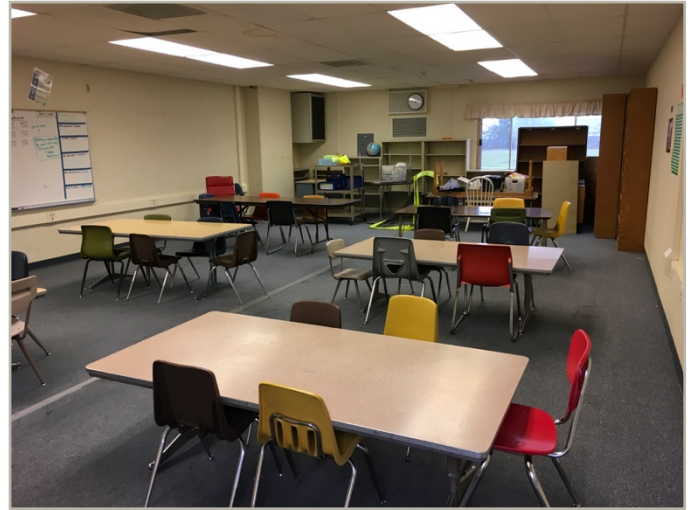
## 10. Portable 31, 32, 33 Classrooms

<b>Address</b>	36901 Spruce Street Newark, California 94560	
<b>Constructed/ Renovated</b>	2002	
<b>Building Size</b>	900 SF each x 3 =2,700	
<b>Number of Stories</b>	1	
<i>System</i>	<i>Description</i>	<i>Condition</i>
<b>Structure</b>	Conventional wood frame structure on steel floor frame, wood roof structure	Good
<b>Façade</b>	Painted wood siding with aluminum windows	Good
<b>Roof</b>	Primary: Flat construction with metal finish	Good
<b>Interiors</b>	Walls: Vinyl covered gypsum board Floors: Carpet Ceilings: ACT	Fair
<b>Elevators</b>	None	--
<b>Plumbing</b>	No supply or waste and venting No water heater	--

Units 1 through 5 are of masonry construction that is painted or has a stucco finish. The roofs are wood framed with wood sheathing. The roof covering is asphalt shingles on Units 1 through 3. Unit 4 has a combination newer TPO type roof with a pyramid center roof section with asphalt shingles. Unit 5 has a newer TPO roof finish. The Portable structures have metal roof that appear to be in fair condition except for number 31. Number 31's roof is leaking and has damaged the ceiling tiles and the carpet.

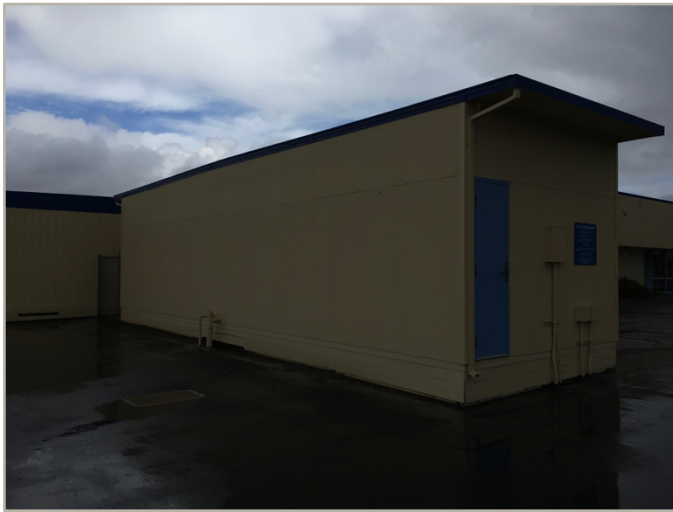
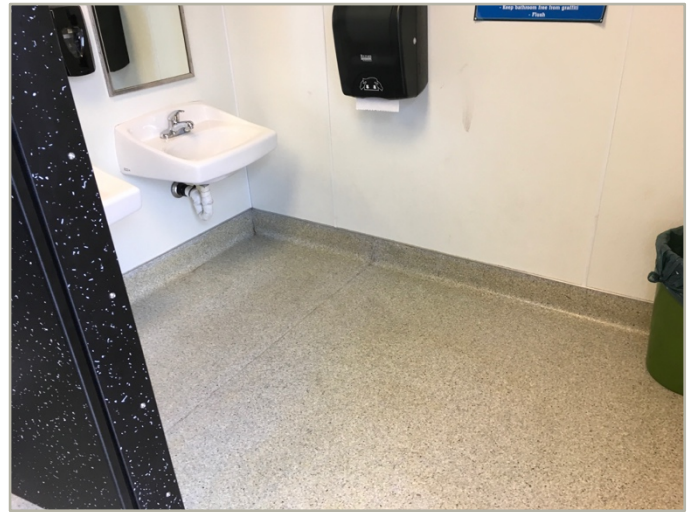
# 11. Portable Restroom

<b>Address</b>	36901 Spruce Street Newark, California 94560	
<b>Constructed/ Renovated</b>	2008	
<b>Building Size</b>	450 SF	
<b>Number of Stories</b>	1	
<i>System</i>	<i>Description</i>	<i>Condition</i>
<b>Structure</b>	Conventional wood frame structure on steel floor frame, wood roof structure	Good
<b>Façade</b>	Painted Stucco with no windows	Good
<b>Roof</b>	Primary: Flat construction with metal finish	Fair
<b>Interiors</b>	Walls: FRP panels Floors: Sheet vinyl Ceilings: ACT	Good
<b>Elevators</b>	None	--
<b>Plumbing</b>	Copper supply and PVC waste and venting No water heater	Good

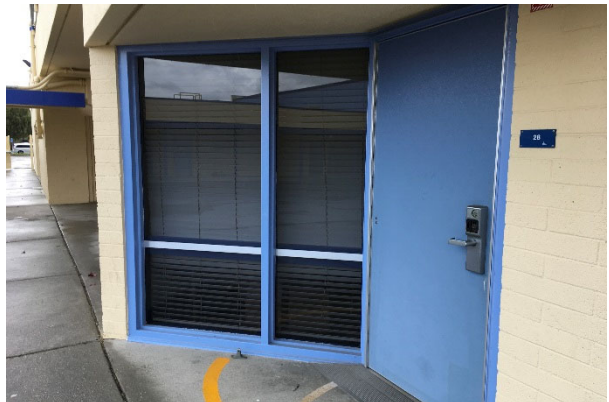
#12	STOREFRONT / FIBERGLASS DOOR UNIT 4
-----	-------------------------------------

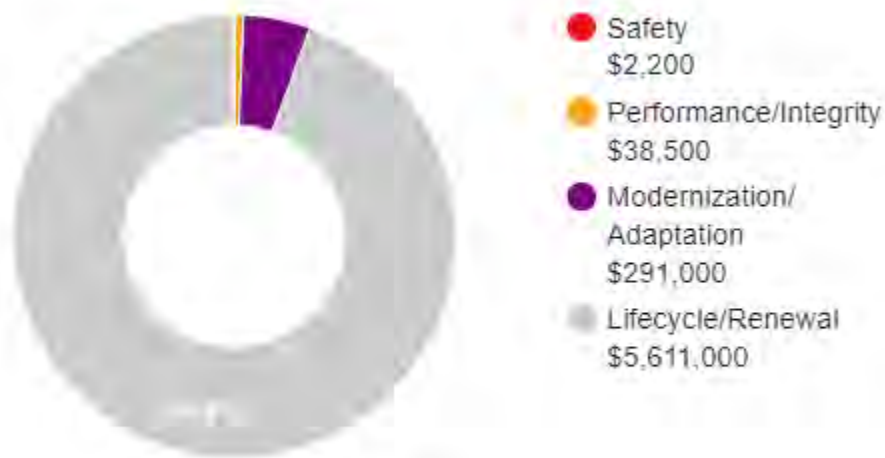
### Plan Type Distribution (by Cost)

Each line item in the cost database is assigned a Plan Type, which is the primary reason or rationale for the recommended replacement, repair, or other corrective action. This is the “why” part of the equation. A cost or line item may commonly have more than one applicable Plan Type; however, only one Plan Type will be assigned based on the “best” fit, typically the one with the greatest significance.

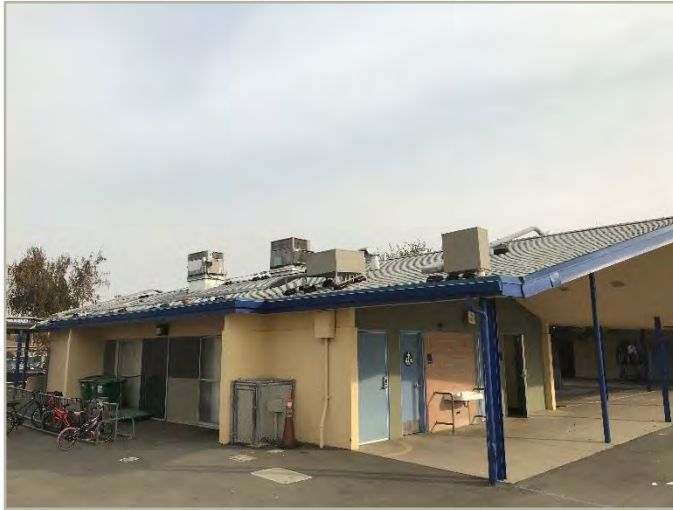
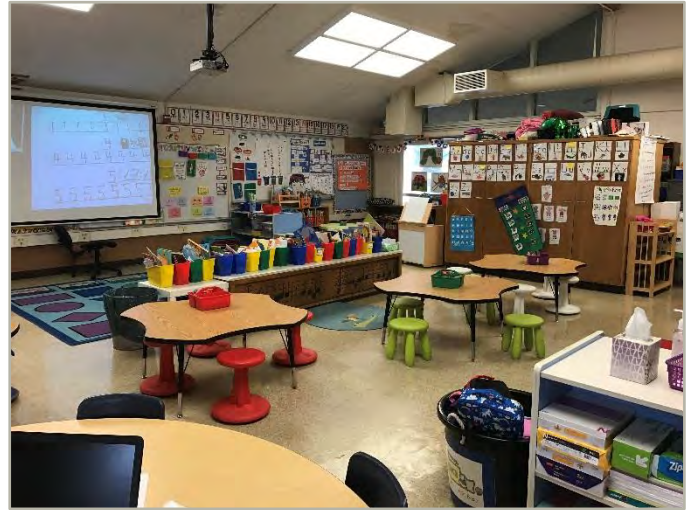
## 2. Original Snow ES Buildings 1,2,3,4 & 5

<b>Address</b>	6580 Mirabeau Drive Newark, California	
<b>Constructed/ Renovated</b>	1960's	
<b>Building Size</b>	Three @ 7,600 sf, one each @ 4,700 and 2,400 sf Total is 29,900 sf	
<b>Number of Stories</b>	1	
<i>System</i>	<i>Description</i>	<i>Condition</i>
<b>Structure</b>	Masonry bearing walls and wood-framed roofs	Good
<b>Façade</b>	Painted brick with aluminum windows	Fair
<b>Roof</b>	Primary: Gable construction with asphalt shingles	Fair
<b>Interiors</b>	Walls: Painted gypsum board & brick, laminated paneling Floors: VCT, epoxy coating, carpet, ceramic tile Ceilings: Painted gypsum board, ACT	Fair
<b>Elevators</b>	None	--
<b>Plumbing</b>	Copper supply and cast-iron waste & venting Elec water heater in Building 5 Buildings 1, 2 3 and 4 - Hot water from Building 6	Fair

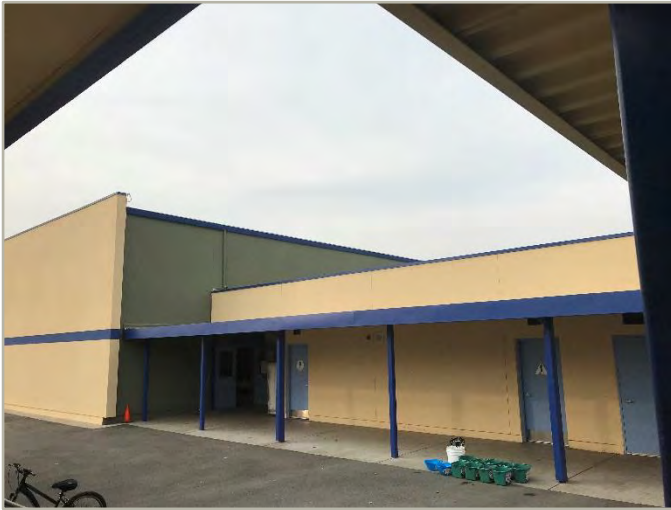
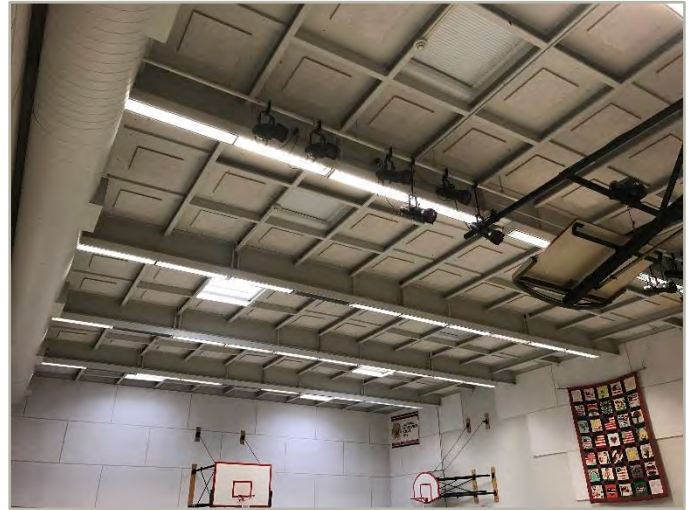
### 3. Building 6 - Multi-Purpose

<b>Address</b>	6580 Mirabeau Drive Newark, California	
<b>Constructed/ Renovated</b>	1991	
<b>Building Size</b>	9,900 sf	
<b>Number of Stories</b>	1	
<i>System</i>	<i>Description</i>	<i>Condition</i>
<b>Structure</b>	Steel frame with metal framed roof decks	Good
<b>Façade</b>	Stucco with aluminum windows	Fair
<b>Roof</b>	Primary: Flat construction with single-ply TPO/PVC membrane Secondary: Flat construction with metal finish	Fair
<b>Interiors</b>	Walls: Painted gypsum board Floors: Carpet, VCT, ceramic tile, wood floor refinishing Ceilings: Painted gypsum board, ACT, exposed structure	Fair
<b>Elevators</b>	Wheelchair lift serving stage	Fair

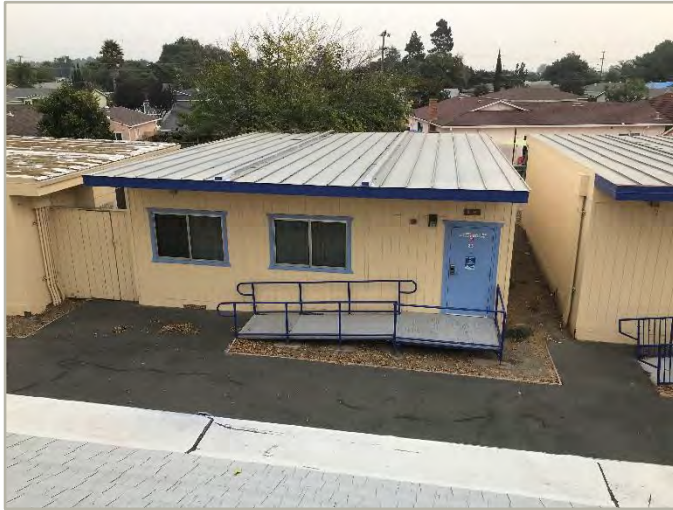
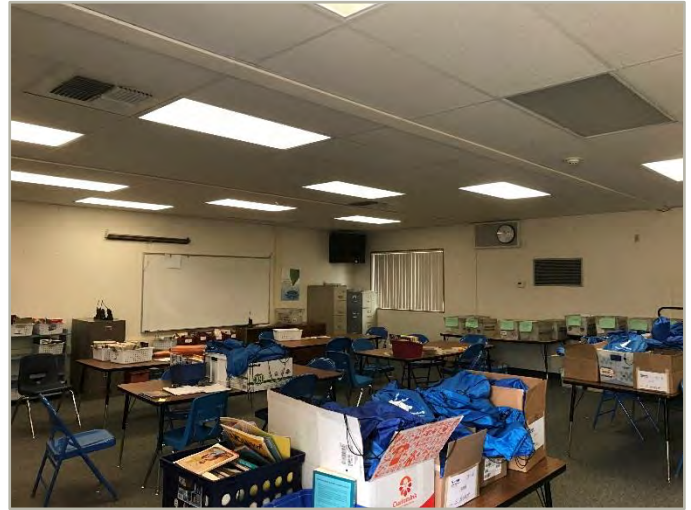
## 4. Portables 1,2 & 3

<b>Address</b>	6580 Mirabeau Drive Newark, California	
<b>Constructed/ Renovated</b>	1960's	
<b>Building Size</b>	3,600 sf (3 @ 1200 sf each)	
<b>Number of Stories</b>	1	
<i>System</i>	<i>Description</i>	<i>Condition</i>
<b>Structure</b>	Conventional wood frame structure with raised floor	Good
<b>Façade</b>	Wood siding with aluminum windows	Fair
<b>Roof</b>	Primary: Flat construction with metal finish	Fair
<b>Interiors</b>	Walls: Painted gypsum board Floors: Carpet Ceilings: ACT	Fair
<b>Elevators</b>	None	--

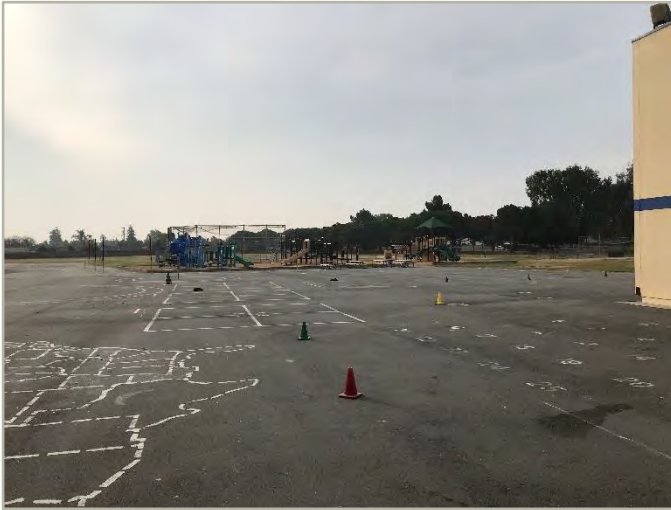
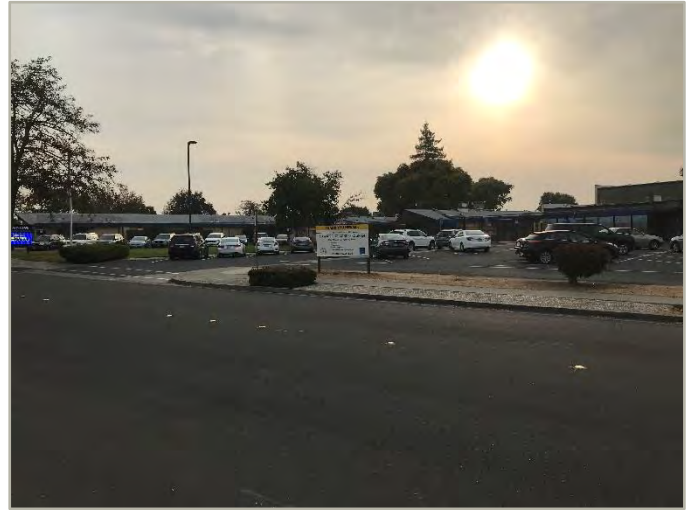
## 5. Site Summary

Site Information		
<b>Lot Size</b>	10 acres (estimated)	
<b>Parking Spaces</b>	43 total spaces all in open lots; 2 of which are accessible	
<i>System</i>	<i>Description</i>	<i>Condition</i>
<b>Pavement/Flatwork</b>	Asphalt lots with areas of concrete and concrete sidewalks, curbs, ramps, and stairs	Fair
<b>Site Development</b>	Property entrance signage, chain-link fencing Playgrounds and sports courts with bleachers, fencing	Fair
<b>Landscaping &amp; Topography</b>	No significant landscaping features Irrigation present No retaining walls Flat site	Fair
<b>Utilities</b>	Municipal water and sewer Local utility-provided electric and natural gas	Fair
<b>Site Lighting</b>	Pole-mounted: HPS Building-mounted: HPS	Fair
<b>Ancillary Structures</b>	Pre-fabricated storage/shipping container	Fair
<b>Accessibility</b>	Presently it does not appear an accessibility study is needed for the exterior site areas. See Appendix C.

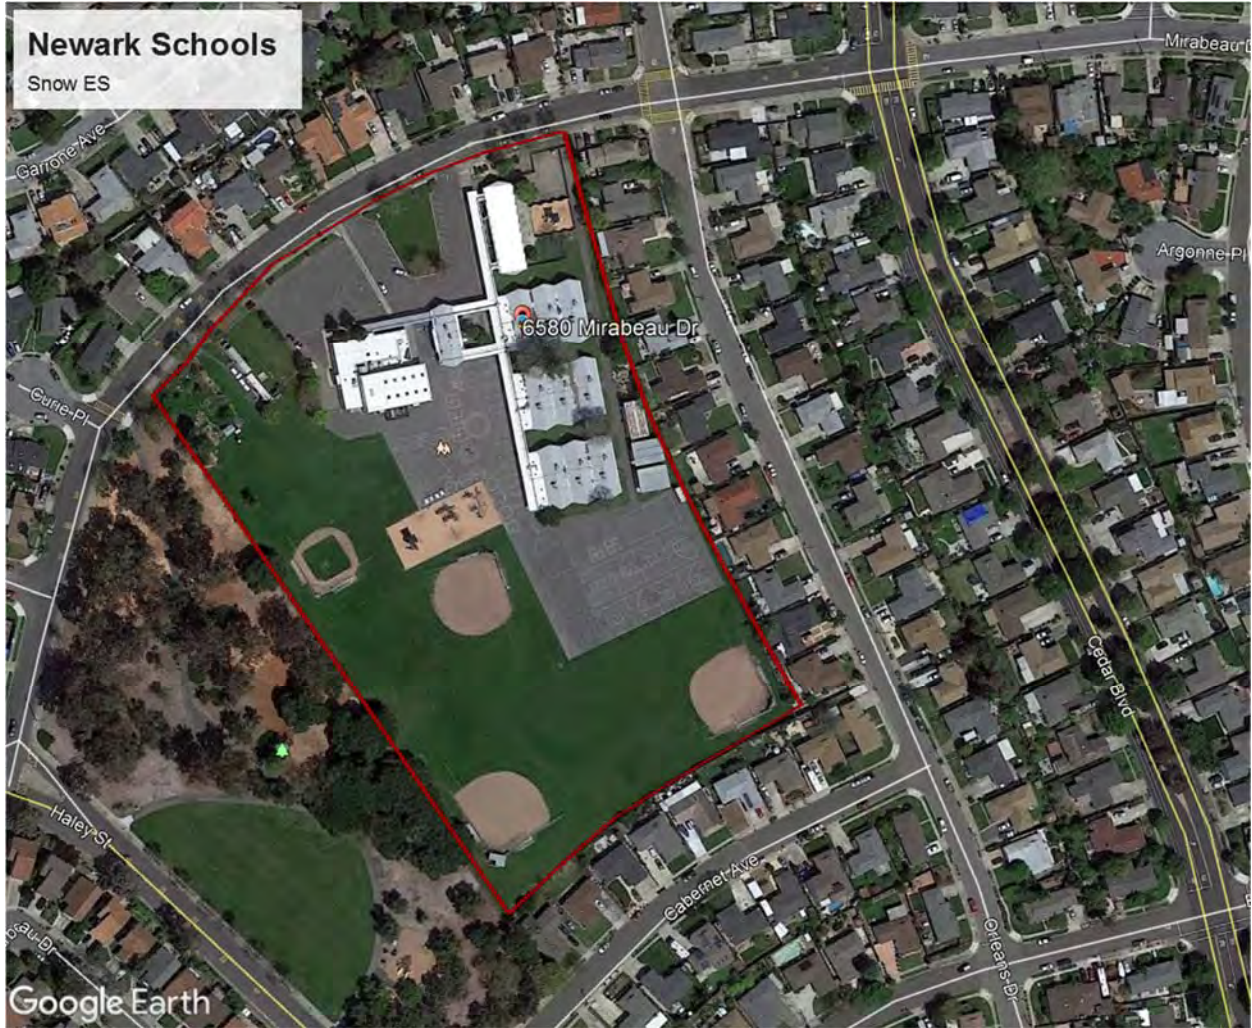
# Site Plan

**Project Name:**  
Snow Elementary School

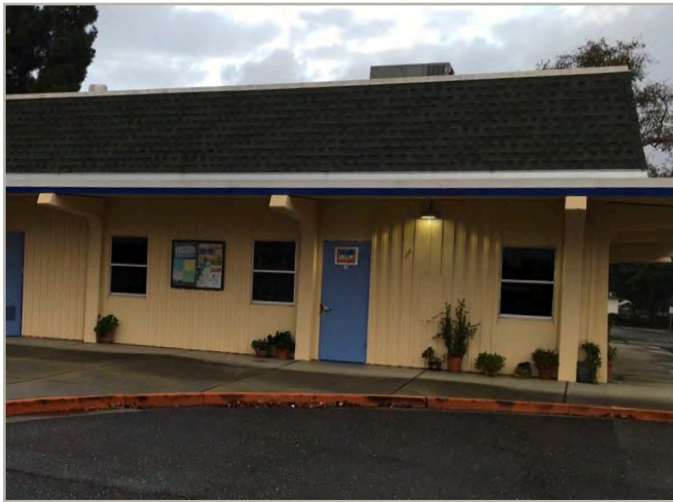
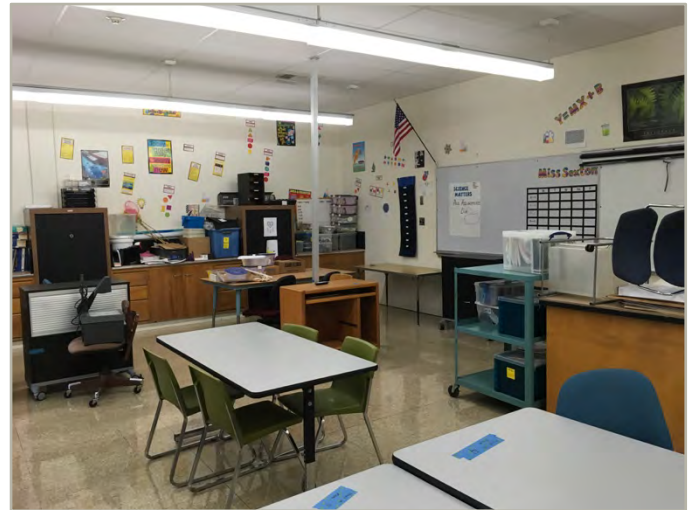
## 2. Unit 1 Crossroads School

<b>Address</b>	35753 Cedar Boulevard; Newark, California	
<b>Constructed/ Renovated</b>	1965 (Estimated)	
<b>Building Size</b>	5,640 SF	
<b>Number of Stories</b>	1	
<i>System</i>	<i>Description</i>	<i>Condition</i>
<b>Structure</b>	Concrete tilt-up structure with masonry and framed bearing walls and wood-framed roofs with wood panel roof sheathing.	Good
<b>Façade</b>	Painted Stucco and T-111 Wood siding with aluminum windows	Good and Fair
<b>Roof</b>	Primary: Flat construction with single-ply TPO/PVC membrane Secondary: Mansard construction with asphalt shingles	Good
<b>Interiors</b>	Walls: Painted gypsum board and CMU Floors: Suspect asbestos Tile Ceilings: Painted gypsum board, ACT.	Good Fair
<b>Elevators</b>	None	--

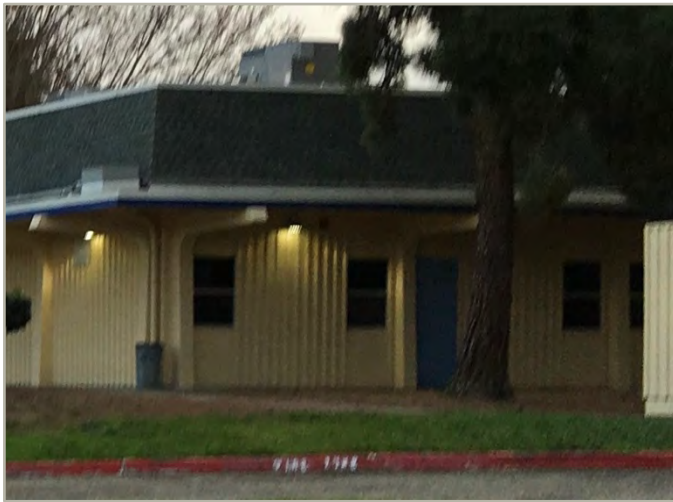
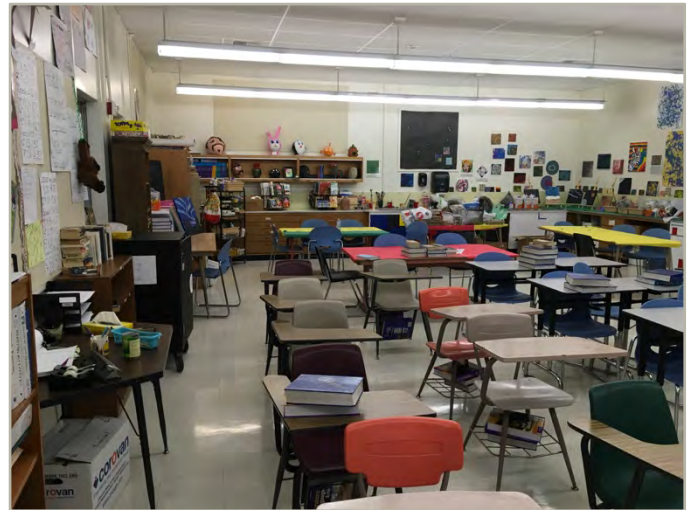
### 3. Unit 2 Bridgeport High School Classrooms

<b>Address</b>	35753 Cedar Boulevard; Newark, California	
<b>Constructed/ Renovated</b>	1965 (Estimated)	
<b>Building Size</b>	5,860 SF	
<b>Number of Stories</b>	1	
<i>System</i>	<i>Description</i>	<i>Condition</i>
<b>Structure</b>	Concrete tilt-up structure with masonry and framed bearing walls and wood-framed roofs with wood panel roof sheathing.	Good
<b>Façade</b>	Painted Stucco and T-111 Wood siding with aluminum windows	Good and Fair
<b>Roof</b>	Primary: Flat construction with single-ply TPO/PVC membrane Secondary: Mansard construction with asphalt shingles	Good
<b>Interiors</b>	Walls: Painted gypsum board and CMU Floors: VCT, Carpet tile, Suspect asbestos tile Ceilings: Painted gypsum board, ACT.	Good Fair
<b>Elevators</b>	None	--
<b>Plumbing</b>	Copper supply and cast-iron waste and venting No water heater	Fair

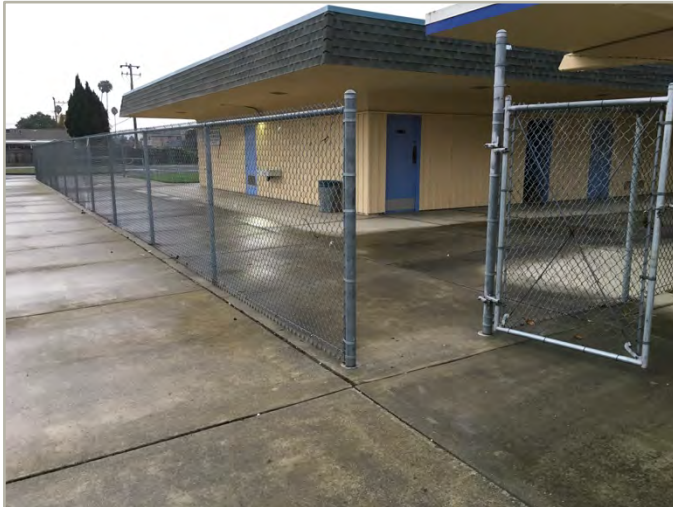
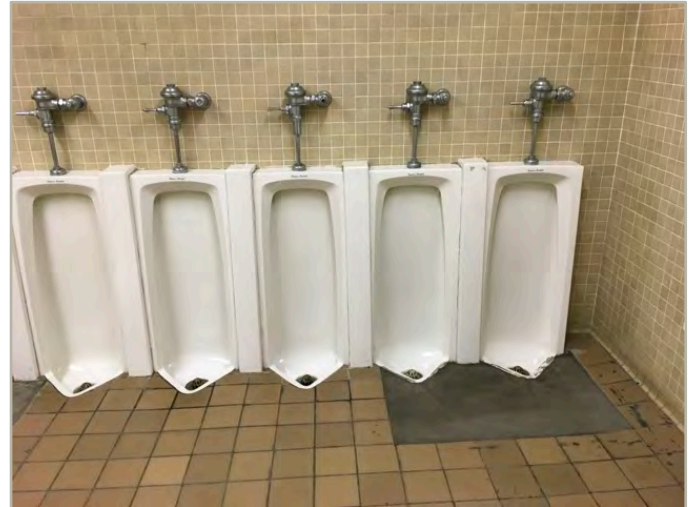
## 4. Unit 3 Newark Adult Classes Restroom & Storage Building

<b>Address</b>	35753 Cedar Boulevard; Newark, California	
<b>Constructed/ Renovated</b>	1965 (Estimated)	
<b>Building Size</b>	3,792 SF	
<b>Number of Stories</b>	1	
<i>System</i>	<i>Description</i>	<i>Condition</i>
<b>Structure</b>	Concrete tilt-up structure with masonry and framed bearing walls and wood-framed roofs with wood panel roof sheathing.	Good
<b>Façade</b>	Painted Stucco and T-111 Wood siding without windows	Good
<b>Roof</b>	Primary: Flat construction with single-ply TPO/PVC membrane Secondary: Mansard construction with asphalt shingles	Good
<b>Interiors</b>	Walls: Painted gypsum board, Ceramic tile and painted CMU Floors: Ceramic tile and unfinished concrete in the storage area Ceilings: Painted gypsum board.	Good Fair
<b>Elevators</b>	None	--

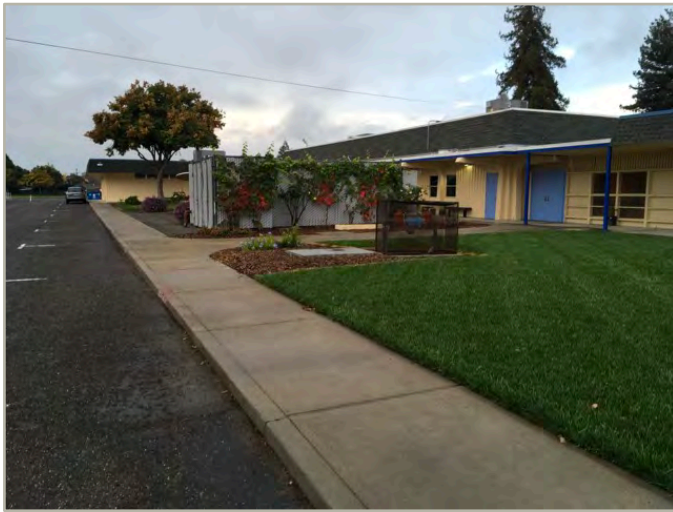
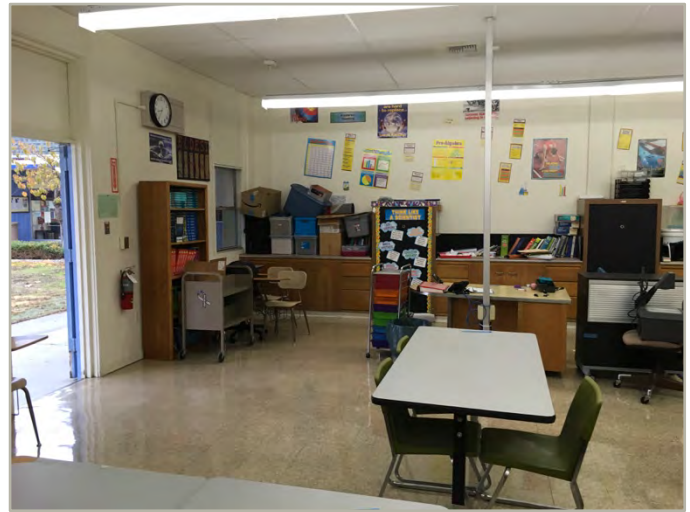
## 5. Unit 4 Newark Adult Classes

<b>Address</b>	35753 Cedar Boulevard; Newark, California	
<b>Constructed/ Renovated</b>	1965 (Estimated)	
<b>Building Size</b>	6,026 SF	
<b>Number of Stories</b>	1	
<i>System</i>	<i>Description</i>	<i>Condition</i>
<b>Structure</b>	Concrete tilt-up structure with masonry and framed bearing walls and wood-framed roofs with wood panel roof sheathing.	Good
<b>Façade</b>	Painted Stucco and T-111 Wood siding with aluminum windows	Good and Fair
<b>Roof</b>	Primary: Flat construction with single-ply TPO/PVC membrane Secondary: Mansard construction with asphalt shingles	Good
<b>Interiors</b>	Walls: Painted gypsum board and CMU Floors: VCT, Carpet tile and Suspect asbestos tile Ceilings: Painted gypsum board, ACT.	Good Fair
<b>Elevators</b>	None	--

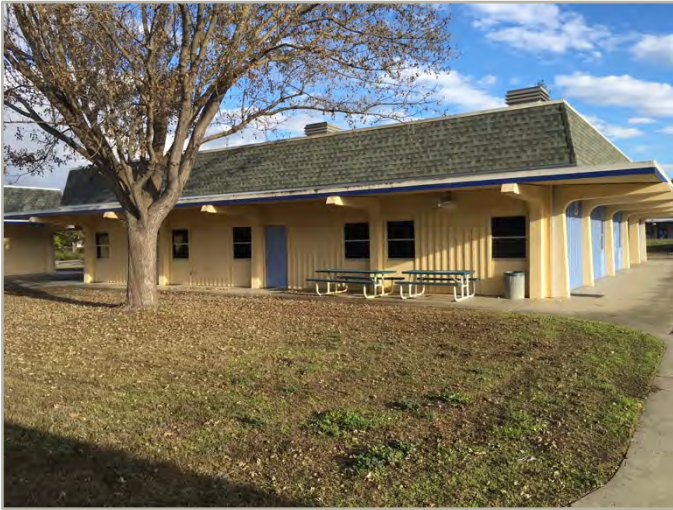
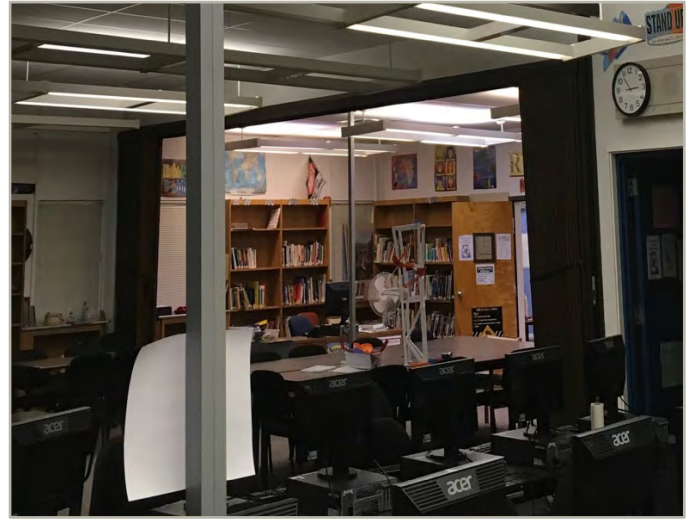
## 6. Unit 5 Bridgeport High School Office

<b>Address</b>	35753 Cedar Boulevard; Newark, California	
<b>Constructed/ Renovated</b>	1965 (Estimated)	
<b>Building Size</b>	5,302 SF	
<b>Number of Stories</b>	1	
<i>System</i>	<i>Description</i>	<i>Condition</i>
<b>Structure</b>	Concrete tilt-up structure with masonry and framed bearing walls and wood-framed roofs with wood panel roof sheathing.	Good
<b>Façade</b>	Painted Stucco and T-111 Wood siding with aluminum windows	Good and Fair
<b>Roof</b>	Primary: Flat construction with single-ply TPO/PVC membrane Secondary: Mansard construction with asphalt shingles	Good
<b>Interiors</b>	Walls: Painted gypsum board and CMU Floors: Carpet, Carpet tile and Suspect asbestos tile Ceilings: Painted gypsum board, ACT and glued acoustical tile.	Good Fair
<b>Elevators</b>	None	--

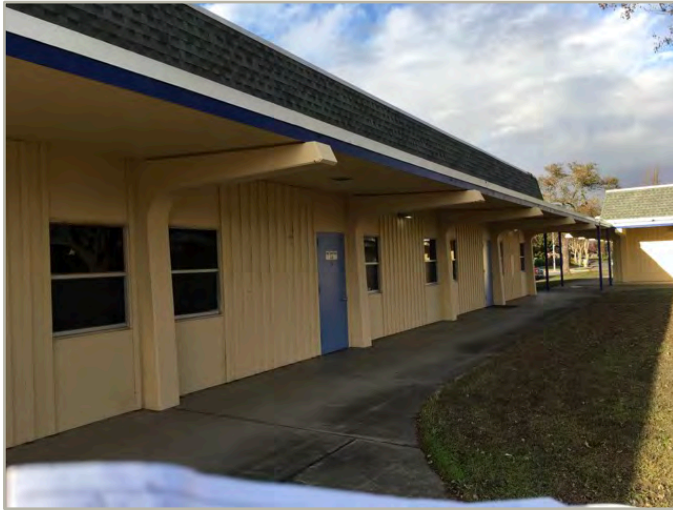
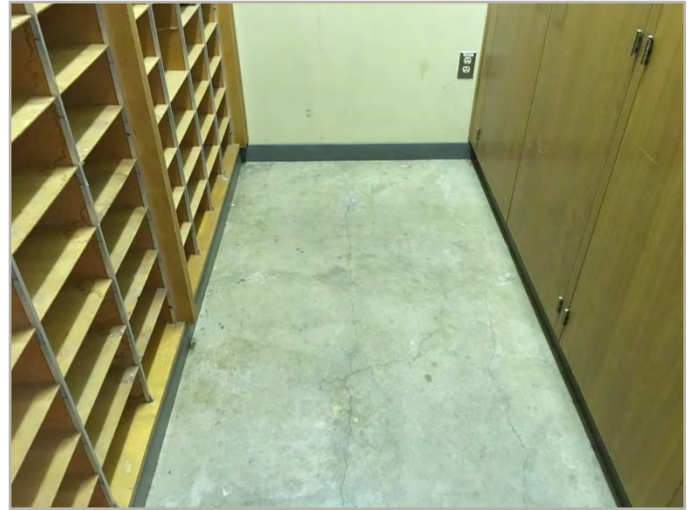
## 7. Unit 6 Bridgeport High School

<b>Address</b>	35753 Cedar Boulevard; Newark, California	
<b>Constructed/ Renovated</b>	1965 (Estimated)	
<b>Building Size</b>	5,910 SF	
<b>Number of Stories</b>	1	
<i>System</i>	<i>Description</i>	<i>Condition</i>
<b>Structure</b>	Concrete tilt-up structure with masonry and framed bearing walls and wood-framed roofs with wood panel roof sheathing.	Good
<b>Façade</b>	Painted Stucco and T-111 Wood siding with aluminum windows	Good and Fair
<b>Roof</b>	Primary: Flat construction with single-ply TPO/PVC membrane Secondary: Mansard construction with asphalt shingles	Good
<b>Interiors</b>	Walls: Painted gypsum board and CMU Floors: VCT and Suspect asbestos tile Ceilings: Painted gypsum board, ACT.	Good Fair
<b>Elevators</b>	None	--

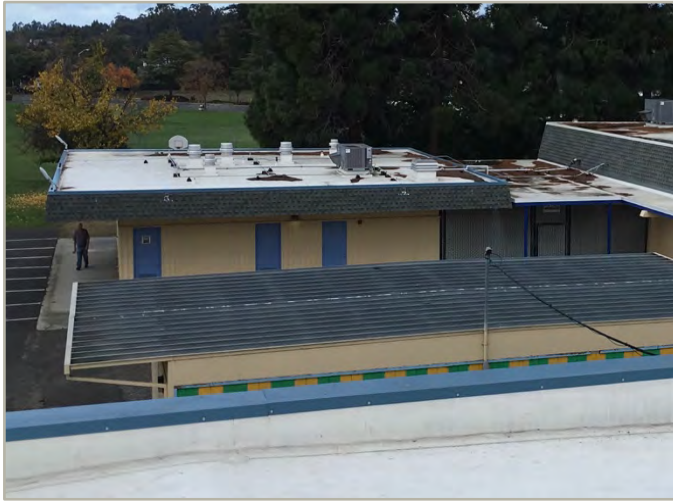
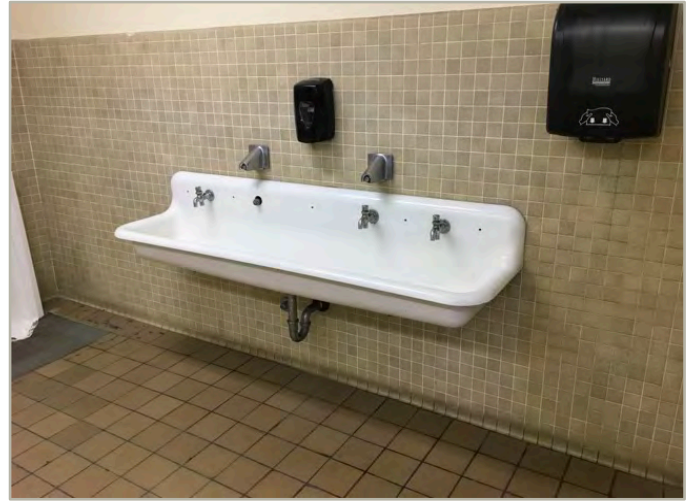
## 8. Unit 7 Bridgeport H.S. Restroom & Storage Building

<b>Address</b>	35753 Cedar Boulevard; Newark, California	
<b>Constructed/ Renovated</b>	1965 (Estimated)	
<b>Building Size</b>	3,792 SF	
<b>Number of Stories</b>	1	
<i>System</i>	<i>Description</i>	<i>Condition</i>
<b>Structure</b>	Concrete tilt-up structure with masonry and framed bearing walls and wood-framed roofs with wood panel roof sheathing.	Good
<b>Façade</b>	Painted Stucco and T-111 Wood siding without windows	Good
<b>Roof</b>	Primary: Flat construction with single-ply TPO/PVC membrane Secondary: Mansard construction with asphalt shingles	Good
<b>Interiors</b>	Walls: Painted gypsum board, ceramic tile and painted CMU Floors: Ceramic tile and Concrete in the storage area Ceilings: Painted gypsum board.	Good Fair
<b>Elevators</b>	None	--
<b>Plumbing</b>	Copper supply and cast-iron waste and venting Gas water heater	Fair
