# FACILITY CONDITION ASSESSMENT

Newark School District  
5715 Musick Avenue  
Newark, California 94560

FACILITY CONDITION ASSESSMENT  
OF  
BIRCH GROVE INTERMEDIATE  
37490 BIRCH STREET  
NEWARK, CALIFORNIA 94560

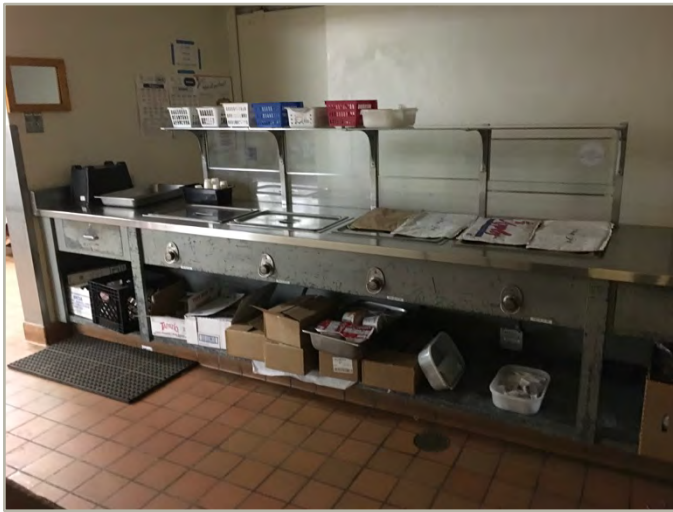
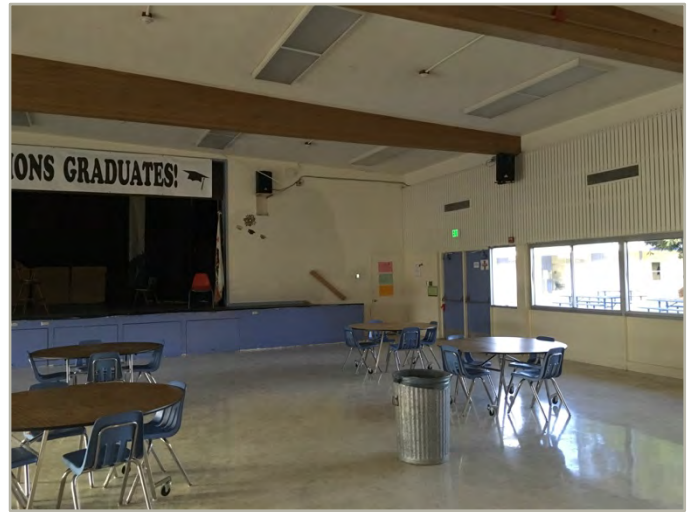
## 9. Unit 8 Multi-purpose / Kitchen

<b>Address</b>	35753 Cedar Boulevard; Newark, California	
<b>Constructed/ Renovated</b>	1965 (Estimated)	
<b>Building Size</b>	10,381 SF	
<b>Number of Stories</b>	1	
<i>System</i>	<i>Description</i>	<i>Condition</i>
<b>Structure</b>	Concrete tilt-up structure with masonry and framed bearing walls and wood-framed roofs with wood panel roof sheathing.	Good
<b>Façade</b>	Painted Stucco and T-111 Wood siding with aluminum windows	Good and Fair
<b>Roof</b>	Primary: Flat construction with single-ply TPO/PVC membrane Secondary: Mansard construction with asphalt shingles	Good
<b>Interiors</b>	Walls: Painted gypsum board, ceramic tile and painted CMU Floors: VCT and Suspect asbestos tile, ceramic tile Ceilings: Painted gypsum board, glued acoustical tiles.	Good Fair
<b>Elevators</b>	None	--

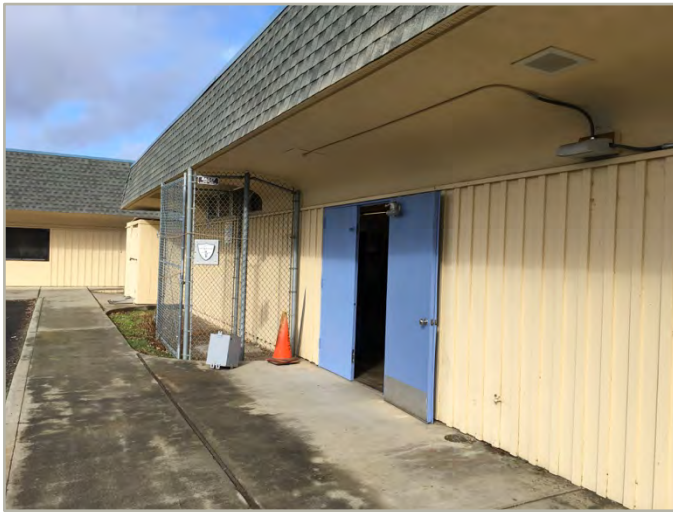
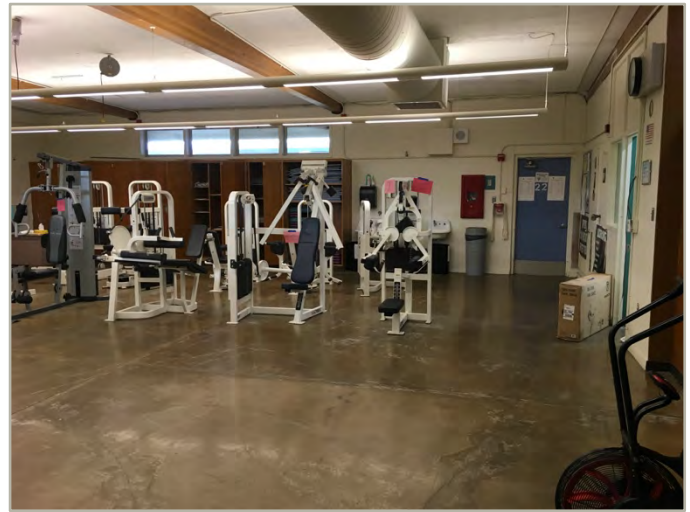
## 10. Unit 9 Newark Adult Classes

<b>Address</b>	35753 Cedar Boulevard; Newark, California	
<b>Constructed/ Renovated</b>	1965 (Estimated)	
<b>Building Size</b>	4,640 SF	
<b>Number of Stories</b>	1	
<i>System</i>	<i>Description</i>	<i>Condition</i>
<b>Structure</b>	Concrete tilt-up structure with masonry and framed bearing walls and wood-framed roofs with wood panel roof sheathing.	Good
<b>Façade</b>	Painted Stucco and T-111 Wood siding with aluminum windows	Good and Fair
<b>Roof</b>	Primary: Flat construction with single-ply TPO/PVC membrane Secondary: Mansard construction with asphalt shingles	Good
<b>Interiors</b>	Walls: Painted gypsum board and CMU Floors: Sealed concrete Ceilings: Painted gypsum board, glued acoustical tile.	Good Fair
<b>Elevators</b>	None	--

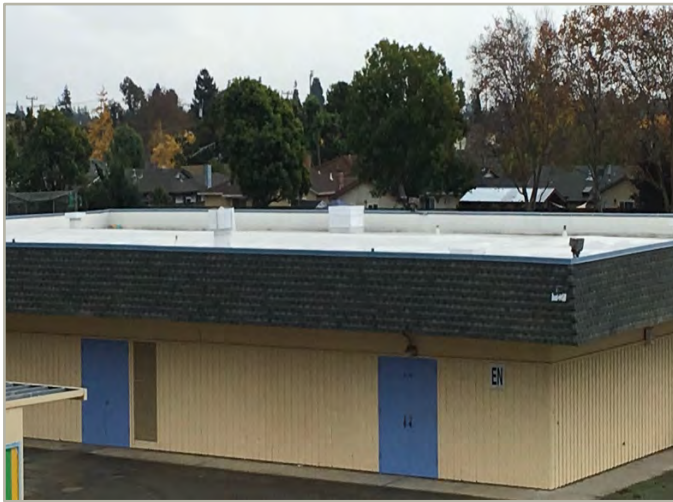
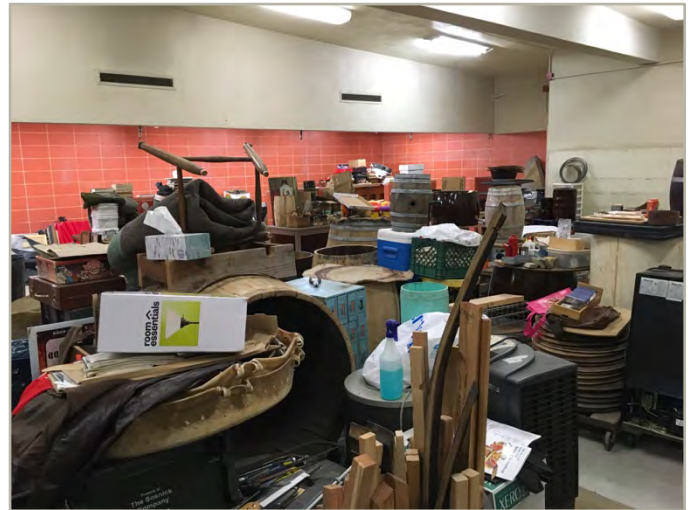
# 11. Unit 10 Storage

<b>Address</b>	35753 Cedar Boulevard; Newark, California	
<b>Constructed/ Renovated</b>	1965 (Estimated)	
<b>Building Size</b>	6,400SF	
<b>Number of Stories</b>	1	
<i>System</i>	<i>Description</i>	<i>Condition</i>
<b>Structure</b>	Concrete tilt-up structure with masonry and framed bearing walls and wood-framed roofs with wood panel roof sheathing.	Good
<b>Façade</b>	Painted Stucco and T-111 Wood siding with no windows	Good and Fair
<b>Roof</b>	Primary: Flat construction with single-ply TPO/PVC membrane Secondary: Mansard construction with asphalt shingles	Good
<b>Interiors</b>	Walls: Painted gypsum board and CMU, ceramic tile Floors: ceramic tile, unfinished concrete Ceilings: Painted gypsum board.	Good Fair
<b>Elevators</b>	None	--

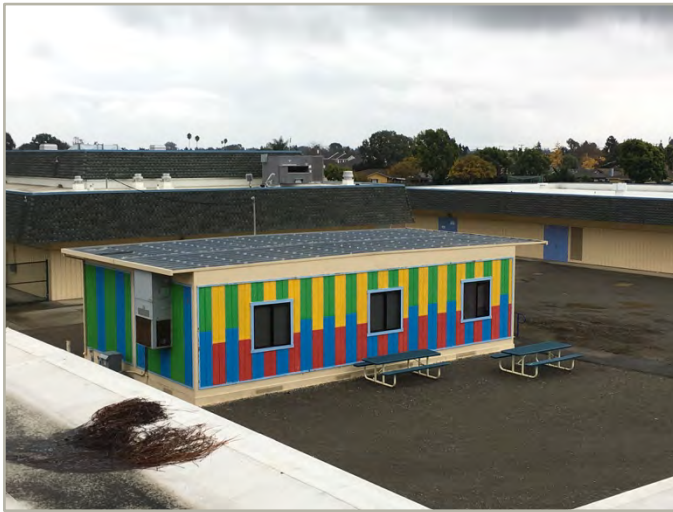
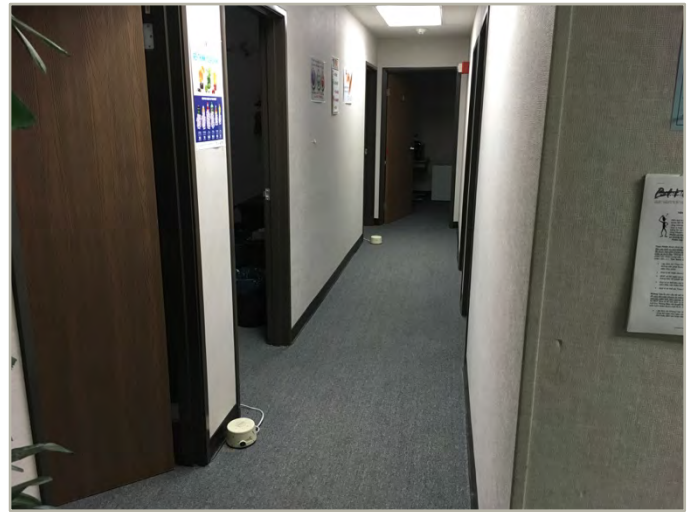
## 12. Portable

<b>Address</b>	35753 Cedar Boulevard; Newark, California	
<b>Constructed/ Renovated</b>	2002 (Estimated)	
<b>Building Size</b>	960 SF	
<b>Number of Stories</b>	1	
<i>System</i>	<i>Description</i>	<i>Condition</i>
<b>Structure</b>	Steel framing with framed walls and metal roof.	Good
<b>Façade</b>	Painted T-111 Wood siding with aluminum windows	Good and Fair
<b>Roof</b>	Primary: Flat construction with metal finish	Good
<b>Interiors</b>	Walls: Vinyl covered gypsum board Floors: Carpet Ceilings: ACT.	Good Fair
<b>Elevators</b>	None	--

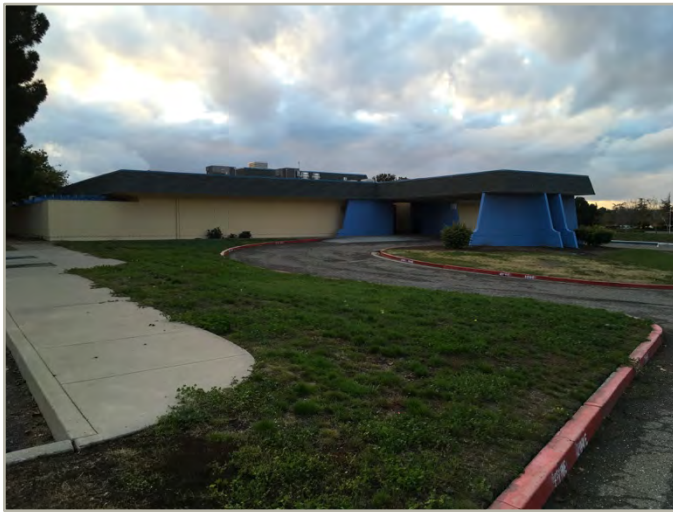
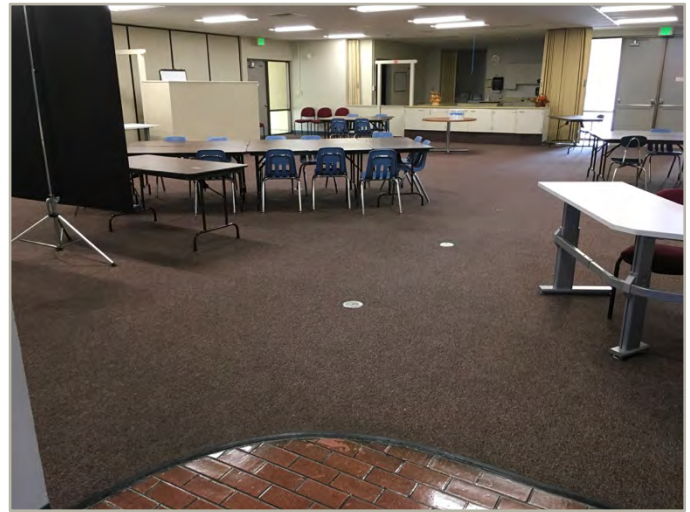
## 13. Whiteford Pre-School

<b>Address</b>	35753 Cedar Boulevard; Newark, California	
<b>Constructed/ Renovated</b>	1975 (Estimated)	
<b>Building Size</b>	11,032 SF	
<b>Number of Stories</b>	1	
<i>System</i>	<i>Description</i>	<i>Condition</i>
<b>Structure</b>	Concrete tilt-up structure with masonry and framed bearing walls and wood-framed roofs with wood panel roof sheathing.	Good
<b>Façade</b>	Painted Stucco and T-111 Wood siding with aluminum storefront windows	Good
<b>Roof</b>	Primary: Flat construction with single-ply TPO/PVC membrane Secondary: Mansard construction with asphalt shingles	Good
<b>Interiors</b>	Walls: Painted gypsum board, ceramic tile and painted CMU Floors: VCT, Carpet and ceramic tile Ceilings: Painted gypsum board, ACT.	Good Fair
<b>Elevators</b>	None	--
<b>Plumbing</b>	Copper supply and cast-iron waste and venting Gas water heaters	Fair

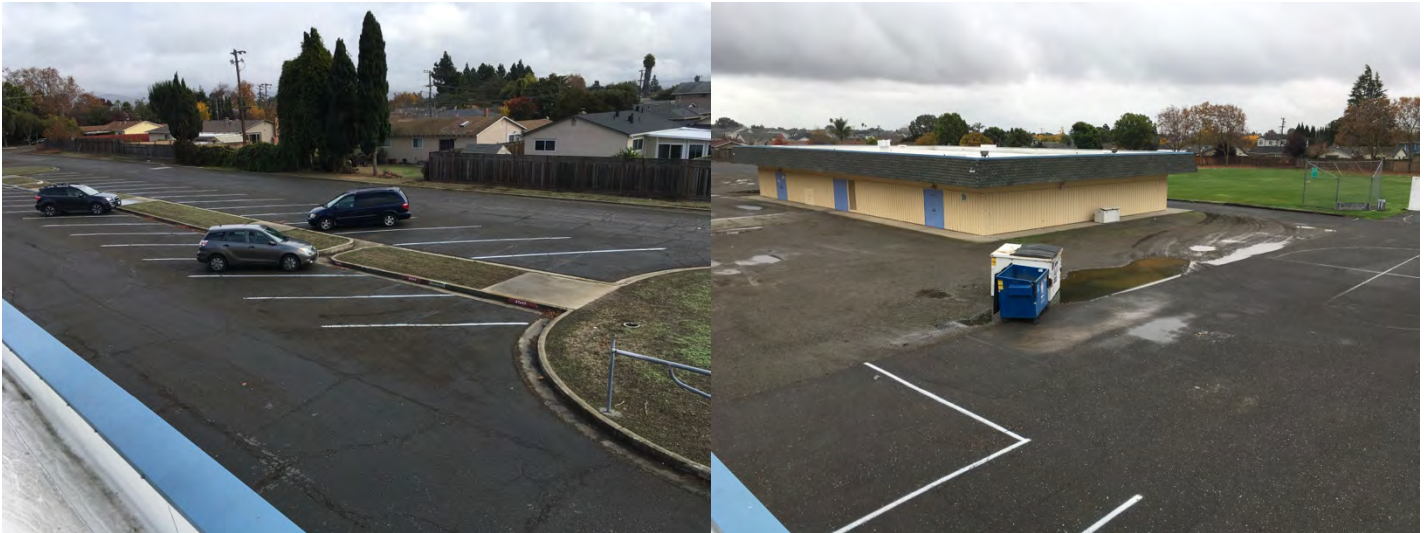
## 13. Site Summary

Site Information		
<b>Lot Size</b>	18.95 acres (estimated)	
<b>Parking Spaces</b>	141 total spaces all in open lots; 6 of which are accessible 147 total	
<i>System</i>	<i>Description</i>	<i>Condition</i>
<b>Pavement/Flatwork</b>	Asphalt lots with areas of concrete and concrete sidewalks, curbs.	Fair
<b>Site Development</b>	Property entrance signage, 725 L.F. of fencing, Playgrounds and sports courts	Fair
<b>Landscaping and Topography</b>	Moderate landscaping features Irrigation present No retaining walls Low to moderate site slopes throughout	Fair
<b>Utilities</b>	Municipal water and sewer Local utility-provided electric and natural gas	Good
<b>Site Lighting</b>	Pole-mounted: halogen Building-mounted: LED	Good
<b>Ancillary Structures</b>	None	--
<b>Accessibility</b>	Potential moderate and minor issues have been identified associated with the site areas concerning water ponding and a detailed accessibility study is recommended. See Appendix C.

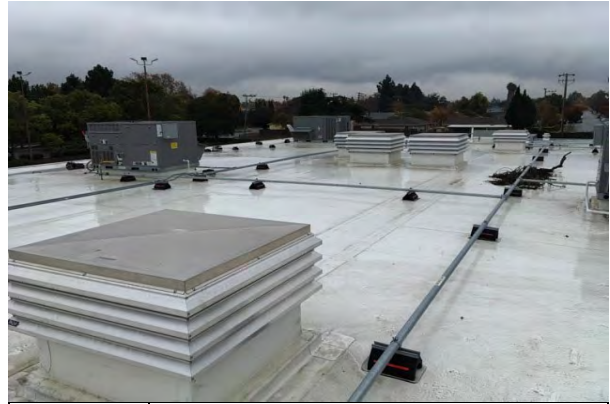
#8	ROOF AND GRAVITY VENT
----	-----------------------

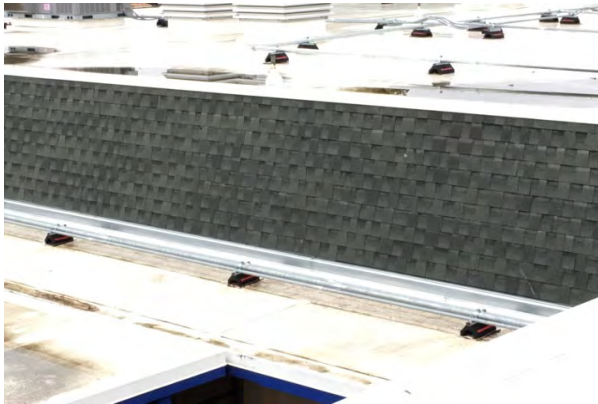
#9	ASPHALT ROOF
----	--------------

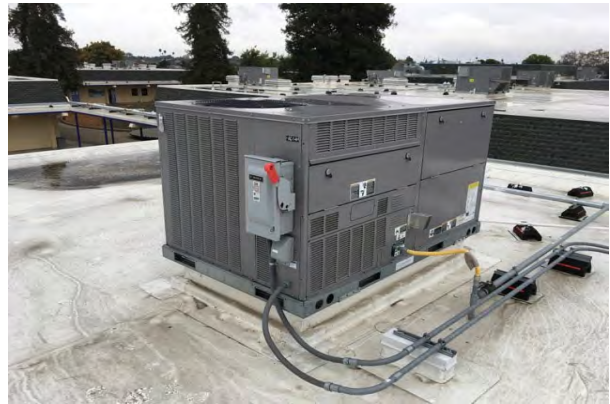
#10	PACKAGED UNIT (RTU)
-----	---------------------

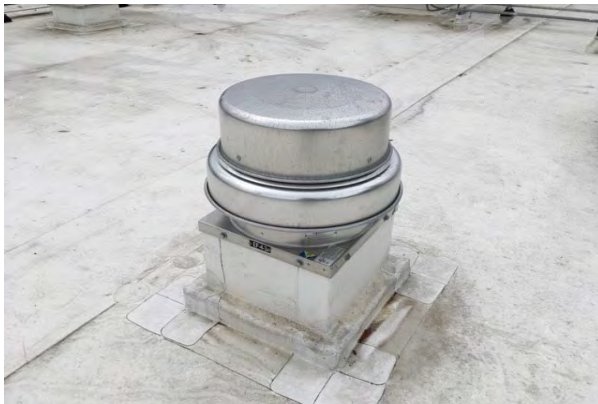
#11	ROOF MOUNTED EXHAUST FAN
-----	--------------------------

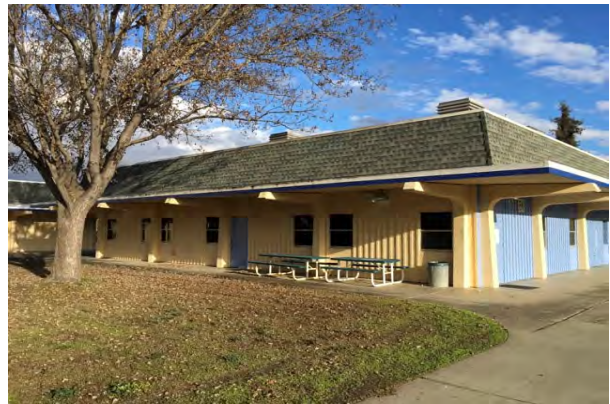
#12	EXTERIOR WALLS
-----	----------------

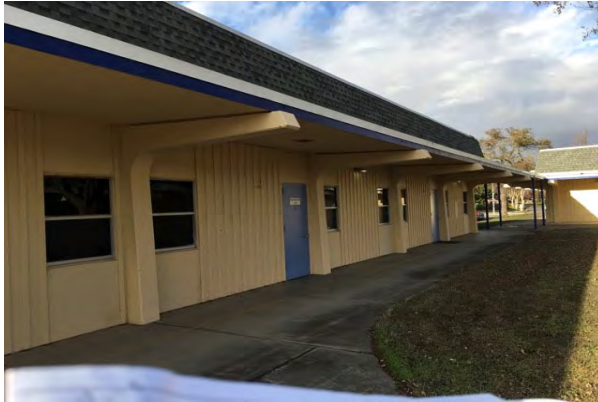
#13	CONCRETE STRUCTURE
-----	--------------------

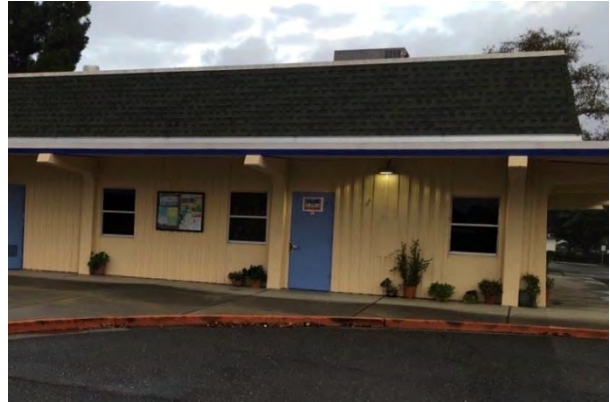
#14	EXTERIOR DOOR AND WINDOW
-----	--------------------------

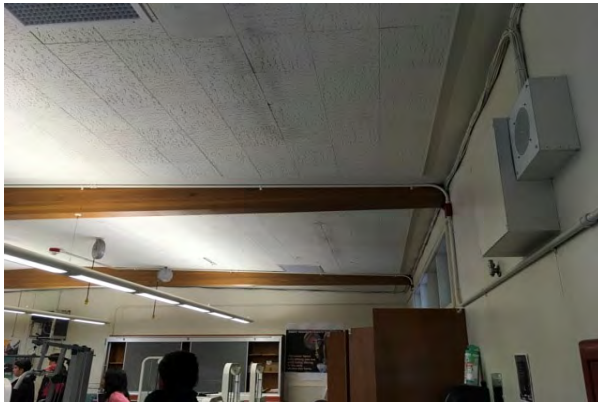
#15	STRUCTURE IN THE WORKOUT CLASSROOM UNIT 9
-----	---

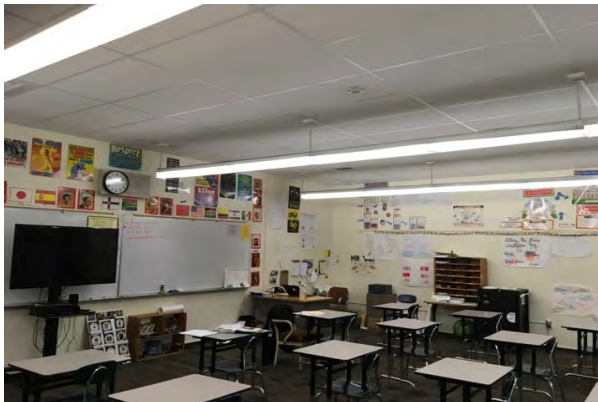
#17	LIGHTING
-----	----------

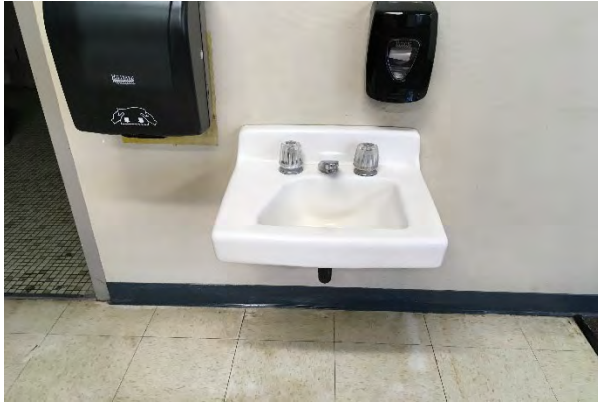
#25	WALL MOUNTED LAVATORY
-----	-----------------------

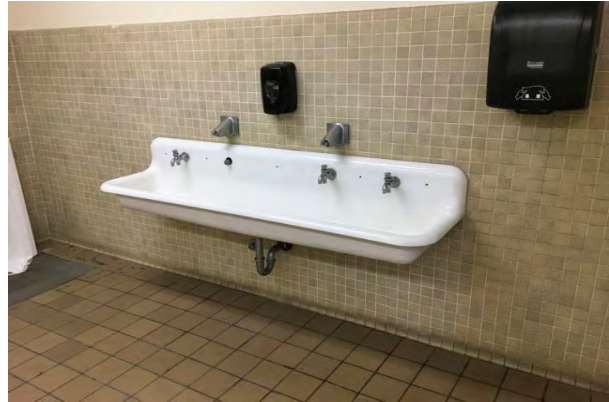
#26	RESTROOM SINK
-----	---------------

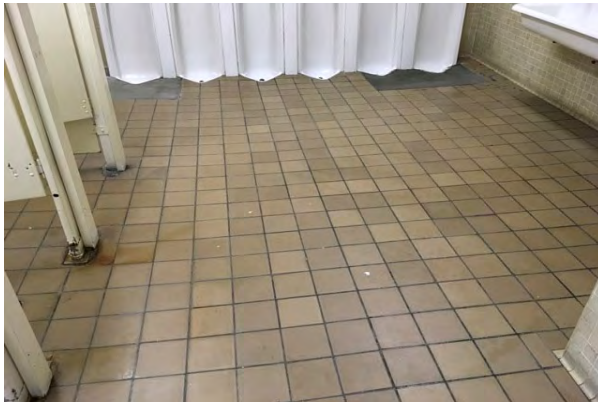
#27	INTERIOR RESTROOM FLOOR FINISH, CERAMIC TILE
-----	--

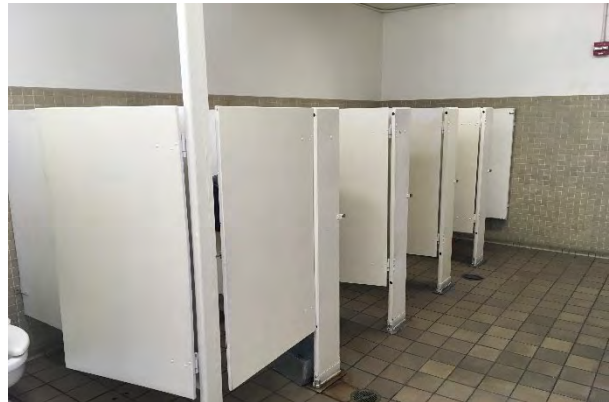
#28	TOILET PARTITIONS, METAL
-----	--------------------------

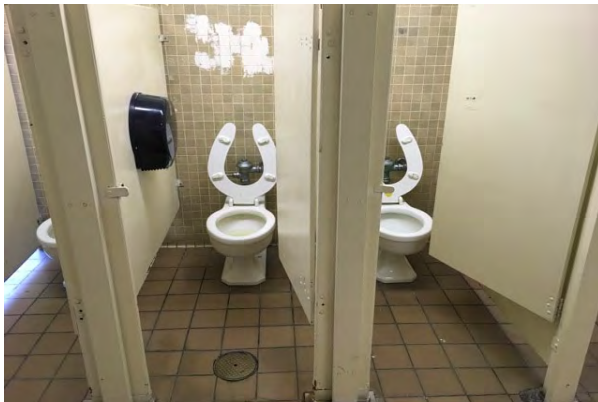
#29	TOILET, TANKLESS
-----	------------------

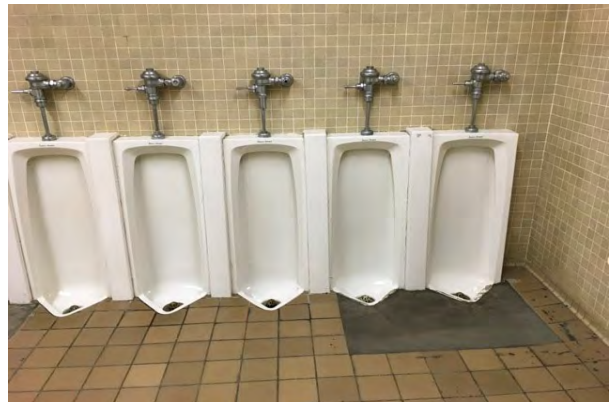
#30	URINAL FLOOR MOUNTED
-----	----------------------

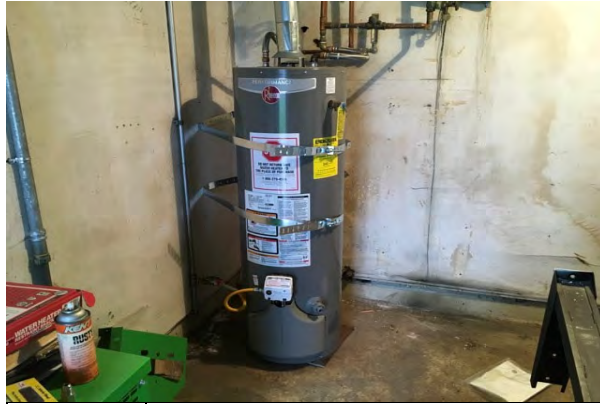
#31	WATER HEATER
-----	--------------

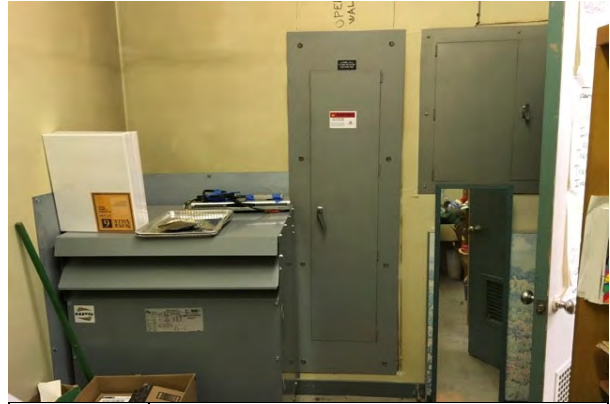
#32	ELECTRICAL DISTRIBUTION
-----	-------------------------

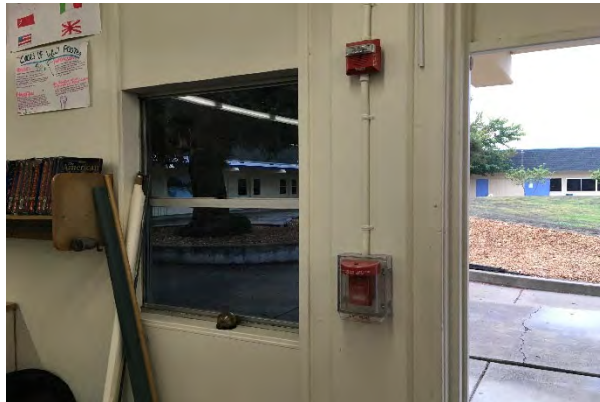
#33	FIRE ALARM SYSTEM
-----	-------------------

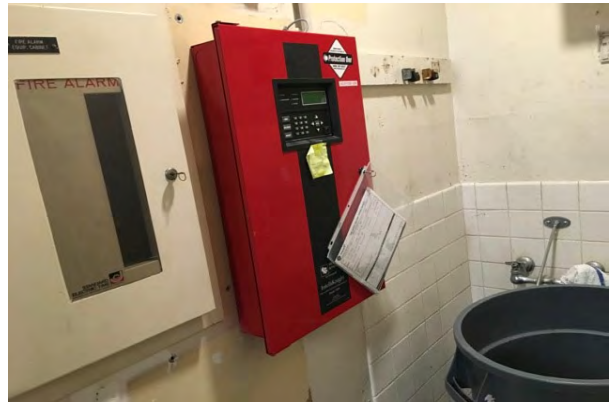
#34	FIRE ALARM PANEL WHITEFORD BUILDING
-----	-------------------------------------

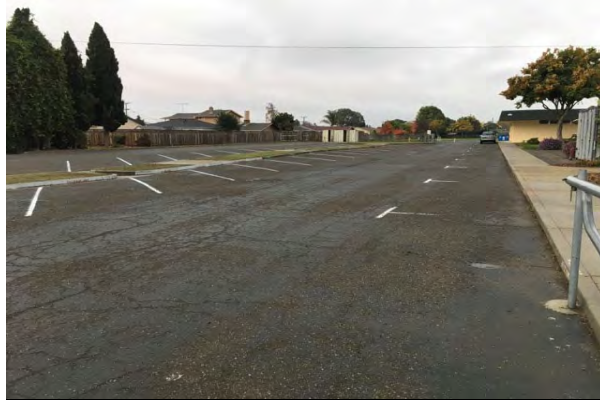
#35	ASPHALT PARKING
-----	-----------------

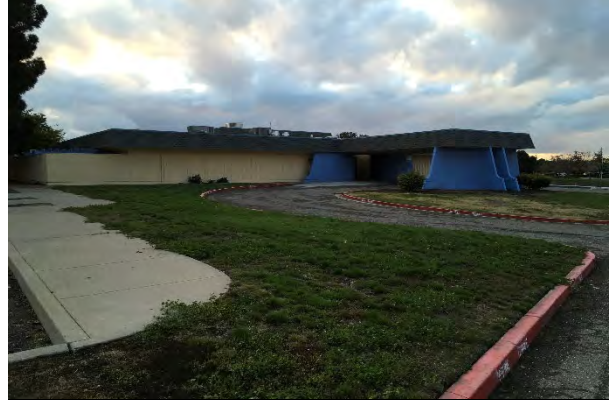
#36	ASPHALT DRIVEWAY AND ENTRY TO WHITEFORD BUILDING
-----	--

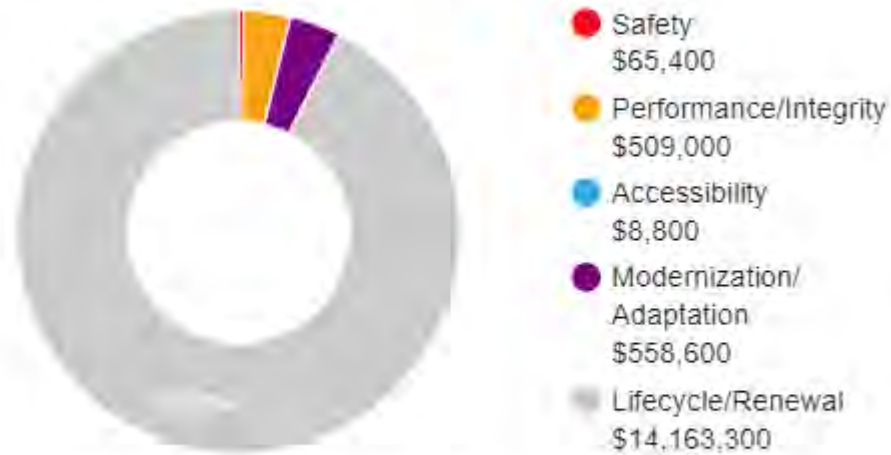
## Plan Type Distribution (by Cost)

Ten year total: \$15,305,100

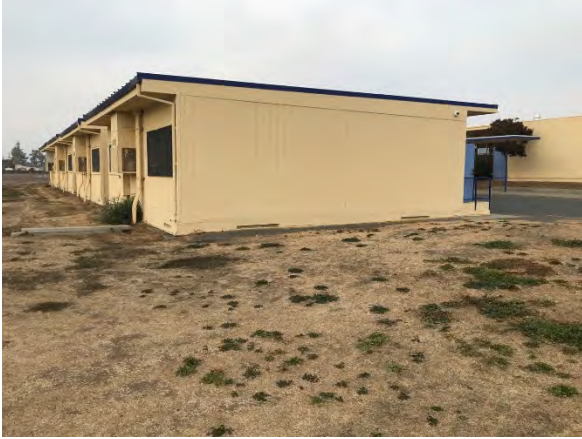
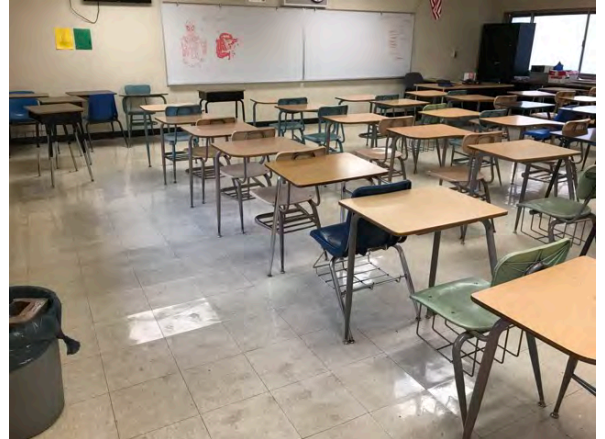
## 14. Portables

<b>Address</b>	6201 Lafayette Avenue, Newark, California	
<b>Constructed/ Renovated</b>	1961	
<b>Building Size</b>	3,600 SF	
<b>Number of Stories</b>	1	
<i>System</i>	<i>Description</i>	<i>Condition</i>
<b>Structure</b>	Lightweight steel studs	Fair
<b>Façade</b>	Painted wood with aluminum windows	Fair
<b>Roof</b>	Primary: Flat construction with metal finish	Fair
<b>Interiors</b>	Walls: Painted gypsum board, vinyl Floors: VCT Ceilings: ACT	Fair
<b>Elevators</b>	None	--
<b>Plumbing</b>	No plumbing	--

<b>HVAC</b>	Individual wall heat pumps	Fair
<b>Fire Suppression</b>	Fire extinguishers	Fair
<b>Electrical</b>	Source and Distribution: Main panel with copper wiring Interior Lighting: T-8, Emergency: NA	Fair
<b>Fire Alarm</b>	Smoke detectors, alarms, strobes, pull stations, back-up emergency lights, and exit signs	Fair
<b>Equipment/Special</b>	None	--
<b>Accessibility</b>	Presently it does not appear an accessibility study is needed for this building. See Appendix C.	
<b>Key Issues and Findings</b>	Aged HVAC equipment Damaged siding.

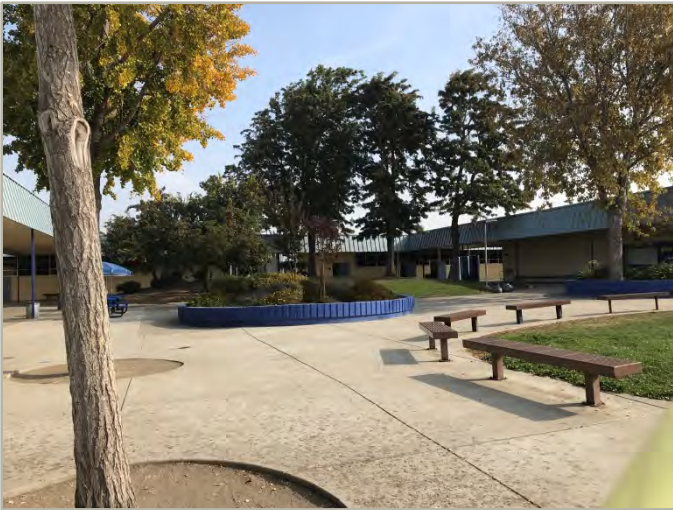
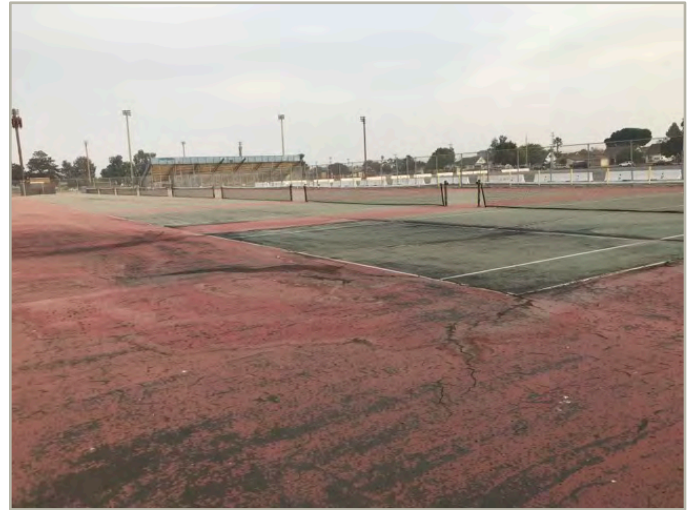
## 15. Site Summary

<b>Lot Size</b>	40.1 acres (estimated)	
<b>Parking Spaces</b>	335 total spaces all in open lots; 6 of which are accessible	
<i>System</i>	<i>Description</i>	<i>Condition</i>
<b>Pavement/Flatwork</b>	Asphalt lots with areas of concrete and concrete sidewalks, curbs, ramps, and stairs	Fair
<b>Site Development</b>	Building-mounted and property entrance signage, chain link fencing, no dumpster enclosures Playgrounds and sports courts with bleachers, fencing, and site lights Limited benches, picnic tables, trash receptacles Outdoor swimming pool, currently unusable	Fair
<b>Landscaping and Topography</b>	Limited landscaping features Irrigation present, not working well Concrete retaining walls Low to moderate site slopes throughout	Fair
<b>Utilities</b>	Municipal water and sewer	Good
<b>Site Lighting</b>	Pole-mounted: LED, HPS, CFL, halogen, incandescent Building-mounted: LED, HPS, CFL, halogen, incandescent	Fair

Severe alligator cracking and potholes,  
significant sidewalk trip hazards,  
Non-operational swimming pool

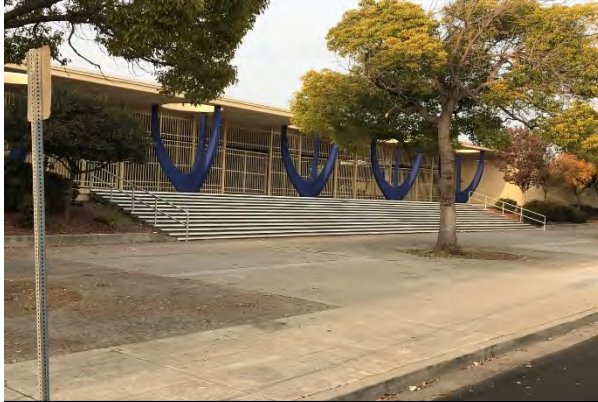
#1	SOUTH ELEVATION
----	-----------------

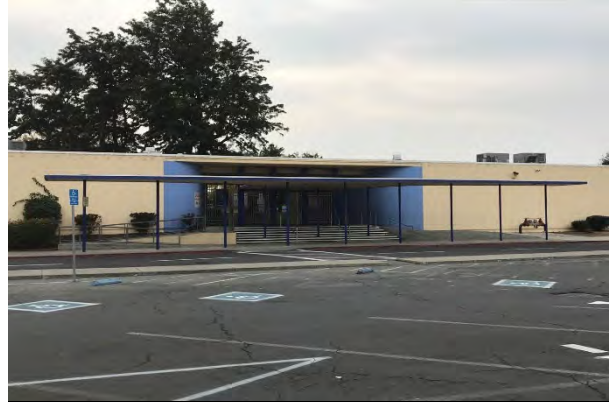
#2	EAST ELEVATION
----	----------------

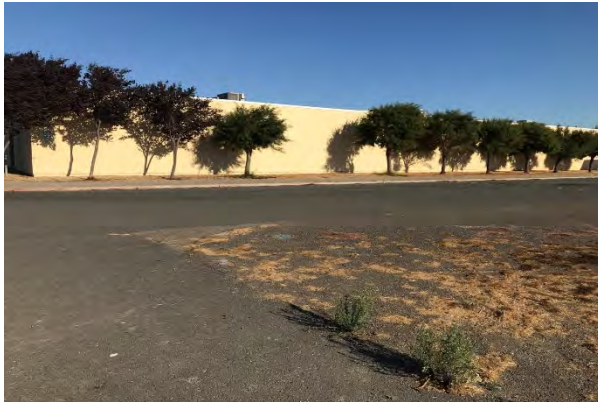
#3	PARTIAL WEST ELEVATION
----	------------------------

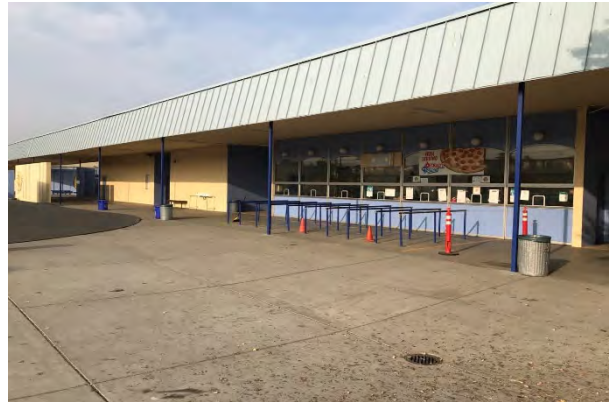
#4	SNACK BAR, GYMNASIUM BUILDING
----	-------------------------------

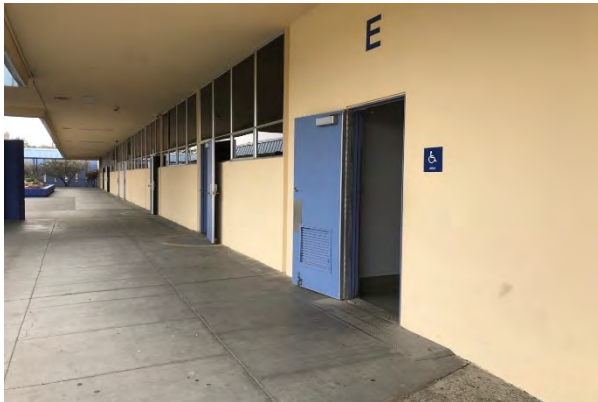
#5	CLASSROOM BUILDING
----	--------------------

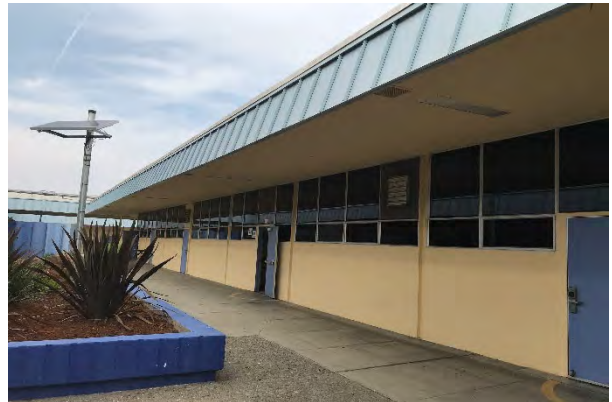
#6	CLASSROOM BUILDING
----	--------------------

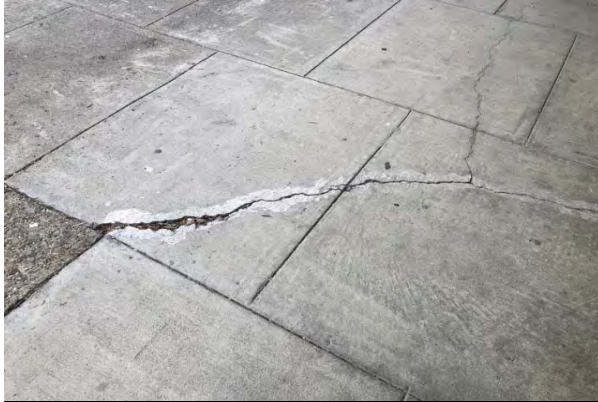
#13	CONCRETE WALKWAY, TRIP HAZARD
-----	-------------------------------

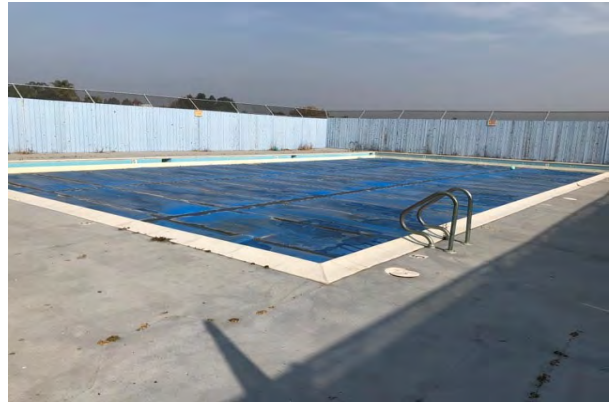
#16	SITE IMPROVEMENTS, POOL ABANDONED IN PLACE
-----	--

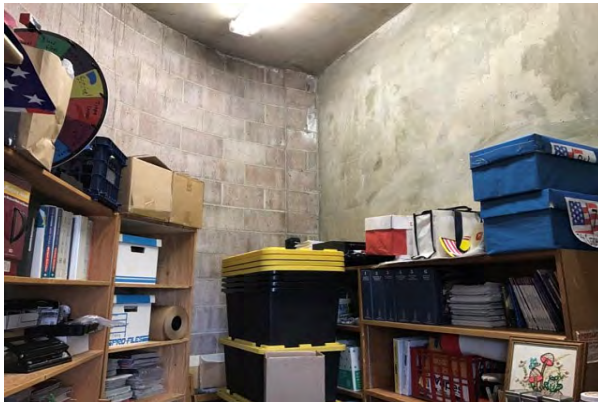
#17	STRUCTURE, CAST CONCRETE AND CONCRETE BLOCK
-----	---

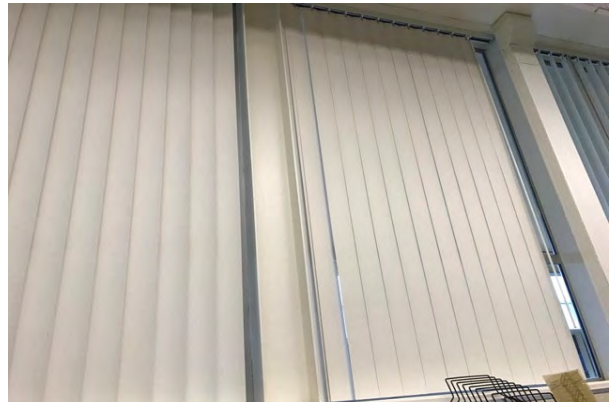
#18	STRUCTURE, STEEL COLUMNS
-----	--------------------------

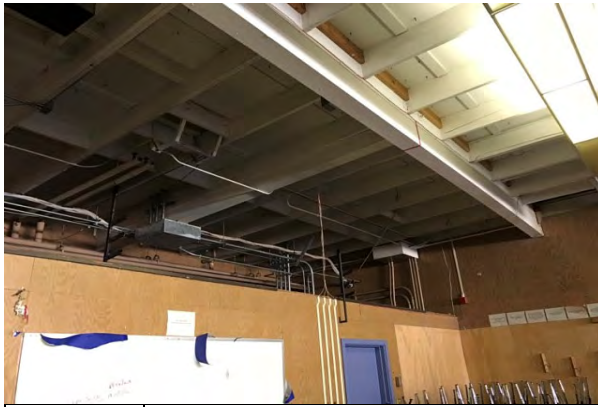
#19	STRUCTURE, WOOD FRAMED ROOF
-----	-----------------------------

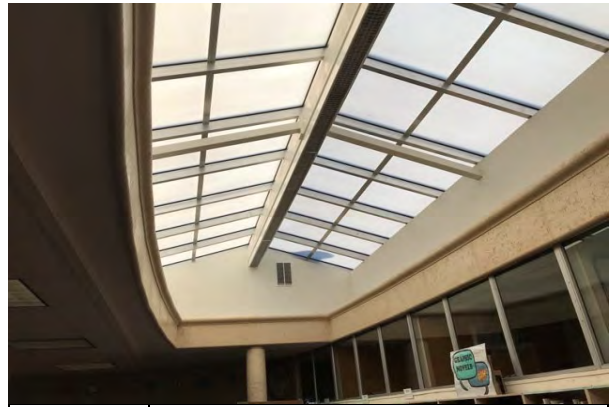
#20	SKYLIGHT AT LIBRARY
-----	---------------------

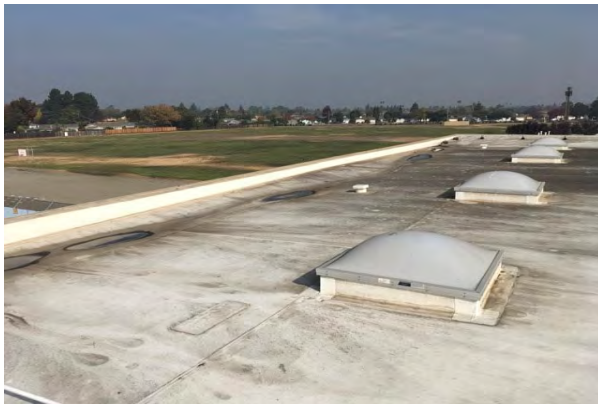
#21	ROOF, SINGLE-PLY TPO/PVC MEMBRANE
-----	-----------------------------------

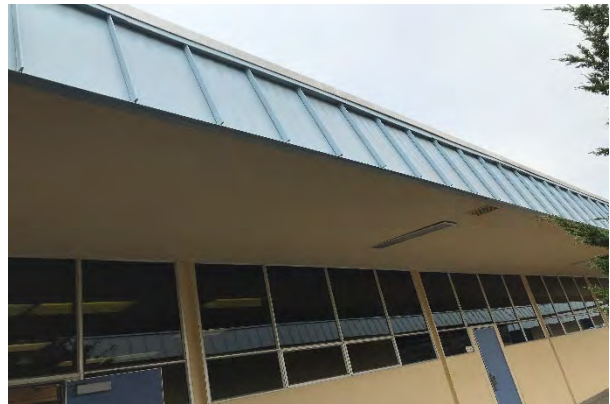
#22	METAL MANSARD ROOF
-----	--------------------

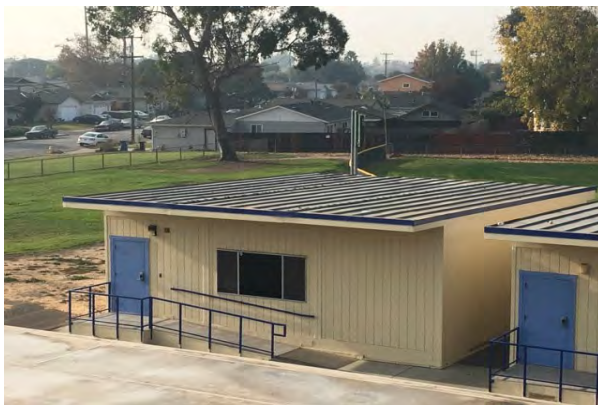
#23	ROOF AT PORTABLES
-----	-------------------

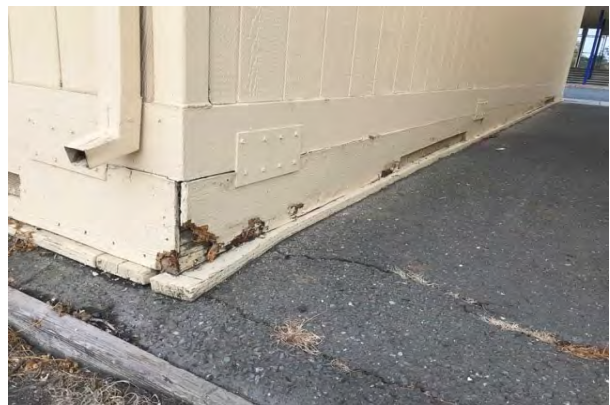
#24	EXTERIOR WALL DETERIORATION AT PORTABLES
-----	--

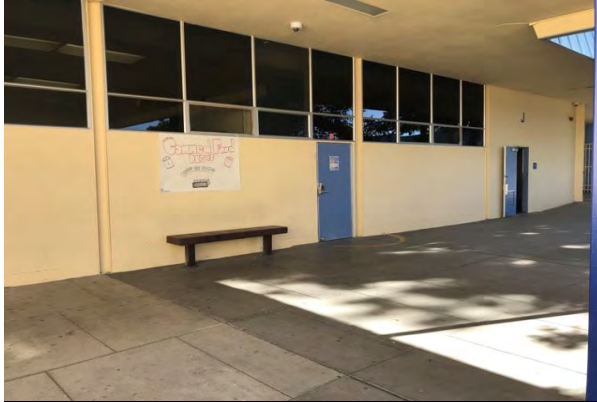
#25	EXTERIOR WALL, PAINTED SURFACE
-----	--------------------------------

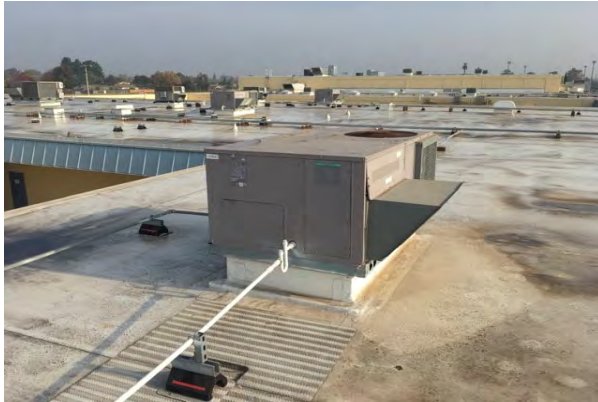
#41	RTU
-----	-----

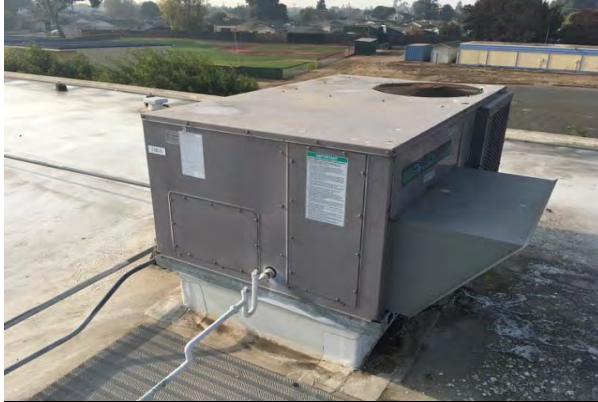
#43	RTU
-----	-----

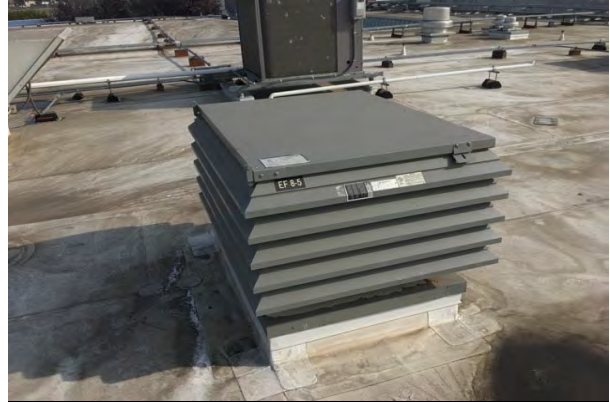
#44	VENTILATION
-----	-------------

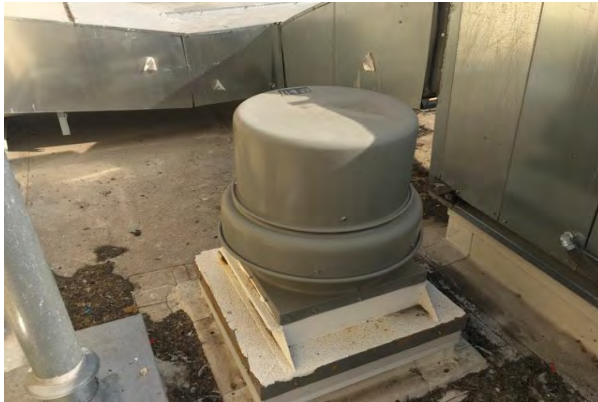
#45	VENTILATION
-----	-------------

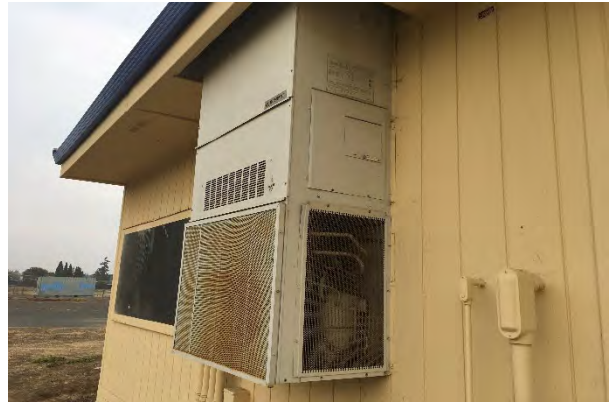
#46	PORTABLE HVAC
-----	---------------

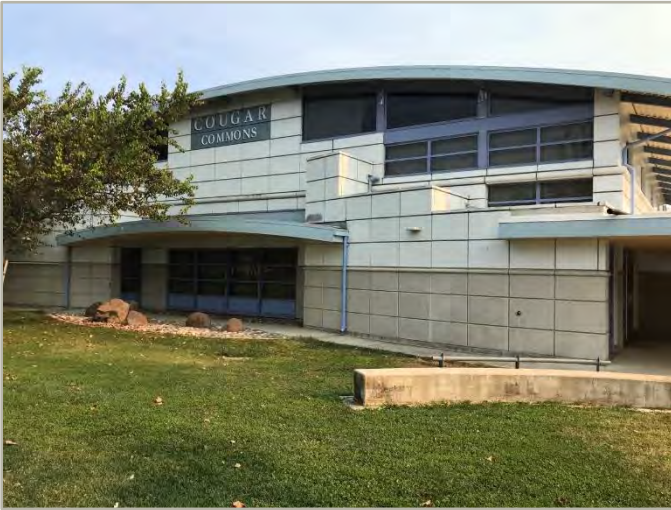
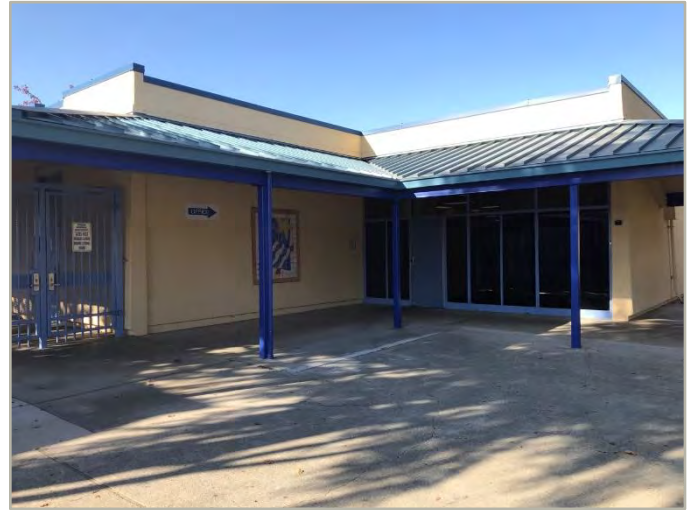
## 2. Building 100

<b>Address</b>	39375 Cedar Boulevard, Newark, California	
<b>Constructed/ Renovated and Addition</b>	1950s/2002	
<b>Building Size</b>	26,000 SF	
<b>Number of Stories</b>	One	
<i>System</i>	<i>Description</i>	<i>Condition</i>
<b>Structure</b>	Original construction, concrete bearing walls on a slab Addition, steel frame on a slab	Fair
<b>Façade</b>	Painted concrete with steel windows, metal panels with aluminum windows	Good
<b>Roof</b>	Primary: Flat construction with single-ply TPO/PVC membrane Secondary: Arched construction with metal finish	Good
<b>Interiors</b>	Walls: Painted gypsum board Floors: Carpet, VCT, quarry tile, epoxy flooring Ceilings: Painted gypsum board, ACT, Unfinished/exposed	Fair
<b>Elevators</b>	None	--

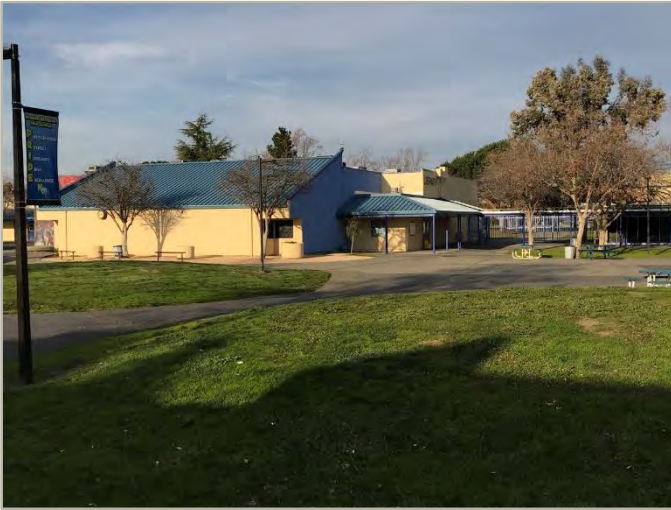
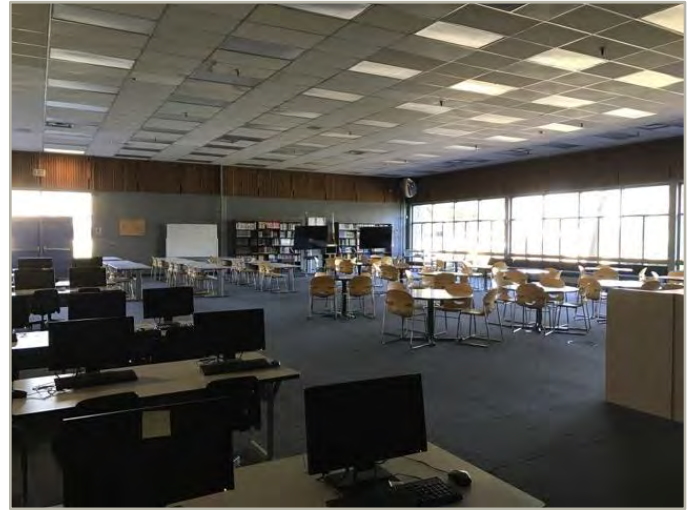
### 3. Building 200

<b>Address</b>	39375 Cedar Boulevard, Newark, California	
<b>Constructed/ Renovated</b>	1950s	
<b>Building Size</b>	8,300 SF	
<b>Number of Stories</b>	One	
<i>System</i>	<i>Description</i>	<i>Condition</i>
<b>Structure</b>	Concrete bearing walls on a slab	Fair
<b>Façade</b>	Painted concrete with steel and aluminum windows	Fair
<b>Roof</b>	Primary: Flat construction with single-ply TPO/PVC membrane Secondary: Shed construction with metal finish	Good
<b>Interiors</b>	Walls: Painted gypsum board, wood panels, vinyl Floors: Carpet, VCT, Ceilings: Painted gypsum board, ACT	Fair
<b>Elevators</b>	None	--

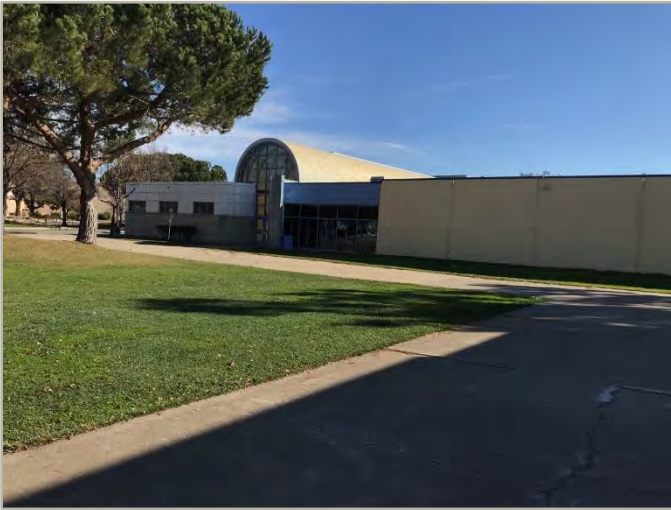
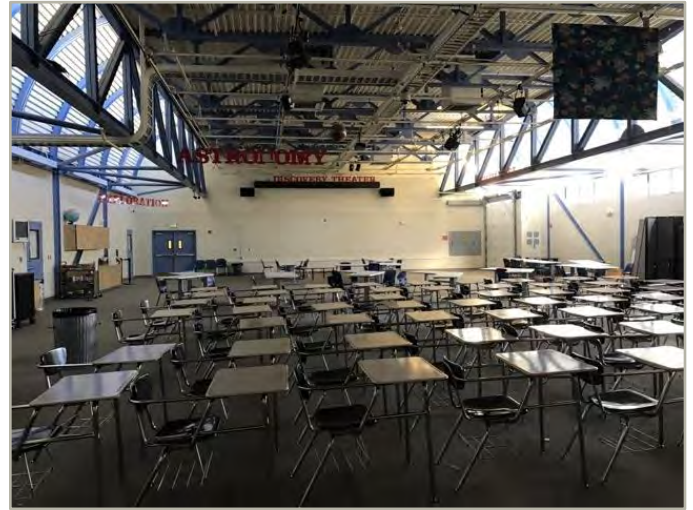
## 4. Building 300

<b>Address</b>	39375 Cedar Boulevard, Newark, California	
<b>Constructed/ Renovated</b>	1950s, 1970s, 2002	
<b>Building Size</b>	63,400 SF	
<b>Number of Stories</b>	One	
<i>System</i>	<i>Description</i>	<i>Condition</i>
<b>Structure</b>	Concrete bearing walls on a slab Conventional wood frame structure on concrete slab/ with raised floor Steel frame with concrete-topped metal decks	Fair
<b>Façade</b>	Painted concrete with steel windows Metal panel with aluminum windows	Fair
<b>Roof</b>	Primary: Flat construction with single-ply TPO/PVC membrane Secondary: Arched construction with metal finish	Good
<b>Interiors</b>	Walls: Painted gypsum board, cultured marble, laminated panels Floors: Carpet, VCT, unfinished, epoxy coating Ceilings: Painted gypsum board, ACT, exposed	Fair
<b>Elevators</b>	None	--

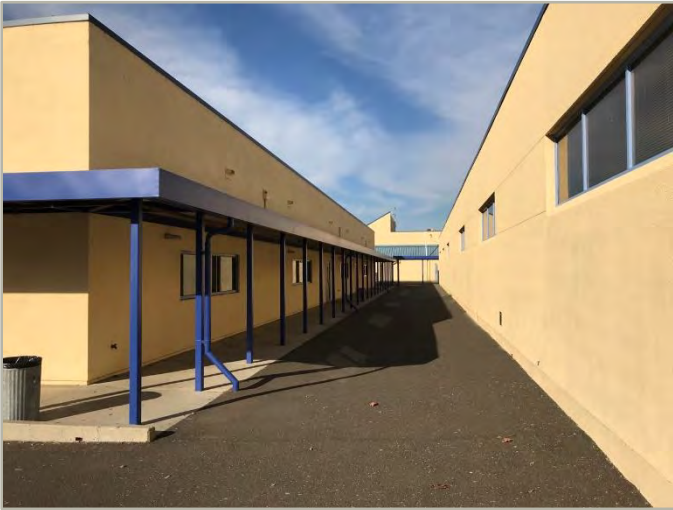
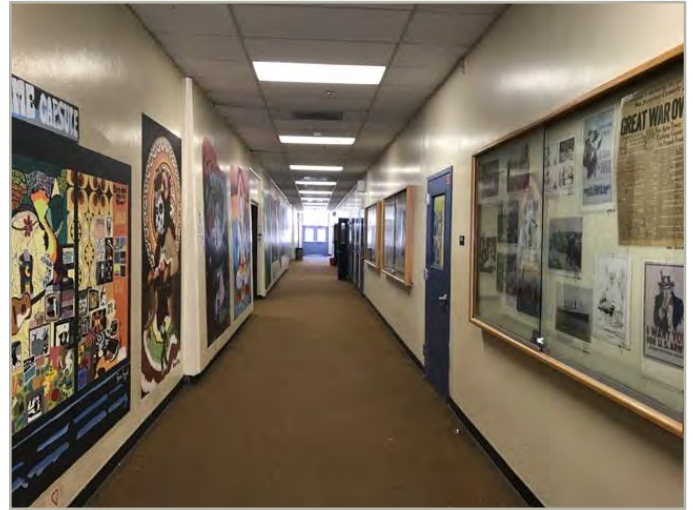
## 5. Building 400

<b>Address</b>	39375 Cedar Boulevard, Newark, California	
<b>Constructed/ Renovated</b>	1950s, 2000s	
<b>Building Size</b>	50,900 SF	
<b>Number of Stories</b>	One	
<i>System</i>	<i>Description</i>	<i>Condition</i>
<b>Structure</b>	Concrete bearing walls on a slab Prefabricated, steel stud frame, classroom modules	Fair
<b>Façade</b>	Painted concrete with steel windows Stucco with aluminum windows	Fair
<b>Roof</b>	Primary: Flat construction with single-ply TPO/PVC membrane Secondary: Flat construction with metal finish	Good
<b>Interiors</b>	Walls: Painted gypsum board, vinyl wall covering, laminated paneling, cultural marble, ceramic tile Floors: Carpet, VCT, epoxy coating, maple flooring Ceilings: Painted gypsum board, ACT	Fair
