# FACILITY CONDITION ASSESSMENT

Newark School District  
5715 Musick Avenue  
Newark, California 94560

FACILITY CONDITION ASSESSMENT  
OF  
BIRCH GROVE INTERMEDIATE  
37490 BIRCH STREET  
NEWARK, CALIFORNIA 94560

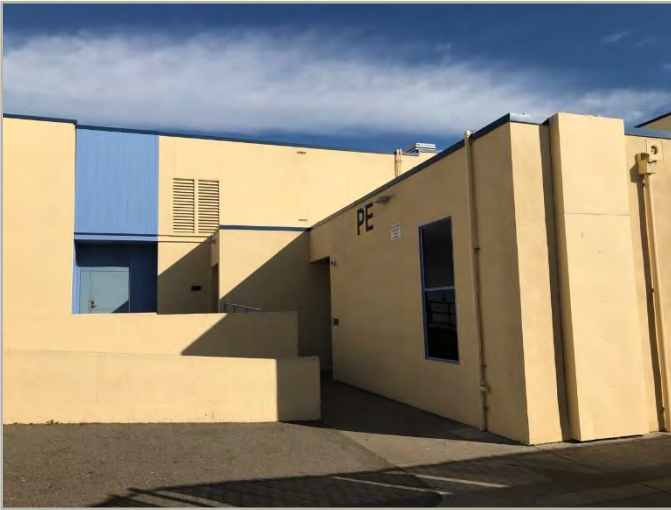
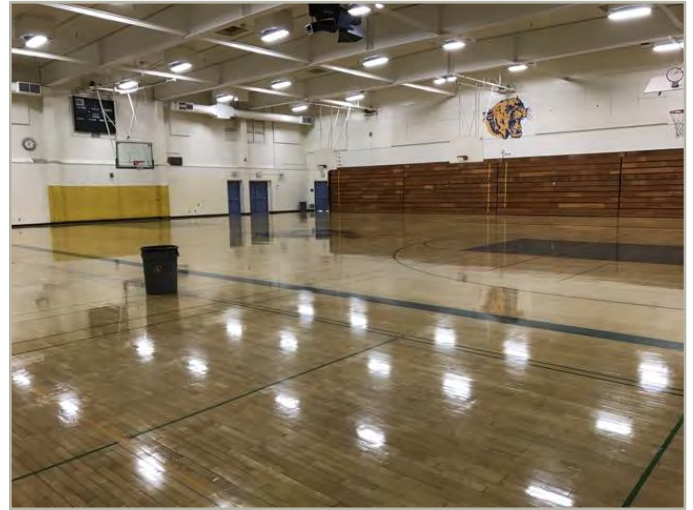
## 6. Building 500/600

<b>Address</b>	39375 Cedar Boulevard, Newark, California	
<b>Constructed/ Renovated</b>	1950s	
<b>Building Size</b>	35,200 SF	
<b>Number of Stories</b>	Two	
<i>System</i>	<i>Description</i>	<i>Condition</i>
<b>Structure</b>	Concrete bearing walls on a slab	Fair
<b>Façade</b>	Painted concrete with steel windows	Fair
<b>Roof</b>	Primary: Flat construction with single-ply TPO/PVC membrane Secondary: Flat construction with metal finish	Good
<b>Interiors</b>	Walls: Painted gypsum board, painted concrete, ceramic tile, cultured marble Floors: Carpet, VCT, ceramic tile, unfinished, maple flooring Ceilings: Painted gypsum board, ACT, exposed	Fair
<b>Elevators</b>	None	--

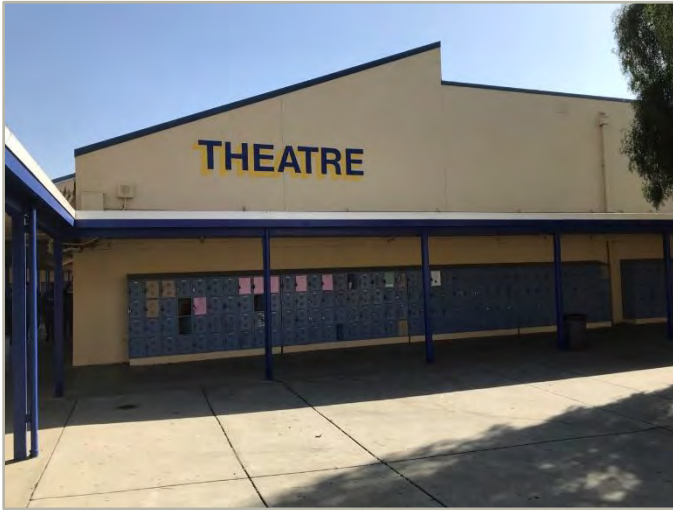
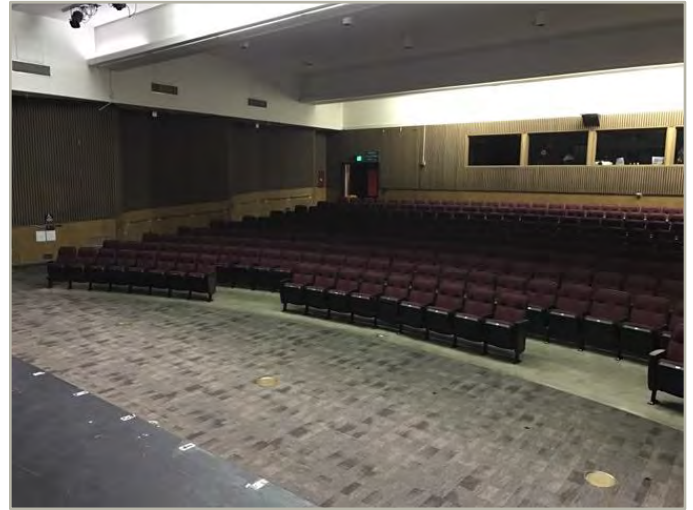
## 7. Building 700/800

<b>Address</b>	39375 Cedar Boulevard, Newark, California	
<b>Constructed/ Renovated</b>	1950s	
<b>Building Size</b>	34,600 SF	
<b>Number of Stories</b>	One	
<i>System</i>	<i>Description</i>	<i>Condition</i>
<b>Structure</b>	Conventional wood frame structure on concrete slab/ with raised floor Concrete bearing walls on a slab	Fair
<b>Façade</b>	Stucco with aluminum windows Painted concrete	Fair
<b>Roof</b>	Primary: Flat construction with single-ply TPO/PVC membrane Secondary: Shed construction with metal finish	Good
<b>Interiors</b>	Walls: Painted gypsum board, painted concrete, wood panels, vinyl, unfinished Floors: Carpet, VCT, wood, unfinished, epoxy coating Ceilings: Painted gypsum board, ACT, unfinished/exposed	Fair
<b>Elevators</b>	Wheelchair lift	Fair

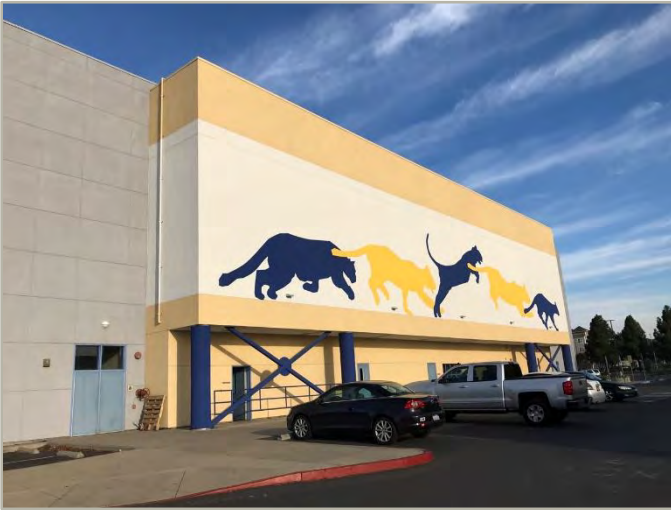
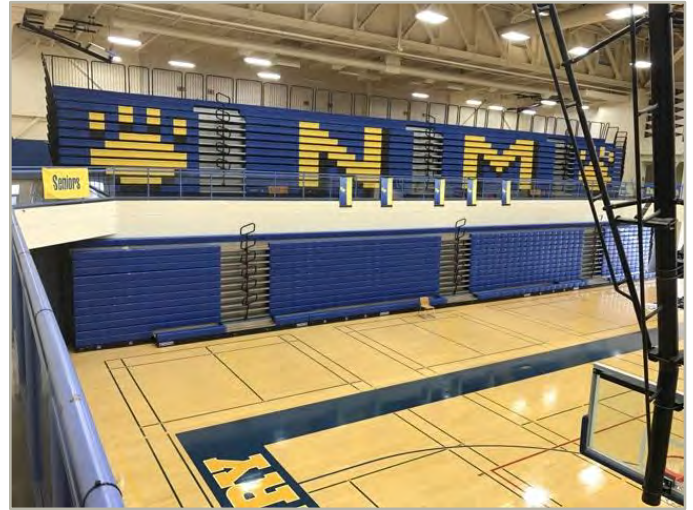
## 8. Building 900, Events Center

<b>Address</b>	39375 Cedar Boulevard, Newark, California	
<b>Constructed/ Renovated</b>	2002	
<b>Building Size</b>	38,000 SF	
<b>Number of Stories</b>	Two	
<i>System</i>	<i>Description</i>	<i>Condition</i>
<b>Structure</b>	Steel frame with concrete-topped metal decks	Good
<b>Façade</b>	Stucco with aluminum windows	Fair
<b>Roof</b>	Primary: Hip construction with metal finish Secondary: Flat construction with single-ply TPO/PVC membrane	Good
<b>Interiors</b>	Walls: Painted gypsum board, concrete, vinyl, cultured marble Floors: Carpet, VCT, epoxy coating, maple flooring Ceilings: ACT, /exposed	Fair
<b>Elevators</b>	Hydraulic 1 car serving 2 floors	Fair

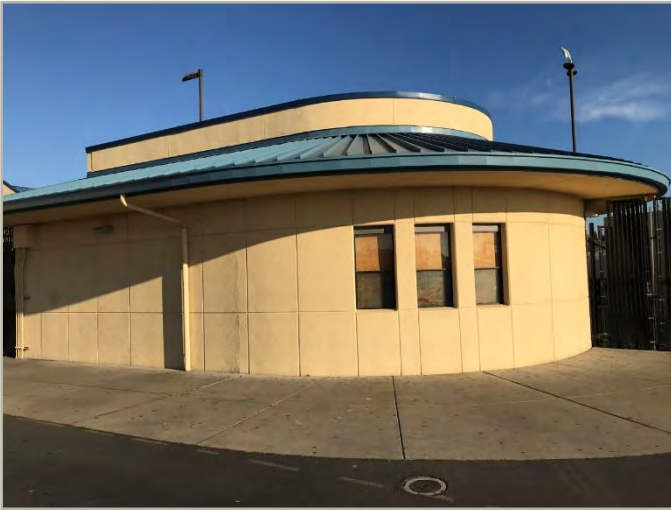
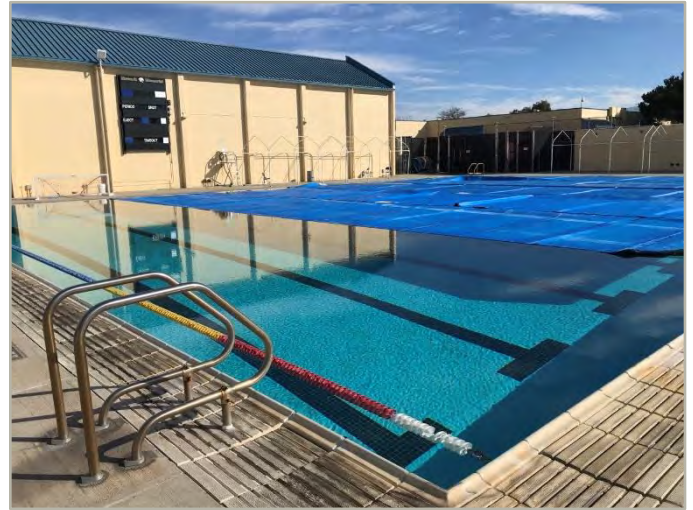
## 9. Pool Building

<b>Address</b>	39375 Cedar Boulevard, Newark, California	
<b>Constructed/ Renovated</b>	1960s	
<b>Building Size</b>	2,400 SF	
<b>Number of Stories</b>	One	
<i>System</i>	<i>Description</i>	<i>Condition</i>
<b>Structure</b>	Conventional wood frame structure on concrete slab	Fair
<b>Façade</b>	Stucco with aluminum windows	Fair
<b>Roof</b>	Primary: Shed construction with metal finish Secondary: Flat construction with single-ply TPO/PVC membrane	Good
<b>Interiors</b>	Walls: Painted gypsum board, ceramic tile Floors: ceramic tile Ceilings: Painted gypsum board	Good
<b>Elevators</b>	None	--

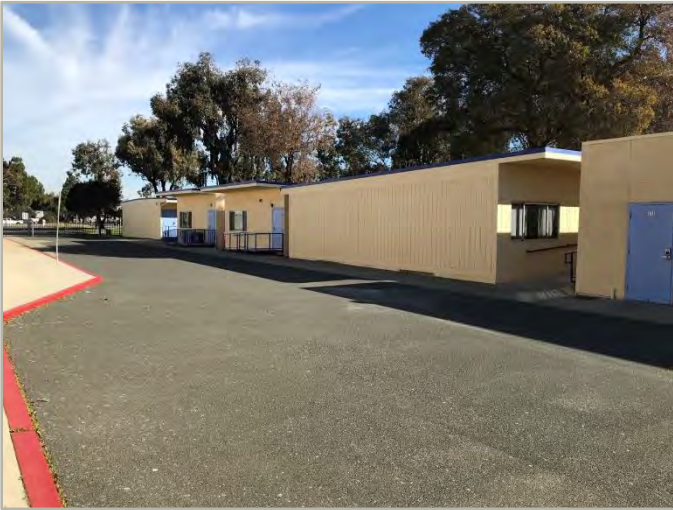
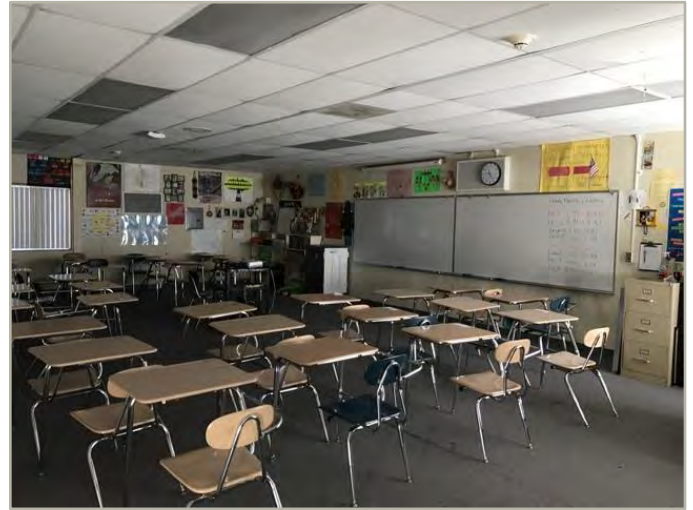
## 10. Portables 334 – 341

<b>Address</b>	39375 Cedar Boulevard, Newark, California	
<b>Constructed/ Renovated</b>	1990s	
<b>Building Size</b>	7,200 SF	
<b>Number of Stories</b>	One	
<i>System</i>	<i>Description</i>	<i>Condition</i>
<b>Structure</b>	Lightweight metal framing on a chassis	Fair
<b>Façade</b>	T-111 with aluminum windows	Fair
<b>Roof</b>	Primary: Flat construction with metal finish or TPO/PVC	Fair
<b>Interiors</b>	Walls: vinyl Floors: Carpet Ceilings: ACT	Fair
<b>Elevators</b>	None	--
<b>Plumbing</b>	Copper supply and cast iron waste and venting Electric water heaters	Fair

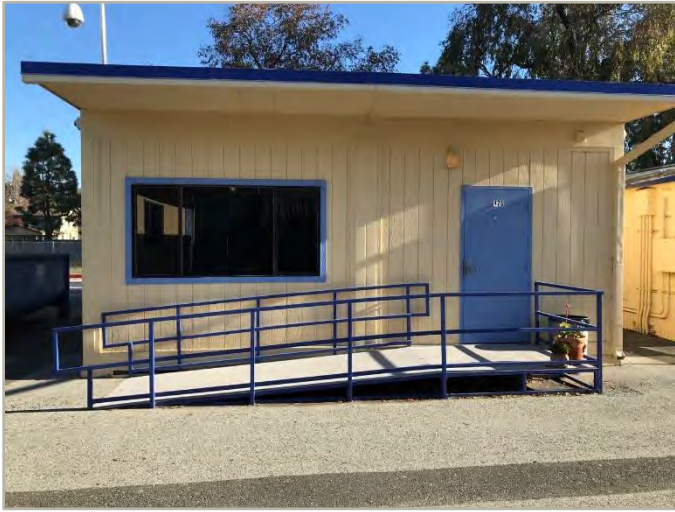
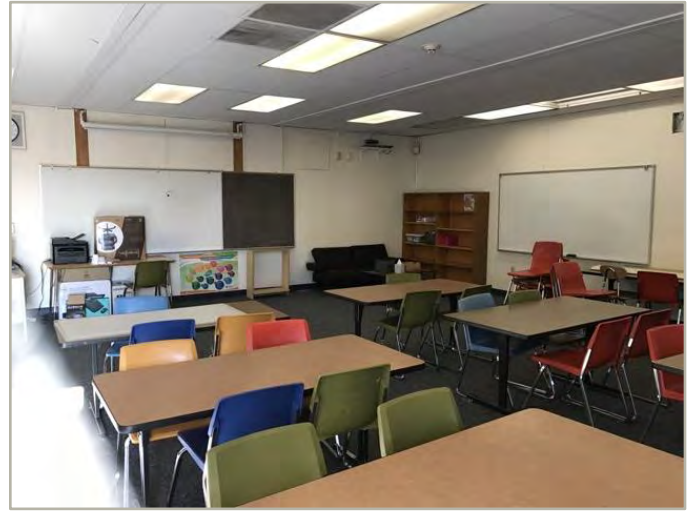
## 11. Portables 467 - 478

<b>Address</b>	39375 Cedar Boulevard, Newark, California	
<b>Constructed/ Renovated</b>	1980s	
<b>Building Size</b>	9,600 SF	
<b>Number of Stories</b>	One	
<i>System</i>	<i>Description</i>	<i>Condition</i>
<b>Structure</b>	Lightweight metal framing on a chassis	Fair
<b>Façade</b>	T-111 with aluminum windows	Fair
<b>Roof</b>	Primary: Flat construction with metal finish or TPO	Fair
<b>Interiors</b>	Walls: vinyl Floors: Carpet Ceilings: ACT	Fair
<b>Elevators</b>	None	--

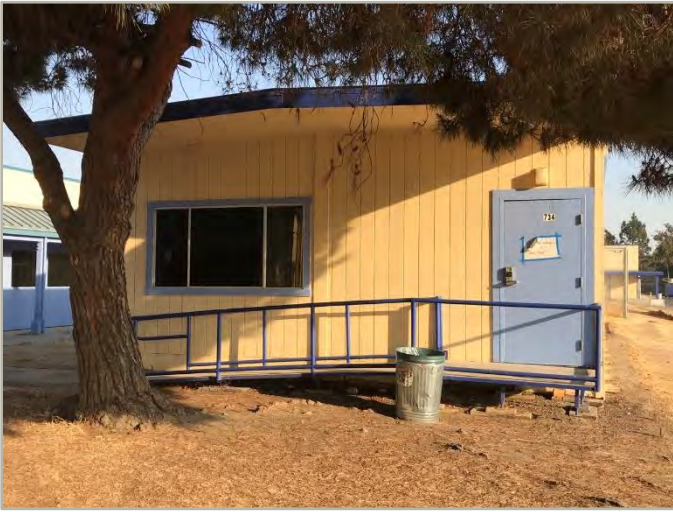
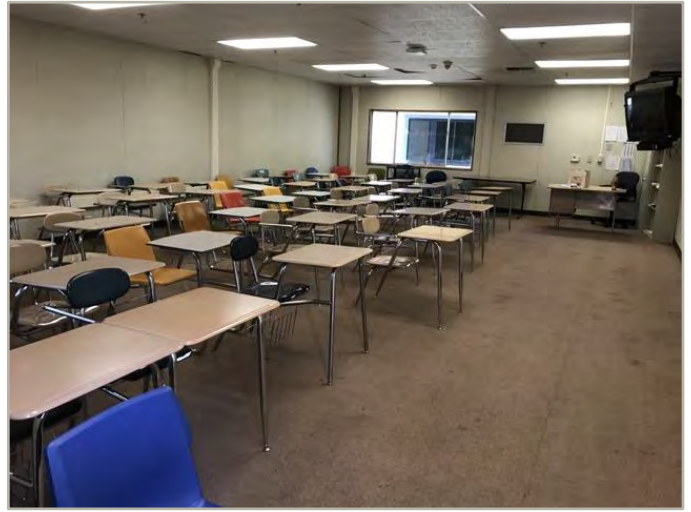
## 12. Portables 732 - 734

<b>Address</b>	39375 Cedar Boulevard, Newark, California	
<b>Constructed/ Renovated</b>	2000s	
<b>Building Size</b>	2,400 SF	
<b>Number of Stories</b>	One	
<i>System</i>	<i>Description</i>	<i>Condition</i>
<b>Structure</b>	Lightweight metal framing on a chassis	Fair
<b>Façade</b>	T-111 with aluminum windows	Fair
<b>Roof</b>	Primary: Flat construction with metal finish	Fair
<b>Interiors</b>	Walls: vinyl Floors: Carpet Ceilings: ACT	Fair
<b>Elevators</b>	None	--
<b>Plumbing</b>	NA	--

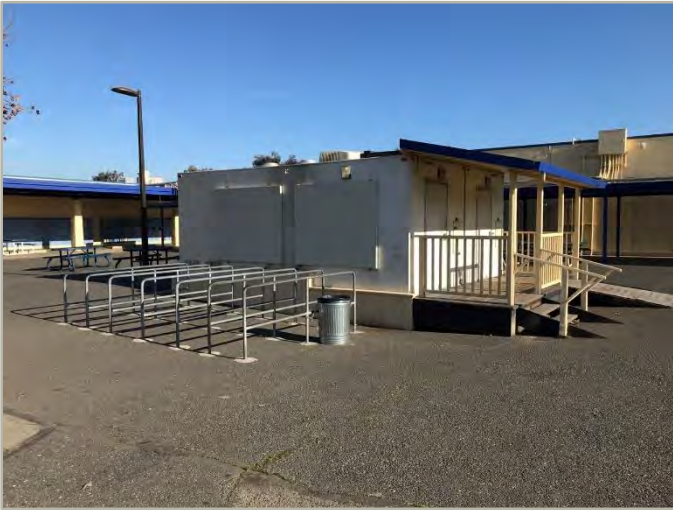
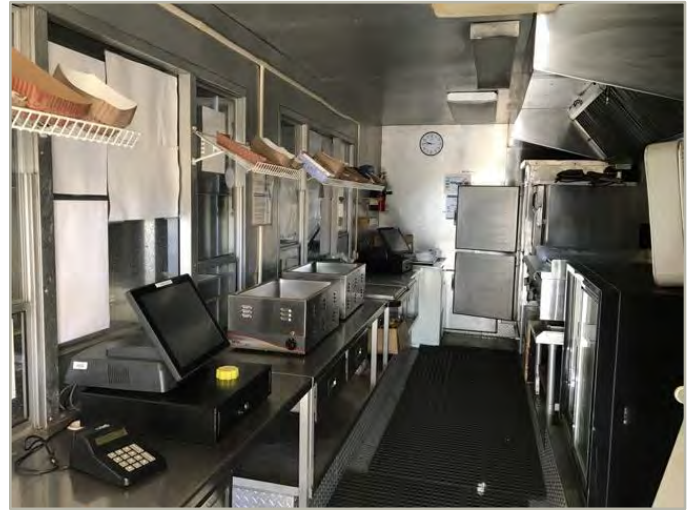
## 13. Snack Bar – Center Plaza

<b>Address</b>	39375 Cedar Boulevard, Newark, California	
<b>Constructed/ Renovated</b>	unknown	
<b>Building Size</b>	250 SF	
<b>Number of Stories</b>	One	
<i>System</i>	<i>Description</i>	<i>Condition</i>
<b>Structure</b>	Truck body	Fair
<b>Façade</b>	Painted metal	Fair
<b>Roof</b>	Primary: Truck body Secondary: Shed roof with metal roofing	Fair
<b>Interiors</b>	Walls: metal Floors: metal Ceilings: metal	Fair
<b>Elevators</b>	None	--
<b>Plumbing</b>	Copper supply and cast iron waste and venting.	Fair

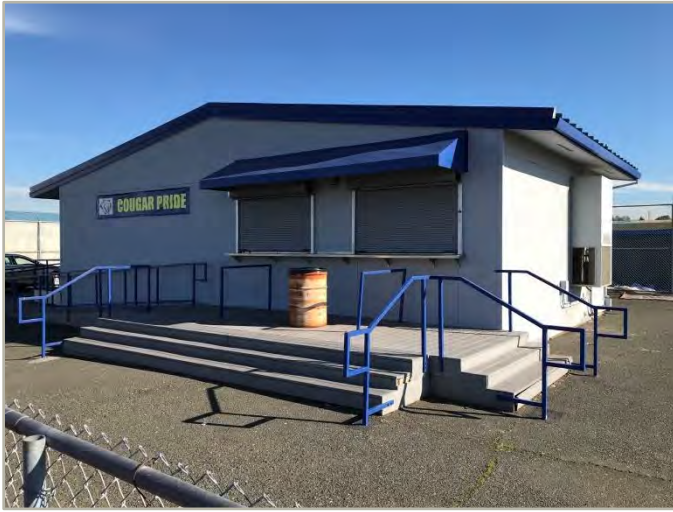
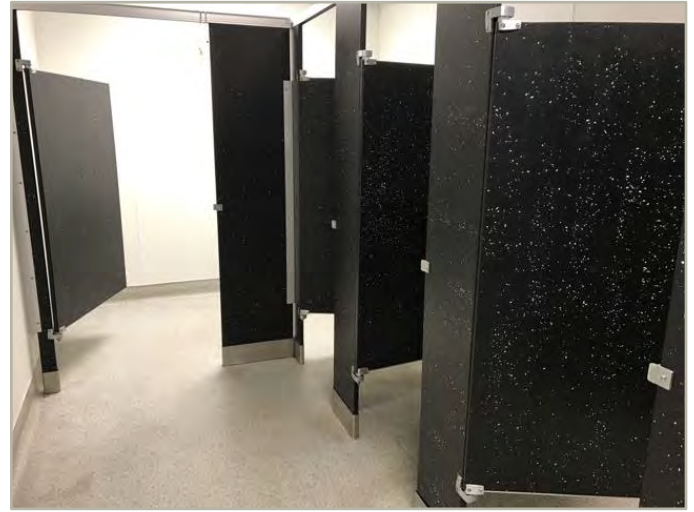
## 14. Snack Shack

<b>Address</b>	39375 Cedar Boulevard, Newark, California	
<b>Constructed/ Renovated</b>	2000s	
<b>Building Size</b>	470 SF	
<b>Number of Stories</b>	One	
<i>System</i>	<i>Description</i>	<i>Condition</i>
<b>Structure</b>	Lightweight metal framing on a chassis	Fair
<b>Façade</b>	T-111 with aluminum windows	Fair
<b>Roof</b>	Primary: Flat construction with metal finish	Fair
<b>Interiors</b>	Walls: FRP Floors: VCT Ceilings: ACT	Fair
<b>Elevators</b>	None	--
<b>Plumbing</b>	Copper supply and cast iron waste and venting Electric water heater	Fair

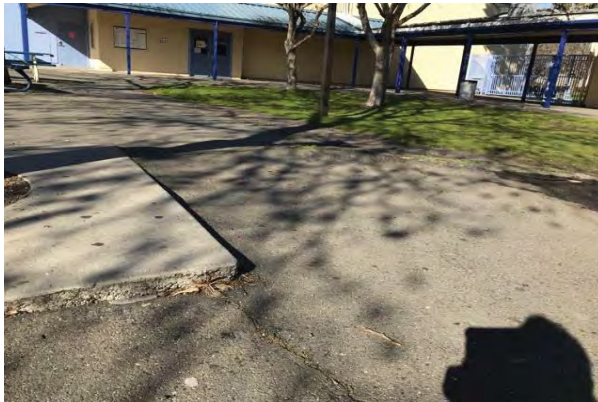
#17	UNEVEN WALKING SURFACES
-----	-------------------------

Severe alligator cracking and potholes,  
Significant sidewalk trip hazards,

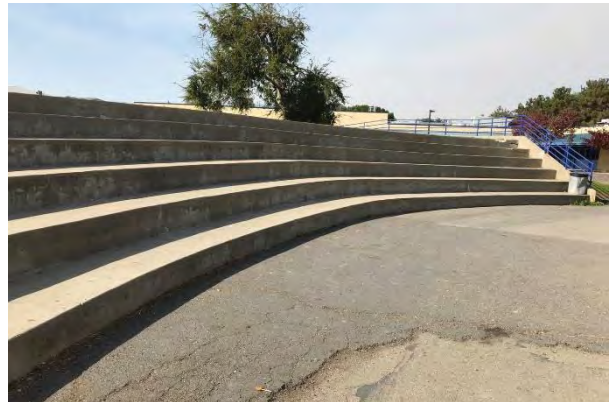
#18	UNEVEN WALKING SURFACES
-----	-------------------------

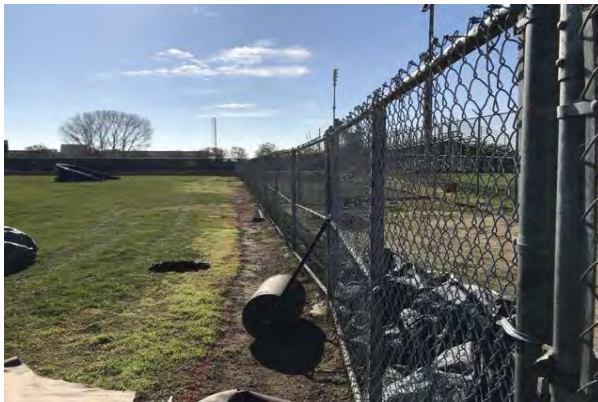
#21	CHAIN LINK, 4' HIGH
-----	---------------------

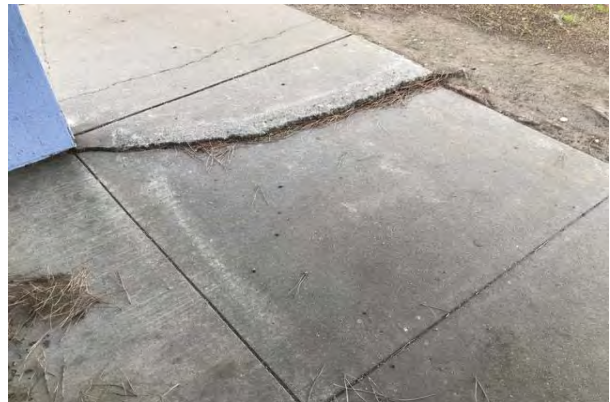
#22	UNEVEN WALKING SURFACE
-----	------------------------

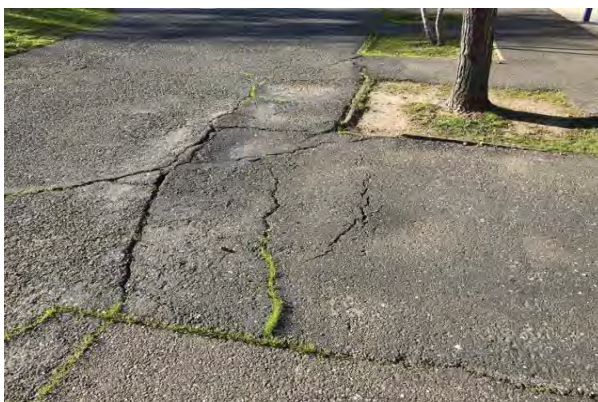
#23	UNEVEN WALKING SURFACE
-----	------------------------

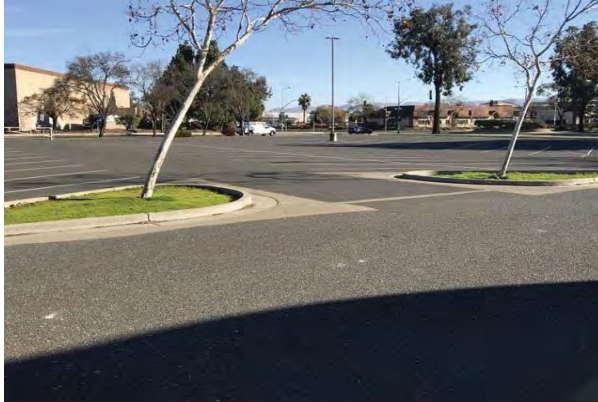
#25	PARKING LOTS, ASPHALT PAVEMENT
-----	--------------------------------

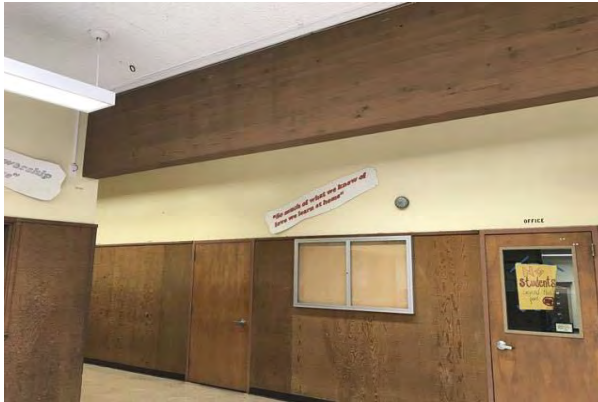
#27	GLU-LAM, BUILDING 700
-----	-----------------------

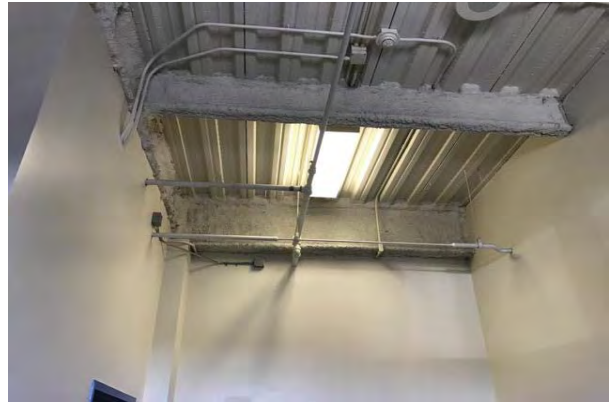
#28	METAL ROOF DECKING, BUILDING 900
-----	----------------------------------

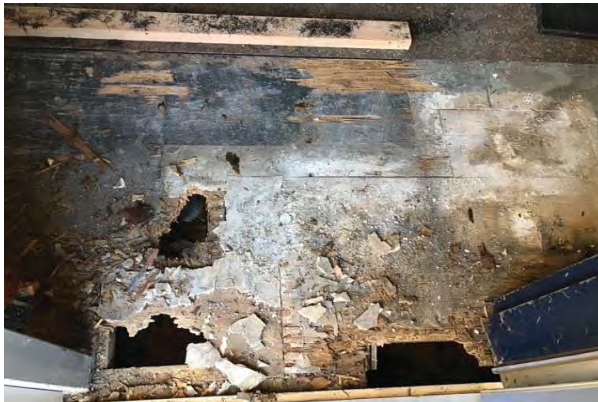
#29	ROTTING SUBFLOOR, WEIGHTLIFTING BUILDING
-----	--

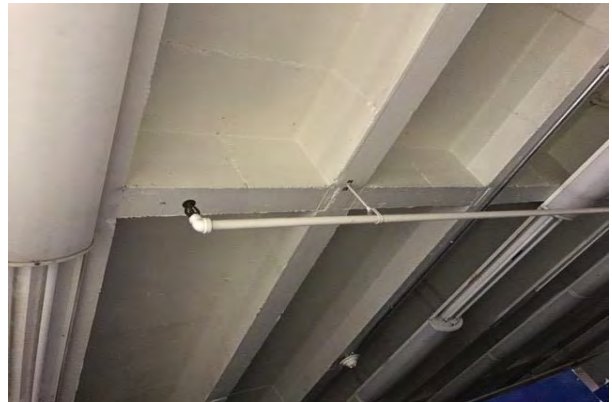
#30	CONCRETE STRUCTURE
-----	--------------------

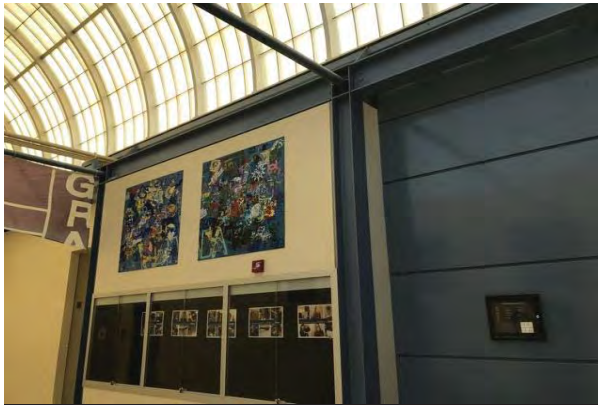
#31	STEEL FRAMING, ARCHED SKYLIGHT, BUILDING 300
-----	--

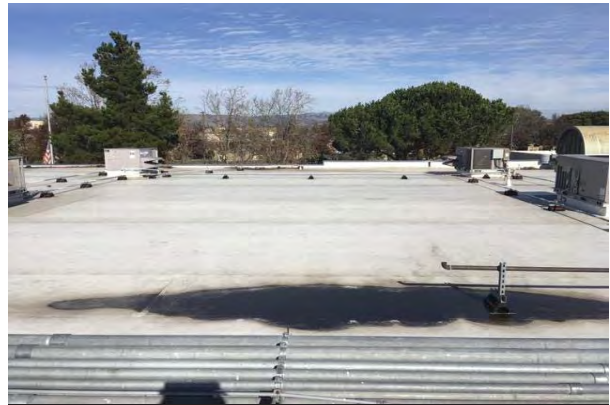
#32	ROOF, SINGLE-PLY TPO
-----	----------------------

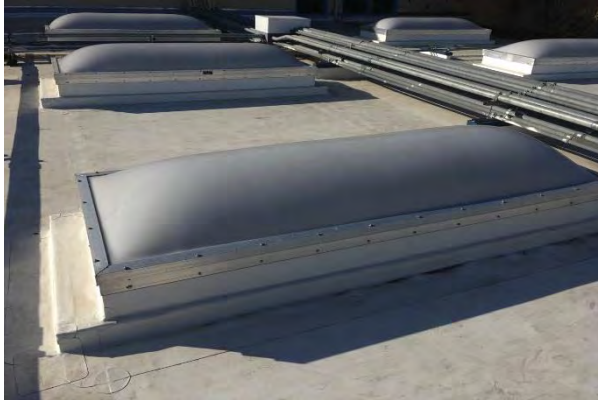
#33	ROOF SKYLIGHT
-----	---------------

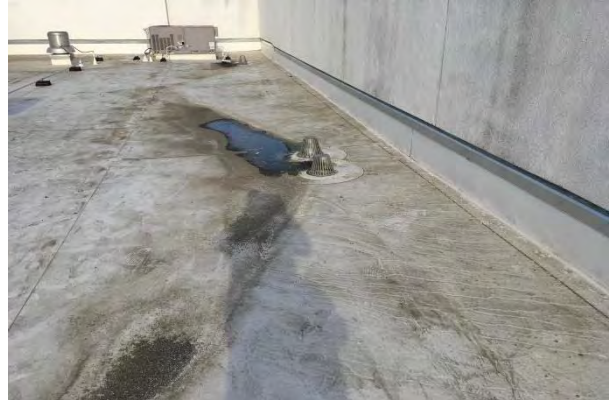
#34	ROOF, SINGLE-PLY TPO
-----	----------------------

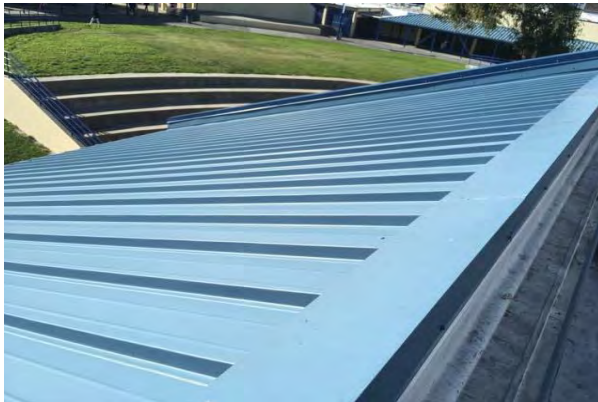
#35	METAL ROOFING
-----	---------------

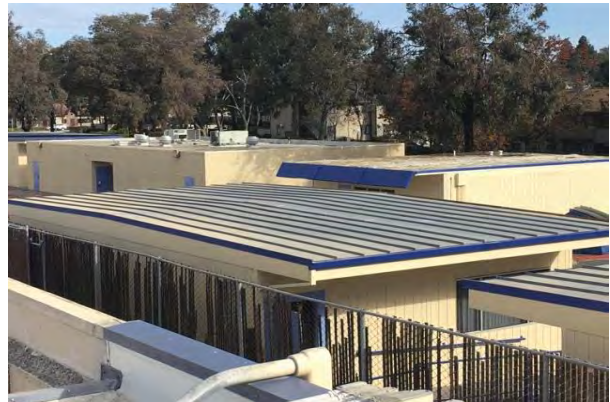
#36	METAL ROOFING
-----	---------------

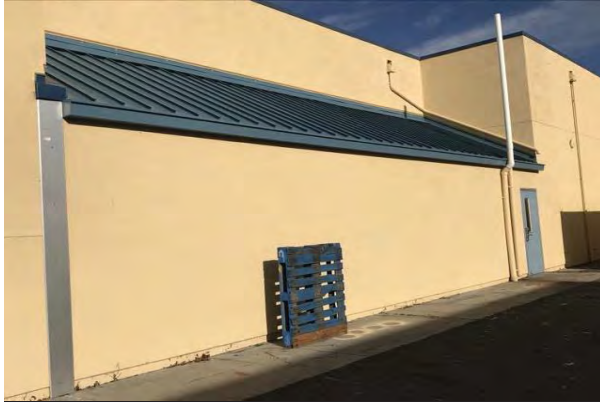
#37	METAL ROOFING
-----	---------------

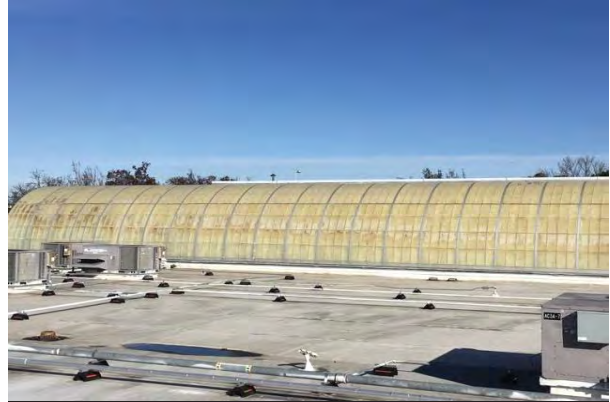
#38	ROOF SKYLIGHT
-----	---------------

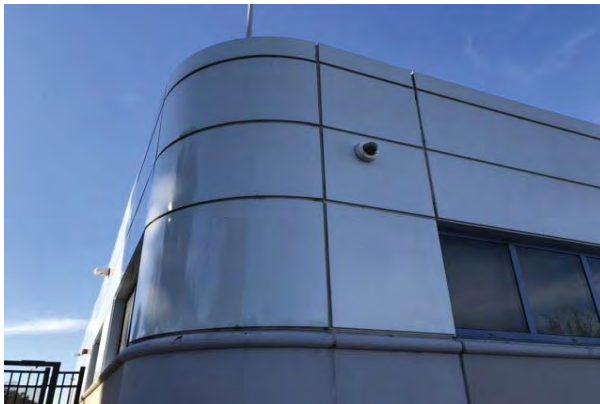
#39	EXTERIOR WALL, METAL PANEL
-----	----------------------------

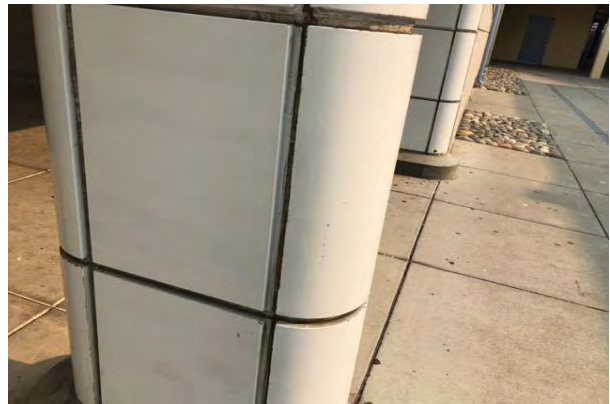
#40	EXTERIOR WALL METAL PANELS
-----	----------------------------

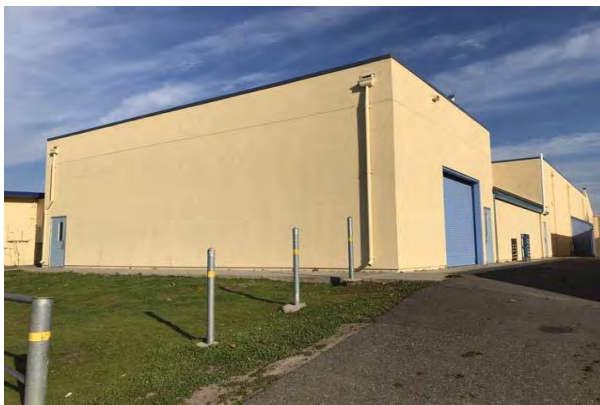
#41	EXTERIOR WALL
-----	---------------

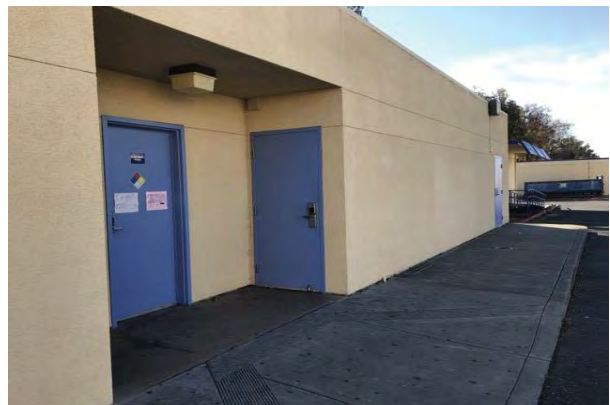
#42	STUCCO WALLS
-----	--------------

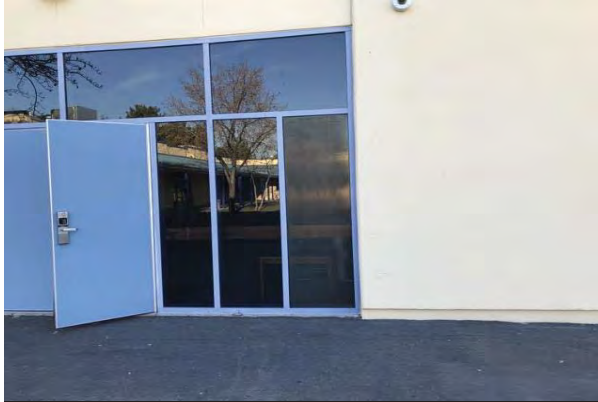
#43	STEEL WINDOWS WITH FIBERGLASS DOORS
-----	-------------------------------------

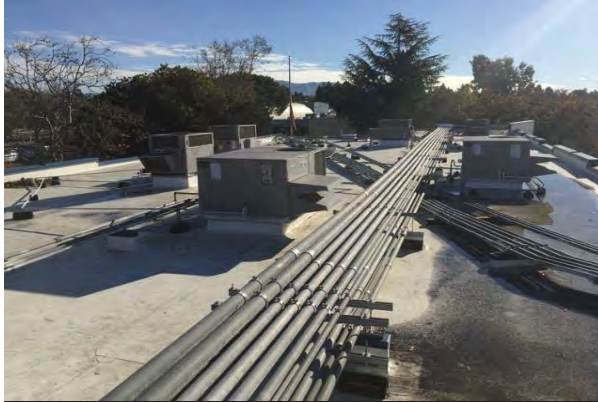
#50	VENTILATION
-----	-------------

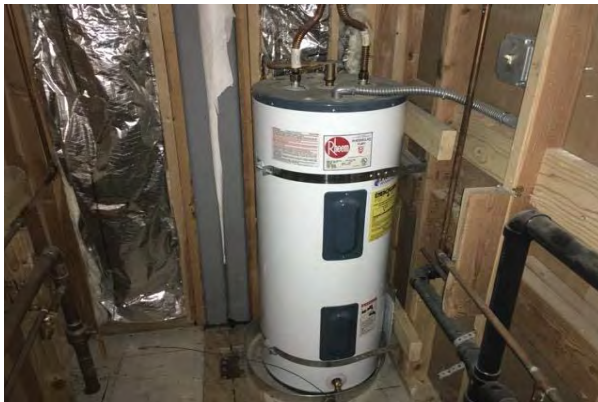
#52	ELECTRIC WATER HEATER
-----	-----------------------

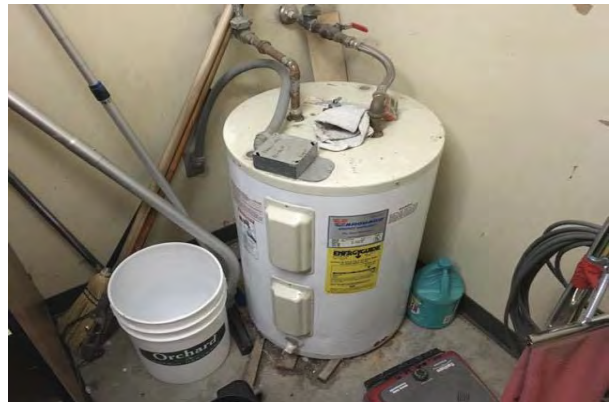
#53	PLUMBING
-----	----------

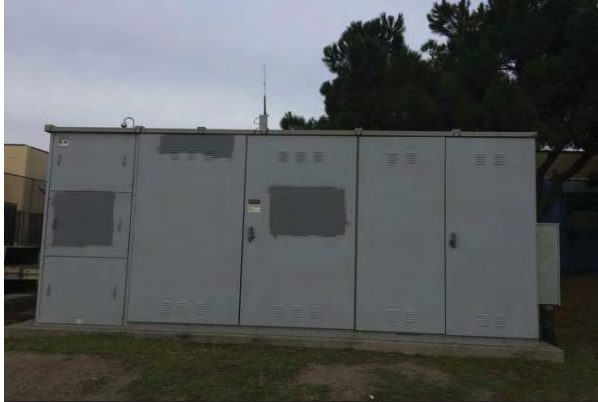
#56	SWITCHBOARD
-----	-------------

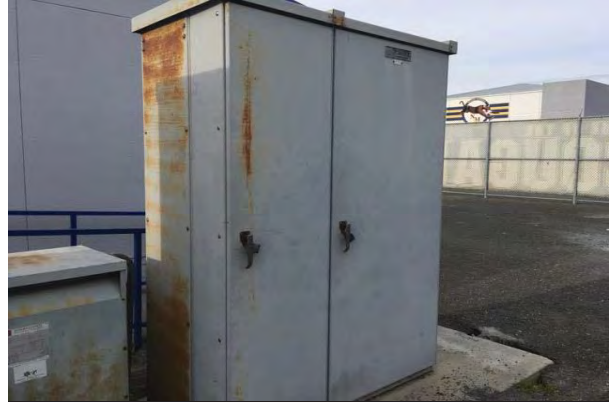
#57	TRANSFORMER
-----	-------------
