## AH-64 Five-Year Safety Performance Review FY16-20

# RQ-7BV2 Shadow Five-Year Safety Performance Review FY16-20

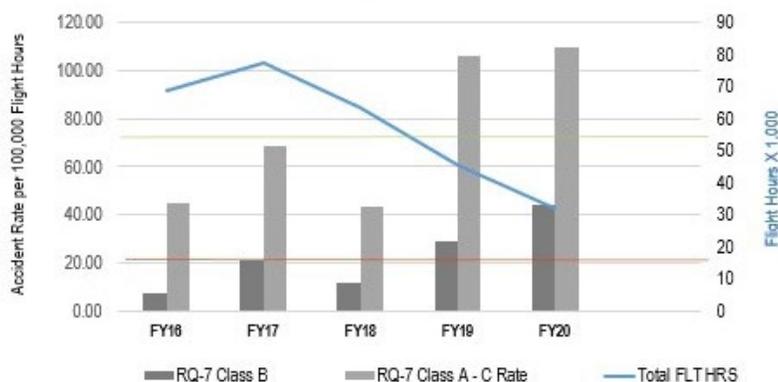
**Unmanned RQ-7 Class A - C Mishap Rate**

RQ-7	2016	2017	2018	2019	2020
Class B Mishaps	5	16	7	14	14
Class B Mishap Rate	7.26	20.72	11.24	29.15	42.88
Class C Mishaps	26	37	20	38	21
Class B - C Mishap Rate	45.01	68.64	43.34	106.19	107.19
Total # of Flight Hours	68,871	77,286	63,226	48,025	32,651

In the last five-year period from FY16 through FY20, the RQ-7 Shadow program has flown 290,209 flight hours, with 198 total RQ-7 Class A-C mishaps reported. There was one Class A, (one RQ-7BV2 landed on another), 54 Class B incidents and 142 Class C's, with no injuries or fatalities reported. The Class A flight mishap rate was negligible at 0.69, being that one Shadow landed on another, the cost of the two UAS exceeded the Class A threshold. The Class B rate was 18.6 and the Class C rate was 49.0 for the last five years.

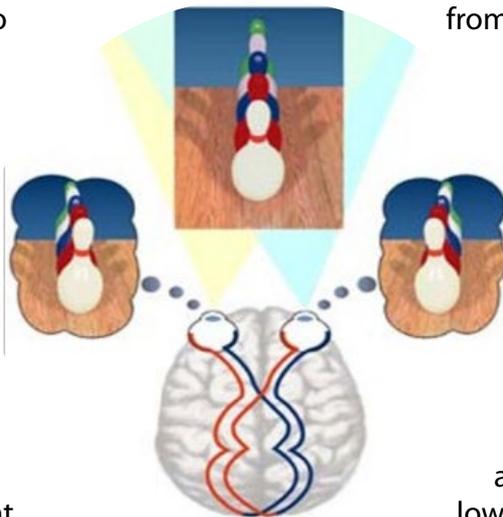
*Stereopsis*

Convergence measures the difference between the physical angles between the two eyes. The information provided by convergence is very limited at distances beyond about 30 feet. Stereopsis combines and compares the pictures provided by the two eyes. The differences between the two images provide distance and depth information. This is also only minimally useful beyond 30 feet. Convergence and stereopsis are the same when wearing NVGs as when unaided. The brain compares

**Consider this scenario:** You are sitting at a 10-foot hover. You look at the ground, approximately 20 feet away. The brain notes that convergence indicates 20 feet. Stereopsis is also correct for 20 feet. The ground is in focus, and the 'focus setting' of the eye is correct for 20 feet. The brain then decides that the ground is, in fact 20 feet away. Put NVGs on. Convergence and stereopsis are both correct for 20 feet – the problem is focus. The focus on NVGs is normally set to 50m (165 feet), optical infinity for the objective lens assembly. The ground is 20 feet away. The focus setting on the lens in the eye is correct for six feet. These numbers are too far apart for the brain to resolve. As a result, the aviator completely loses any sense of where the ground is. This is the reason
