Parking and Storage Return to Service

SUMMARY LETTER

Providing guidance during Parking & Storage and support for a smooth return to service

25 May 2021

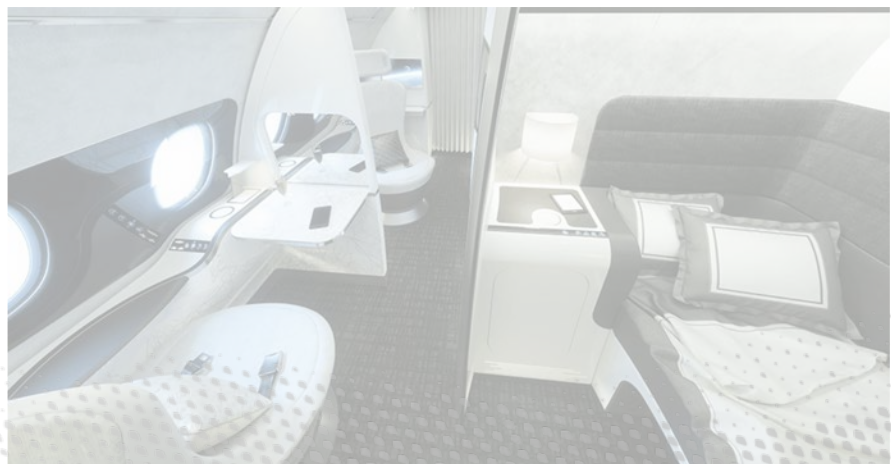
ATA 25 PASSENGER SEATS AIRBAG ELECTRONIC MODULE ASSEMBLY (EMA) FAILURE (ALL PROGRAMS / OPTIONAL EQUIPMENT)

Some operators reported several cases of AMSAFE EMA (Electronic Module Assembly) batteries unserviceable after aircraft parking or storage. Root-cause analysis highlighted a risk of EMA batteries depletion on passenger seats that are equipped with an AMSAFE EMA “NextGen” which contains a Lithium battery and exposed to elevated temperatures during parking and storage periods. More details and additional recommendations can be found in ISI [00.00.00379](#) and AMSAFE VSB 14518-25-01.

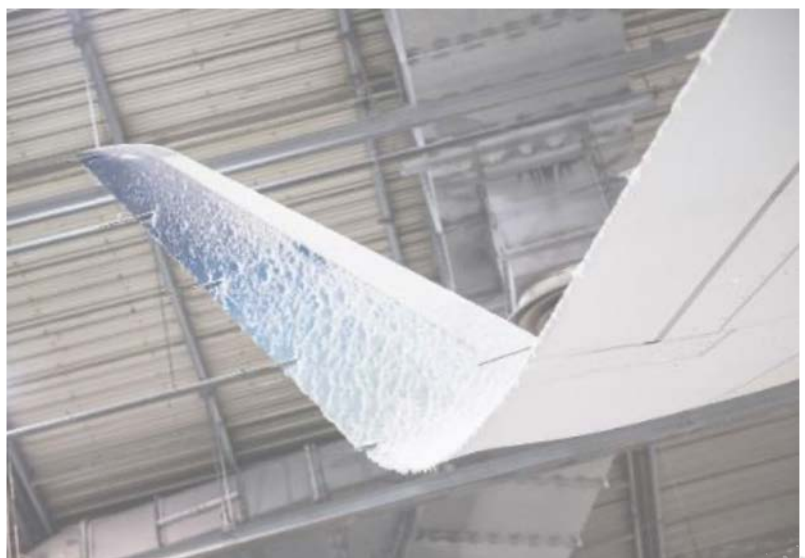
ATA 30 ANTI ICING PROTECTION RECOMMENDATIONS (A320Neo / A350)

Following parking/storage, some operators have reported Nacelle Anti-Ice PRSOV valve(s) issues during the subsequent flight. To avoid unnecessary removals when dispatch messages are triggered, it is recommended to follow the FCOM procedure (increase N1 up to 35%) or to cycle the NAI Push Button to clear the faults.

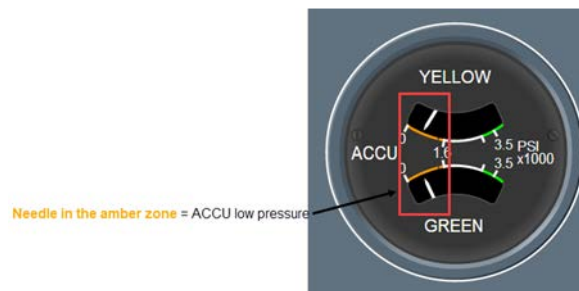
ATA 32 SPURIOUS DISPATCH MESSAGE (NO GO) (A350 PROGRAM)

Post parking/storage, some A350 operators reported spurious dispatch messages (NO GO) at or after pushback if the aircraft is powered up with low braking accumulator pressure, causing delay.

If the aircraft is powered up with a braking accumulator in the Amber zone prior return to service, it is recommended to perform BITE scanning of BSCS1 and BSCS2 after power-up to confirm no fault is latched (MP TASK A350-A-45-45-XX-00002-345A-A) in BSCS.

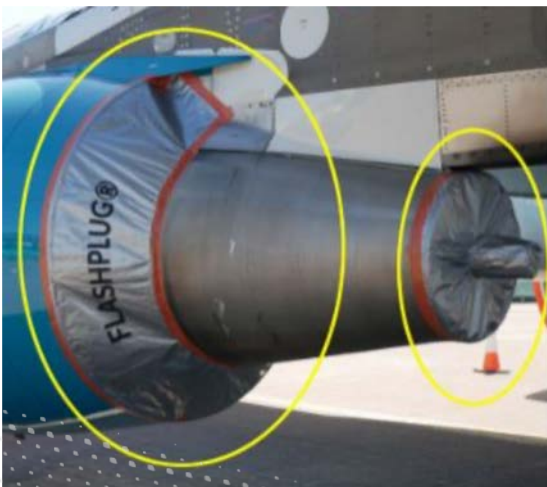
This engine preservation solution has been developed in response to operators' need to preserve their engines on-wing. Not only is the solution a fast and cost effective one, but the FLASHPLUG® is also smaller and easier to handle than traditional engine preservation solutions. The FLASHPLUG® weighs a mere 700 grams and can be folded into a tiny package for future use in the fly-away kit and can be shipped in a usual document express envelope. It takes less than 10 minutes for a mechanic to fit the FLASHPLUG®. Any question, please contact Cedric Chamfroy (cedric.chamfroy@airbus.com) or Jack Schwartz SATAIR (jack.schwartz@airbus.com).

- Installation time of 8 minutes (one mechanic)
- Low cost (cheaper than film & tape option)
- Re-usable (can be re-fit multiple times)
- Special Adhesive Formulation (will not damage paint or leave sticky residue)
- Small & lightweight (can be packed with Fly Away Kit)
