## IMPALA TAILINGS AND OPEN PIT PROJECT: CLOSURE COSTS 2011

# Up Front Engineering Design Report for the New Tailings Disposal Facility at Impala Platinum Mine, Rustenburg

Report Number 414226/4rev1

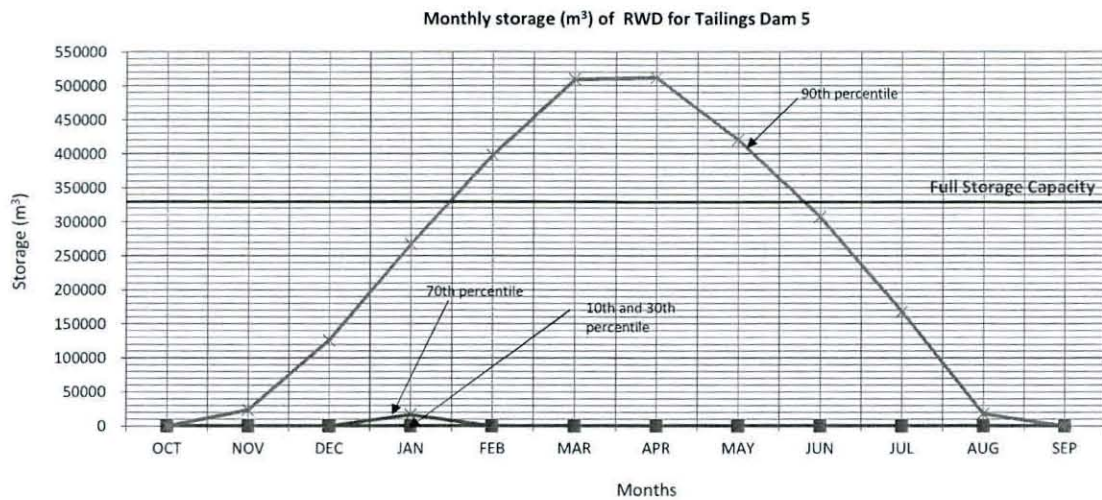
Figure 4-1 RWD 1: storage summary at Tailings dam 5 Phase 1

- Figure 4-1 shows the storage in RWD 1 during the Phase 1 development.
- Figure 4-2 shows the combined storage in RWD 1 and RWD 2 during the Phase 2 development.
- Figure 4-3 shows the combined storage in RWD 1 and RWD 2 during the combined tailings dam development. The big difference between Figure 4-2 and Figure 4-3 is that the tailings deposition rate increased from 625,000t/month to 1,666,666t/month and the associated return water to the process plants correspondingly is higher.

From the figures below (Figure 4-1, Figure 4-2 and Figure 4-3), it is observed that major storage within the Return water dams (RWDs) only occurs in the 90<sup>th</sup> percentile monthly rainfall scenario which is above average rainfall conditions.

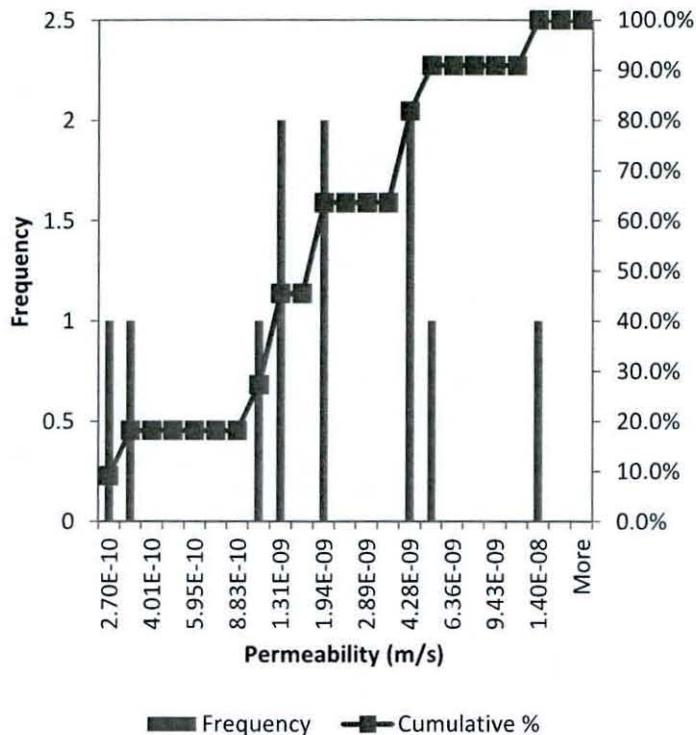
Figure 5-1: Full permeability database

- In Figure 5-1 is shown the full permeability database. The average permeability assessed on a log basis is  $1.7e-9\text{m/s}$ .
- In Figure 5-2 is shown the full database excluding the highest permeability value of  $1.4e-8\text{m/s}$ . The average permeability assessed on a log basis is  $1.4e-9\text{m/s}$ .

A copy of the geotechnical test results are attached in Table 5-1. The permeability test results values vary between  $2.7e-10\text{m/s}$  and  $1.4e-8\text{m/s}$ . The permeability test results can be interpreted as follows as shown in Figure 5-1 and Figure 5-2.

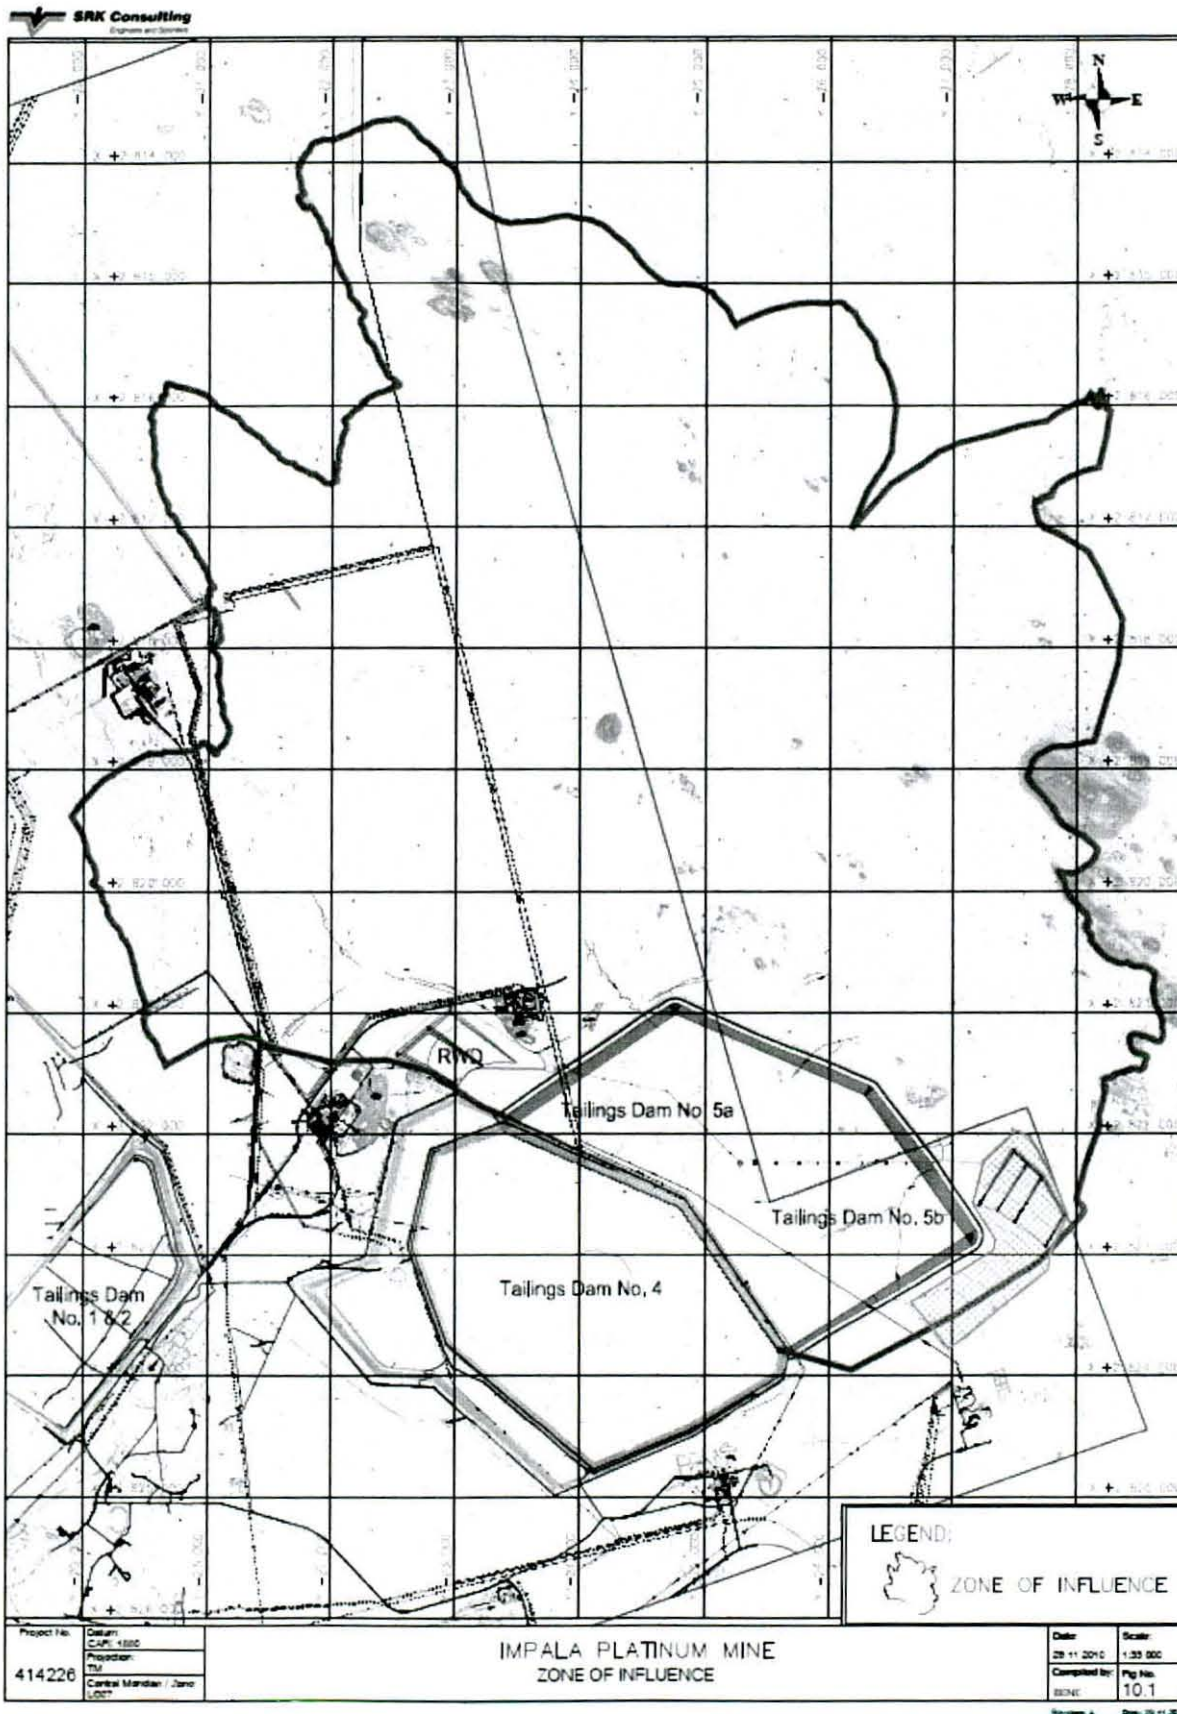
Figure 10-1: Zone of Influence Final Tailings Dam Complex

A zone of influence was determined for the residue disposal facility and is presented in Figure 10-1.

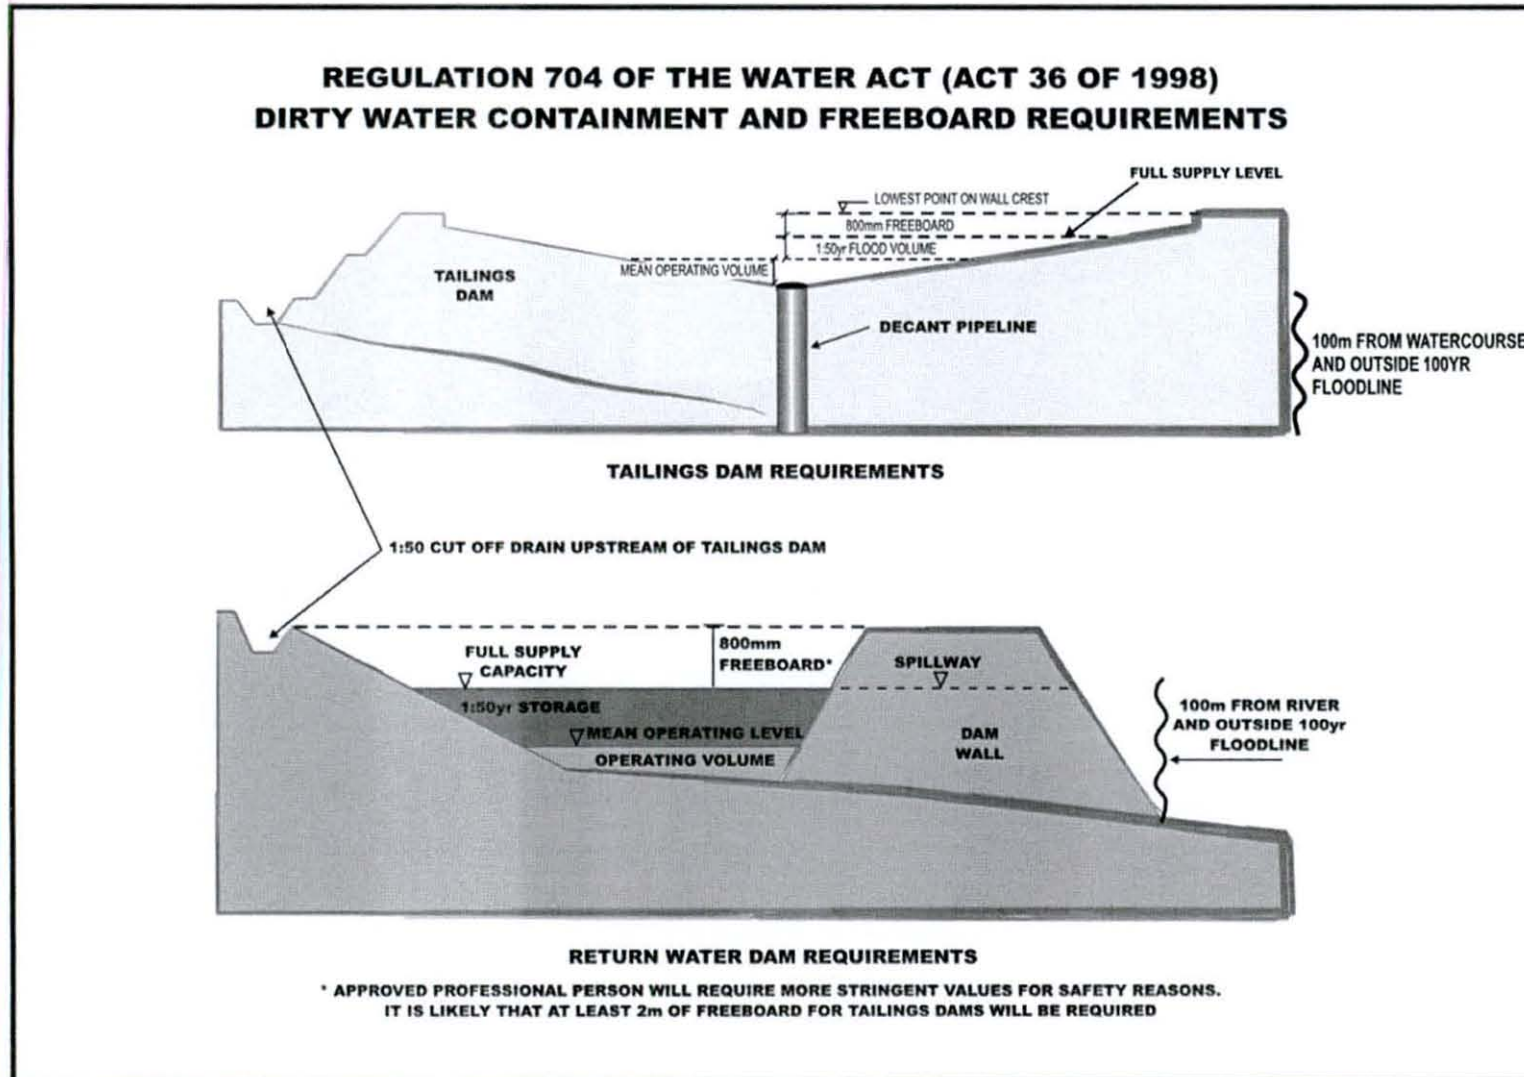
Figure 12-1: Dirty Water Containment and Freeboard Requirements

The management of water at the Impala Tailings Dam forms an important aspect in calculating the sizes of the penstock towers as well as the return water dam. The principals of managing water can be described as follows and the management is carried out in accordance with the requirements of Regulation 704 of the South African National Water Act (Act 36 of 1998) as is presented in Figure 12-1.

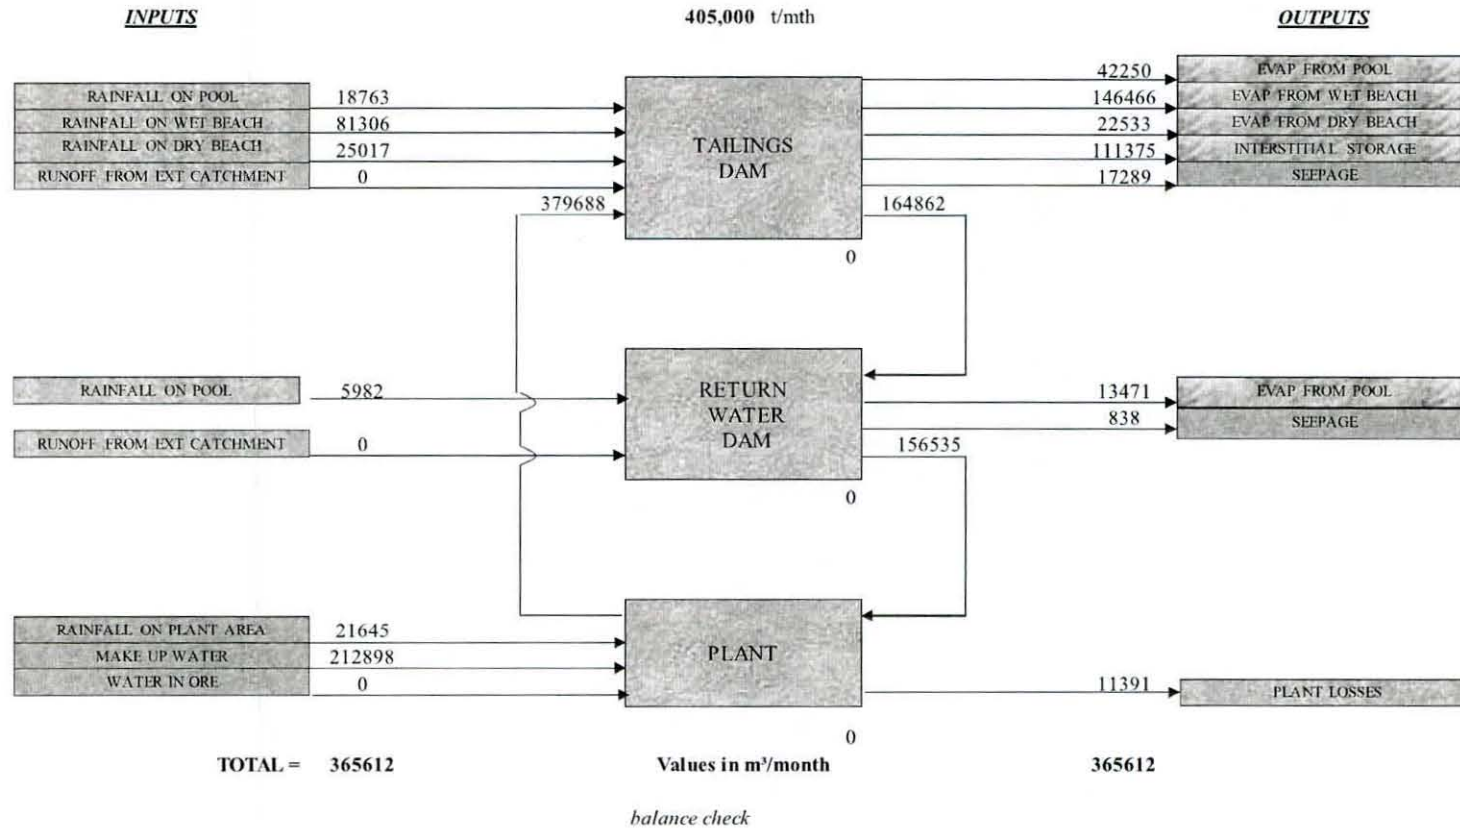
**Figure 12-2: Average Monthly Water Balance for Impala Platinum Mine (Tailings dam No. 5 Phase 1) : basin permeability: 2.9e-9m/s**

\*\*\*The average consumption per month is **0.5m³/t**.

The water balance diagram for average monthly conditions is presented in Figure 12-2 and Figure 12-3, considering two basin seepage rates.
