GROUP <b>Electrical</b>	MODEL <b>2013MY Optima (QF/TF) 2013MY Soul (AM)</b>
	NUMBER <b>080</b>	DATE <b>April 2015</b>

**SUBJECT: COMBINED TSB/ SERVICE ACTION: AVN SYSTEM  
UPGRADE (SA189)**

This bulletin provides the procedure for upgrading the navigation system software of some 2013MY Optima (TF/QF) and some 2013MY Soul (AM) vehicles, to improve Bluetooth® connectivity. Kia is requesting the completion of this Service Action on all affected vehicles. Before conducting the procedure, verify that the vehicle is included in the list of the affected VINs.

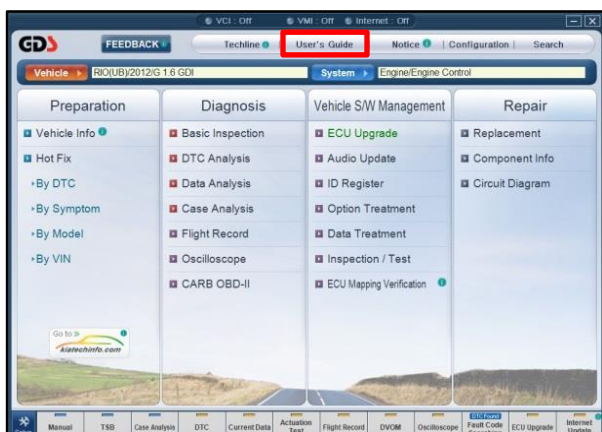
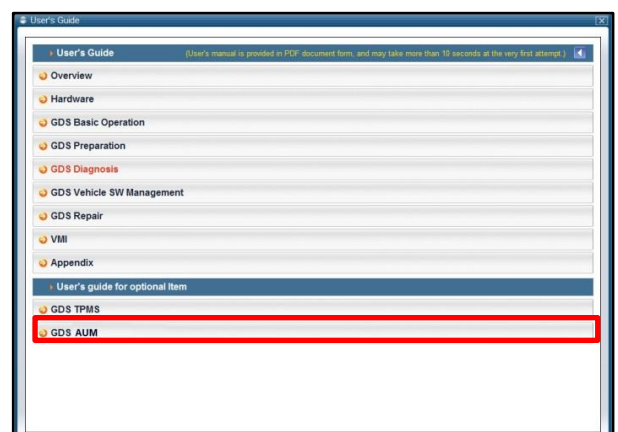
1. Start the vehicle or connect the Midtronics GR8-1299 charger.
2. If performing the update using the GDS AUM, refer to TSB SST 032 or click on **User's Guide** > **GDS AUM** on the GDS main screen, as shown below, and follow the on-screen instructions.

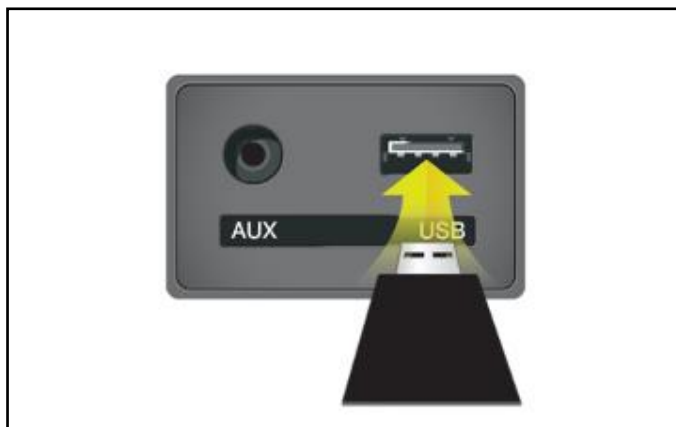
- If performing the update using a USB stick, obtain the 13MY upgrade USB drive from your Service Manager and insert it in the vehicle's USB port. Make sure to allow for the sound file to play for one second before proceeding to the next step.

*Images shown are for demonstration only purposes and will vary by model.*

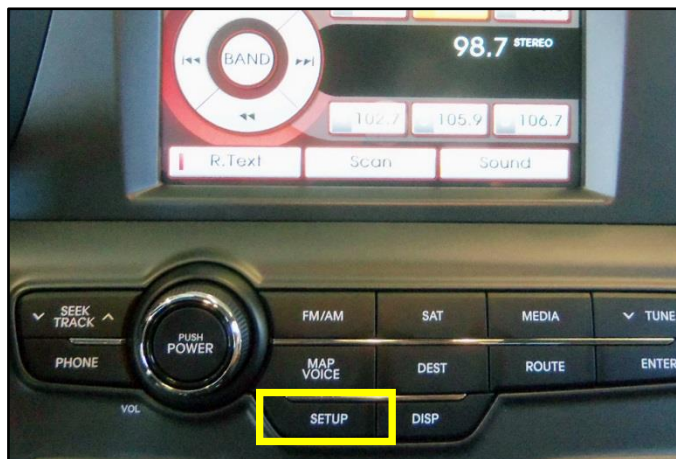
- Press the **SETUP** button.

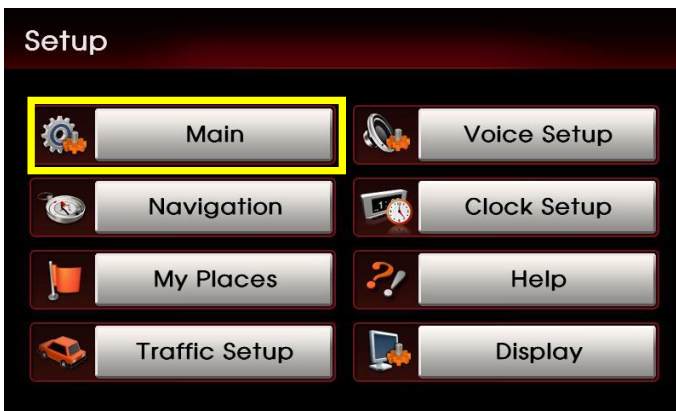
- Touch **Main** on the screen.

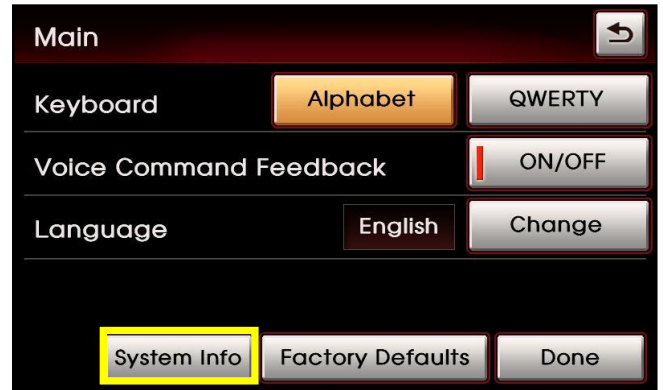
6. Touch **System Info** on the screen.

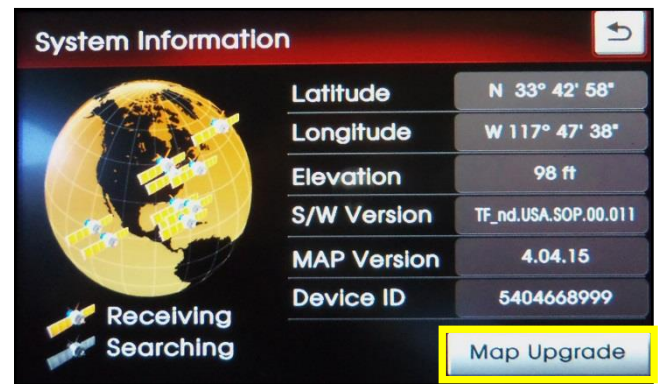
7. Touch **Map Upgrade** on the screen.

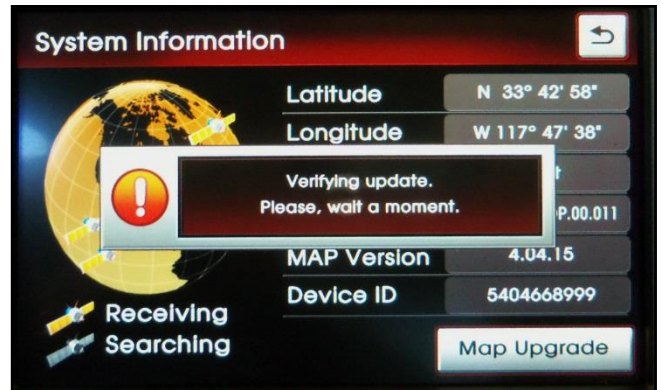
8. The system will verify the update on the USB thumb drive.

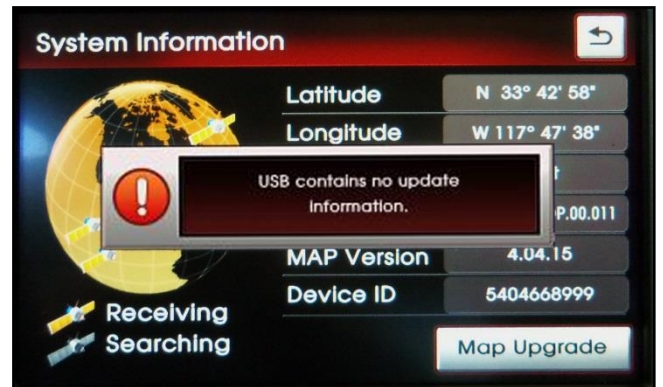
9. If update verification is not successful, the system will display an error message. Make sure the correct USB thumb drive is being used for the update.

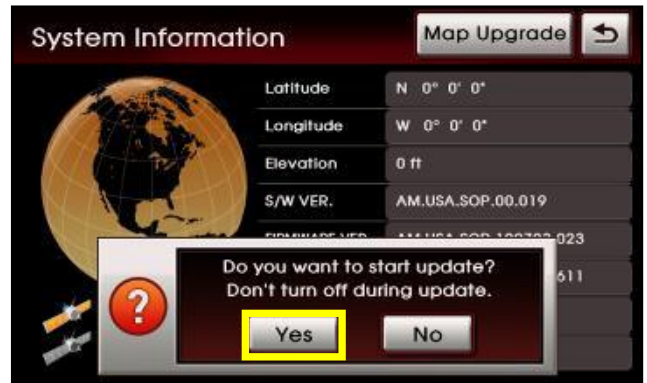
- If update verification is successful, touch **YES** on the screen to begin installation.

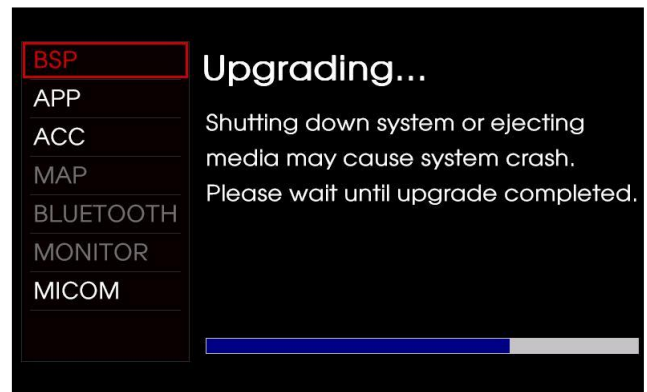
- The system will begin the upgrade and the progress will be displayed on the bar graph. Once the update is complete, the system will restart.

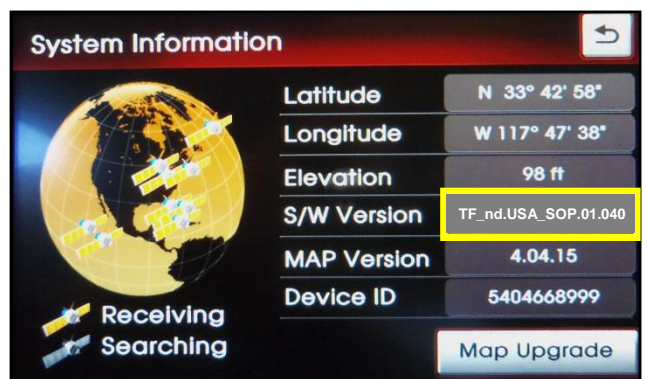
- Once the system restarts, access the System Information screen (**SETUP > Main > System Info**) to confirm the upgrade software version matches the information shown in the table below:

Model	New Software Version
Optima (TF/QF)	TF_nd.USA_SOP.01.040
Soul (AM)	AM.USA.SOP.00.025

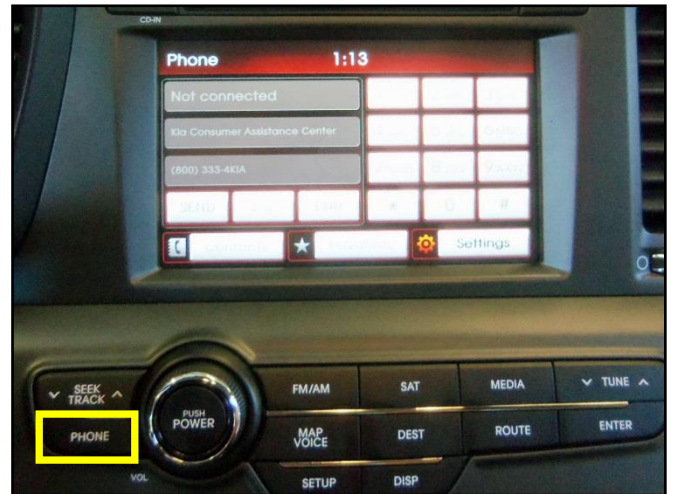
- 1. Press the **PHONE** button to display the dialing screen.

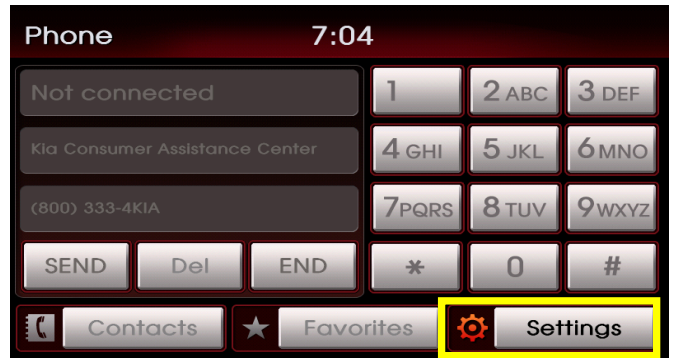
- 2. Press **Settings** on the screen.

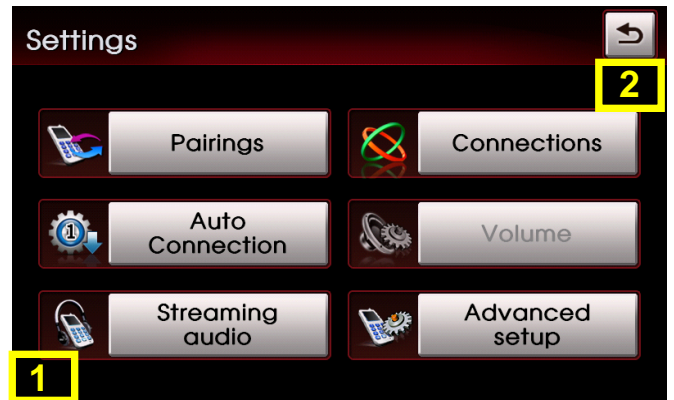
- 3. To access the Bluetooth Engineering Mode, use a finger to touch the bottom left corner of the screen (1), then, immediately touch area above the **Connections** button (2), as shown.

- Perform step 3 again to access the Bluetooth Engineering Mode screen and confirm the upgrade software version matches the information shown in the table below:

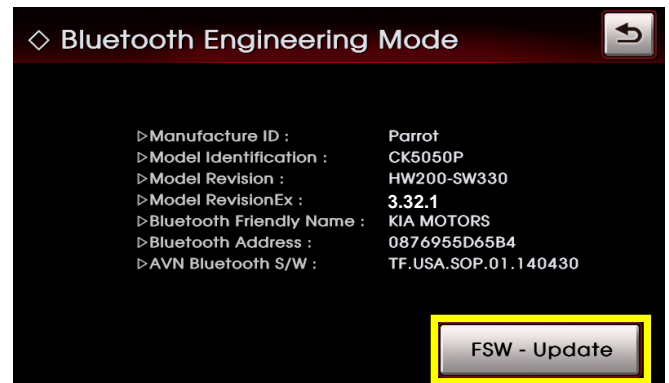
- Once in the Bluetooth Engineering Mode screen, press **FSW – Update** to begin the installation.

The update will take approximately two (2) minutes to complete.

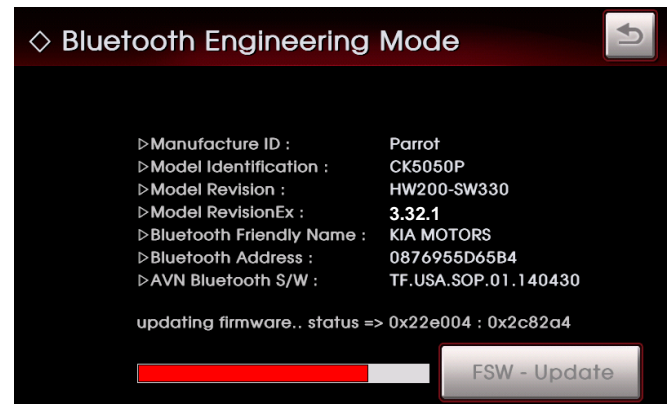
- The system will begin the upgrade and the progress will be displayed on the bar graph. Once the update is complete, cycle the ignition and power up the head unit.

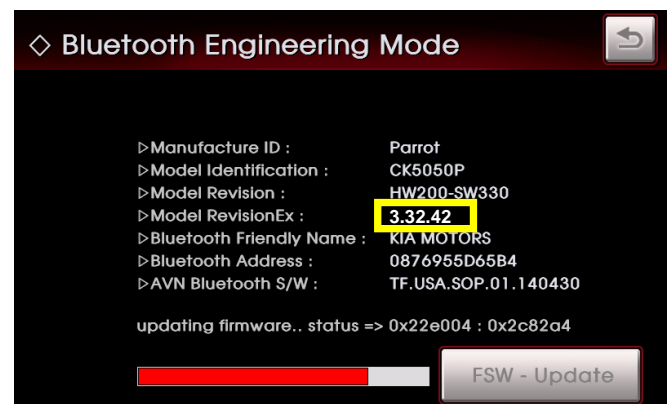
Bluetooth Software Version
3.32.42
