## NBT-EVO Head Unit Cannot be Swapped between Vehicles for Testing. 'Component Protection Active'

This Service Information bulletin supersedes SI B65 13 16 dated **March 2018**.

Affects vehicles with SA609 - Navigation System Professional (NBT-EVO HU-H2)

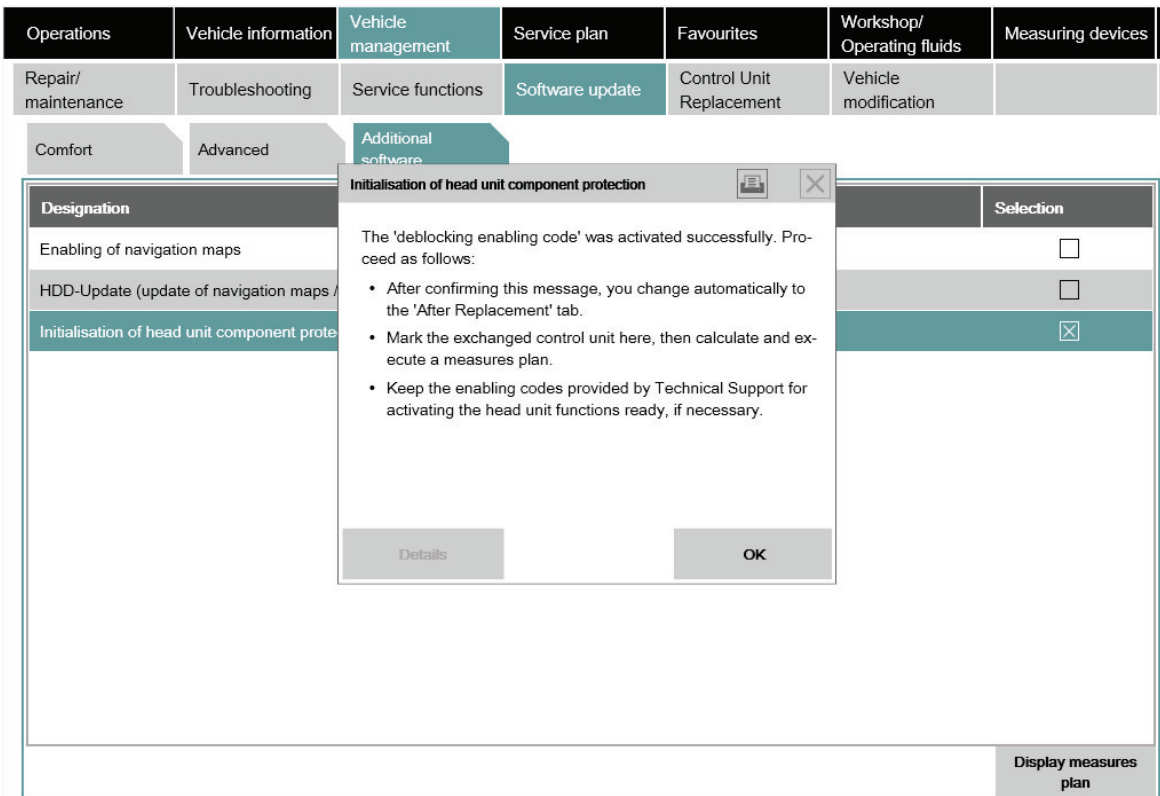
5. Confirm the dialogue to download enabling codes.

6. Confirm deblocking of the component protection.

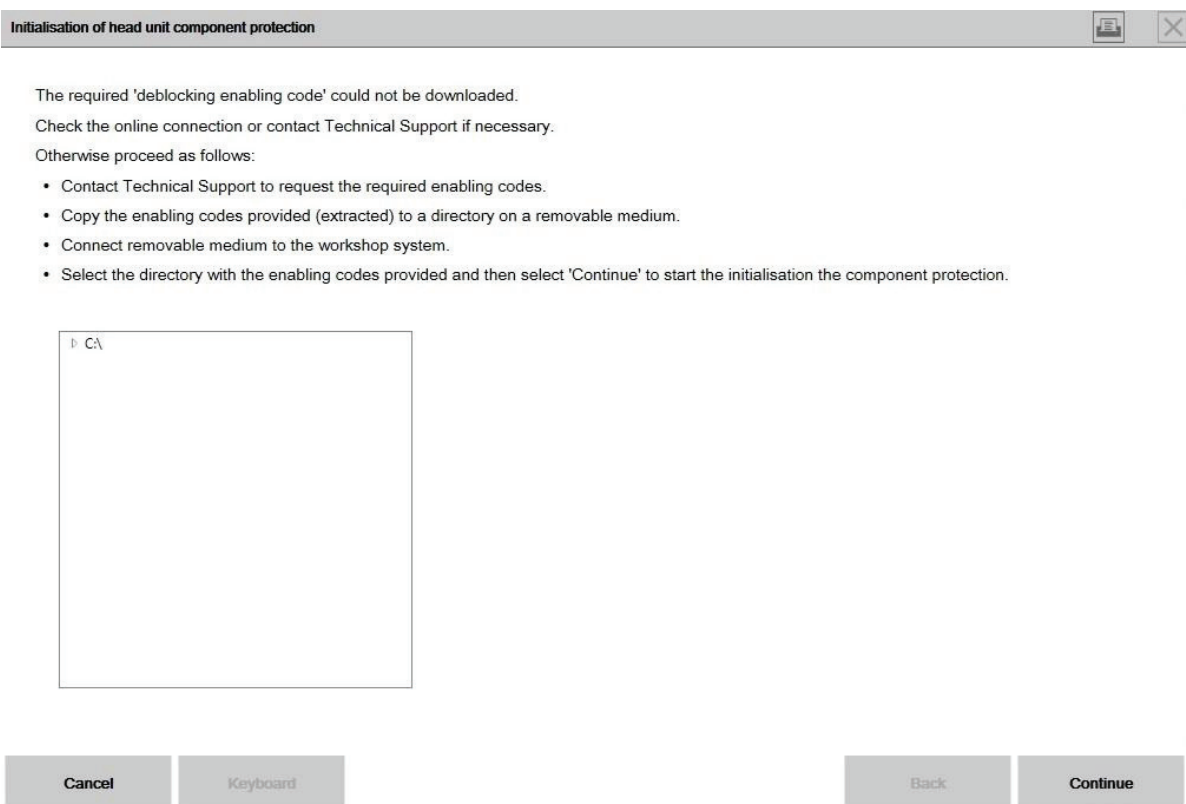
12. Select the "Import" checkbox in the dialogue on the manual import of enabling codes. Then confirm the dialogue.

13. Select the storage location (folder) of the unpacked enabling codes in the next dialogue.
