TECHNICAL SERVICE BULLETIN

INTELLIGENT KEY NOT DETECTED IN CENTER CONSOLE

APPLIED VEHICLES: 2021-2022 Sentra (B18)
APPLIED DATES: 2021: All
2022: Built before June 24, 2022
APPLIED GRADES: SV, SR

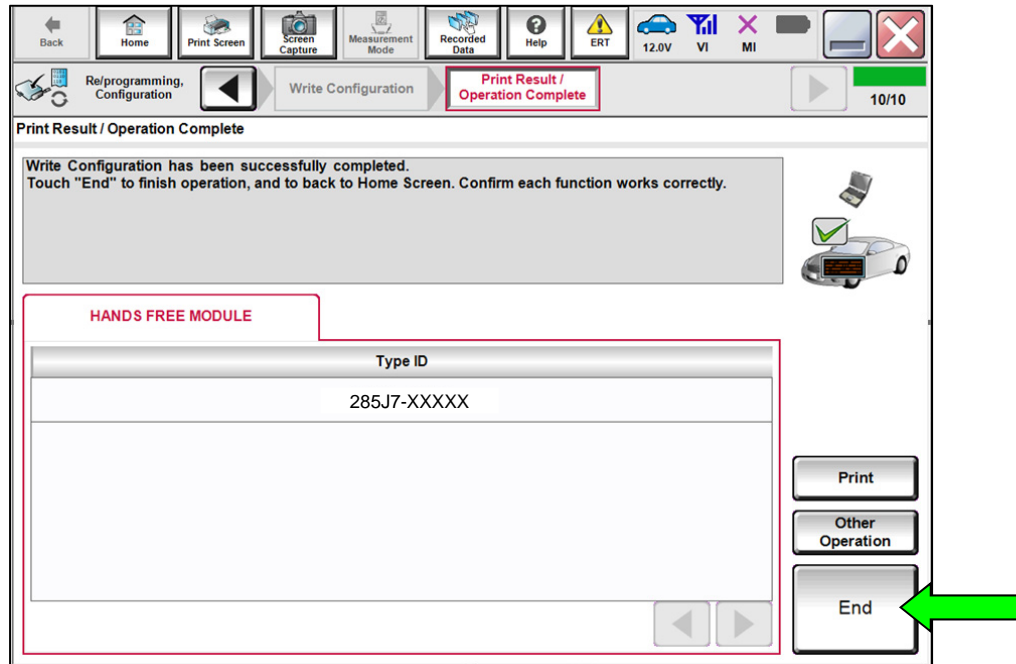
Figure 14

21. Confirm that the **Type ID** is now as follows:

- Vehicles with RES: "285J7-6LE1B".
- Vehicles without RES: "285J7-6LE4B".

22. Select **End**.
