Subject: N232399010 - Service Update  
TCM Loss of Communication

Models: 2023 Cadillac CT4  
2023 Cadillac CT5  
2023 Cadillac Escalade  
2023 Cadillac Escalade ESV  
2023 Chevrolet Silverado 1500 New  
2023 Chevrolet Suburban  
2023 Chevrolet Tahoe  
2023 GMC Sierra 1500 New  
2023 GMC Yukon  
2023 GMC Yukon XL

## N232399010 TCM Loss of Communication

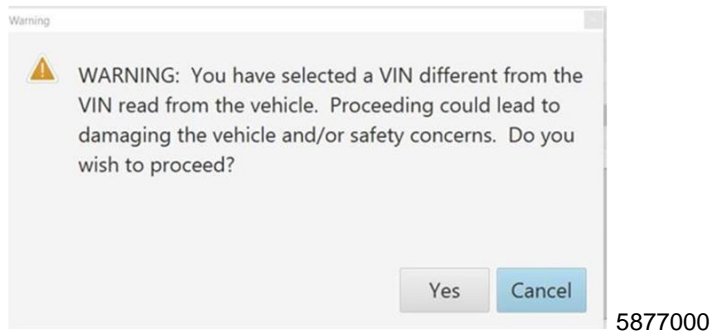
**Important:** If the vehicle VIN DOES NOT match, the message below will be shown.

**Important:** Techline Connect screens shown above.
