SERVICE INFORMATION BULLETIN

NUMBER: 15-205-16R

SUBJECT: Reprogramming File Availability to Address Operational Concerns with “Gen 2.0” and “Gen 2.1” Fujitsu-TEN (F10) / Denso-TEN (D10) Navigation and 7” Display Audio Units

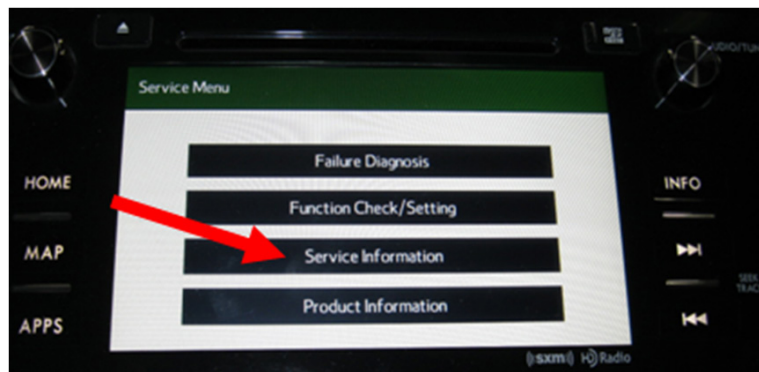
- Switch the unit into “Diagnosis Mode” by pressing and holding the HOME button while pressing the “AUDIO/TUNE” button 5 (five) times.

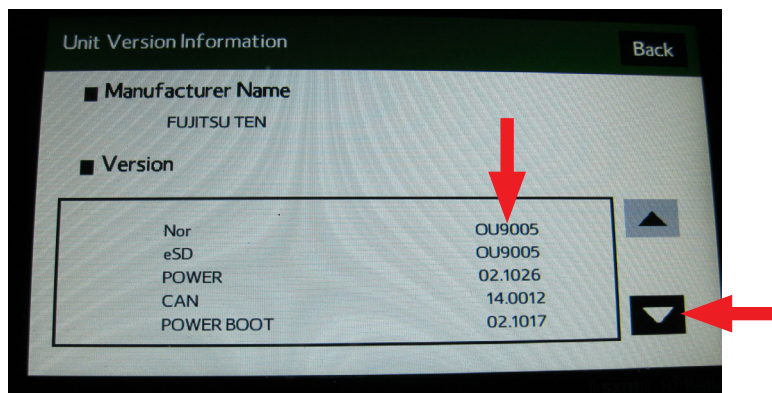
- Press “Push” next to DA (or AVN for Navigation units)

- Verify the current versions according to the Update File Applicability / Information table shown table shown on page 7. Use the down arrow to scroll to the bottom of the list for complete verification.
- If the software version is current, press and HOLD the HOME button to exit the Diagnostic Mode and complete the procedure as no updates are necessary. If no updates are necessary, continue your diagnosis of the customer concern. If the Version ID numbers are prior to (lower than) those shown in the table above, proceed with **Step 2**, preparing the USB memory (Flash Drives) then **Step 3**, the software update procedure.

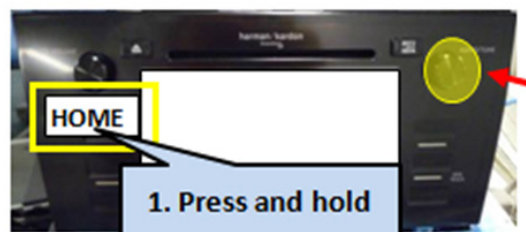
2. Press "AUDIO/TUNE" button 5 times

- Once the USB icon is illuminated, switch the unit

into “Diagnosis Mode” by pressing and holding the HOME button while pressing the “AUDIO/TUNE” button 5 (five) times.

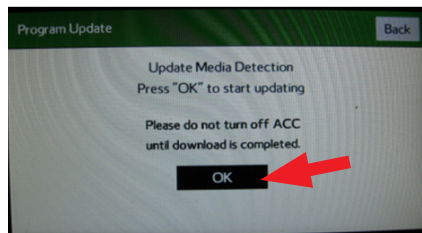
Wait for “OK” to activate (turn black)

NOTE: The “OK” button will not activate (turn black) if the wrong Update File(s) are on the flash drive. Re-format the flash drive and reload the proper Update Files starting from the beginning of Step 2.
