IBM Storwize V7000

*Troubleshooting, Recovery, and  
Maintenance Guide*

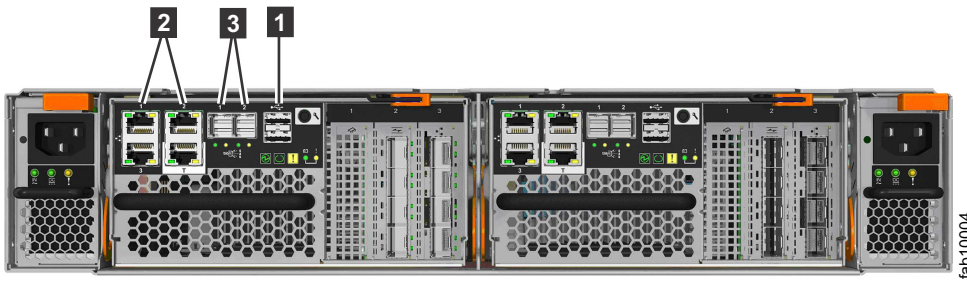
Figure 8. Node canister ports

Figure 8 illustrates the location of the ports.

- **1** USB ports. Each canister has two USB ports. One port is used during installation.
- **2** Ethernet ports. Each canister has two 1 Gbps Ethernet ports.
  - Port 1** Must be connected for system management. Can optionally be used for iSCSI host connectivity.
  - Port 2** Optional. Can be used for iSCSI host connectivity or to provide an alternative (redundant) management address.
- **3** Serial-attached SCSI (SAS) ports. Each canister has two SAS ports. Ports 1 and 2 are exclusively used for connecting to expansion enclosures.

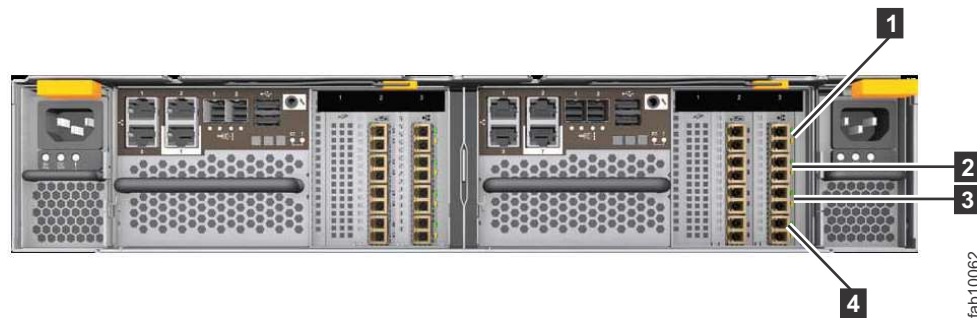
*Figure 13. 10 Gbps Fibre Channel over Ethernet/iSCSI host interface adapter ports*

The adapter has four Ethernet ports, none of which are used for system management. The ports are named 1, 2, 3 and 4 (Figure 13) when installed in a slot.

- 1** Port 1
- 2** Port 2
- 3** Port 3
- 4** Port 4

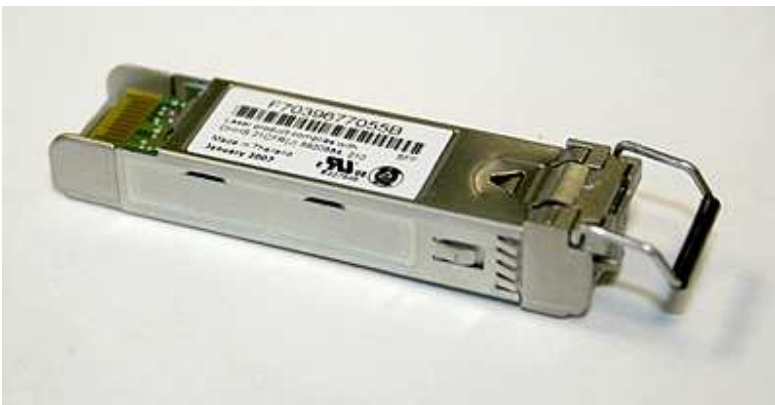
Figure 23. SFP transceiver

The SFP transceiver can vary, depending on the type of network adapter used. Figure 23 illustrates an SFP transceiver.

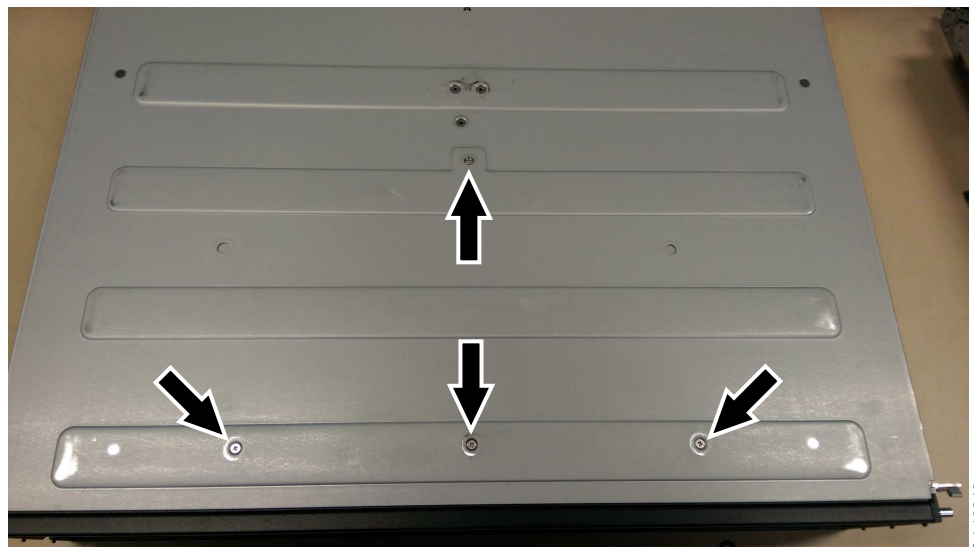
15. Remove the four screws from the bottom of the enclosure. Three screws are near the front and one is near the middle. Label these screws to indicate the location from which they are removed and place them aside. Figure 33 illustrates the location of the screws on the bottom of the enclosure.

Figure 33. Bottom enclosure screws

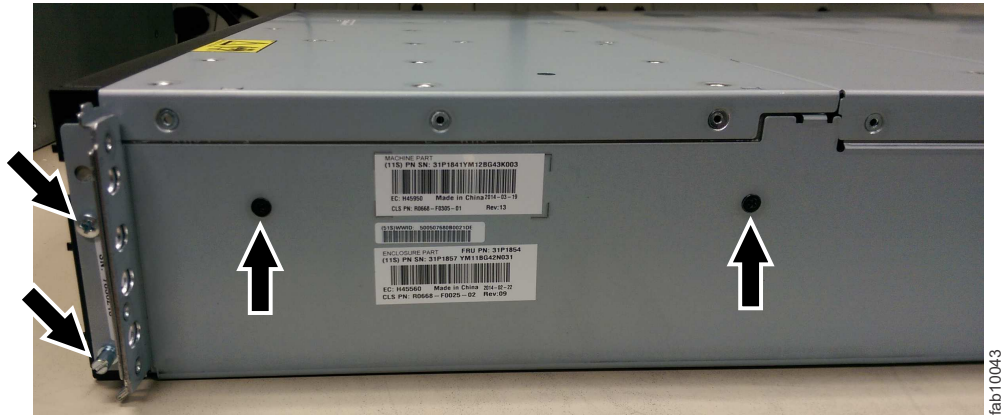
16. Turn the enclosure over again so that the top of the enclosure is facing upward and the front is facing towards you.
17. Remove the three screws and one screw-pin on the right side that secure the midplane assembly to the enclosure. Label each screw to indicate the removal location and place the screws aside. Figure 34 illustrates the location of the screws and screw-pin on the right-side of the enclosure.

Figure 34. Right-side enclosure screws

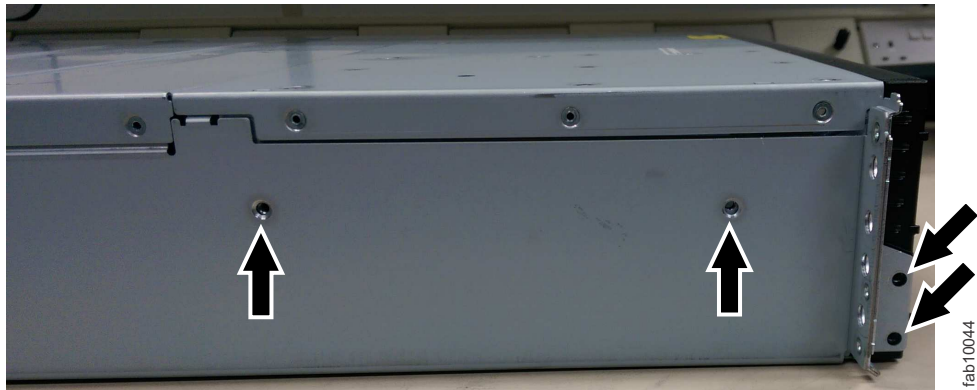
18. Remove the three screws and one screw-pin on the left side that secure the midplane assembly to the enclosure. Label each screw to indicate the removal location and place the screws aside. Figure 35 illustrates the location of the screws and screw-pin on the left-side of the enclosure.

Figure 35. Left-side enclosure screws

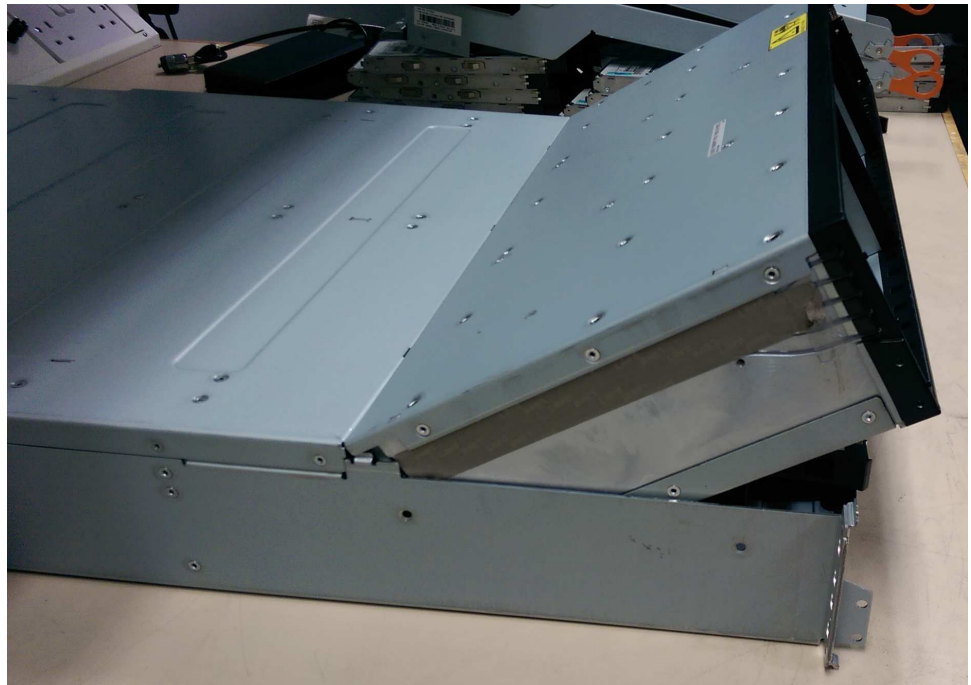
19. Remove the midplane assembly from the chassis by rotating up the midplane assembly to about 45°, then withdraw the midplane assembly from the front of the enclosure. Figure 36 on page 171 shows the midplane assembly at a 45-degree angle.

Figure 36. Angled midplane assembly

20. Unpack the replacement midplane assembly. Grasp the midplane assembly with two hands to hold the assembly at a 45° angle.
21. Insert the tabs on the midplane assembly into the tab holes in the enclosure and rotate down the front of the assembly.

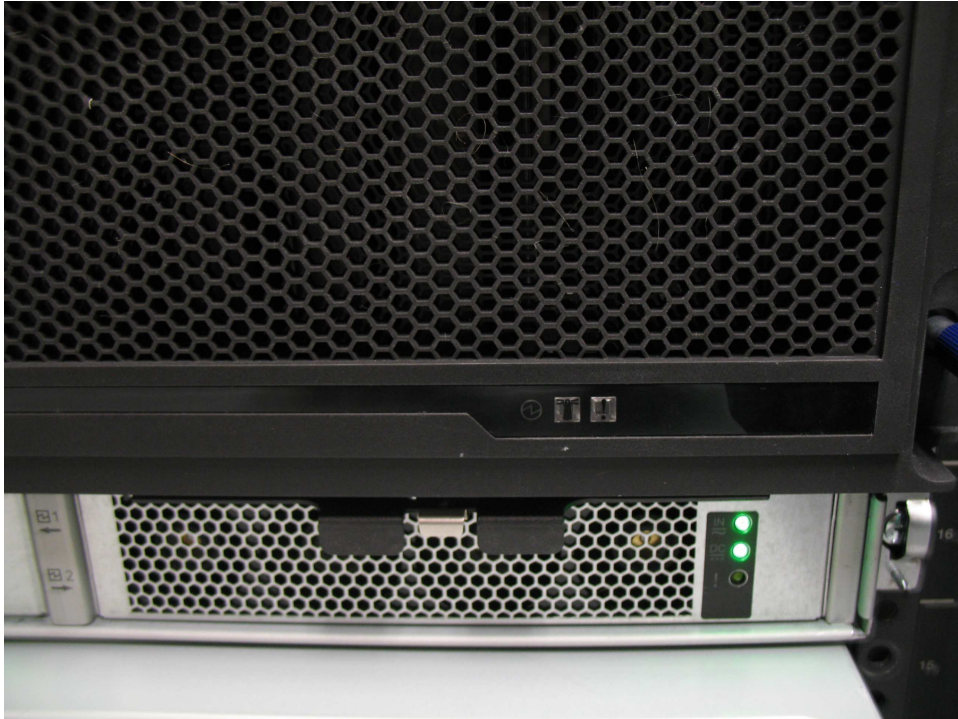
You must remove the bottom fascia to access and service either PSU. However, as Figure 71 on page 217 shows, you do not have to remove the front fascia.

Figure 71. Fascia removed from the PSUs

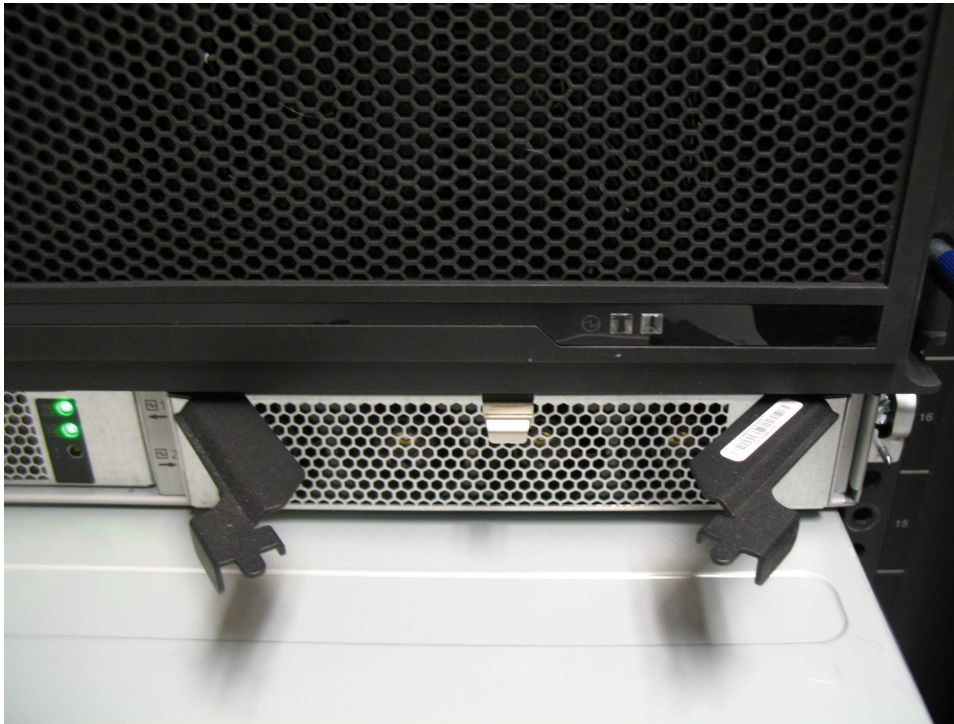
1. Read all safety information.
2. Remove the 1U fascia that covers the PSUs on the front of the expansion enclosure, as described in “Removing the fascia: 2076-92F” on page 214.
3. Press on the handle lock to release the handles on the PSU.
4. Rotate the handles outward, as shown in Figure 72.

*Figure 72. Releasing the power supply handles*

Each PSU provides cooling to the lower part of the enclosure. Ensure that the second PSU in the enclosure is powered on and operating correctly. For example, in Figure 72 on page 218, PSU 1 is operating while PSU 2 is being removed.

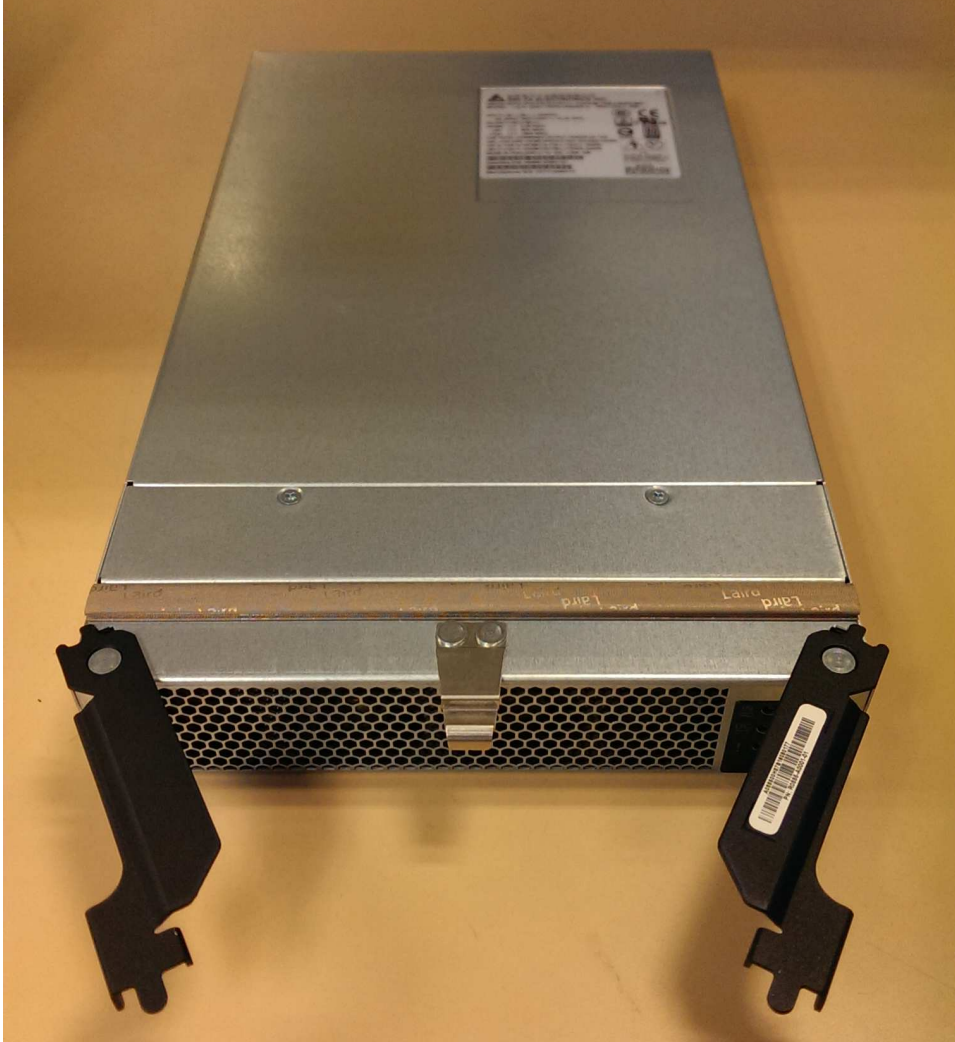
5. Carefully pull the PSU out of the expansion enclosure chassis and place it in a safe location, as shown in Figure 73 on page 219.

Figure 73. Removed power supply

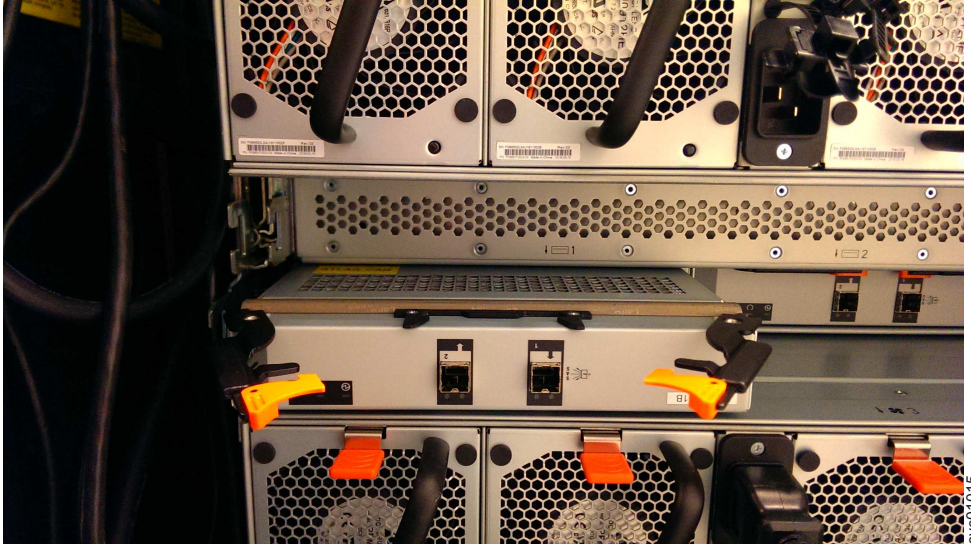
1. Read all safety information.
2. Locate the expansion canister to be removed.
3. Release the lower cable management arm to swing it out of the way, as described in “Moving the cable management arms” on page 201.
4. Remove the SAS cables from the expansion canister, as described in “Removing and installing a SAS cable: 2076-92F” on page 223.
5. Rotate the handles on the expansion canister outward, as shown in Figure 77 on page 223.

Figure 77. Removing the expansion canister

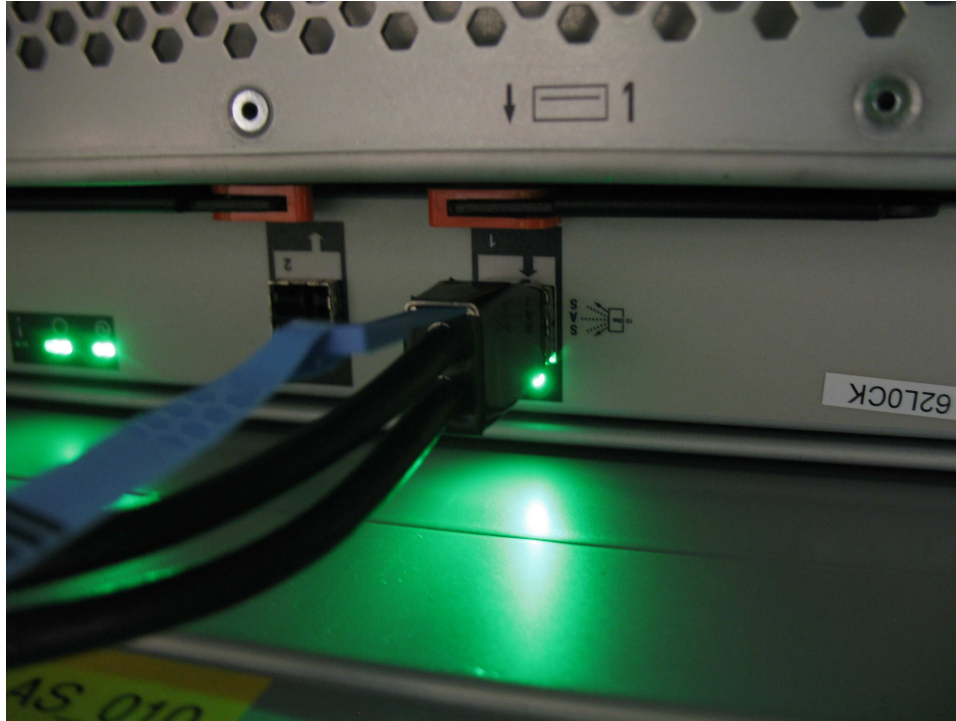
For example, Figure 80 on page 226 shows the LEDs of expansion canister 1 on a 2076-92F expansion enclosure. The SAS cable is successfully inserted in to port 1 (input); port 2 (output) does not contain a SAS cable.

Figure 80. SAS cable correctly inserted into the SAS port

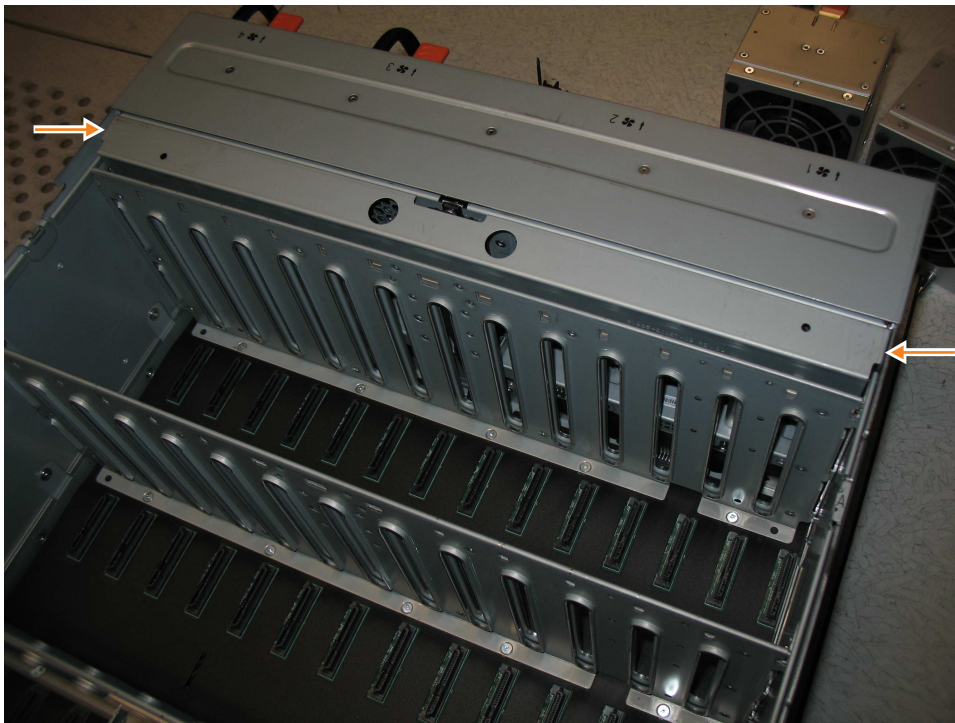
Figure 85. Location of the FIB cover

1. Using a cross head screwdriver, remove the narrow metal cover that is over the FIBs, as shown in Figure 85. The screws are on each side of the chassis. Place the cover and cover screws in a safe location.

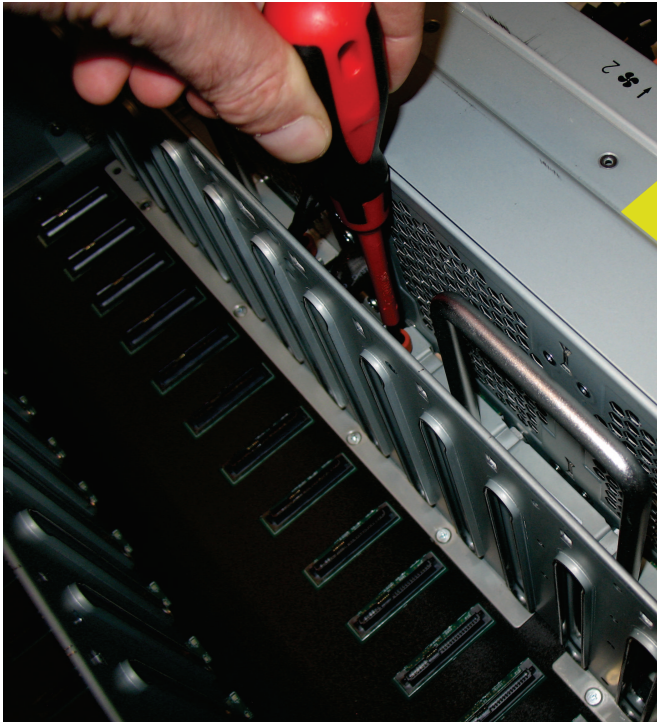
Figure 86. Loosen the FIB screws

2. Use a cross head screwdriver to loosen the retaining screws on the FIB, as shown in Figure 86 on page 230.

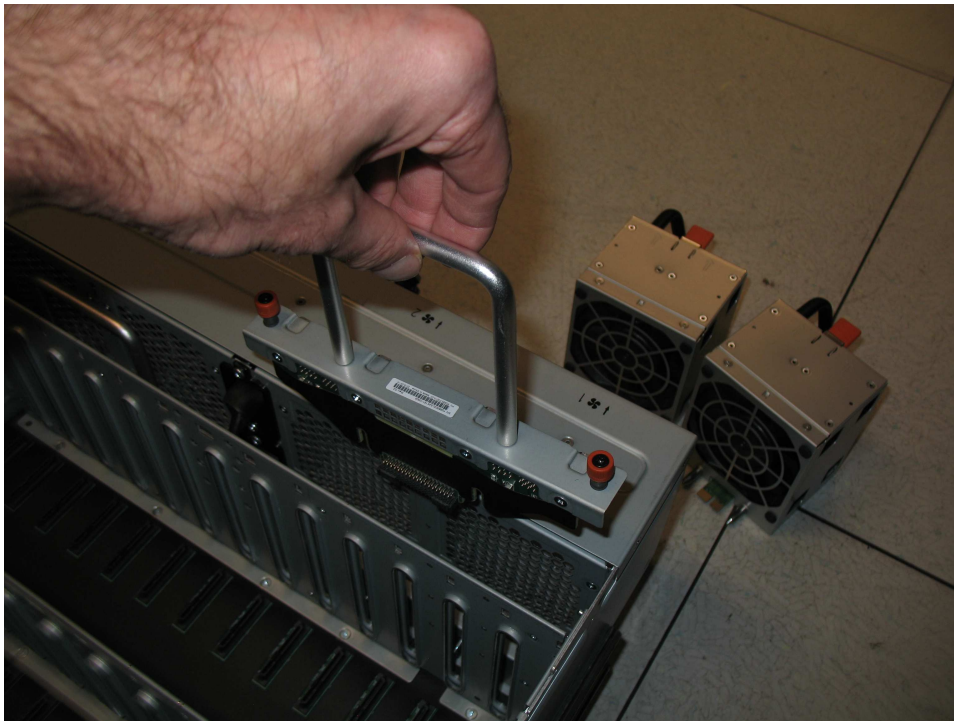
Figure 87. Remove the FIB from the chassis

3. Use the handle to pull the FIB out of the expansion enclosure chassis, as shown in Figure 87.

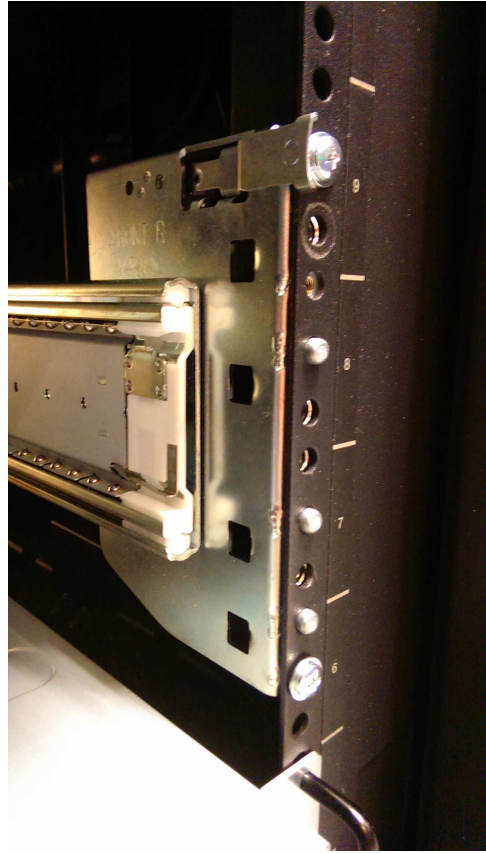
Figure 94. Example of the required rack space

For example, Figure 94 on page 235 shows the front of the rail that is attached to the frame.

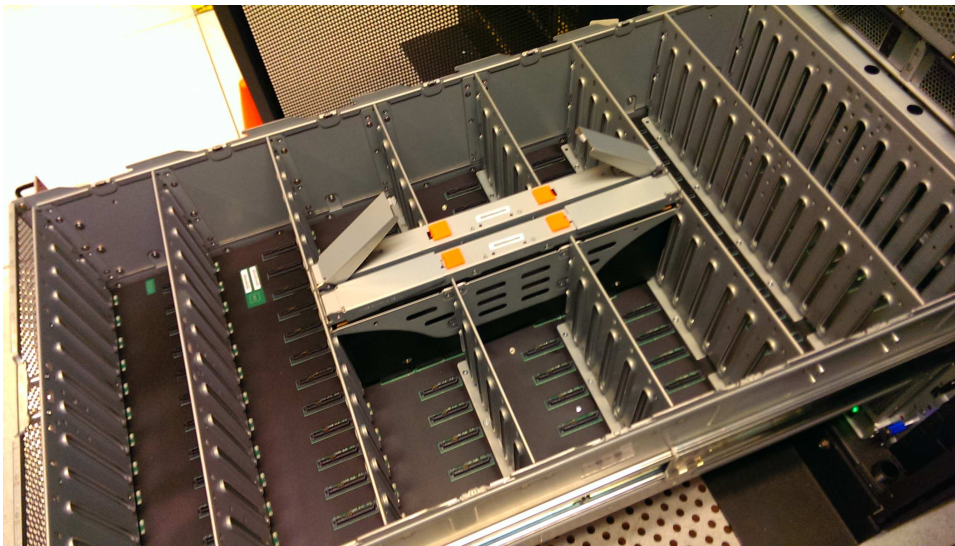
Figure 112. Location of secondary expander modules

The 2076-92F expansion enclosure contains two secondary expander modules, as Figure 112 shows. The secondary expander modules provide SAS connectivity between the expansion canisters and the drives. Each drive has 2 SAS ports. SAS port 1 of each drive is connected to secondary expander module 1. SAS port 2 of each drive is connected to secondary expander module 2. Each expansion canister is connected to both secondary expander module 1 and secondary expander module 2. If secondary expander module 2 is missing or is faulty, the expansion canisters can communicate only with SAS port 1 on each drive. Similarly, if secondary expander module 1 is missing or is faulty, the expansion canisters can communicate only with SAS port 2 on each drive.

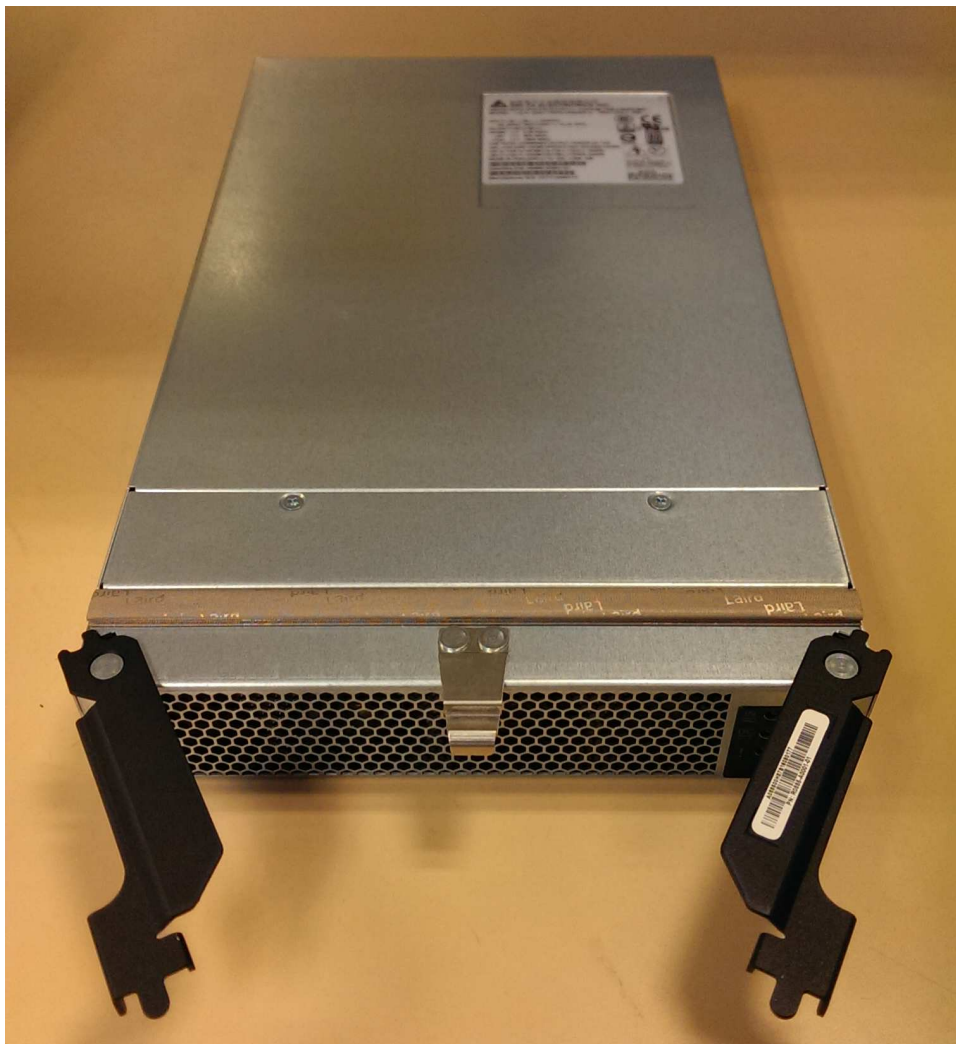
Figure 118. Preparing to install the power supply

1. Read all safety information.
2. Rotate the handles on the PSU outward, as shown in Figure 118.

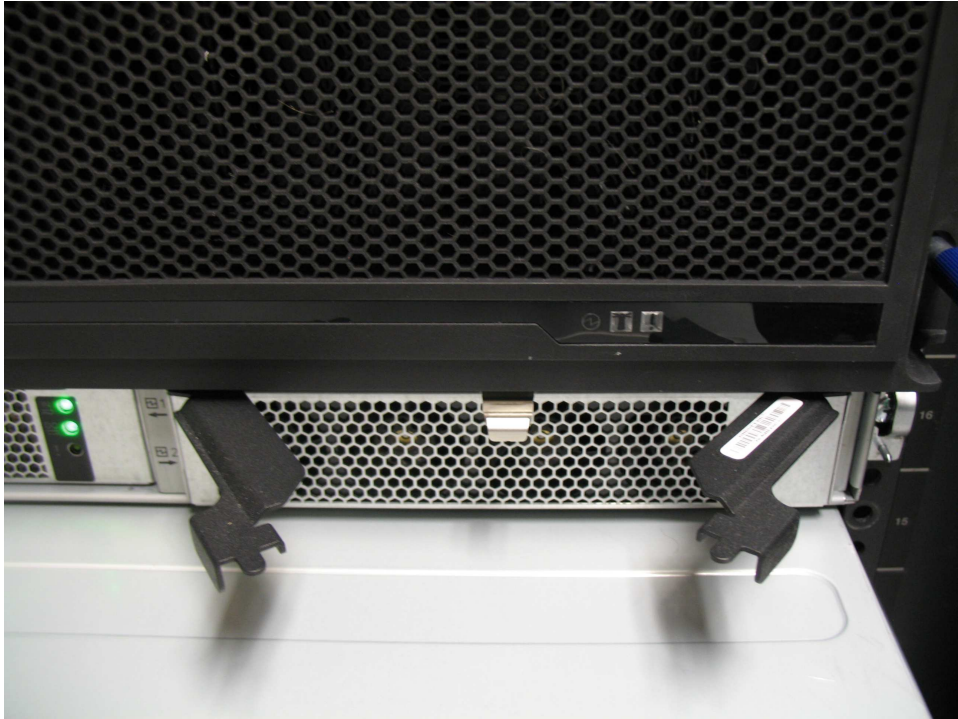
*Figure 119. Install the power supply*

3. Slide the PSU forward into the chassis until it clicks in to place, as shown in Figure 119 on page 255.

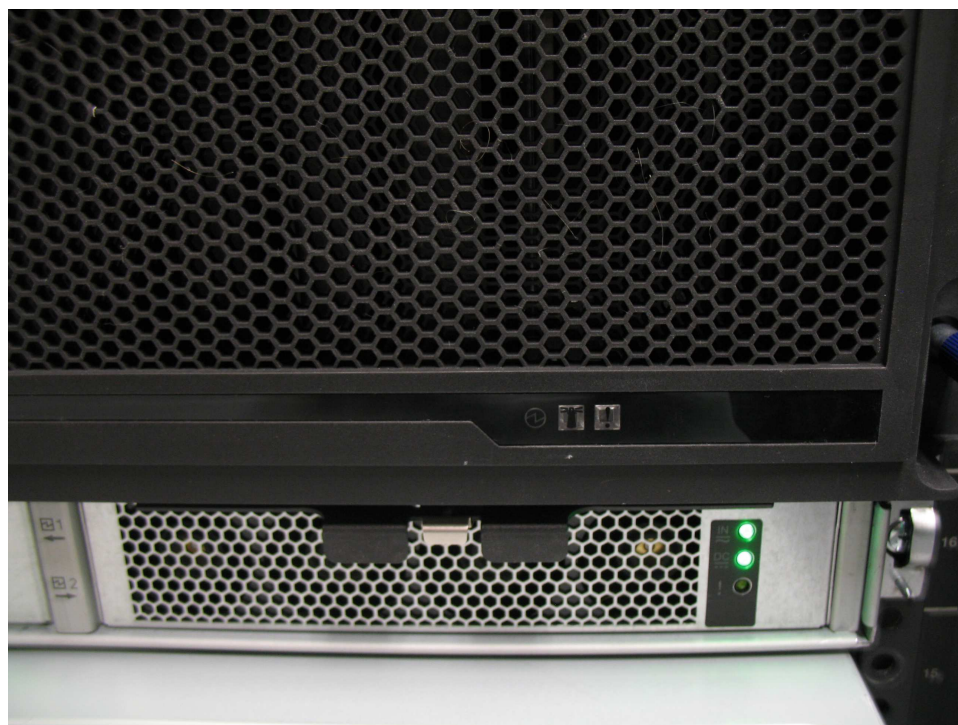
Figure 120. Power supply indicators

4. Close the handles on the PSU and ensure the handle lock clicks in to place.
5. Verify that the AC input and the DC power indicators are lit on the front of the PSU, as shown in Figure 120 on page 256.

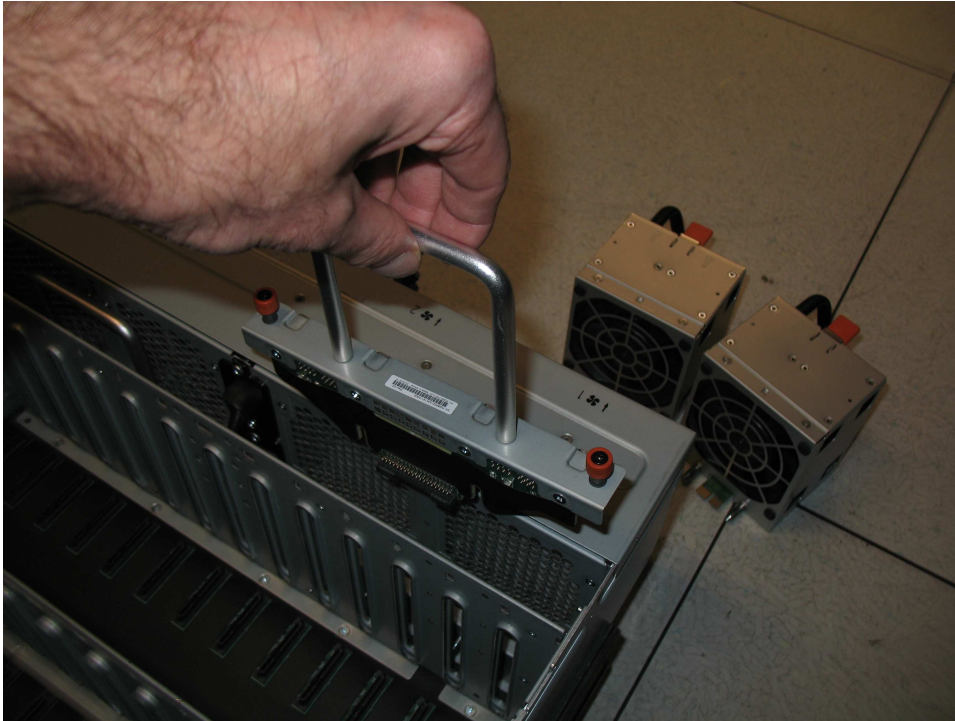
Figure 135. Insert the new FIB in the chassis

2. Carefully insert the new FIB into the expansion enclosure chassis, as shown in Figure 135 on page 267.

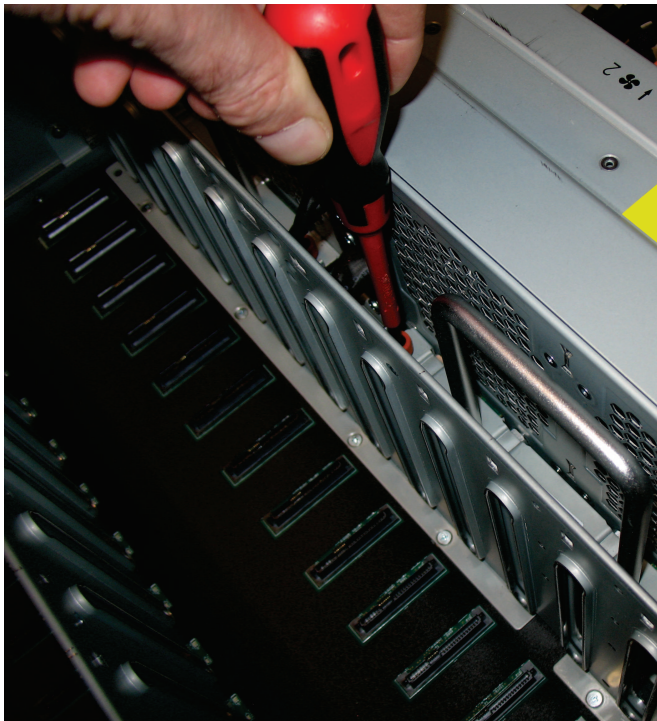
Figure 136. Secure the FIB to the drive board

3. Use a cross head screwdriver to tighten the retaining screws that secure the FIB to the drive board, as shown in Figure 136.

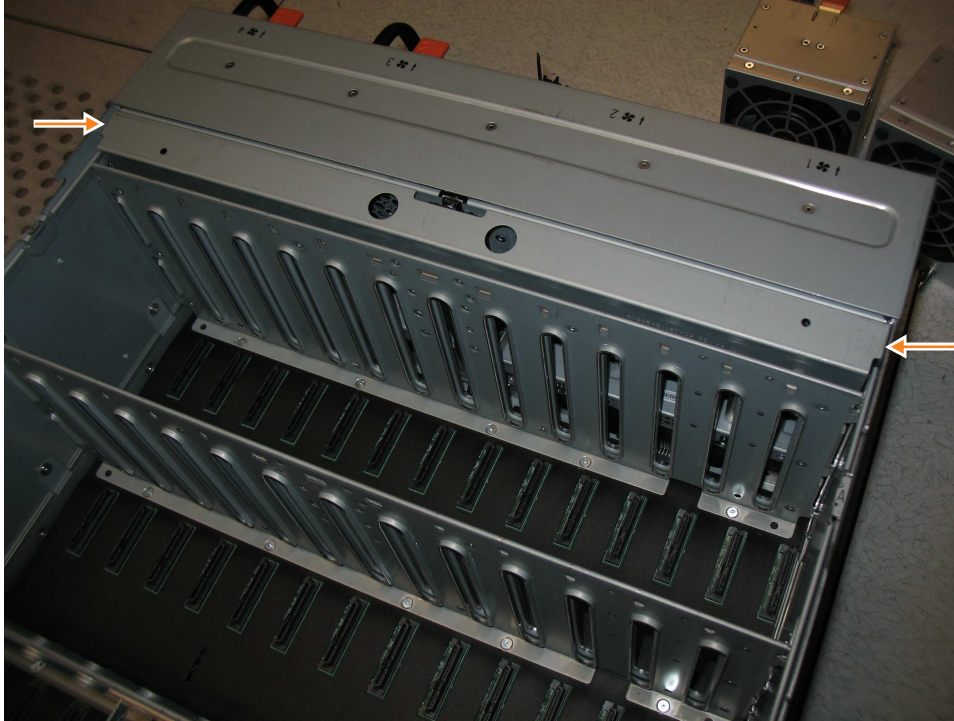
Figure 137. Replace the FIB cover

4. If needed, repeat steps 2 on page 266 and 3 on page 267 to replace the other FIB.
5. Replace the narrow metal cover, which is shown in Figure 137, over the FIB assemblies. The attachment screws are on each side of the chassis.
