Intel[®] Visual Compute Accelerator 2 (Intel[®] VCA 2)

Product Specification and Hardware Guide

A reference document for server OEMs providing an overview of product features, integration requirements, and validation guidelines.

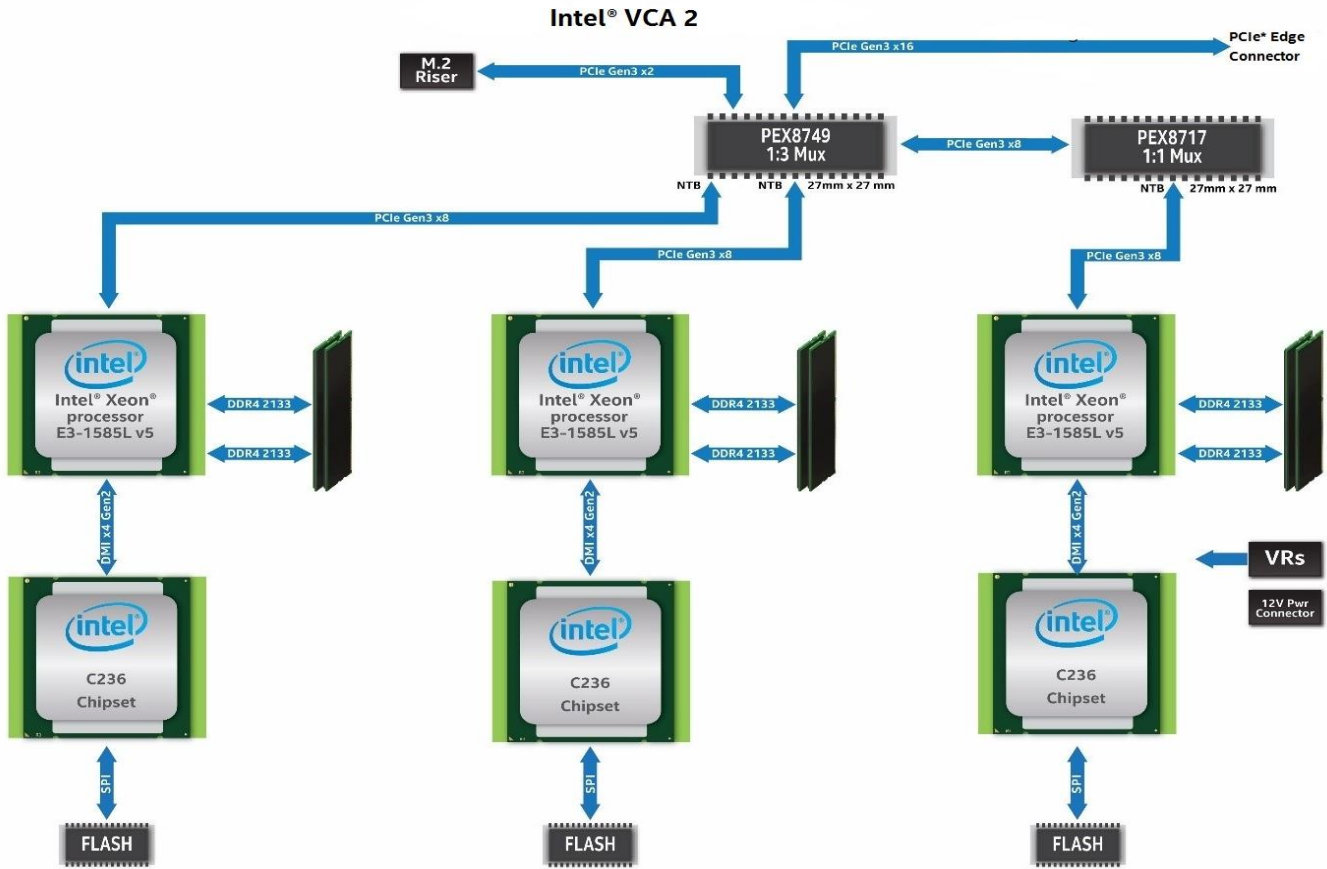
Figure 1. Product architectural block diagram

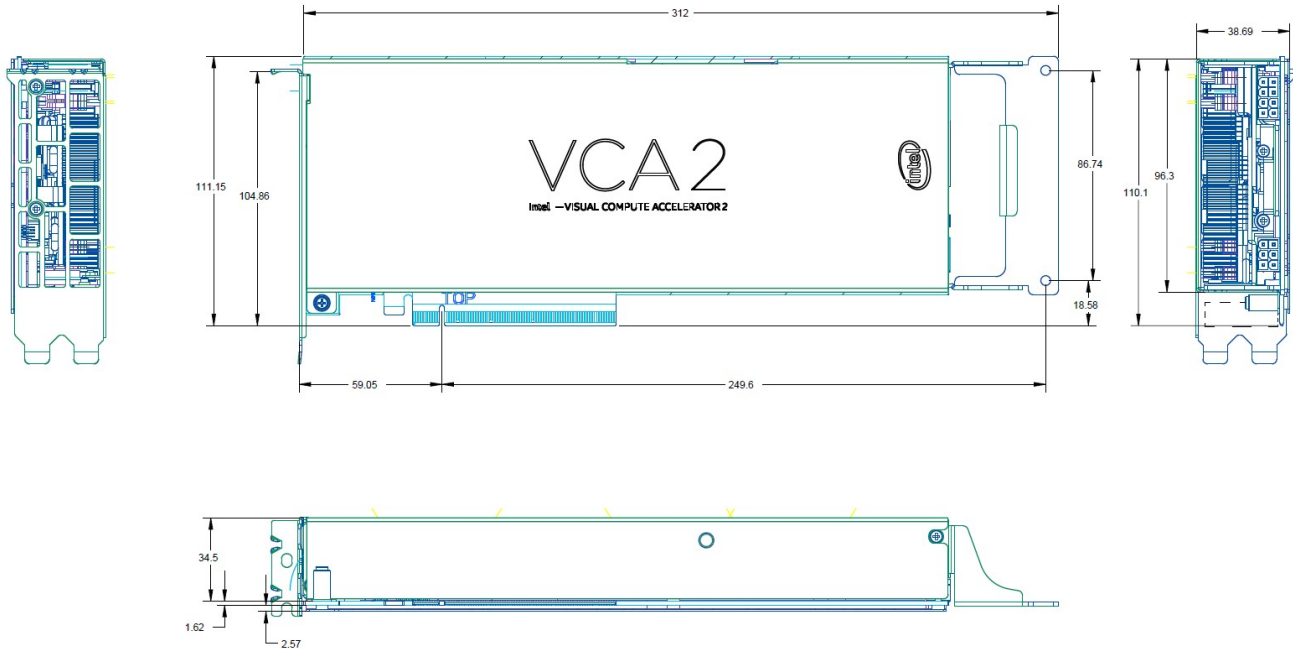
Intel® VCA 2 is a “near” full-length, full-height, double-width PCIe* 3.0 x16 add-in card. It includes a bracket that extends the card to full length for systems that fully support the PCIe specification.

Figure 2. Intel® VCA 2 dimensions

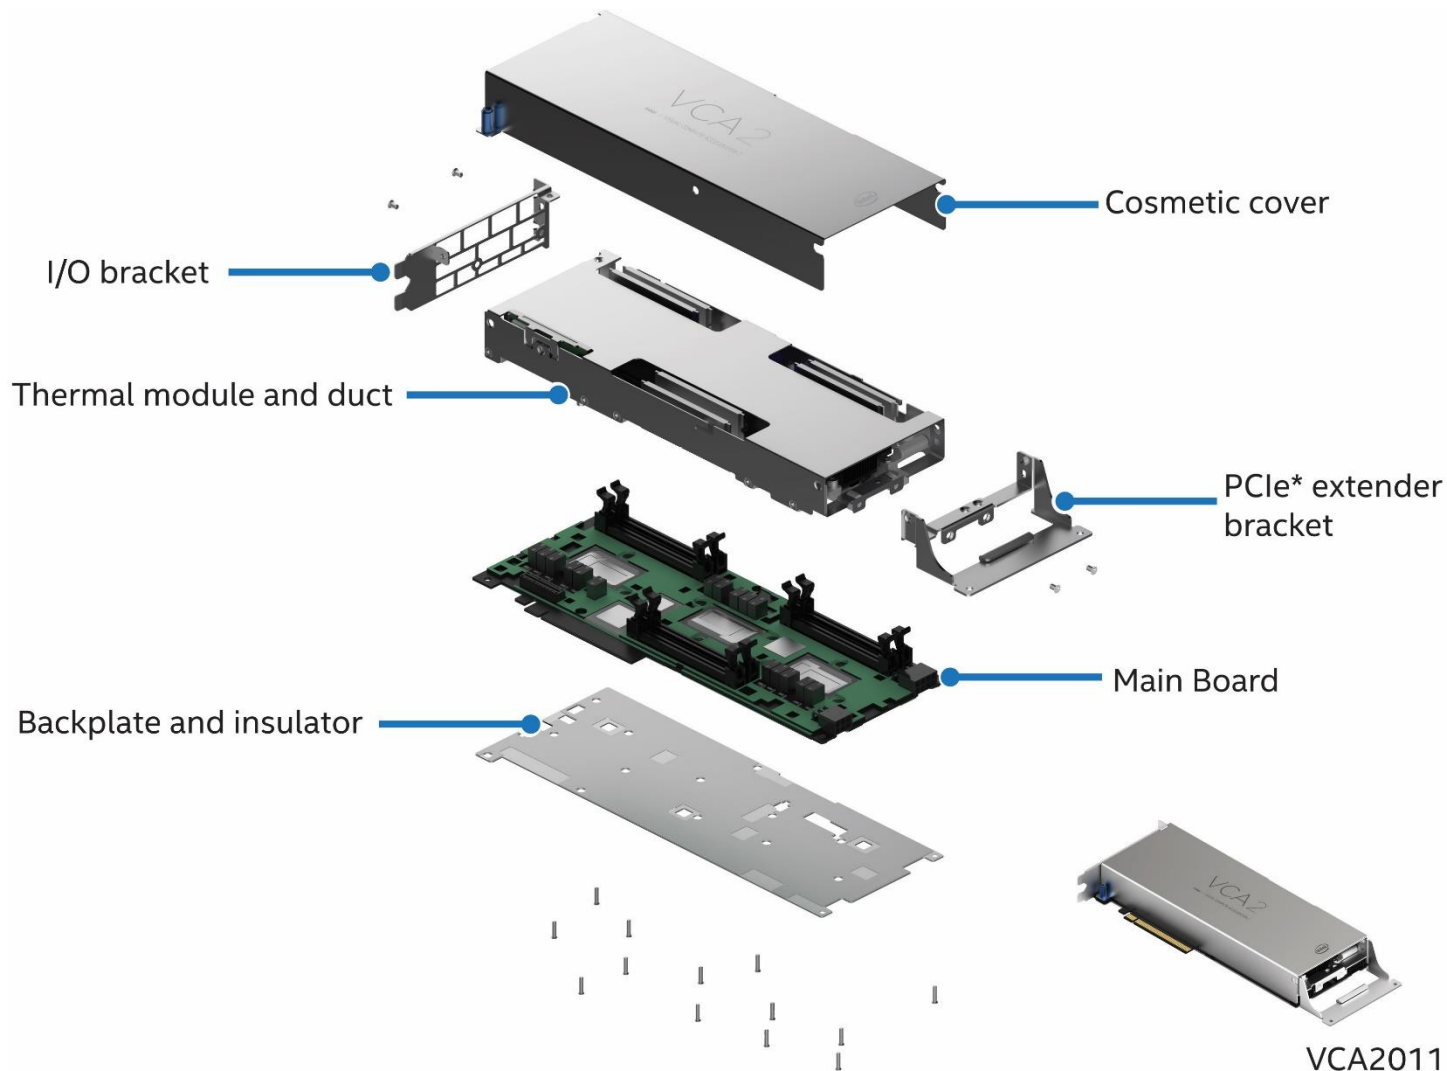
The Intel VCA 2 assembly consists of several detachable components to allow for card configuration and serviceability. Figure 3 displays the full card assembly.

Figure 3. Intel® VCA 2 detachable components

Advisory Note: Intel VCA 2 must have the provided mechanical support bracket (or other custom support bracket) mounted to the card to ensure proper support when installed in the system. Failure to properly support the installed card may cause serious damage should the system be exposed to any level of shock or vibration or is transported to the end user location.

When in operation, the card temperature will rise. The cosmetic cover, thermal module, and duct must be in place to allow for proper airflow over and through the card assembly. Failure to have the card covers installed results in overheating which may impact performance or proper operation of the card.

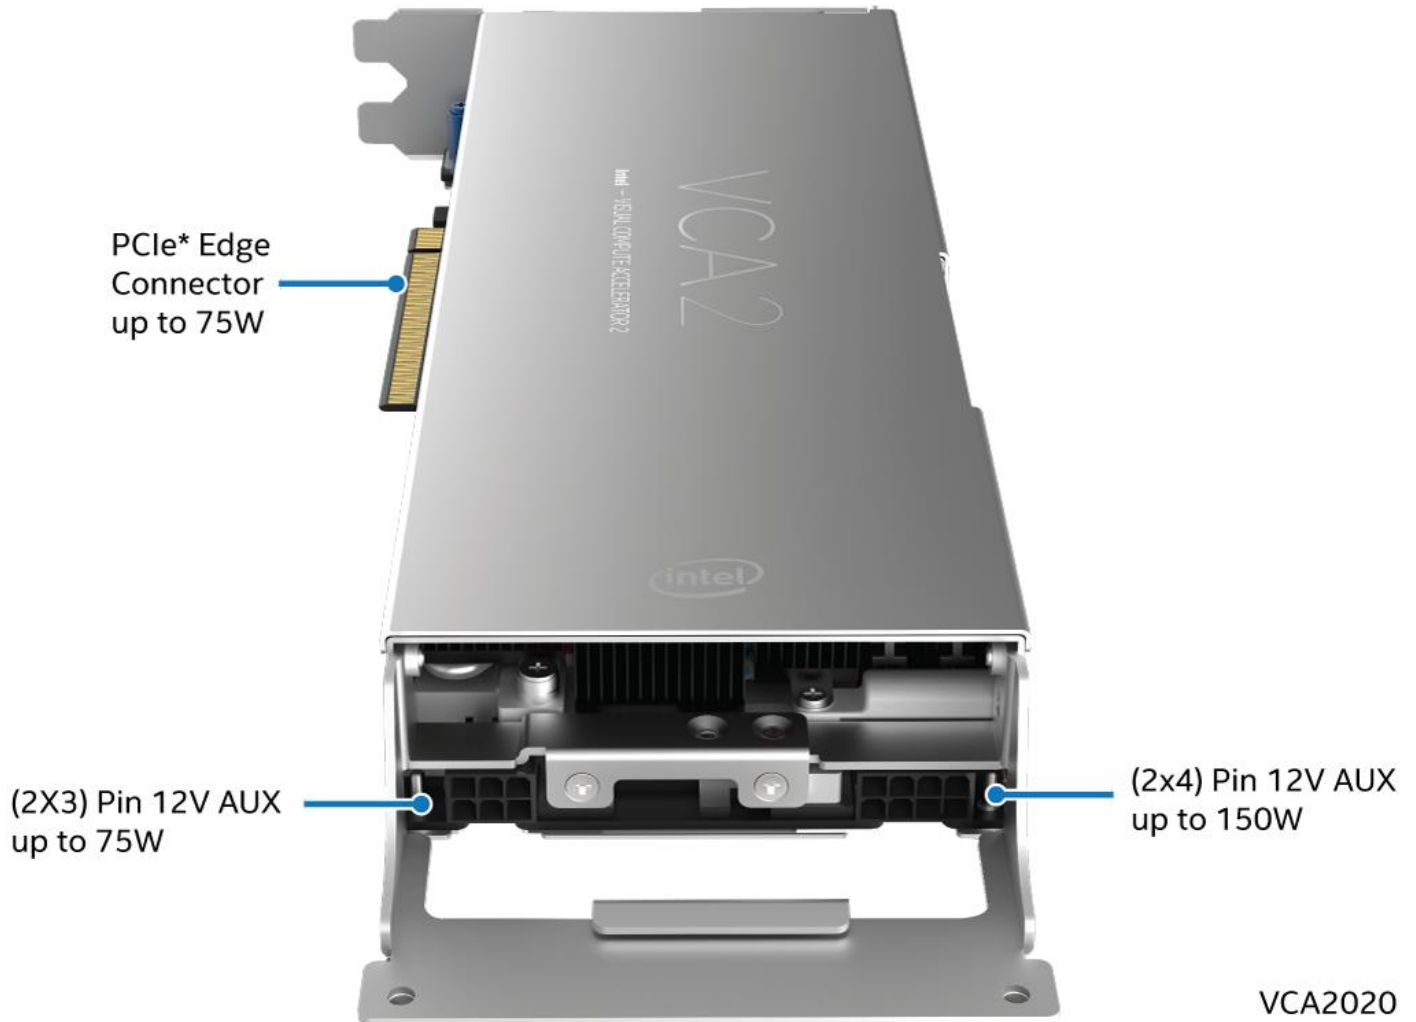
VCA2020

Intel VCA 2 has a maximum TDP of 235 W. per the PCIe specification, the PCIe x16 connector can support up to 75 W. The remaining power to the card must be supplied via the 2x3 (75 W) and 2x4 (150 W) 12 V AUX power connectors on the card as shown in Figure 6.

Figure 6. Intel® VCA 2 card power connectors

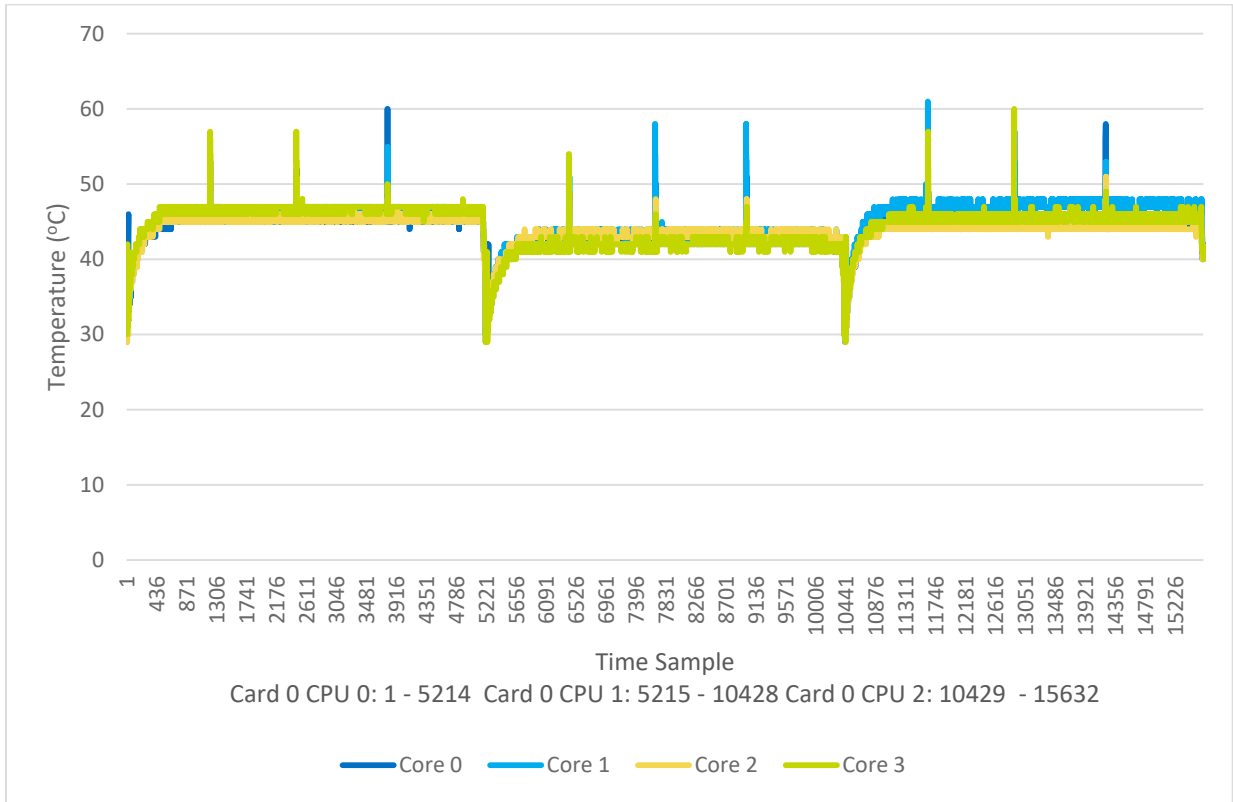
The temperature while booted in idle mode is ~35 °C. Temperature during workload is expected to reach ~60 °C. During transcoding workload, the script runs the load more times to ensure frame rate achieved is correct. Also longer input file is used during temperature profile. Temperature values from the VCA nodes are captured for every 10ms during the avc_benchmark script in a log file (avc_benchmark_temp_log.txt) and sorted along the Card and CPU in log file (avc_benchmark_sorted_temp.txt). Each VCA node has 4 cores and each core temperature is captured. If the average temperature is captured is higher than ~60 °C, the possible cause of temperature is CFM requirements may not be met. Check the fan settings in BIOS. For example, on Intel® Server Board S2600WT based systems, this can be enabled in BIOS setup by configuring the following two options on the PCI Configuration screen.

Figure 14. Temperature profile while transcoding

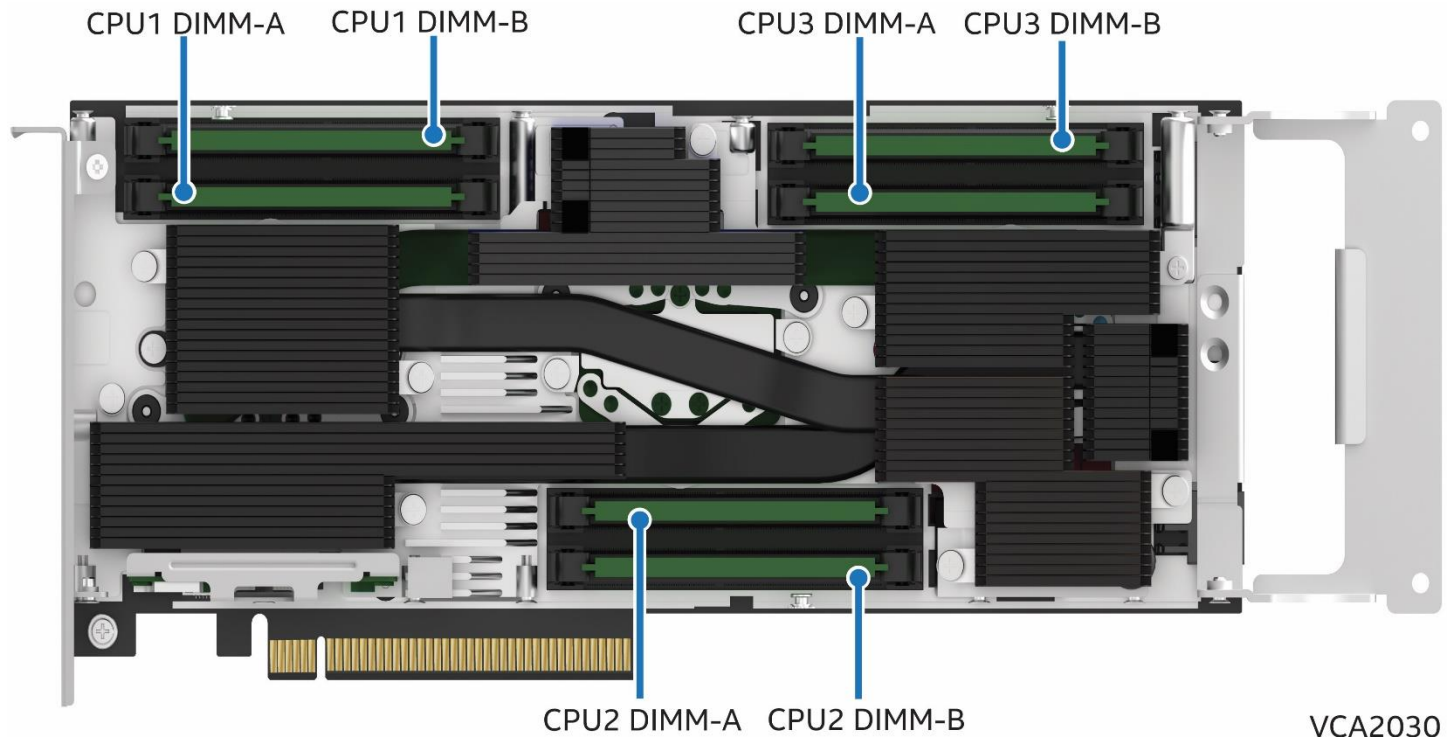
Intel® VCA 2 includes three processors identified as CPU 1-3. Each of the three processors includes two memory channels identified as A and B. Each memory channel supports one SODIMM socket. Each processor can support up to 64 GB of memory. Figure 15 below identifies the SODIMM sockets for each processor.

Figure 15. Intel® VCA 2 card DIMM slots

- All DIMMs must be DDR4 DIMMs.
- All processors must have at least one DIMM installed.
- To get better performance, it is recommended to install both DIMMs (e.g.: instead of 1 16GB DIMM, install 2 8GB DIMMS)
- DIMM slots for each processor must be installed in order, beginning with DIMM Slot A.
- When only one DIMM is installed for any given processor, it must be populated in the DIMM A slot.
