In the Matter of: Entergy Nuclear Operations, Inc.
(Indian Point Nuclear Generating Units 2 and 3)

SUBJECT: Entergy Nuclear Operations Inc.
Indian Point Nuclear Generating Unit Nos. 2 & 3
Docket Nos. 50-247 and 50-286
Amendment 3 to License Renewal Application (LRA)

Based on discussion with the NRC Staff on 12/4/07 and industry discussion with the NRC Staff on 12/12/2007 and 1/30/2008, the response to this RAI provided in Entergy Letter NL-07-138, Dated 11/16/2007 is being revised. The only section that requires revision is LRA Figure 2.5-2 and associated discussion.

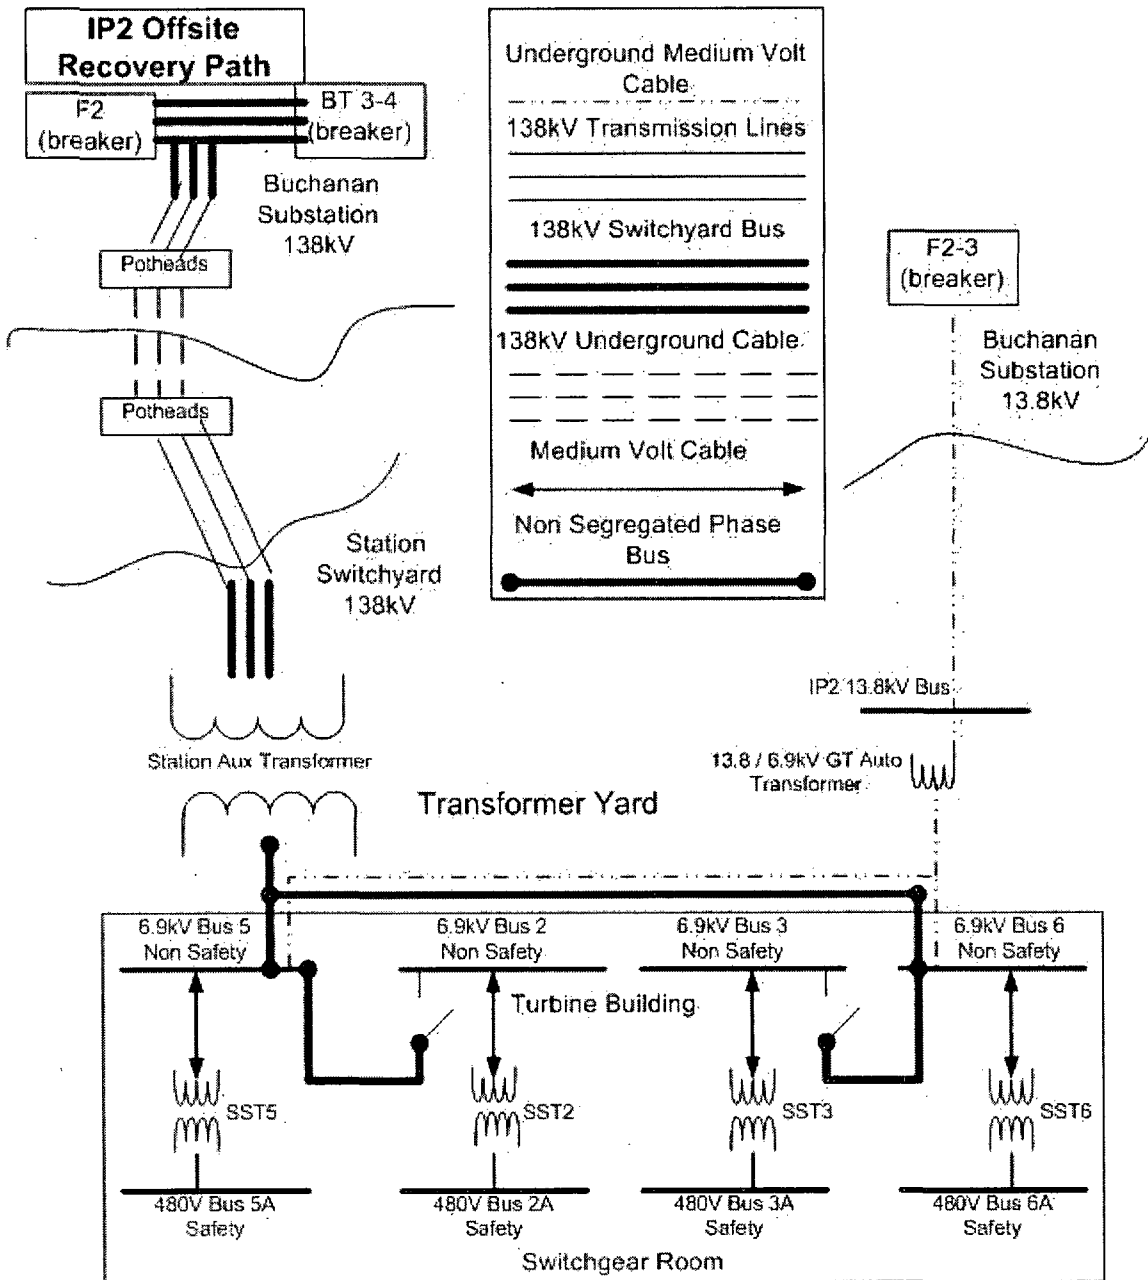
Figure 2.5-2
IP2 Offsite Power Scoping Diagram

As shown in the revised LRA Figure 2.5-2, the 6.9 kV buses receive offsite power from either the 138 kV / 6.9 kV station auxiliary transformer or the 13.8 kV / 6.9 kV GT autotransformer. The station auxiliary transformer is connected to the 138 kV Buchanan substation, the primary offsite power source, via switchyard bus, overhead transmission conductors, and underground transmission conductors through ~~motor-operated disconnect F3A~~ switchyard breakers F2 and BT 3-4, which ~~is~~ are located at the Buchanan substation. The GT autotransformer is connected to the 13.8 kV Buchanan substation, the secondary offsite power source, via underground medium voltage cable through breaker F2-3, which is located at the Buchanan substation.
