UNITED STATES
NUCLEAR REGULATORY COMMISSION
WASHINGTON, D. C. 20555

SUBJECT: MEETING ON PHILIPPINES NUCLEAR POWER PLANT (PNPP),
BETHESDA, SEPTEMBER 18, 1979

POSITION PAPER NO. 2 OF NSSEEP

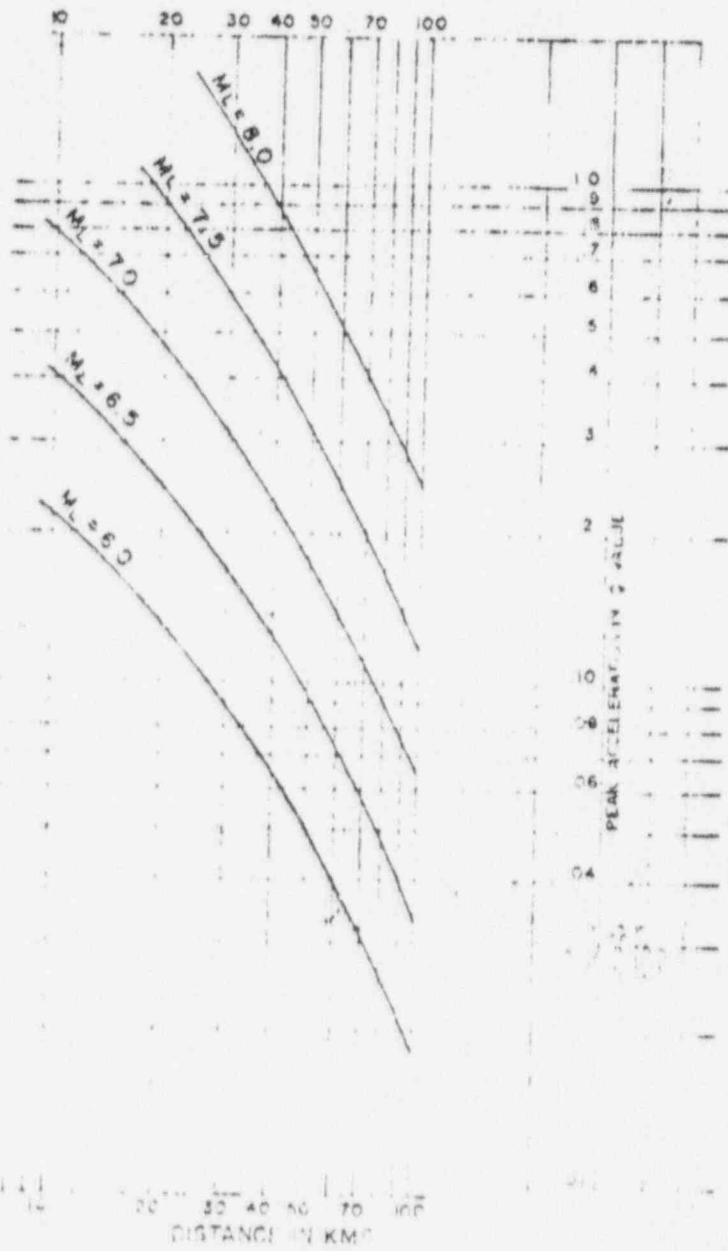
Figure 1 (NSSEEP)

Attenuation Curves Philippine Seismicity

$A = 0.01g = 3.19 + 1.27 ML - 2.095 \ln(R + r_0)$
 ML = local magnitude, R = distance in km, $r_0 = 30$ km.

and submit that these curves are more reliable and applicable.
Figure 1 NSSEEP.

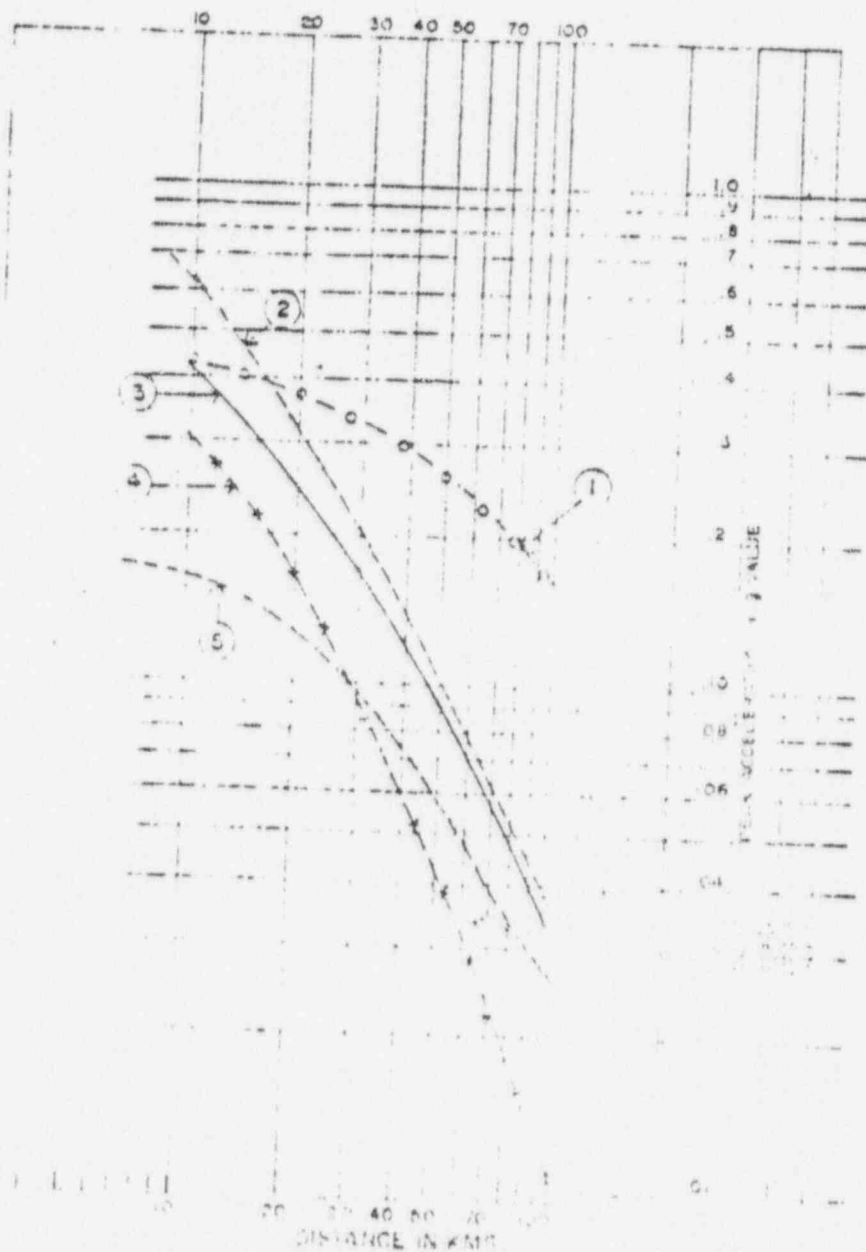
Comparison of attenuation curves for magnitude 6.5.
 All curves taken from U.S. National Bureau of Standards, Building Science
 Series 40, "Engineering Practices for Disaster Mitigation," p. 23. "Except Philippine
 Su-Hizon, for magnitude 6.5. Low risk curves are used, not as
 high risk curves, and certainly not upper risk curves. Geology,
 and other factors, were used to, modify the

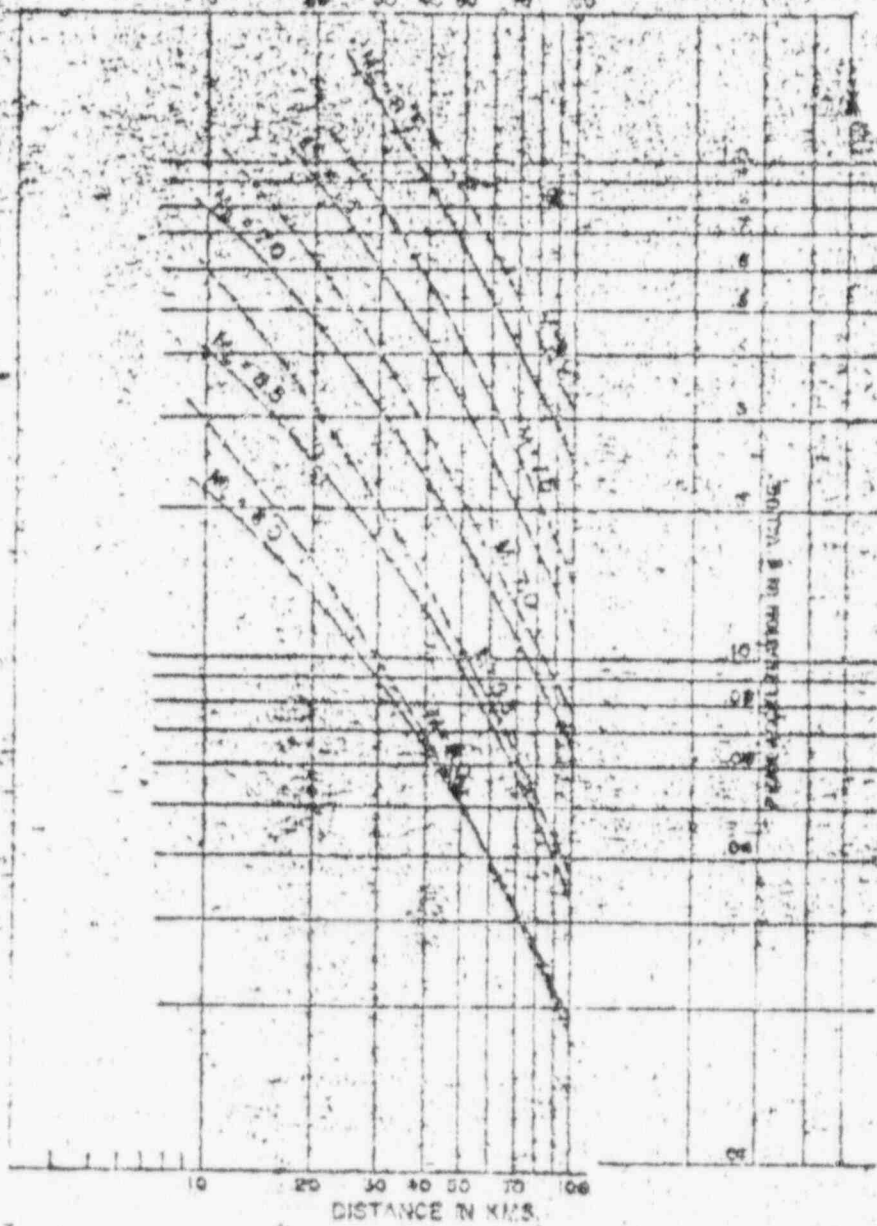
COMPARISON OF ATTENUATION CURVES:

Kandai (California and Japanese Earthquakes)

Manila Observatory (Philippine Earthquakes)

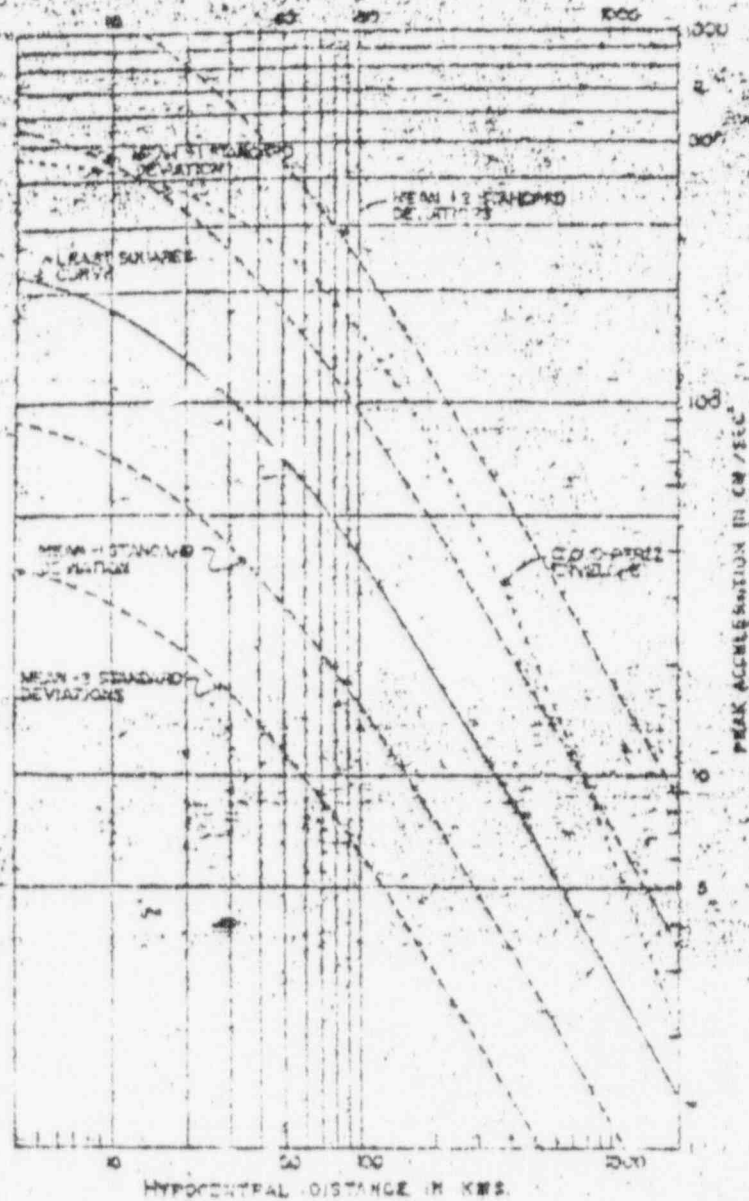
Figure 5 (INSSEEP)

PEAK GROUND ACCELERATION
IN TERMS OF DISTANCE FROM CAUSATIVE FAULT

WORLDWIDE SET OF 518 STRONG MOTION RECORDS
WITHOUT NORMALIZATION OF MAGNITUDE

There is presented herewith Neville C. Donovan curves taken from "Earthquake Hazards for Buildings" from previously cited "Building Practices for Disaster Mitigation" p. 39, Figure 5 (NSSEEP).
