NEW CAR ASSESSMENT PROGRAM LANE DEPARTURE WARNING CONFIRMATION TEST NCAP-DRI-LDW-22-02

2022 Ford Escape PHEV FWD

DYNAMIC RESEARCH, INC. 355 Van Ness Avenue, STE 200 Torrance, California 90501

Final Report

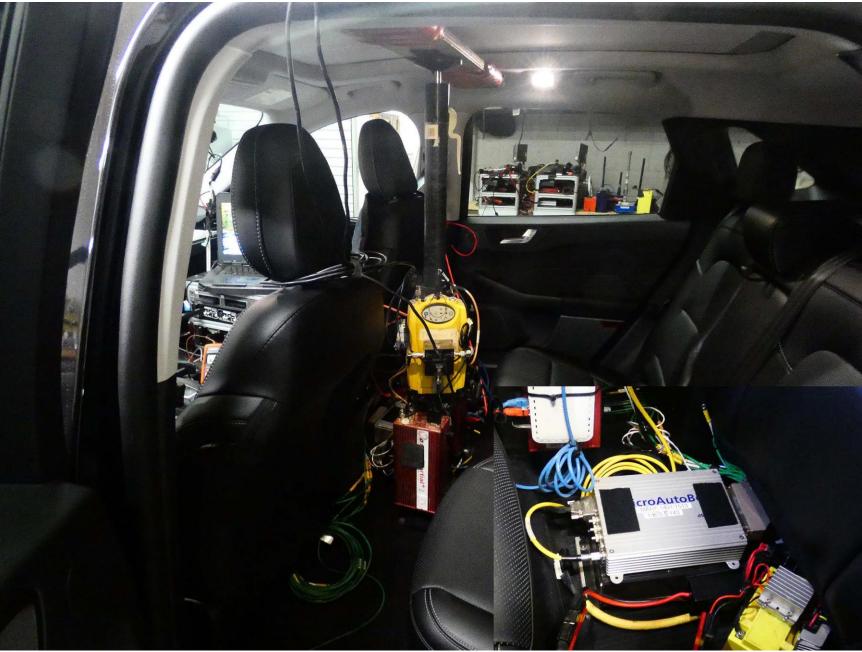
Figure A6. DGPS, Inertial Measurement Unit, and MicroAutoBox Installed in Subject Vehicle

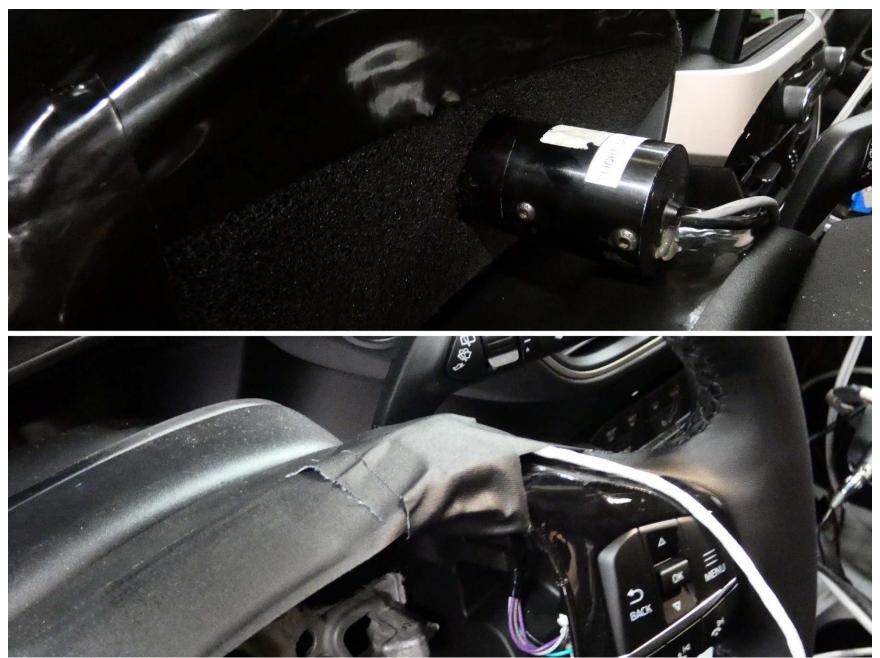
Figure A8. Sensors for Detecting Visual and Haptic Alert

The LDW system alerts the driver with a visual and haptic alert. The visual alert is displayed in the instrument panel and consists of an image of two white lane lines. When LDW activates, the lane line corresponding to the side in which the vehicle crossed turns red. The haptic alert consists of a steering vibration with an approximate frequency of 21 Hz.

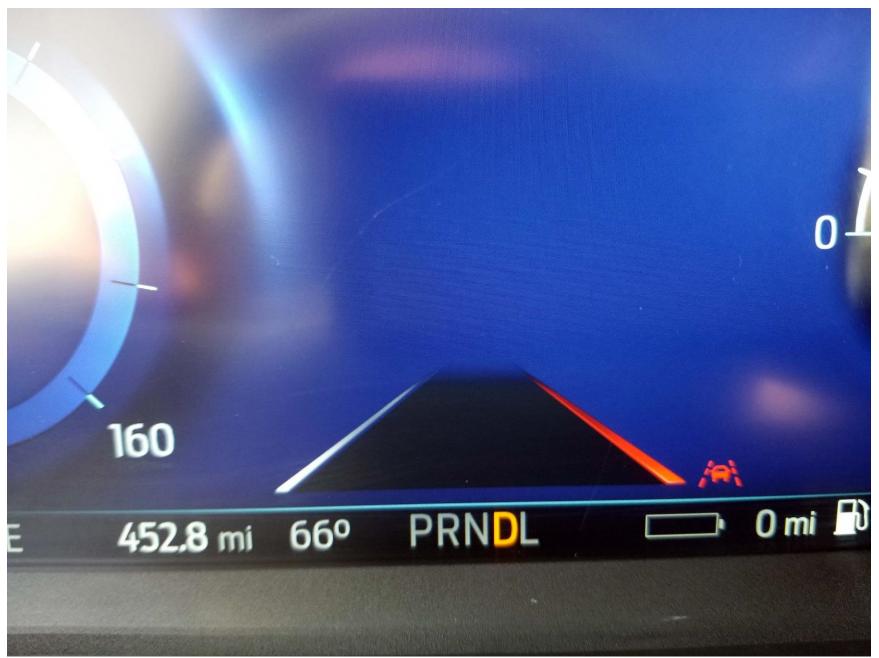
Figure A9. Visual Alert

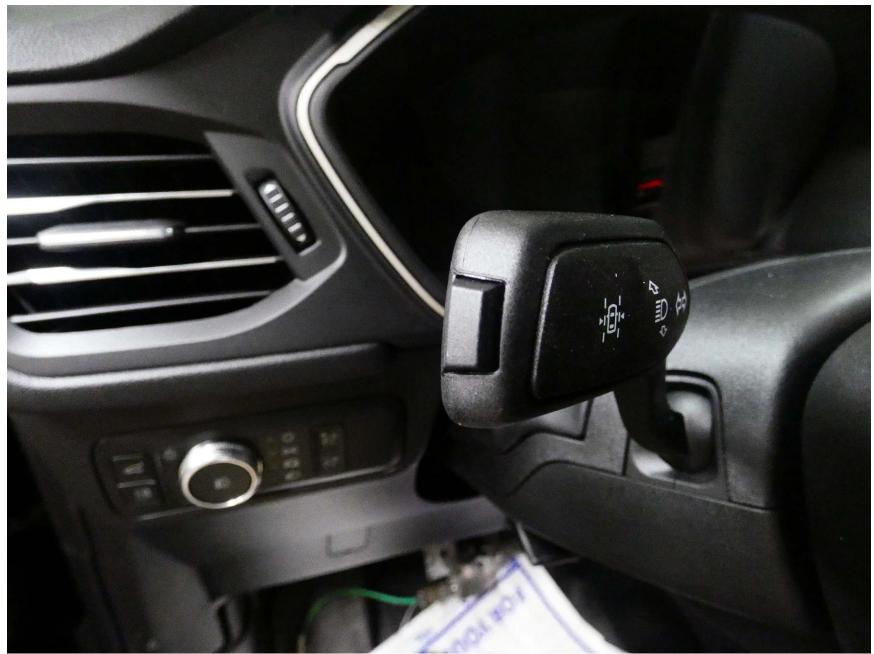
Figure A10. LDW System On/Off Button

The LDW system can be turned on/off using the button located on the lever on the left-side of the steering wheel column.
