Recall 1017E – Fuel Leak at Fuel Pump Discharge Pipe:

(Note: Recall 1017E replaces previous recall 0516J)

SUBJECT VEHICLES

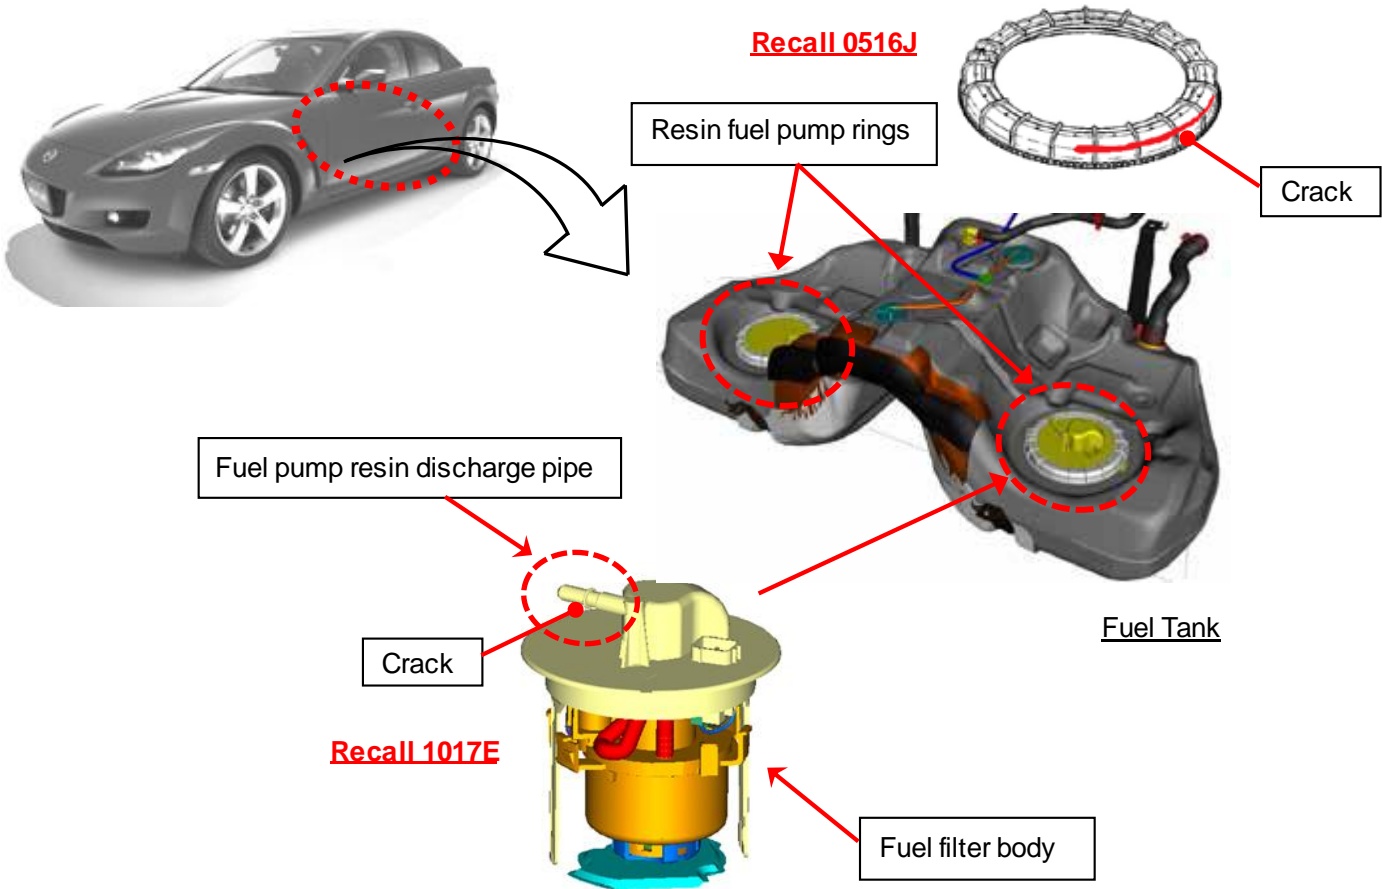
Due to insufficient heat insulating performance, the resin fuel pump rings, which are located on the top surface of the fuel tank, may deteriorate by heat from the engine and exhaust pipes. Continuous use of the vehicle may allow the deterioration to progress, leading to a crack in the fuel pump rings and subsequent fuel leak, which may increase a risk of fire.

Due to insufficient durability of the resin discharge pipe of fuel pump, the discharge pipe may deteriorate, affected by the pressure of fuel inside the pipe and by heat from the engine and exhaust pipe. Continuous use of the vehicle may allow the deterioration of discharge pipe to progress, leading to a crack in the discharge pipe and subsequent fuel leak, which may increase a risk of fire.
