Kalamazoo**VALLEY** community college

FY 2023 - 2027 Facilities Master Plan

SEPTEMBER 30, 2021

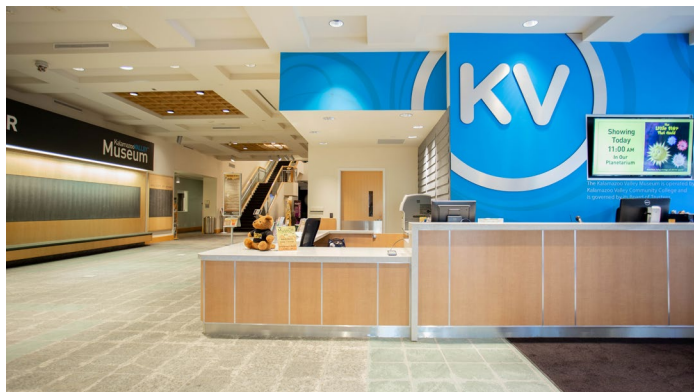
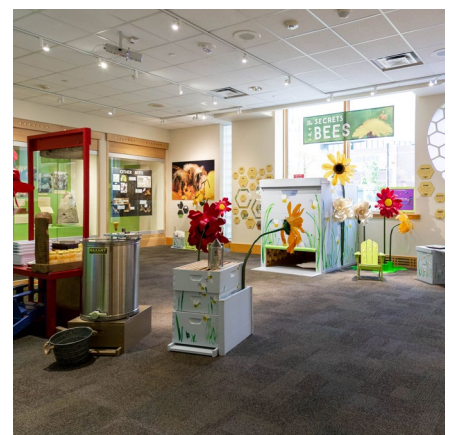
The Universe Theater and Planetarium was a state-of-the-art facility in 1998, and is still very much regarded as being top-of-the-line. Its attendance is the largest of any given program that the museum puts on each year. The domed planetarium seats 109 occupants. It is used for a variety of multi-media programs and features a Digistar projection system. A major upgrade to projection, sound and lighting was completed in November 2016.

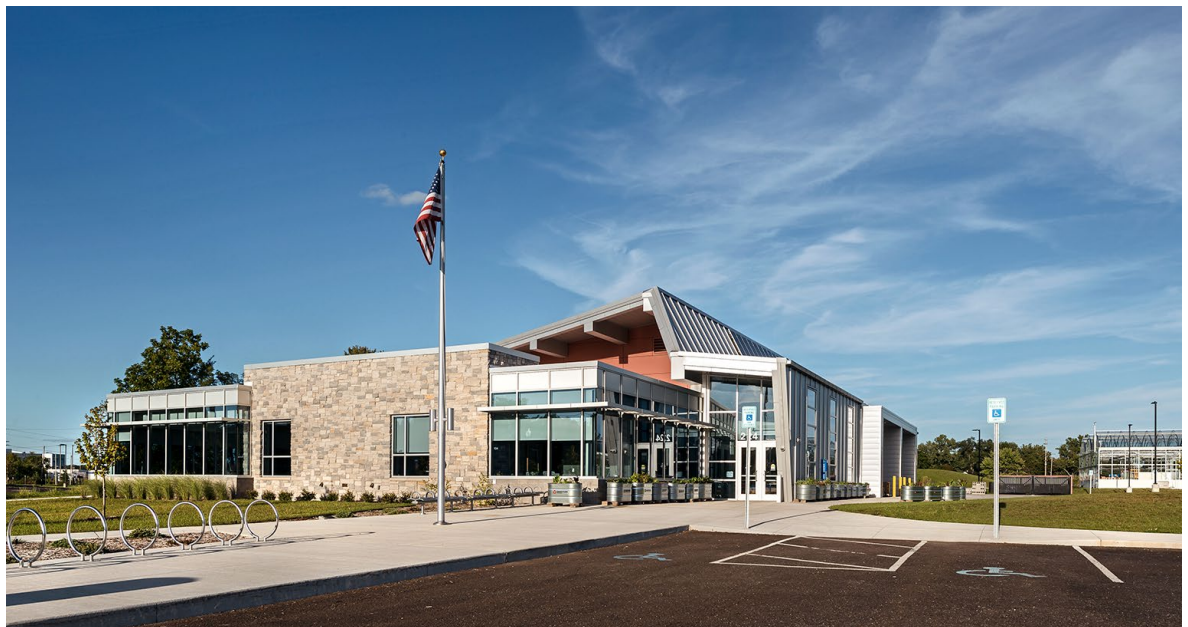
Exterior Materials: The exterior walls of the building are clad in insulated metal panel, stone veneer and decorative concrete masonry units. The dynamic roof form is clad with an insulated metal panel. Consideration should be given to providing an enclosed central receiving area separate from the food processing zone.

Window and Glazing Systems: The glazing systems include aluminum-framed curtain wall and entrances. Large curtain walls are located at the entries and around the "A" Wing. The entrances to the building are aluminum-framed, featuring wide stile units with power operators for barrier-free accessibility. The administrative offices in the "A" Wing and the "B" and "C" Wings have fixed punched openings for windows. All systems are clear anodized, thermally broken aluminum frames with tinted, insulated glazing

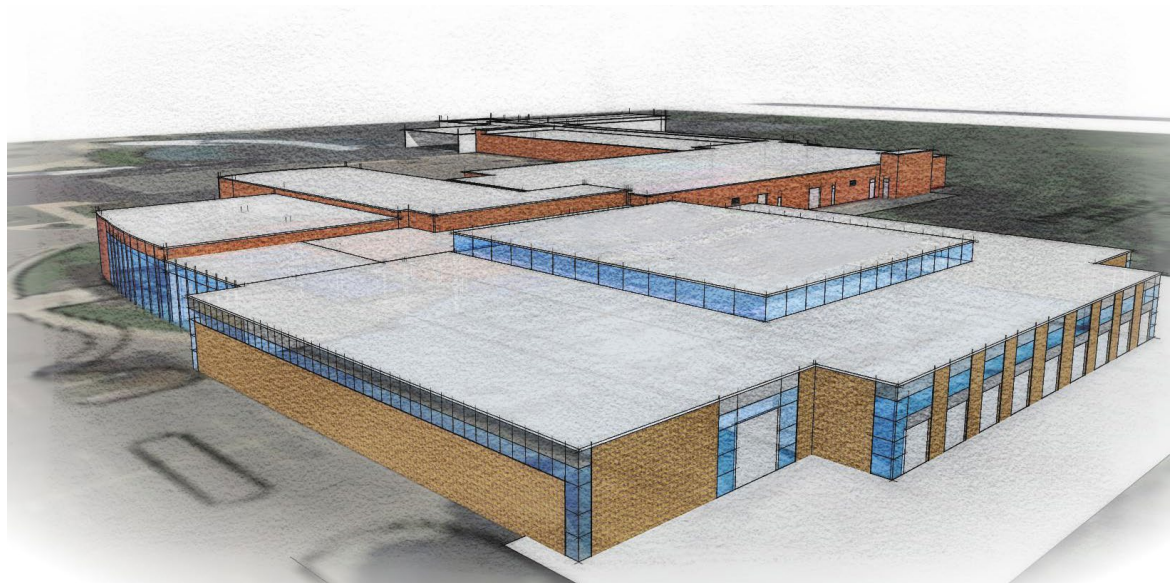
The proposed plan for addressing program growth is centered around a major addition (approximately 38,000 square feet) to serve the Auto Tech program. Proposed to be located at the southwest corner of the Texas Township facility, the new addition will provide an increased number of vehicle repair labs, unit labs and classrooms. The space will be designed to support education in emerging technologies, such as autonomous vehicle repair.

The new addition will open up existing space for reshuffling and renovation to many of the technology program spaces. As part of the reshuffling of space, synergies will be emphasized between programs allowing for greater collaboration within the advanced technology community. Classroom spaces will be located to provide greater access of use by all technology programs.

Expanded lab spaces for HVAC technology will provide dedicated space for HVAC repair and an independent space for hydronic technology instruction. Electrical technology space improvements will address growth within that program. The metallurgy lab will be relocated to provide better adjacency to the Machine Tool program space that was recently expanded to address their program demand. The welding lab will be renovated to provide better workflow and material flow. Computer Information Systems (CIS) will be relocated to the technology wing to provide better opportunities for collaboration with many of the technology programs.
