DEVELOPMENT OF A BRAZING PROCESS FOR
Cb-1Zr HEAT RECEIVER TUBES

FINAL REPORT
DEVELOPMENT OF A BRAZING PROCESS FOR
Cb-1Zr HEAT RECEIVER TUBES

CONTRACT NAS3-10603

SPACE POWER SYSTEMS DIVISION
NASA LEWIS RESEARCH CENTER
CLEVELAND, OHIO
PAUL E. MOORHEAD, PROJECT MANAGER

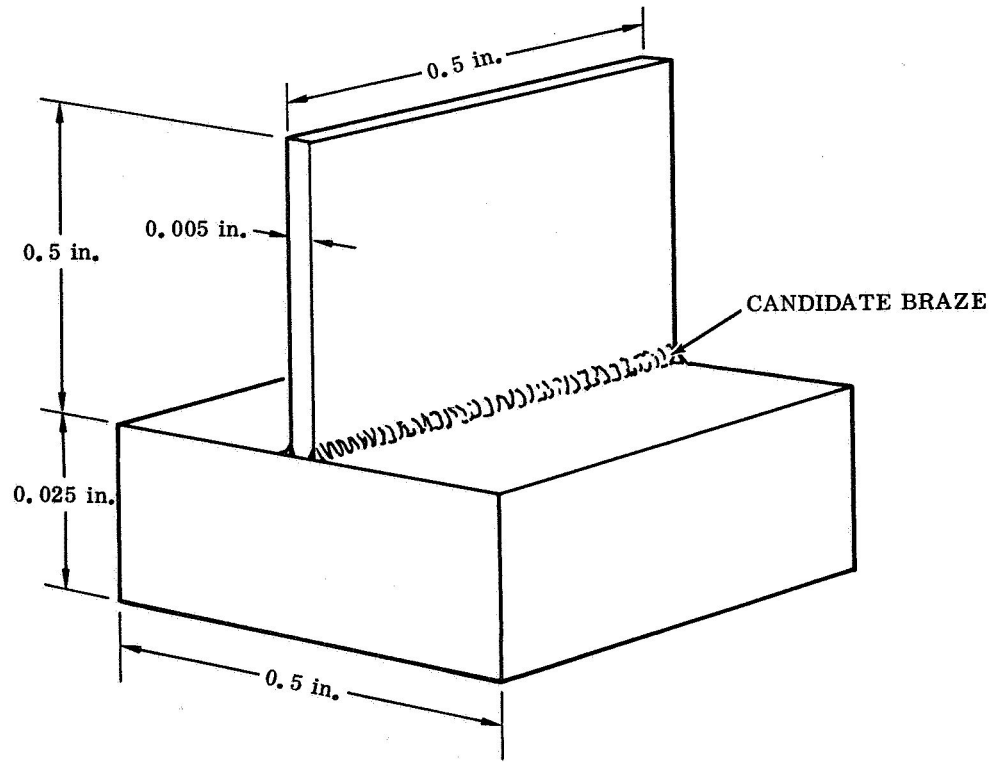
FIGURE 2. BRAZED Cb-1Zr T-JOINT SPECIMEN; Metallography and Bend Tests

Initial screening tests of candidate braze alloys were conducted using the metallography T-joint shown in Figure 2. Each T-joint was comprised of a 0.5-inch square vertical member of 0.005-inch thick Cb-1Zr foil set perpendicularly to a horizontal base member of 0.025-inch Cb-1Zr sheet, which in effect simulates the internal fin/tube joint of interest. Both members were held in place with faying surfaces in contact by tack welded one-mil tantalum or columbium foil straps. Next a small particle of braze alloy was lightly tack welded to the horizontal member immediately adjacent to the joint interface. (Tacking under an argon blanket eliminated the need for organic binders, such as polybutene, which are sources of undesirable interstitial-element contaminants.) In the case of foil alloys, a small piece of foil was interposed between the faying surfaces along the entire bond line. Finally, each T-joint loaded with a specific candidate braze alloy was heated inductively to the minimum braze temperature in the vacuum brazing rig shown in Figure 3 (15 kw Lepel high-frequency induction furnace). A cylindrical tantalum susceptor around each specimen provided rapid and uniform specimen heating - an approximate average of 400 degrees F/minute (Fig. 4). Specimen temperature was measured with a Pyro micro-optical pyrometer, previously calibrated and corrected for emissivity variation against a Pt/Pt-13Rh thermocouple installed on a dummy specimen. A vacuum brazing environment of 1×10^{-5} Torr or better was maintained throughout each braze cycle,

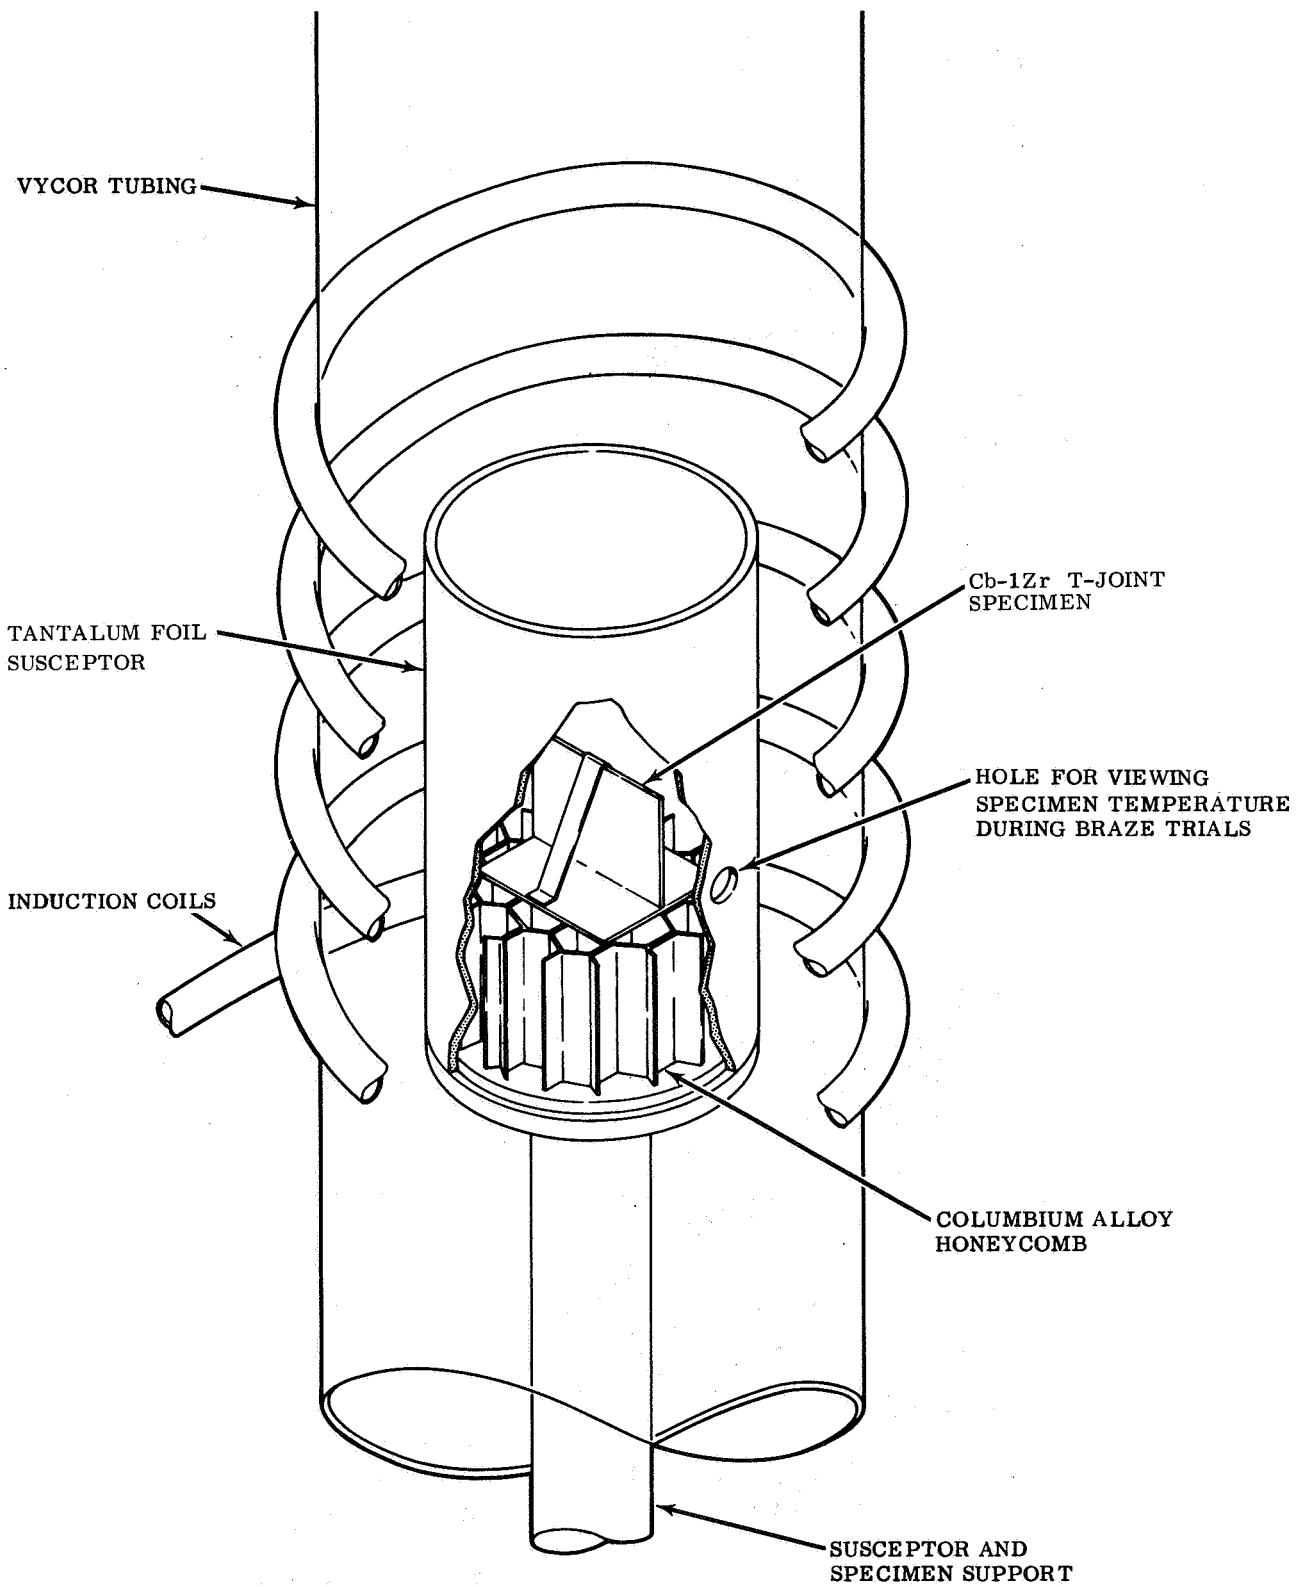
FIGURE 4. SCHEMATIC DIAGRAM OF THE LABORATORY BRAZING FURNACE
