Southwest Florida
Water Management District

EDOT MITIGATION PLAN JANUARY 26, 2010

Southwest Florida Water Management District
Resource Regulation Division
Strategic Program Office
Brooksville, Florida 34604-6899

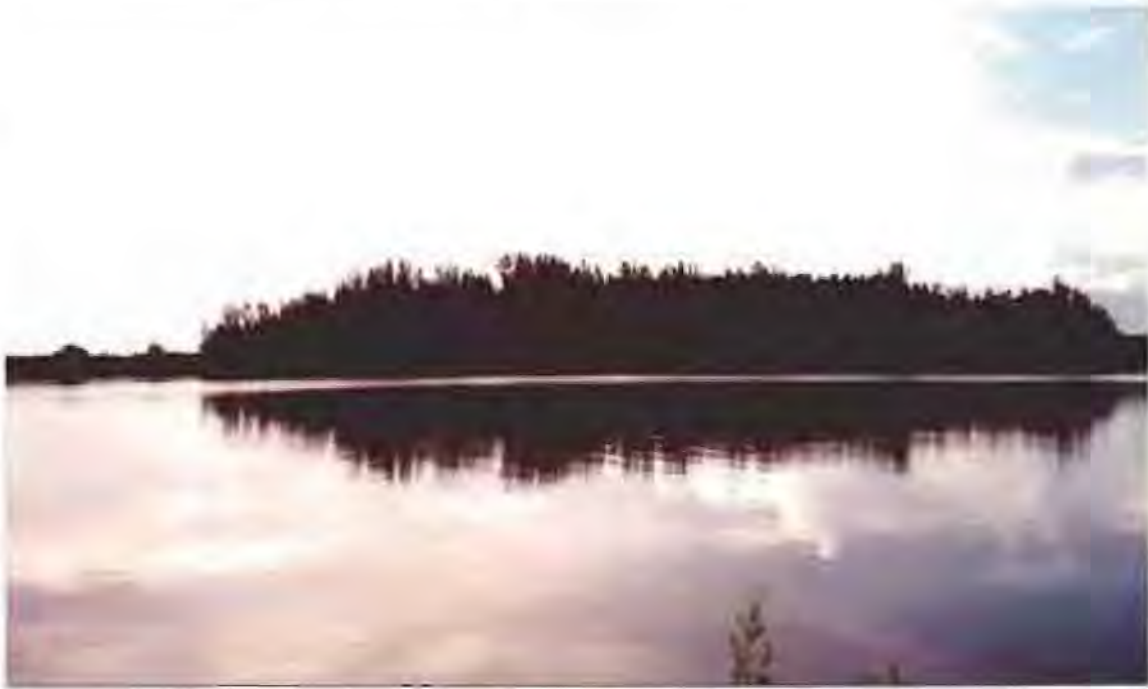
View from the southern shoreline of the Cattle Dock bayou area, looking north at the Brazilian pepper and Australian pine dominating the peninsula of the Phase I area.

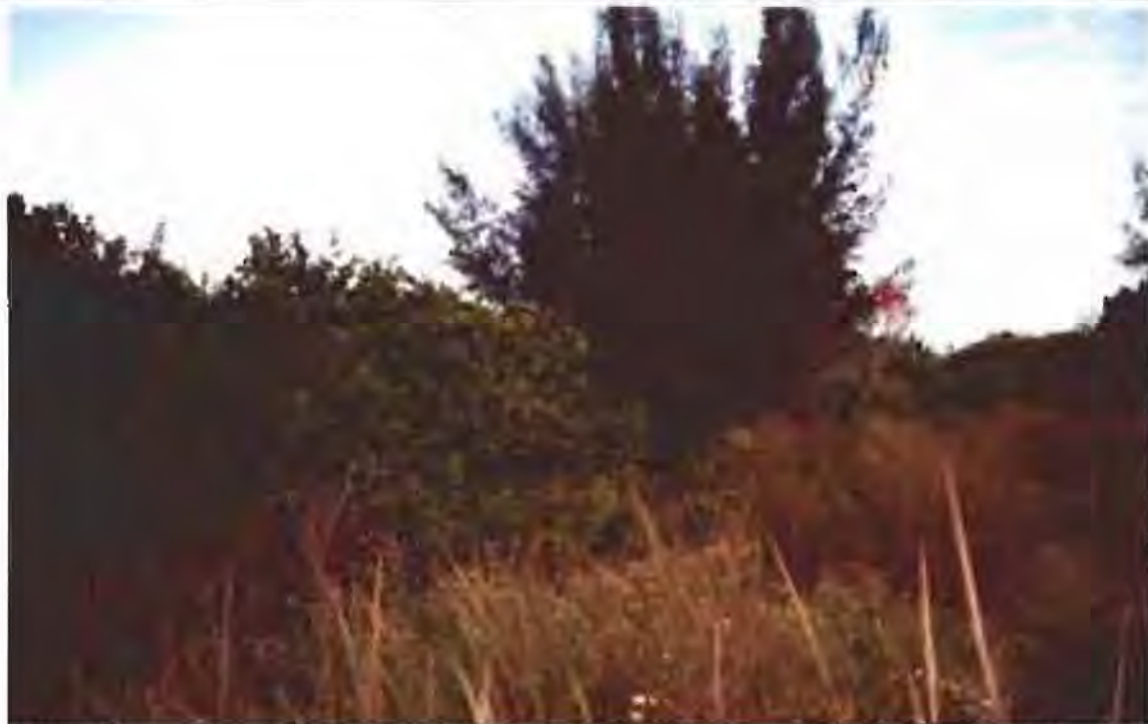
View along the access road located along the eastern boundary of the Phase II construction area, access road is one of the few upland areas not dominated by B. pepper.

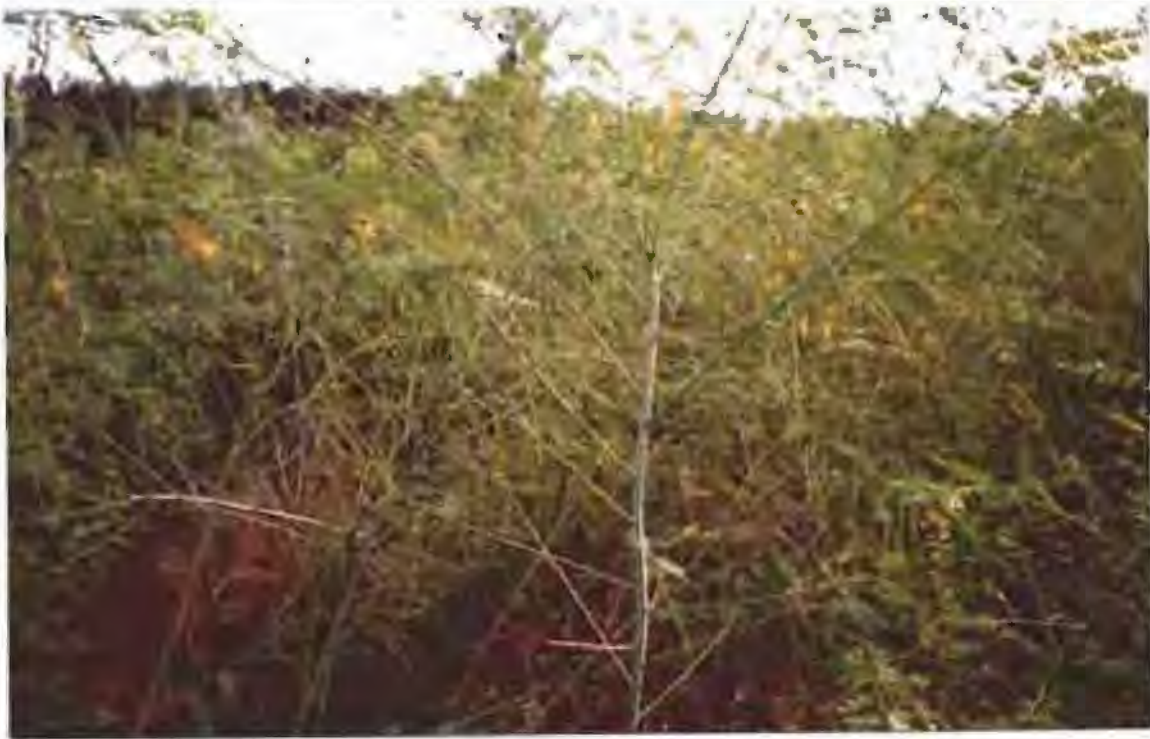
The freshwater marsh has cattails, willows, and a recent invasion of sesbania species.

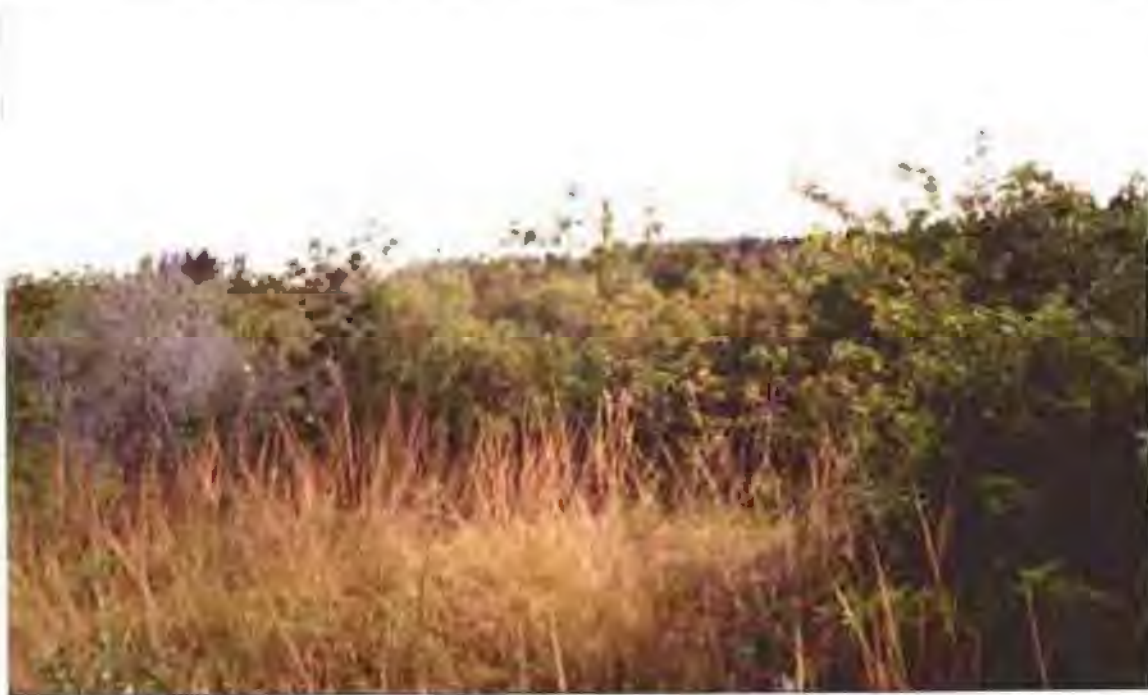
Additional view along the access road, looking over dense B. pepper coverage and A. pine (background) along the southern Phase II boundary.

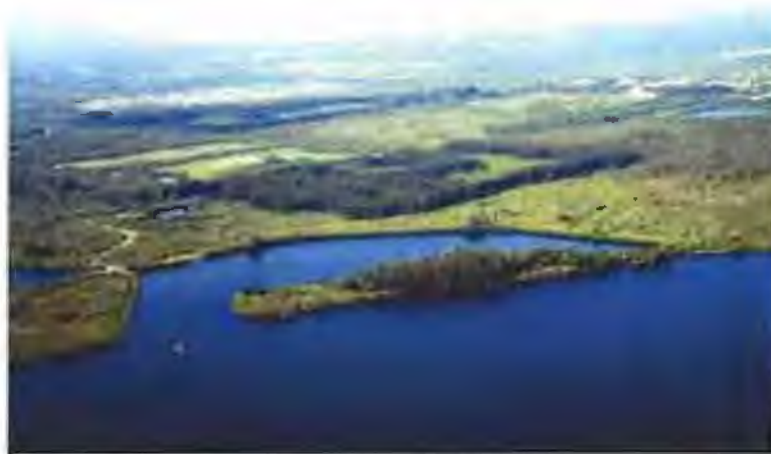
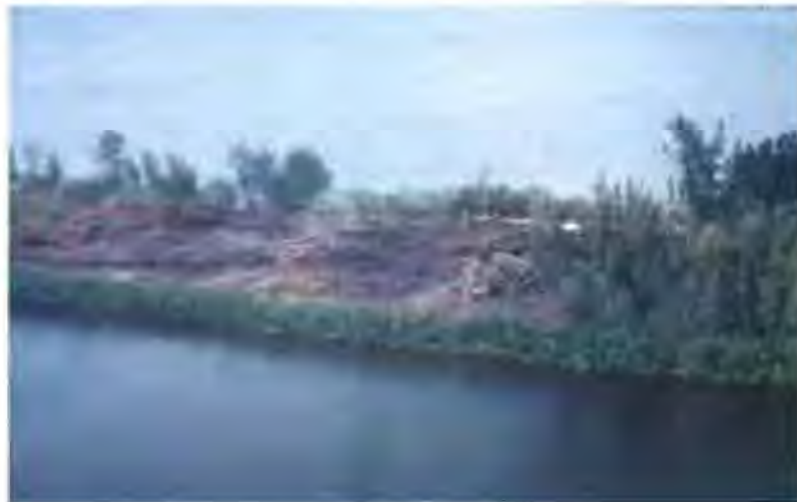
Cattle Dock Point – Phase I

Top & Middle Photos – 1995 infrared aerial (top) and 2000 site aerial (middle). To the north of the boat basin, the filled peninsula includes dominant cover of Australian pine (dark green) with the majority of the remaining portion covered with Brazilian pepper.

Bottom Photo – Phase I construction (2001) commences with eradication of the exotic vegetation while preserving and enhancing the mangrove fringe.

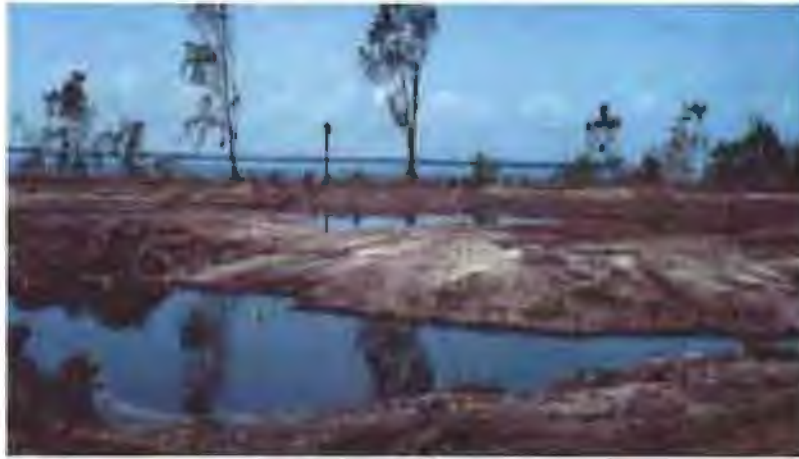
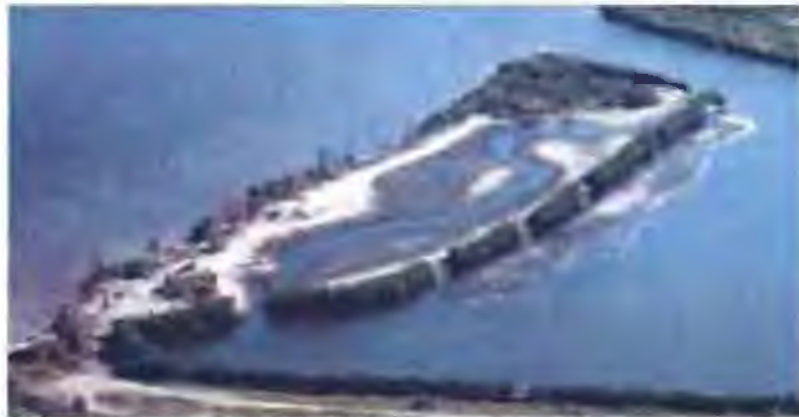
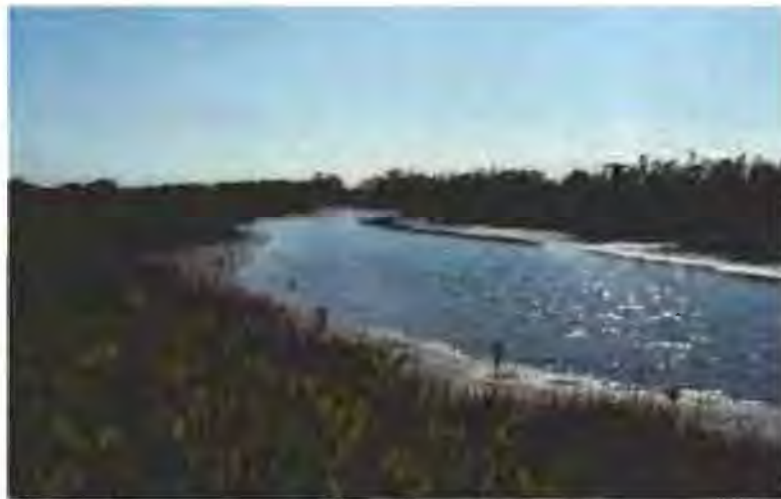
Cattle Dock Point – Phase I

Top & Middle Photos – 2001, view of the peninsula after appropriate grading to construct intertidal channel and adjacent marsh habitat. The cut fill material is placed in the boat basin to create salt-marsh platforms.

Bottom Photo – 2004, the planting of saltmarsh cordgrass, black rush, and seashore paspalum has generated and recruited to provide extensive cover, and the natural recruitment of white mangrove seedlings provide additional habitat diversity to the area.

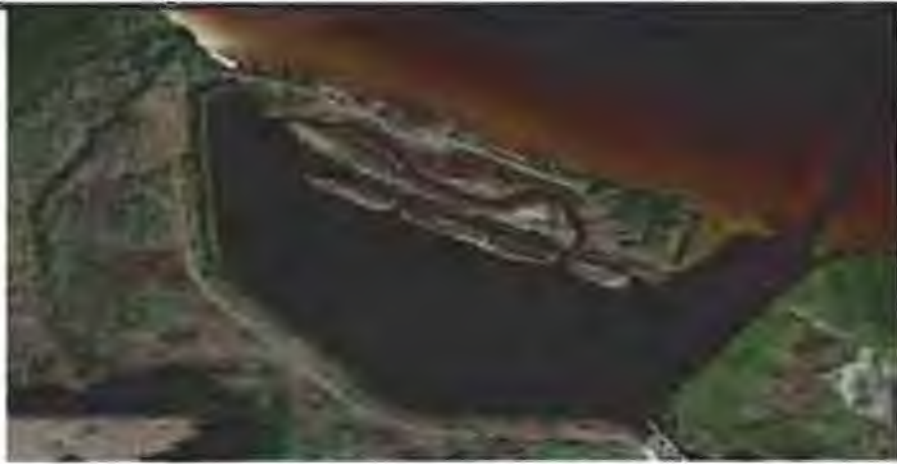
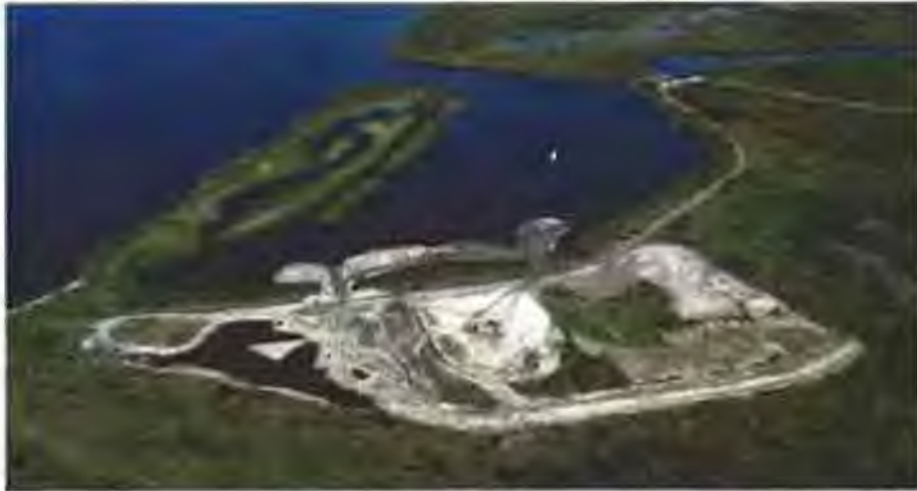
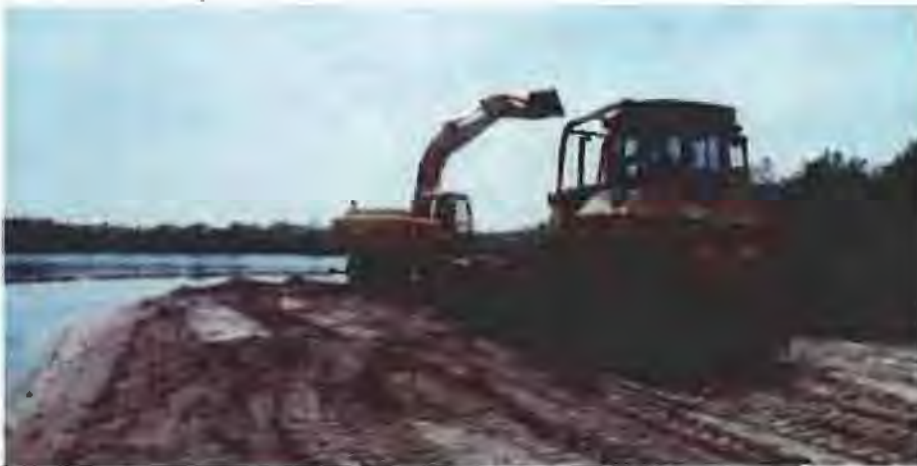
Cattle Dock - Phase II

Top Photo – (Feb. 2004) – View of the completed and high quality habitat conditions for Phase I. Pre-construction, the Phase II area (lower left) has extensive cover of Brazilian pepper, and is bordered to the west by preserved high salt-marsh and mangrove habitat.

Middle & Bottom Photo - (Summer, 2004) – Brazilian pepper eradicated and grading of the filled upland commences to create intertidal marsh habitat. Graded material is placed in the boat basin to create salt-marsh habitat platforms.

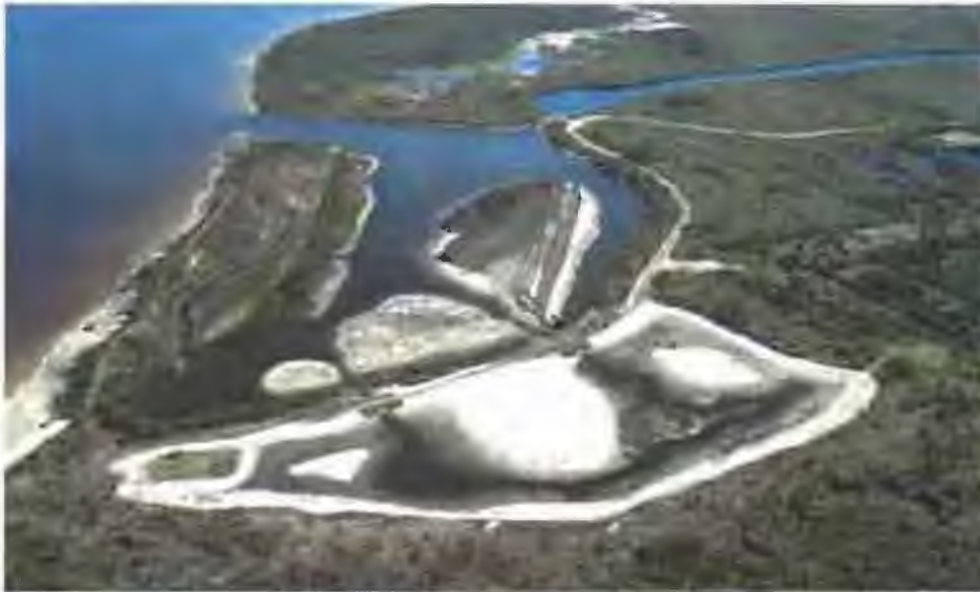
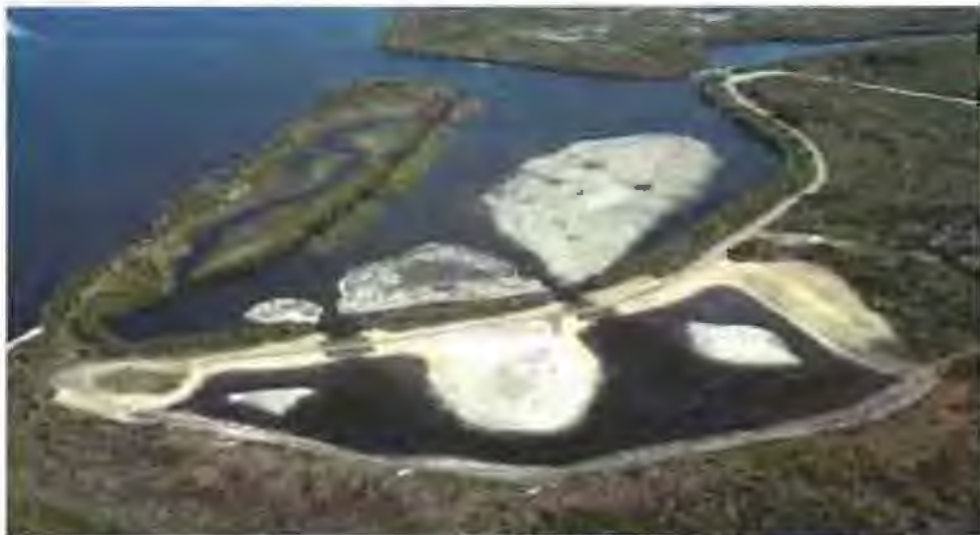
Cattle Dock – Phase II

Top Photo – (January, 2005) – Dredging of the intertidal marsh and associated meandering channel is evident. Three upland islands located within the marsh are taking shape, and fill material for the three marsh platforms is being extended into the boat basin.

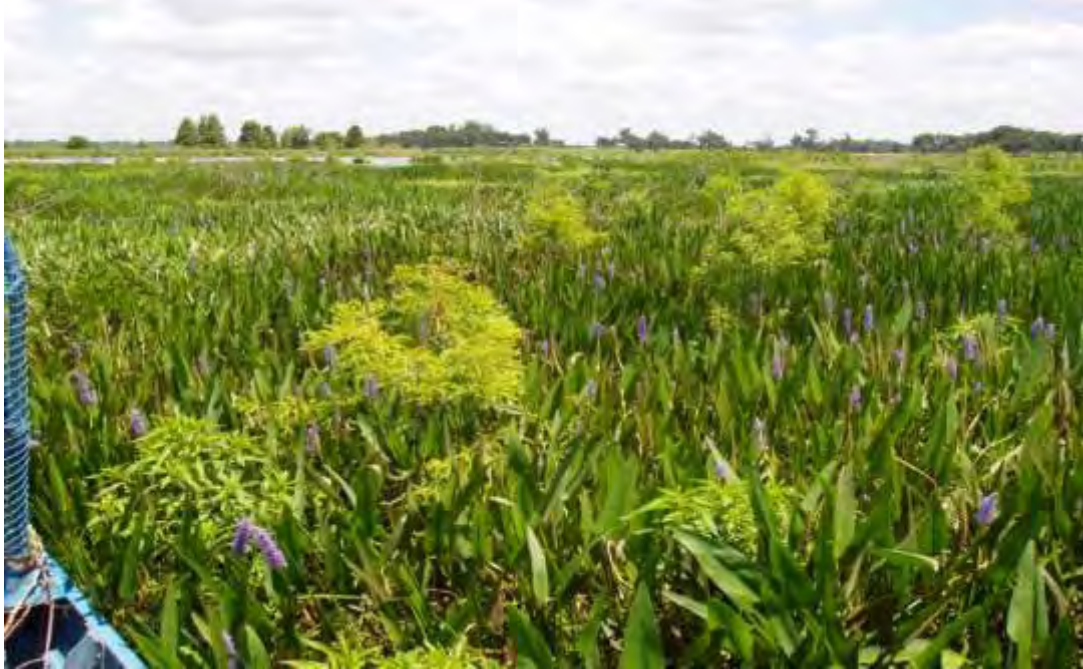
Restored eastern marsh area has dense coverage of planted pickerelweed, fireflag, bulrush, spikerush, and pockets of cypress. The marsh provides water quality treatment and attenuation of flow diverted from the contributing Baker Creek Canal.

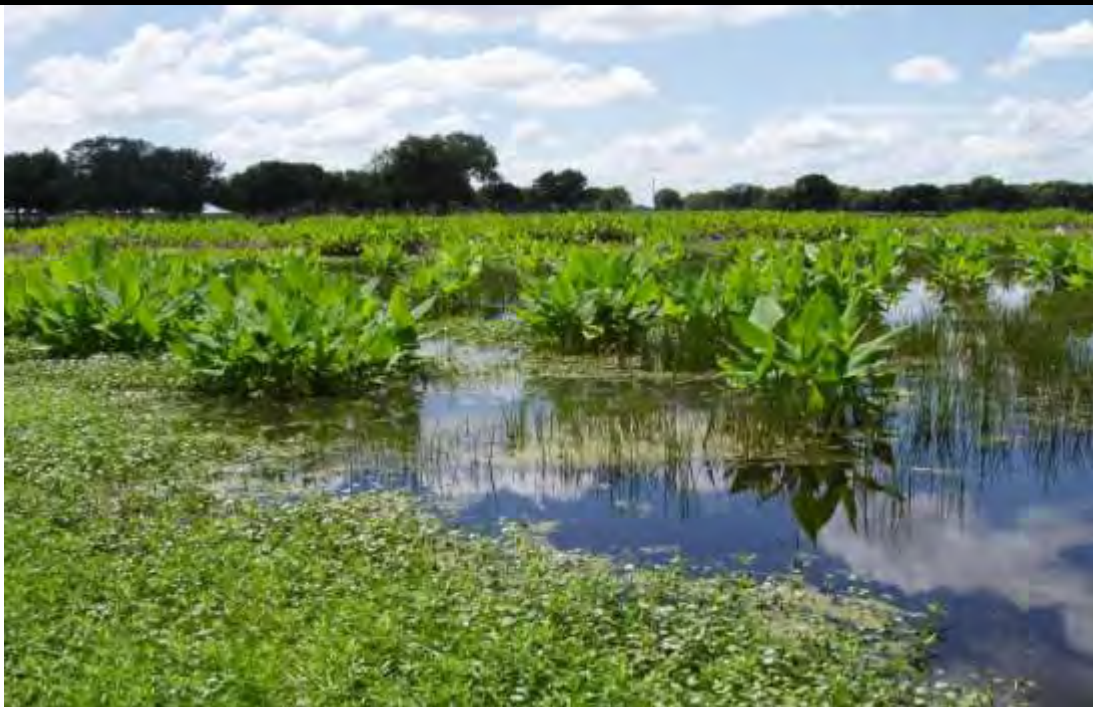
Restored western portion of the marsh has more open water features, with scattered pockets of fireflag, bulrush, and other obligate species. The combination of shallow and deep water areas in the marsh provide diverse habitats utilized by a variety of wildlife species.

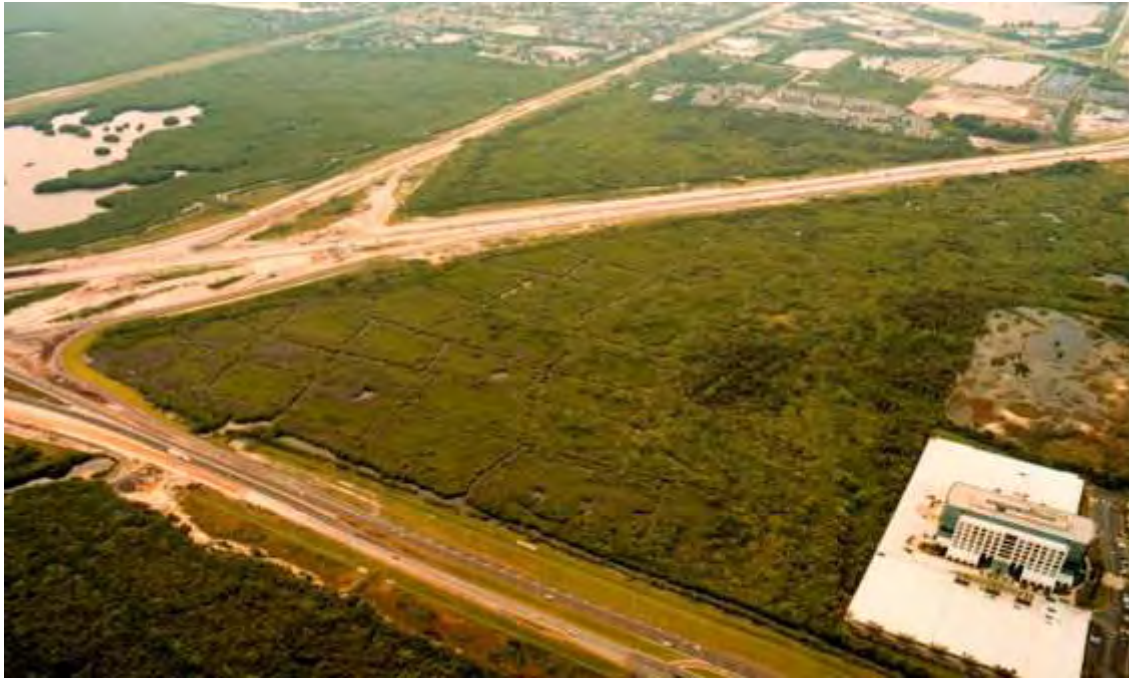
North Tract (2003) – pre-construction view looking south over Ulmert Road (foreground). The dark green forested areas adjacent to Franklin Templeton building (lower right) are predominantly dense stands of Melaleuca and Brazilian pepper. Remaining portion to I-275 (middle) is mangrove habitat.

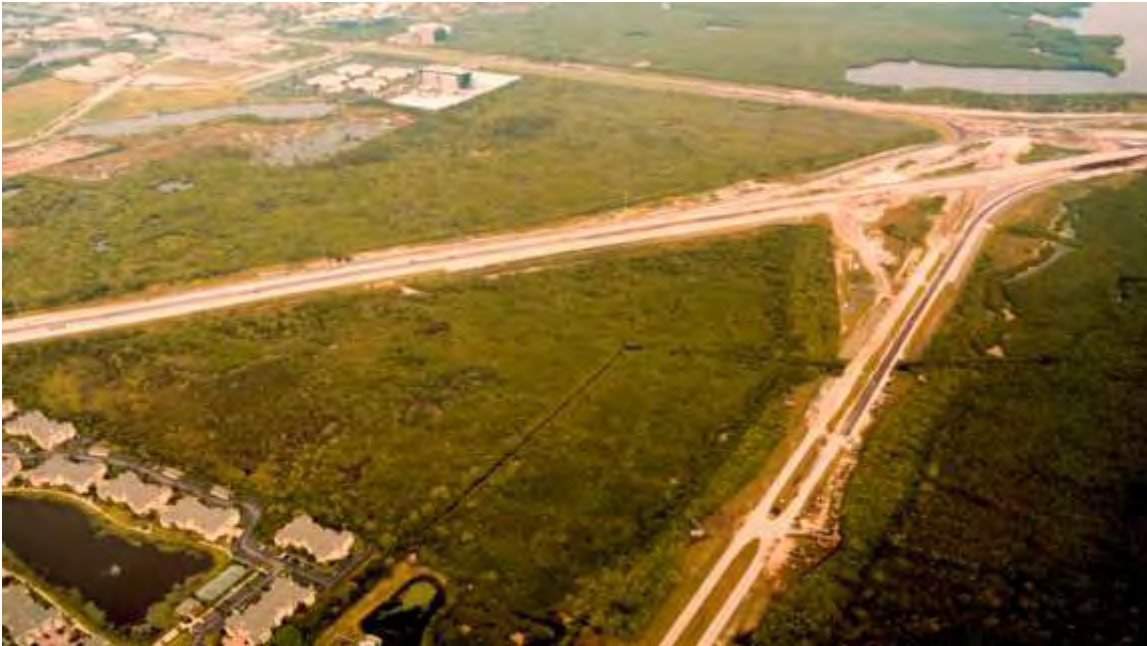
South Tract (2003) – pre-construction view looking north over 9th Street (right) and I-275 (middle). The dark green forested areas adjacent to apartment buildings (lower left) are dense stands of Melaleuca and Brazilian pepper.

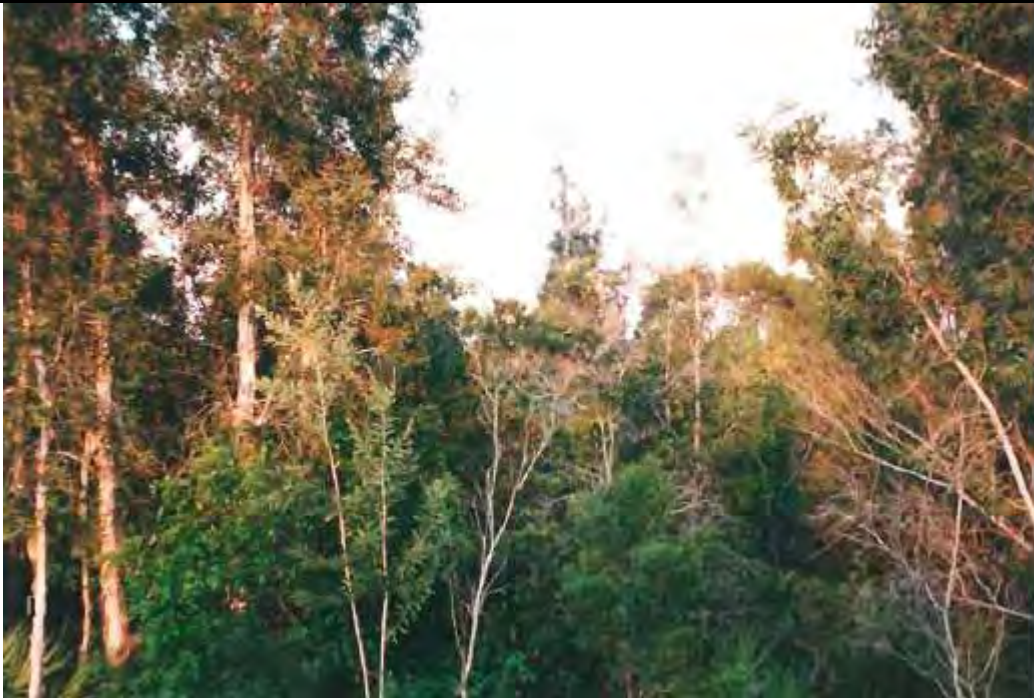
North Tract (2003) – Pre-construction view from Franklin Templeton building, looking east over dense coverage of Melaleuca and B. pepper in the filled upland area.

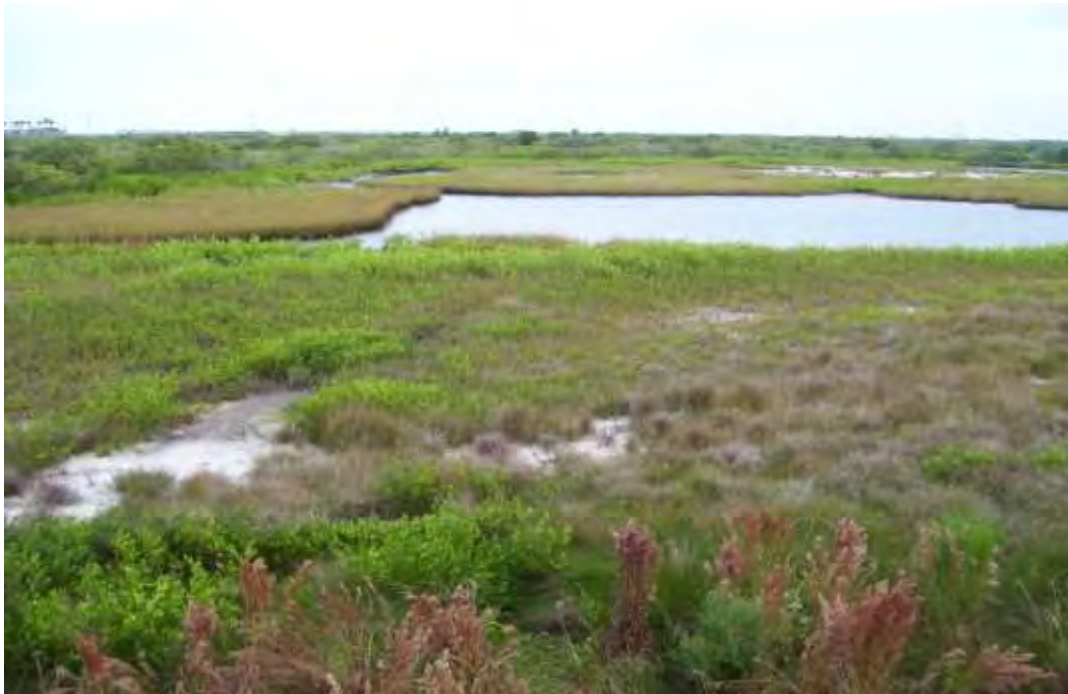
North Tract (2009) – same eastern view overlooking the graded upland area at the most northern constructed tidal lagoon, predominantly plantings of smooth cordgrass in the low tide zone around the lagoons, other species include salt-grass, seaside paspulum, needle rush and sand cordgrass at higher elevations. Mangrove seedlings (light green) have naturally recruited and generated; particularly within the low marsh zones.

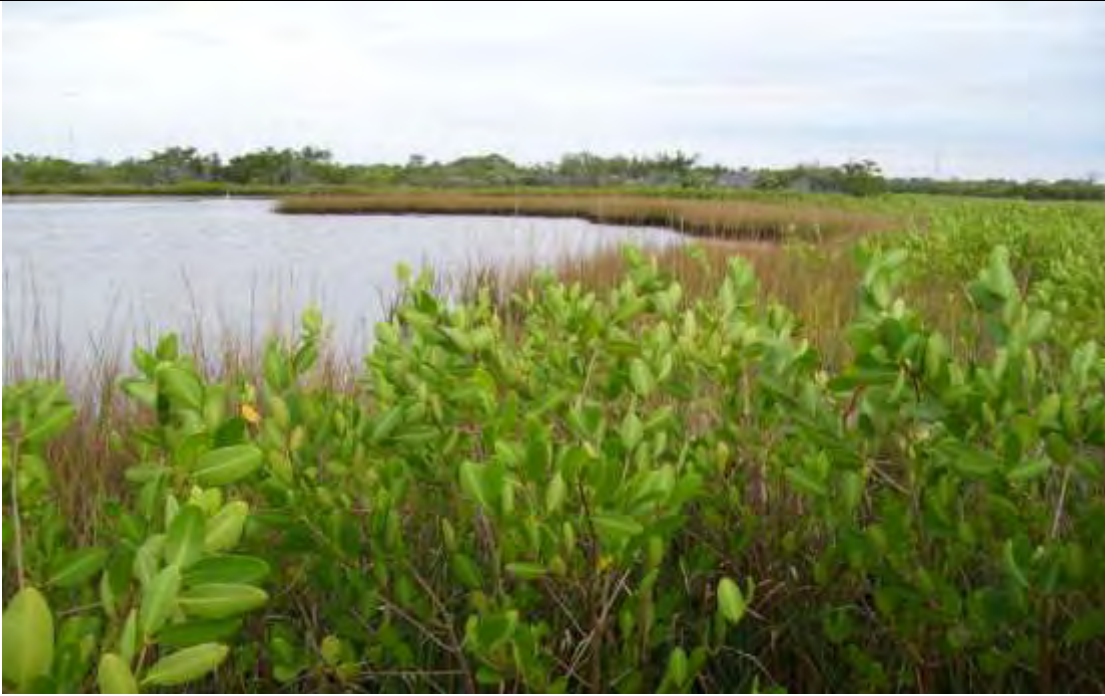
North Tract (2009) – improved tidal channel connectivity access from the constructed lagoons to Tampa Bay have resulted in productive havens for fish and invertebrate species in the lagoons; and subsequently the bird and mammal species that nest and forage on the property.

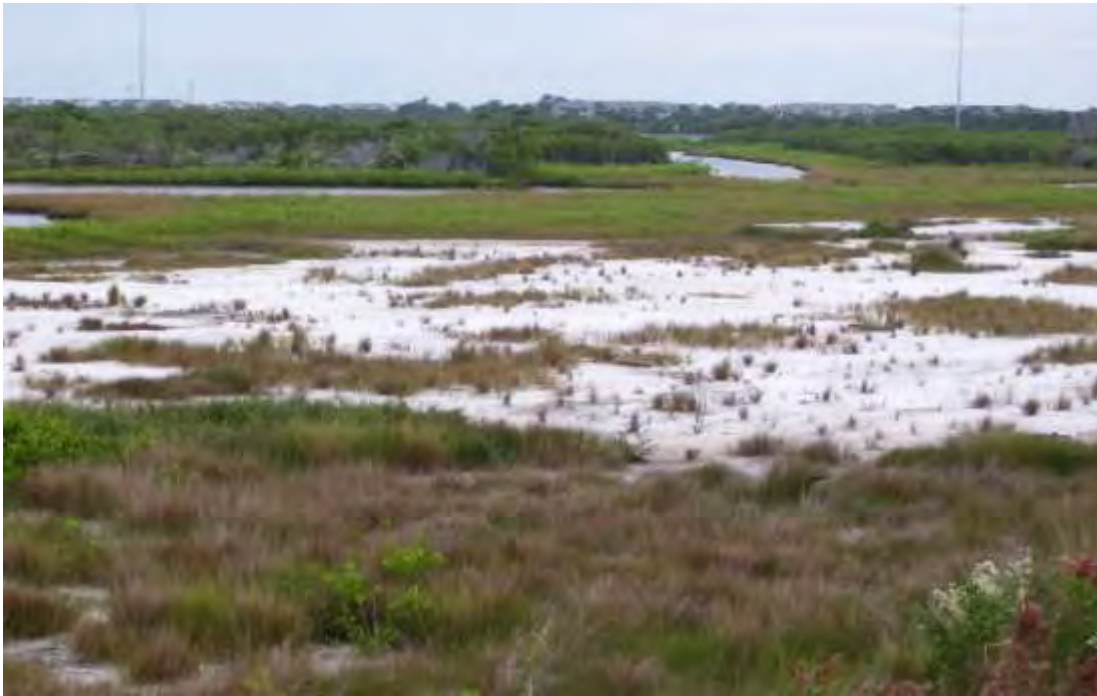
North Tract – a portion of the salt-marsh have grade elevations constructed slightly above high tide elevations, allowing for irregular flushing with salt water that established rare and unique saltern habitat. The salterns are productive ecosystems for birds and mammals to forage on fiddler crabs and other species that inhabit the area.

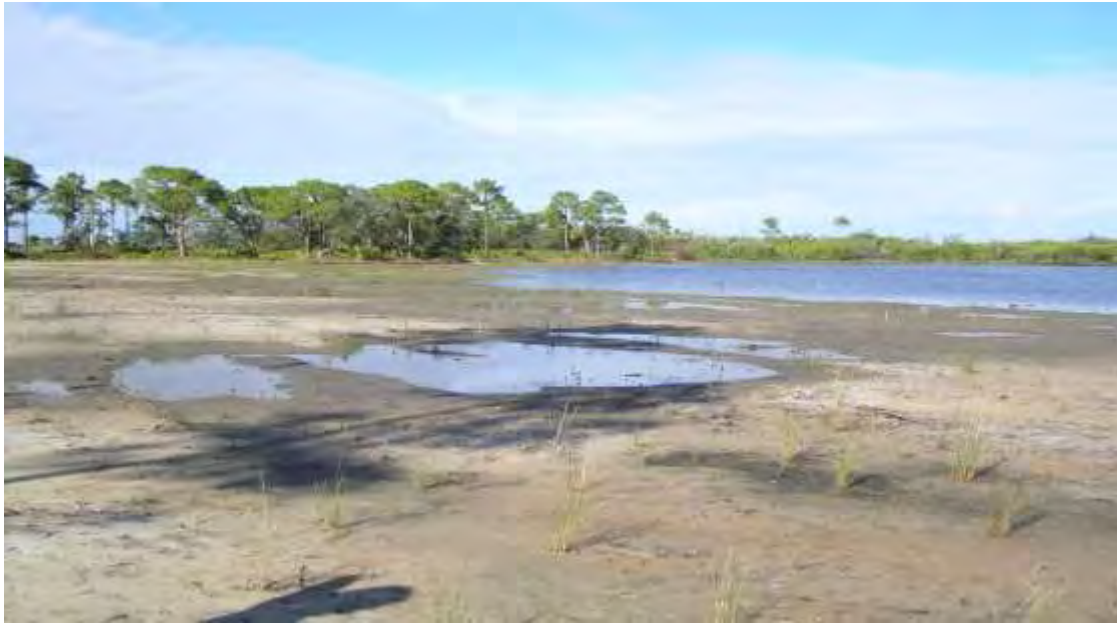
South Tract (2004) – constructed lagoon and planted salt-marsh located within the southeast upland area previously dominated by *B. pepper* & *Melaleuca*. Remnant pine flatwood adjacent to Interstate-275 (background) was protected from construction and the habitat enhanced by eradicating exotic vegetation.

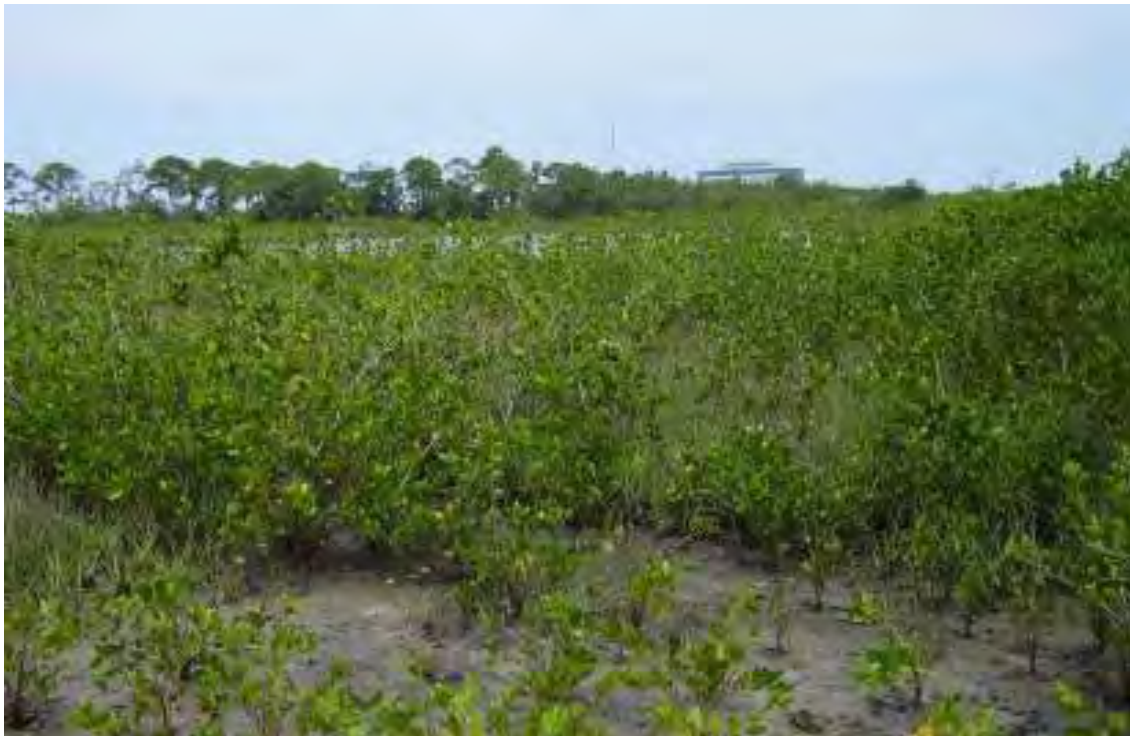
South Tract (2009) – along with the construction of salterns, much of the salt-marsh has transitioned as mangrove species have naturally recruited and generated around the lagoon.

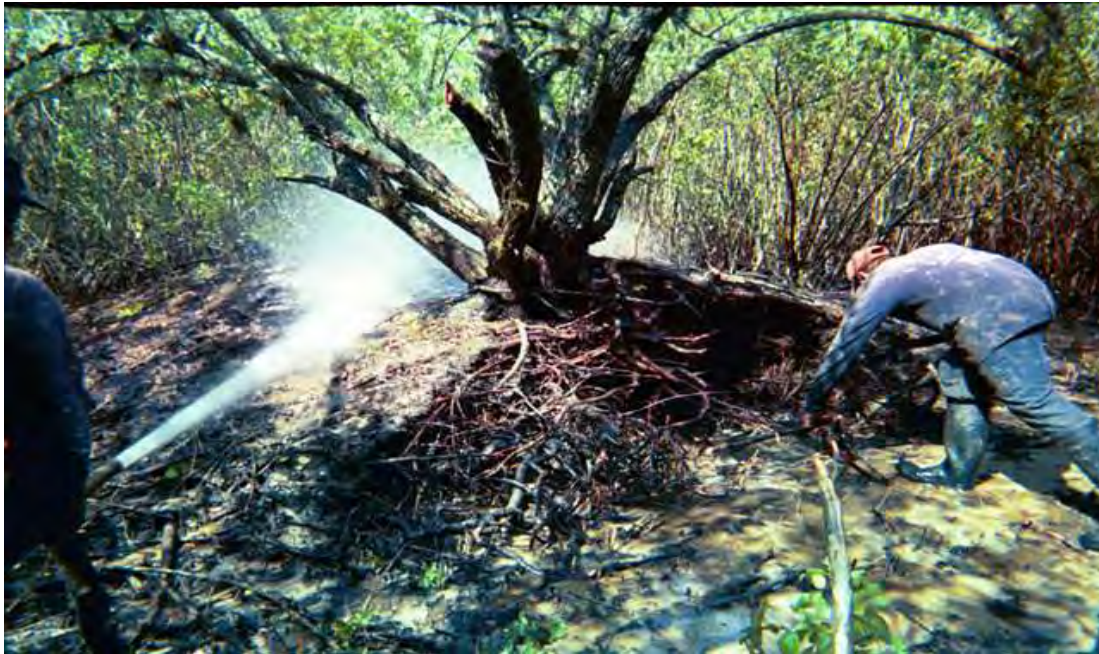
Gateway was the first restoration project in the region to utilize high pressure water hoses to “hydroblast” the mosquito ditch spoil mound material held together by B. pepper roots. By displacing the material, B. pepper mortality occurs since the roots are exposed to salt water, and the species cannot regenerate when the mounds are lower than high tide elevations.

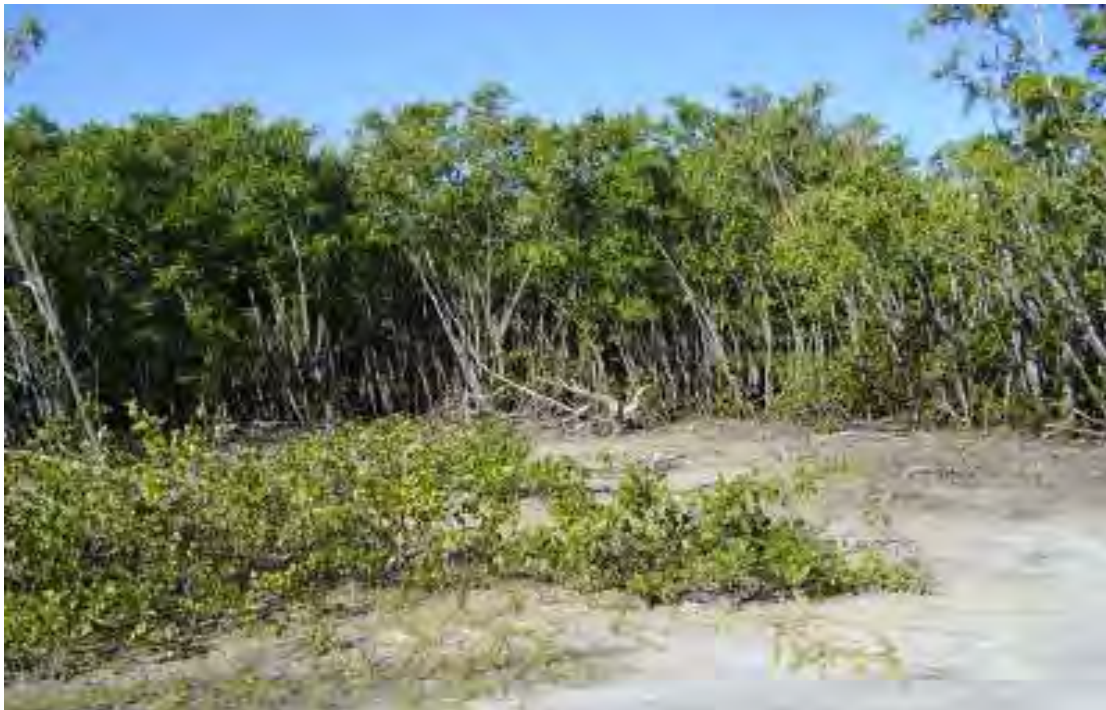
Existing mangroves adjacent to the graded spoil mounds provide a seed source for natural recruitment and generation of mangrove seedlings within the first year after construction.

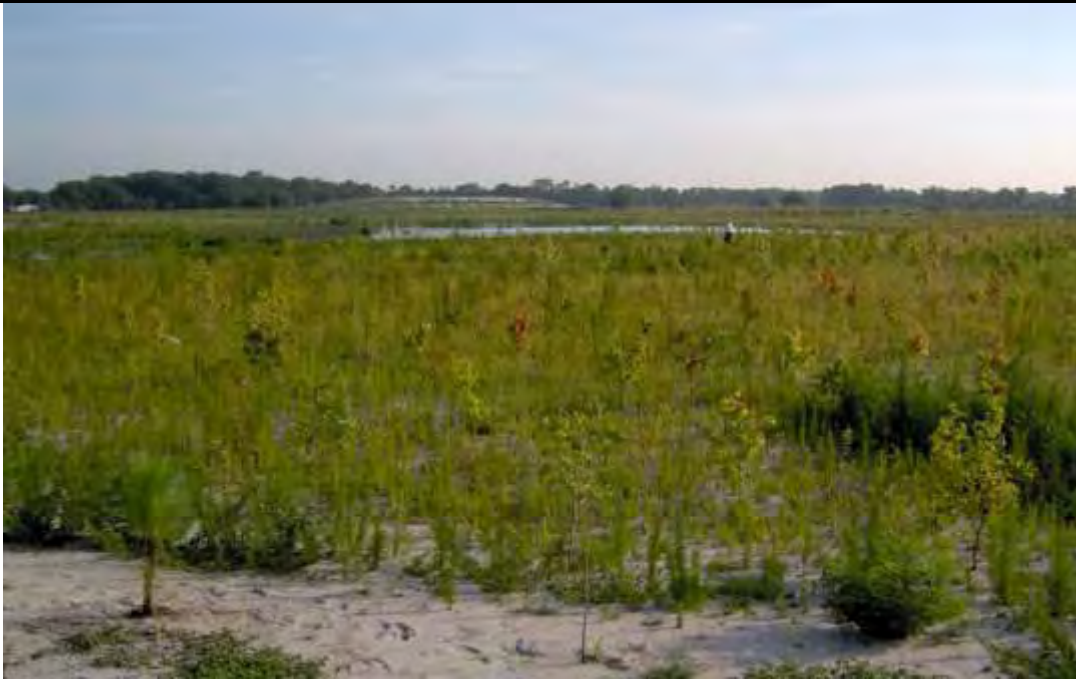
2009 - view from the southern limits of the constructed wetland, looking north over facultative forested wetland creation area. Dominant planted species in the facultative zone include cordgrass, soft rush, sawgrass, St. John's-wort, red maple, sweet bay, slash pine, cabbage palm, and laurel oak.

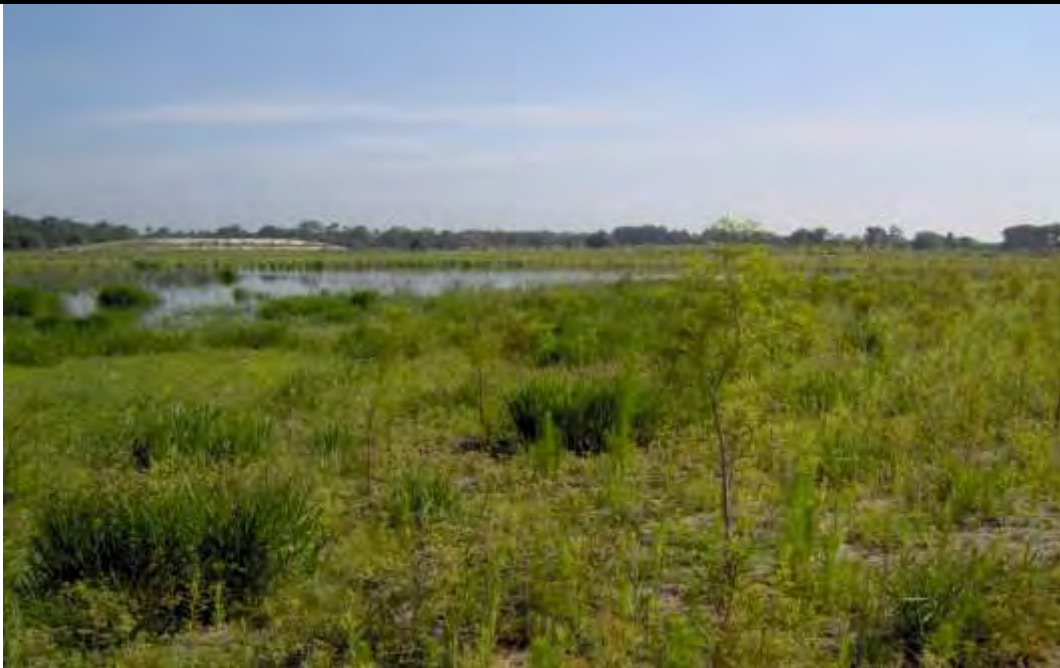
Along with the open water components, the constructed obligate zone includes plantings of pickerelweed, arrowhead, bulrush, fireflag, wild rice, bald cypress, black gum, pap ash, and red maple. The wetland attracts many wildlife species, particularly a variety of wading bird and waterfowl species.

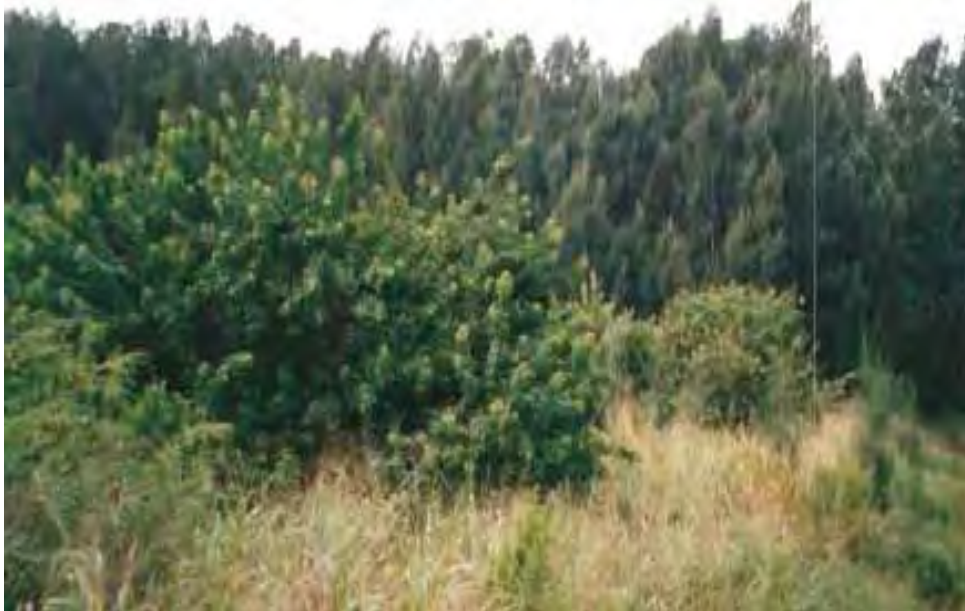
Pre-Construction (1999) - wetlands are buffered by uplands with extensive coverage of exotic & nuisance species such as Australian pine (background), Brazilian pepper, Johnson grass, ragweed and dog fennel.

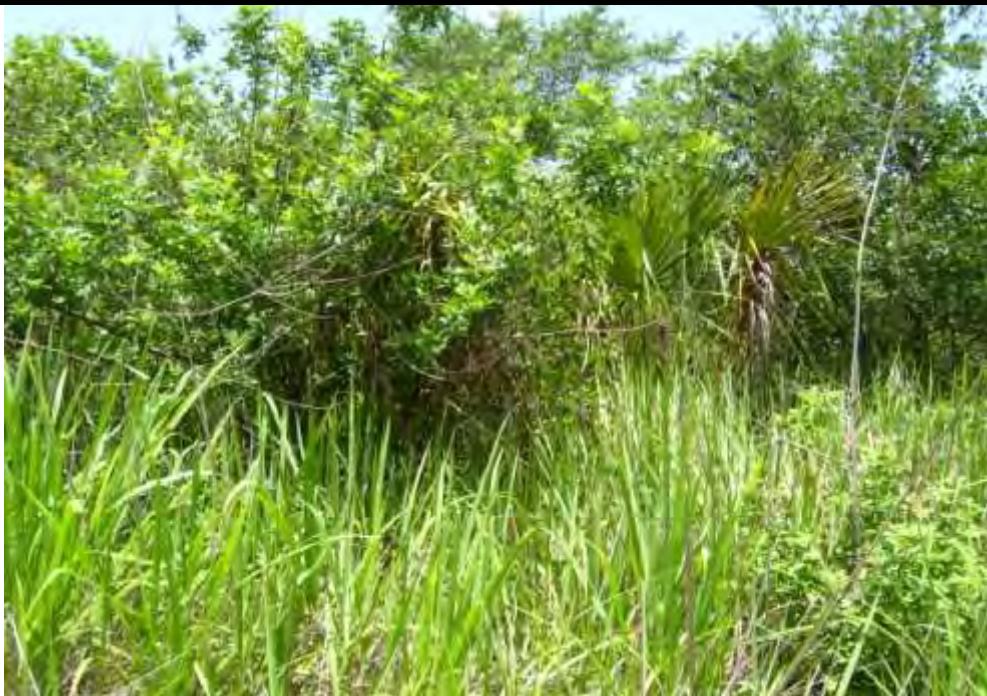
Pre-Construction (1999) – the mangrove is buffered by dense Brazilian pepper, cogon grass, and scattered cabbage palm

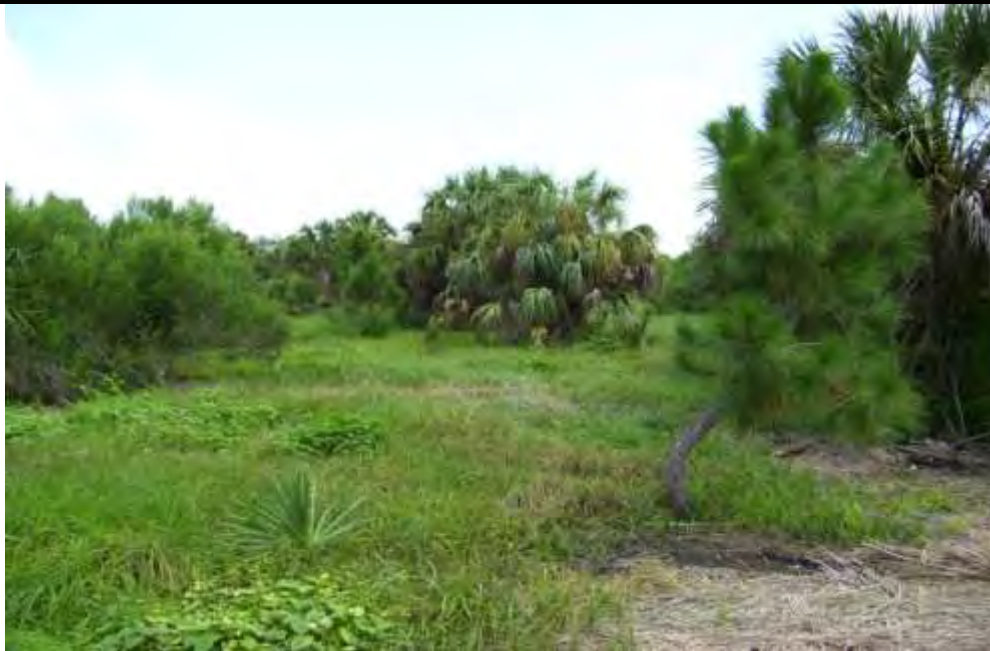
Current Post-Construction Habitat (2009) – exotics have been eradicated, preserved cabbage palms, natural recruitment of salt-bush, wax myrtle, and planting of slash pine. More open understory provides more wildlife access and utilization.

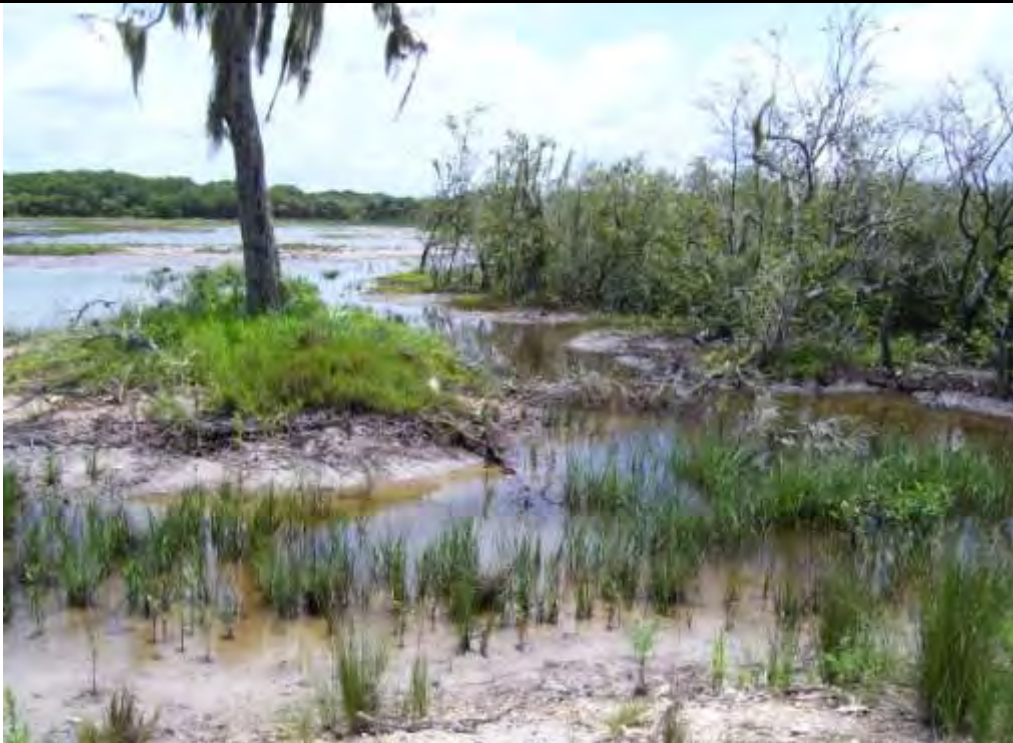
Current Post-Construction Habitat (2009) – the mangrove in the project area (right) is further enhanced and buffered by the braided tidal marsh habitat constructed along the northern side of the mangrove.
