Southwest Florida
Water Management District

EDOT MITIGATION PLAN JANUARY 26, 2010

Southwest Florida Water Management District
Resource Regulation Division
Strategic Program Office
Brooksville, Florida 34604-6899

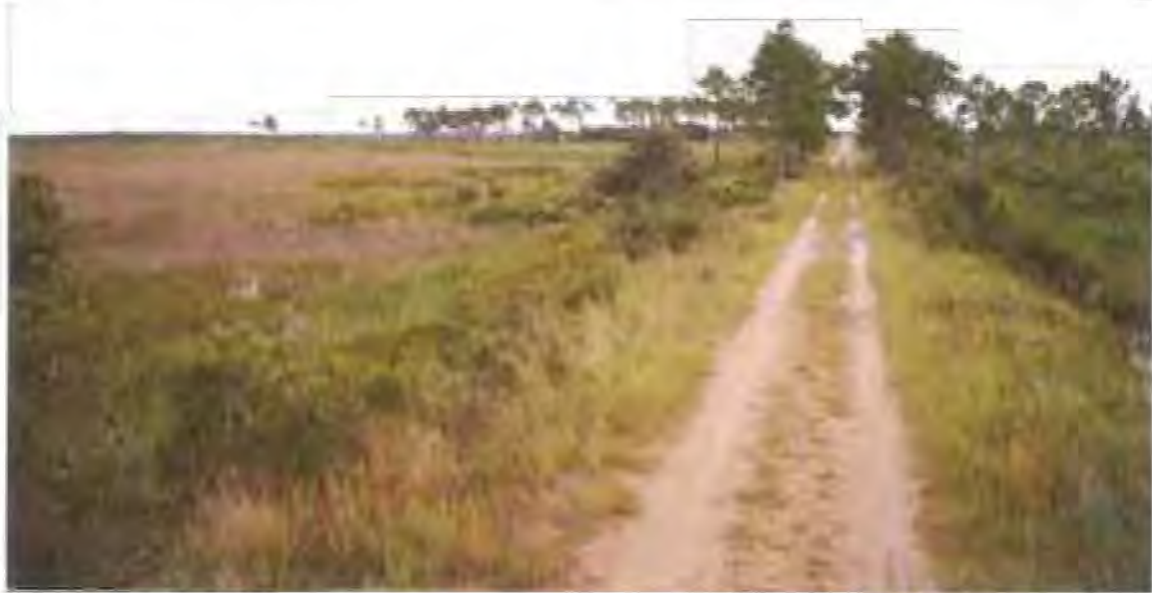
The majority of the proposed earthwork activities include removing nine miles of the elevated railroad tram grade depicted above. This abandoned tram blocks and diverts surface and ground water flow from north to south (left to right), effectively impounding surface water within habitats upstream and minimizing contributing flow to the habitats directly downstream of the berm.

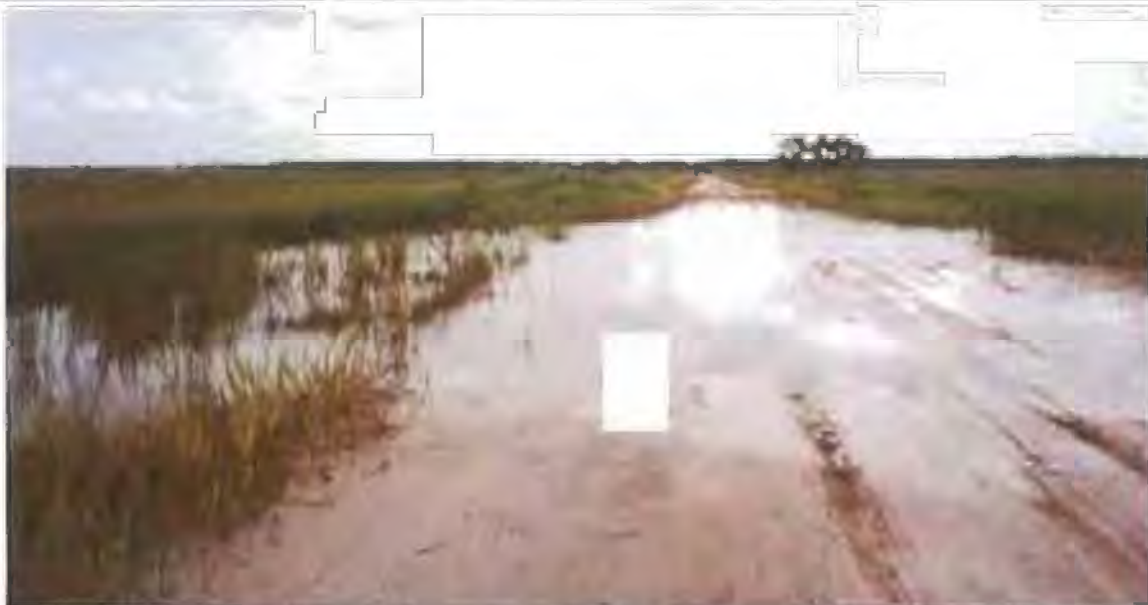
This photo depicts a portion of the post-construction road shortly after tram removal. The berm material was graded into the adjacent lateral ditches to restore historic grade elevations and contributing hydrology. Native vegetation is naturally recruiting into the filled ditches. The lowered road grade still provides vehicle access necessary for land management activities, including through the surface water at wet crossings.

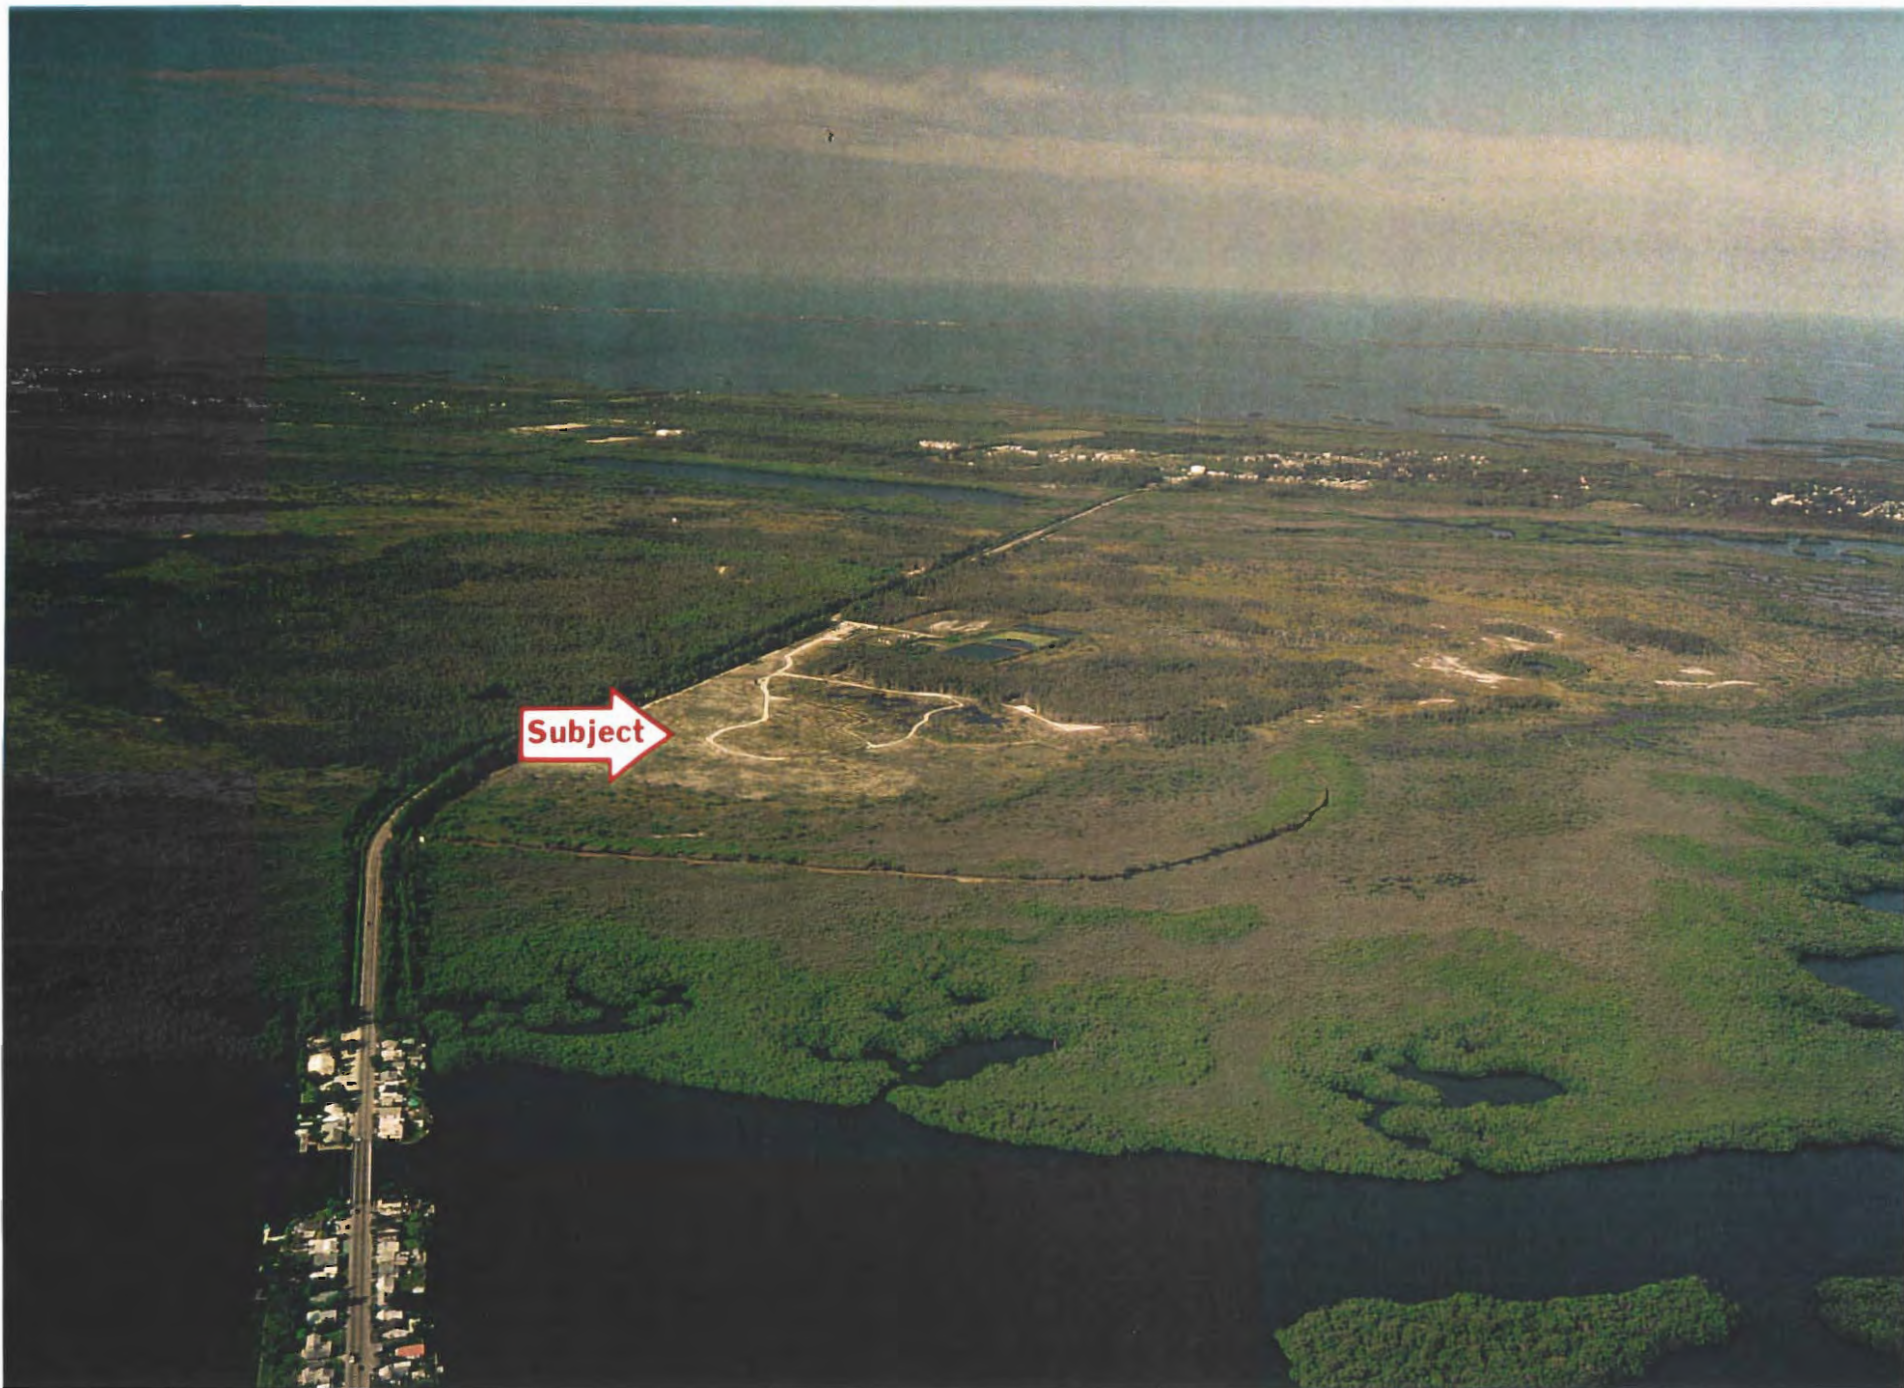
SEPTEMBER 1997 - PHASE I EXOTIC VEGETATION REMOVAL COMPLETE AT LITTLE PINE ISLAND - VIEW FROM MATLACHA PASS AQUATIC PRESERVE

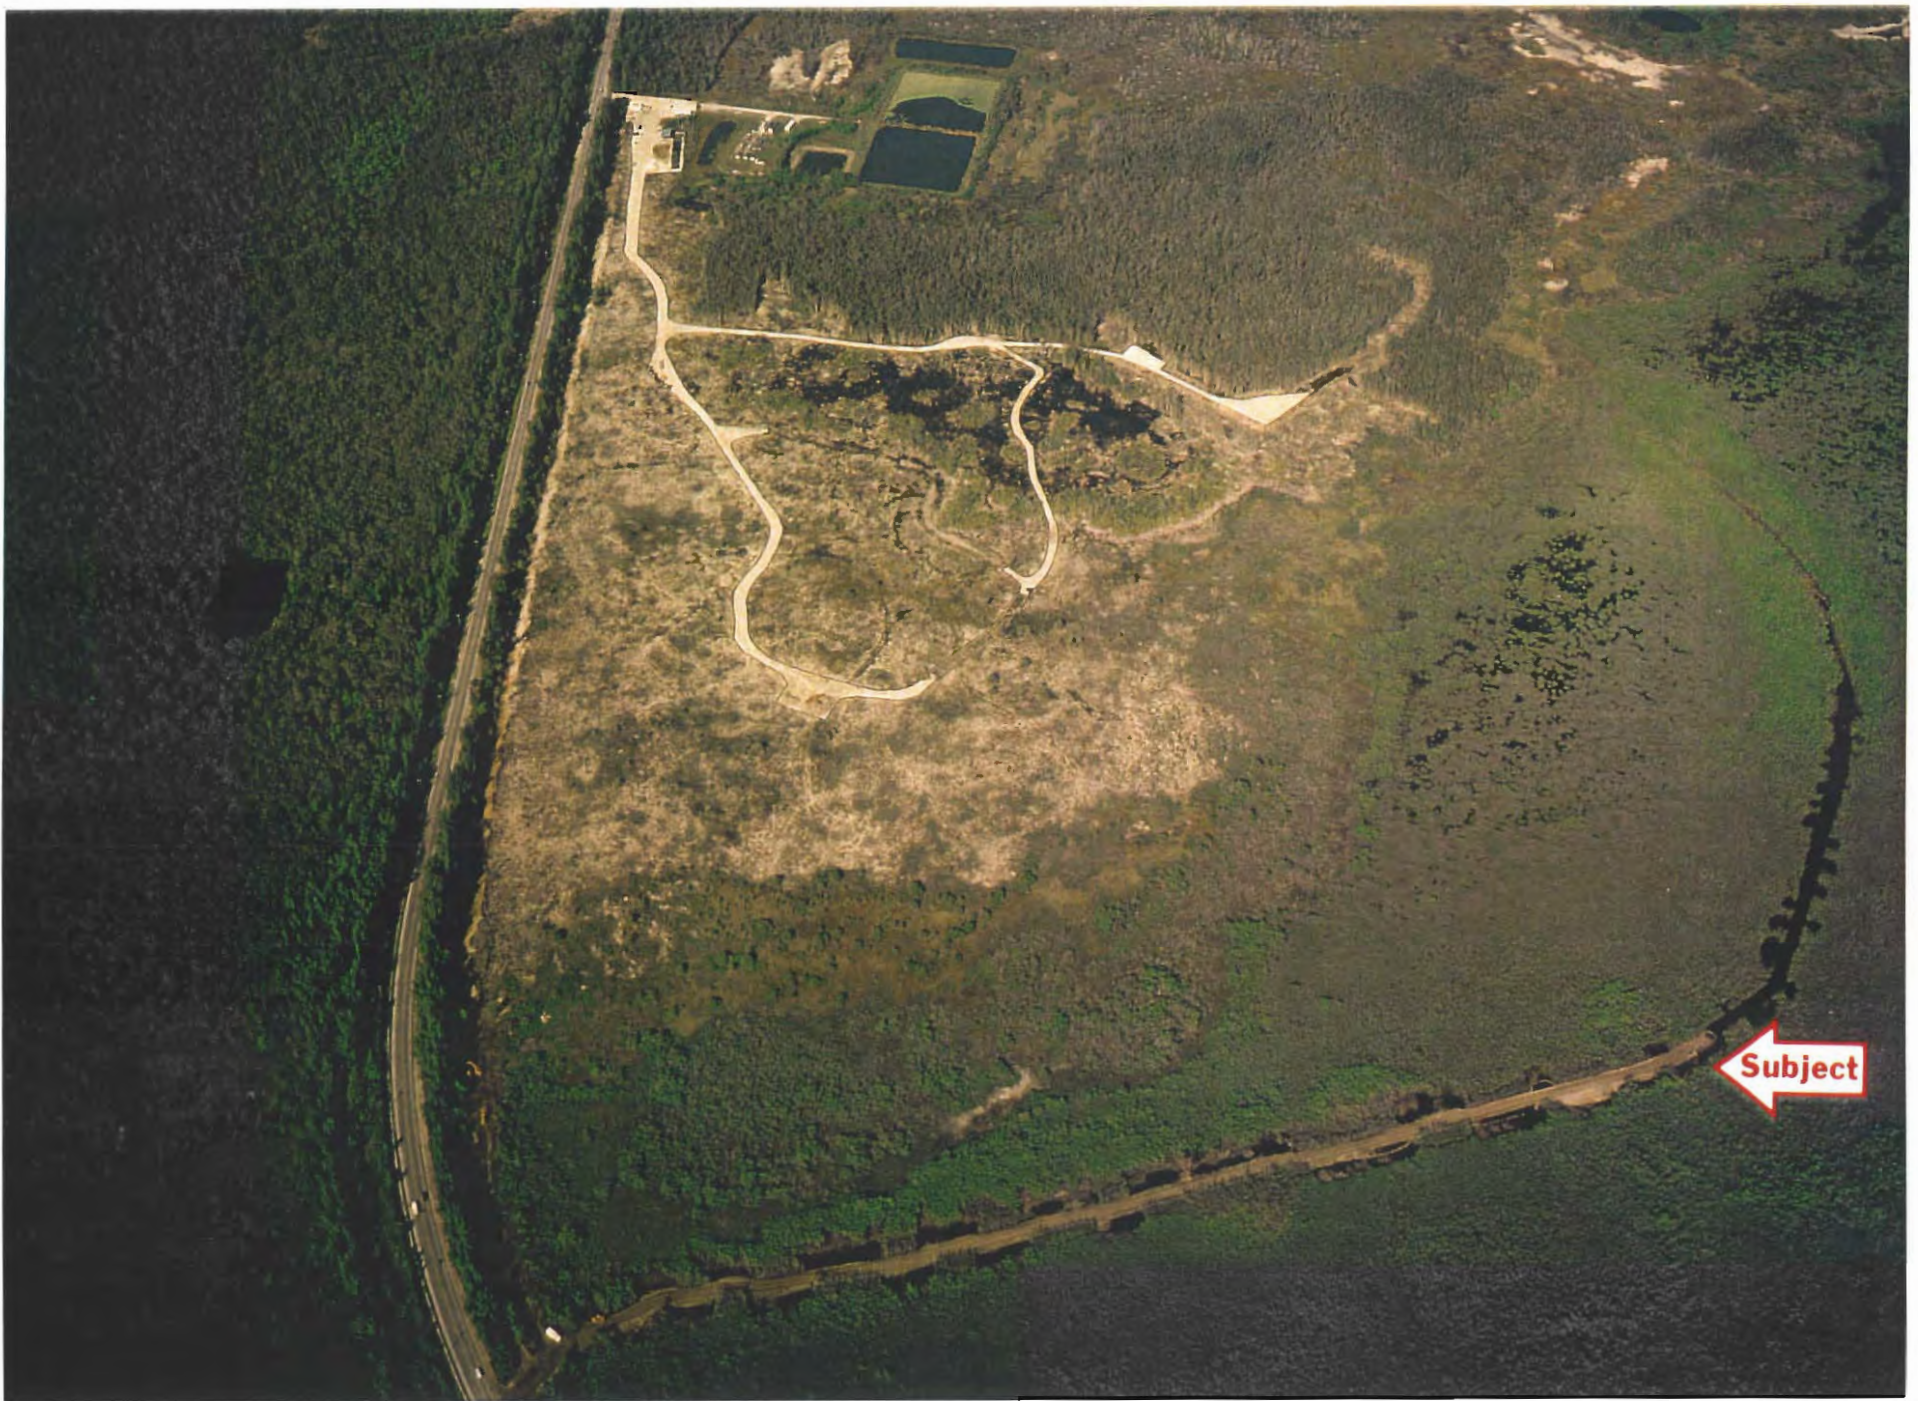
SEPTEMBER 1997 - PHASE I HYDROLOGIC RESTORATION AT LITTLE PINE ISLAND -
DRAINAGE CANALS ARE FILLED TO RESTORE SHEET FLOW

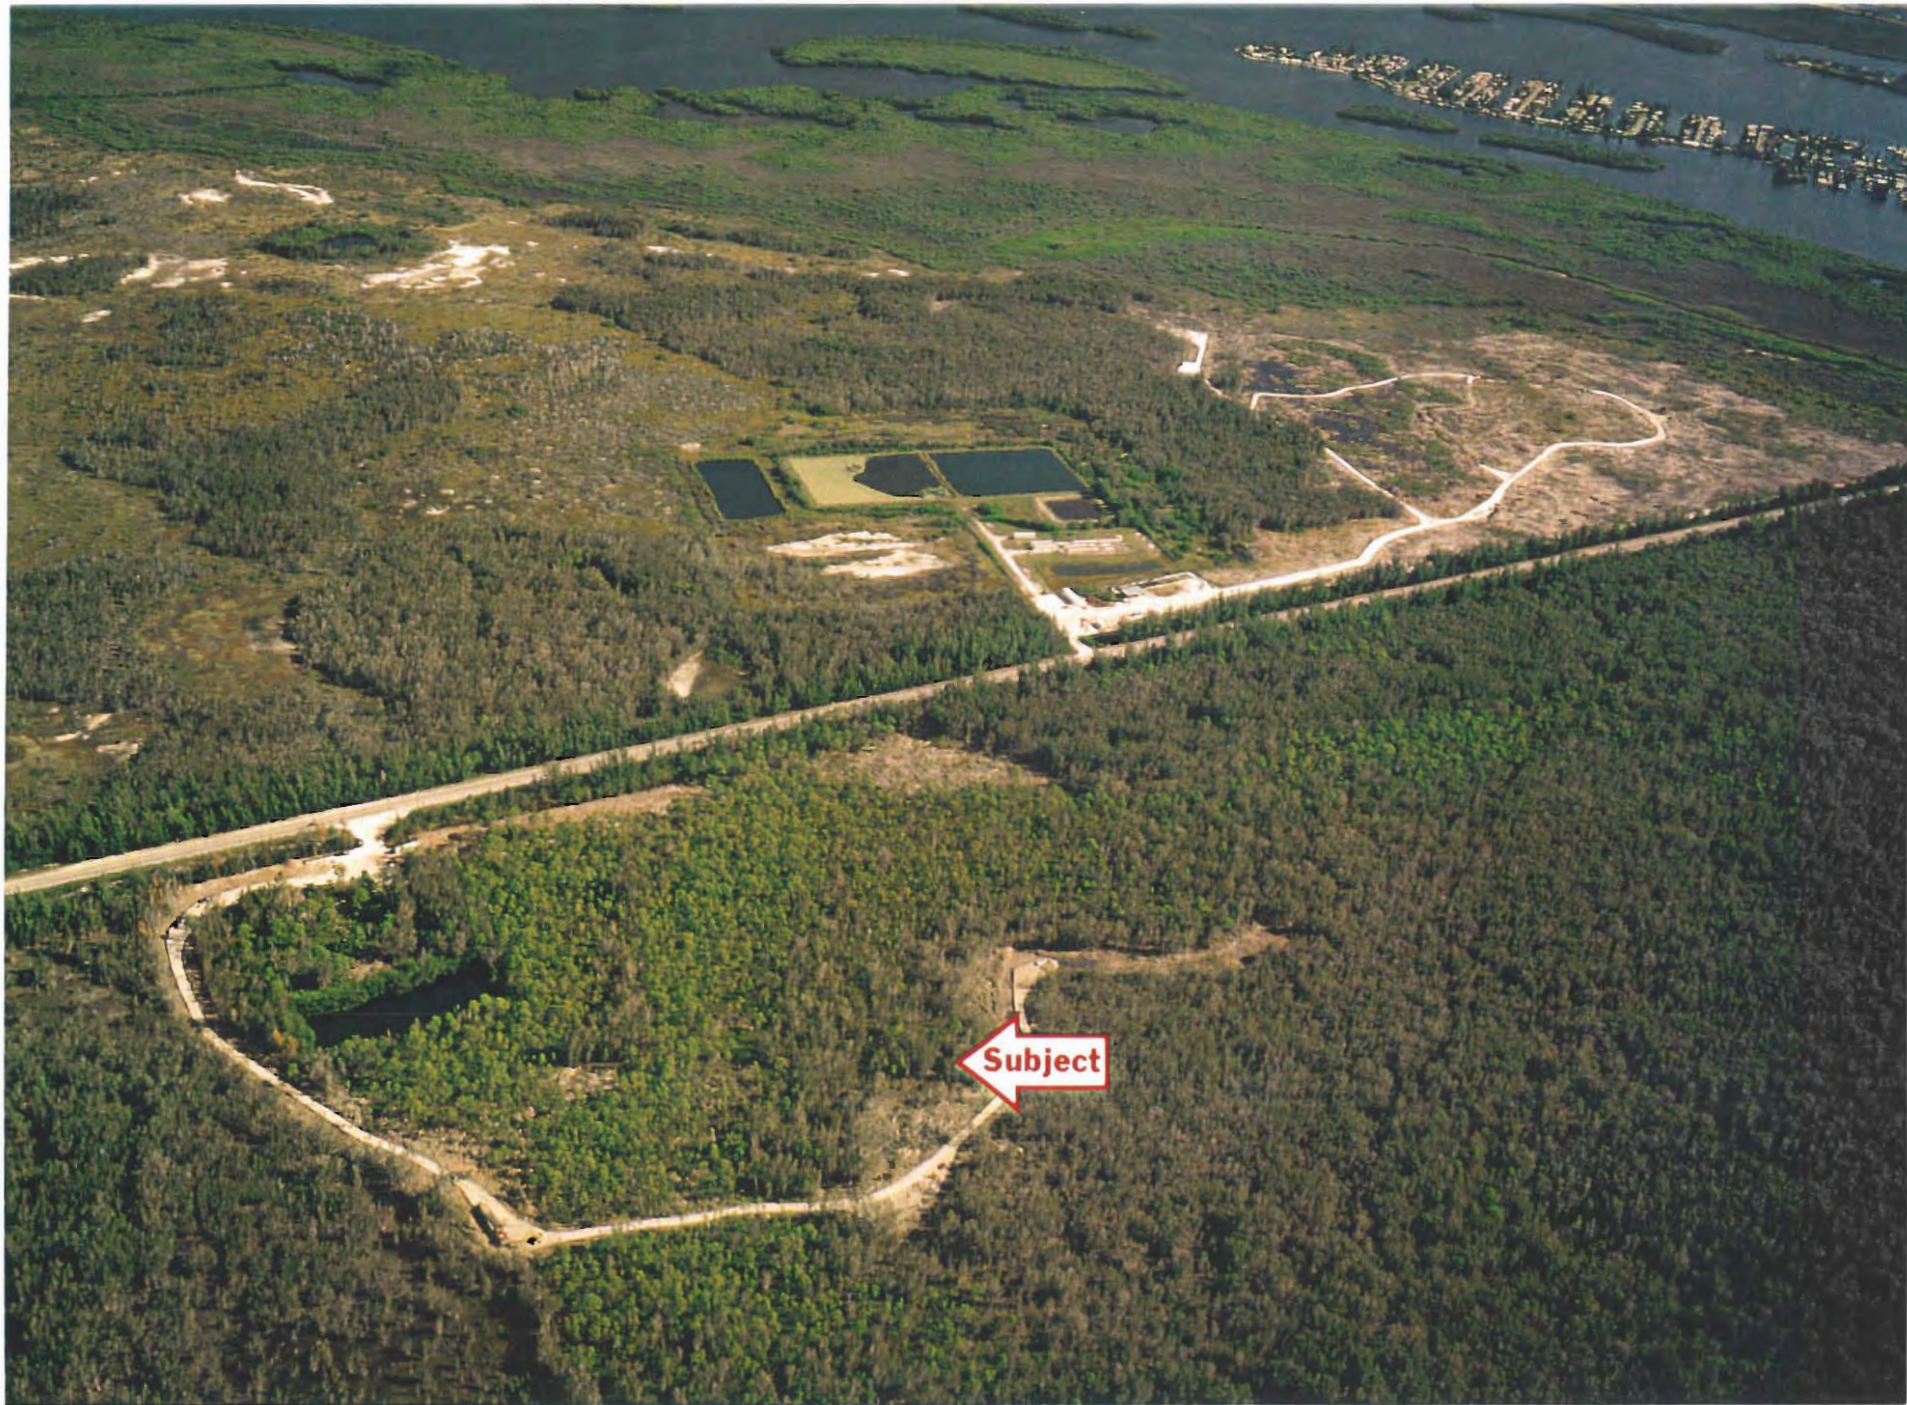
SEPTEMBER 1997 - COMMENCEMENT OF EXOTIC VEGETATION REMOVAL FROM FORESTED WETLANDS AT LITTLE PINE ISLAND

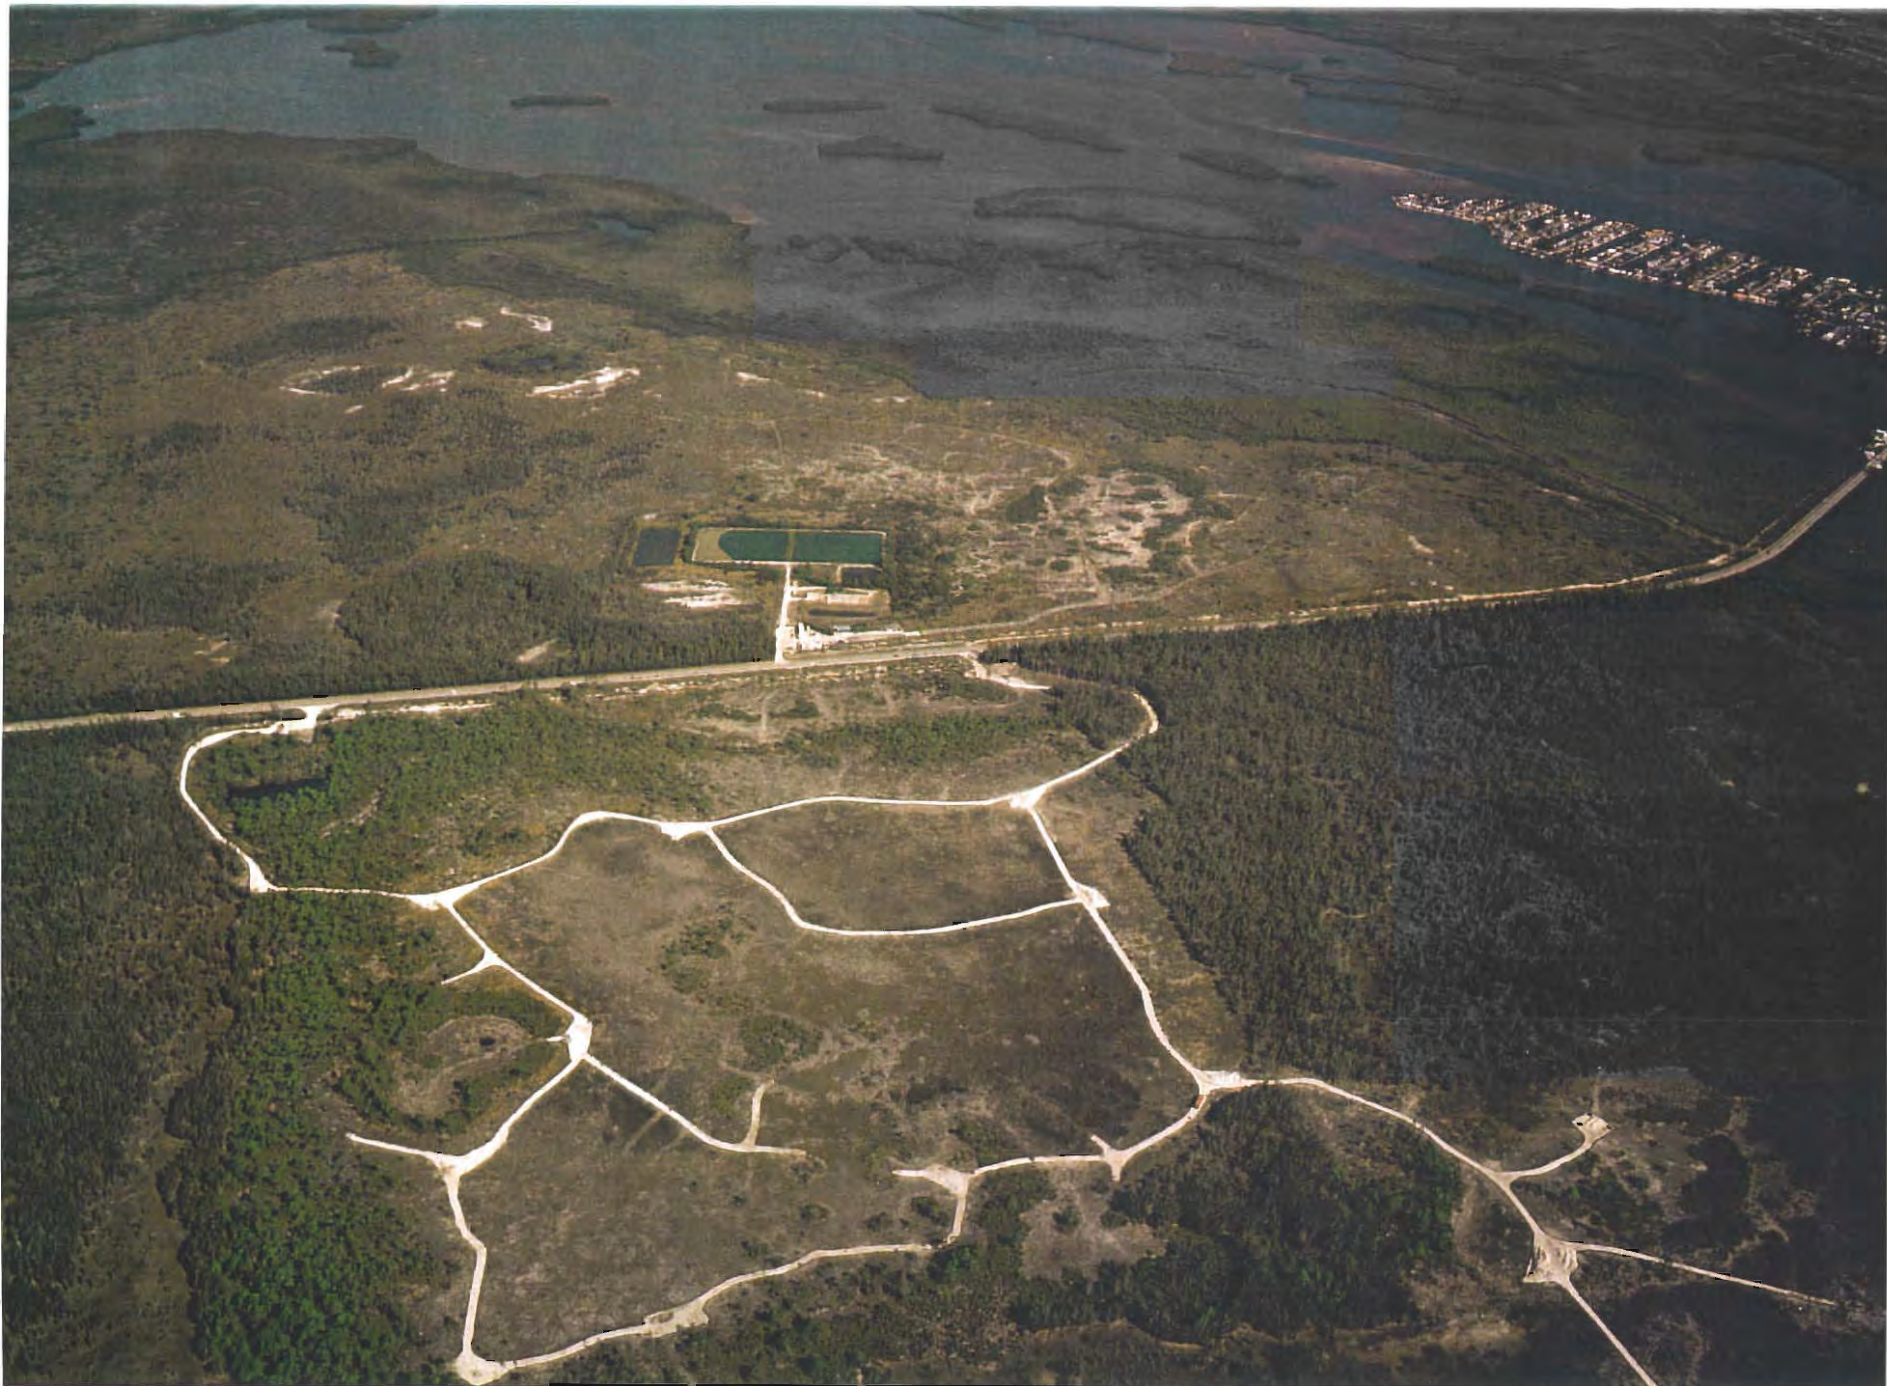
FEBRUARY 2000 - EXOTIC VEGETATION REMOVAL AND HYDROLOGIC RESTORATION OF LITTLE PINE ISLAND COMPLETED IN PHASES I, II, AND V. TEMPORARY ROADS REMOVED FROM PHASES I AND II.

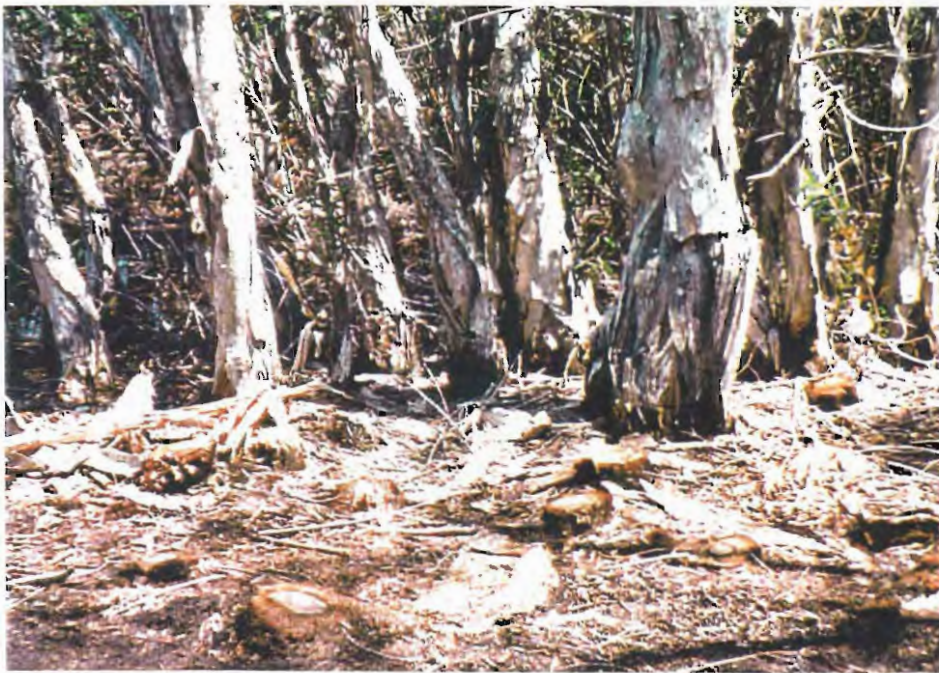
Dense melaleuca infestation in former herbaceous wetlands has greatly reduced wetland functions including wildlife habitat at Little Pine Island

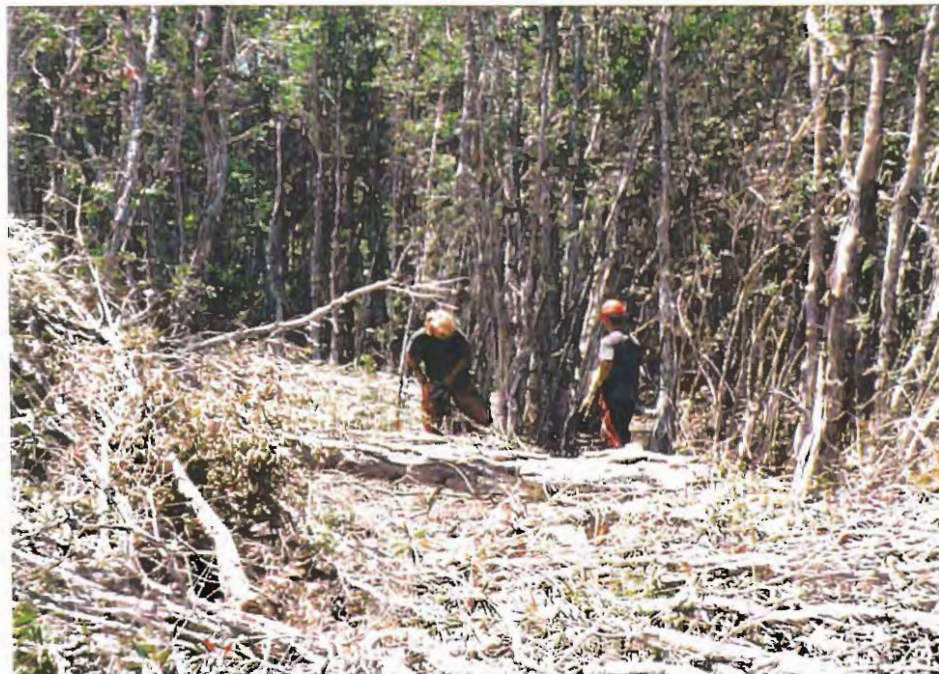
All exotic vegetation is cut using chain saws and manual labor so as to minimize the impacts to wetland habitat

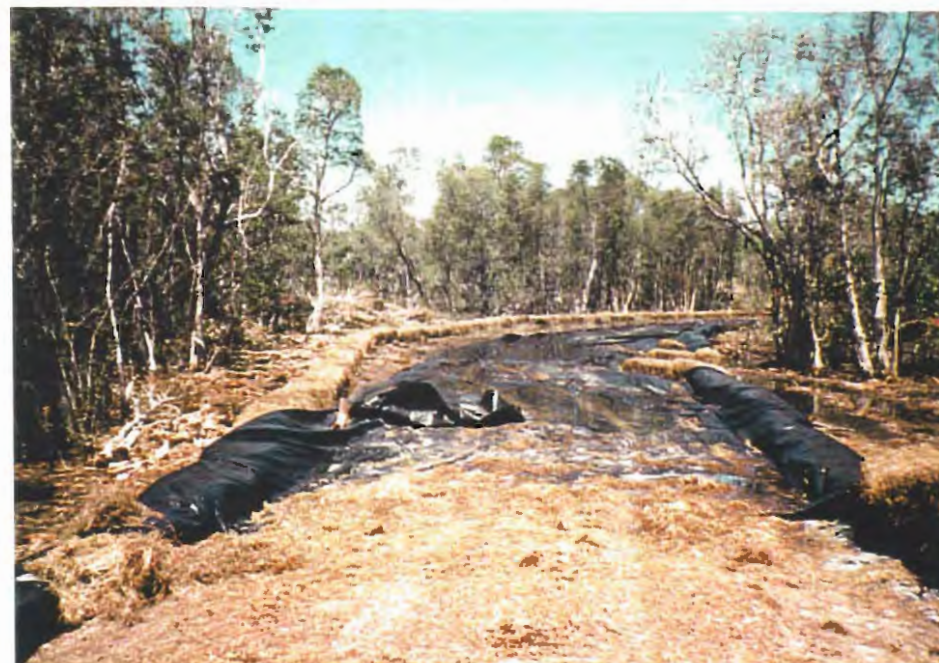
Temporary roads are underlain by filter cloth so as to reduce impacts to habitat and facilitate road removal

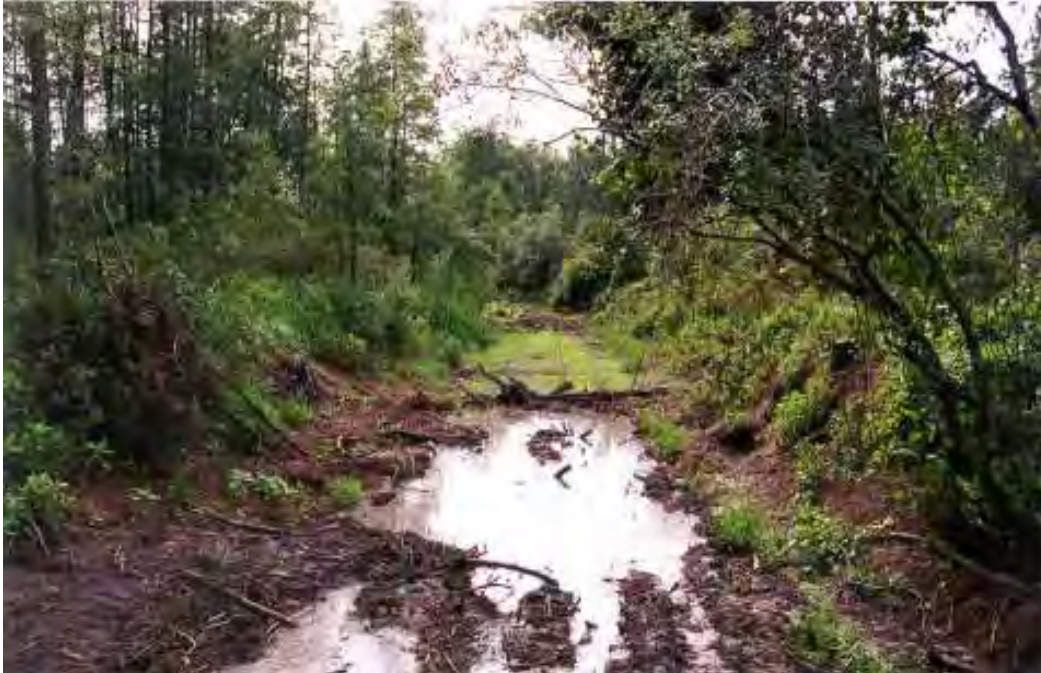
Spring, 2001 – view of the 1.3 mile east-west ditch prior to construction. The associated tram road fill material is located adjacent to the road (right). The substantial ditch dewatered the adjacent wetlands and the tram road diverted historic wetland drainage flow patterns.

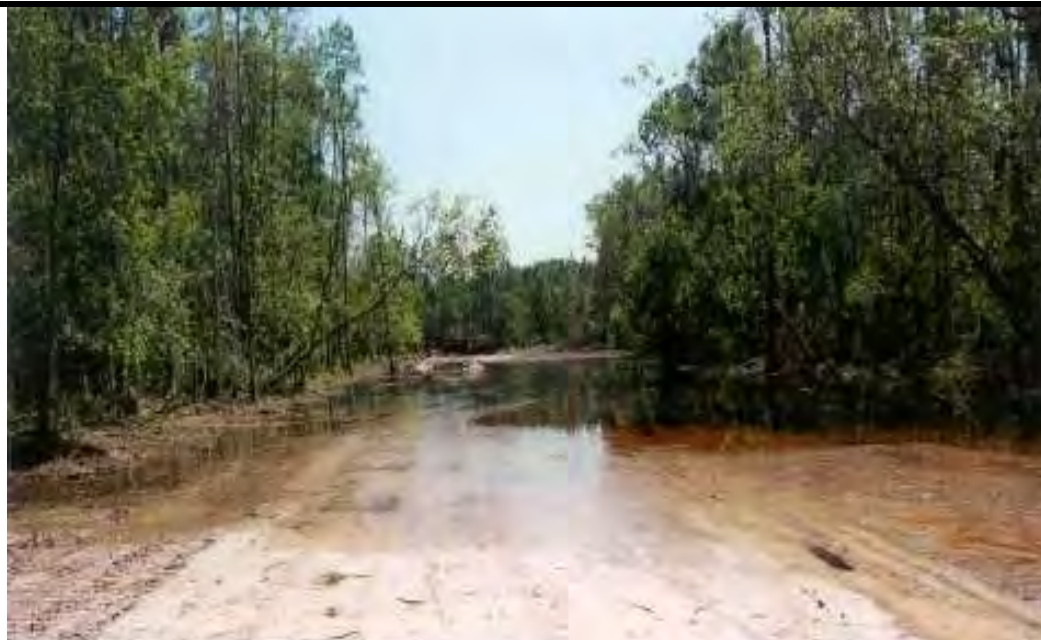
Summer, 2001 – same view as above, the ditch has been backfilled with the tram fill material. Ground and surface water sheet flow hydrology and associated hydroperiods have been restored to adjacent wetlands and within the footprint of the ditch & tram road.

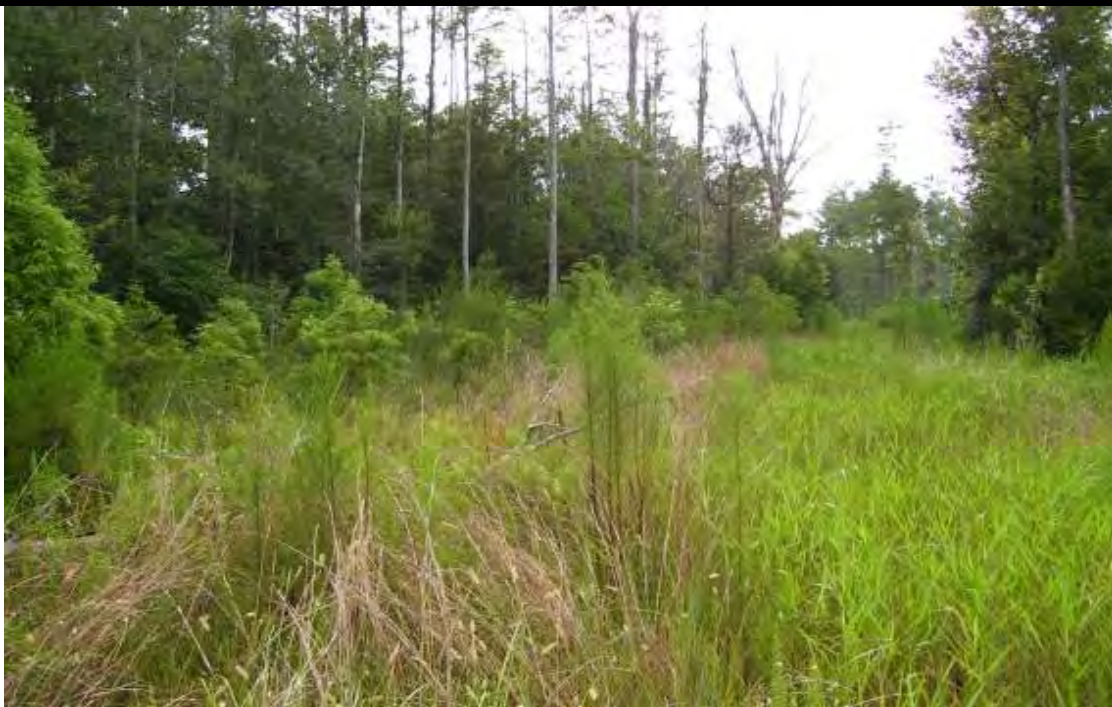
Summer, 2009 – same view as the previous photos. The restored wetland grade has naturally generated with herbs such as maidencane and broomsedge. Planted cypress and generated hardwoods & shrubs (e.g. red maple, sweet gum, wax myrtle) are present along the forested wetland edge (left).

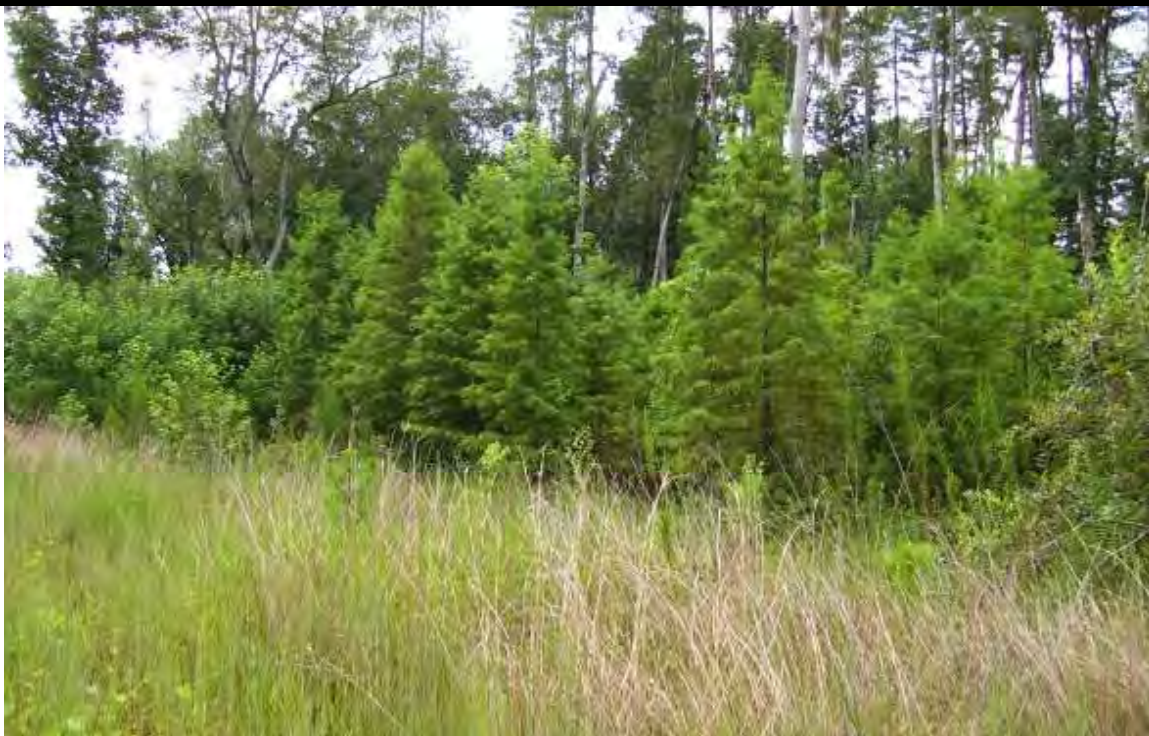
Summer, 2009 – majority of cypress planted within filled ditch has grown to heights taller than 20 ft., with hardwood saplings recruiting & generating within herbs.

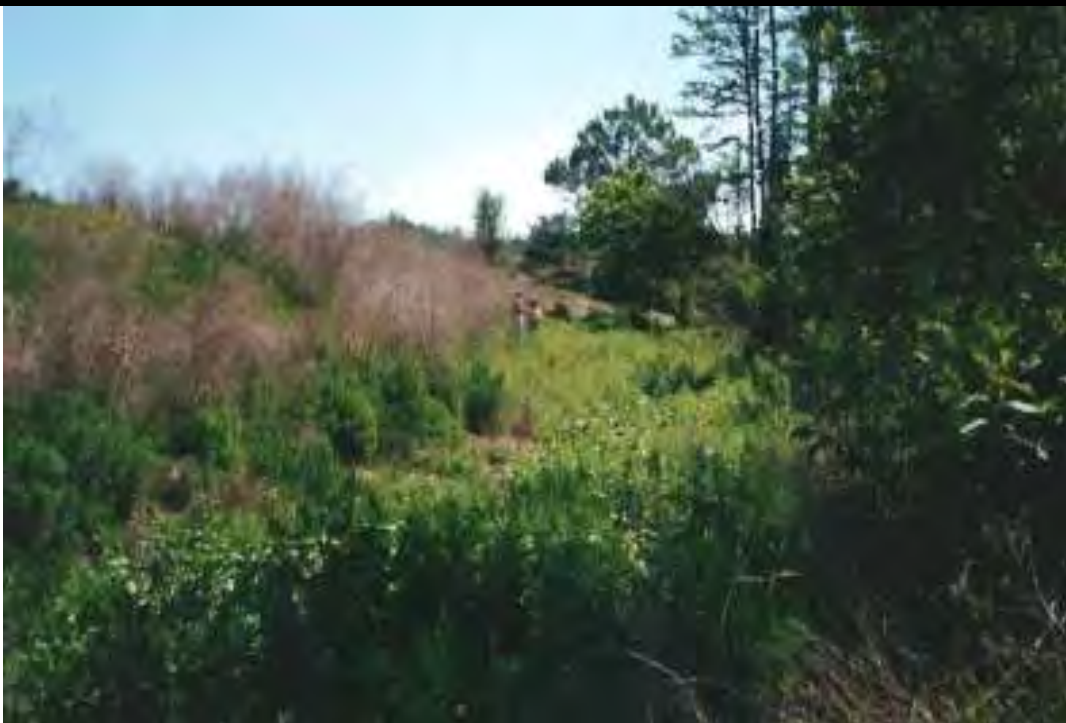
Summer, 2000 – along with bisecting some wetlands, ditch was also located along the perimeter of some wetlands (right), with associated deposited fill (left) blocking and diverting contributing flow to the wetlands.

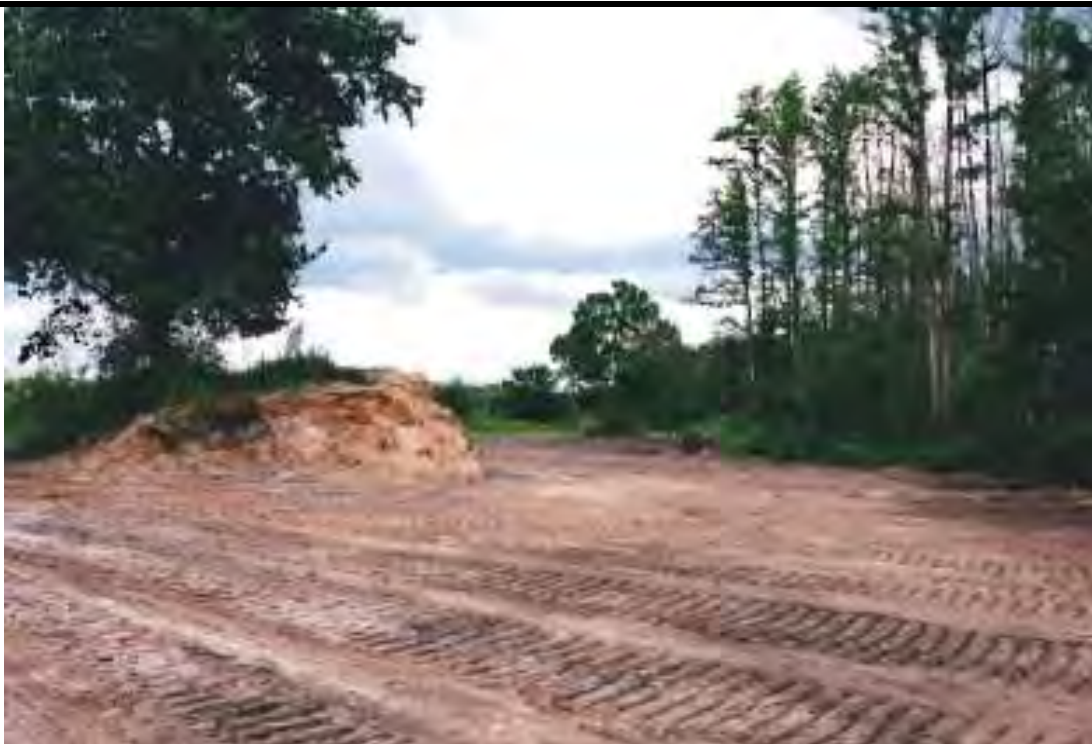
Summer, 2001 – same view of ditch segment after backfilling spoil material into the ditch. Some oak trees (left) were preserved from the earthwork activity.

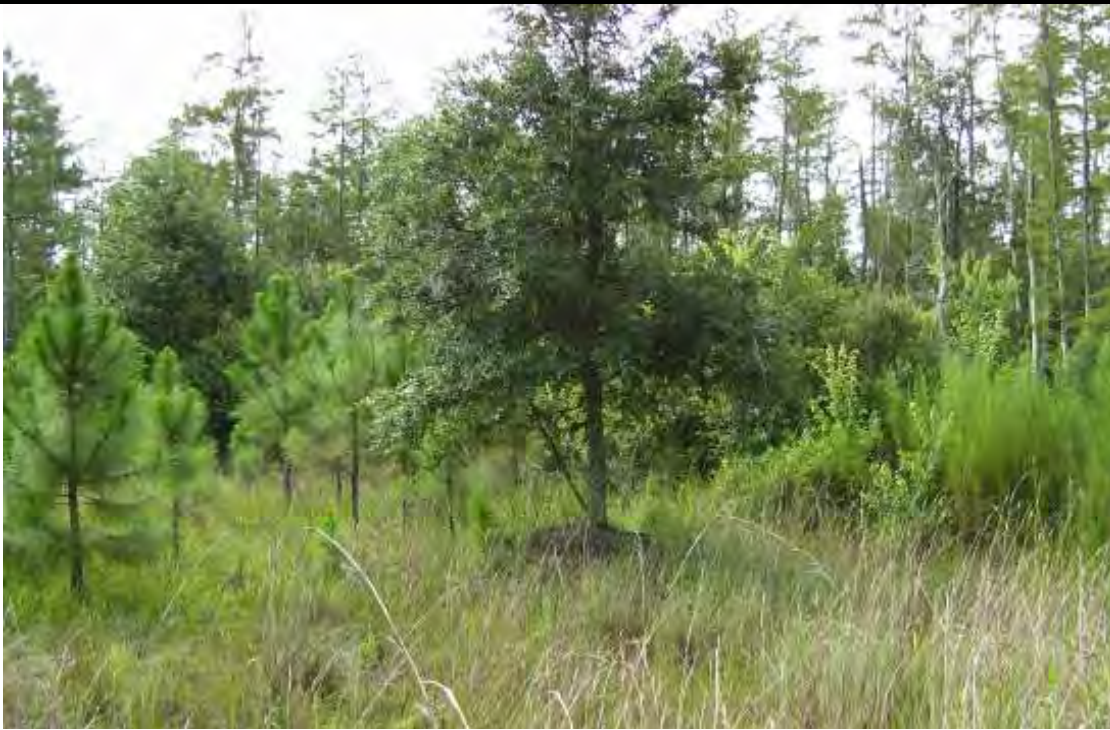
Summer, 2009 – the preserved laurel oak on the slight mound (center) was present along the lower inner edge of the tram road; the removed road (left) and filled ditch (right) has naturally generated ephemeral wetland habitat with slash pine & maple recruited over generated sedges.

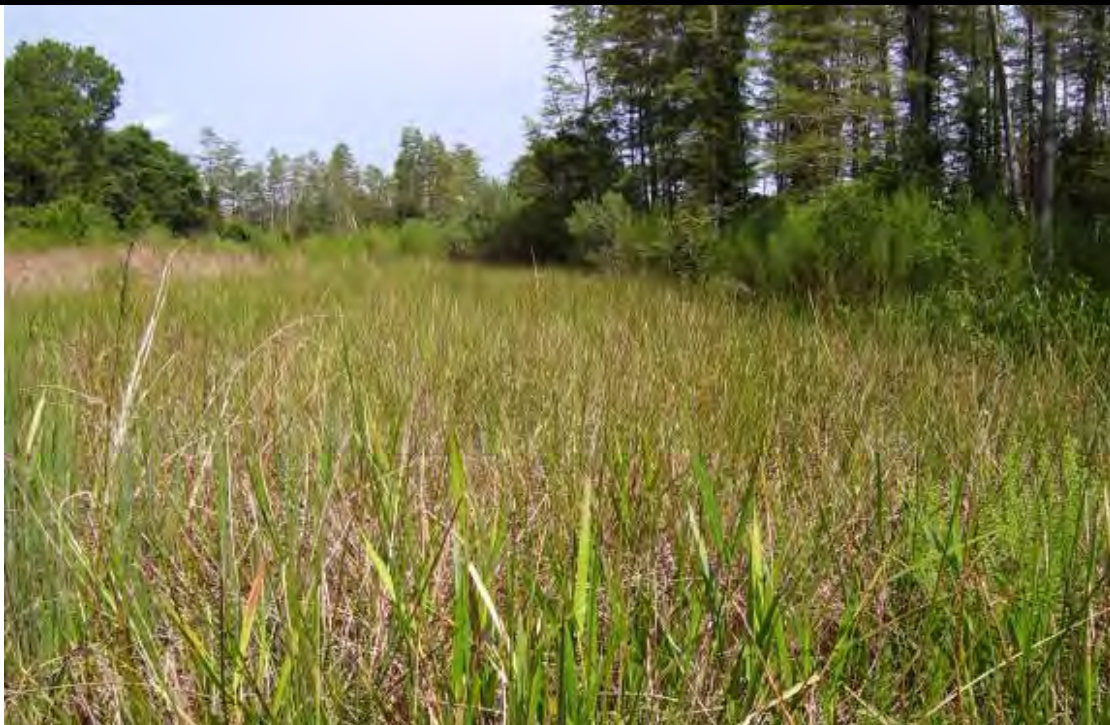
Summer, 2009 – this filled ditch and removed road segment has generated dense coverage of maidencane and soft rush that recruited from adjacent cypress dome.

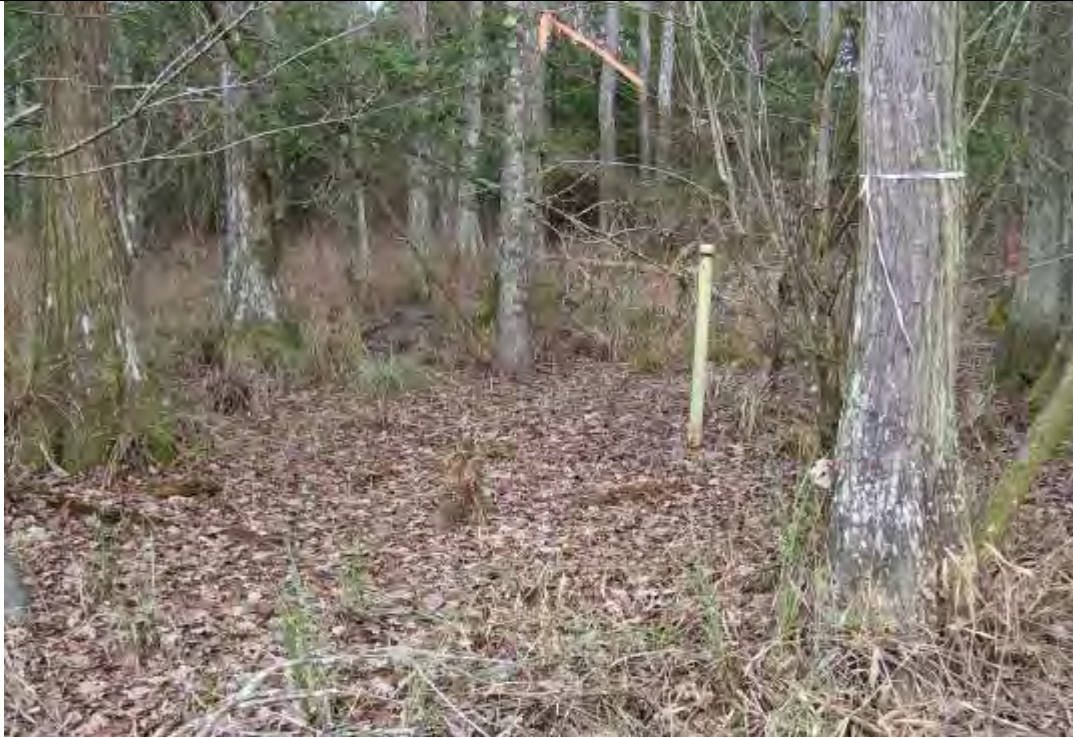
Summer, 2000 – prior to construction, monitor wells installed within wetlands have water levels consistently 4-5 feet below grade. No water stains on the well casings indicate the lack of adequate & appropriate hydroperiods.

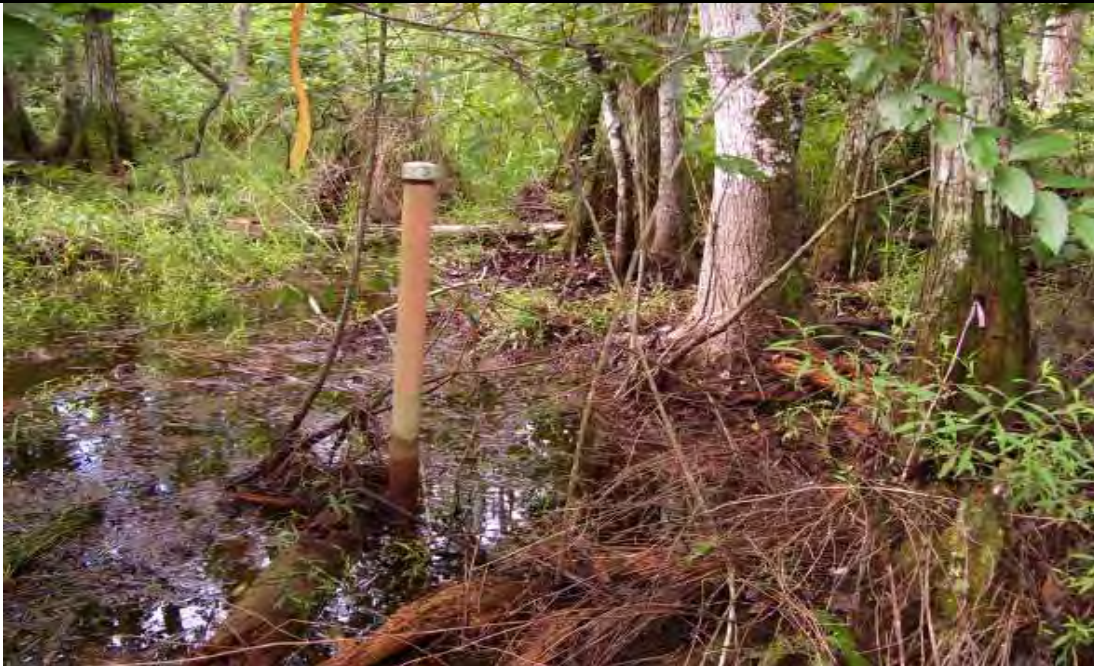
Summer, 2009 – as evident by the water stains on the well casing, restored hydrology has resulted in appropriate surface water hydroperiods within the wetlands during the rainy season.
