Southwest Florida
Water Management District

EDOT MITIGATION PLAN JANUARY 26, 2010

Southwest Florida Water Management District
Resource Regulation Division
Strategic Program Office
Brooksville, Florida 34604-6899

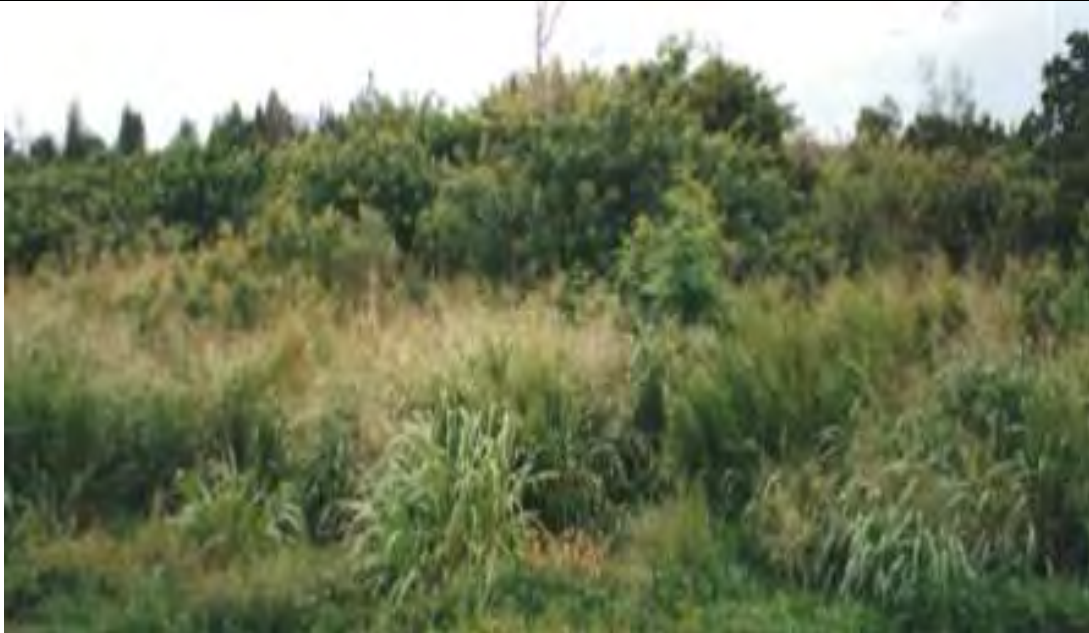
Pre-Construction (2002) – previously a row crop field prior to public acquisition, the site had generated extensive coverage of exotic and nuisance species such as Brazilian pepper, dog fennel, ragweed, ruderal grass species such as Guinea grass, and Australian pine.

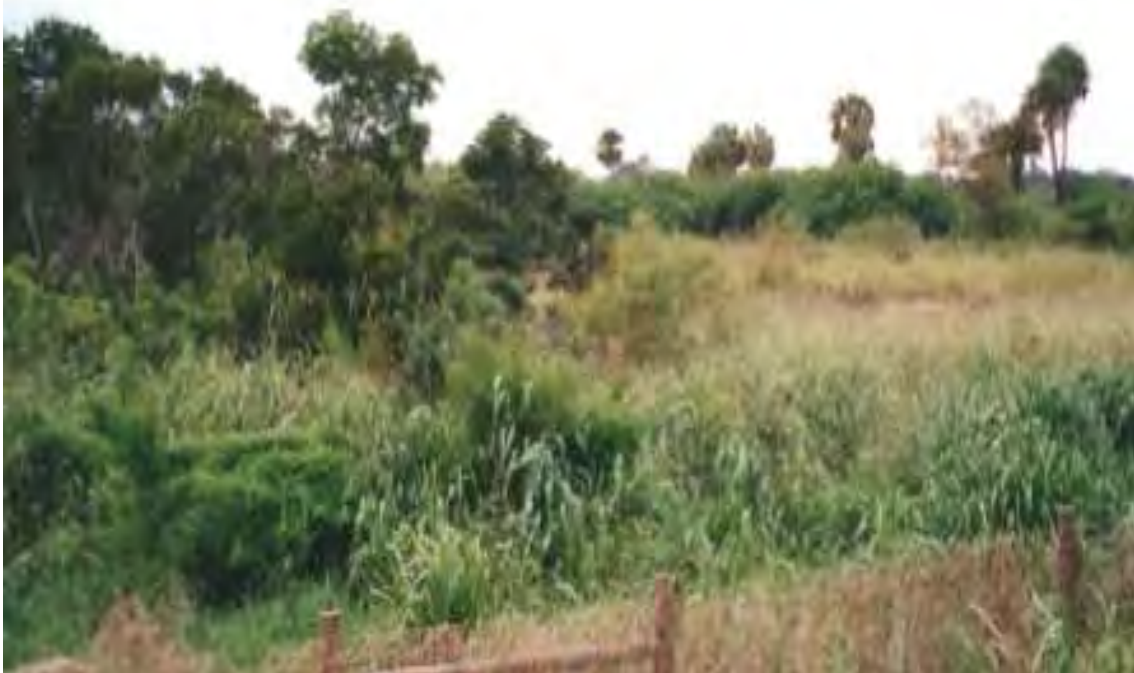
Pre-Construction (2002) – view from Cockroach Bay Road looking south over the site. The low quality ruderal habitat would have eventually transformed into a dense thicket of Brazilian pepper. Scattered cabbage palms (right) were preserved within the marsh creation design & coastal hammock buffer restoration activities.

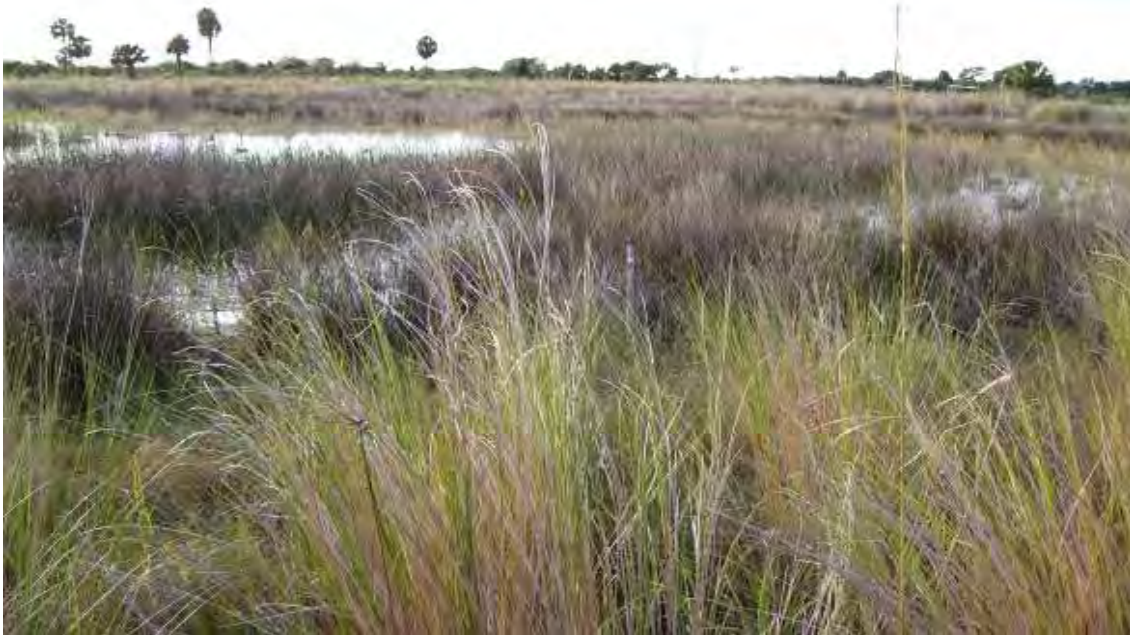
Current Post--Construction (2009) – created emergent marsh zones have dominant coverage provided by bulrush and black-rush, with additional coverage provided by pickerelweed, arrowhead, and water hyssops. The emergent zones have concentrated shallow surface water during the dry season, providing foraging opportunities for many wading bird and waterfowl species.

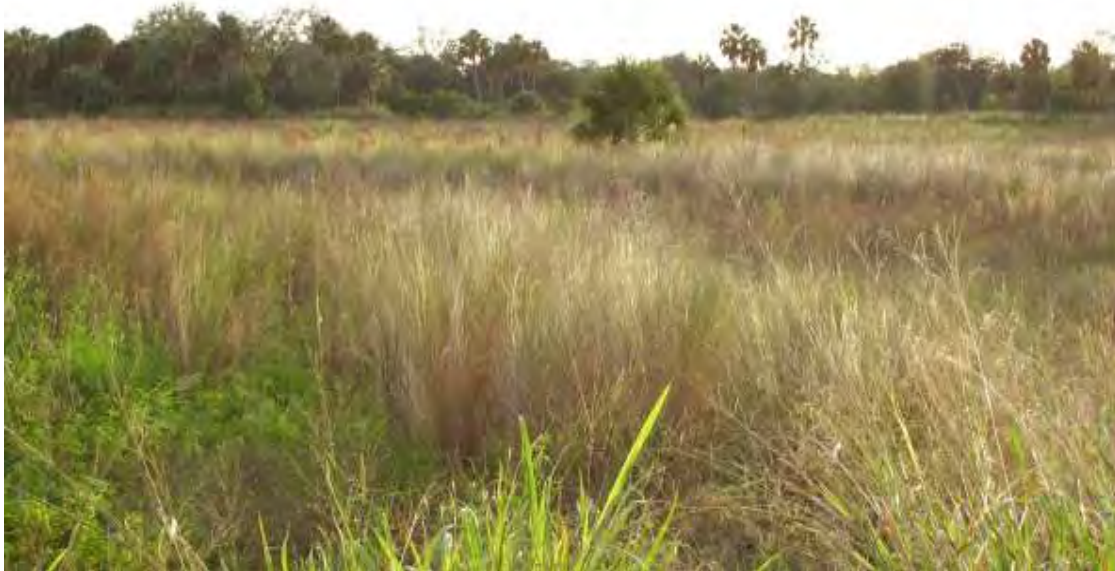
Current Post-Construction (2009) – created wet prairies have dominant coverage provided by sand cordgrass, salt-grass, broosedge, and hairawn muhly. These ephemeral zones provide foraging, nesting, and denning opportunities for wildlife species that also utilize the emergent zones and adjacent upland habitats. The project's southern limits and adjacent coastal hammock habitat bordering Cockroach Bay are evident in the background.

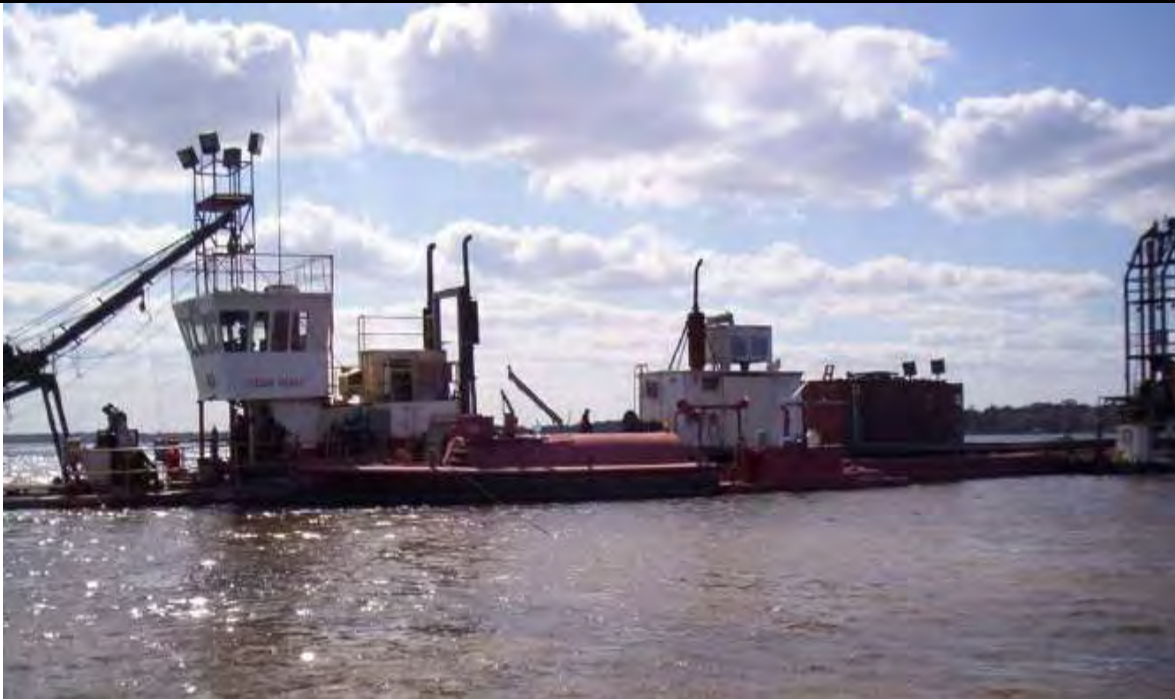
View of the barge used to hydraulically dredge the inorganic sediments accumulated within the bottom grades of Lake Panasoffkee.

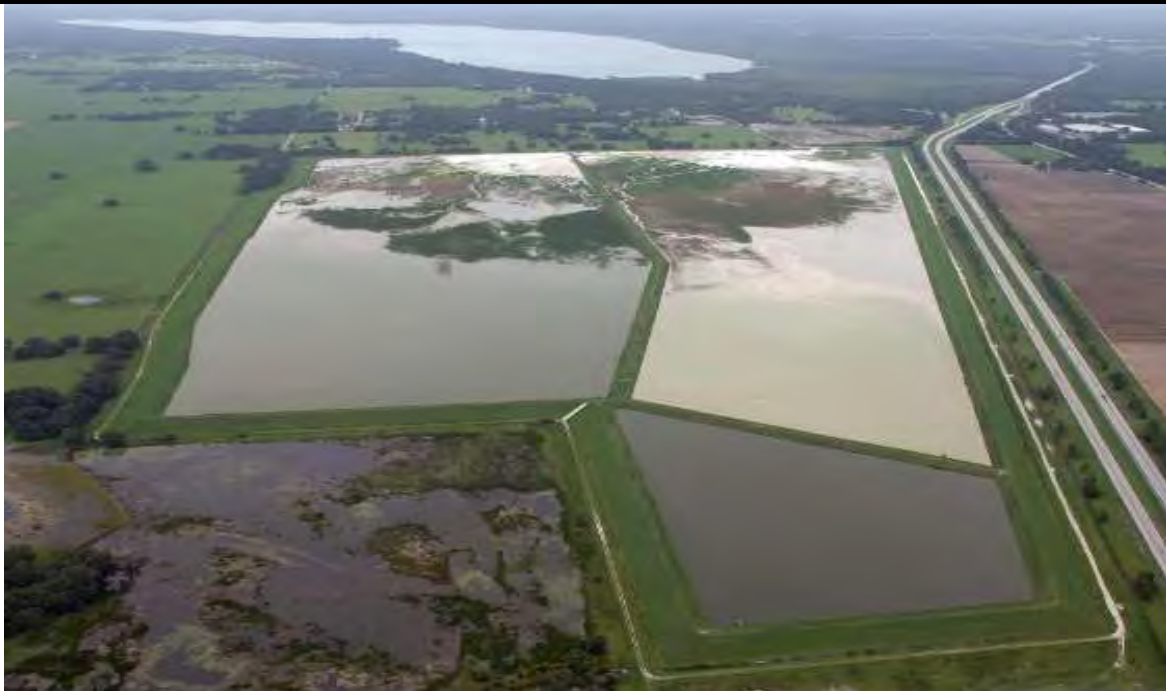
Aerial view of the sediment disposal cells constructed south of the lake (top of photo), the I-75 bridge wetland crossing being mitigated with this project is on the top right side of the photo.

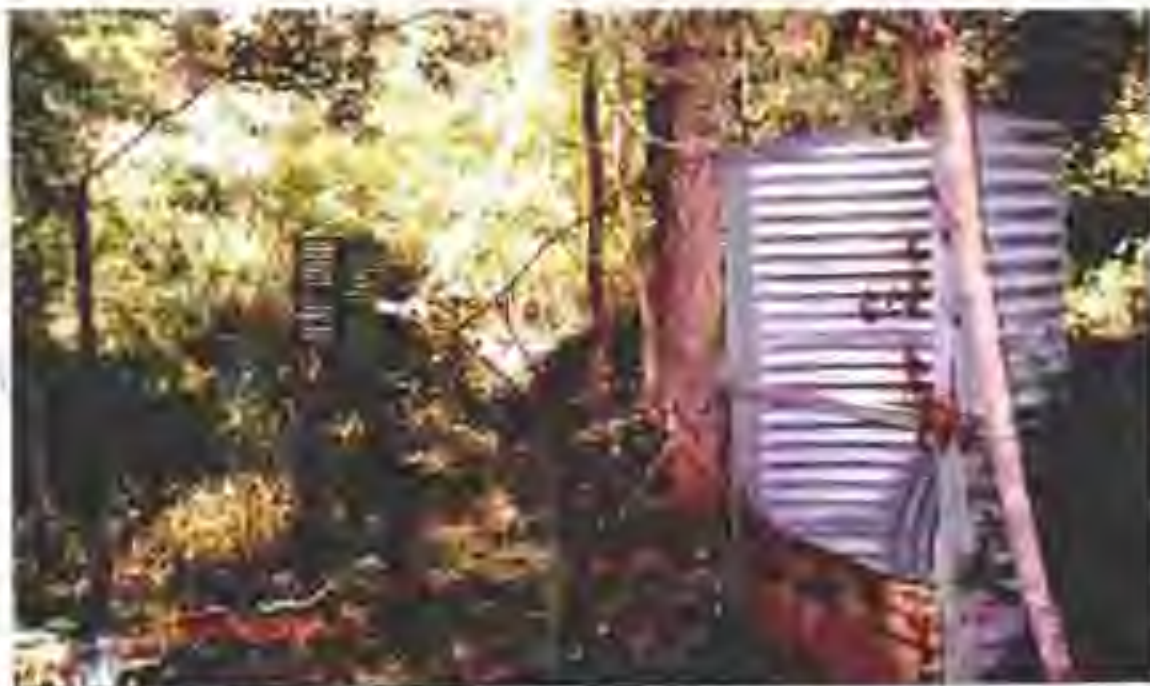
Photo 4 - The two outfall structures with flashboard risers that control the water elevation and flow from Ledwith Lake north to Levy Lake.

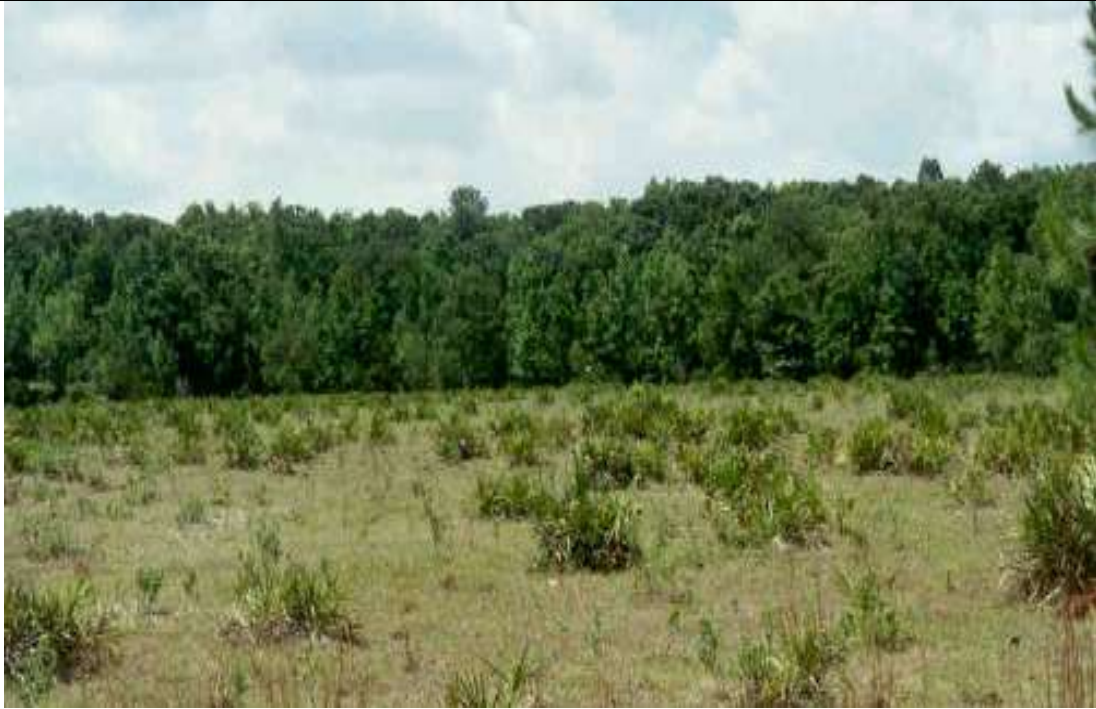
The palmetto prairies have been enhanced with pine plantings, bahia herbicide treatments, and incorporating a prescribed fire program.

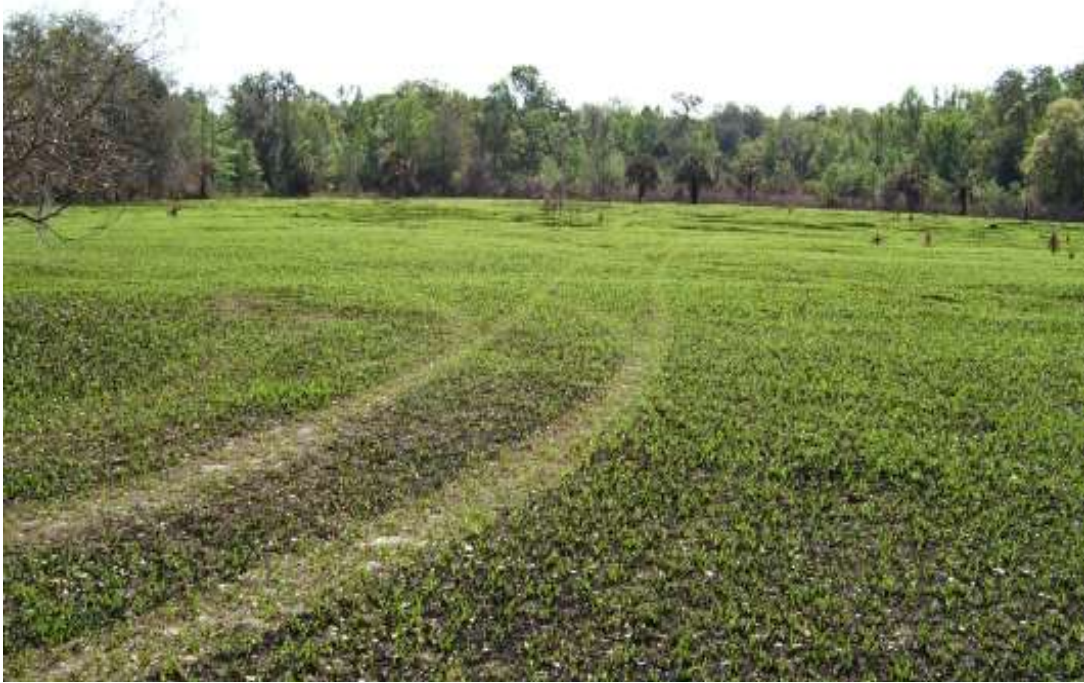
The upland restoration activities within the western side of the tract has incorporated a combination of herbicide treatments, prescribed fire program (photo taken after 2007 burn), native species seeding and plantings.

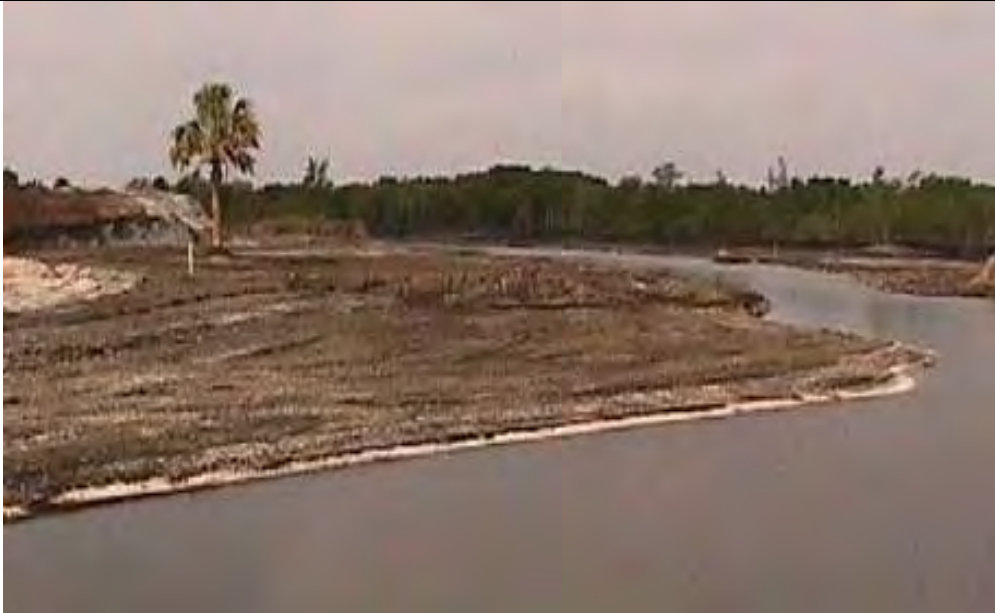
During 2003 construction of the northern tidal pool and creek system, included removal of stockpiled spoil material and lowering grade to allow tidal connection and flow.

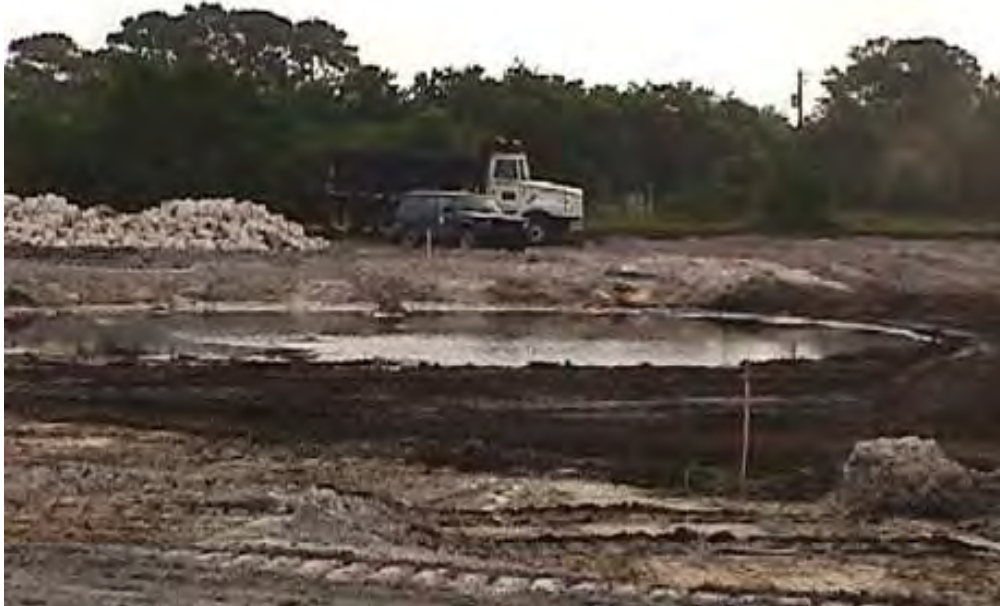
Some fill material removal and the 2003 grading of the field was conducted to create a circular ephemeral freshwater marsh.

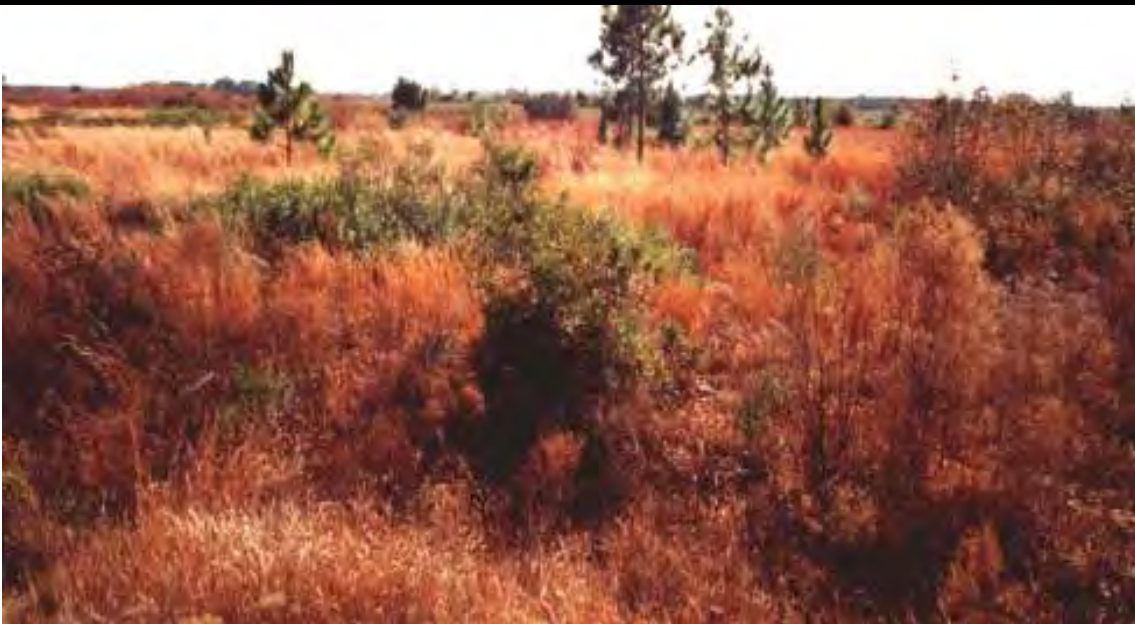
Wetland 12 (2001) – Pre-construction view of habitat conditions, due to the substantial water table drawdown associated with the ditch network, the marsh is dominated by upland and facultative species such as broomsedge, gallberry, dog fennel, wax myrtle, and scattered slash pine.

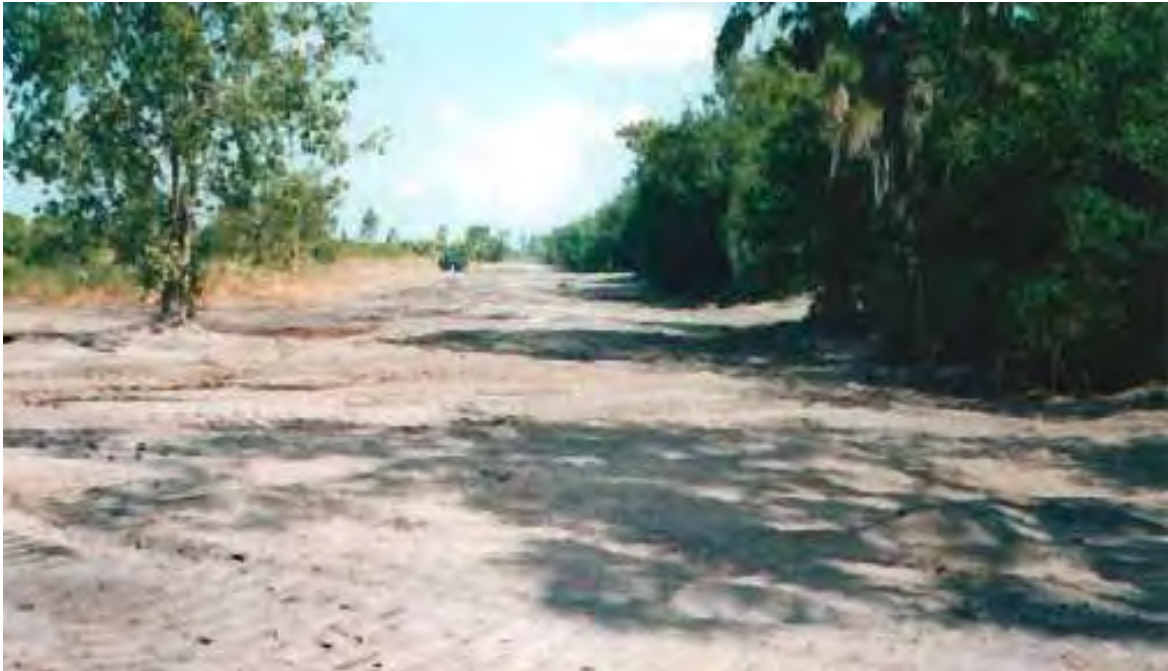
Wetland 12 (Spring, 2002) – view from the southern terminus of the marsh, looking north over the western half of the 22-acre marsh and filled central ditch, trees on right are located on remnant spoil material not used for backfill.

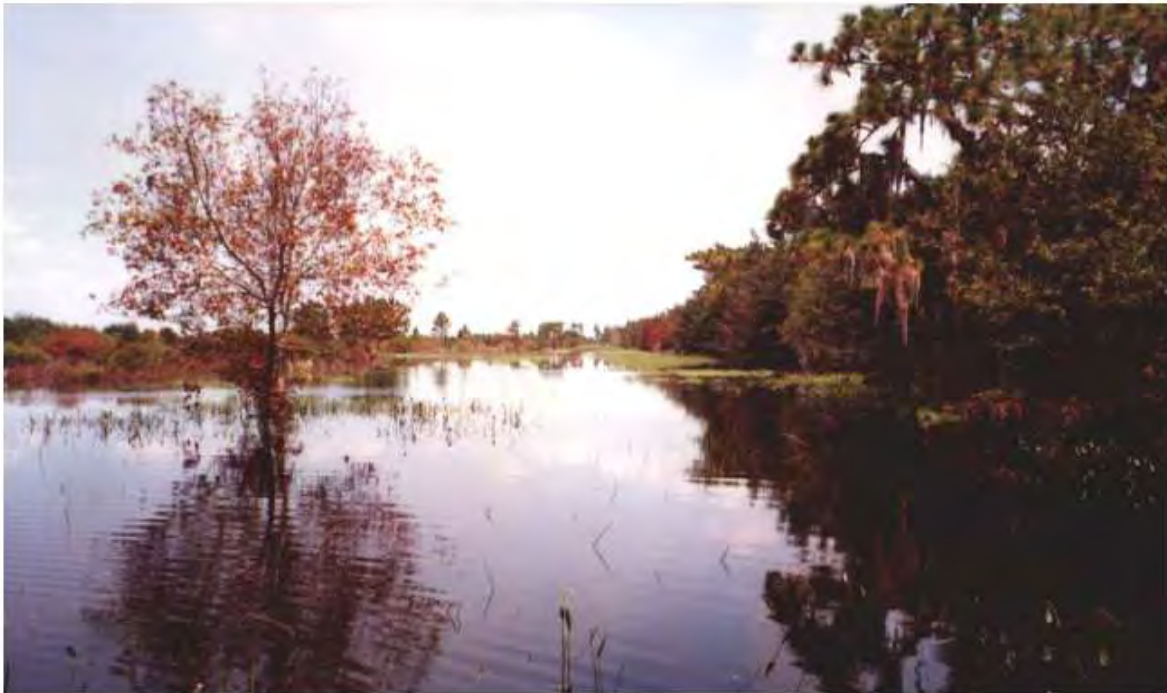
Wetland 12 (Summer, 2002) – summer rains have restored appropriate emergent marsh hydrology, resulting in mortality of upland vegetation and natural generation of hydrophytic herbs.

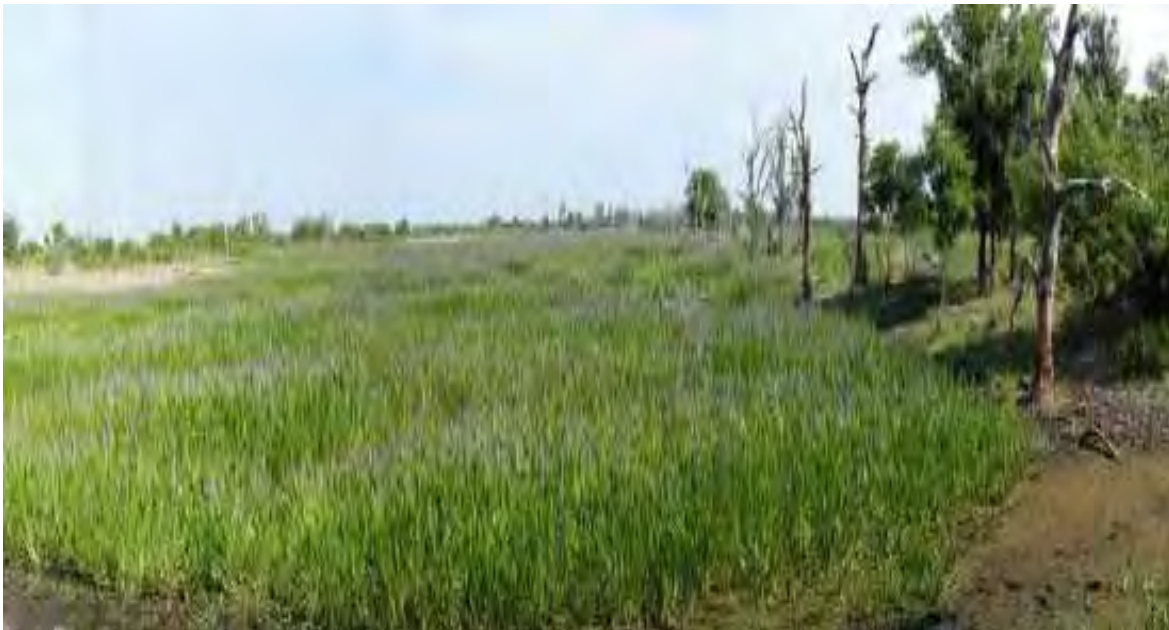
Wetland 12 (Summer, 2009) – with herb plantings in the filled ditches in 2002, supplemental plantings throughout the marsh in 2004, regenerated and recruited herbs, the marsh has gradually filled in with dense coverage of species dominated by pickerelweed, arrowhead, and fireflag. Some live trees and snags are still present on the remnant spoil mounds.

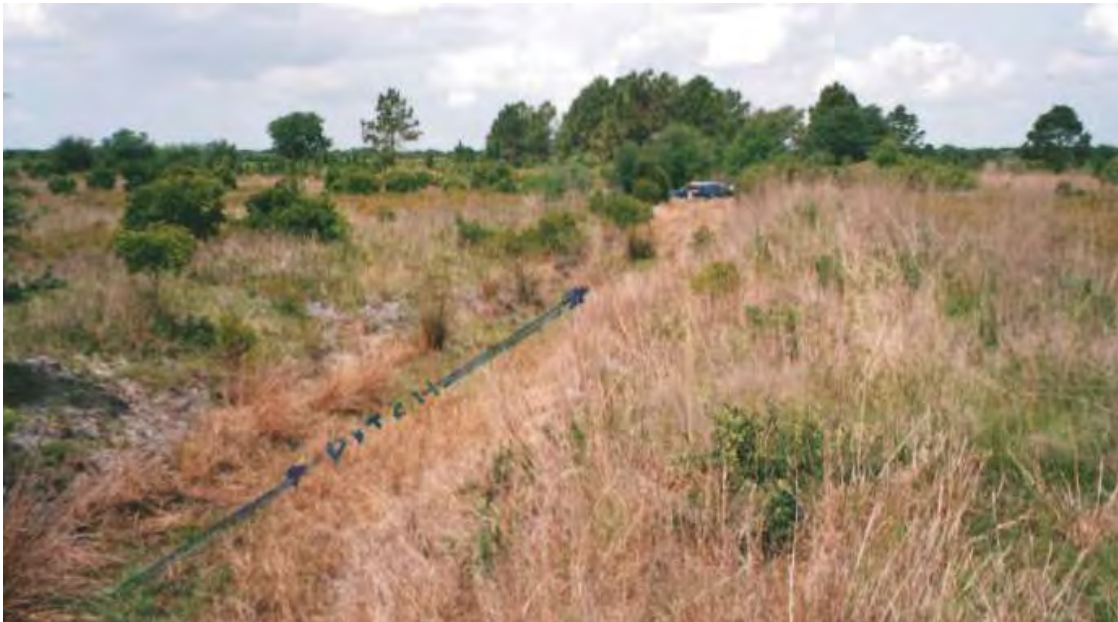
Wetland 6 (2001) – Pre-construction view of habitat conditions from the eastern portion of the marsh looking west. Under natural conditions, the ephemeral, wet prairie marshes have shallow and short duration hydroperiods, so even small ditches (center) adequately drawdown the water table and substantially reduce the hydroperiod, resulting in the establishment of facultative species such as broomsedge, gallberry, dog fennel, and wax myrtle.

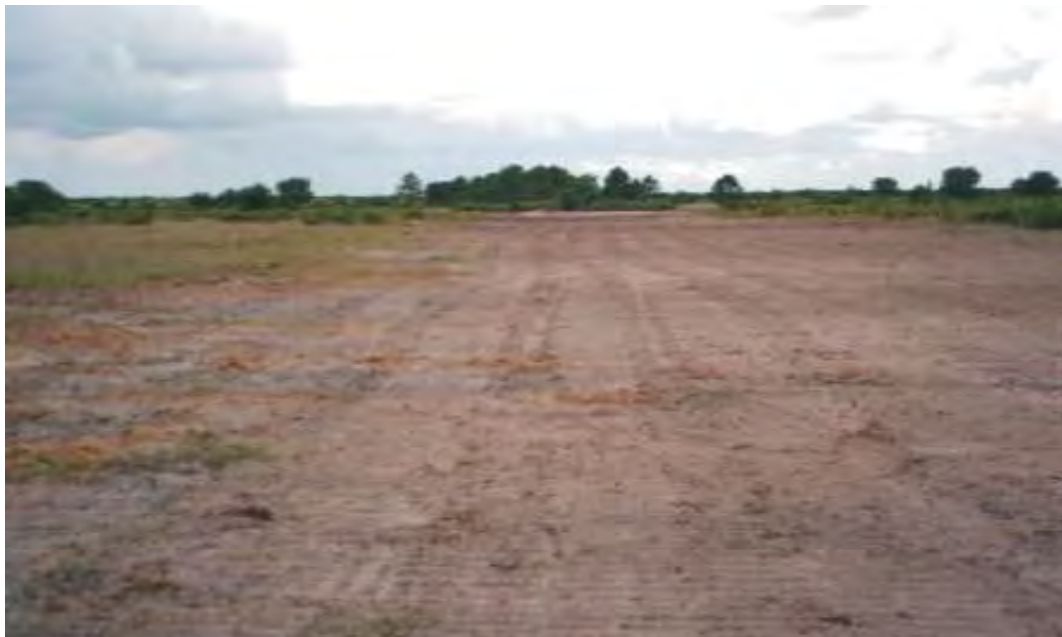
Wetland 6 (Spring, 2002) – same western view over the earthwork area of the graded spoil material and backfilled ditch.

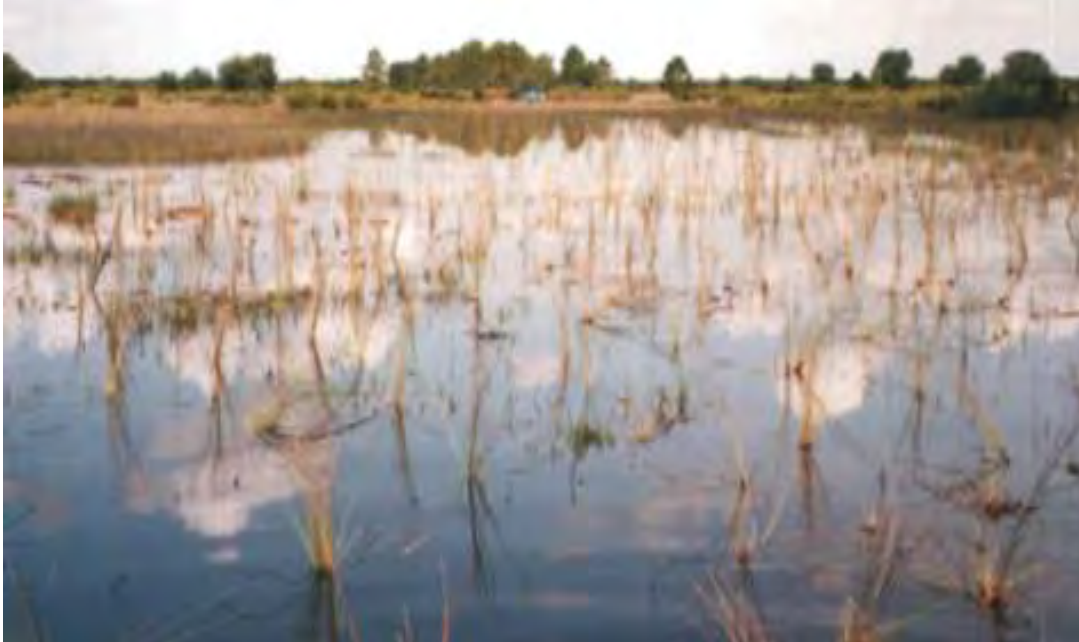
Wetland 6 (Summer, 2002) – summer rains have restored appropriate wetland hydrology; the graded area has been planted with soft rush.

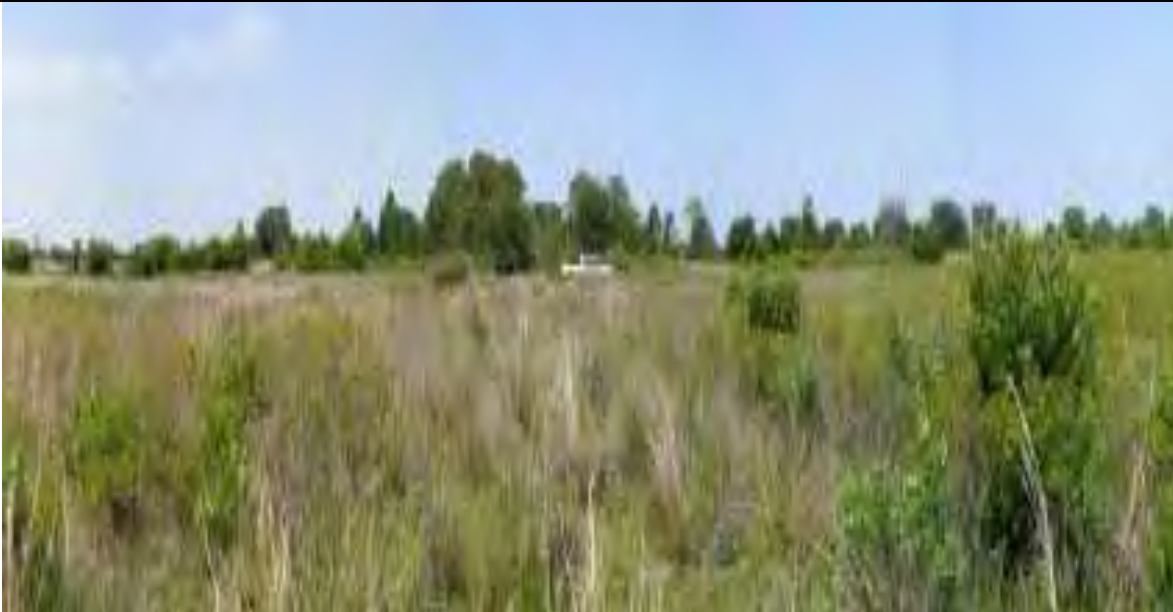
Wetland 6 (Summer, 2009) – the restored ephemeral hydrology has provided longer hydroperiods of shallow surface water, resulting in more desirable and diverse vegetative and habitat conditions utilized by more wildlife. Of particular note is the regeneration and proliferation provided by St. John's-wort.

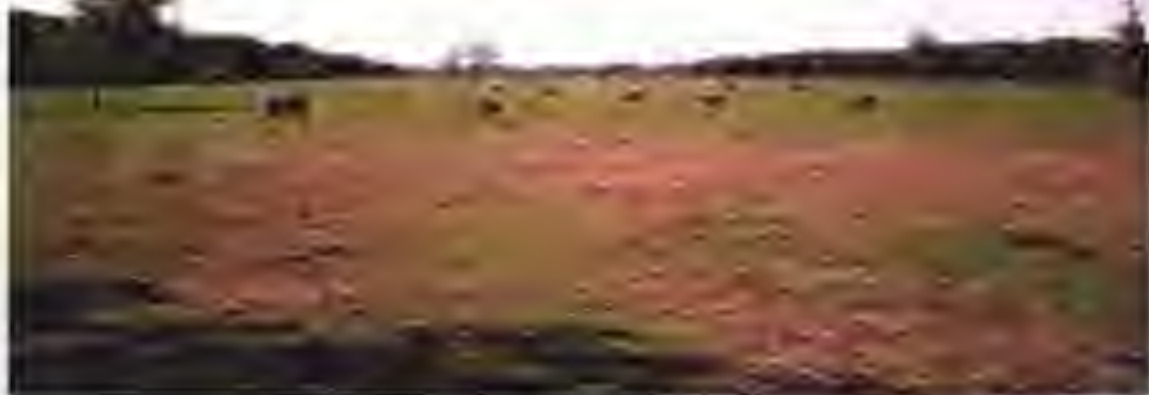
View of the northeast bahia pasture prior to marsh restoration, looking east from near the lakeshore berm. Banana Creek Canal with oaks on adjacent spoil material (left) and northern upland oak hammock (right).

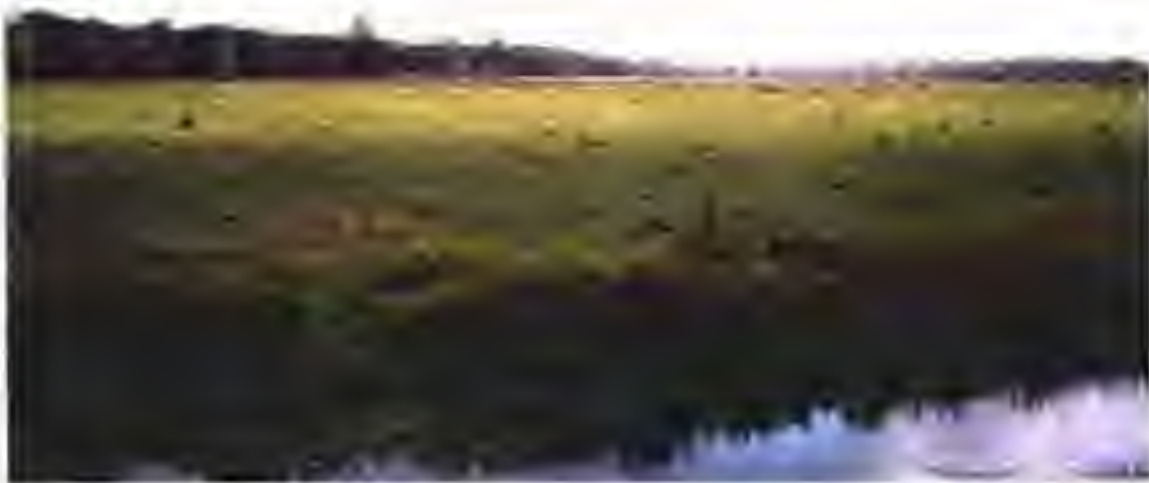
View from atop the remnant central berm prior to construction. Overlooking the adjacent drainage ditch and northeast bahia pasture.

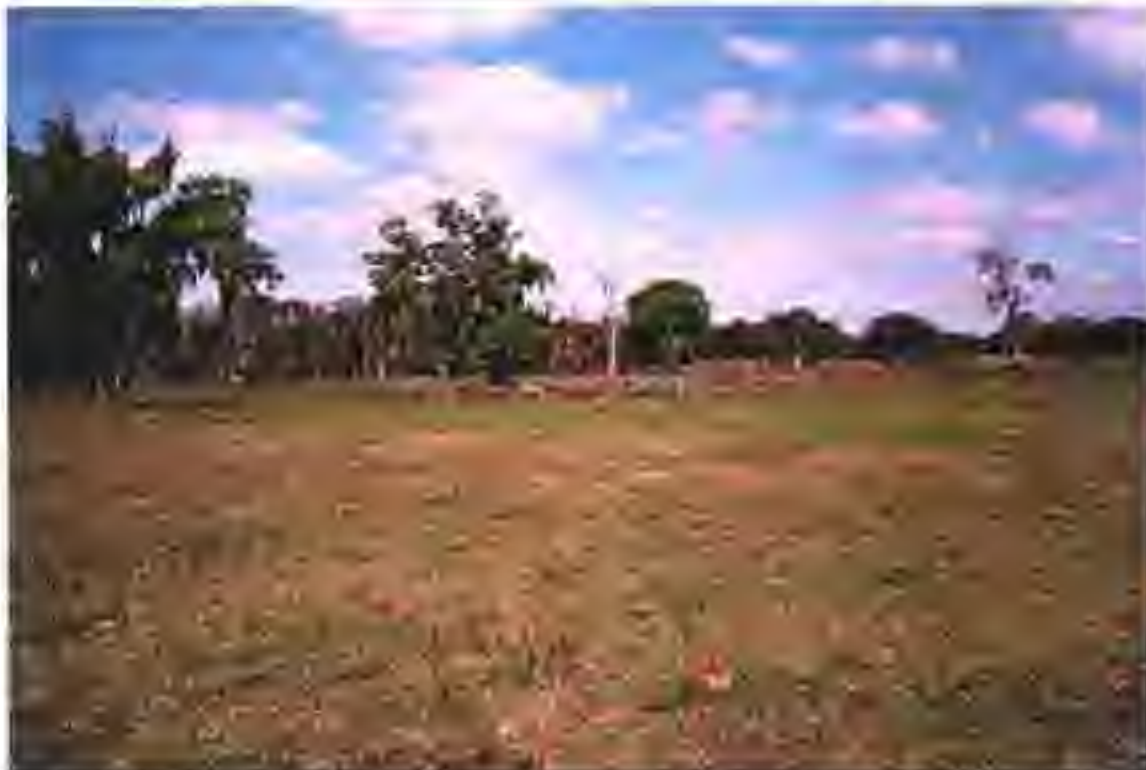
View from the southwest property boundary, looking north at the western pasture that was historically forested wetlands. The remnant forested wetland is in background (left). The lone tree on the far right is the flagged tree in the photo below.

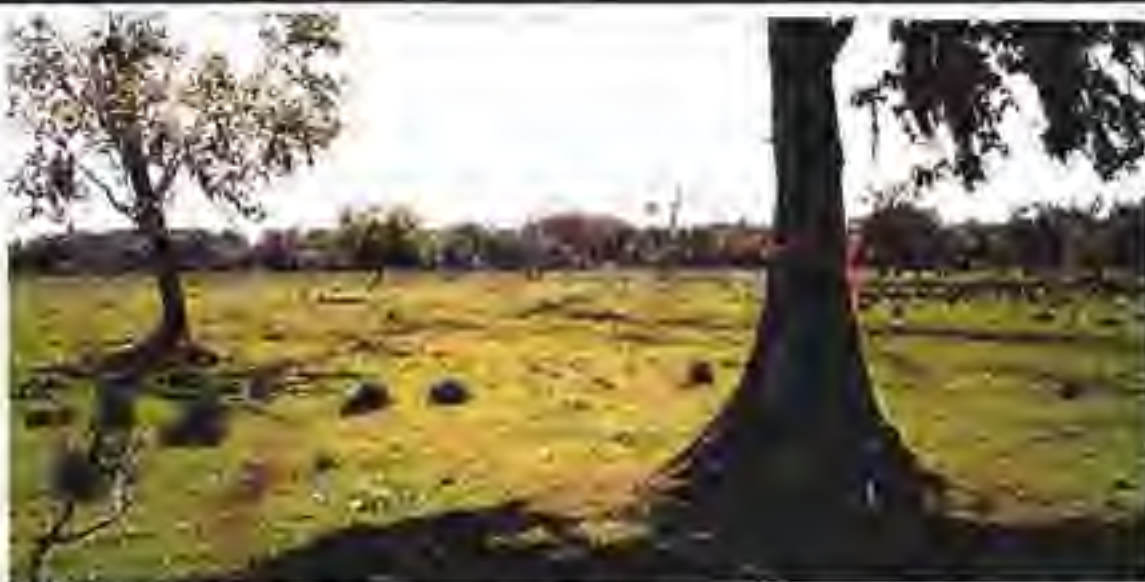
Opposite view from the top photo, where the access road crosses the western pasture proposed for forested wetland restoration. There is sufficient groundwater hydrology to support scattered soft rush, particularly adjacent to the remnant forested wetland (right).

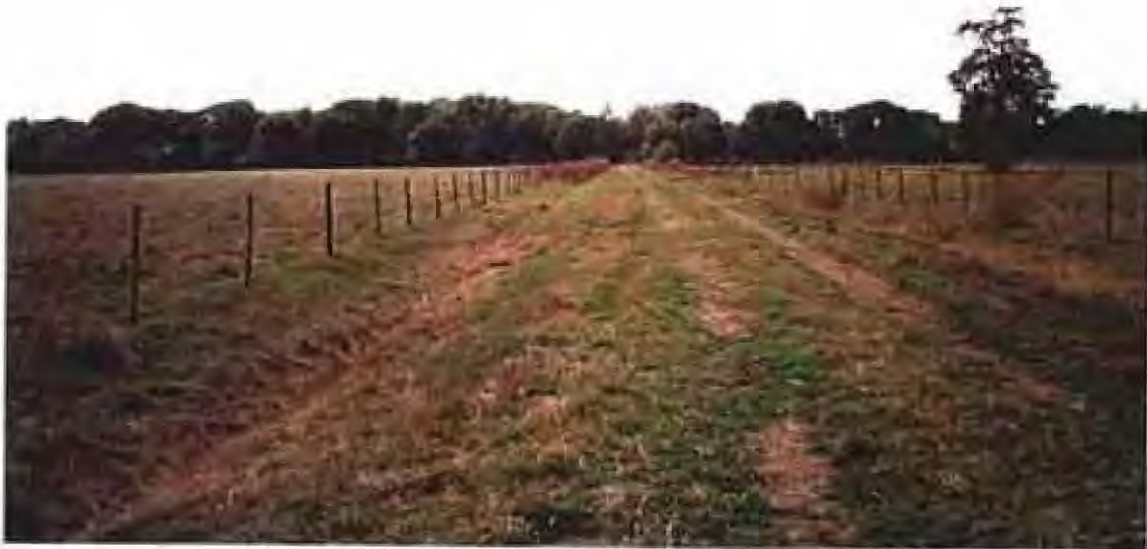
View south of the north portion of East Road where it crosses the northeast pasture. The Banana Creek Canal with trees on the adjacent spoil material is in the background. The road will be elevated and culverts installed to restore west-east surface water sheet flow and adjacent marsh habitat.

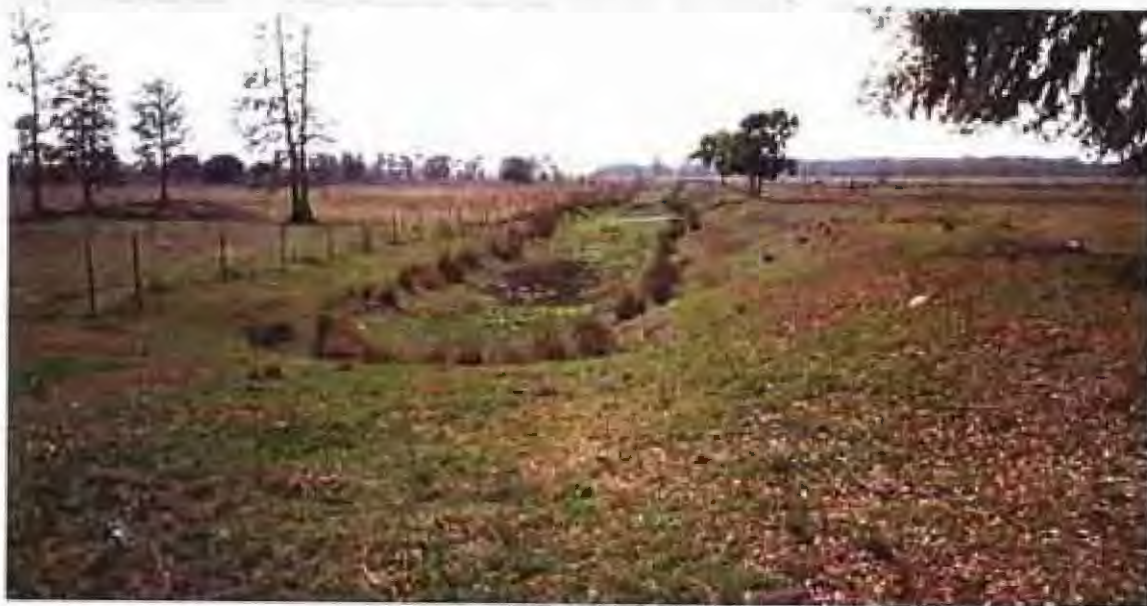
View south from the north end of the remnant and unstable Center Road and adjacent ditch that diverts and drains water south to the Banana Creek Canal. The ditch will be backfilled and clean fill used to reconstruct and elevate the road to restore west-east sheet flow hydrology and adjacent marsh habitat.

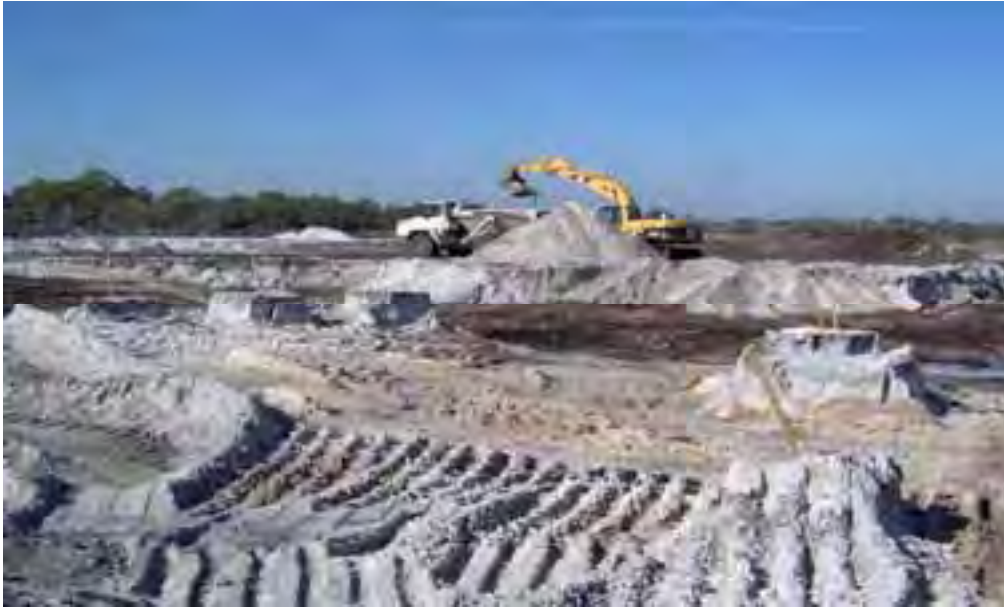
***View of the southwest Gator Pond during earthwork activities.
Dredging material used to stabilize the Center and Eastern Access Road berms.***

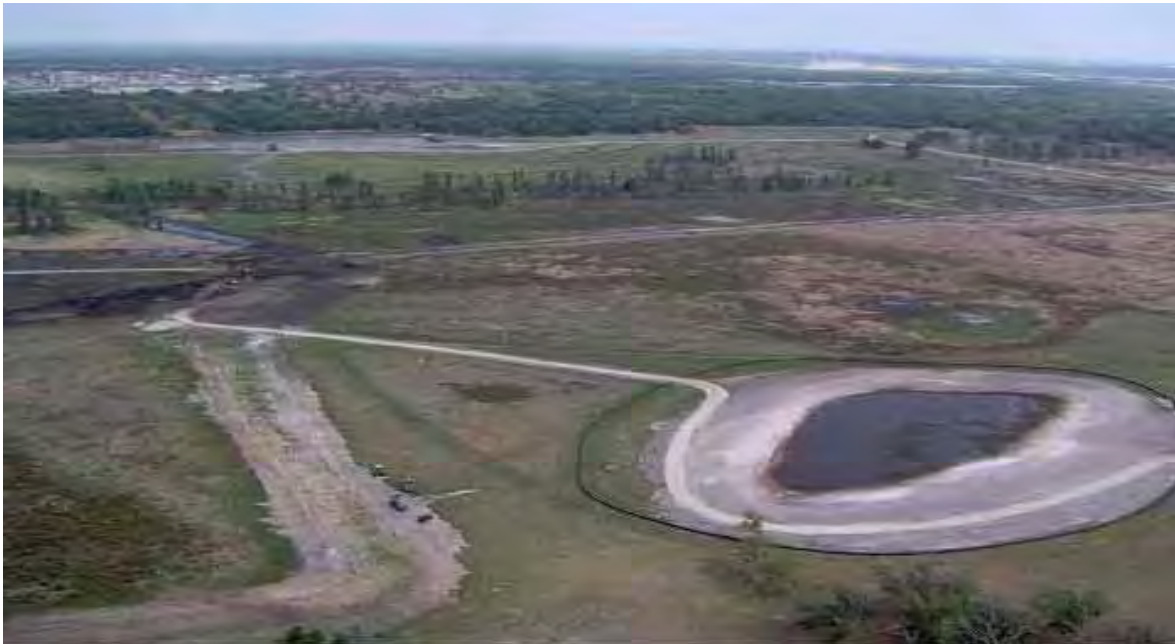
***View of the finished Gator Pond, backfilled ditch (left), and Western Access Road
during the late stages of construction. Construction equipment moving east
to backfill the Banana Creek Canal (center).***

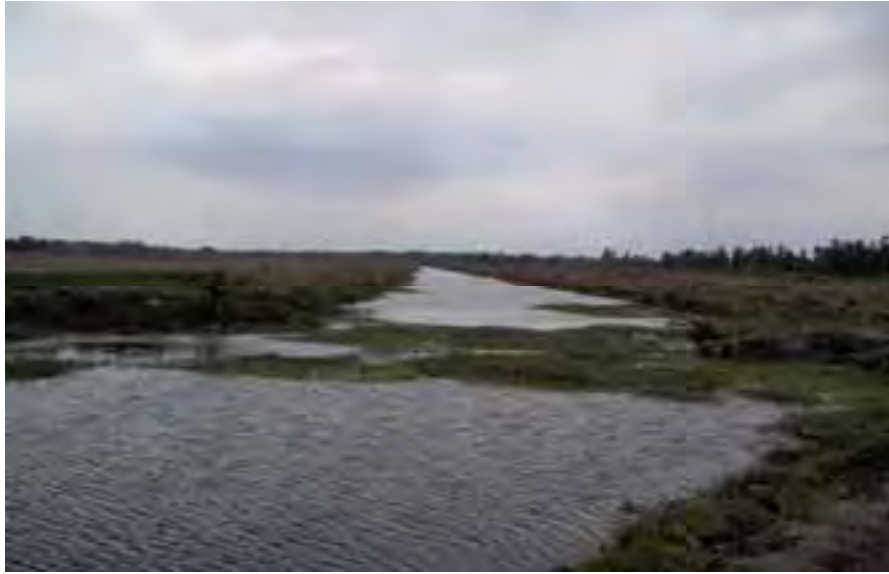
View from Center Road, looking west at the Banana Creek Canal just prior to backfilling with the adjacent spoil material.

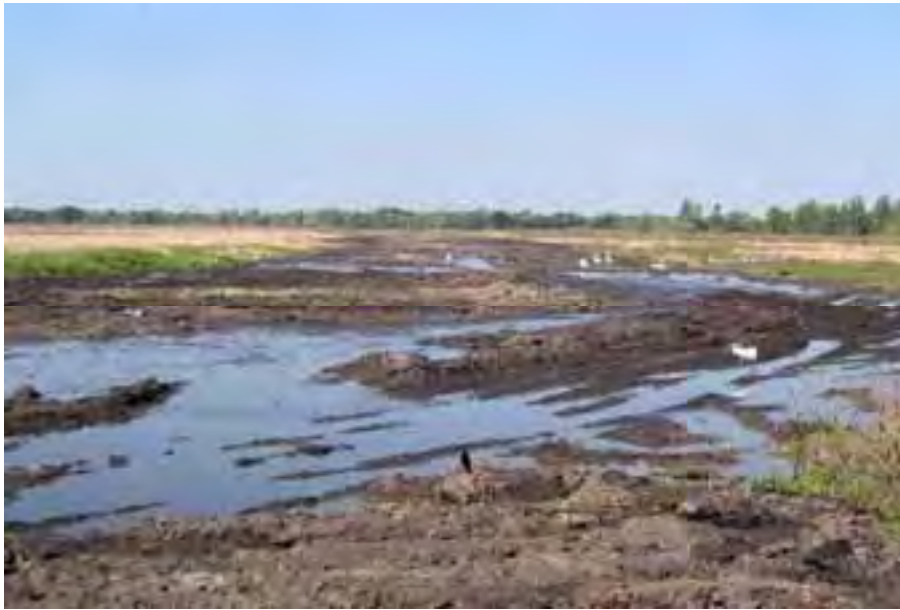
Same view of the Banana Creek Canal a week later, just after filling and prior to planting with herbs such as pickerelweed and arrowhead.

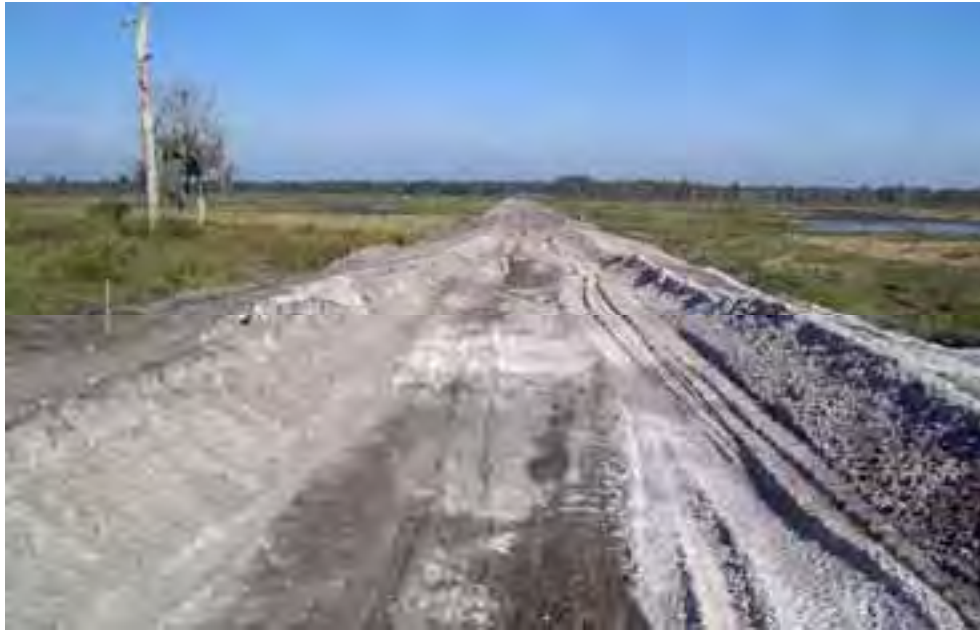
Standing on the southern end of the Center Road looking north. Fill material was used to elevate the remnant road (3,050 ft. long), and culverts installed to restore west-east sheet flow hydrology through the restored and enhanced wetland habitat.
