Southwest Florida
Water Management District

EDOT MITIGATION PLAN JANUARY 26, 2010

Southwest Florida Water Management District
Resource Regulation Division
Strategic Program Office
Brooksville, Florida 34604-6899

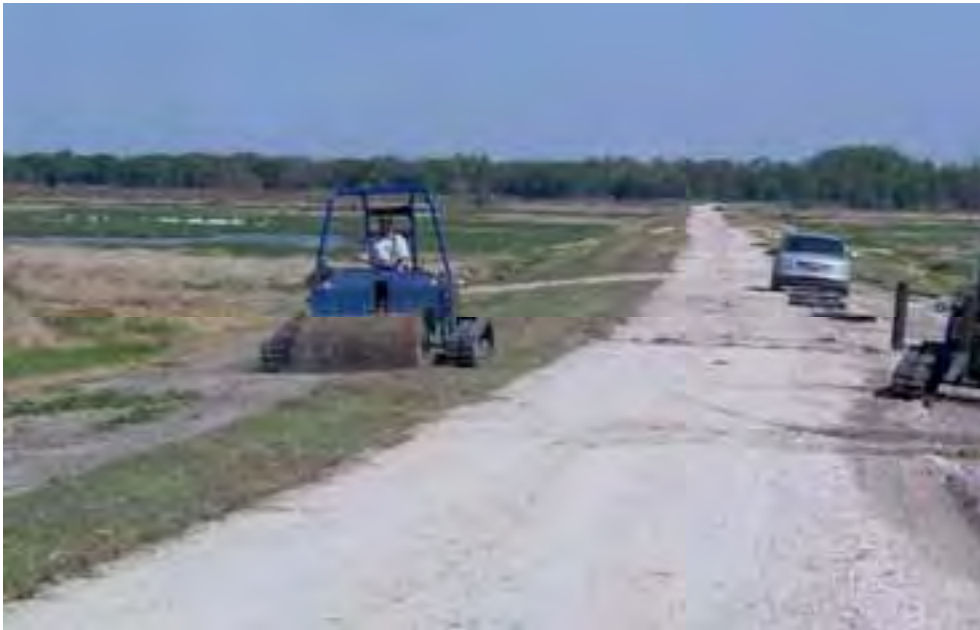
Final construction of the Center Road and sod being installed to stabilize the slopes. Water starting to pool upstream and attracting white pelicans and wading birds (left).

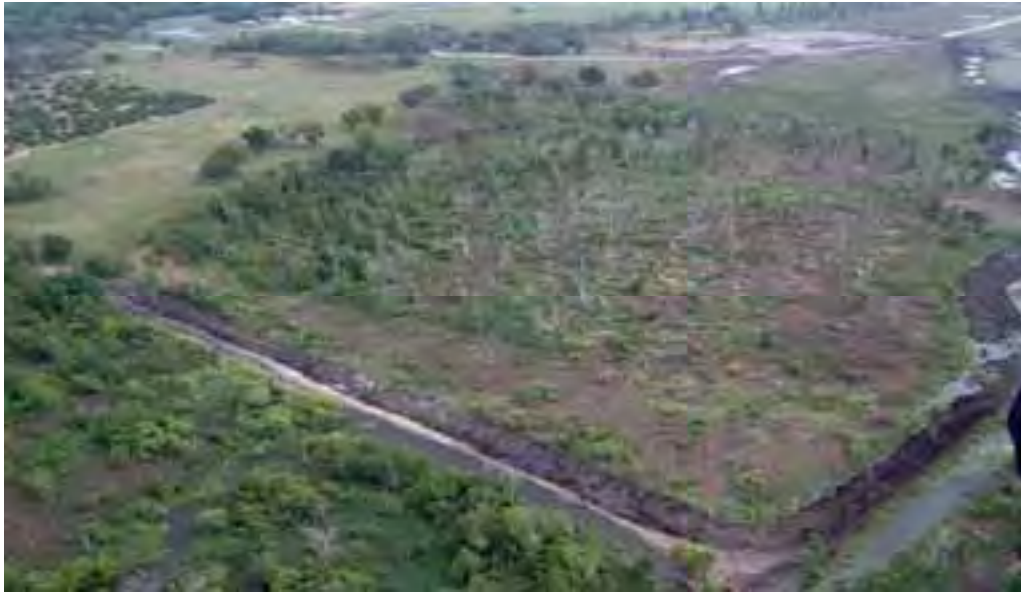
View from the western boundary of the property looking east. The north-south levee (900 ft. long, avg. 5 ft. tall) has just been backfilled into the adjacent ditch to restore western water sheet flow through the remnant forested wetland and proposed forested wetland restoration area. View of a backfilled portion of the Banana Creek Canal is evident along the right side of the photo.

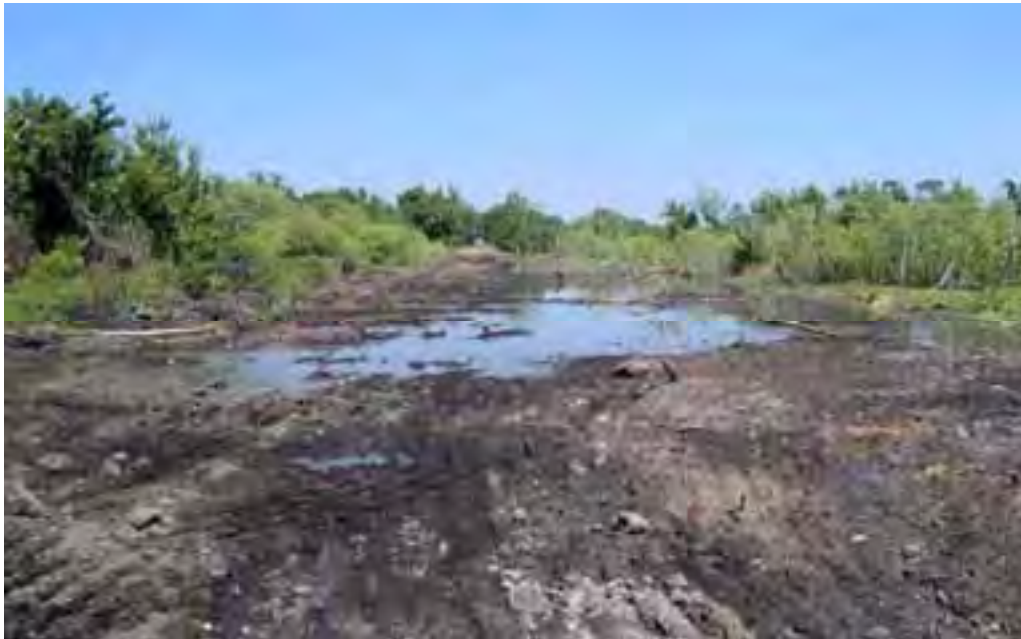
View from the southwest property boundary looking north at the footprint of where the levee was just pushed back into the ditch to restore sheet flow hydrology. The graded area was then planted with hydrophytic plants and trees.

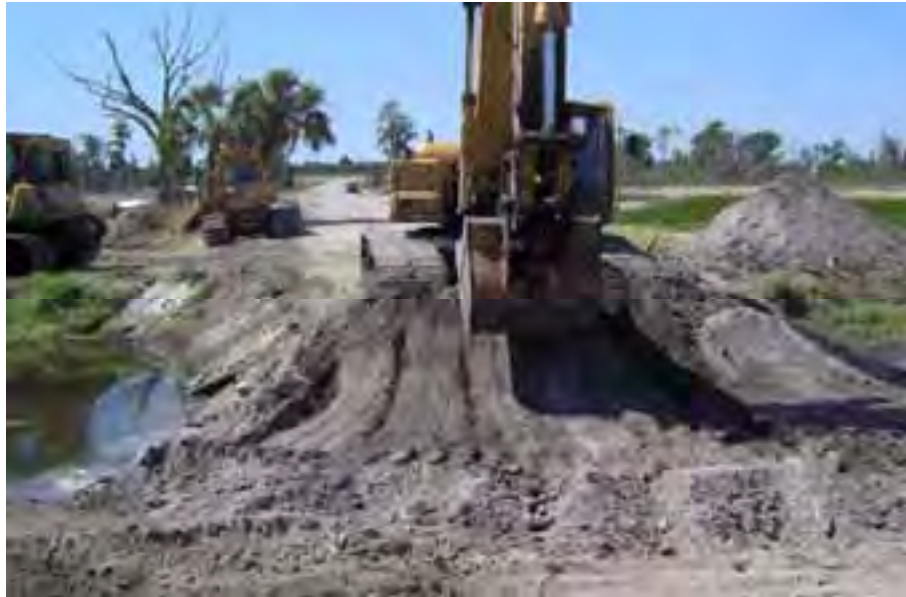
Ditch block construction was conducted where the East Road berm crosses the Banana Creek Canal. This portion of the canal was not backfilled to preserve the existing large oaks and maples along the rim spoil material. The rim material has a hiking trail under the canopy used by both the public and wildlife to gain access around the site.

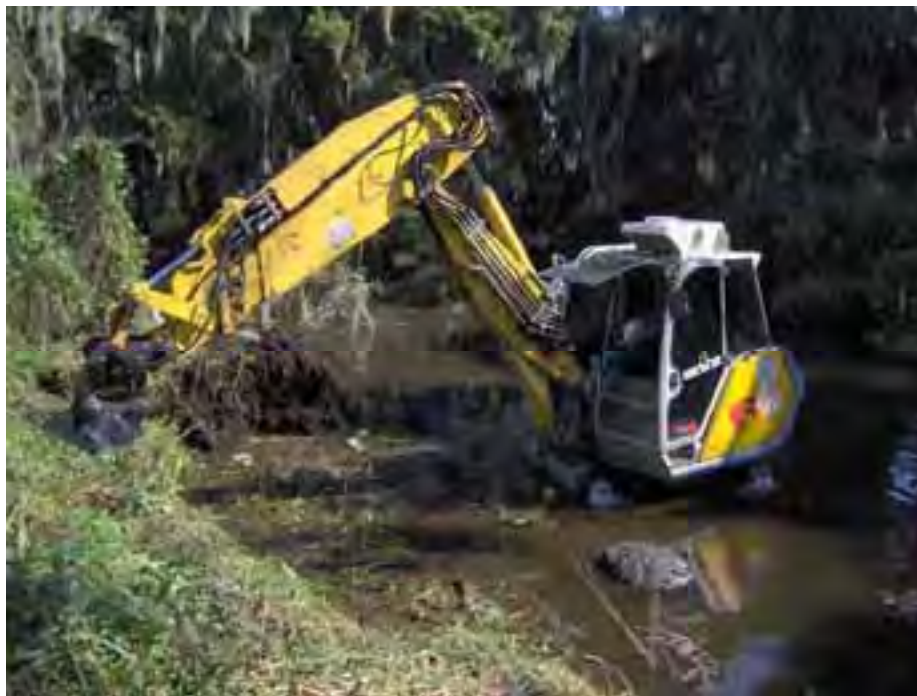
A Menzi unit was utilized in areas where traditional equipment could not access through water, such as this breaching of the rim spoil material to provide hydraulic connectivity to the preserved portion of the Banana Creek Canal.

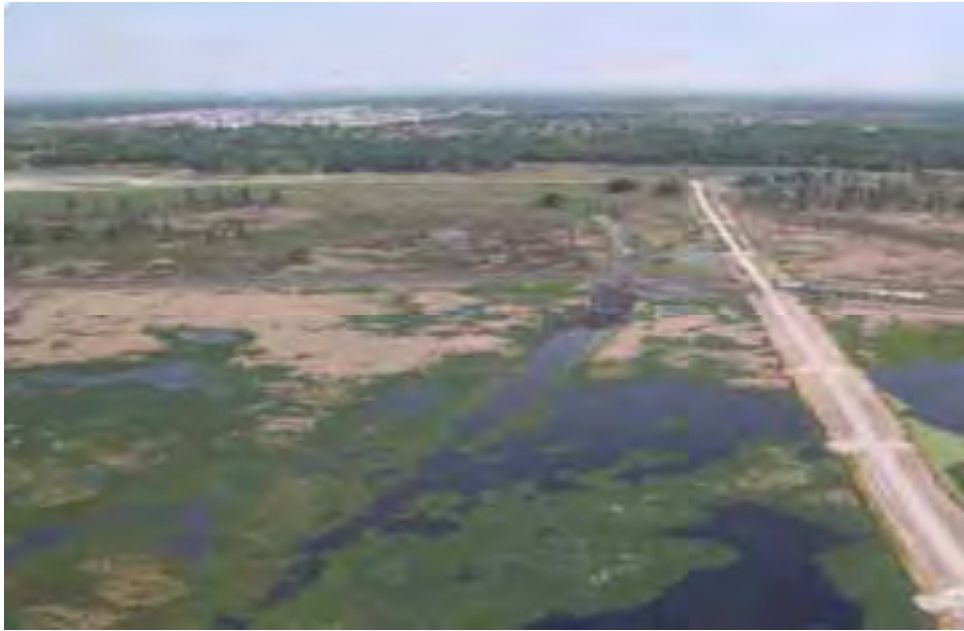
The 3,050 ft. long Center Road berm just after construction as sod is being installed on the slopes. To minimize the potential of sedimentation, the road berms were constructed prior to filling the western segment of the Banana Creek Canal and contributing ditches. An open water component west (left) of the Center Road is heavily used by water fowl, wading birds and alligators.

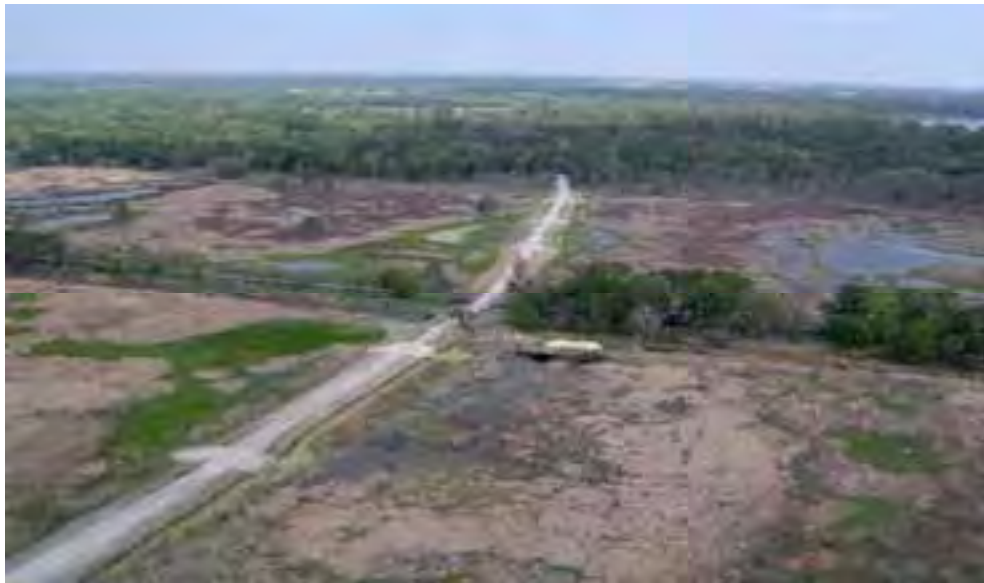
The 2,000 ft. long East Road just after construction. As with the Center Road, the restored sheet flow is evenly distributed by a series of culverts, as well as "saddle" swales installed at lower road elevations to allow overflow during periodic flood events.

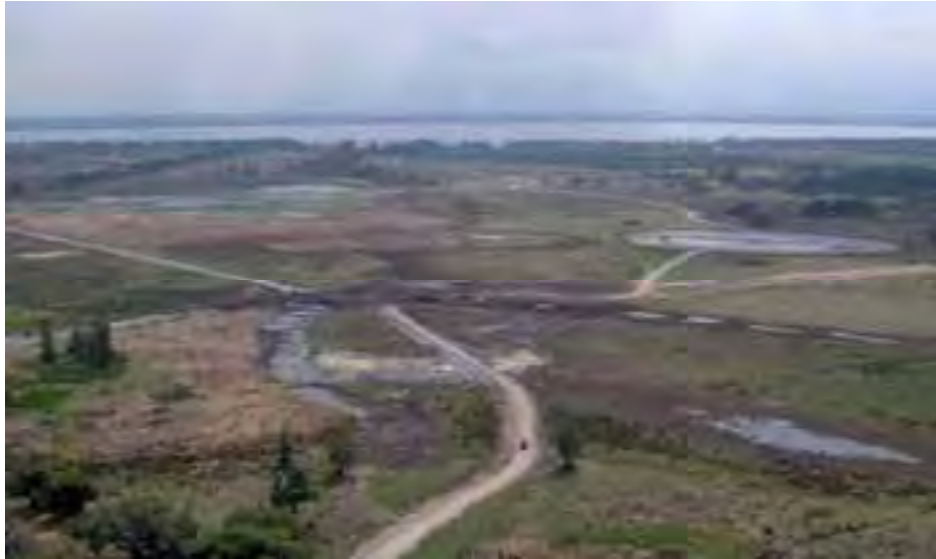
The West Road was historically a dry road crossing at natural grade over the pasture. The new road is within the same footprint and still at natural grade, but was reconstructed with crushed concrete. The majority of the road is now below the surface water elevations, maintaining a wet crossing used by vehicles only when necessary. Backfilling of the Banana Creek Canal and contributing ditches are evident (right to left), conducted just prior to removing the western levee to restore flow.

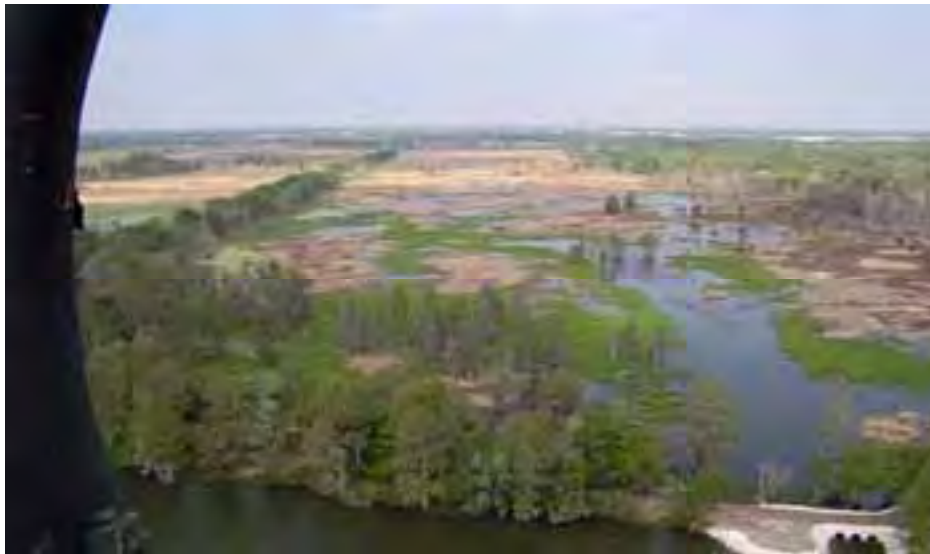
View of the former northeast bahia pasture, with the tree-lined eastern segment of the Banana Creek Canal spoil material evident to the left. This photo was taken after the north rim ditch was backfilled and hydrology restored, but prior to supplemental planting in the open water area. The new outfall to Lake Hancock includes culverts installed within the lakeshore berm (lower right).

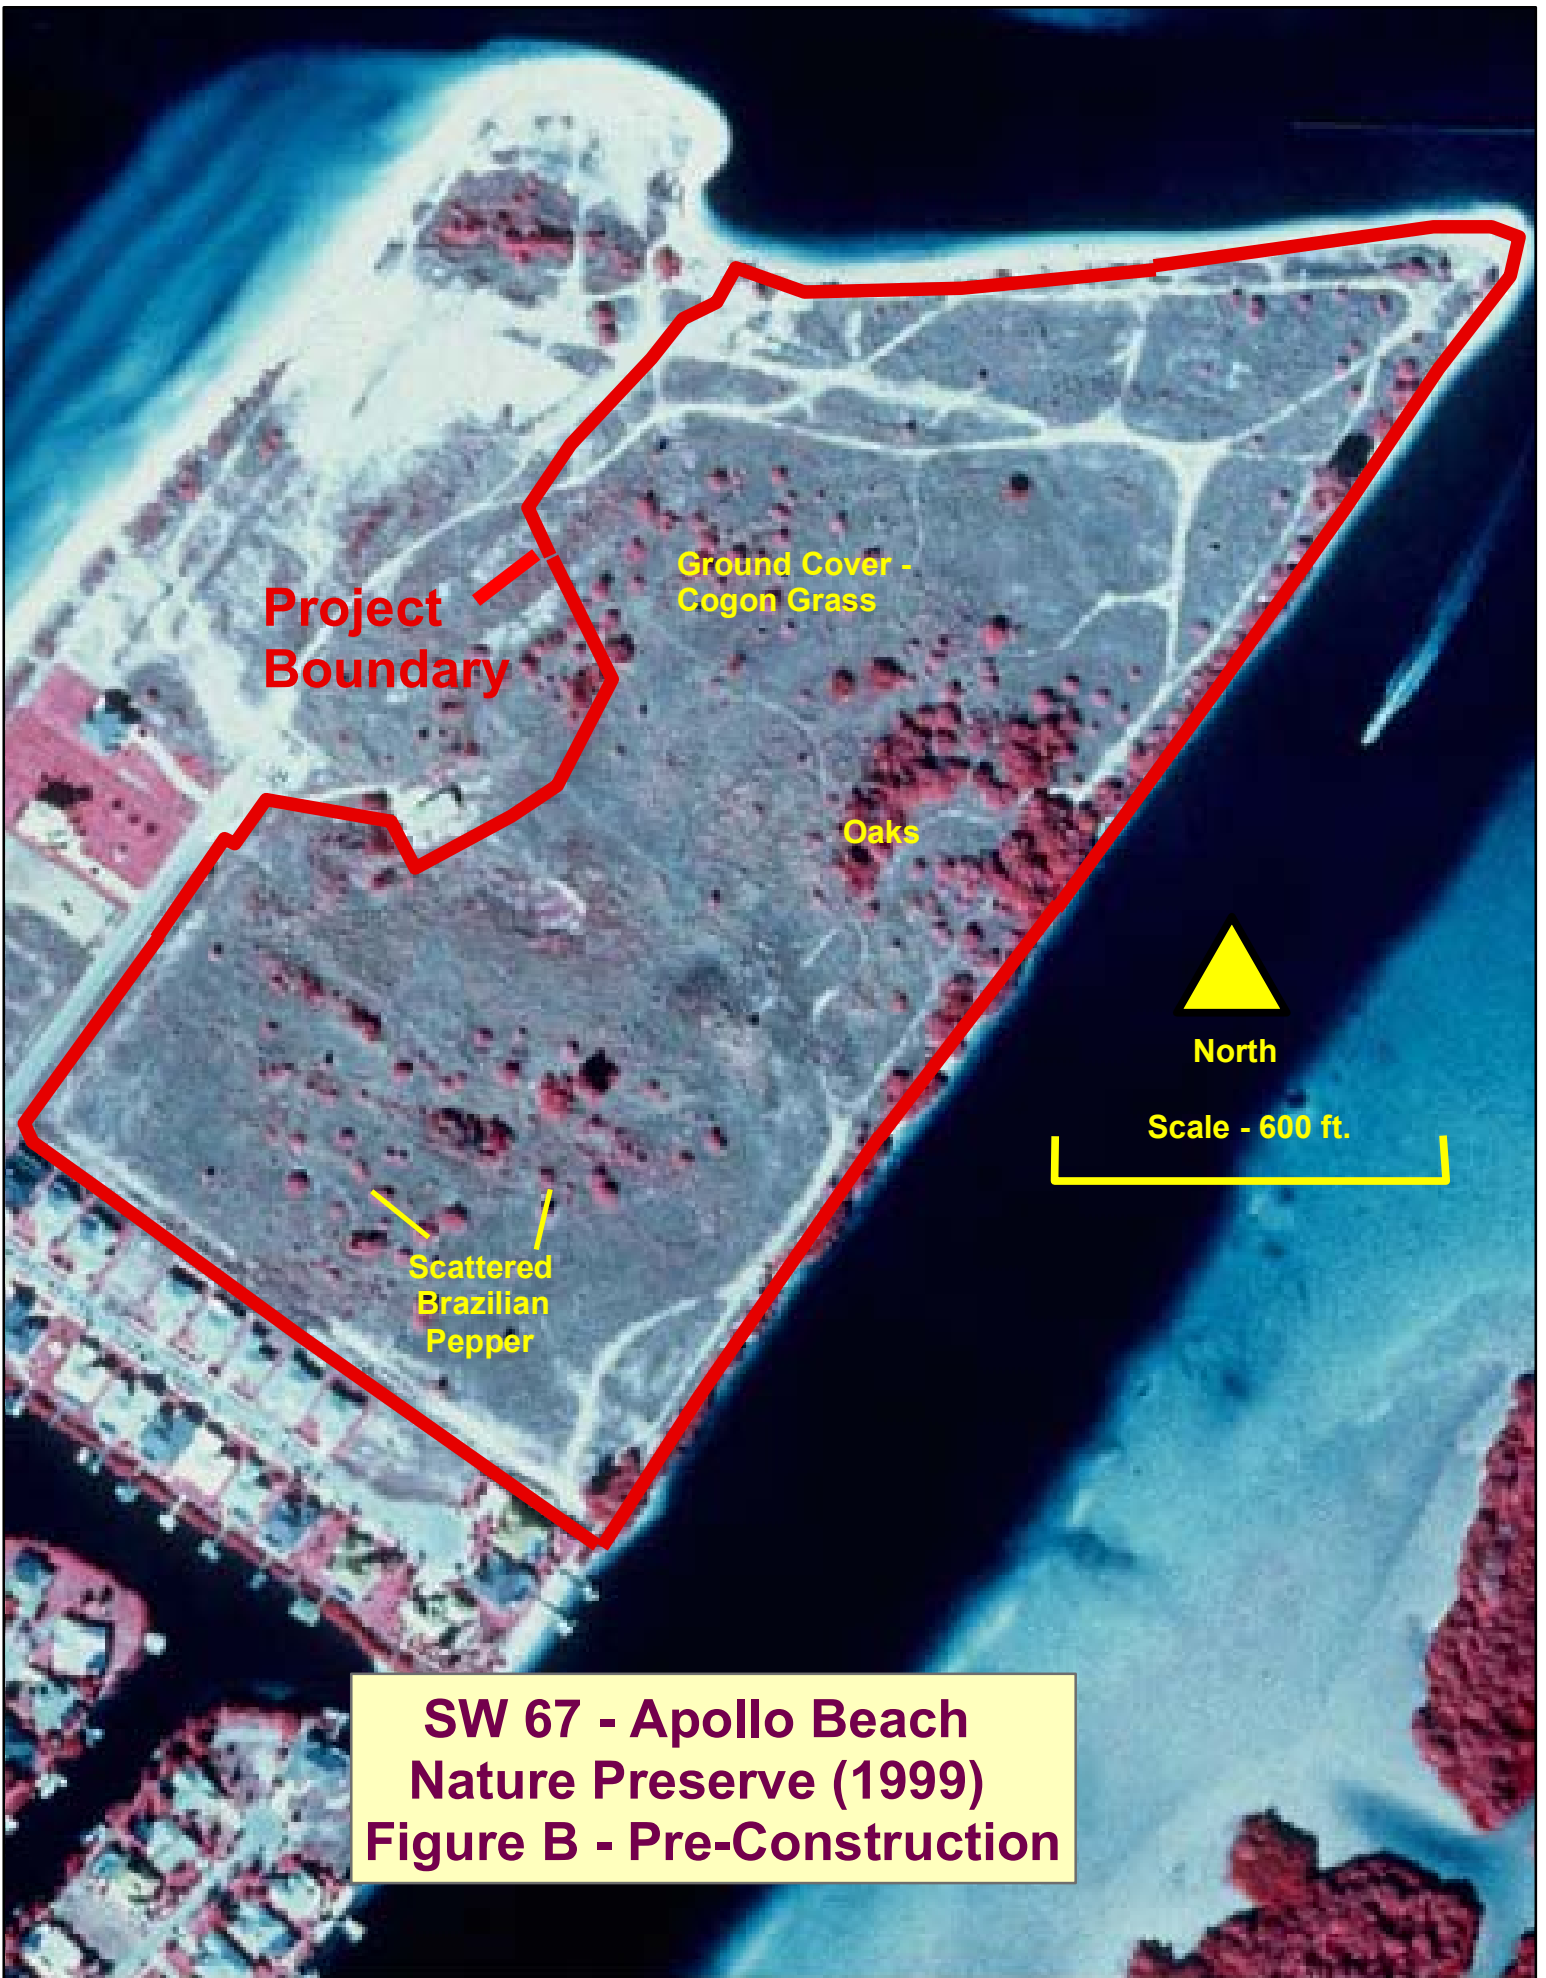
**SW 67 - Apollo Beach
Nature Preserve (1999)
Figure B - Pre-Construction**

**Project
Boundary**

Ground Cover -
Cogon Grass

- B. Brief description of pre-construction condition:** Prior to construction in 2004, the majority of the site included a relatively level spoil "plateau" essentially covered with a monoculture of cogon grass, and minor cover provided by goldenrod, beggar's-tick, dog fennel, ragweed, and several upland grasses (site photos, Figure B). A narrow strip of white and black mangroves were established along the southern shoreline, couple areas of dense concentrations as well as scattered Brazilian pepper; with scattered cabbage palm, salt-bush, wax myrtle, and Australian pine. The site represented very low quality habitat, dominated by exotic vegetation, and minimal benefits for wildlife use.

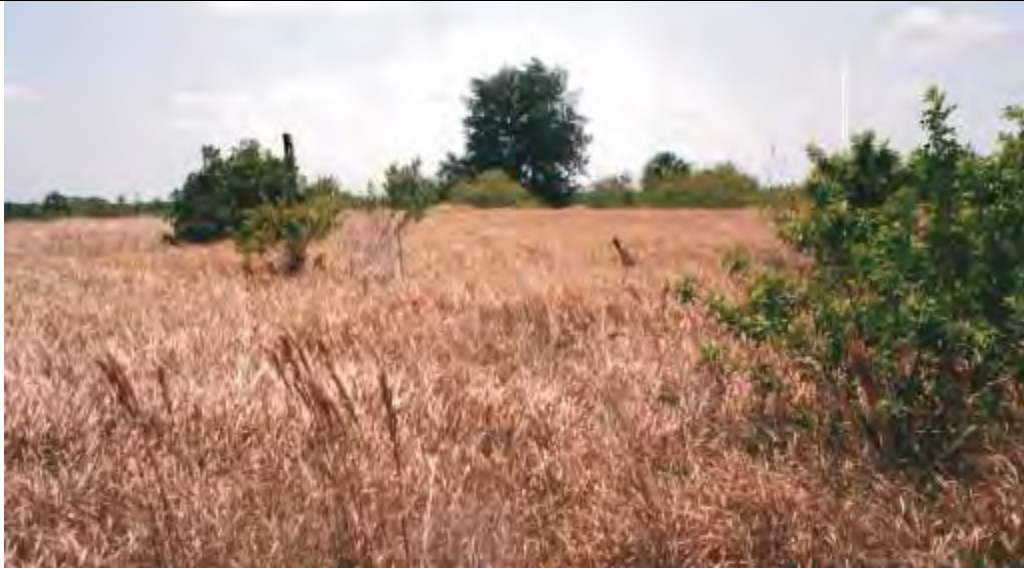
Pre-Construction Conditions (2002) - low quality habitat conditions included dense ground coverage of predominantly cogon grass with scattered Brazilian pepper.

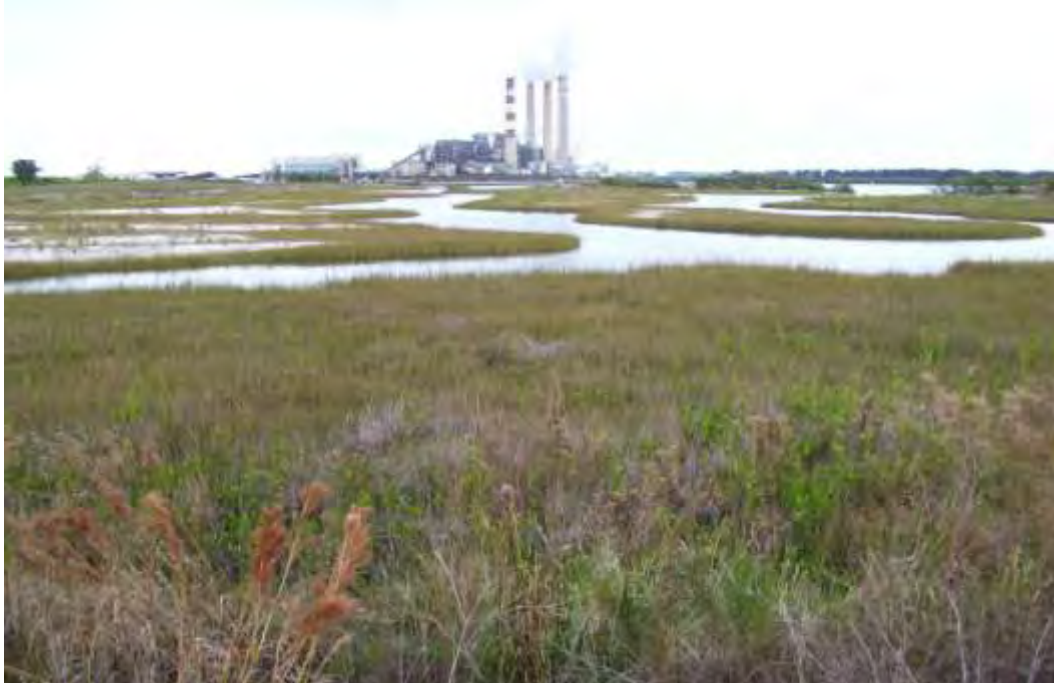
Current Constructed Conditions (2009) - view from the western edge of the project looking north over the created salt-marsh & inter-tidal channel habitats (TECO Big Bend Power Plant in background). The low salt-marsh habitat provides the designated FDOT mitigation, with dominate coverage provided by smooth cordgrass with naturally recruited mangroves. The high salt-marsh has dominant coverage of salt-grass, seashore paspalum, marsh-hay cordgrass; as well as areas of rare saltern habitat (upper left).

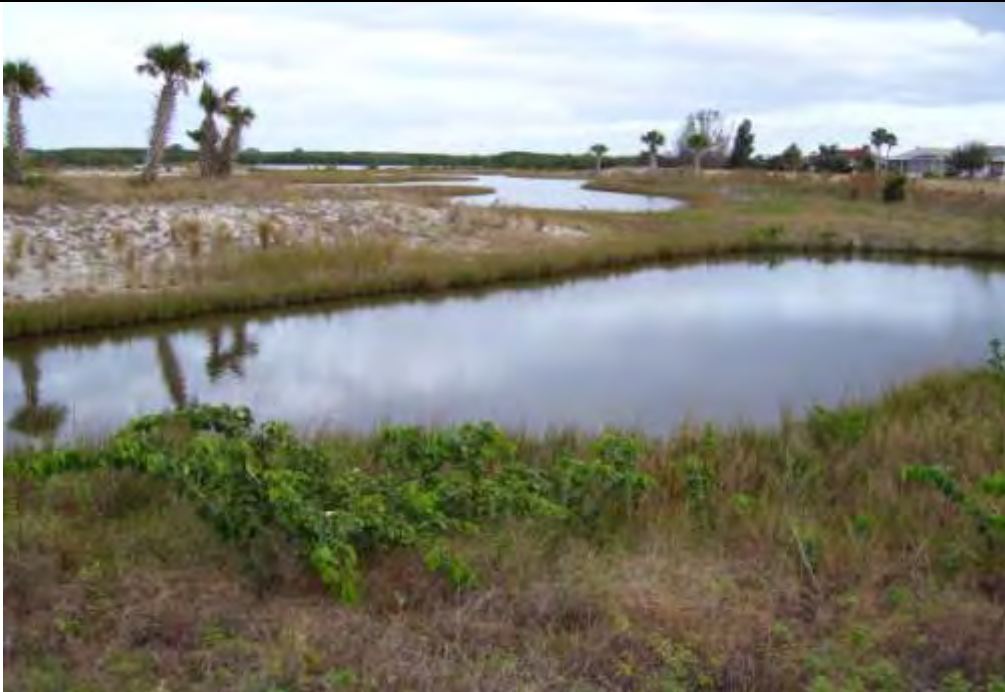
Current Post-Construction Conditions (2009) – another view of the constructed lagoons and channels adjacent to created marsh and dune habitat (left). Southern boundary of the tract is evident along the adjacent residential community (right).

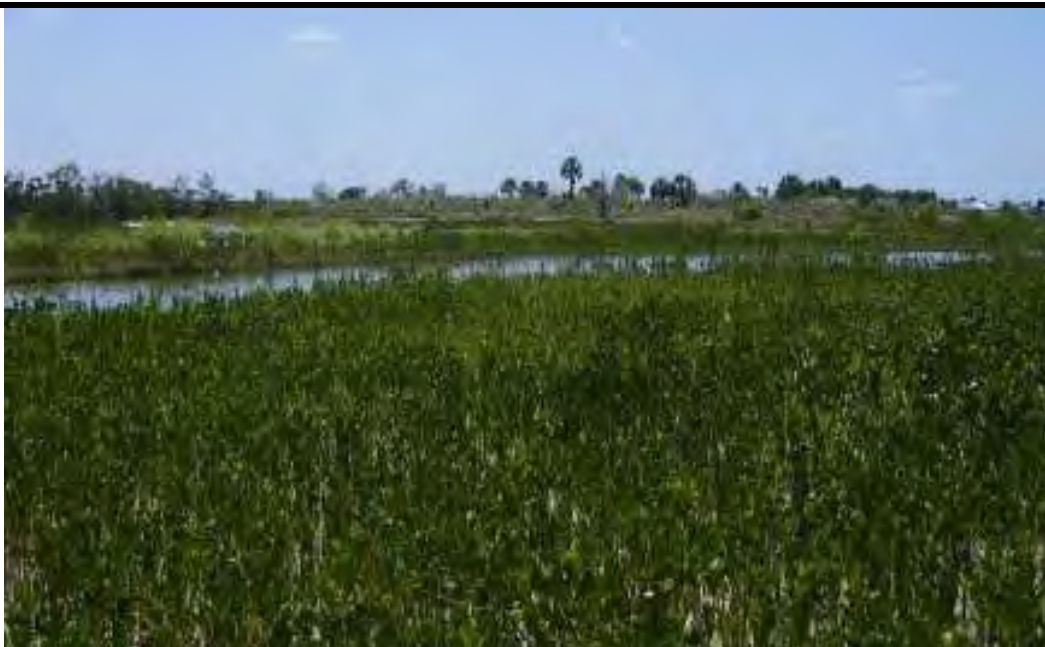
Current Constructed Conditions (2009) – mangrove species have naturally recruited and generated within some of the salt-marsh habitat. Above are dense white mangrove saplings within a marsh zone constructed adjacent to a channel in the northern portion of the tract.

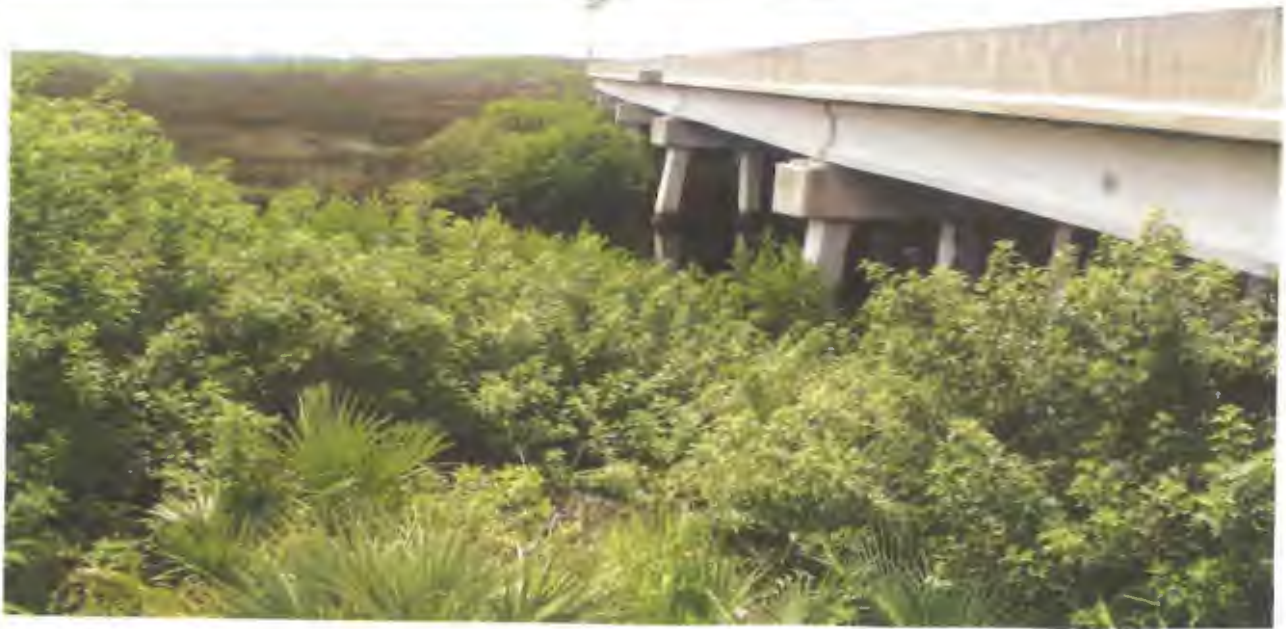
Site A – Pre-Construction (2001) – view from the northern bridge embankment area, looking south over the tidal branch. Brazilian pepper along the embankment (foreground) with mangroves and black rush south of the open water and adjacent to the bridge.

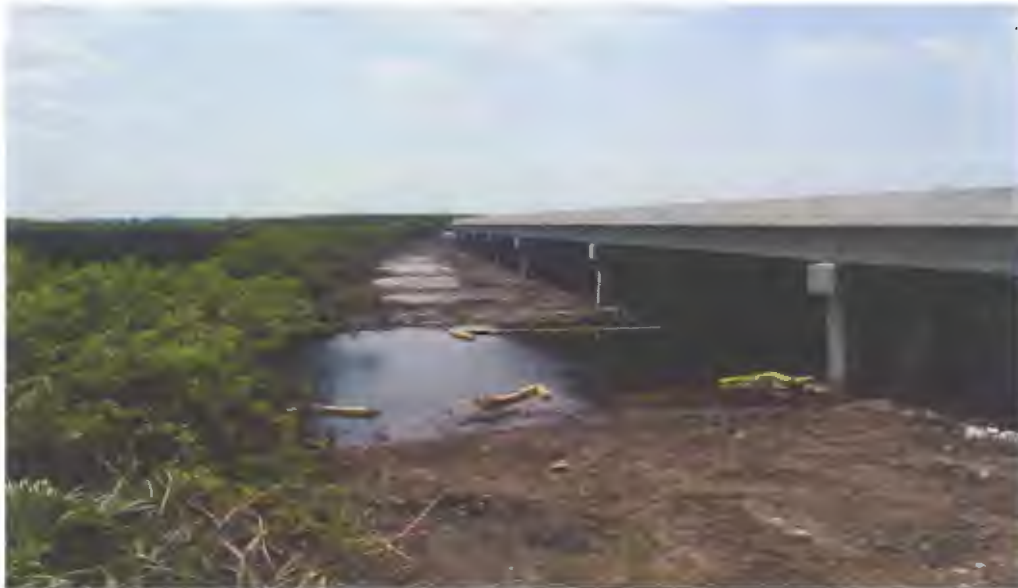
Site A – Post-Construction (Sept. 2003) – the new northbound bridge has been constructed and old bridge removed, exposing bare soil that was under the bridge. The exposed area was planted with white mangrove and black rush.

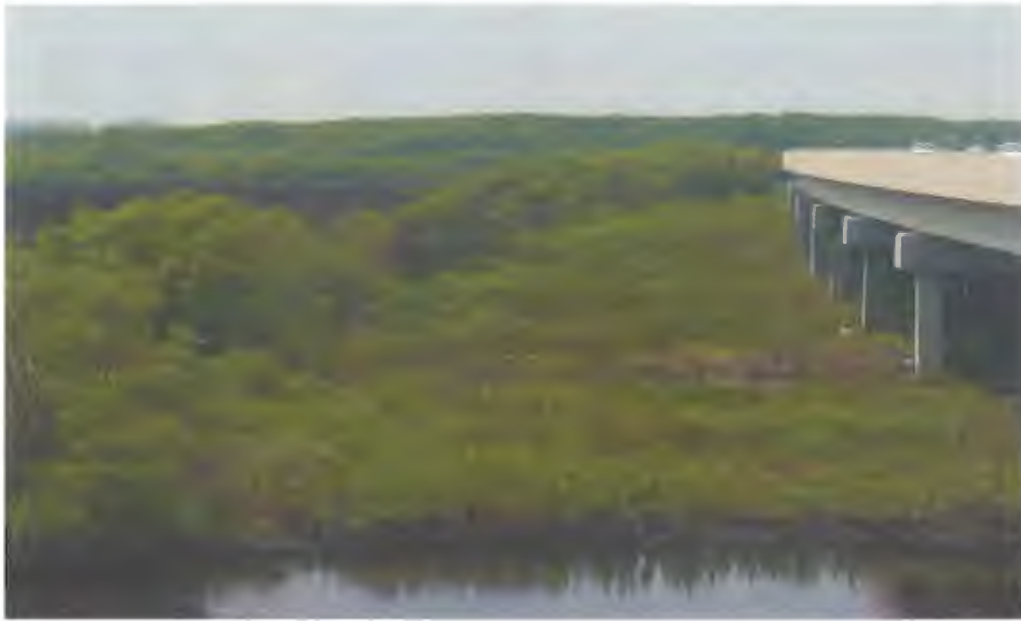
Site A (July, 2004) – planted stock and natural recruitment of desired vegetation provides extensive ground coverage. Herbicide maintenance to eradicate exotics conducted quarterly in 2004 and 2005.

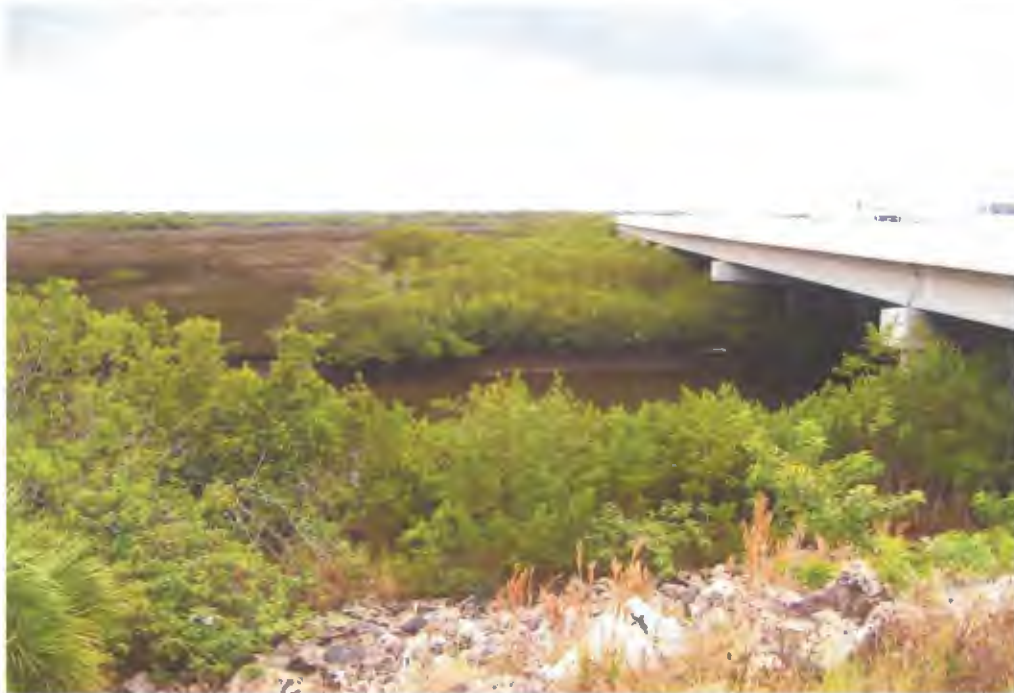
Site A – (February, 2008) – 10-15 ft. tall white and red mangroves dominate and successfully cover the cleared area previously under the old bridge.

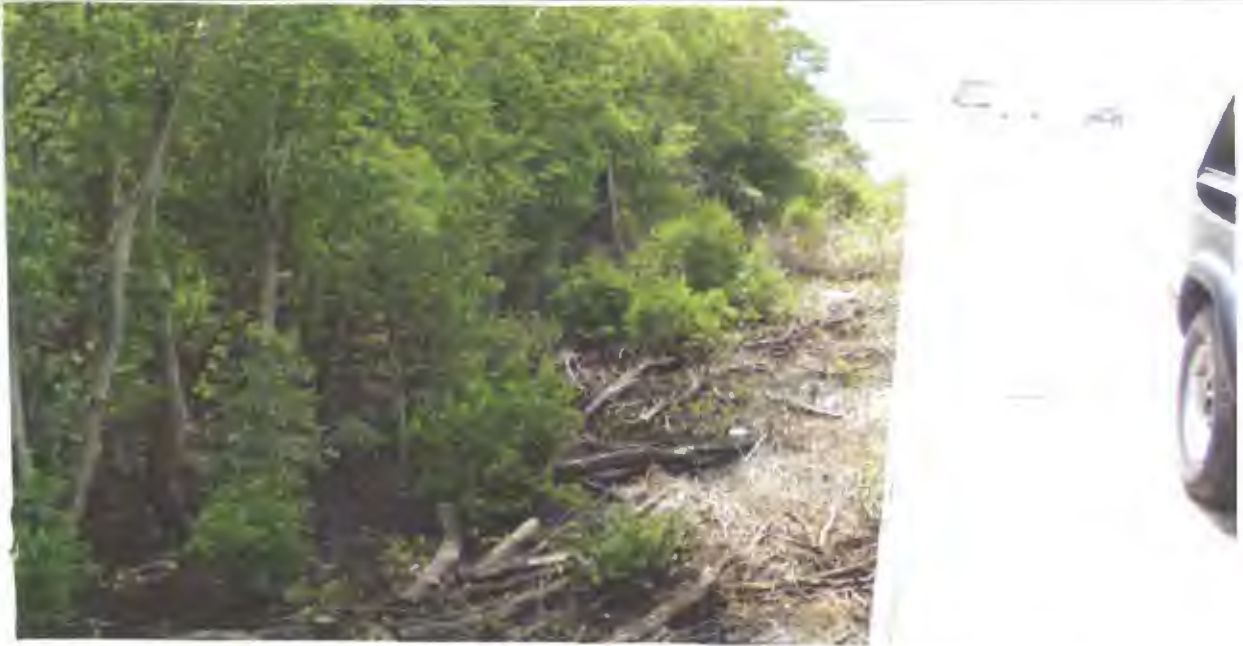
Site B – Pre-Construction (2001) – view from top of the northbound bridge, looking south at the large mangroves on Bird Key. Note the designated temporary impact area has minimal vegetative coverage; primarily limited to scattered leather fern and woody debris.

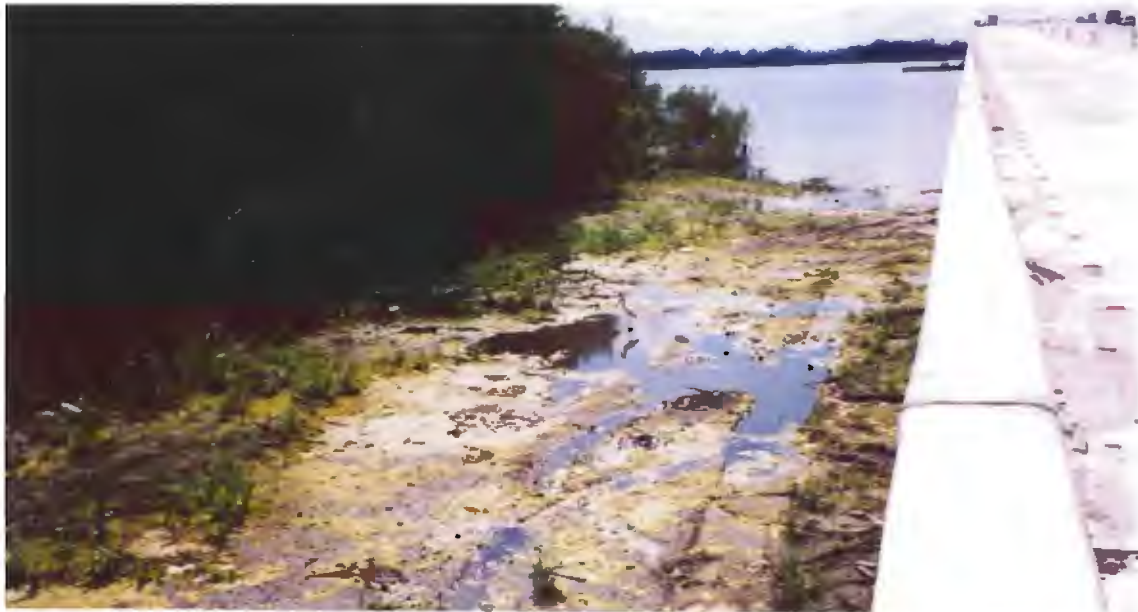
Site B – Post-Construction (Sept. 2003) – the new northbound bridge has been constructed and old bridge removed, exposing bare soil that was under the bridge. None of the large mangroves were impacted, the exposed soil area was planted with white mangrove, black rush and saltmarsh bulrush.

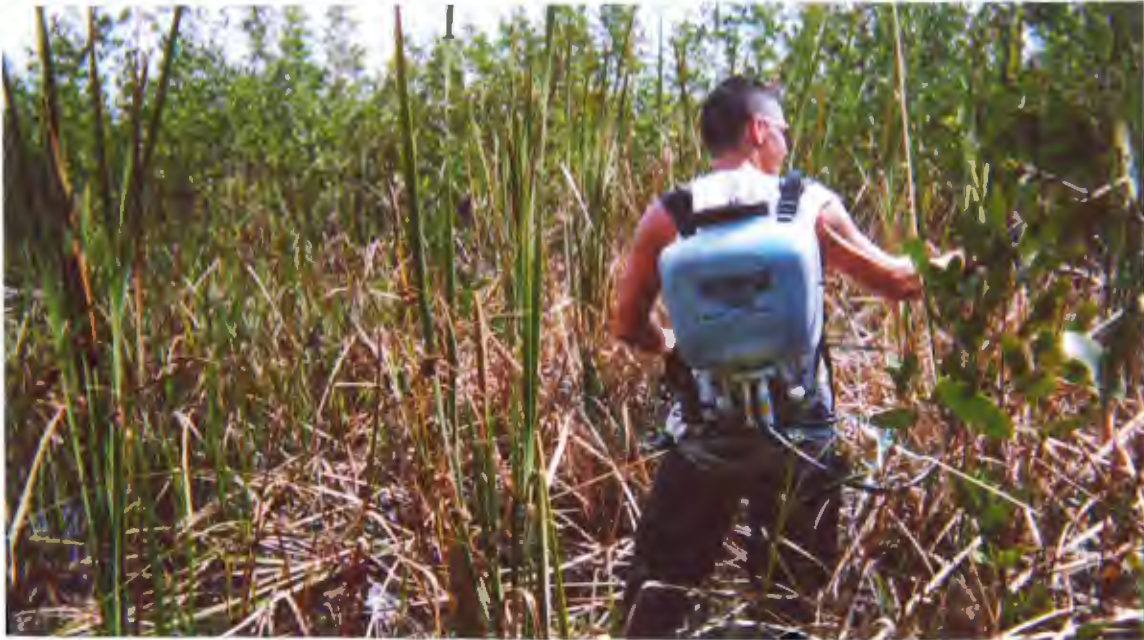
Site B (March, 2005) – Herbicide maintenance to eradicate exotics conducted quarterly in 2004 and 2005; primarily cattails with scattered Brazilian pepper.

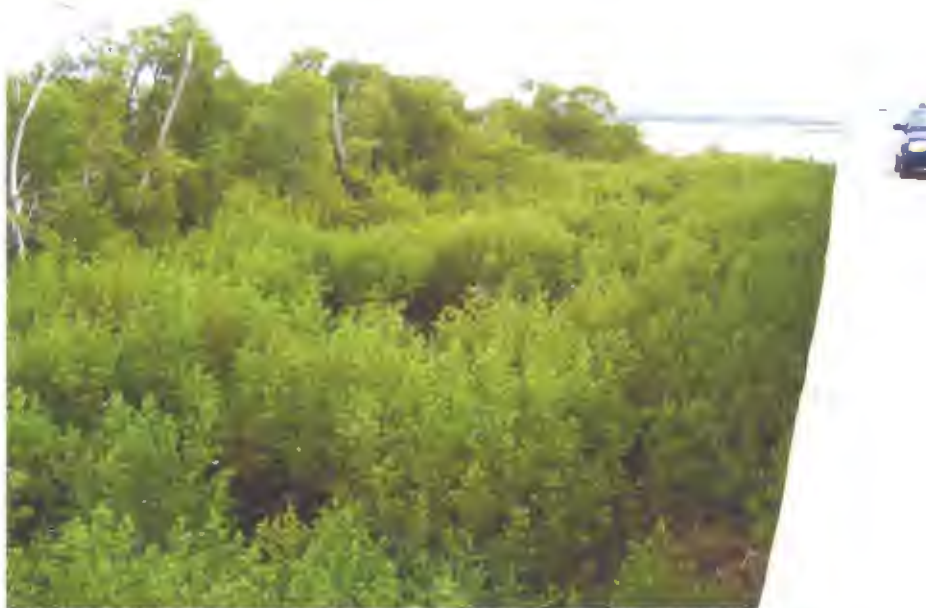
Site B – (February, 2008) – 10-15 ft. tall white and red mangroves dominate and successfully cover the exposed soil area. Mortality of a few mature mangroves (background) resulted when Hurricane Charley crossed the bridge in 2004.

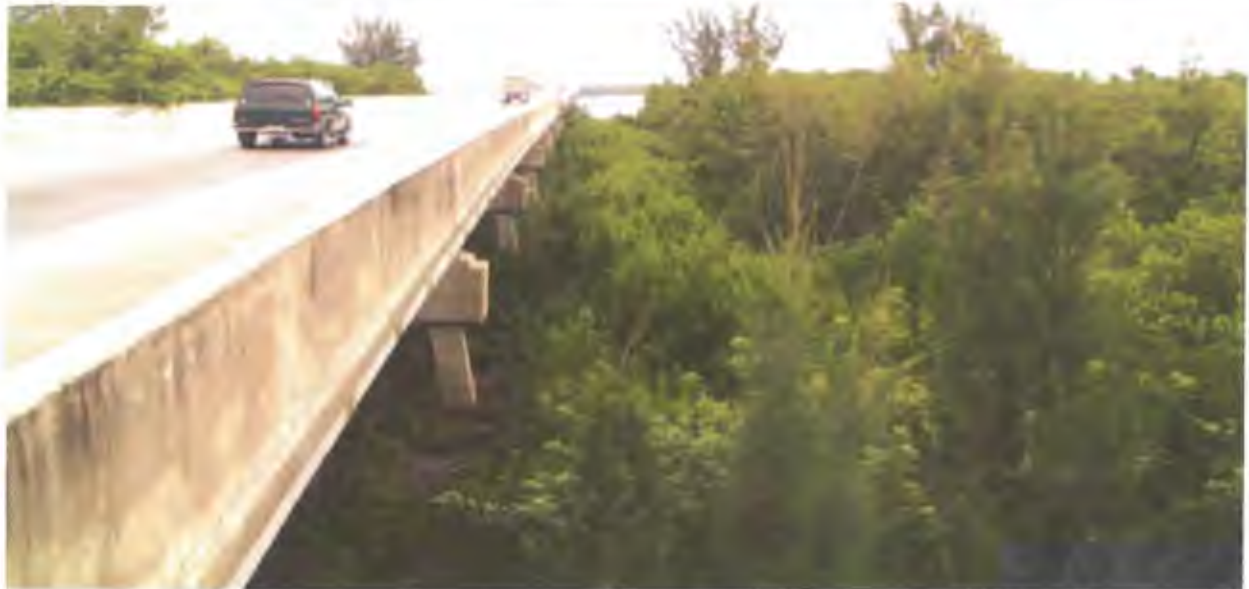
Site C – Pre-Construction (2001) – view from the northbound bridge's southern embankment, looking north at the temporary wetland impact area associated with construction equipment access to remove the span. Dominated by trimmed mangroves, and few Brazilian pepper and Australian pine along the embankment.

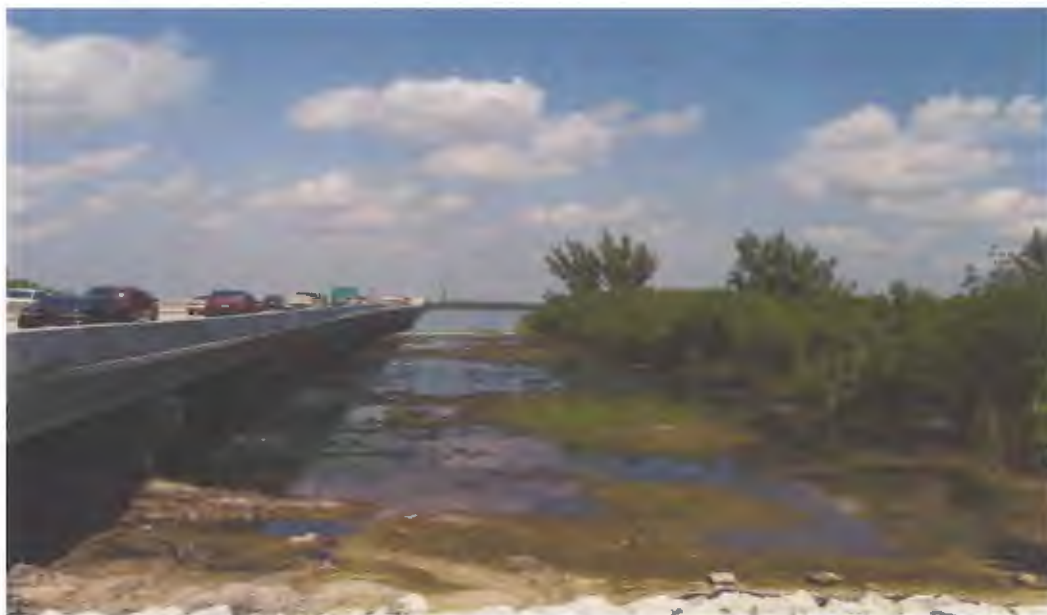
Site C – Post-Construction (Sept. 2003) – the new northbound bridge has been constructed and old bridge removed, exposing bare soil that was under the bridge. The area was planted with white mangrove, black rush and saltmarsh bulrush.

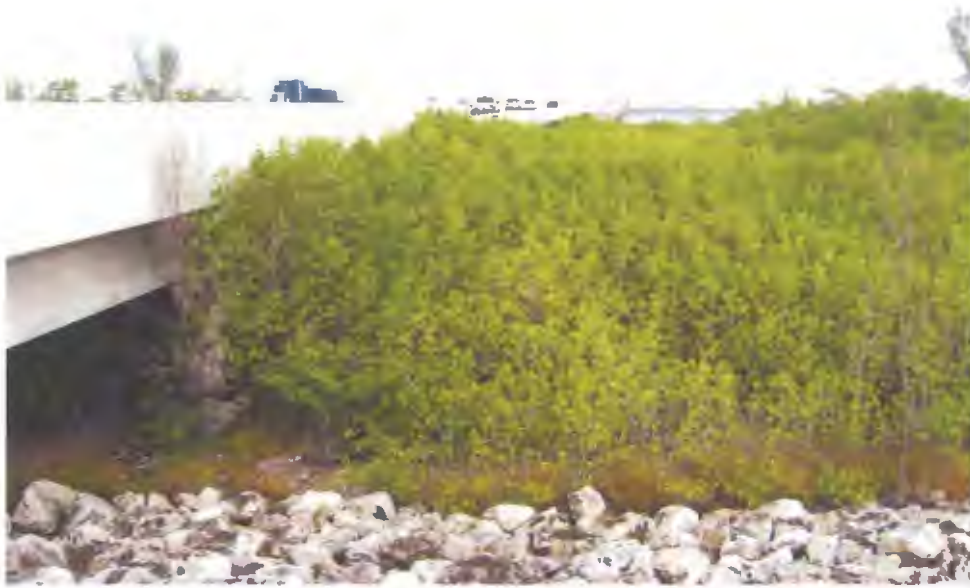
Site C (February, 2008) – following herbicide maintenance in 2004-2005 to help establish vegetative coverage, planted and naturally recruited mangroves have achieved density and heights meeting and in most cases, exceeding pre-construction conditions.

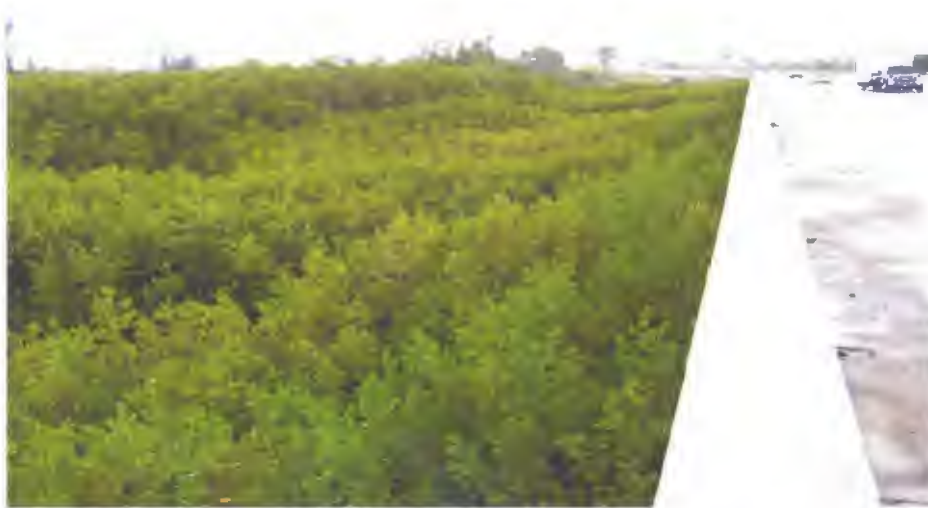
Site C – (February, 2008) – view from river, looking south toward the embankment over planted mangrove area. Limits of cleared vegetation during construction seen along the break between the smaller and larger mangroves (background).

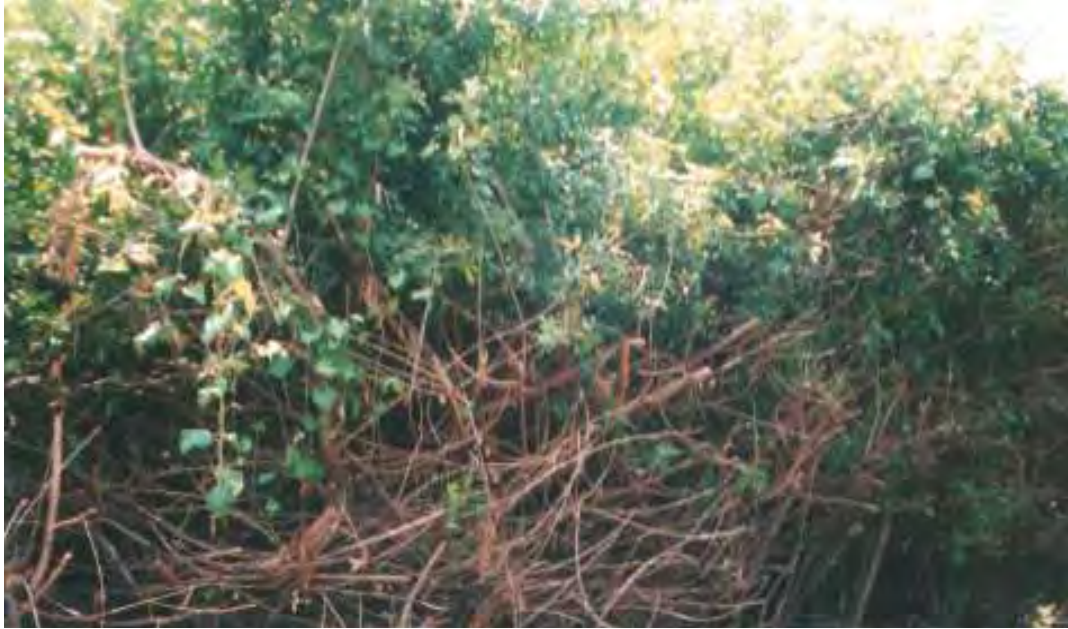
2003 - portions of both designated wetland habitat enhancement areas had extensive and dense coverage of Brazilian pepper that substantially minimized wildlife access and foraging opportunities.

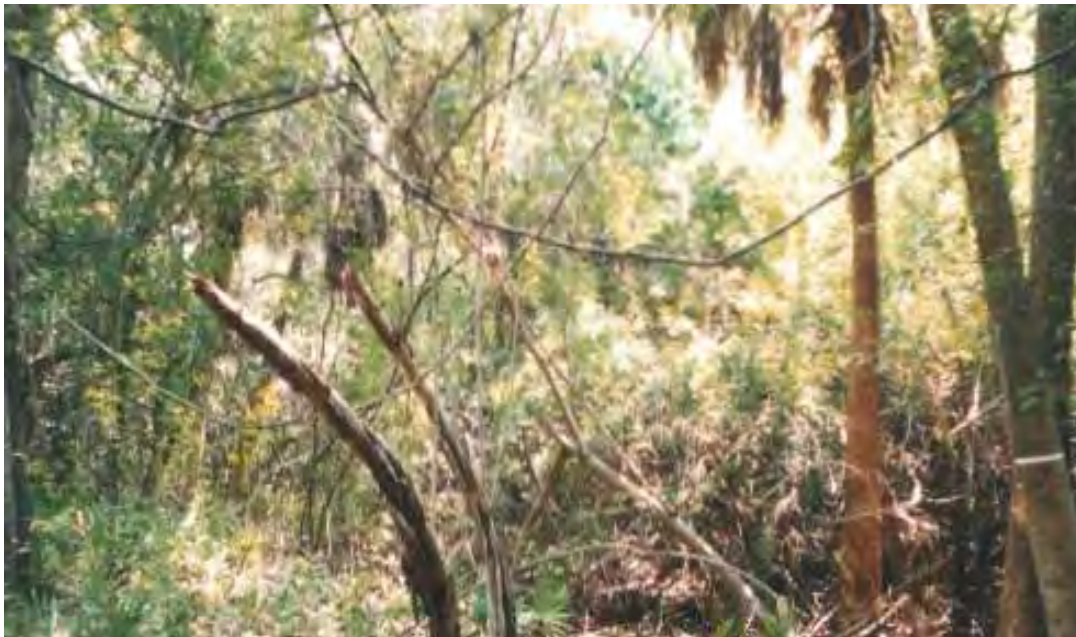
2003 – majority of the northwest designated mitigation area had less extensive Brazilian pepper coverage mixed within the wetland (right) and adjacent upland habitat buffers (left).
