Southwest Florida
Water Management District

EDOT MITIGATION PLAN JANUARY 26, 2010

Southwest Florida Water Management District
Resource Regulation Division
Strategic Program Office
Brooksville, Florida 34604-6899

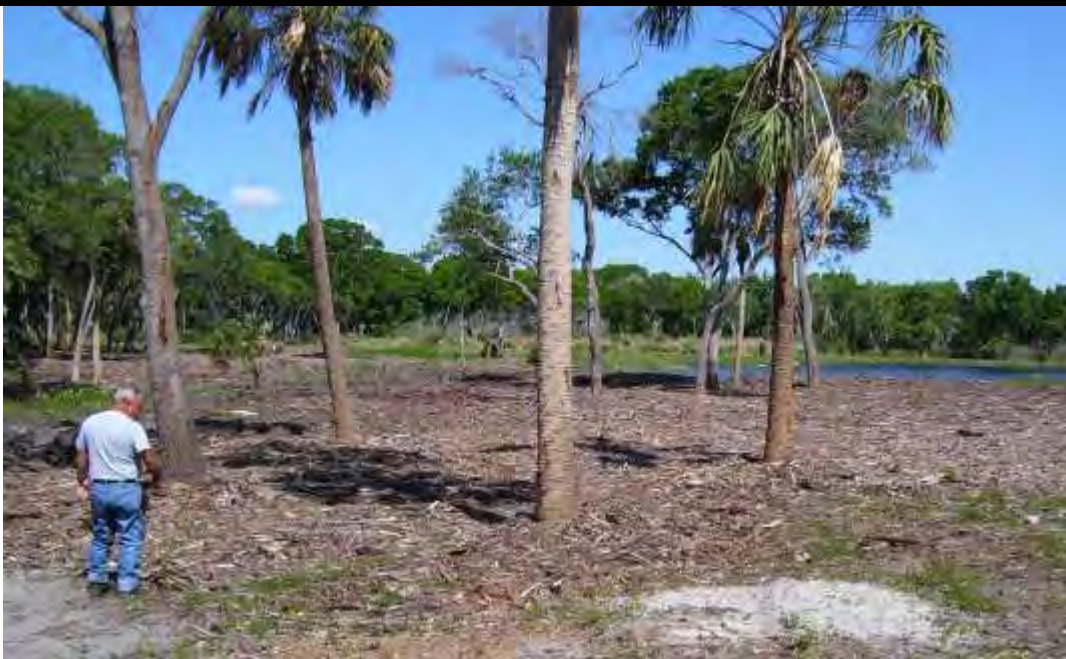
2006 – portion of northwest mitigation area after eradication of dense Brazilian pepper, preserving the remaining native trees and shrubs, and preparing the site for supplemental planting.

Due to the muck and seasonal high water conditions of this swamp, it was necessary to mechanically eradicate and remove the B. pepper during dry season periods. Hydraulic dredging of lake bottom sediments were also conducted in 2004 and 2005; with \$12 million expended by the WMD and the City of St. Petersburg. The combination of the lake dredging and wetland enhancement provides substantial ecological improvement and interdependent mosaic of wetland and surface water habitats. In addition, the City received grants toward funding exotic and nuisance species removal within the remaining areas (primarily upland habitats) of the Preserve not providing mitigation credit. This total eradication effort further minimizes the exotic and nuisance species seed sources that recruit into the wetlands. Wildlife species depend on many upland and wetland ecosystems for various functions and values within their life cycles. With the lake improvement, wetland and upland enhancement activities conducted in the Preserve, this provides an exponential increase of overall ecological value compared to just enhancing one habitat component.

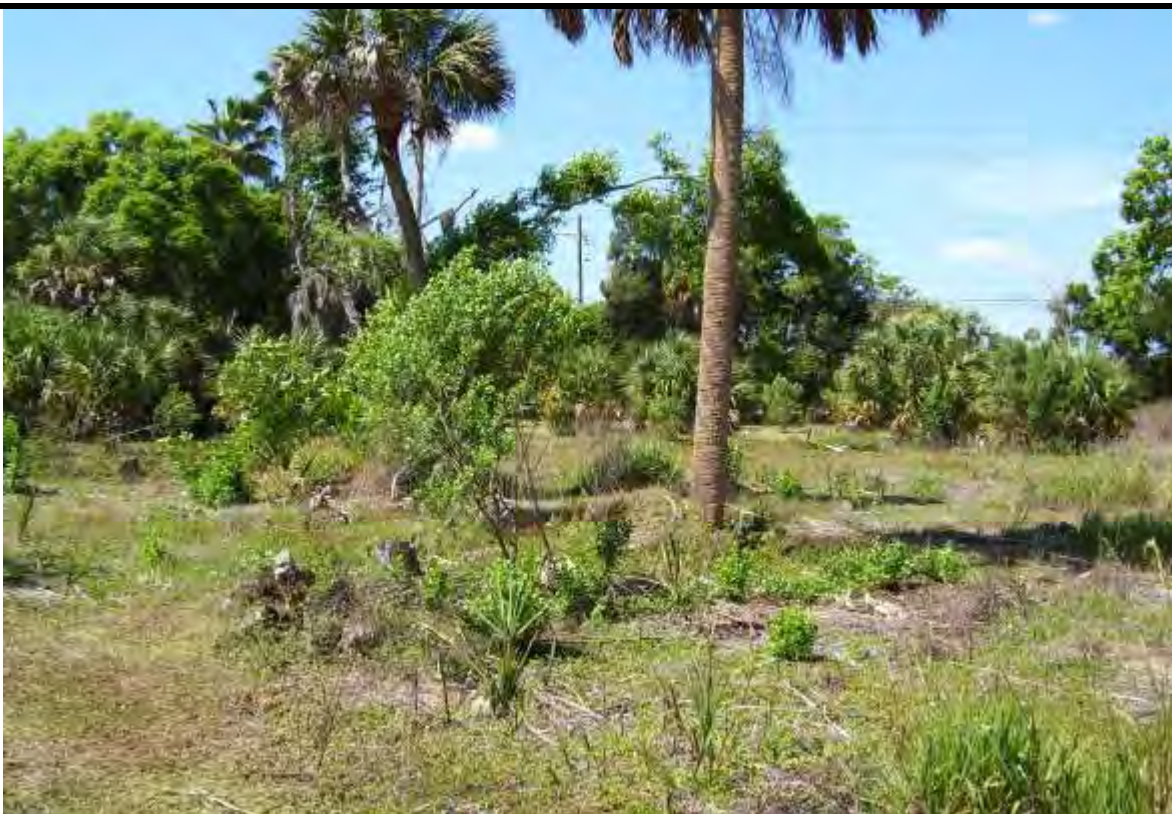
2008 – ephemeral wetland in the northwest area that was previously covered with dense Brazilian pepper, natural regeneration of hydrophytic vegetation and supplemental plantings of trees and shrubs.

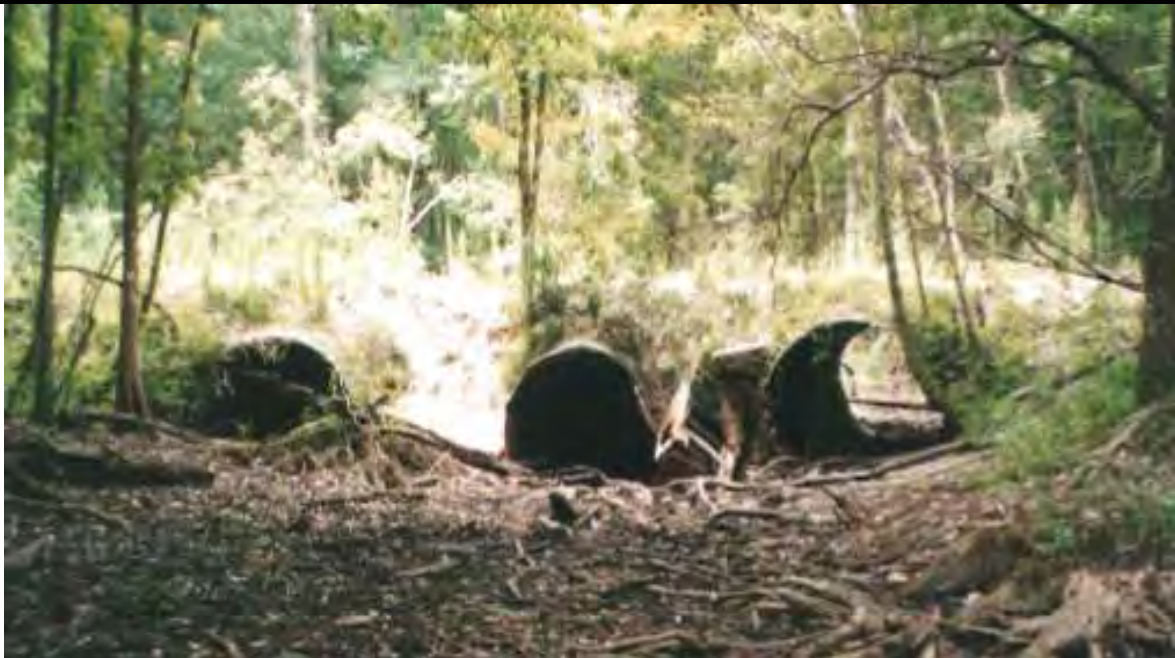
Pre-Construction - Site 2 (2005) – these three dilapidated culverts provide the only hydrologic connections from upstream to downstream through the 700 ft. wide Pithlachascotee River wetland floodplain. The sidebanks of the access road berm are unstable from erosion.

Project Site 2 – This access road berm over the Pithlachascotee River is used for maintenance and management of the Serenova property. The three pre-existing 48-inch culverts had water stain indicators that demonstrate normal flow conditions exceeding 70% of the available flow capacity of the culverts, resulting in pooling of water upstream of the crossing and detaining flow from reaching the downstream wetland floodplain. The floodplain crossing is very wide (700 ft.), so the contributing flow is funneled through the large culverts that substantially minimize the expansion of surface water patterns throughout the downstream floodplain, while impounding and extending the hydroperiods of the upstream floodplain wetlands. The pre-existing culverts were undersized and without rip-rap material, scouring of berm material resulted in downstream sedimentation. Restoration of flow patterns included replacing the three main culverts with cross-drains of similar size and dimension, then adding two culverts within two other areas of the berm to restore historic surface water flow conditions to the downstream wetlands. Rip-rap material was

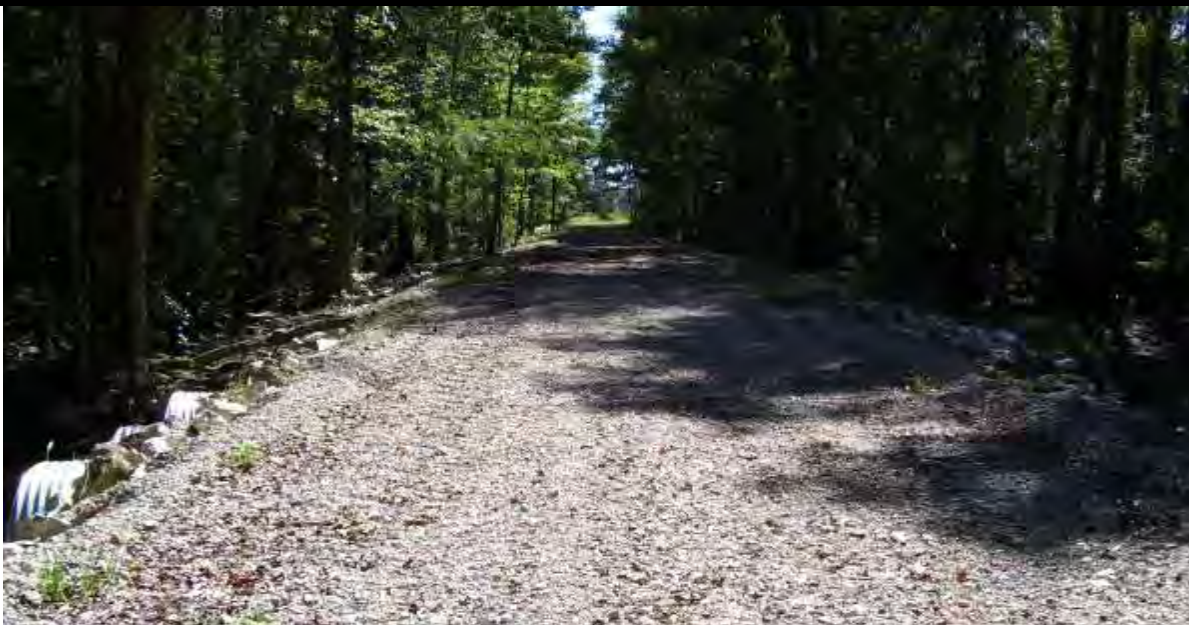
Post-Construction - Site 2 (2009) – in addition to the three new culverts installed at the river channel crossing (left), additional culverts were placed at other strategic locations in the berm to restore appropriate hydrologic regimes and connectivity within impounded wetlands upstream and dewatered wetlands downstream. The access road was stabilized with the installation of rock rubble along the sideslopes and limerock base material on the surface. Wildlife routinely utilize the road for access across the floodplain.

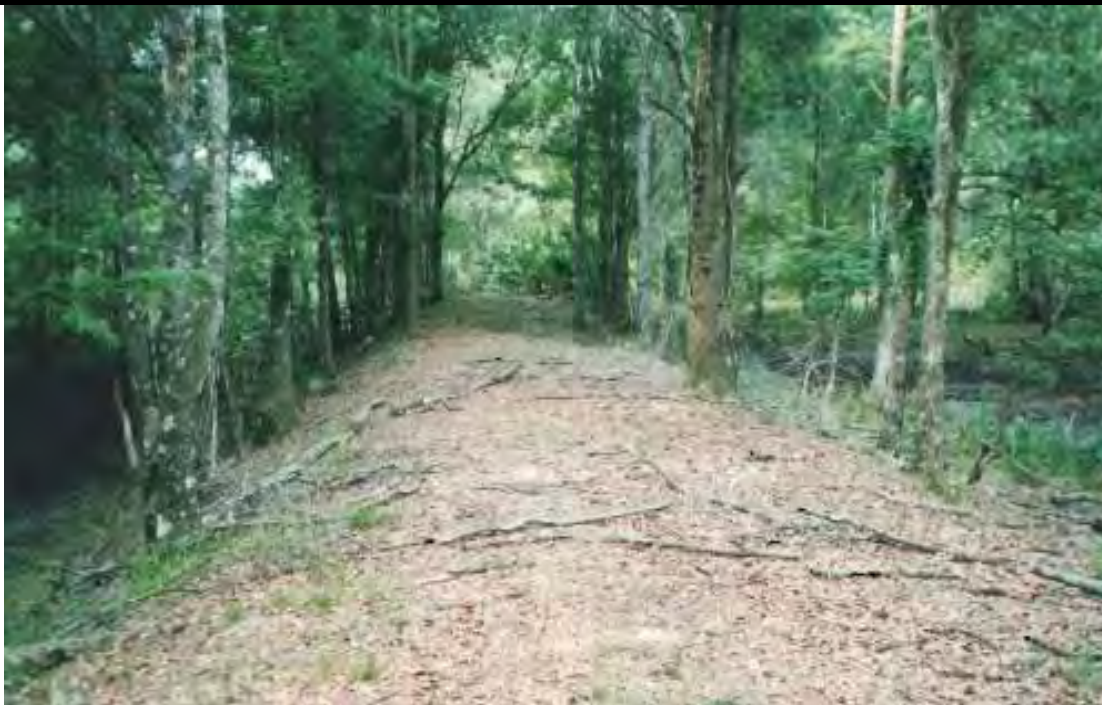
Pre-Construction - Site 4 (2005) – the northern half of the abandoned tram berm crossing the Pithlachascotte River wetland floodplain, blocking and diverting flow to the river channel instead of downstream wetland floodplain habitat.

Project Site 4 – This remnant tram road had a dilapidated bridge and considering there was already accessibility over the Pithlachascotte River at Site 2, neither replacing the bridge nor placing culverts within the access berm were necessary. Similar to the other two floodplain crossings, flow conditions were detained upstream and more concentrated within the main channel, resulting in impounding some water upstream and minimize the spread of water into the downstream floodplain areas. In order to restore normal floodplain flow patterns, the entire berm material was graded in late 2007 and early 2008 to backfill the adjacent ditches. The earthwork area was stabilized by seeding a mix of winter rye and bahia. Natural recruitment and generation of hydrophytic herbs dominated by soft rush and sedge species occurred during subsequent years. Tree saplings (dominated by red maple) have recruited and generated from the adjacent seed source, and gradually the canopy gap will be restored to forested cover. Direct wetland enhancement was estimated at 11 acres (length 700 feet x width 700 feet = 11 acres). Wetland restoration from within the footprint of the berm and adjacent ditches is one acre. **TOTAL – 12 Acres**

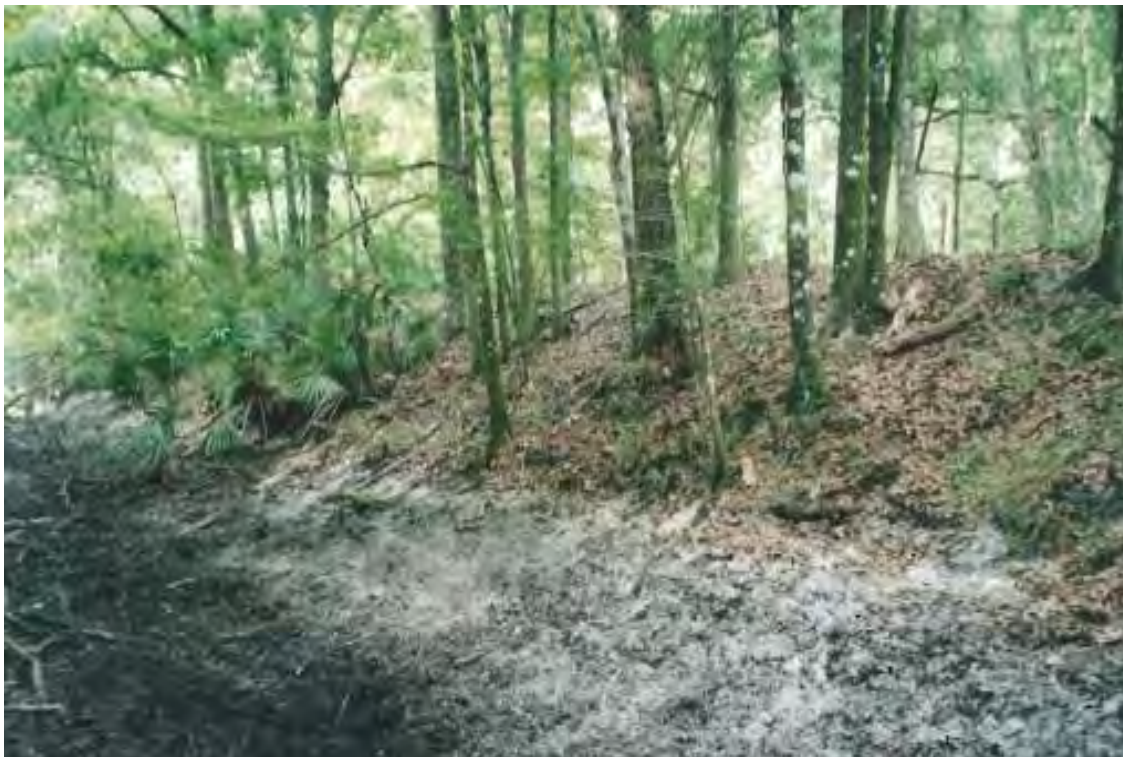
Pre-Construction - Site 4 (2005) – side view of the berm crossing the floodplain. Fill material will be graded back into the dredged donor area (left), elevating and restoring the historic wetland floodplain grade.

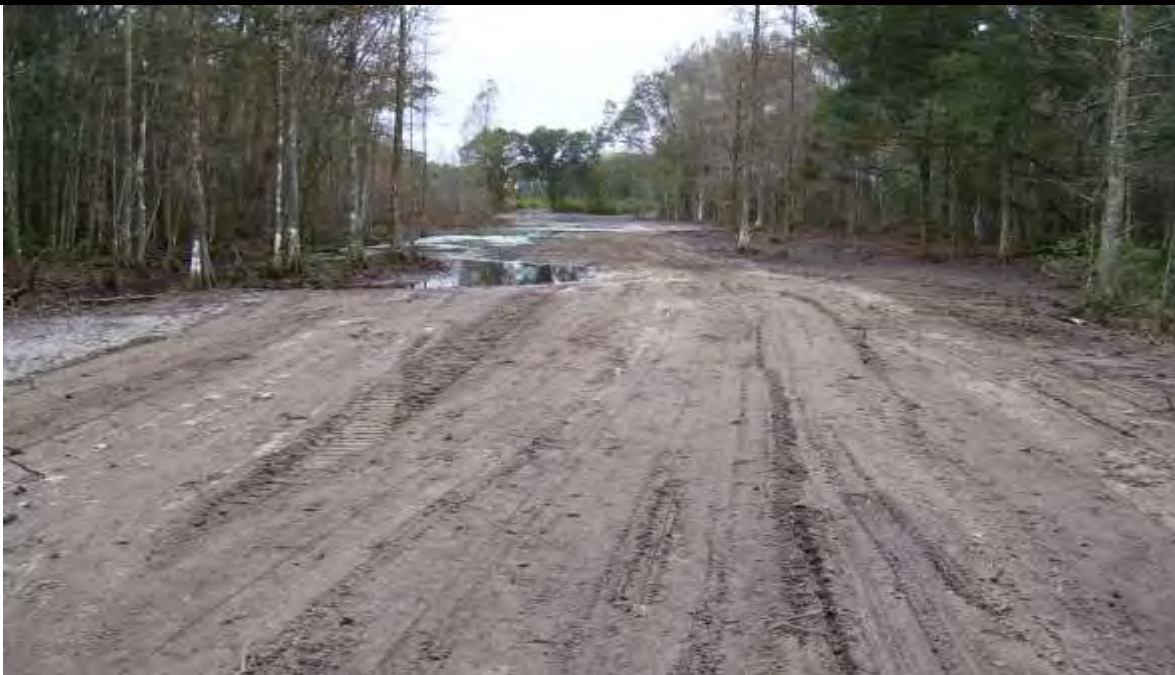
During Construction - Site 4 (February, 2008) – berm material has been graded to fill adjacent ditches, followed by seeding with winter rye and bahia for initial soil stabilization. The base flow through the river channel was maintained, however water sheet flow & seepage has been restored through the floodplain wetland.

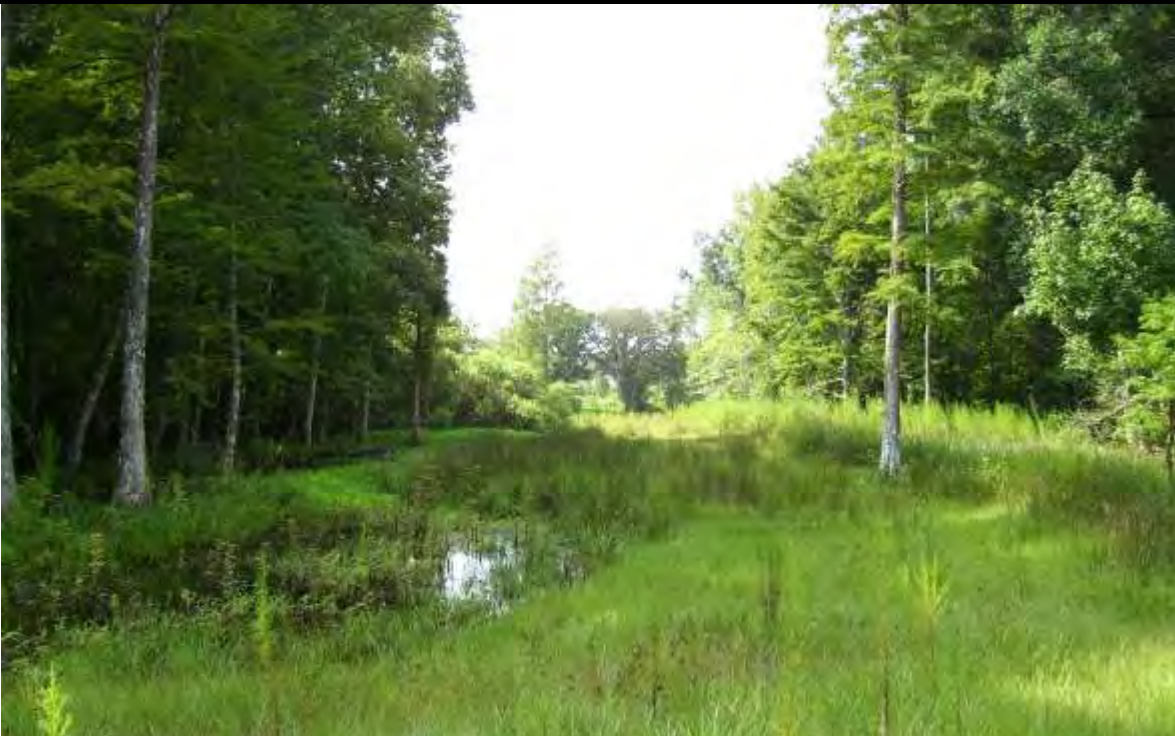
Post-Construction - Site 4 (July, 2009) – extensive coverage of naturally recruited and generated herbs such as soft rush and sedges; as well as seedlings of hydrophytic trees that will gradually mature to fill in the canopy gap.

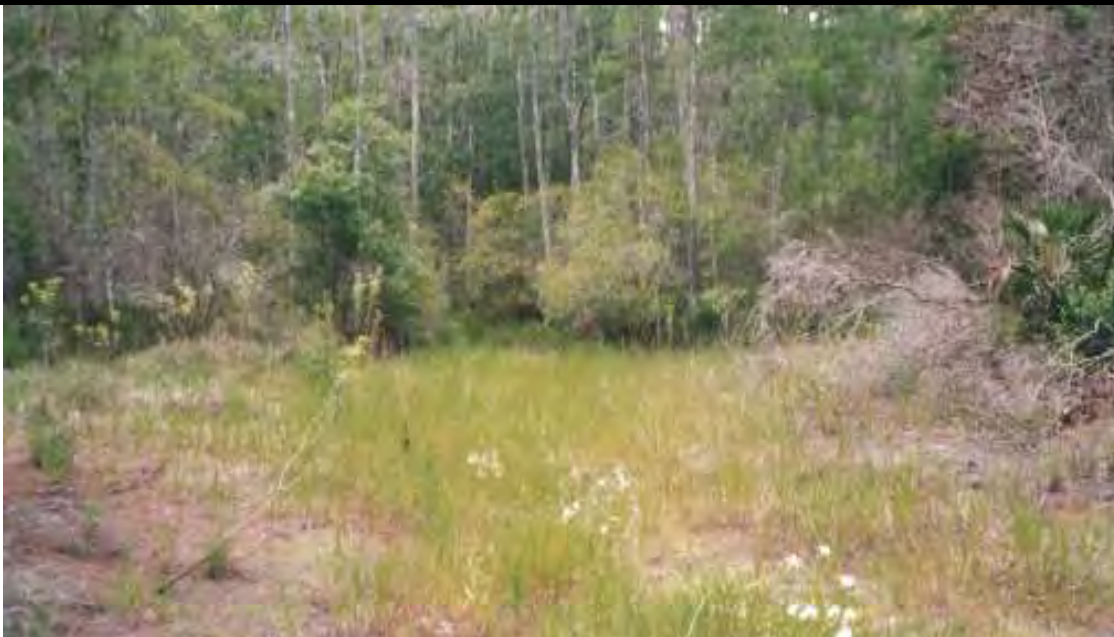
Pre-Construction - Site 8 (2005) – the outfall ditch draining the wetland varies in width & depth, however substantial water flow conveyance was observed during rainy seasons.

Project Site 8 – This is a large outfall ditch, with a bottom width over ranging 15-30 ft, and top-of-bank width varying 30-50 ft. The ditch depth from top-of-bank varies because most of the ditch was dredged through elevated topography to provide positive hydraulic gradient flow, however some portion of the ditch was over five foot deep. But because of the excessively drained, sandy soil conditions, the ditch hydroperiods are intermittent. Even though the cypress wetland is large, the area of direct wetland enhancement was estimated near the northern extent of the system. The construction included three ponds dredged from within the ditch and the resulting fill material was used to construct two large ditch blocks. By constructing the ponds and blocks from within the footprint of the previous ditch, the construction was able to avoid disturbing any of the palmetto habitat bordering the ditch. These blocks have halted the dewatering, and the ponds provide a water source for wildlife during the dry season. Direct wetland enhancement was estimated at 2 acres (length 300 feet x width 350 length = 2 acres). **TOTAL – 2 acres.**

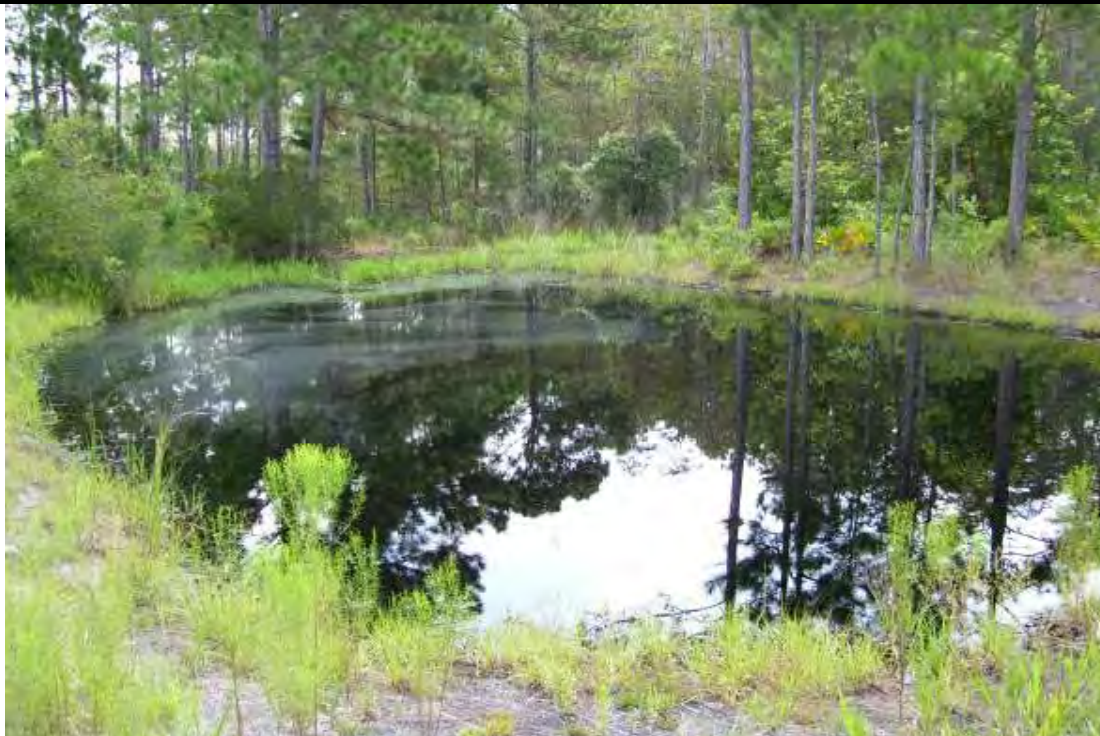
Post-Construction - Site 8 (July, 2009) – the ditch is several hundred feet long, with three small ponds dredged in the ditch footprint to provide fill material necessary to construct two large ditch blocks between each of the ponds. The ponds provide a water source for wildlife during the dry season and the adjacent ditch blocks have stopped the draining of the wetland.

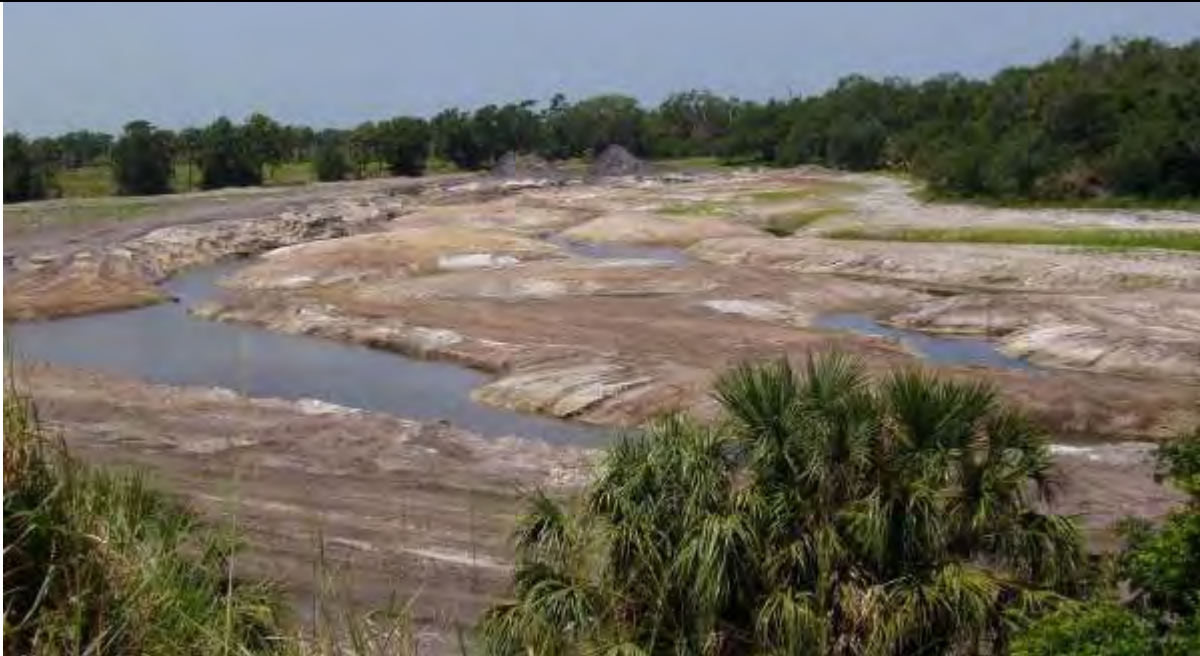
During Construction (2005) – view from atop observation mound, looking west over upland field graded to construct braided tidal channels and marsh zones.

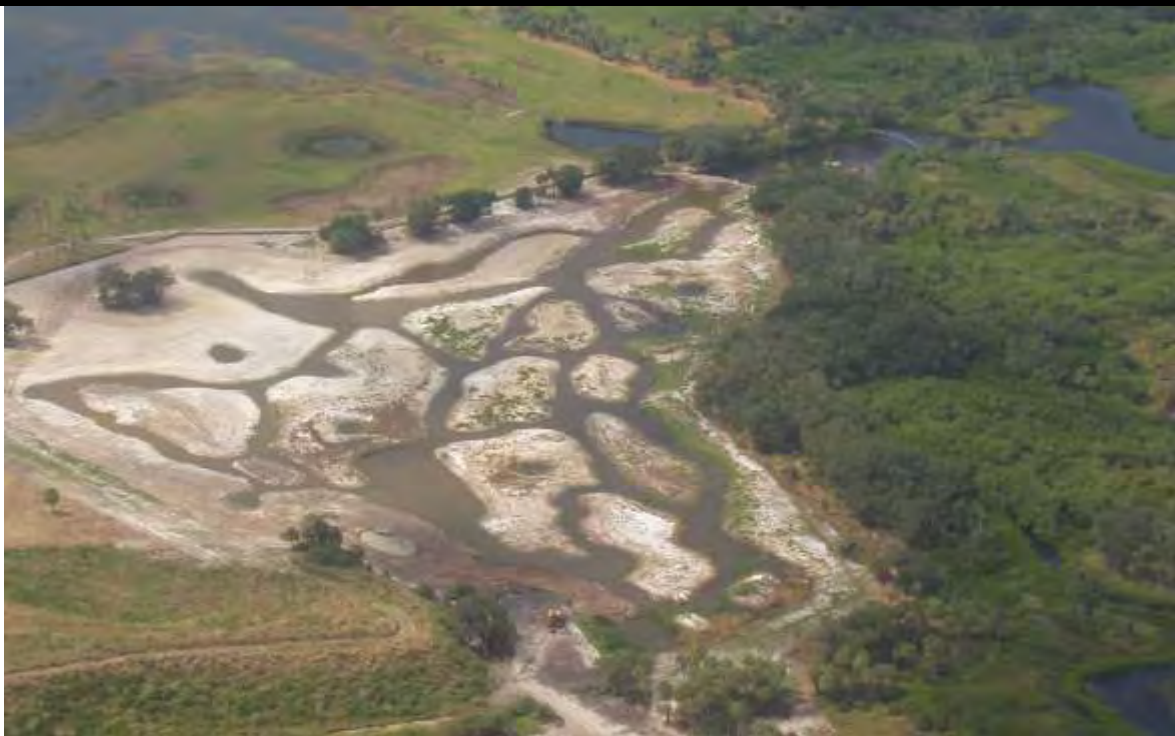
Final grades have been achieved but the canal fill block (upper center) has not been breached yet to allow tidal waters to inundate the site. Observation mound is lower left, and freshwater wetland creation is upper left.

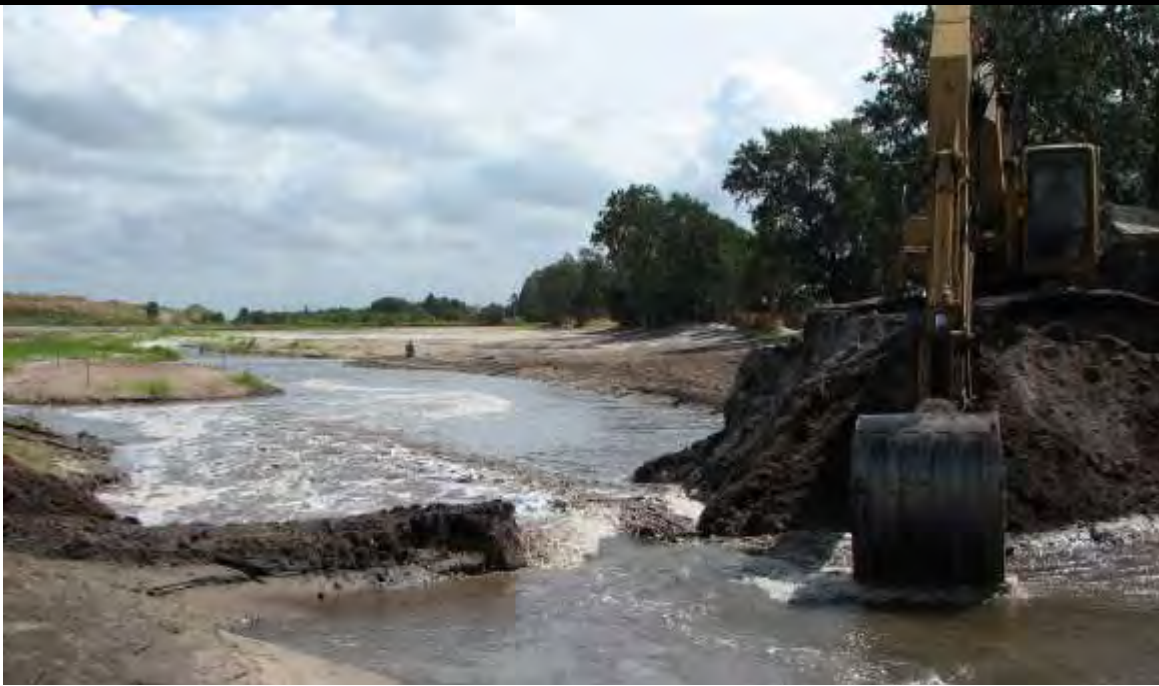
Marsh grades are final and the backhoe breaches the canal block to open tidal connection and flow into the constructed wetland.

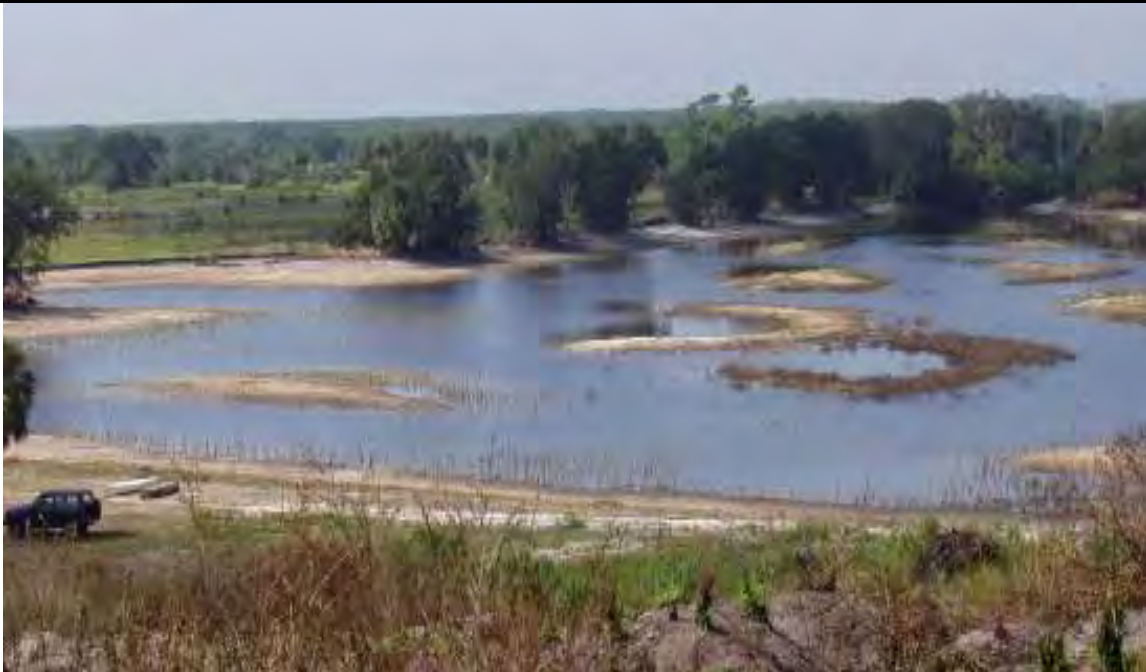
Tide elevations have equalized and herb planting is depicted, planted species include smooth cordgrass, marsh-hay cordgrass, knotgrass, and sand cordgrass along the perimeter.

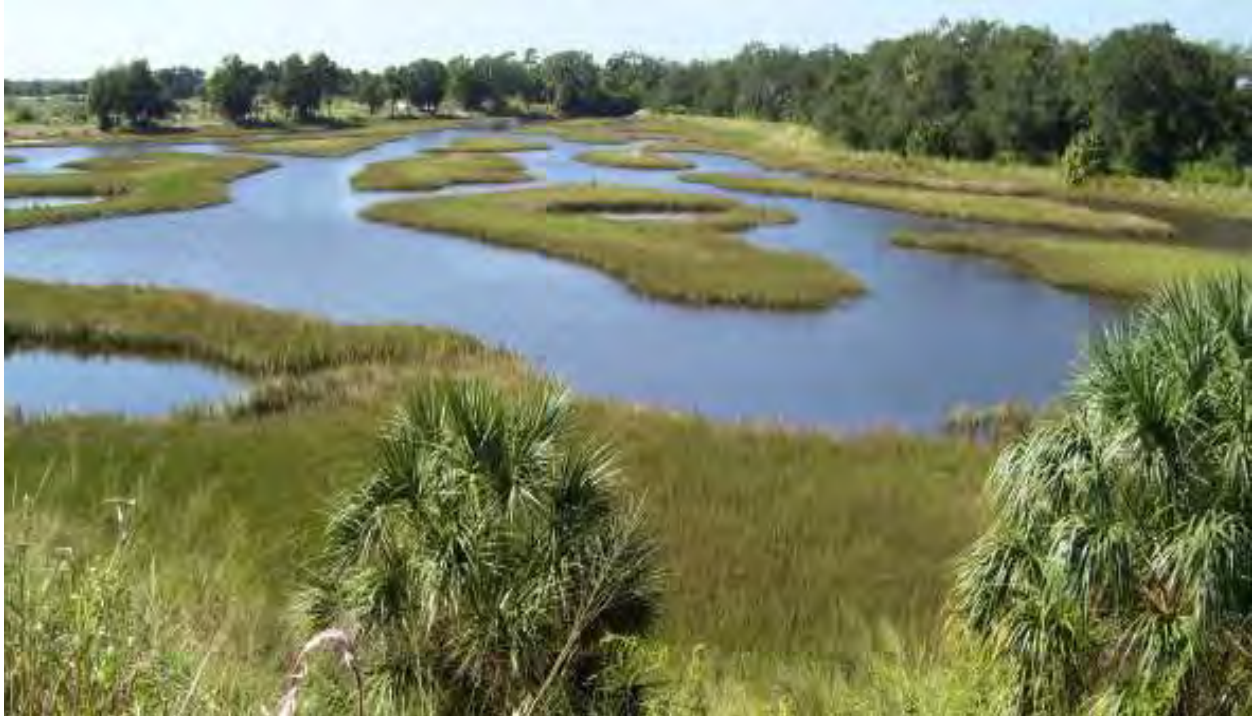
Current Conditions (2009) – view from atop observation mound, dense cordgrass coverage on the marsh zones separated by braided tidal channels.

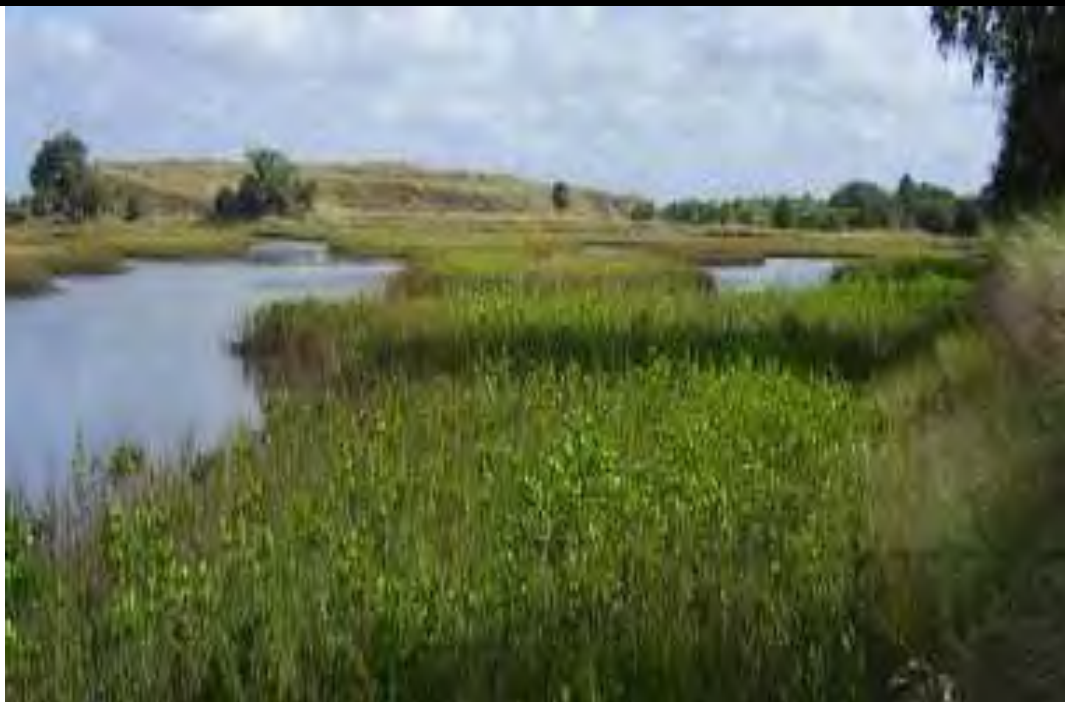
2009 - view from northwest project boundary, looking east toward observation mound (background), sand cordgrass perimeter and oak hammock is on the right. Mangrove saplings have generated within some of the marsh zones.

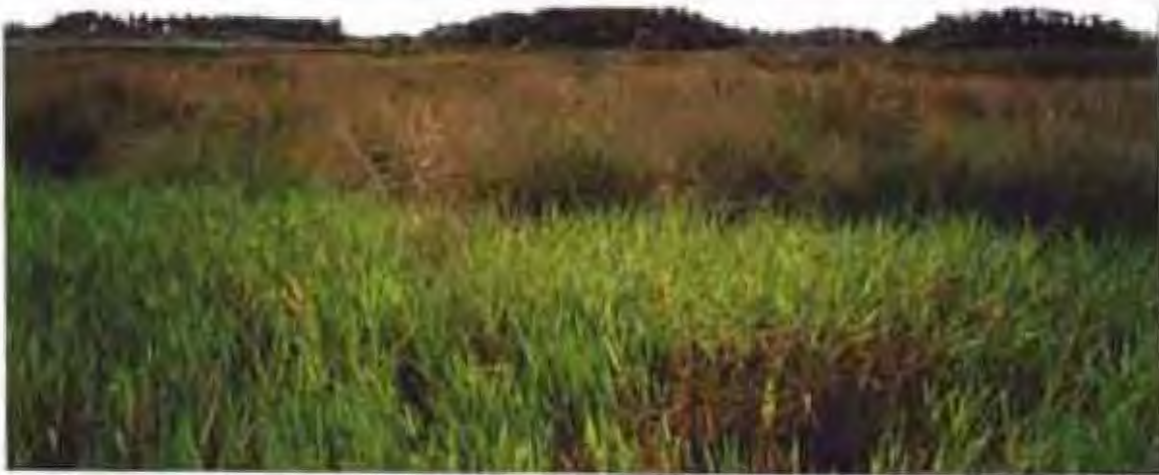
The majority of the tract is covered with a high quality marsh with a dominance of maidencane and sand cordgrass along the outer zone (foreground). Pickerelweed, smartweed, and maidencane dominate the interior, with scattered pockets of sawgrass, Carolina willow and forested wetland islands (background).

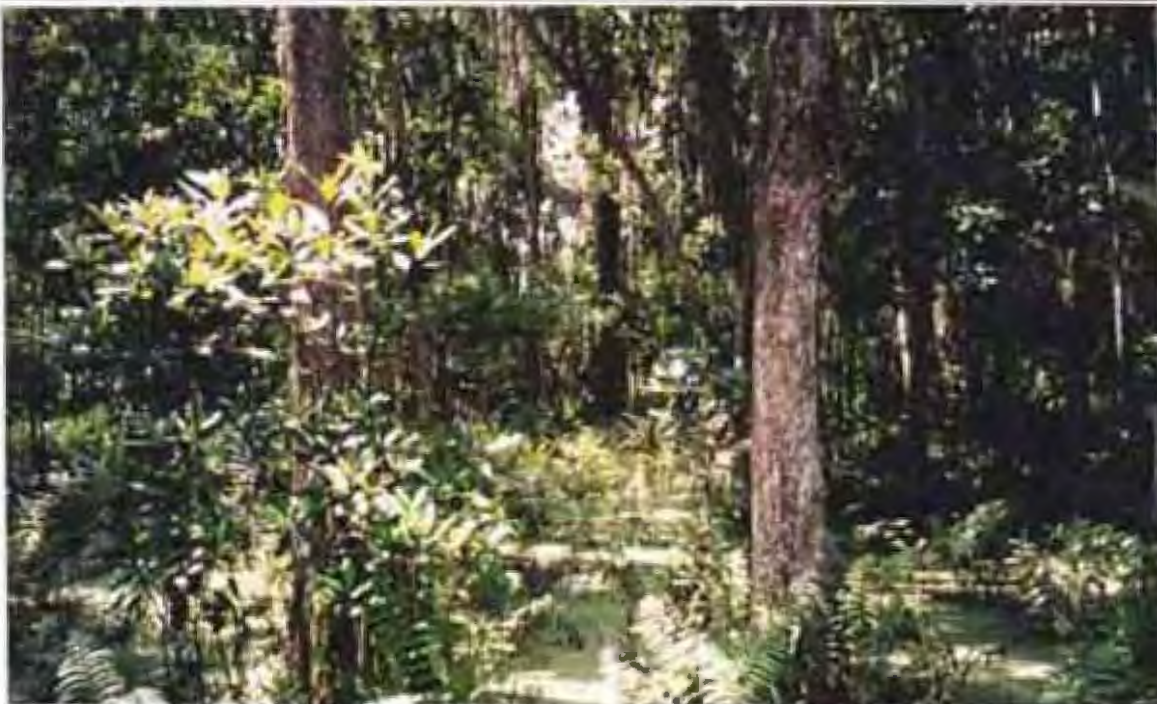
The forested wetlands are located along the southwestern portion of the property and islands within the marsh. Dominant overstory and sub-canopy is provided by sweet bay, swamp bay, tupelo, cypress, and red maple. Understory vegetation includes a dominance of lizard's-tail and various fern species.

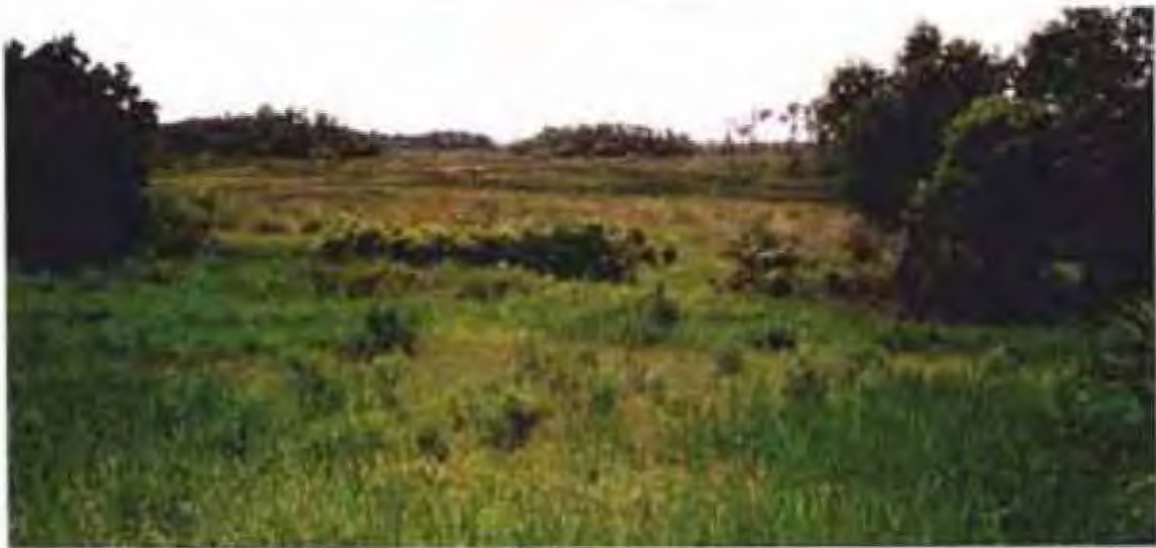
Within the property boundary, the upland buffers (foreground) along the western and northern perimeters of the marsh (background) have a dominant cover of bahiagrass. Other species include broomsedge, euthamia, dog fennel, blue maidencane, and goldenrod. Scattered myrtles and live oaks are also present.

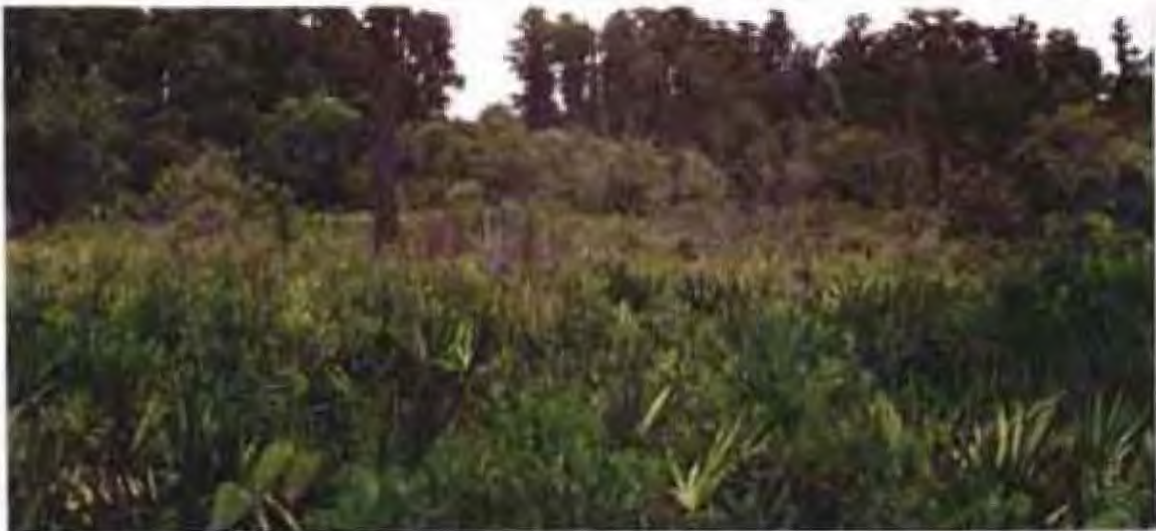
Within the property boundary, the upland buffers along the eastern and southeastern perimeter of the marsh are pine flatwoods that have dominant cover of saw palmetto, gallberry, fetterbush, wax myrtle and scattered slash pine. A forested perimeter dominated by cypress (background) is present along the marsh within the southeastern and southwestern portion of the property.

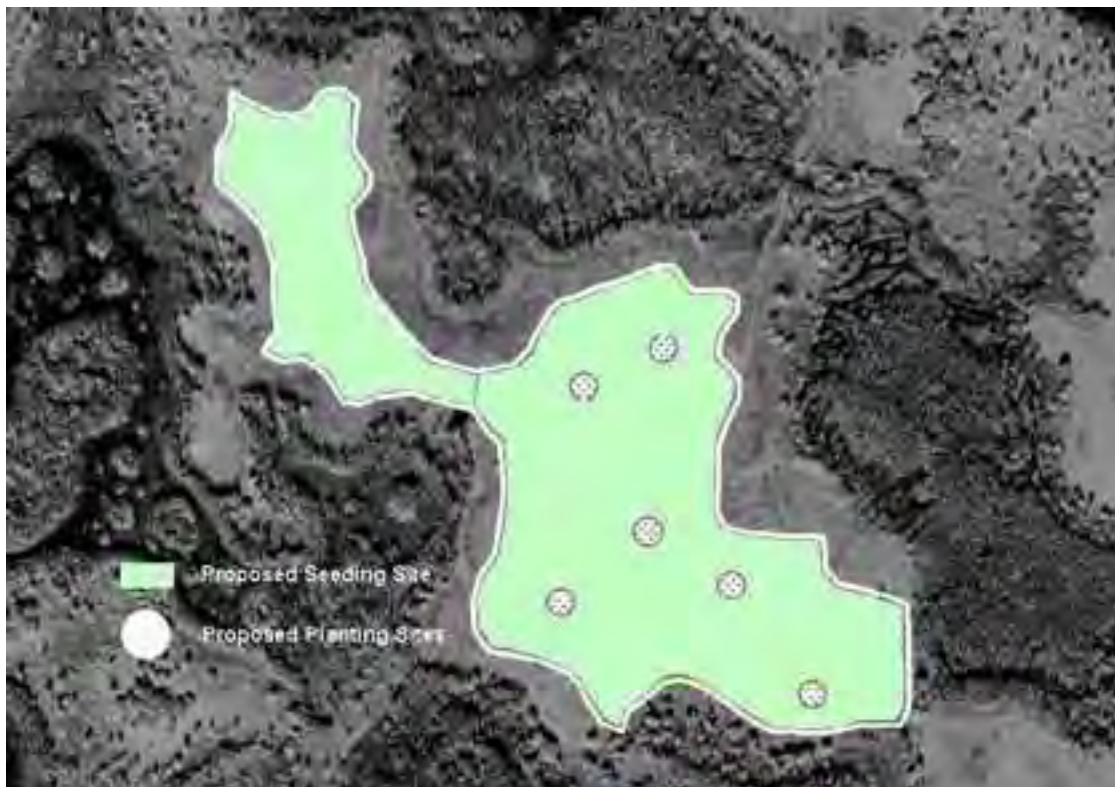
Figure 7. Conner Preserve Upland Restoration Site 2.

Consists of 50-acres located in the south-central region of the tract almost exclusively in Section 13 Township 25 Range 18. The dominant soils are Adamsville and Smyrna fine sands, with smaller pockets of Sellers mucky loamy fine sand, Cassia fine sands, and Narcossee fine sands (National Cooperative Soil Survey 1982).

Site 2 will be restored in 2008 using a combination of direct seeding and plant installation (Figure 7). Site preparation will begin 1-2 years in advance of seeding with 2-3 aerial herbicide applications per year to effectively reduce bahia grass, accompanied by one or two disking treatments. If introduced grasses (bahia, Bermuda, cogon, natal) are sufficiently eradicated, the site may be allowed to lie fallow the summer prior to seeding to provide a firmly packed seedbed, facilitate full recharge of soil moisture profile, enhance nutrient availability, and to reduce recruitment of undesirable weeds. The site will be burned in February 2008, followed by several aerial applications of either Roundup or AquaStar herbicide, and another burn, if feasible. Disking and rolling requirements will be based on the results of the 2006 and 2007 seeding events and site conditions. In November 2008, seeding will be conducted on the entire 50-acres, followed by installation of primarily wiregrass on approximately 8-acres around the perimeter and westernmost portion of the site. An aerial application of Plateau may be applied at a rate of 12 ounces per acre 4-5 months after seeding to reduce survival of bahia grass seedlings. Installation of longleaf pine will be conducted on the site after success criteria are achieved.

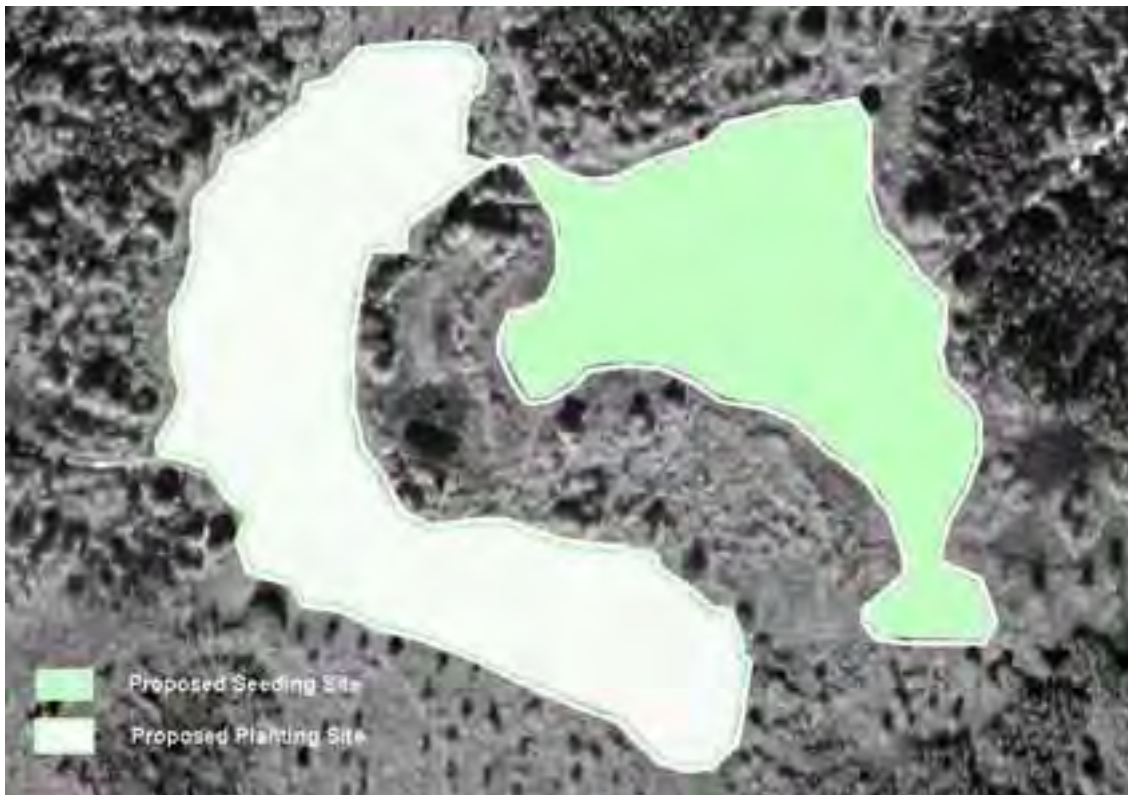
Figure 8. Conner Preserve Upland Restoration Site 3.

This site is 22-acres in size and located in the northwest portion of the tract at the junction of Sections 11, 12, 13, & 14 in Township 25 Range 18. The dry upland ridges are characterized by Tavares and Adamsville fine sand (National Cooperative Soil Survey 1982). These will be targeted for restoration of sandhill vegetation. The lower elevations, which will be re-vegetated to pine flatwoods groundcover, are comprised primarily of Smyrna fine sands.

Site 3 will be restored in 2006 using a combination of direct seeding and plant installation (Figure 8). Site preparation for Site 3 will start in February 2005, when the site will be burned. Herbicide applications will then be conducted throughout 2005. In 2006, the site will continue to be treated with herbicide to remove nuisance and exotic vegetation, and burned periodically as fuel loads allow. Disking will be conducted in mid- to late-summer, followed by one more herbicide treatments and potentially shallow disturbance with a chain drag immediately before seeding. Site preparation on Sites 3, 4, and 5 may be more intensive than on Sites 1 and 2 because the former sites will be treated with a Grasslander seeder instead of the modified sod sprigger. In November 2006, seed will be distributed on the eastern lobe of the site, and in the interior of the western lobe, and then plants will be installed on 8-acres in the western lobe in July or August 2007. Installation of longleaf pine will be conducted after success criteria are achieved.

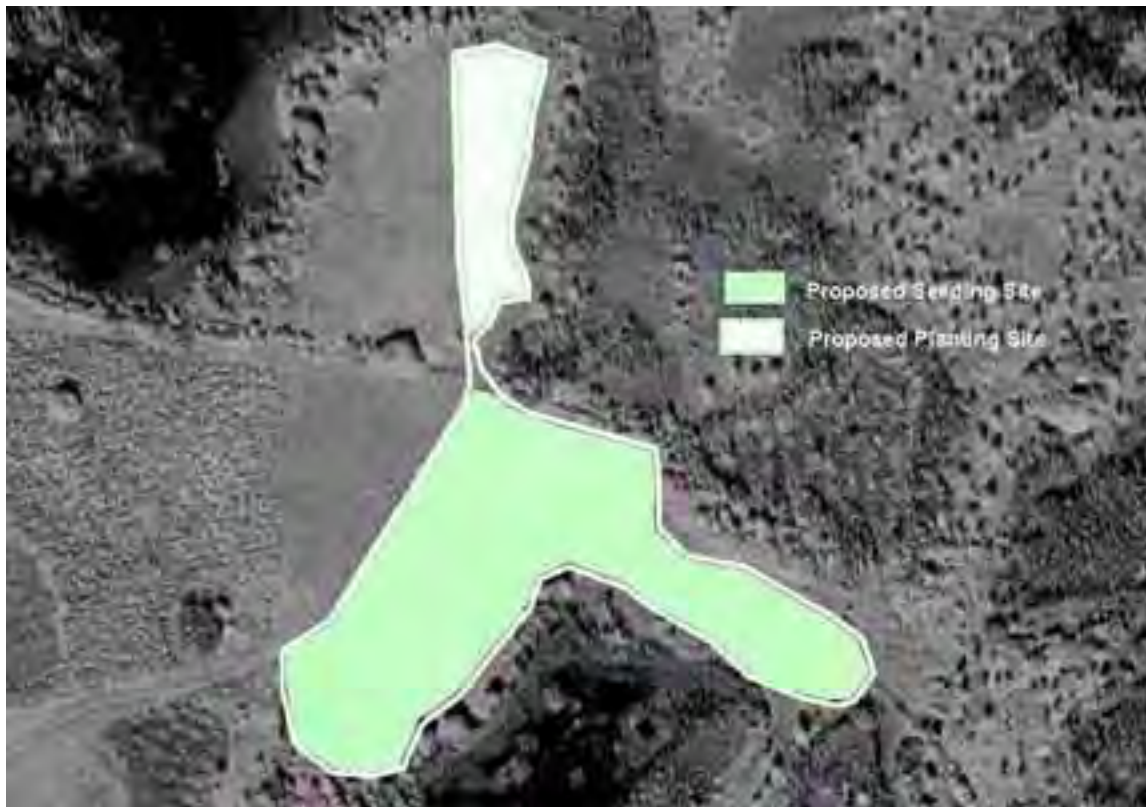
Figure 9. Conner Preserve Upland Restoration Site 4.

elevations, which once supported pine flatwoods, are comprised of Ona fine sands (National Cooperative Soil Survey 1982).

Site 4 will be restored in 2007 using a combination of direct seeding and plant installation (Figure 9). The site will be burned in February/March 2006, and herbicide treatments will commence through 2006 and 2007, with burns conducted as necessary to reduce biomass. The site will be seeded in November 2007, and plants will be installed on 6-acres in the narrow, unseeded portions of the site in July/August 2008. Aerial applications of Plateau may be applied at a rate of 12 ounces per acre to reduce competition and establishment of bahia grass. A long period of herbicide treatment prior to seeding the site is anticipated to reduce the post-construction herbicide needs on the site. Installation of longleaf pine will be conducted on the site after success criteria are achieved.
