Southwest Florida
Water Management District

EDOT MITIGATION PLAN JANUARY 26, 2010

Southwest Florida Water Management District
Resource Regulation Division
Strategic Program Office
Brooksville, Florida 34604-6899

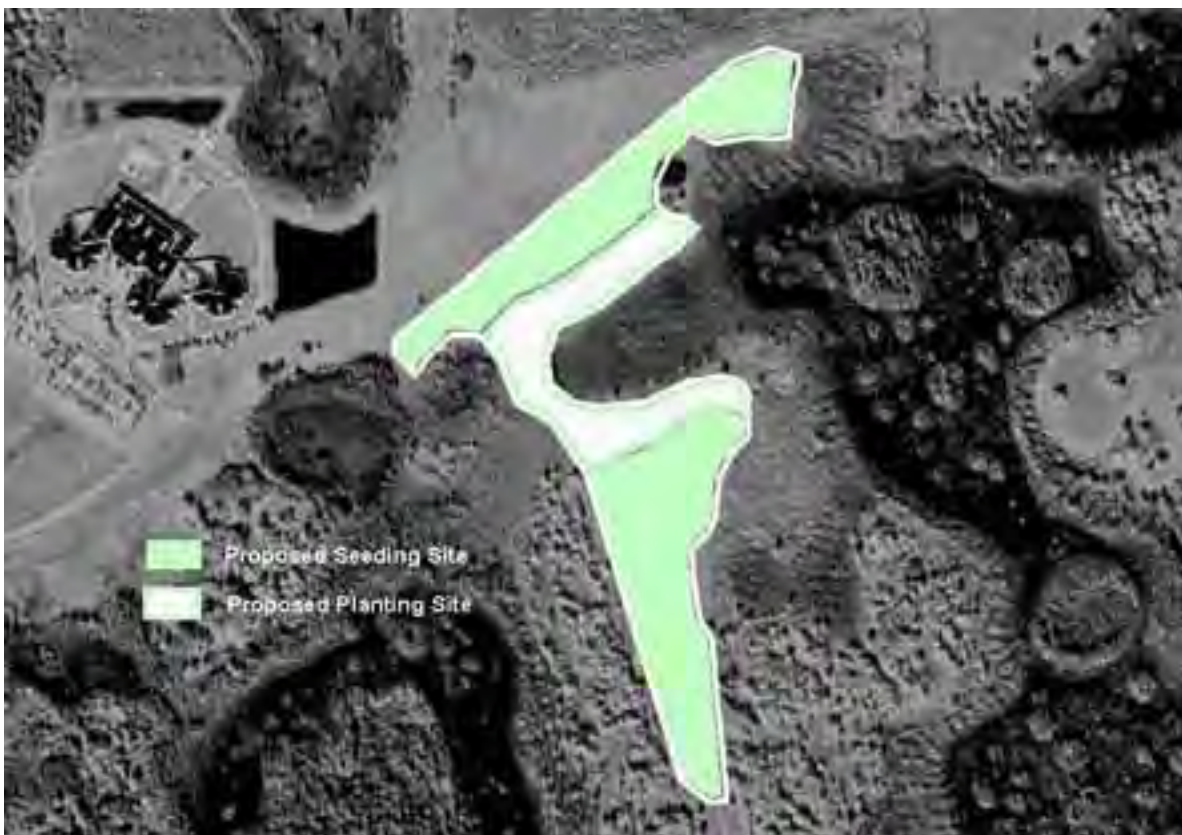
Figure 10. Conner Preserve Upland Restoration Site 5.

Site 5 will be restored in 2009 using a combination of direct seeding and plant installation (Figure 10). The site will be burned in February 2008. Herbicide treatments will then be conducted throughout 2008 and early 2009, with fire applied as necessary to reduce above-ground biomass. Seeding will be conducted in November/December 2009, followed by plant

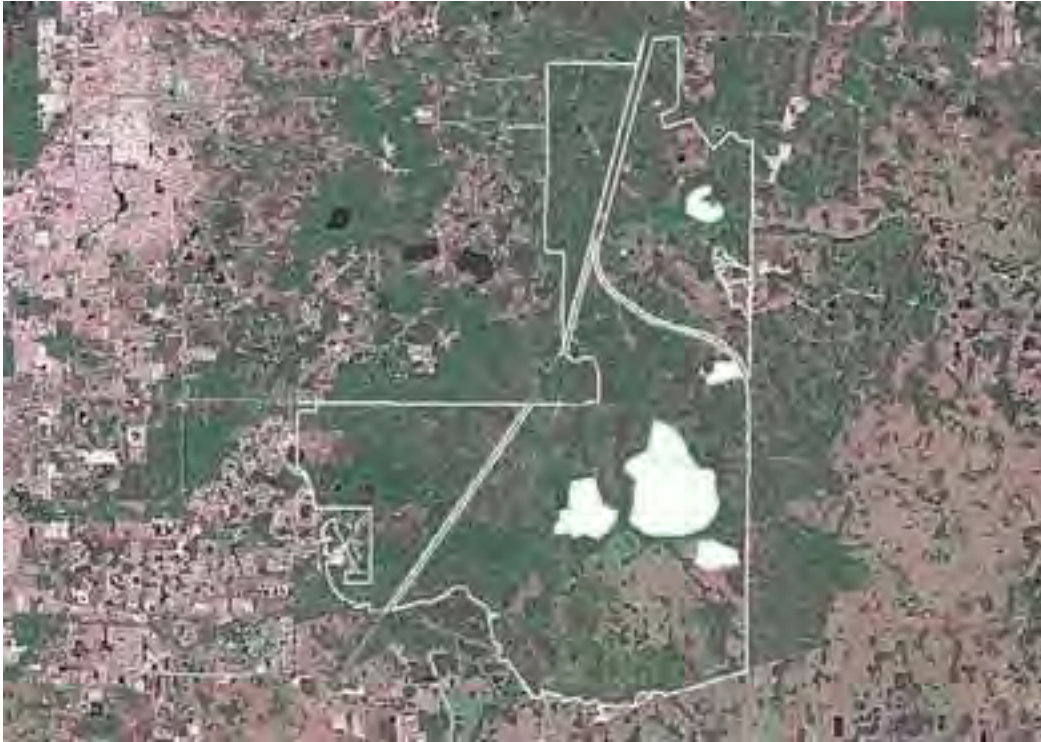
Figure 11. Starkey Wilderness Park. Five seed donor sites are available.

Six seed donor sites are proposed to be utilized for seed collection. Five of the proposed seed donor sites are located on the Starkey Wilderness Park in Pasco County (Figure 11). Approximately 1,200 acres of pine flatwoods are suitable and available for harvesting on this property. Starkey is about 10 miles west of the Conner Preserve, and travel distance between the two properties is approximately 18 miles. The pine flatwoods that characterize the donor sites have been managed with growing season fire at 3-4 year intervals for approximately 30 years. The soils characterizing these flatwoods include Pomona, Myakka, Immokalee, Smyrna, and Candler fine sands (National Cooperative Soil Survey 1982). Predominant species on these seed donor sites include wiregrass (*Aristida beyrichiana*), bottlebrush three-awn (*Aristida spiciformis*), toothachegrass (*Ctenium aromaticum*), panic grasses (*Dicanthelium* spp.), splitbeard bluestem (*Andropogon ternarius*), broomsedge (*Andropogon virginicus*), roserush (*Lygodesmia aphylla*), bog button (*Lachnocaulon anceps*), narrow-leaved sabatia (*Sabatia brevifolia*), blackroot (*Pterocaulon pycnostachyum*), false hoarhound (*Eupatorium rotundifolium*), saw palmetto (*Serenoa minor*), gallberry (*Ilex glabra*), sand live oak (*Quercus geminata*), and longleaf pine (*Pinus palustris*).

All of the seed donor sites will be matched to the appropriate restoration site based on vegetation, soil type and elevation characteristics. See Appendix C for a detailed discussion of proposed donor site preparation and harvesting techniques.

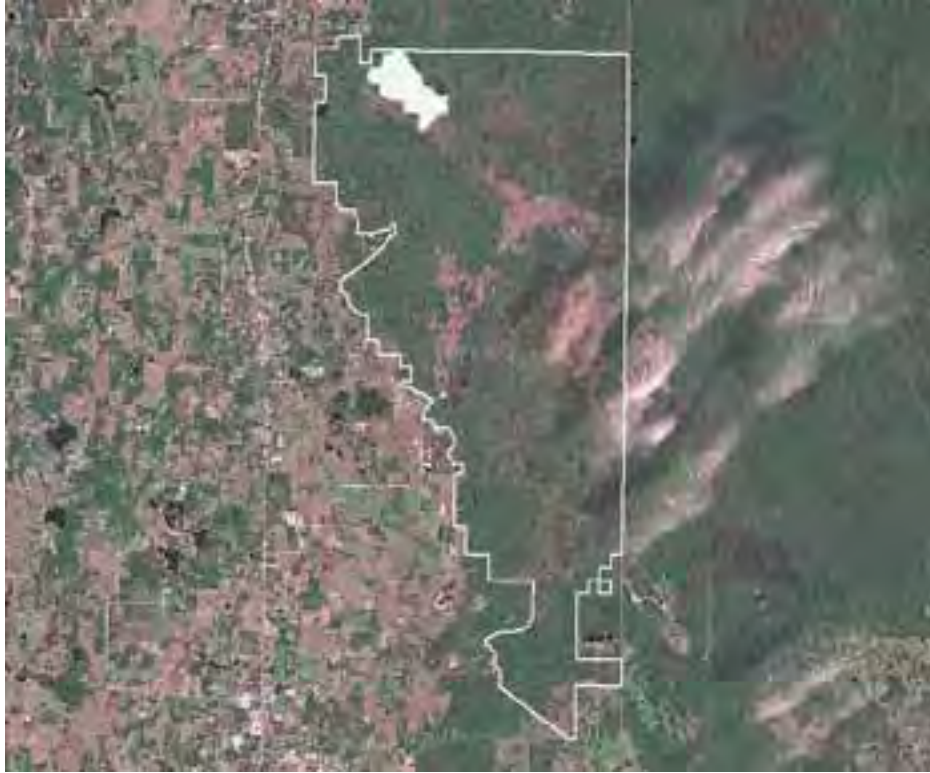
Figure 12. Green Swamp West seed donor site.

The sixth donor site is located in the Green Swamp West Wildlife Management Area, also in Pasco County (Figure 12). There are approximately 900 – 1,100 acres available for harvesting on this property, although the majority is sandhill vegetation. Green Swamp West is located approximately 22 miles to the east of the Conner Preserve. The travel distance between this seed donor site and the Conner Preserve is about 35 miles. The dominant soils include Tavares, Millhopper and Astatula fine sands (National Cooperative Soil Survey 1982).

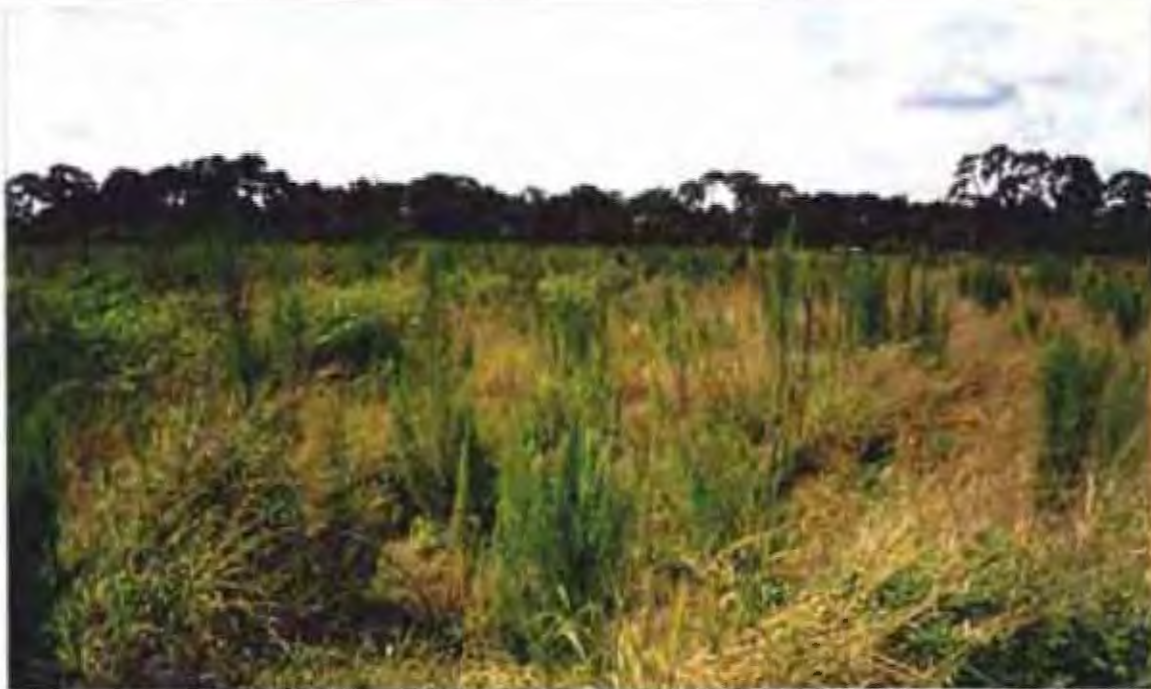
The citrus groves were removed from the uplands, allowing the generation of nuisance vegetation such as natalgrass, bahiagrass, dog fennel, ragweed, smutgrass, chickweed, beggar'-tick, and nutsedge.

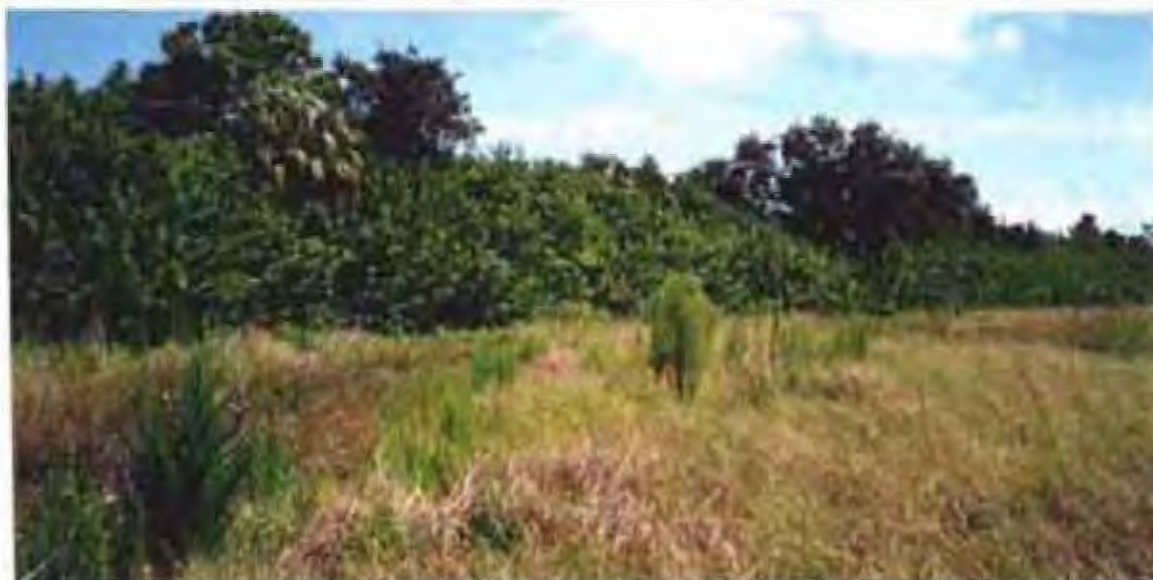
Upland-cut swales (left and right) were used to provide grove drainage to collector ditches. Two large ditches were constructed along the perimeter between the grove and coastal hammock. The associated spoil ridges are covered with a dense stand of Brazilian pepper (background).

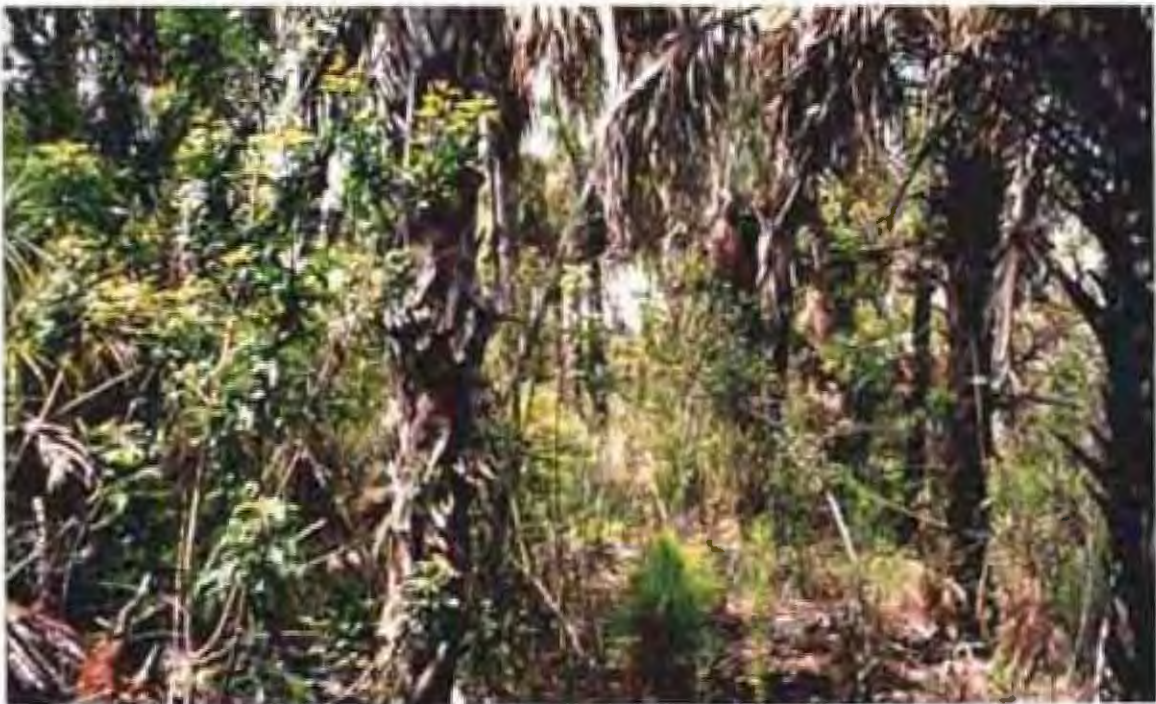
The coastal wetland hammock has a dominant cover of cabbage palm with scattered oaks and slash pine. The Brazilian pepper provides minor to moderate coverage. Other common species include salt-bush, saw palmetto, broomsedge, and swamp fern.

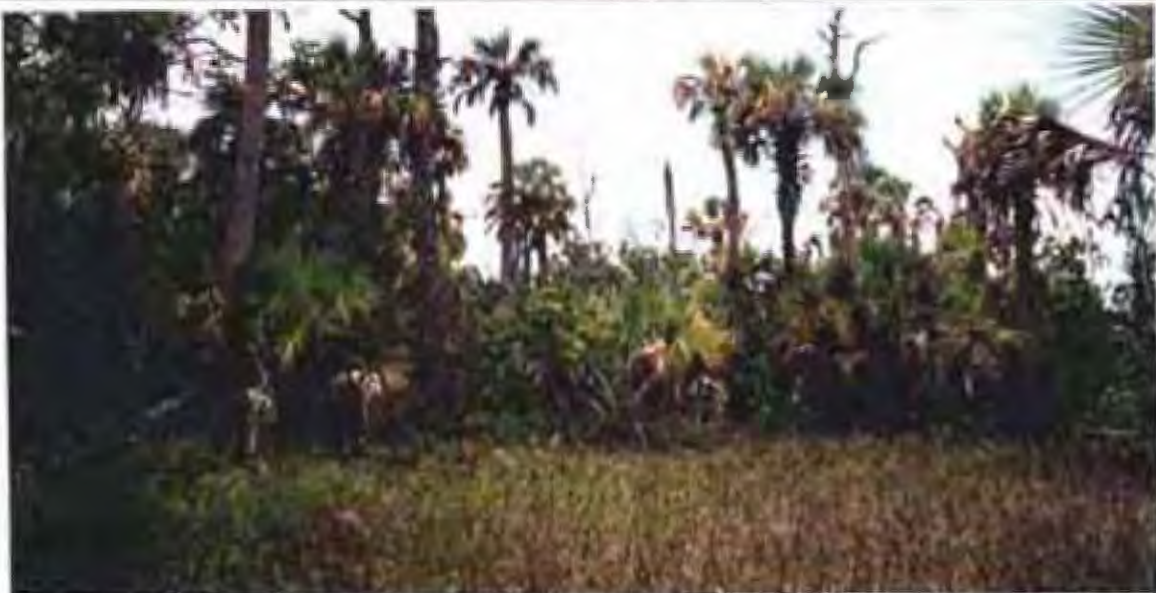
The hammock has a few marsh pockets, dominant species include sawgrass, cordgrass, and for this particular marsh, a dominance of black needle rush and marsh fleabane.

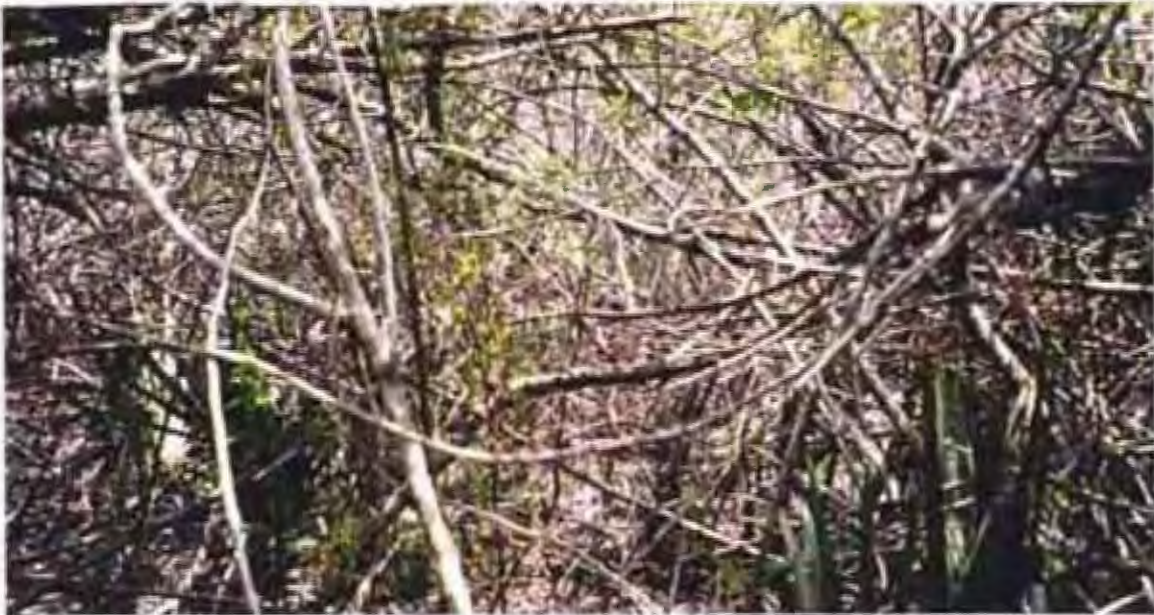
The transition between the coastal hammock and the mangrove & salt-marsh area is a dense stand of Brazilian pepper with very minimal coverage of other species; scattered small cabbage palm, salt-bush, and leather fern.

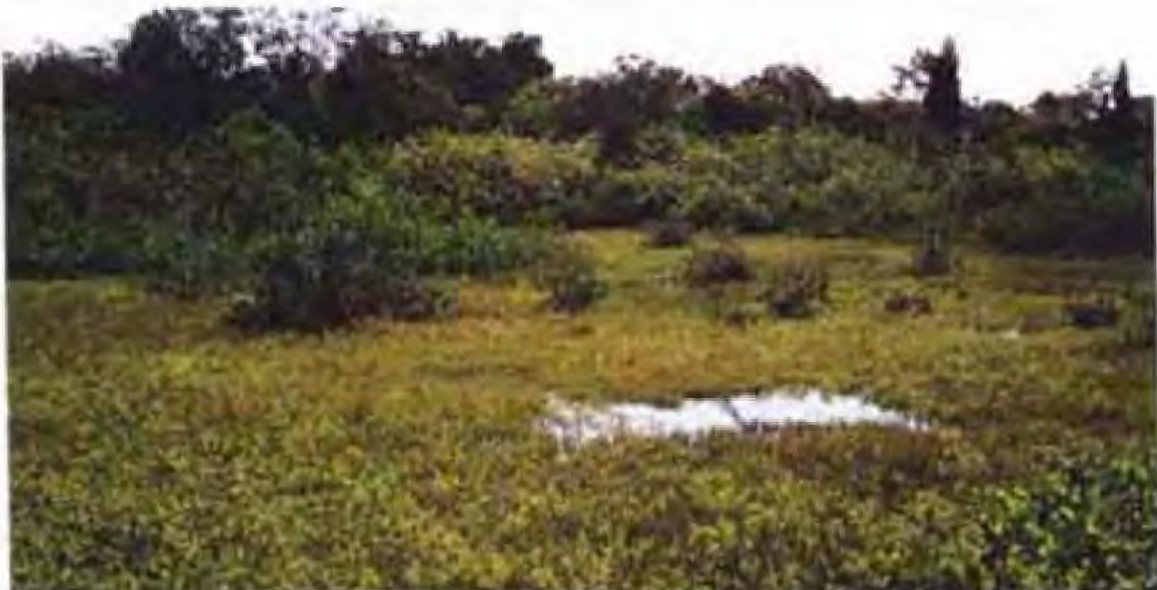
View from within the core of the mangrove & salt-marsh area, looking east toward the B. pepper transition and coastal hammock. The salt-marsh has dominant cover of glasswort, saltwort, and salt-grass. Shrub-size white and black mangroves transition to larger mangroves along the northwestern and western portions of this ecosystem.

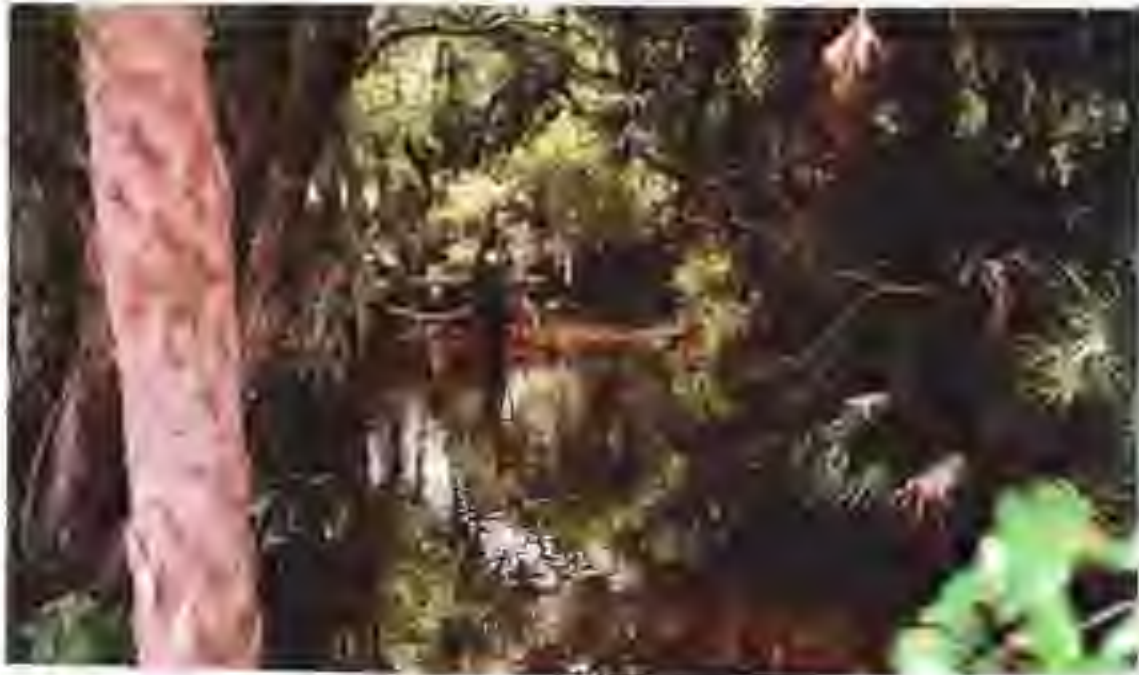
Photo 1 – Fox Creek meanders along the western boundary of the tract. Deeply incised, the creek is bordered by a mesic hammock dominated by live oak and cabbage palm.

Adjacent to Fox Creek, there is a mature mesic hammock buffer consisting of live oak (*Quercus virginiana*), cabbage palm (*Sabal palmetto*), and sand live oak (*Quercus geminata*) (Photo 1). The banks of Fox Creek are incised, which has precluded the establishment of riparian vegetation, though some leatherfern (*Acrostichum danaeifolium*) does exist near the toe-of-slope. The upland adjacent to the northern portion of the creek is an improved pasture covered with bahiagrass (*Paspalum notatum*) (Photo 2). Though few native groundcover species exist, native trees and shrubs are beginning to regenerate with the removal of cattle. Species include scattered seedlings of saw palmetto (*Serenoa repens*) and sand live oak. The soils in the area are well drained and densely occupied by both active and inactive gopher tortoise (*Gopherus polyphemus*) burrows. Within the northern portion of the improved pasture, there are several large live oaks and a few pignut hickory (*Carya glabra*), which are providing habitat and food to a population of Sherman's fox squirrels (*Sciurus niger shermani*).

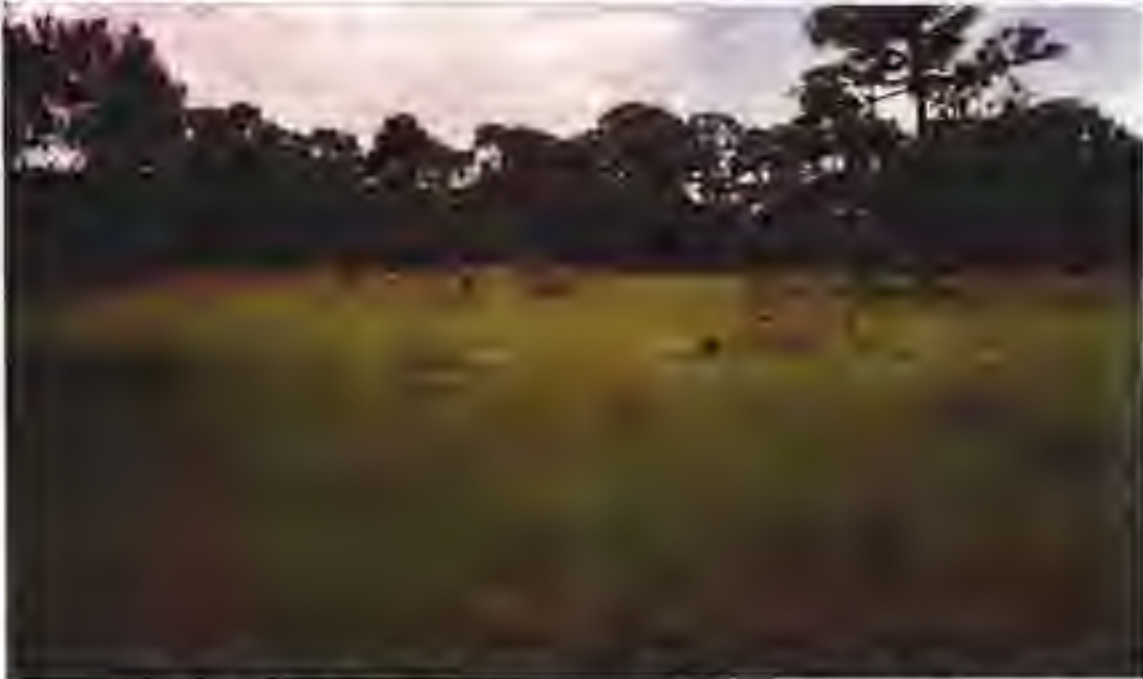
Photo 2 – The northwest pasture is dominated by bahia and will be restored into a scrub habitat community.

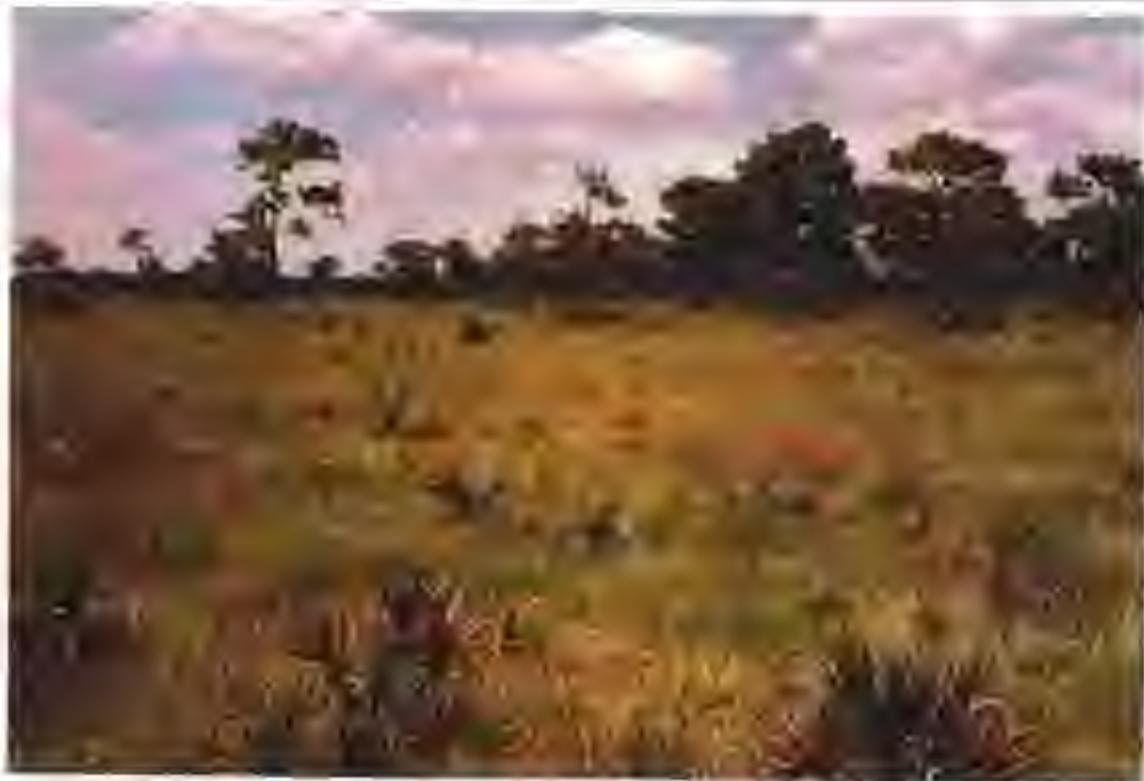
Photo 3 – Portions of the semi-improved pasture with scattered palmetto and sedges mixed with the bahia (foreground) will be graded to create wetlands. Remnant pine flatwoods (background) will be preserved and enhanced as part of the proposed mitigation plan.

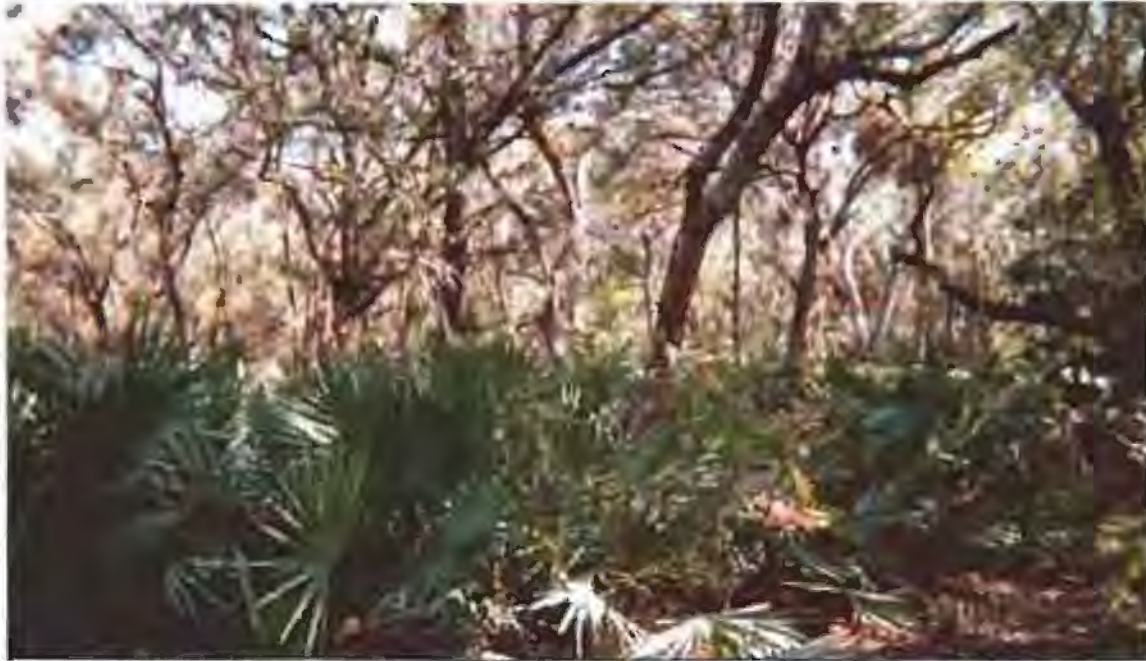
Forested Wetland Enhancement (FWE 1) – This mesic oak hammock has dominant cover of laurel oak, live oak, water oak, and cabbage palm. Understory is minimal except pockets of saw palmetto.

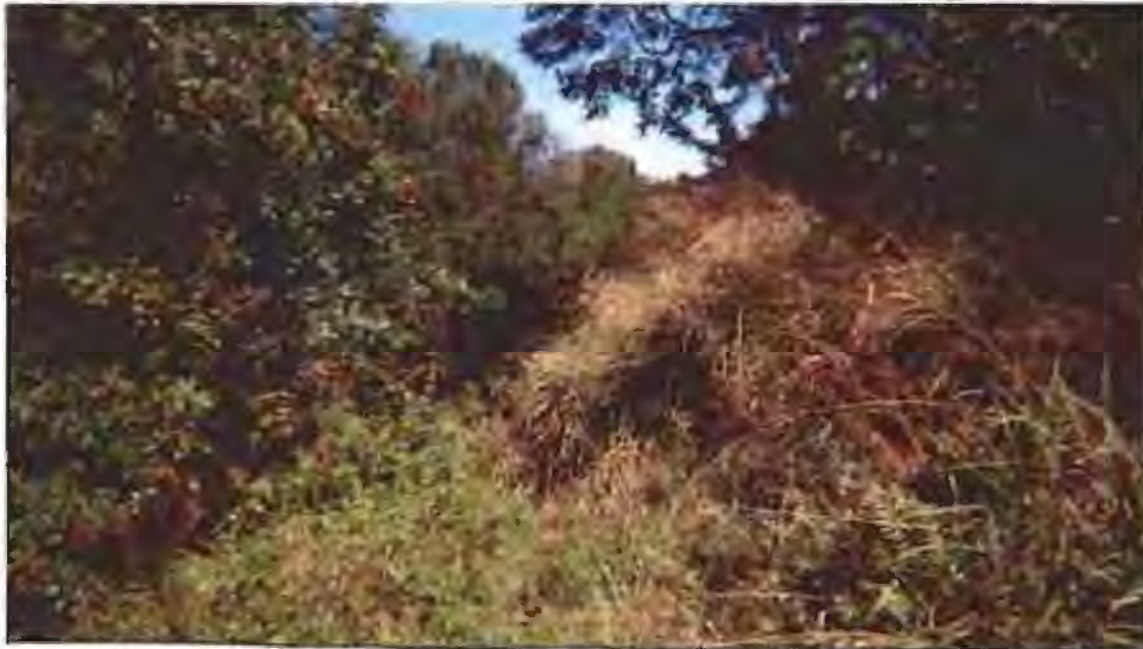
Forested Wetland Enhancement (FWE 1) – One of the large north-south ditches that collects surface water from the uplands and directly discharges to the channelized creek north of property boundary. Spoil material (right) is 15-20 ft. wide and 5-6 ft. high, covered with paragrass and various sedges. This material will be backfilled into the ditch to restore grade, seeded, and planted with shrubs and trees. Additional enhancement will include eradication of Brazilian pepper (left) that has encroached into this wetland.

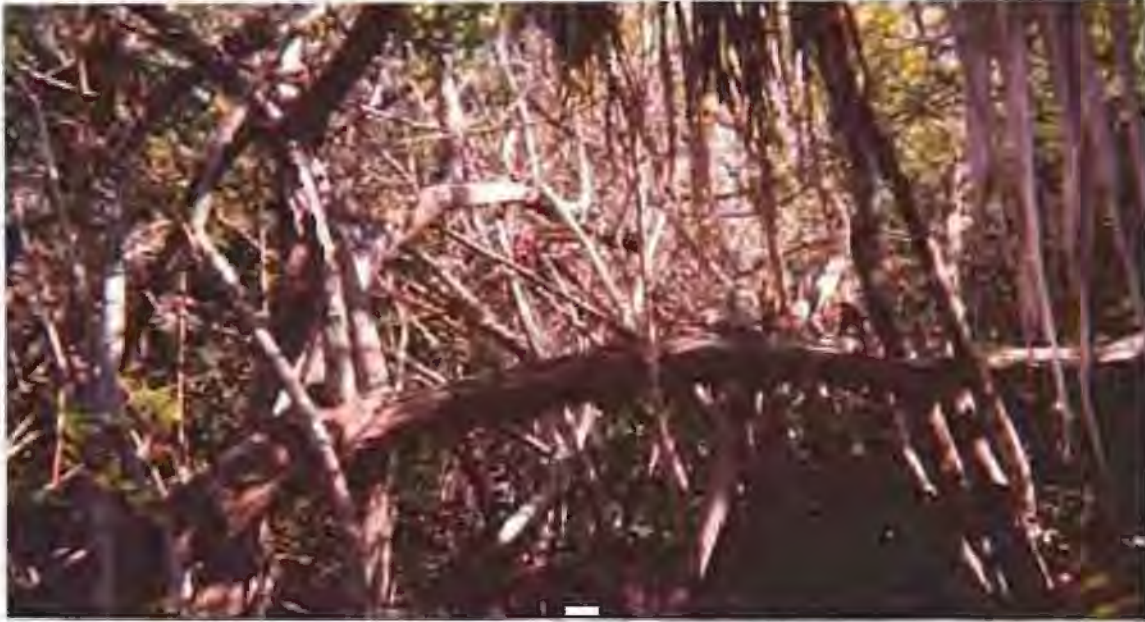
Forested Wetland Enhancement (FWE 2,3) – Brazilian pepper is prominent within many areas of the mesic hammocks, particularly along the transition interface with the adjacent marsh habitat.

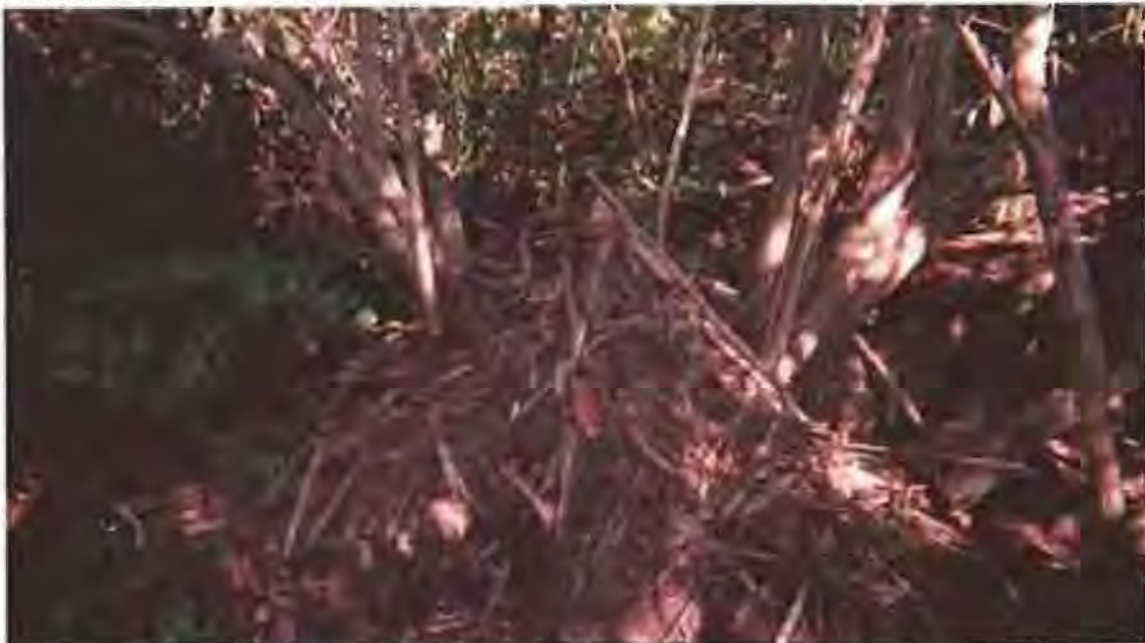
Forested Wetland Enhancement (FWE 2,3) – The mesic hammocks provide refuge for nesting, foraging, and denning by a variety of wildlife that utilize the range of habitats (Manatee River, Gamble Creek, brackish marshes, hammocks, upland restoration areas) within the vicinity of Hidden Harbour. This alligator nest was built within the base of a B. pepper near one of the tidal creek fingers bisecting the hammocks.

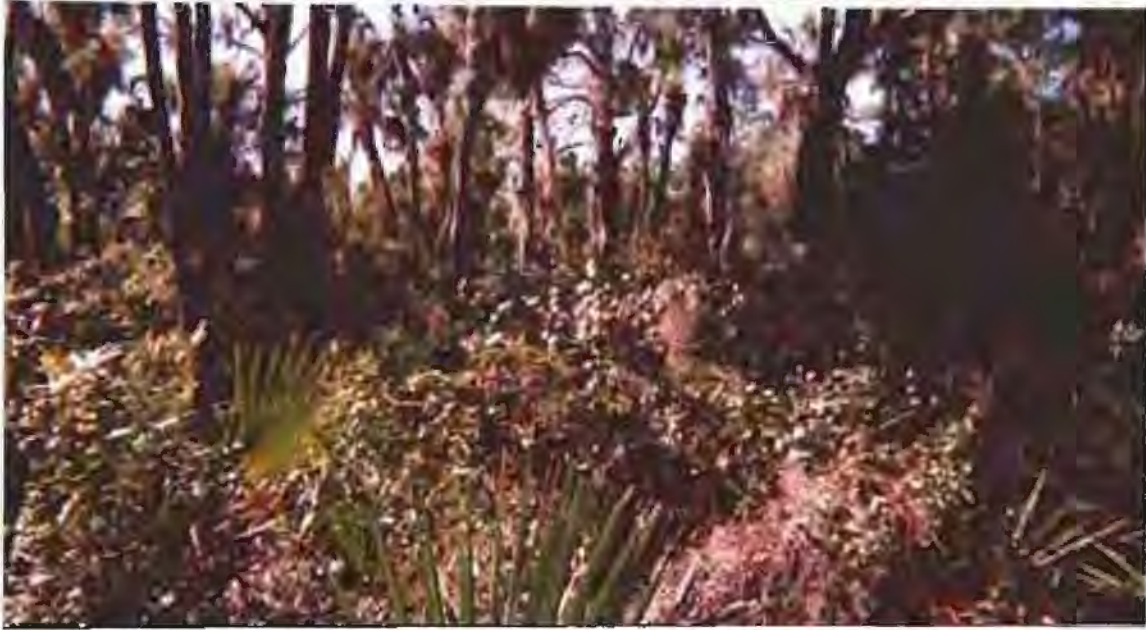
Forested Wetland Enhancement (FWE 3) – *These mesic hammocks have a dominance of laurel oak, live oak, cabbage palm, red cedar, and scattered large slash pine. Understory coverage varies in density with scattered saw palmetto, mysine, grapevine, greenbriar, and swamp fern along the lower slopes.*

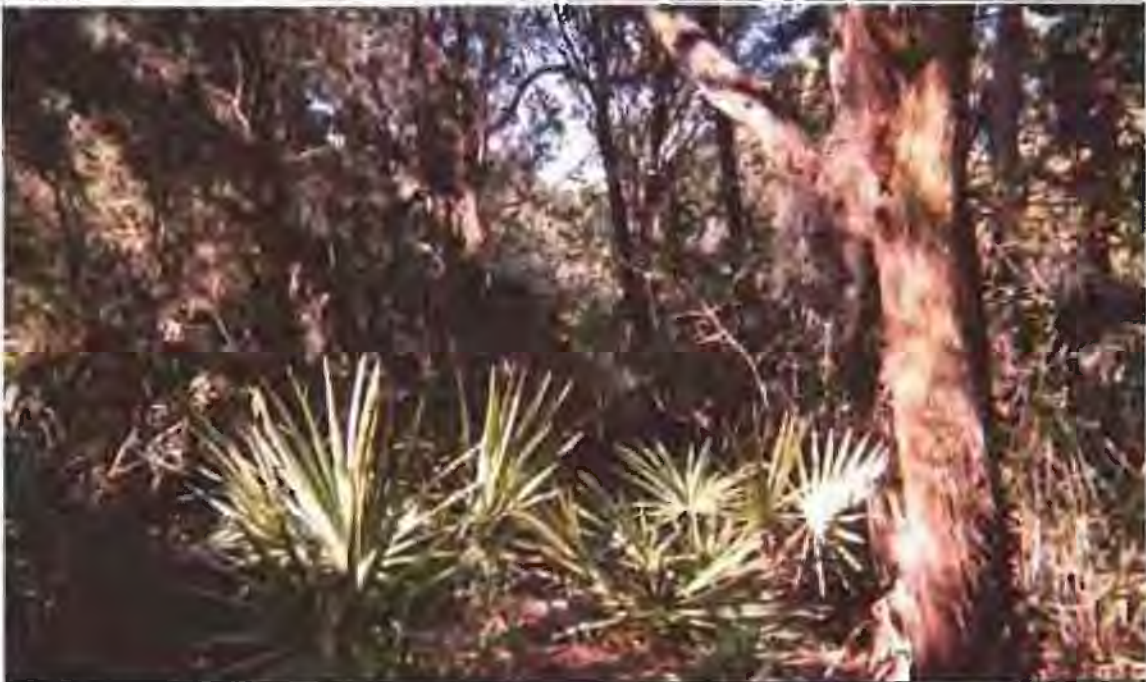
Forested Wetland Enhancement (FWE 3) – *Another view of the mesic hammock with an area of more red cedar coverage. These hammocks will be enhanced with the eradication of Brazilian pepper that will open more area for desirable species to recruit and generate.*

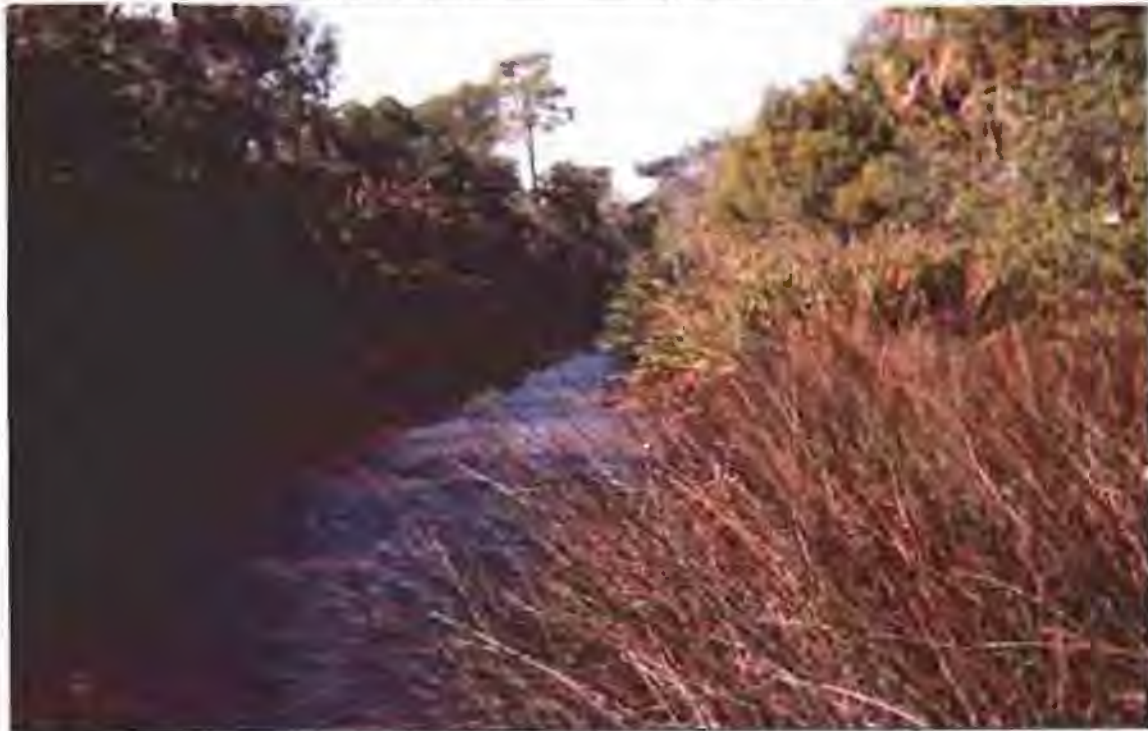
Forested Wetland Enhancement (FWE 3) – One of the tidally- connected, dead-end finger creeks that bisect the hammocks, providing more inter-related mosaic of habitats for wildlife use. Substantial fish, amphibian and wading bird activity present within these systems due to variable water levels. Dominant vegetation within the marsh zone includes black needlerush and leather fern.

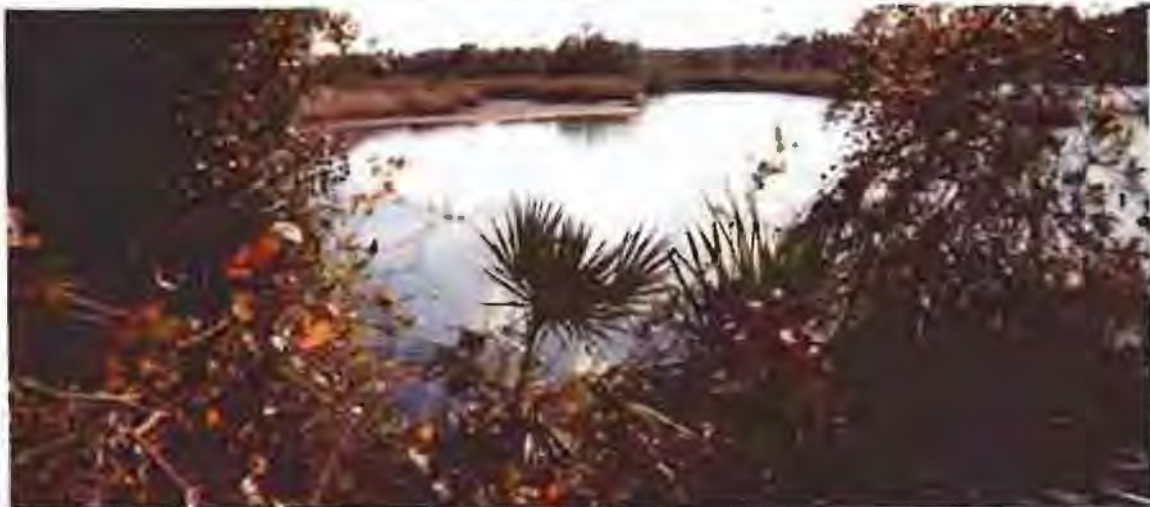
Manatee River – View from along the north shoreline of the Manatee River along the southwest boundary of Hidden Harbour, looking southeast toward two tidal creek channels and adjacent brackish marsh habitat leading into the forested wetland habitat (FWE 3).

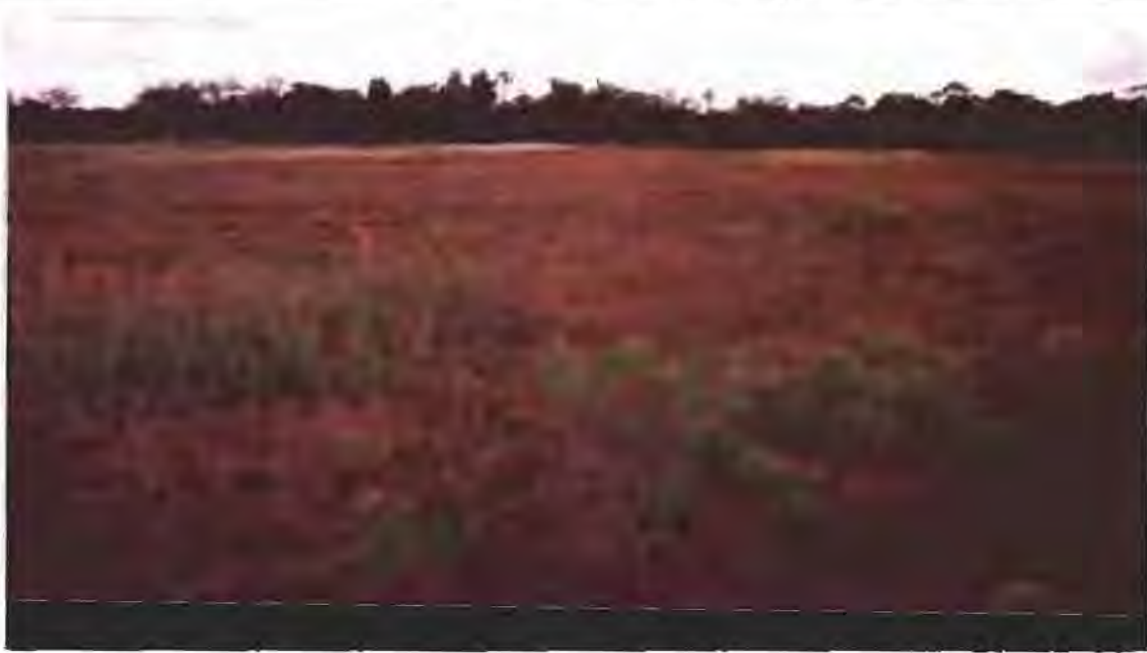
Upland Habitat Restoration (UHR 2) – This area was cleared but not rock raked, allowing the generation of low panicums, flat-top goldenrod, muhly grass, and broomsedge; good foraging area for deer entering from the hammocks. Proposed restoration includes dense plantings of slash pine, live oak, gallberry, fetterbush, wax myrtle and saw palmetto.

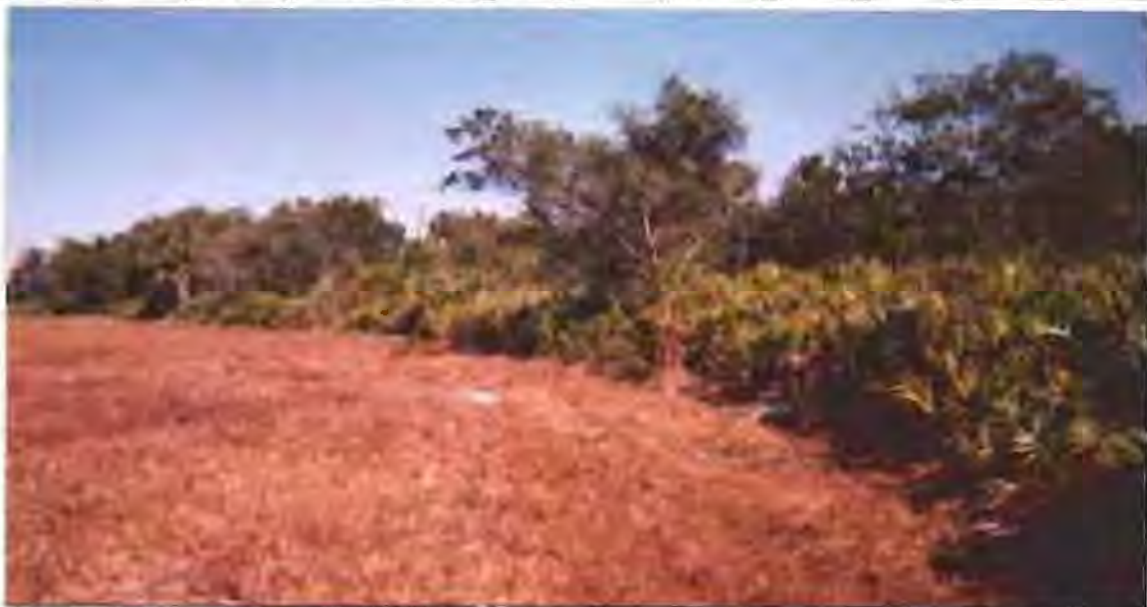
Upland Habitat Restoration (UHR 2) – A narrow band of palmetto and live oaks remain along the steep sideslopes of Gamble Creek and the Manatee River. The restoration of UHR 2 will provide a riverine buffer and wildlife corridor connection between forested wetland habitats north (FWE 1&2) and south (FWE 3).

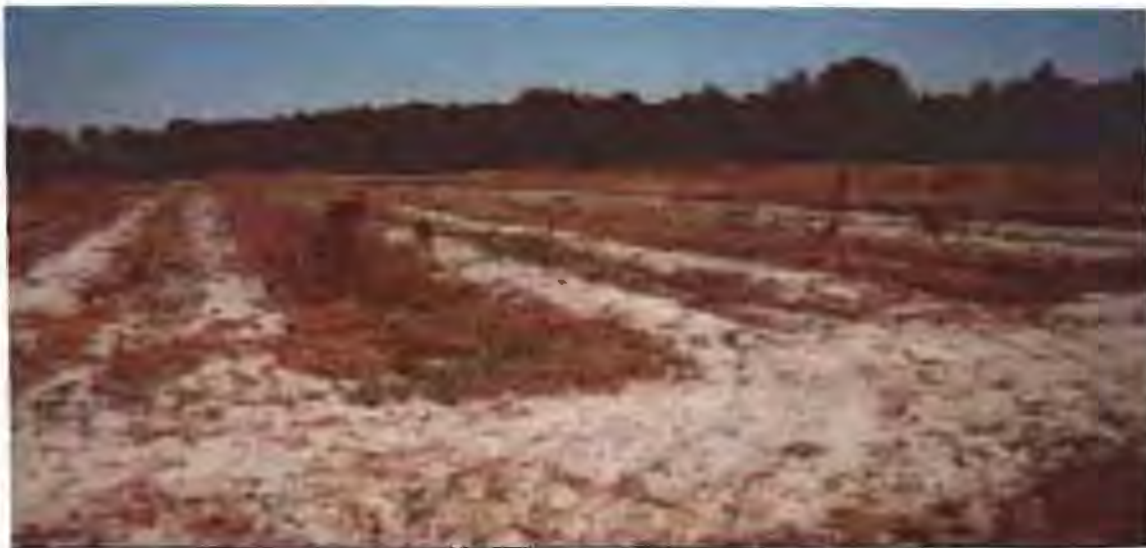
Marsh Creation (MC 1) – This upland peninsula is surrounded by forested wetlands east and west (FWE 2), Gamble Creek to the south, and additional former row crop area to the north. Marsh creation will be conducted to provide foraging opportunities and wildlife habitat corridor connections between the wetlands. Upland habitat restoration (UHR 1) will provide additional habitat diversity, wildlife connectivity and buffer the marsh from the adjacent wetlands and creek.

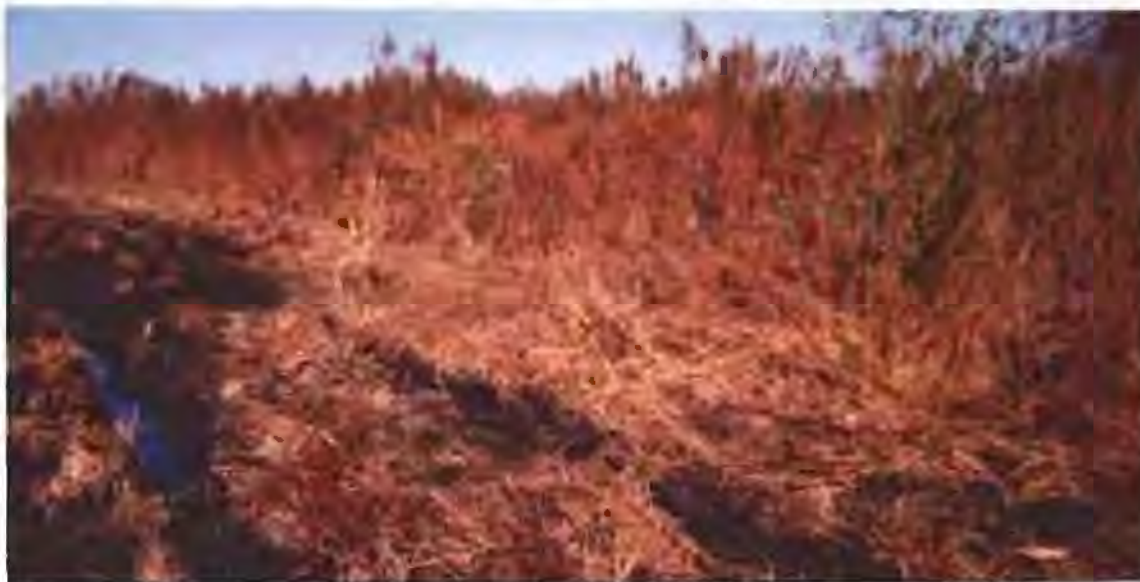
Marsh Enhancement (ME 1) – This seepage marsh has dominant coverage of broomsedge, fennel, and maidencane. Proposed enhancement includes herbicide eradication of the fennel and primrose willow. The access road crossing (forefront) will be vacated, allowing the vegetation to regenerate.

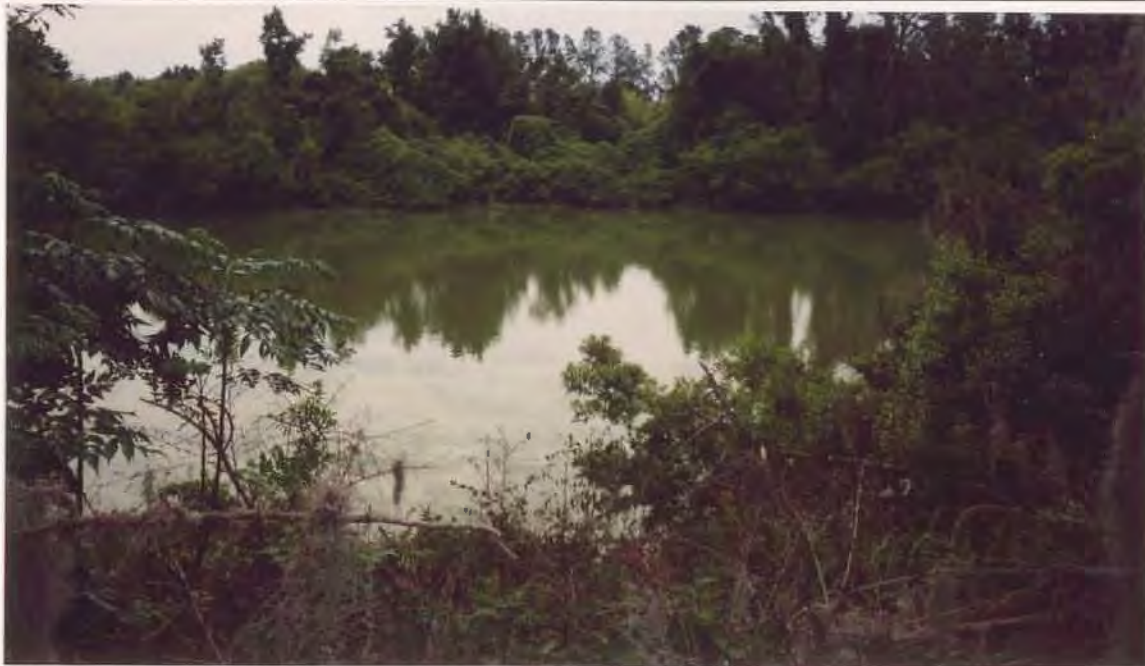
Wetland Restoration – One of the open water pits adjacent to Stallion Hammock. Proposed plan includes grading the upland spoil ridge (background) into the pit; elevating the bottom of the pit to appropriate grades to restore wetland habitat.

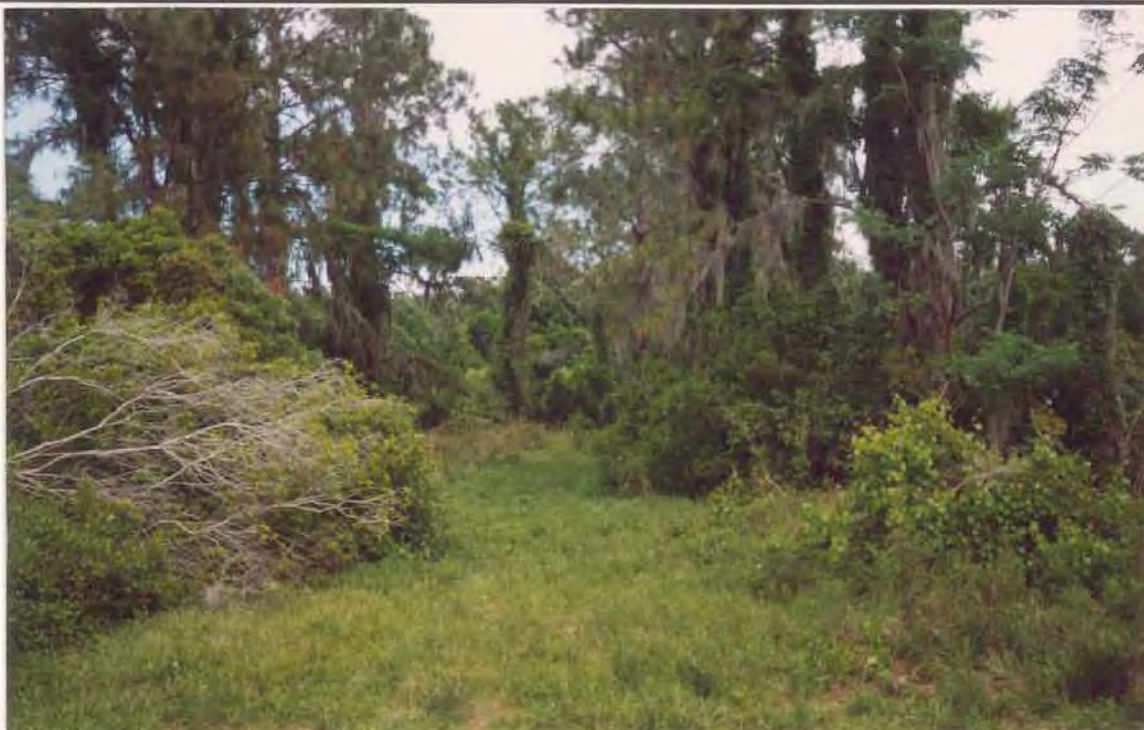
Spoil Ridge – One of the narrow spoil ridges proposed for grading into the adjacent pits. Vegetation primarily includes pines, wax myrtle, grapevine and bahiagrass.

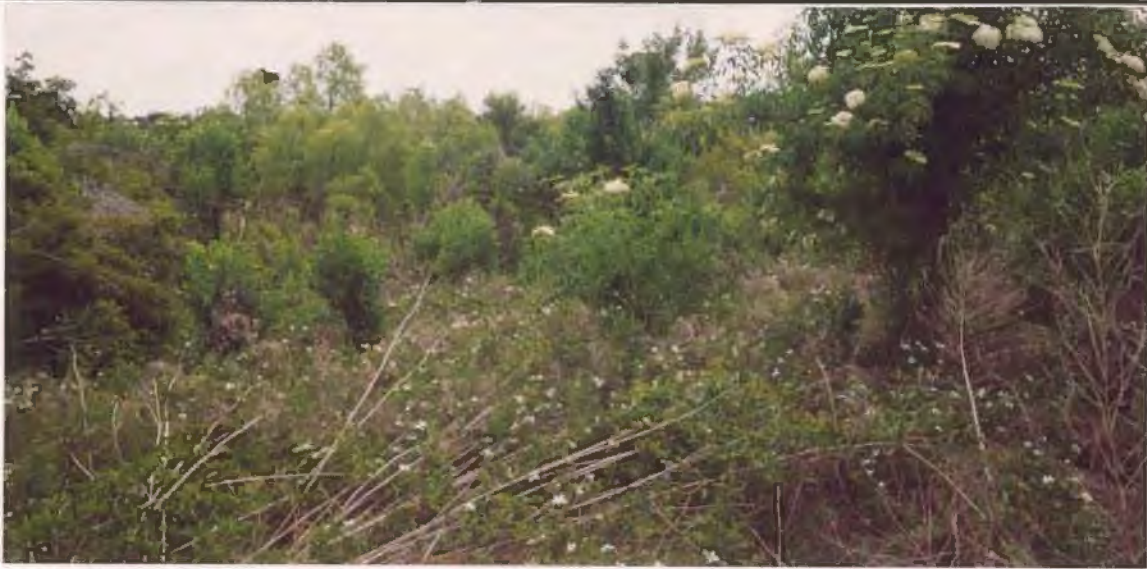
Forest & Shrub Wetland Enhancement – A naturally regenerated wetland within the mine reclamation area; near the historic location of the mined eastern tributary to Stallion Hammock. The wetland is dominated by facultative species (elderberry, salt-bush, wax myrtle, blackberry) and hydrologically altered by a large ditch proposed for fill.
