Southwest Florida
Water Management District

EDOT MITIGATION PLAN JANUARY 26, 2010

Southwest Florida Water Management District
Resource Regulation Division
Strategic Program Office
Brooksville, Florida 34604-6899

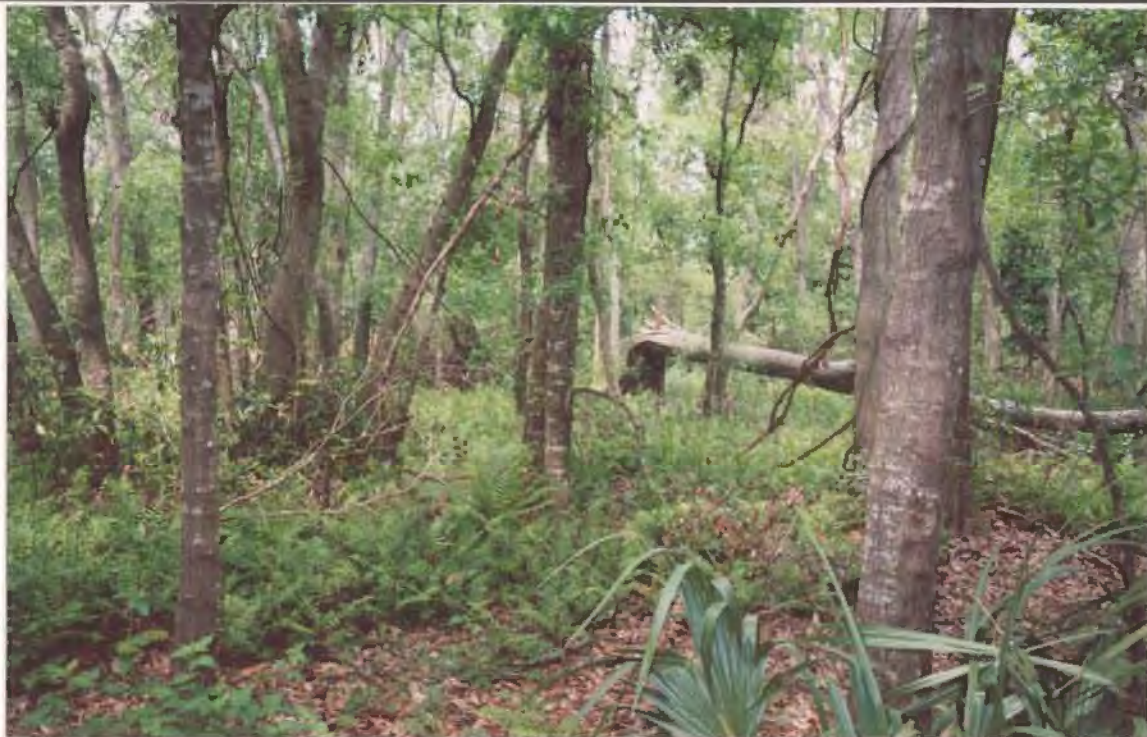
Stallion Hammock – The remaining forested wetland hammock has forested canopy dominated by laurel oak, red maple, and bays; understory dominated by various fern species. The wetland hydrology is primarily from contributing basin groundwater seepage with periodic floodwater overflow from the narrow, incised Pringle Branch.

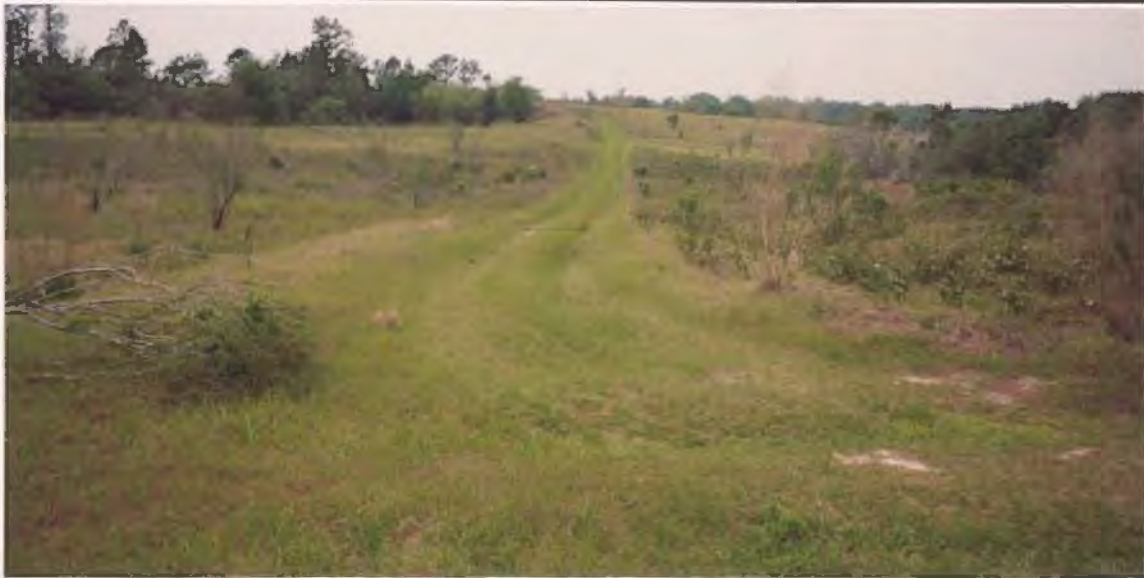
Upland Enhancement – The uplands between the pit slopes east of the proposed wetland restoration area has rolling terrain. Dominant vegetative cover includes bahiagrass, fennel, blackberry, salt-bush and minimal canopy species. Proposed enhancement will include planting various tree species.

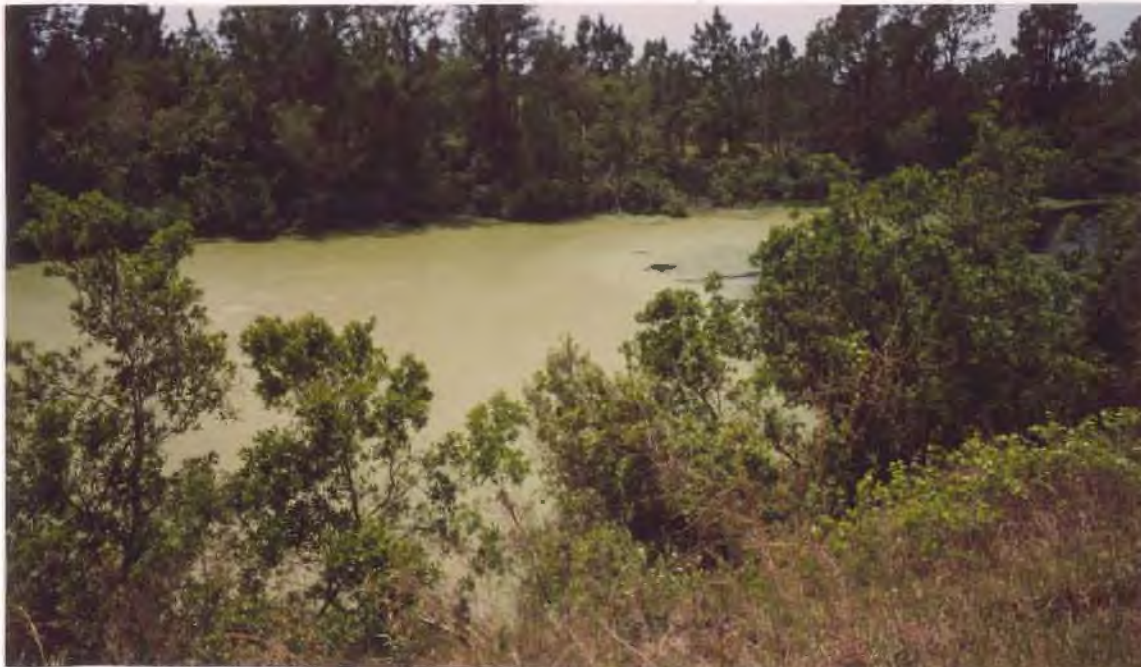
Pit Slopes – One of the pits not proposed for fill. Average slope grades are 4:1, 8-10 feet elevation drop from the upland to the water. These buffers average 50 ft. wide with vegetative cover dominated by preserved pines, myrtle and grapevine. Some of the pits have duckweed due to stagnant and non-flowing water.

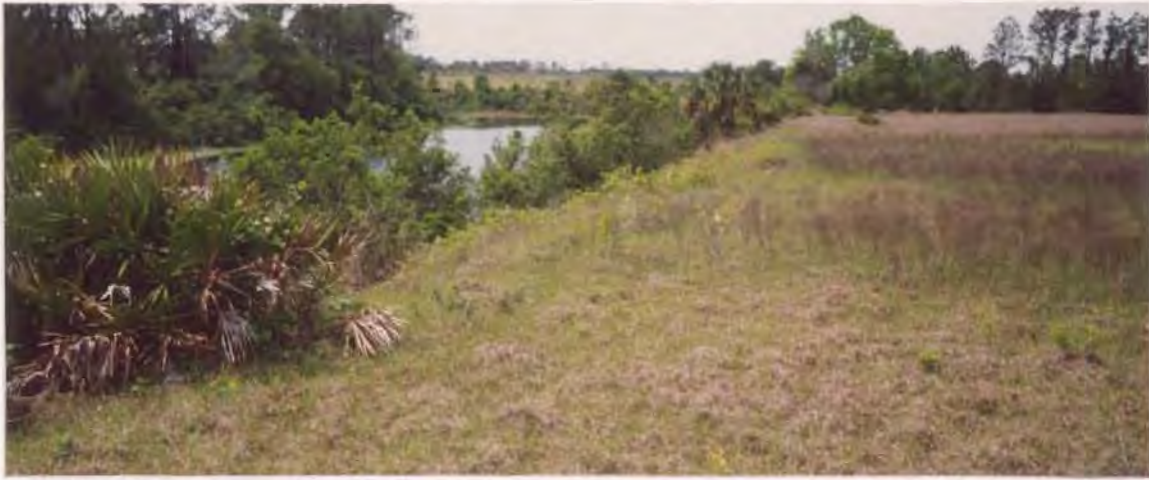
Upland Enhancement – The majority of pit areas (not proposed for filling) have water elevations several feet below top-of-bank, typically 4:1 slopes of pine, oak, and myrtle buffers. The fallow uplands are dominated by bahiagrass. By planting trees in these fallow areas, there will be more habitat connectivity and corridors between the tract's native habitats and the open water components used by wildlife.

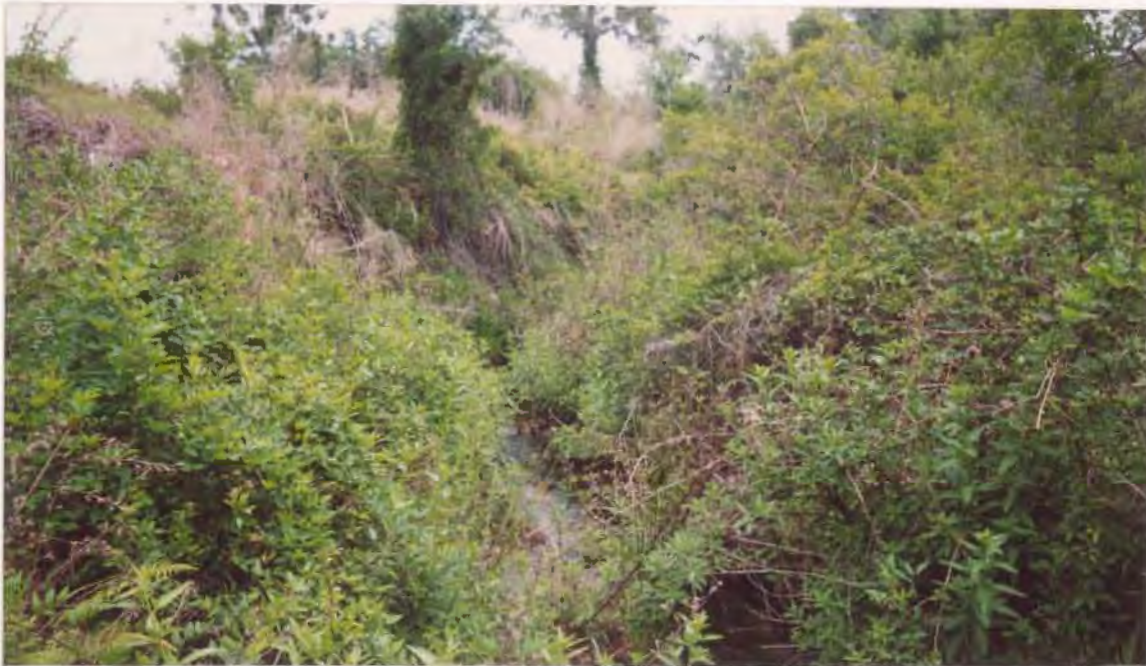
Hydrologic Connections – The majority of the ditches between the pits have sheer slopes with bottom grade elevations several feet below top-of-bank. The slopes and dense vegetative cover (predominantly exotics) present hazards for wildlife access. These connections will be enhanced by grading the slopes to resemble natural creek conditions; with wide swales, gentle slopes, planting wetland vegetation and adjacent upland buffers to create habitat corridors for wildlife.

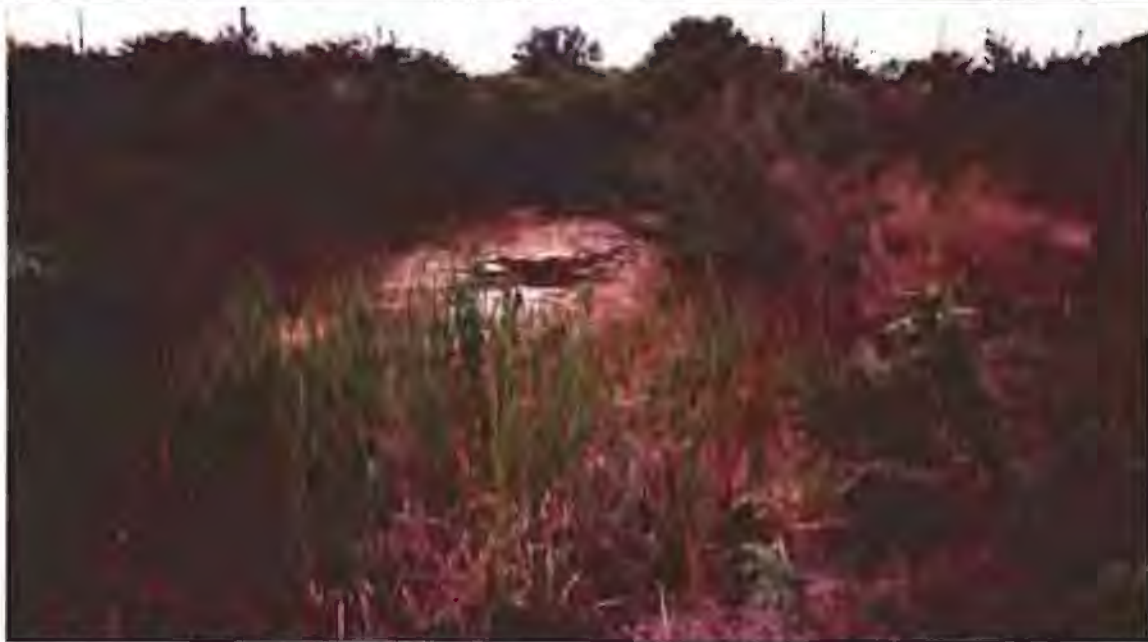
Tropical Fish Ponds – Typical vegetative conditions include a substantial dominance of exotic and nuisance species such cattails, torpedo grass, duckweed, primrose willow; with side bank coverage of bermuda grass and Brazilian pepper. Proposed plan includes herbicide eradication of existing vegetation, regrading the fish ponds to create and plant forested and marsh wetland habitat, and buffer with restored upland habitat.

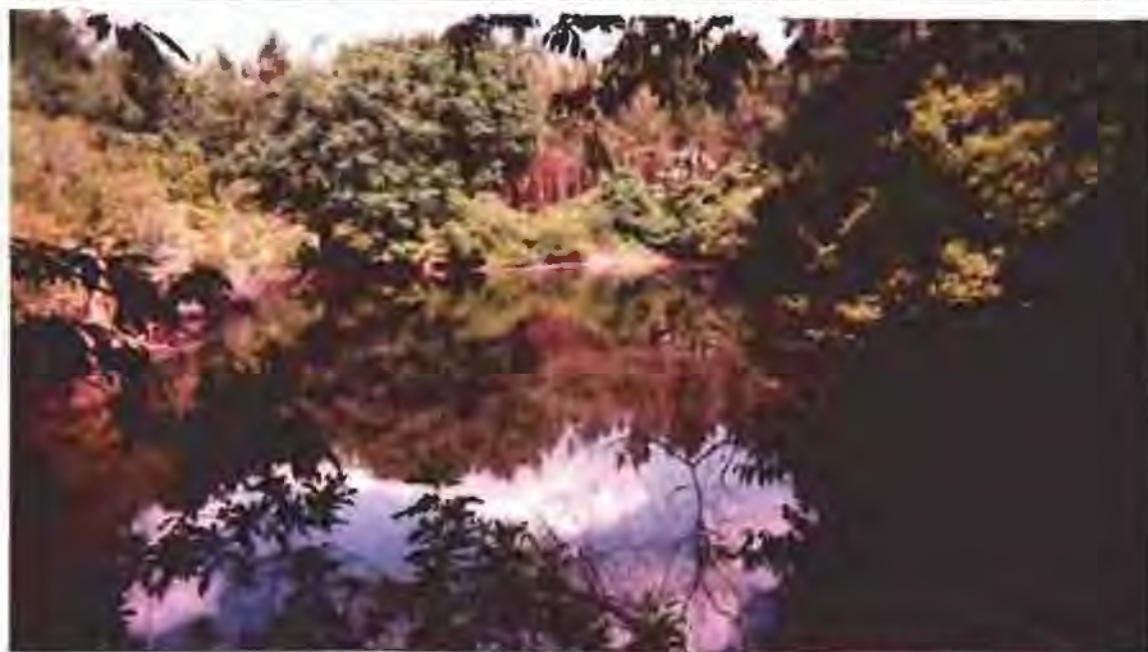
Retention Pond – The small dredged retention pond is located north of the fish ponds. The proposed plan includes backfilling a portion of the pond to create and plant a littoral zone. The wetland creation displacing the fish pond area will hydrologically outfall to this regraded pond for additional water quality treatment and attenuation before outfalling into Smith Creek and Bullfrog Creek.

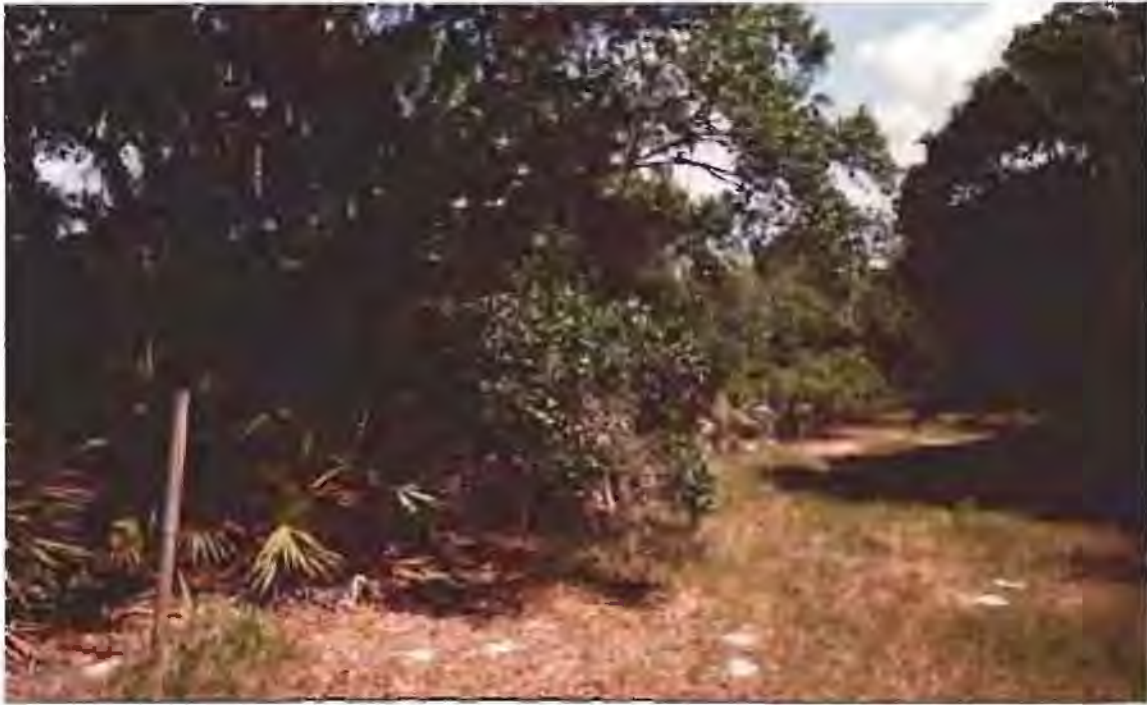
Oak Hammock Buffer – A high quality habitat buffer (left) is located adjacent to Bullfrog Creek. In the northwest portion of the property, a narrow open canopy break along the buffer provides an easily accessible wildlife corridor and gopher tortoise forage on the bahiagrass.

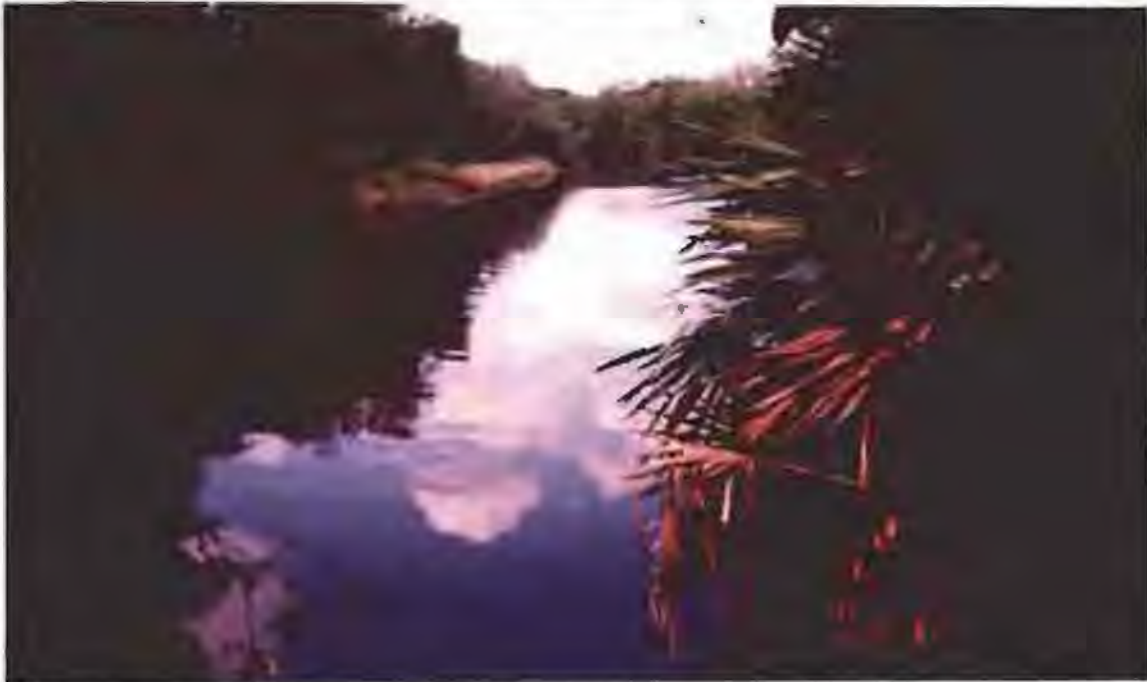
Bullfrog Creek - The upland and wetland habitat improvements proposed for the Ekker Tract will provide many water resource and wildlife benefits for the creek and Tampa Bay.

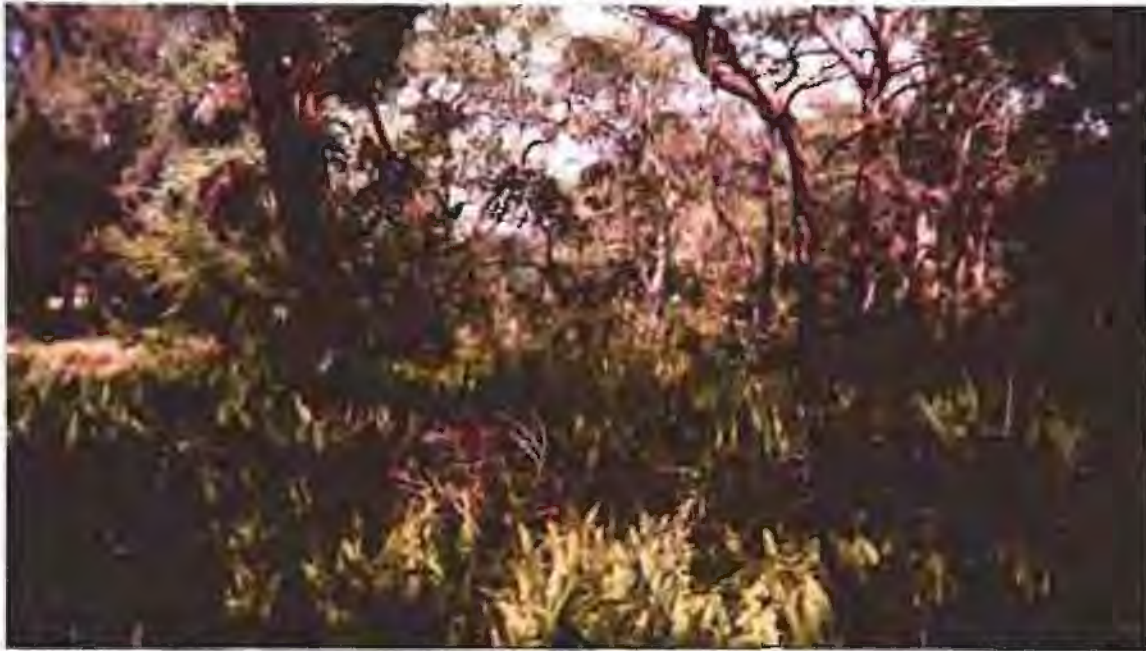
Oak Hammock – The oak hammock in the northwest portion of the property has diverse coverage provided by live oak, laurel oak, cabbage palm, longleaf pine, saw palmetto, and various fern species. Scattered exotic species such as Brazilian pepper and Australian pine (far left) will require eradication.

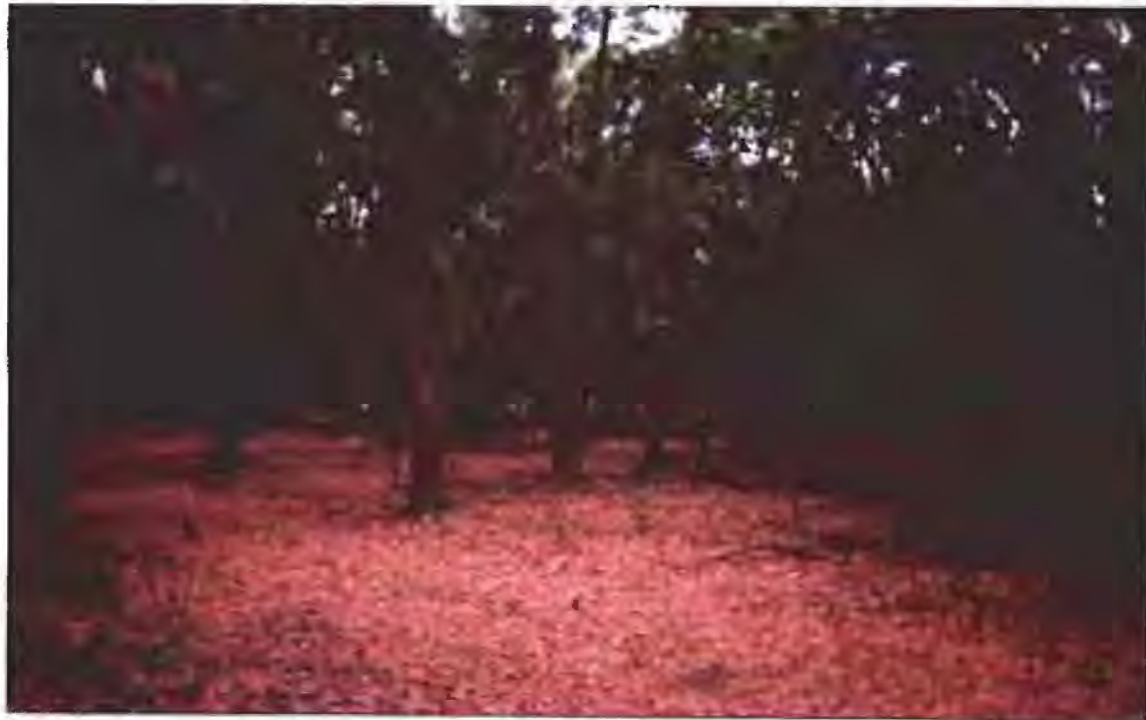
Oak Hammock – Dense laurel oak canopy within the southwest portion has minimized understory coverage. Planned activities include selective laurel oak thinning and supplemental planting of various shrubs and herbs such as cabbage palm, wax myrtle, broomsedge, wiregrass and carpetgrass.

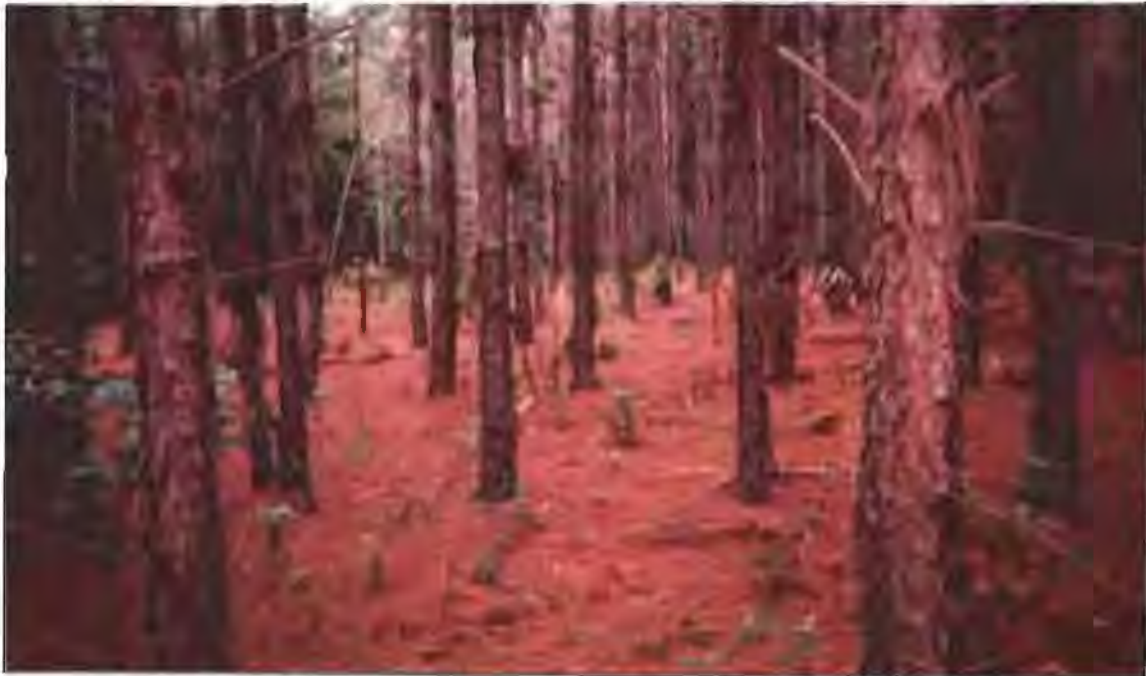
Pine Plantation – Typical condition of dense pines and minimal ground cover due to canopy closure and pine straw thatch. Proposed plan includes eradicating scattered Brazilian pepper, thinning the pines, minimizing thatch, and planting shrubs and herbs such as saw palmetto, wax myrtle, gallberry, broomsedge and wire grass.

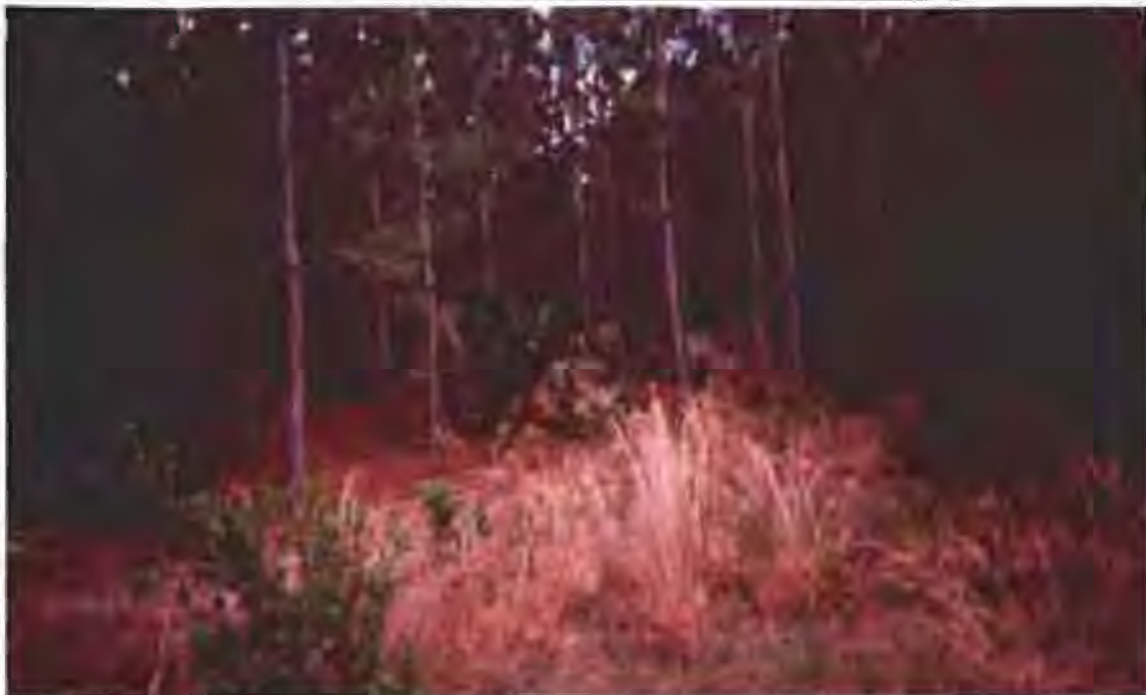
Pine Plantation – Canopy openings within and adjacent to the pine plantations support appropriate herb and shrub vegetation. As pines are thinned and thatch is minimized, these ecotones will provide opportunities for natural recruitment and generation of understory vegetation.

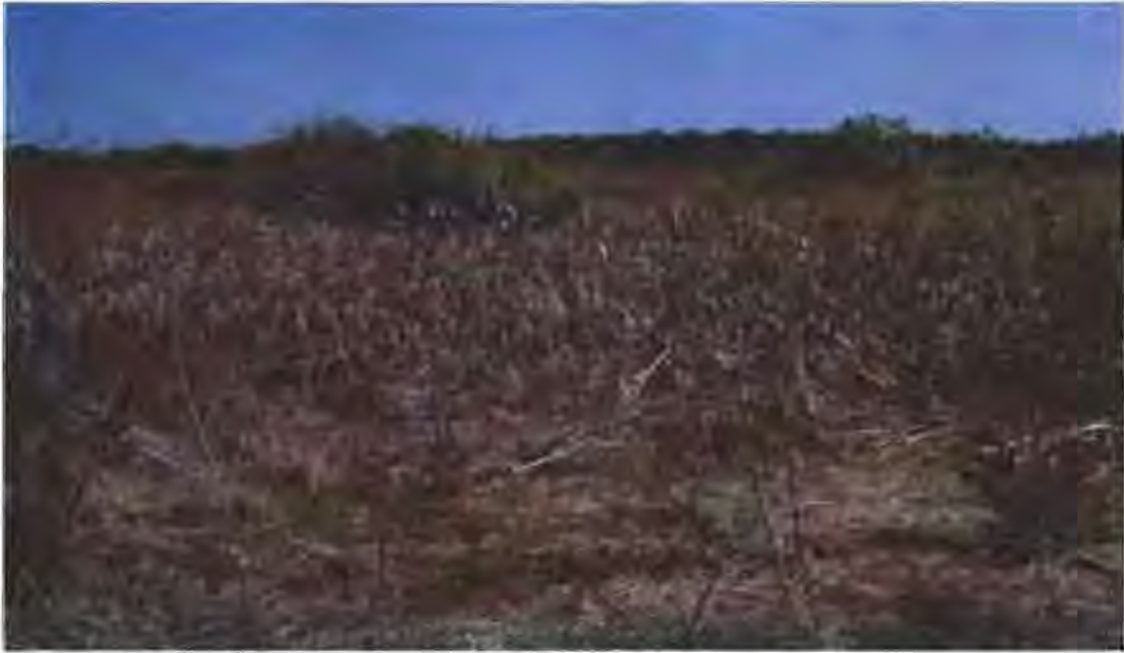
Wetland Enhancement – Wetland 1 is a small, ephemeral isolated marsh (0.4 acre) with cattails in the core. Proposed herbicide eradication of the cattails, allowing maidencane to regenerate, along with supplemental planting of soft rush and pickerweed. Brazilian pepper (background) will also be eradicated and replaced with pine plantings.

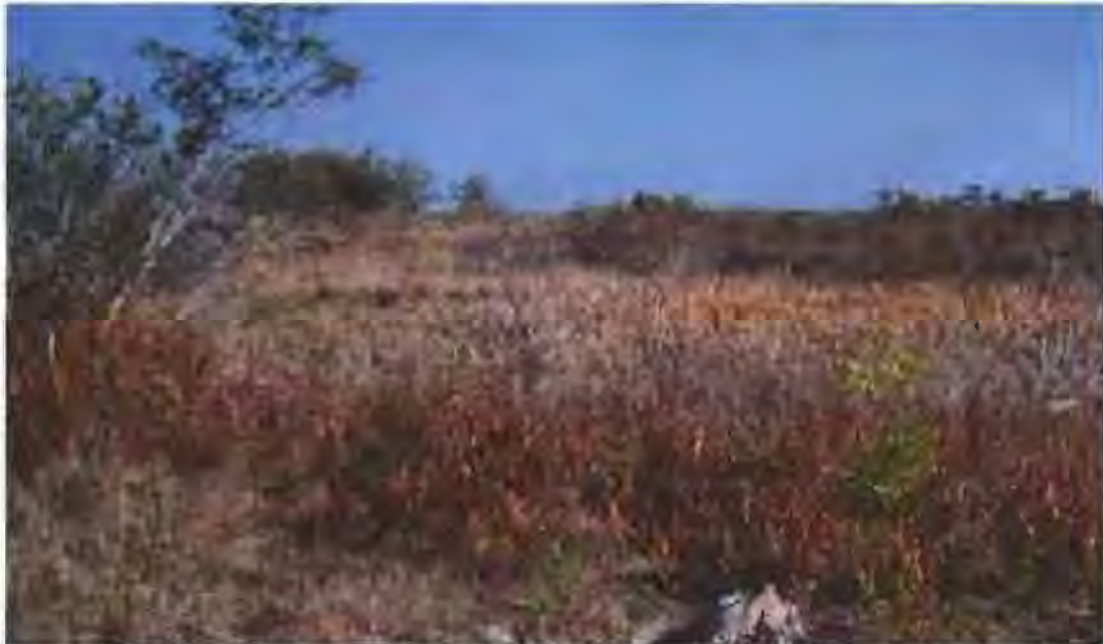
Wetland Enhancement – Wetland 2 has similar functions and characteristics as Wetland 1, except for a buffer of wax myrtle and Brazilian pepper. The B. pepper and cattails will be eradicated, with supplemental planting of wetland herbs where necessary.

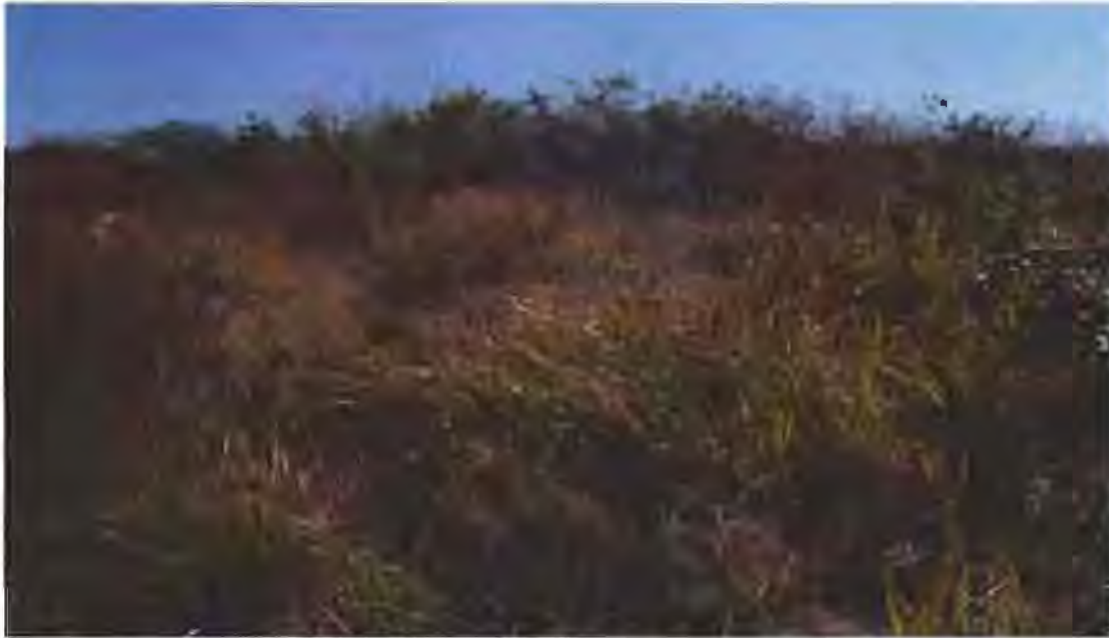
Upland Enhancement – The dominant exotic vegetation generated within the uplands include cogon grass (foreground) and Brazilian pepper (background). Eradication and control of the exotic vegetation will allow native species regeneration and supplemented with pine plantings.

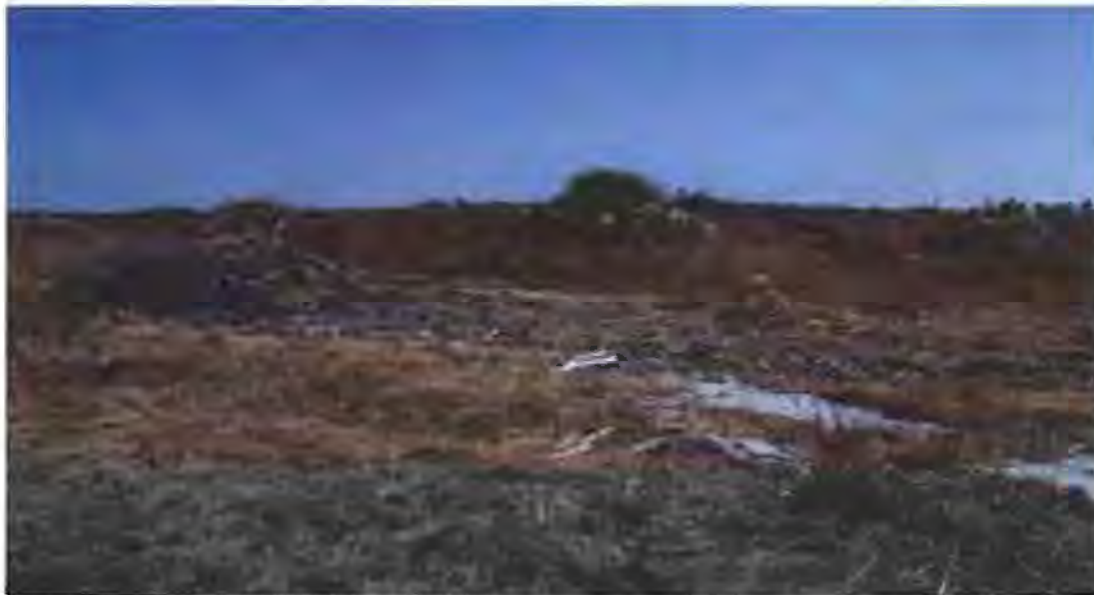
Upland Enhancement – Some eradication and piling of B. pepper has been conducted in the past for a portion of the project area. Removing the remaining and regenerated B. pepper within the project area, planting pines, and incorporating the area into a prescribed burn program will minimize the B. pepper seed source and regeneration rates.

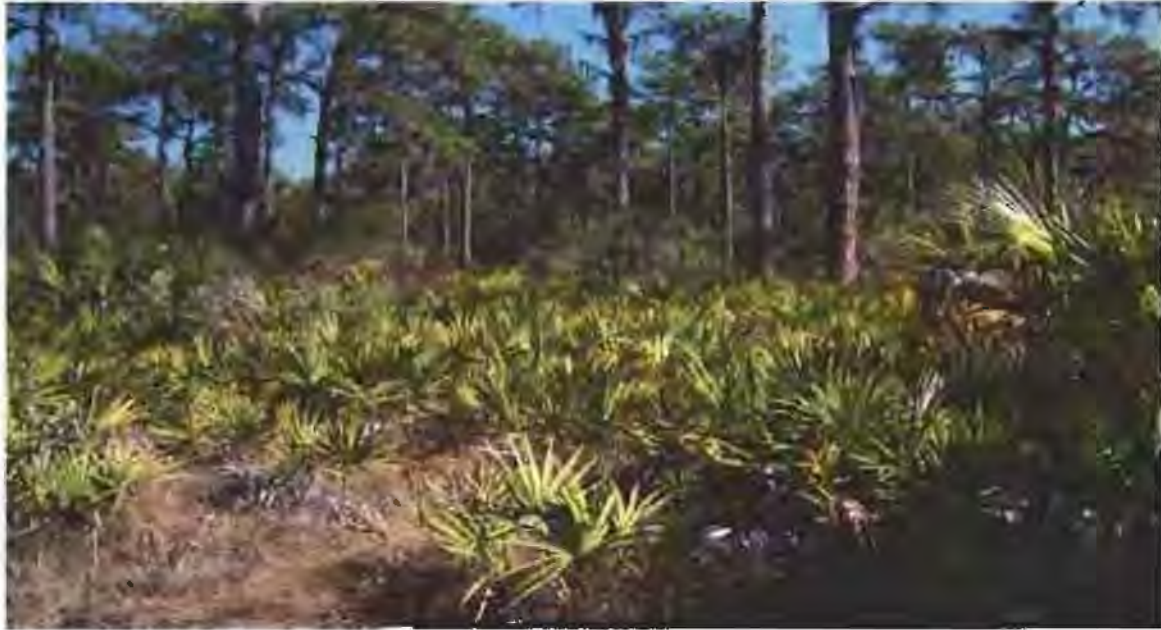
High quality flatwood habitat within the LMR tract, located along the southeast boundary of the designated project area. By enhancing, restoring and managing appropriate habitats in the project area, there will be more vegetative cover and foraging opportunities to attract more wildlife from the adjacent native habitats.

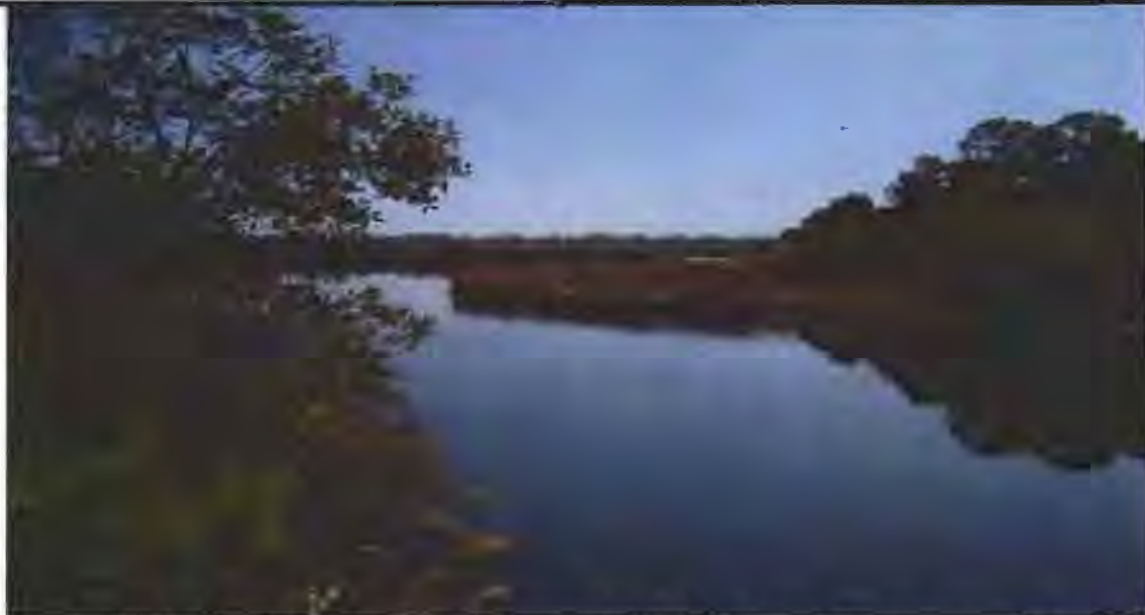
Many of the highest quality ecosystems at the LMR tract are associated with the Little Manatee River. An inter-related mosaic of habitats such as estuarine marshes, hardwood hammocks, and sand pine scrub along the riverbanks. However, the existing habitat buffer along the northern bank of the river is narrow along portions of the designated project area. With the habitat improvements, the buffer, connectivity and corridor along the river will be enhanced for wildlife access.

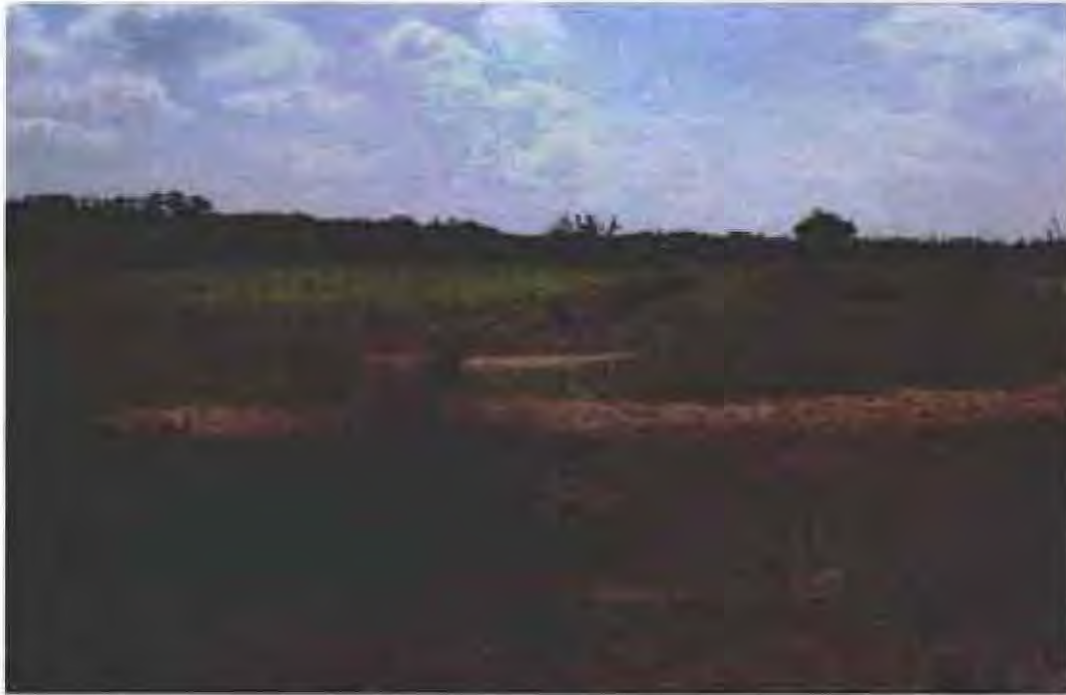
Wetland Restoration – Eastern view from the western project boundary, at the intersection of north-south and east-west cross ditch in the 90-acre pasture. Grading and planting is proposed to restore the forested wetland (foreground) and marsh habitat (background).

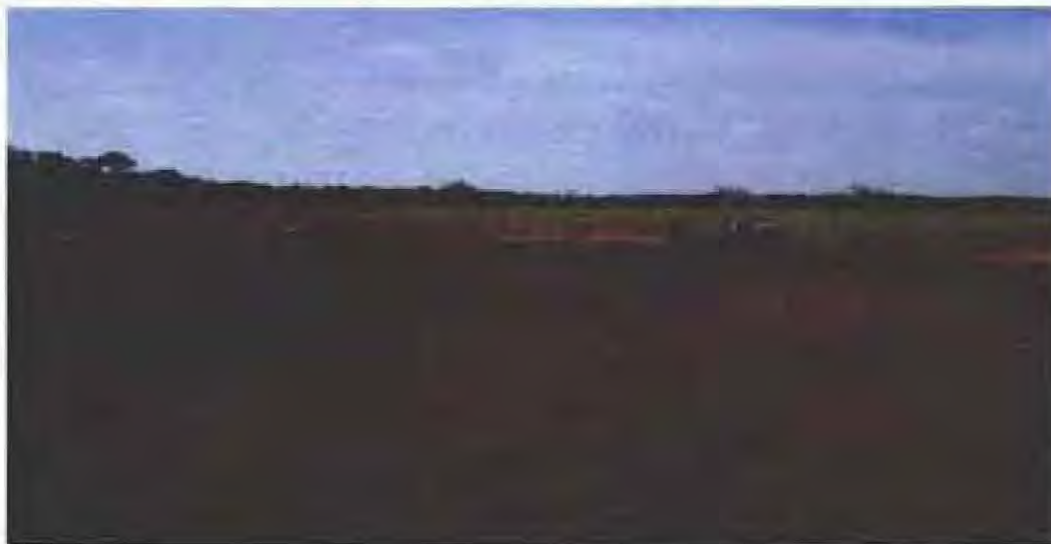
Wetland Restoration – Northern limits of the pasture along access road, looking south at the proposed forested wetland restoration area (foreground) and marsh habitat (background).

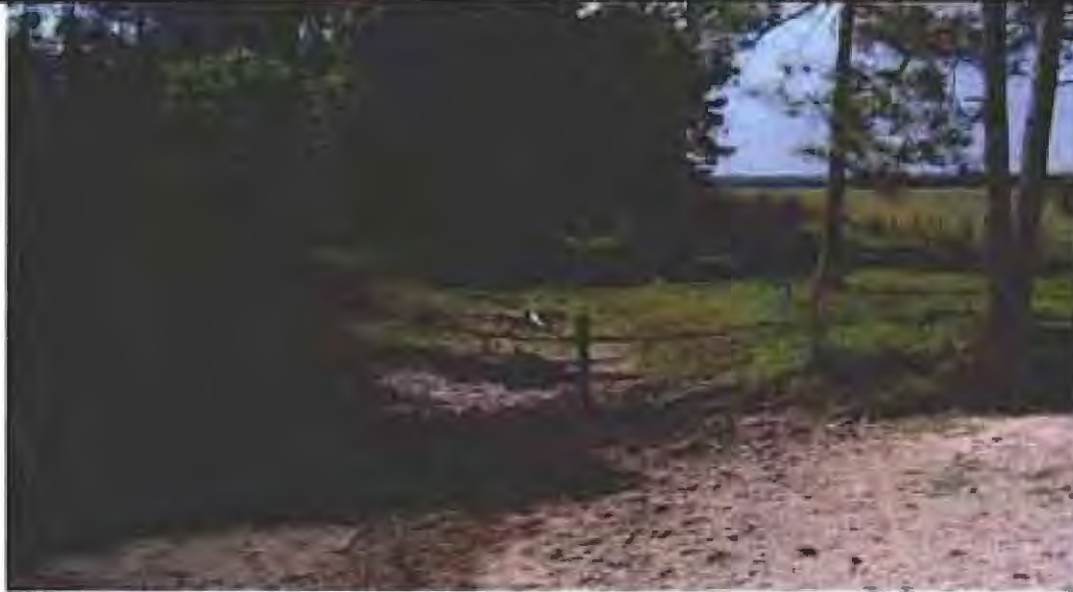
Wetland Enhancement #11 – View from the access road looking south at the north-south drainage ditch (avg. 10-15 ft., 2 ft. deep). Historically a cypress strand, the drainage has resulted in pines and oaks recruiting and generating in the strand (left) and conversion of wetland to pasture (right). Proposed plan includes filling ditch to restore drainage patterns to enhance forested wetland and restore wetland in the pasture.

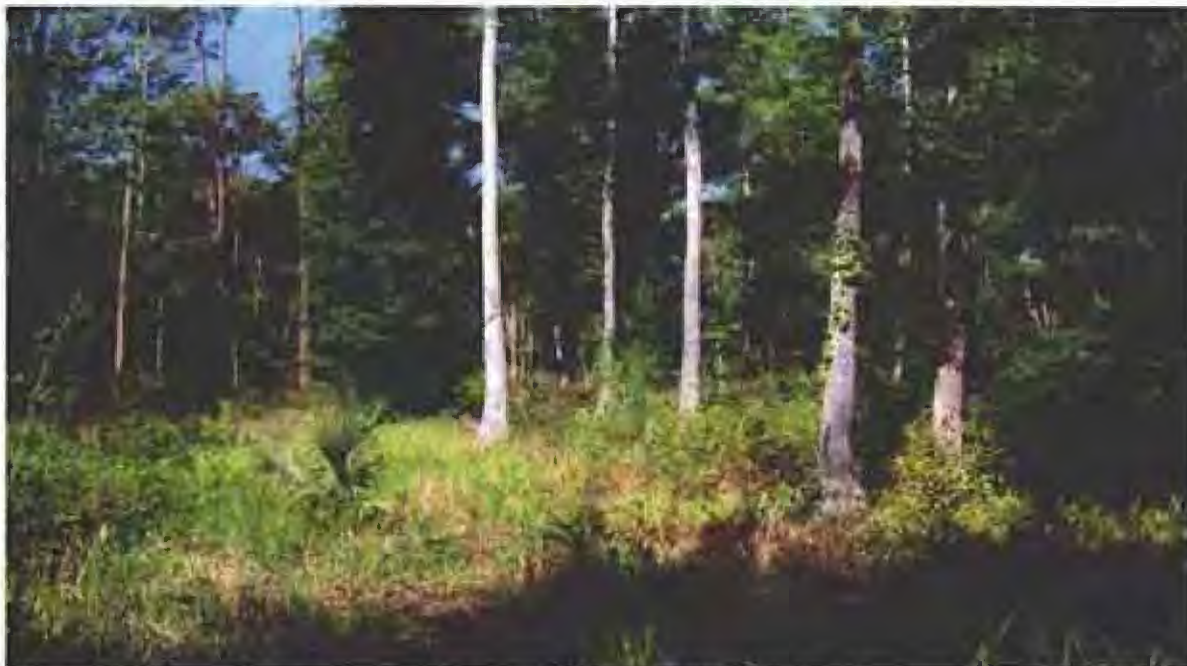
Wetland Enhancement #6 – Due to ditching and drainage, hydroperiods are minimal; allowing pines and hardwoods such as live oak, laurel oak, and red maple to generate within the historically cypress-dominated wetlands. Enhancement will include restoring hydrology and drainage patterns through the wetlands.

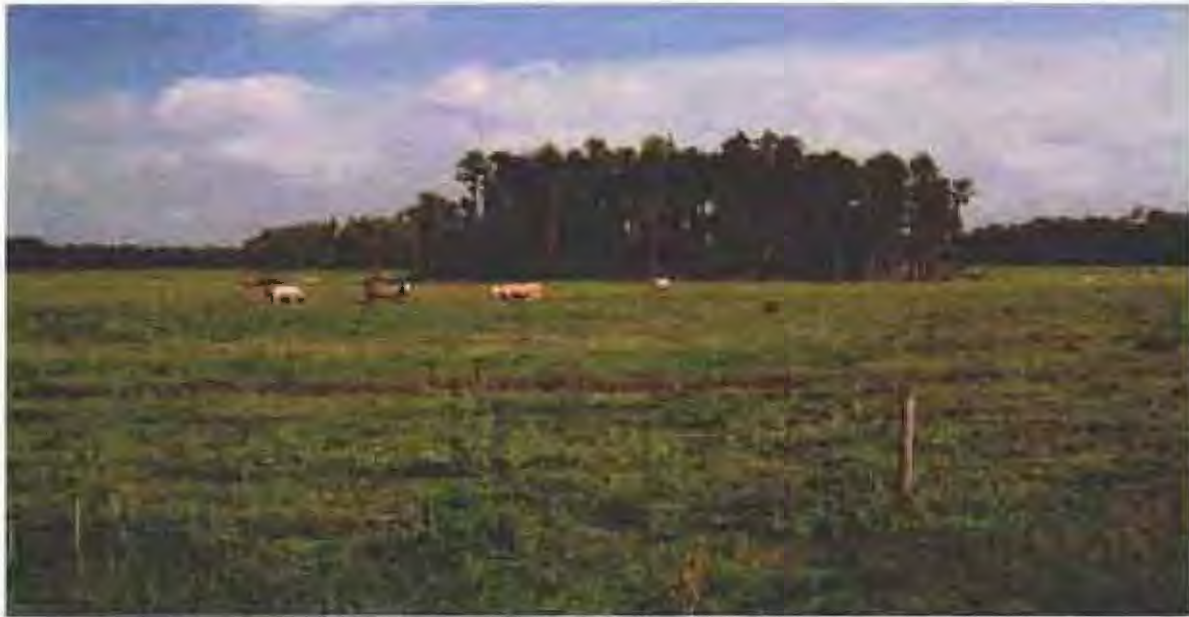
Upland Restoration #2 – View of the pasture and swales (foreground) cut for drainage. Wetland #9 (background) is drained to west (left) through Wetland #8. The ditches will be filled to restore wetland and upland hydrology, and the pasture will be restored to pine flatwood habitat. Wetland #8 will have the cypress canopy restored.

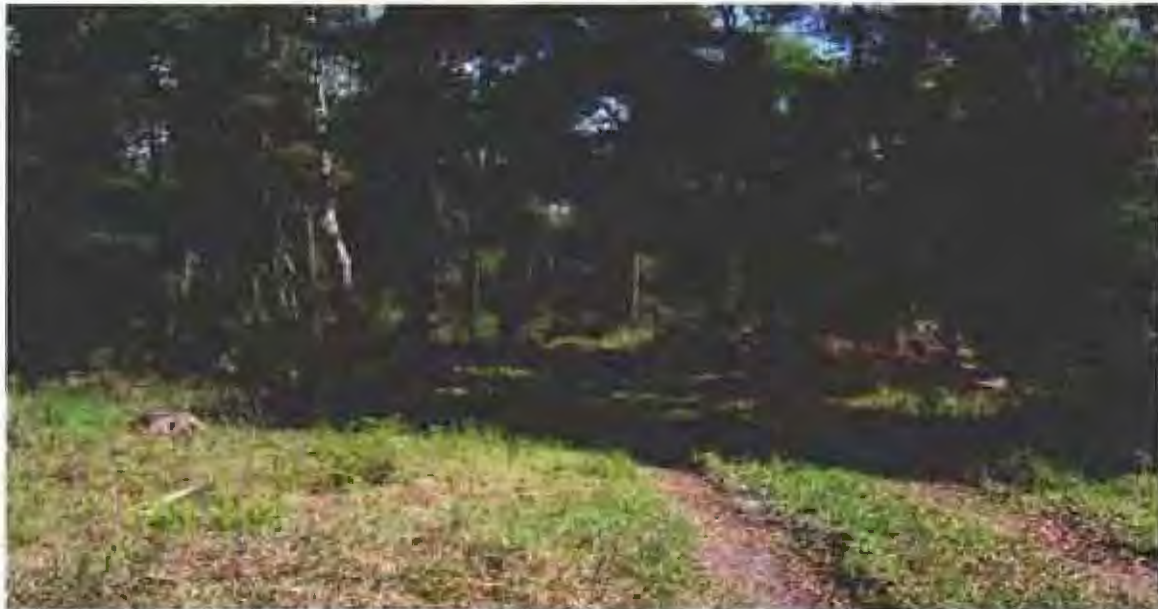
Upland Enhancement #2 – Hardwoods such as live oak, laurel oak, and red maple have recruited and generated within the historic pine flatwoods. Enhancement will include adopting these upland areas into prescribed burn management on a 3-5 year cycle to decrease hardwoods and open understory for generating more foraging herbs for wildlife.

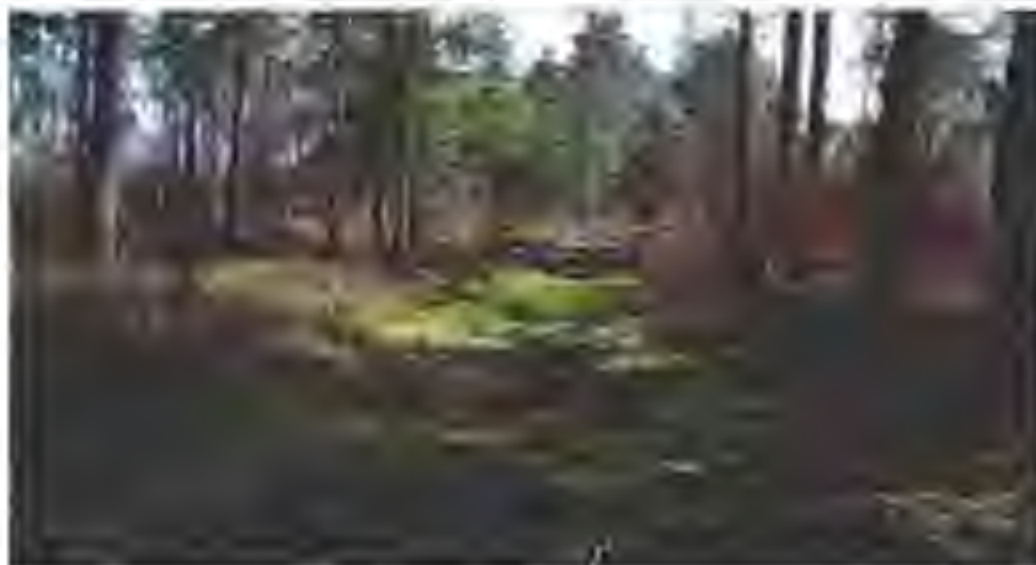
North-South Ditch – The main ditch drains and diverts drainage flow patterns in not only the wetlands, but also the adjacent uplands. Surface and ground water conditions will be restored by combination of total ditch filling, as well as installation of 50-70 ft. long ditch blocks. This will provide wide natural crossings and some open water sources in the flatwoods for wildlife, which is particularly valuable during the dry season.

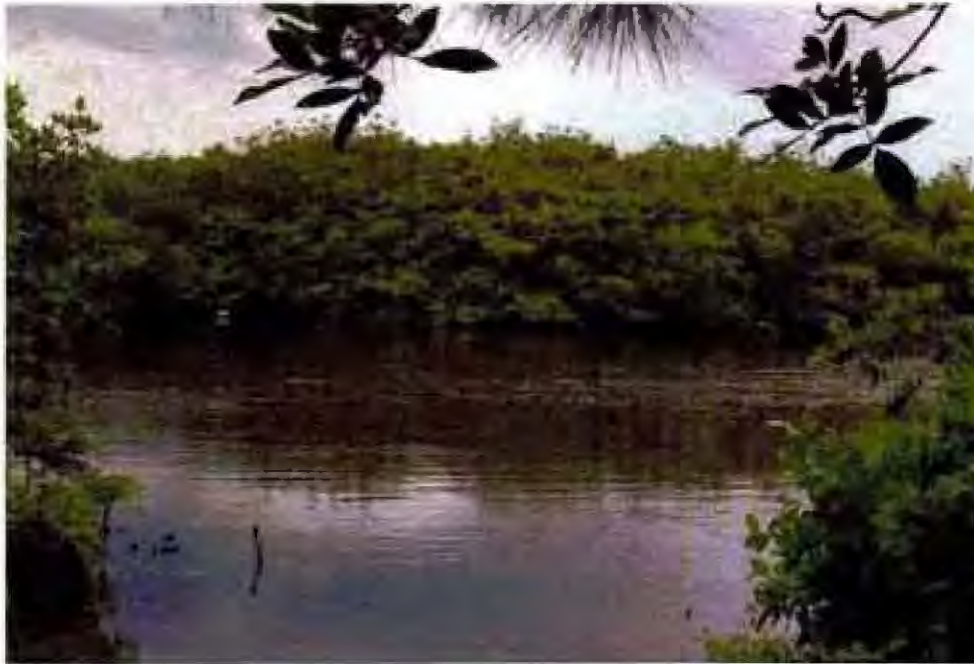
Mobbly Creek meanders through the Preserve from the ponds in the northern portion of the tract to Tampa Bay. The creek is predominately bordered by mangrove habitat.

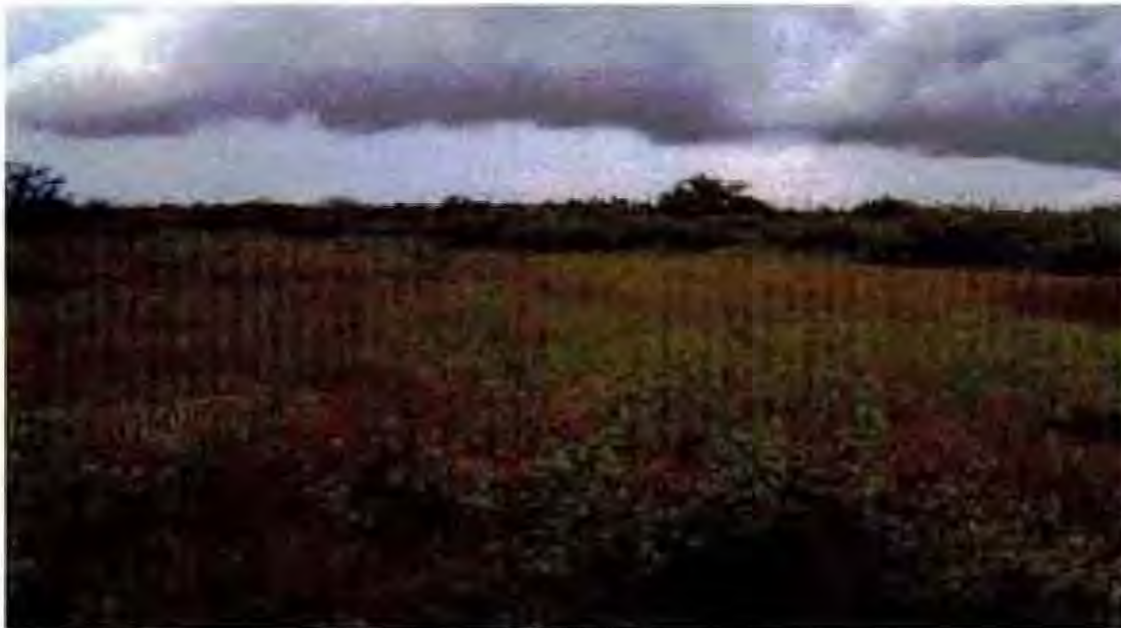
Filling mosquito ditches will restore and enhance appropriate tidal connectivity, fluctuation and duration to enhance existing salt marsh habitat. Dominant marsh habitat conditions include vegetative cover of salt grass, glasswort, black rush, saltwort, and mangrove saplings.
