Southwest Florida
Water Management District

EDOT MITIGATION PLAN JANUARY 26, 2010

Southwest Florida Water Management District
Resource Regulation Division
Strategic Program Office
Brooksville, Florida 34604-6899

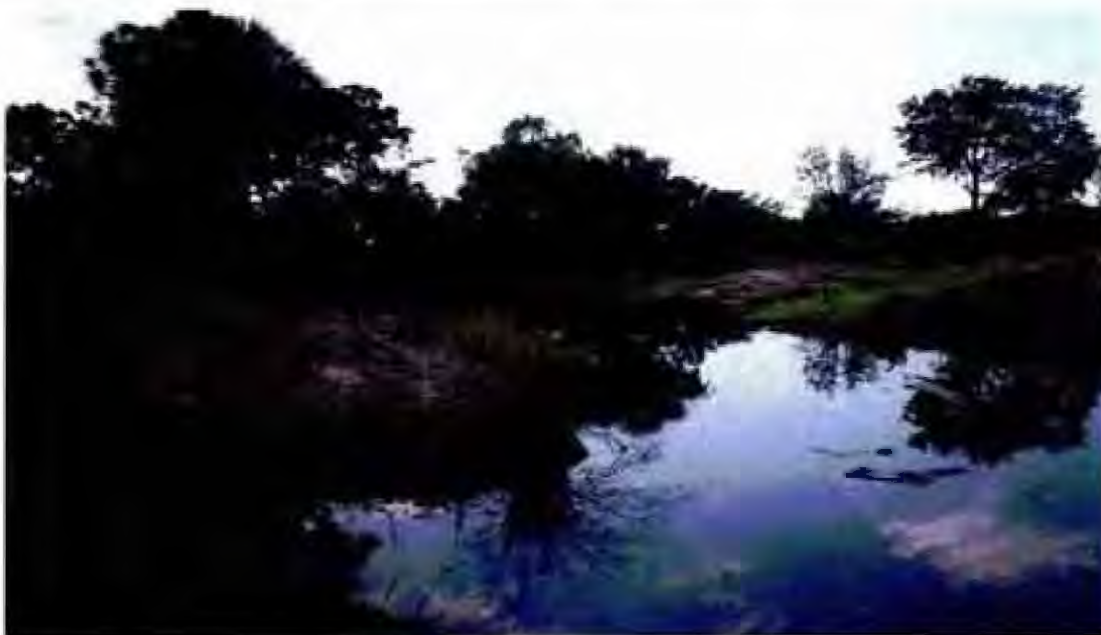
One of the mosquito ditches proposed for filling by the adjacent spoil mounds. Brazilian pepper has been eradicated to provide construction equipment access to grade the spoil mounds. The remaining cabbage palm on the mounds will be relocated on-site to improve habitat conditions within the Preserve.

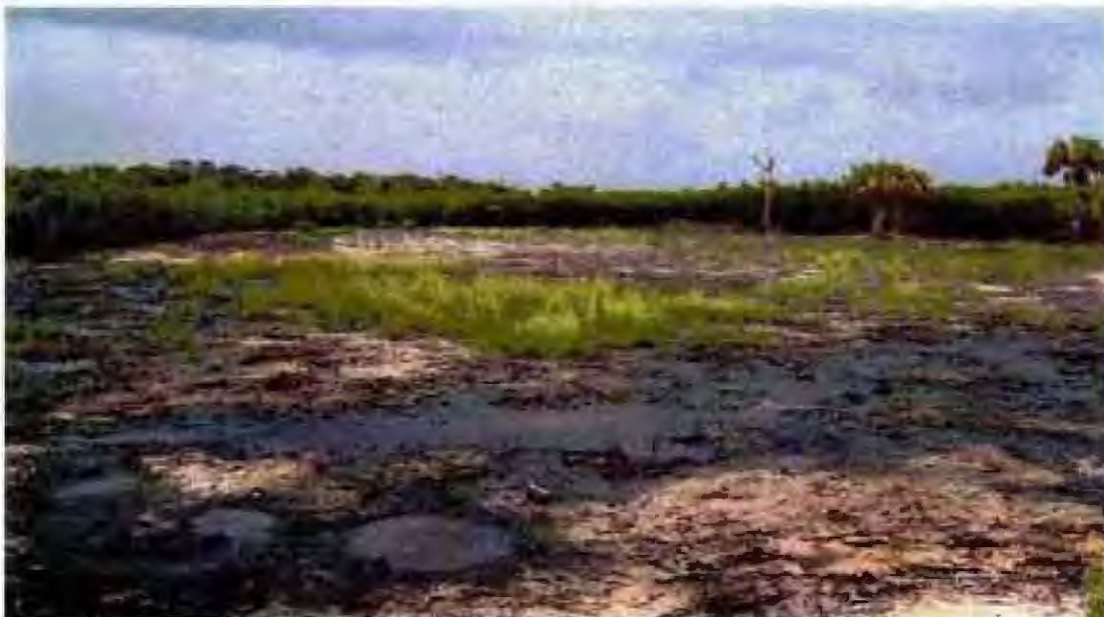
An area in the Central Marsh where Brazilian pepper was eradicated in 2006 to provide access to the spoil mounds with dozers and hydroblast equipment. Some salt grass has naturally generated, supplemental planting will be conducted where necessary to provide additional ground cover.

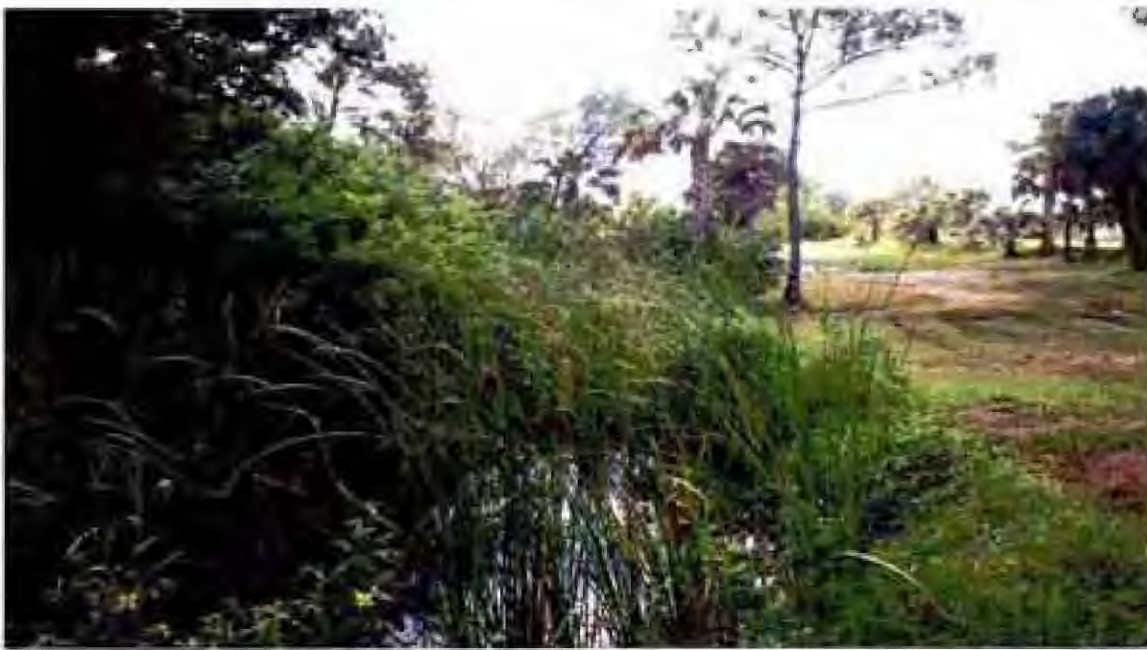
The ditch (left) and cleared area (right) will be graded to create an oligohaline creek and marsh habitat that will provide treatment and attenuation of water discharging from the ponds before flowing into Mobbly Creek. The marsh habitat will be planted with appropriate species such as black needlerush, saw-grass and cordgrass.

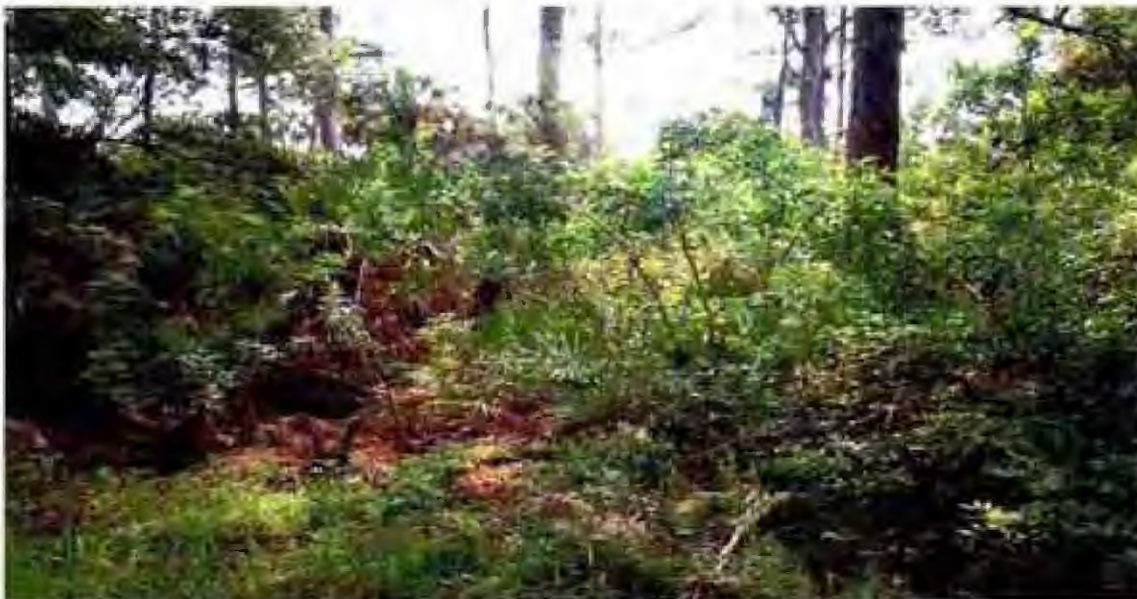
The upland habitat of pine flatwoods has areas with moderate sub-canopy coverage of Brazilian pepper that will be eradicated to further enhance the overall habitat conditions of the Preserve.

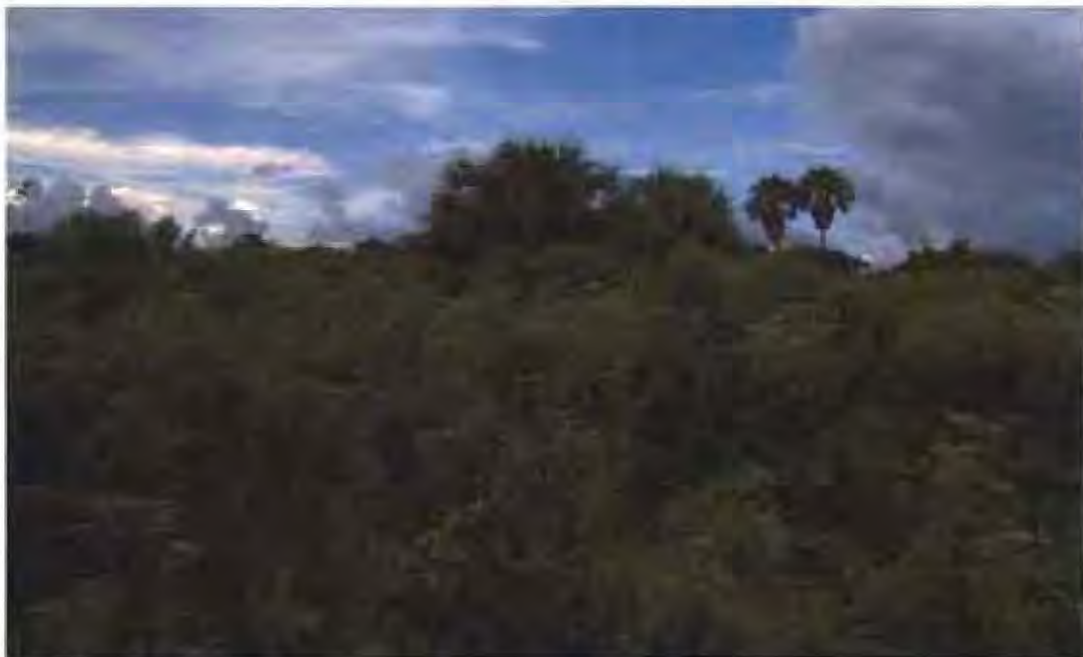
The eradicated Brazilian pepper on the South Parcel has been replaced with extensive generated coverage of nuisance species such as ragweed, dog fennel, saltbush and euthamia.

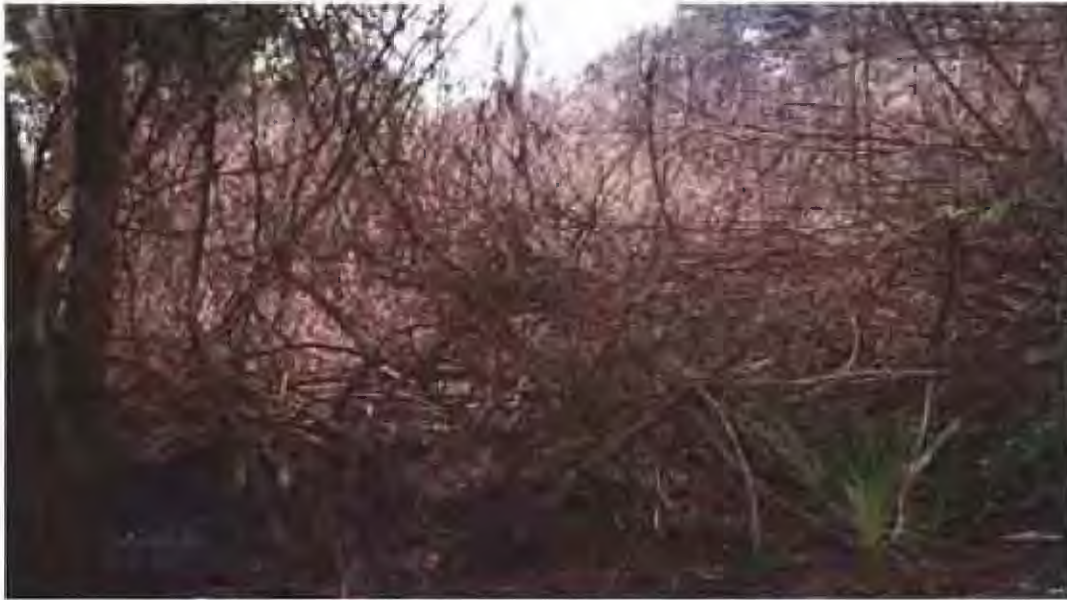
*Alligator Creek meanders through the North Parcel.
Dominant cover is provided by extensive and dense Brazilian pepper.*

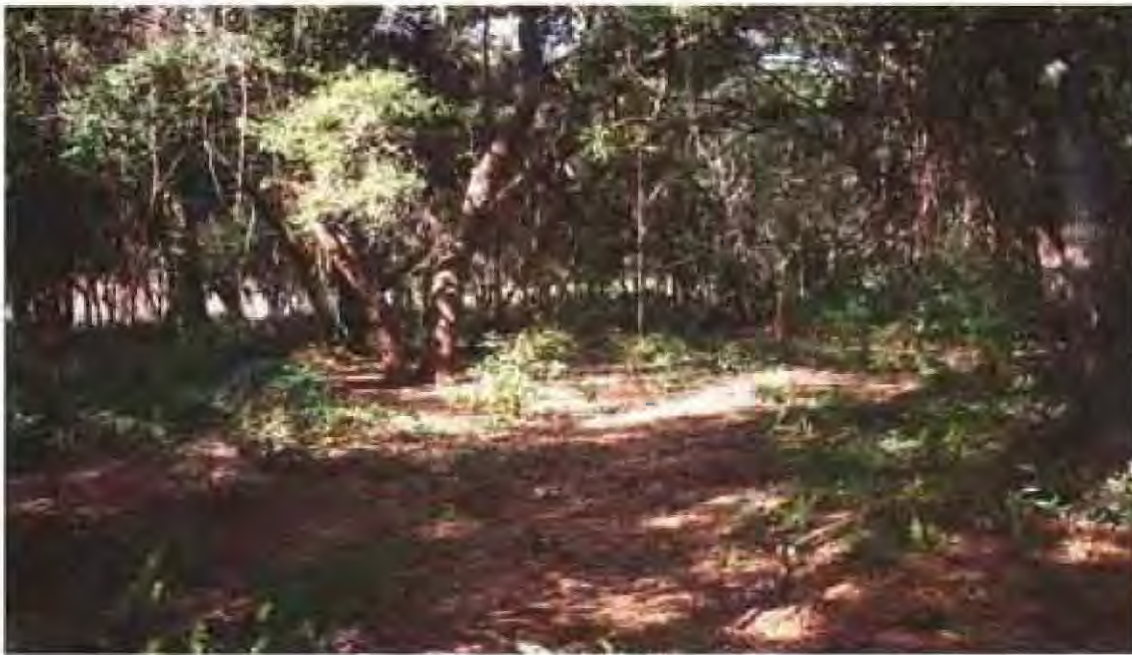
*The least disturbed habitats include the live oak hammocks in the North Parcel.
Enhancement will primarily include eradication of Brazilian pepper
and other exotic and nuisance species;
as well as adopting appropriate land management activities.*

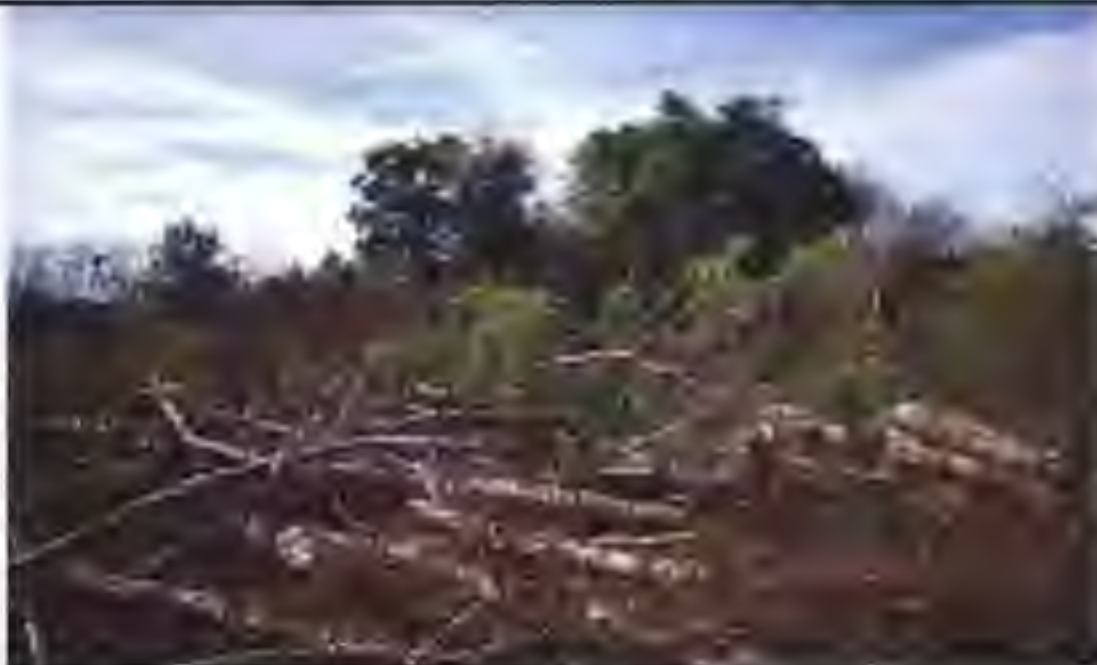
The area of the proposed creation of Marsh #3 is low quality conditions of exotic and nuisance species, including cut Brazilian pepper and mimosa trees. Proposed conditions will remove vegetation and lower the grade elevations to create high quality marsh habitat.

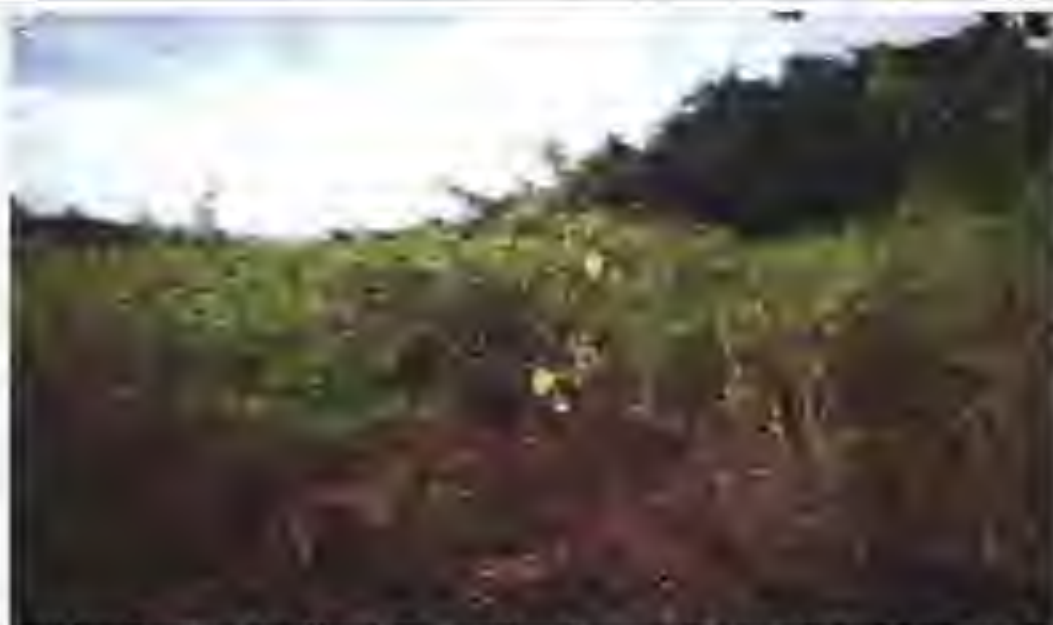
The shrub wetland within the North Parcel has low quality habitat with extensive coverage of primrose willow and Carolina willow that generated within an historic borrow pit. The proposed conditions will include dredging this area to create Marsh #4 and bordered by forested wetlands. Fill material from constructing Marsh #3 will create hammock islands in the marsh.

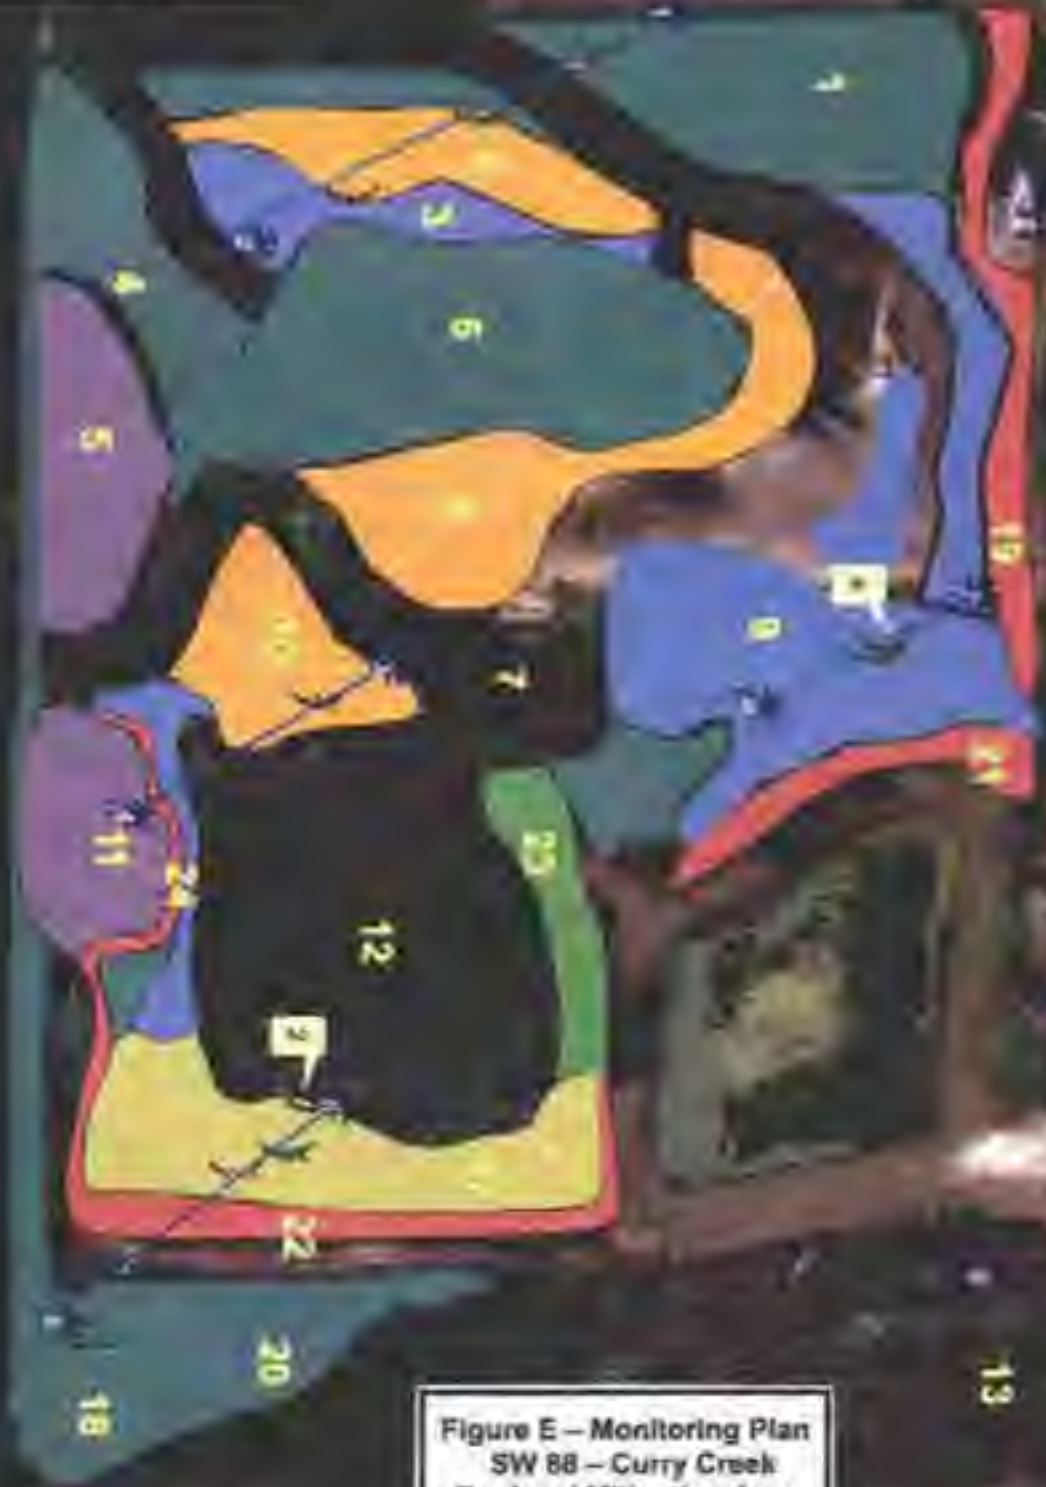
Figure E – Monitoring Plan
SW 88 – Curry Creek
Regional Mitigation Area

Curry Creek Monitoring Points and Transects

X 5. Success criteria and associated monitoring plan. Monitoring and success criteria for habitat enhancement are specified in the issued permits; refer to Figure E for the monitoring photo stations and the photos taken during the initial monitoring inspection.

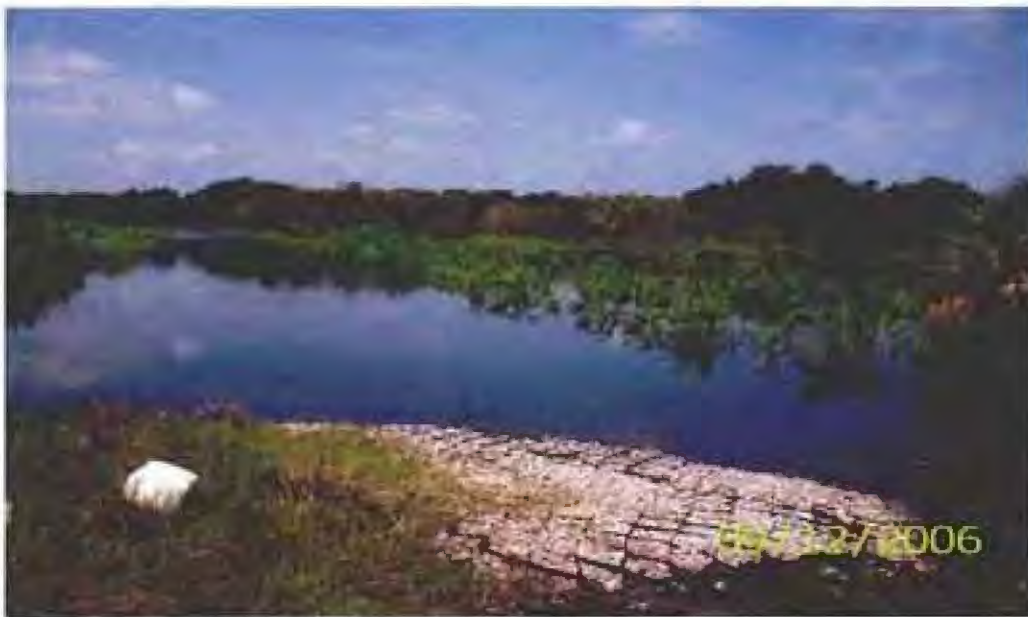
As the rainy season progresses, surface water rises and flows over the widest portions of the weir. Wetland vegetation such as fireflag (above) naturally regenerated and recruits through the slough.

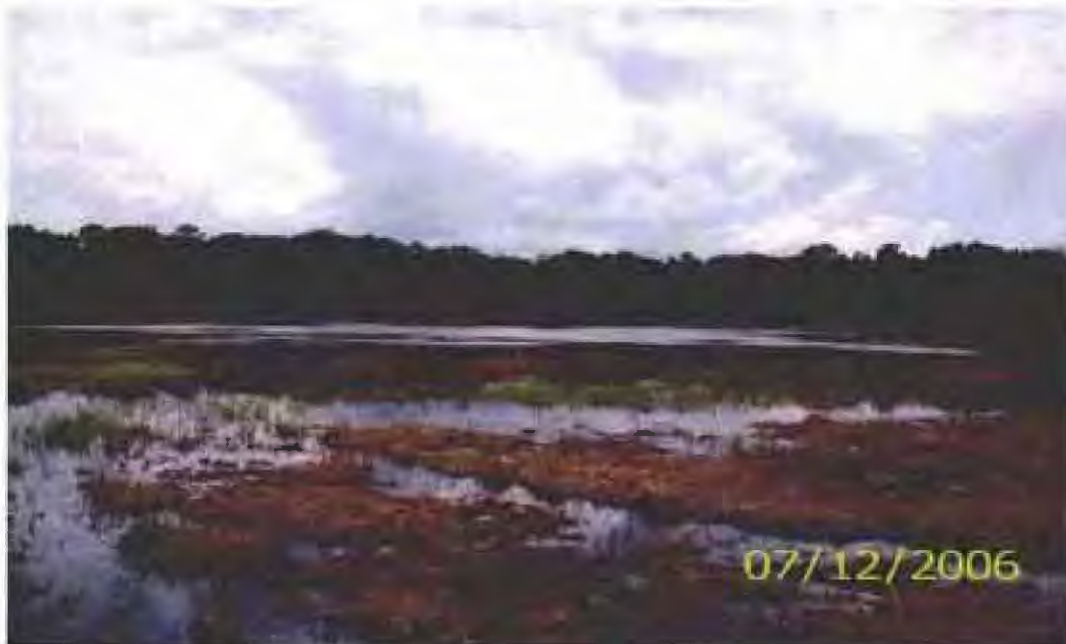
As appropriate wetland hydrology restores within the sloughs, mortality of pasture grasses occur (foreground), and replaced with regeneration and recruitment of hydrophytic vegetation..

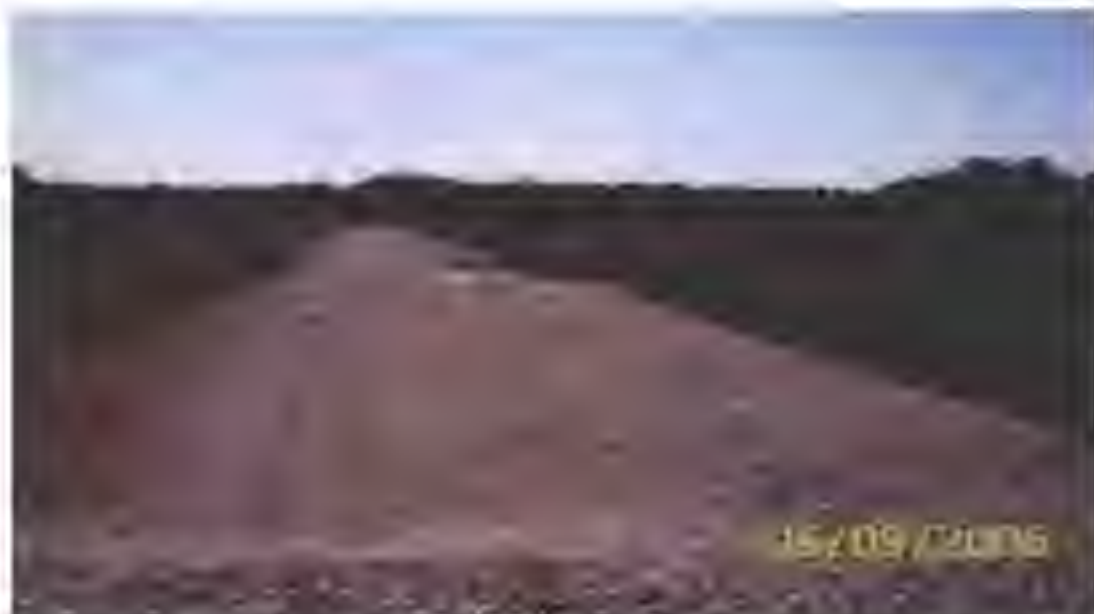
An 810-ft. long discharge weir was constructed to detain surface water, thus restoring the natural hydroperiod of a large slough wetland.

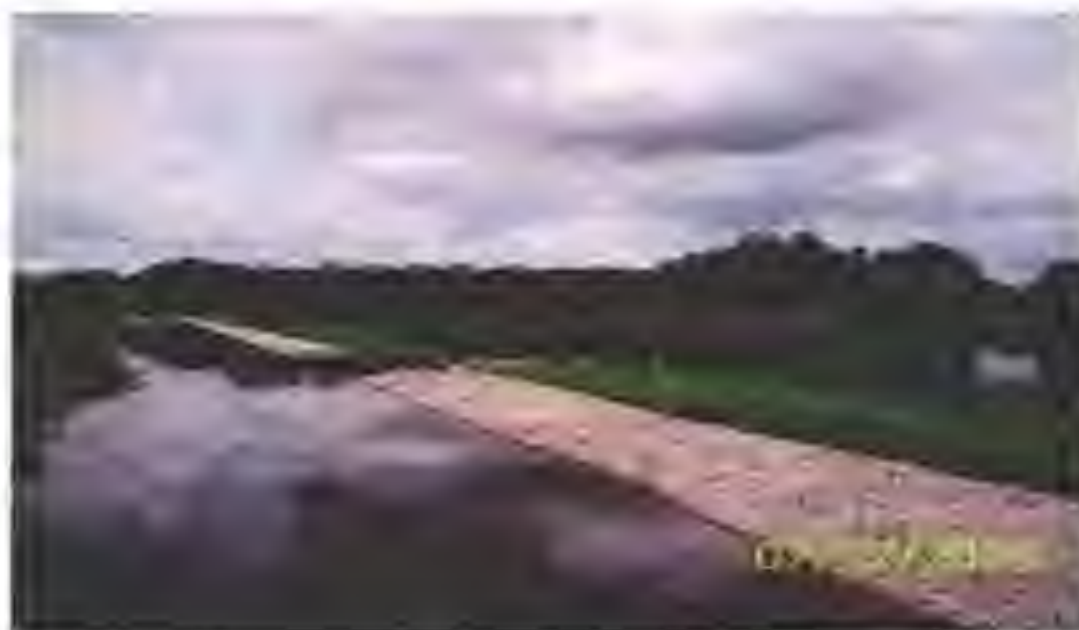
The discharge weir has a combination of two lower discharge elevations constructed with concrete, as seen above at the water overflow in the center of the weir. The broad "overflow" portion of the weir has limerock anchored within 6-inch geoweb containment system. A geotextile liner was placed under the rock to provide additional stability.

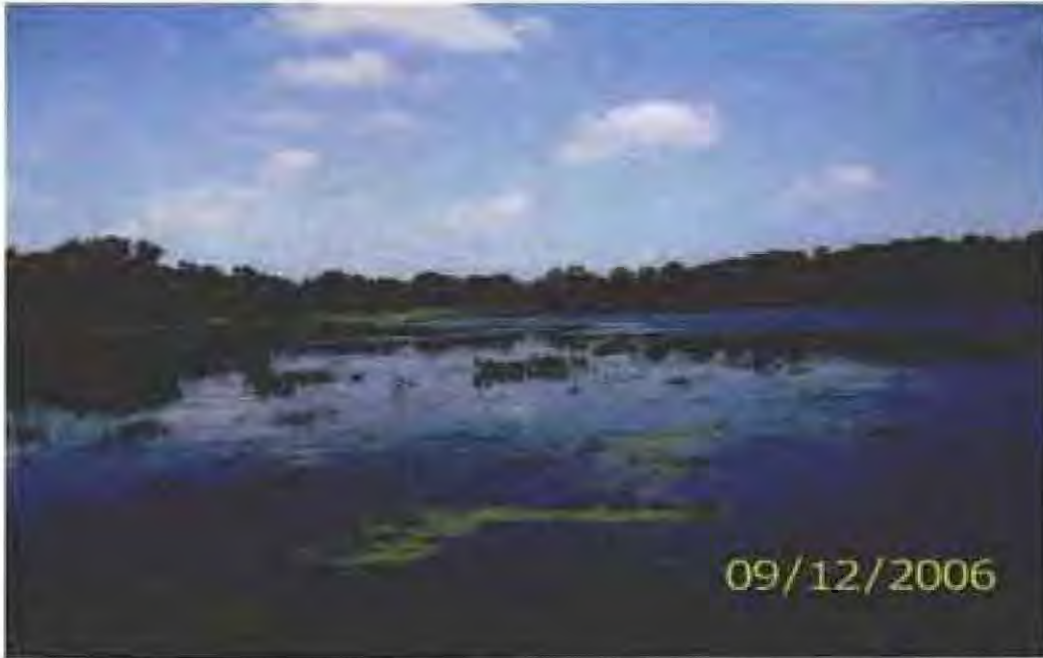
Achieving appropriate wetland hydroperiod has not only resulted in the natural generation of desirable vegetation, but has also minimized the ability of the limpoglass to regenerate.

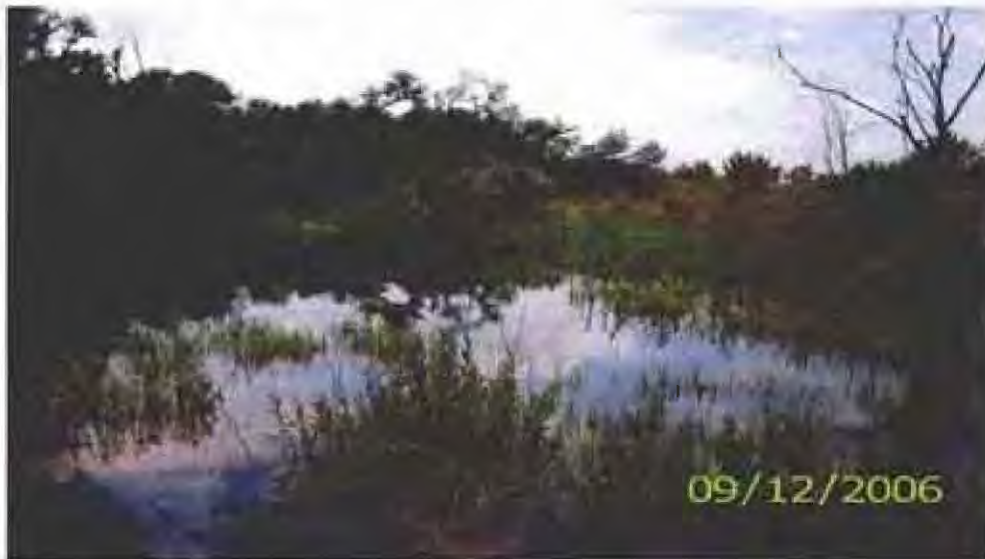
The restored surface water has not only extended to the outer facultative zones to eradicate the pasture grasses and restore marsh habitat (center), but also restores appropriate hydrology for the mixed wetland hardwood systems (left).

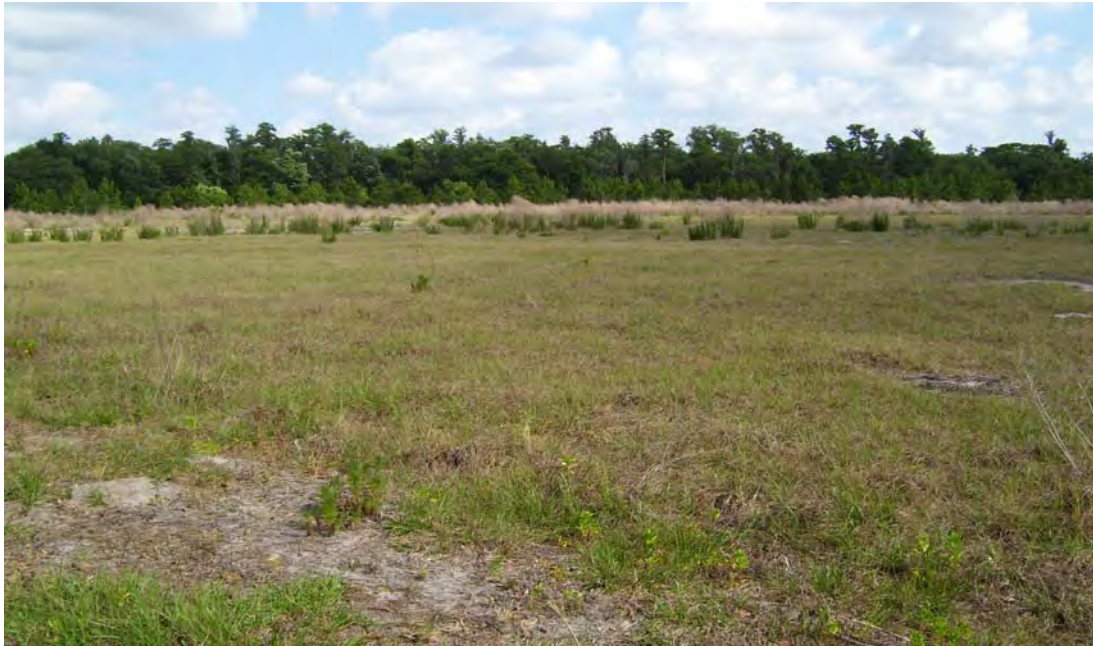
The majority of the upland acreage at the Buffer Preserve includes fallow fields dominated by bahia and scattered dog fennel. Hillsborough County Conservation plans to restore these upland areas into pine flatwood and sandhill habitat; improving conditions for additional wildlife activity and corridor connectivity for the Buffer Preserve and adjacent Brooker Creek Preserve.

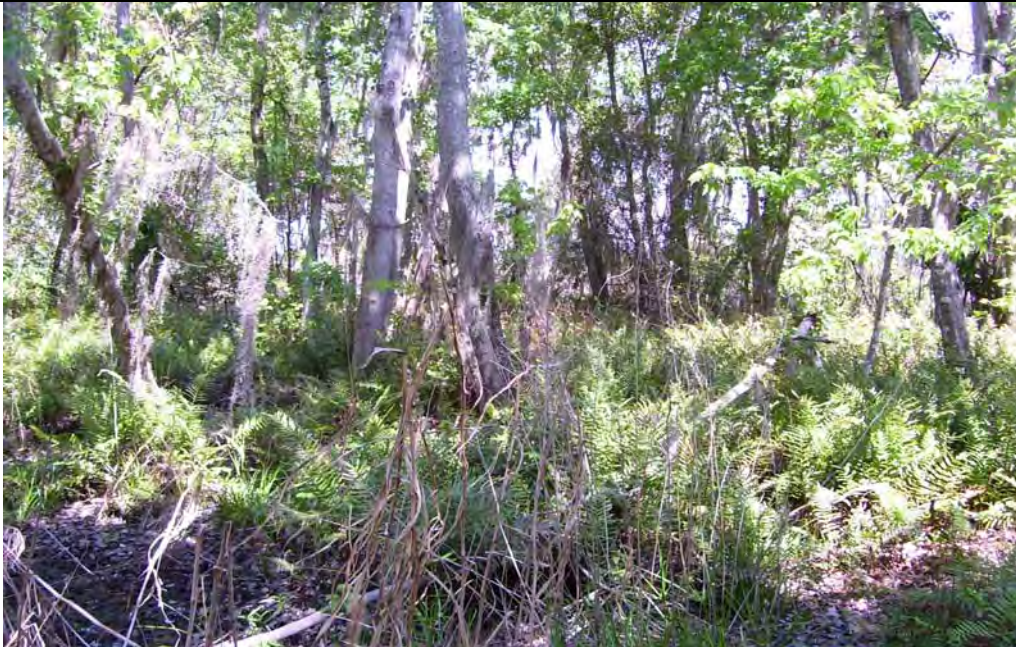
The forested wetland floodplain (FWE – 4) bordering Brooker Creek is dominated by cypress, tupelo, bays and maple over ferns. The rim ditch along the west perimeter of the floodplain diverts and transports a large percentage of the base flow away from the creek. The historic flow pattern will be restored to the creekbed following ditch block construction.

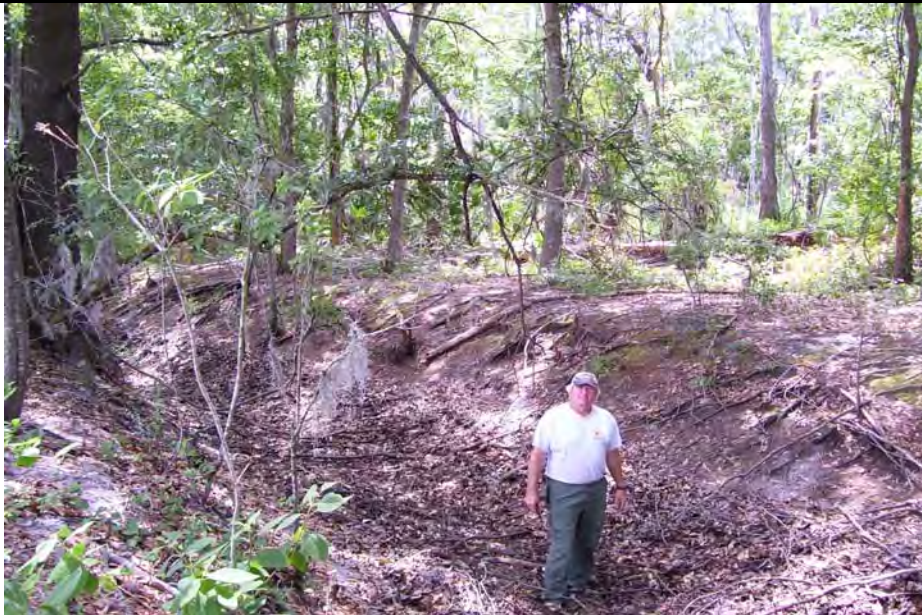
The majority of the upland-cut rim ditches are 4-6 feet deep and 15-20 feet wide between top-of-banks. Ditches under tree canopy typically have minimal ground cover vegetation. These ditches divert contributing upland groundwater flow that historically seeped into the adjacent wetlands. The ditch blocks will stop the flow diversion, and retain water so that seepage can be restored to the wetlands.

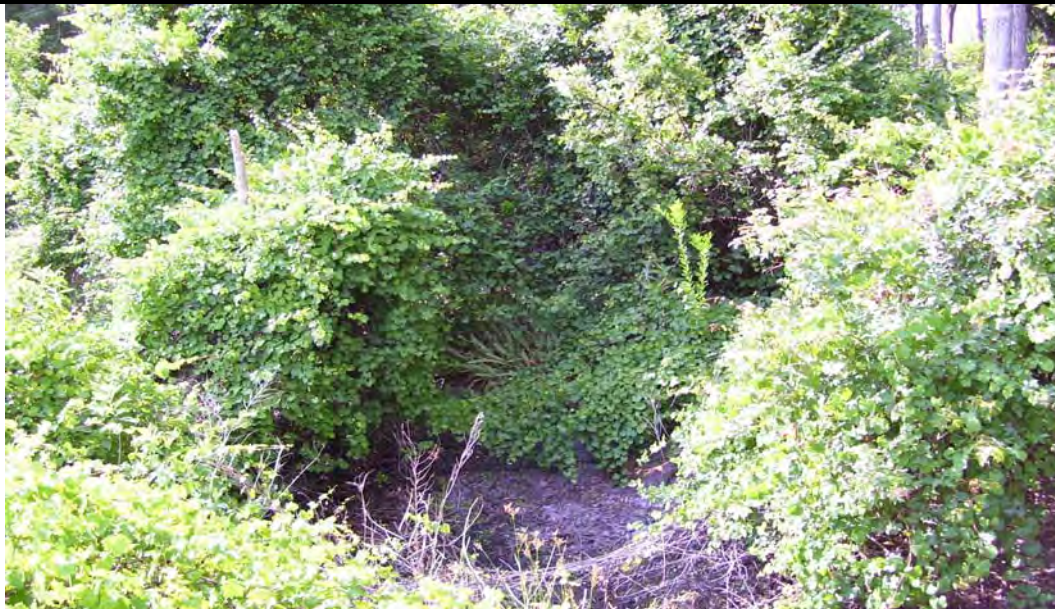
Vine coverage is more common along the banks of the rim ditches without canopy cover, resulting in more difficult and restrictive conditions for wildlife access between the upland and wetland habitat. Along with the hydrologic improvements, construction and planting of wide earthen ditch blocks will provide better upland & wetland connectivity for wildlife access.

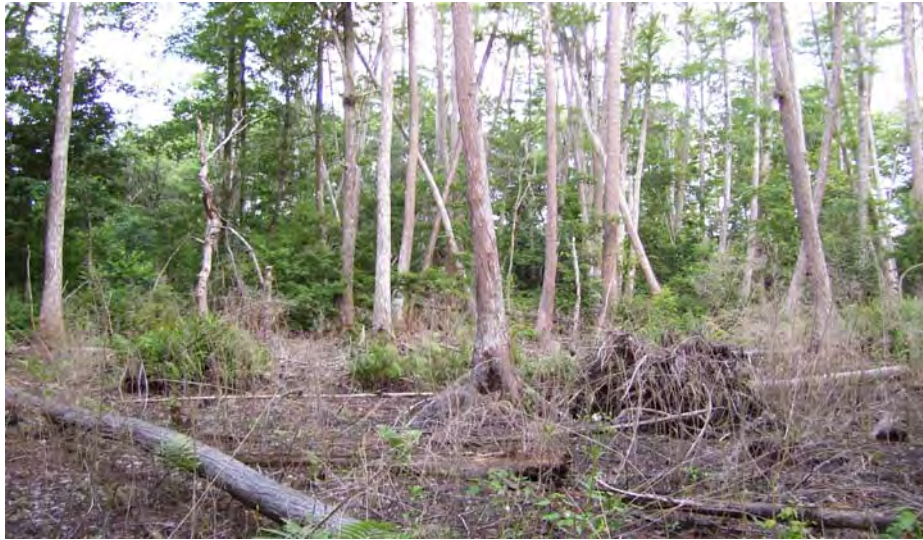
The interior of the forested wetland (FWE – 5) bordering the north side of the elevated driveway; the historic contributing water from south of the driveway has been blocked by the driveway berm; resulting in minimal wetland hydroperiod, organic soil oxidation, and subsequently unstable and toppling of cypress. The canopy becomes more open to expose the understory; allowing nuisance vegetation and facultative hardwood species to recruit and generate.

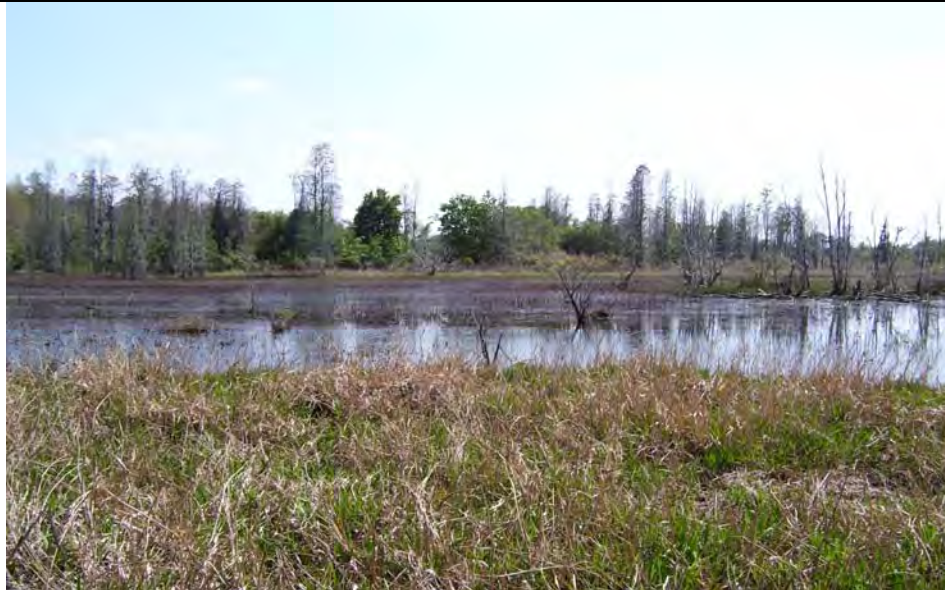
The marsh interior (NFWE – 4) of the wetland south of the driveway. Without positive outfall of drainage, this wetland's unstable hydroperiod from surface water impoundment has resulted in tree and herb generation during droughts, followed by more plant mortality during frequent rain events; note open water where herbs were present and tree snags. The proposed drainage improvements from culvert installation will help restore more stable and appropriate hydroperiods for the wetland habitat south and north of the driveway.

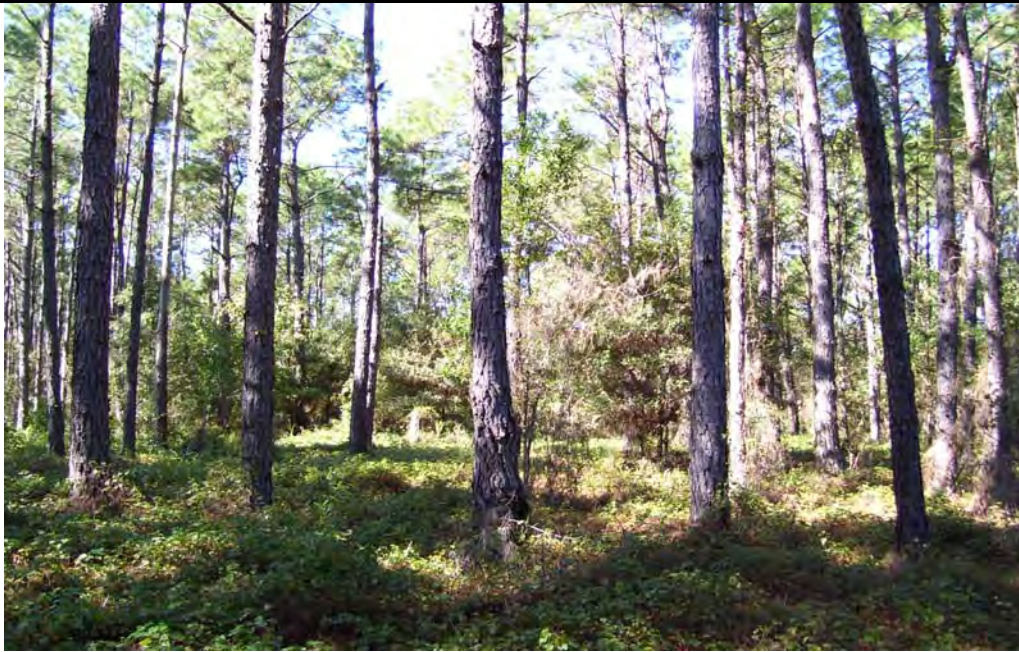
The additional 66 acres acquired along the northwest corner of the Buffer Preserve (Fig. D) provide a wonderful habitat buffer, and wildlife corridor connections to and from the adjacent Brooker Creek Preserve. During the 1970's, all the uplands on this additional tract were comprised of improved pastures. Large planted pine, along with natural recruitment generation of scattered oaks, maples, wax myrtle and herb ground cover provide good habitat mosaic with the adjacent wetlands.

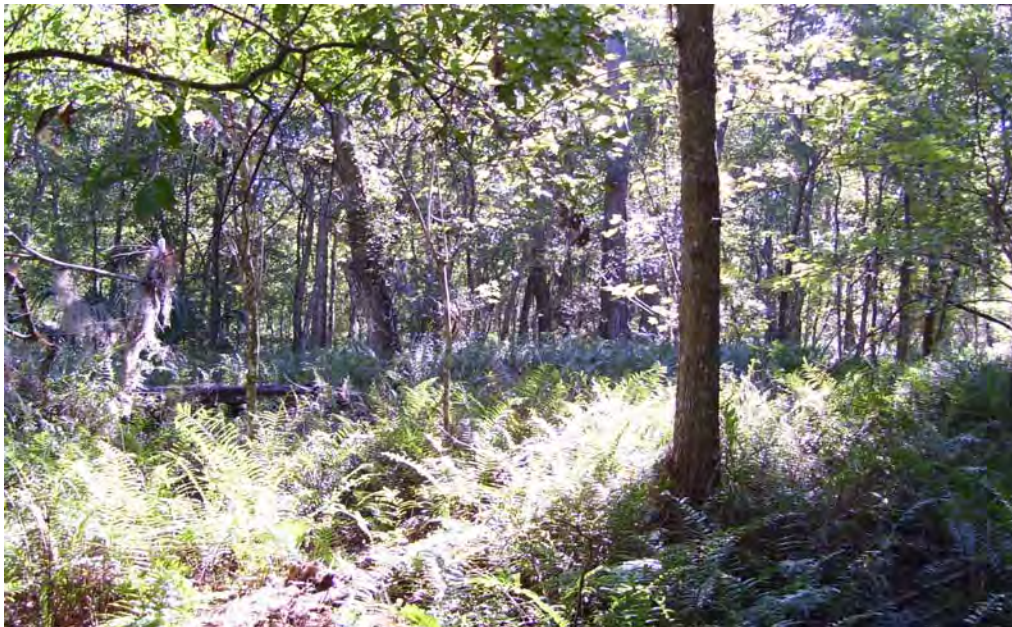
Half of the additional acreage is comprised of forested wetlands with moderate to dense canopy of cypress, maple, tupelo and bays; and ground cover dominated by fern species; much of this wetland habitat borders Brooker Creek.

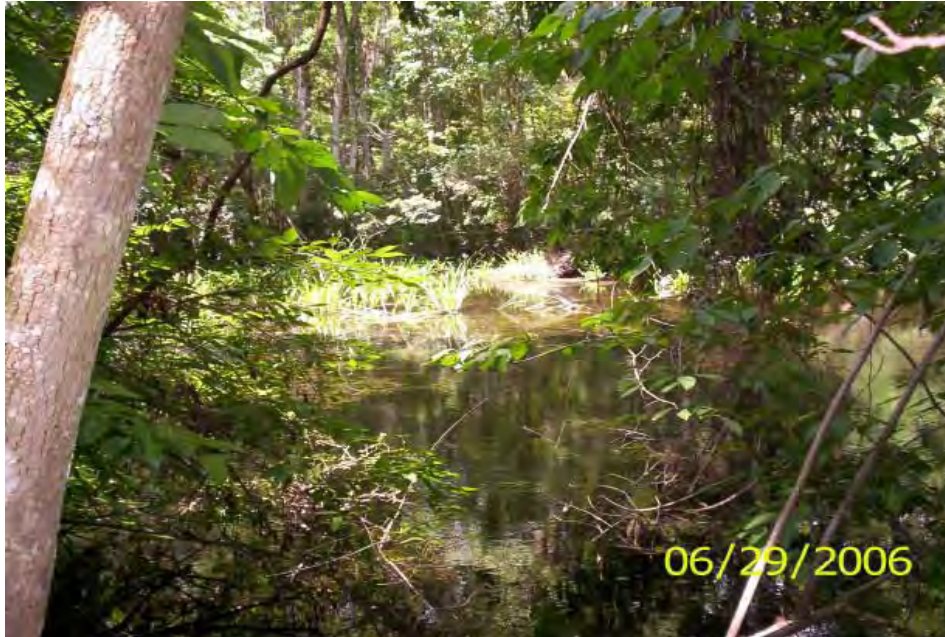
View of the spring surrounded by mixed hardwood wetland habitat. The forested wetland has diverse coverage of many tree species including red maple, sweet bay, American elm, popash, sweet gum, black gum, water oak, laurel oak and cabbage palm.

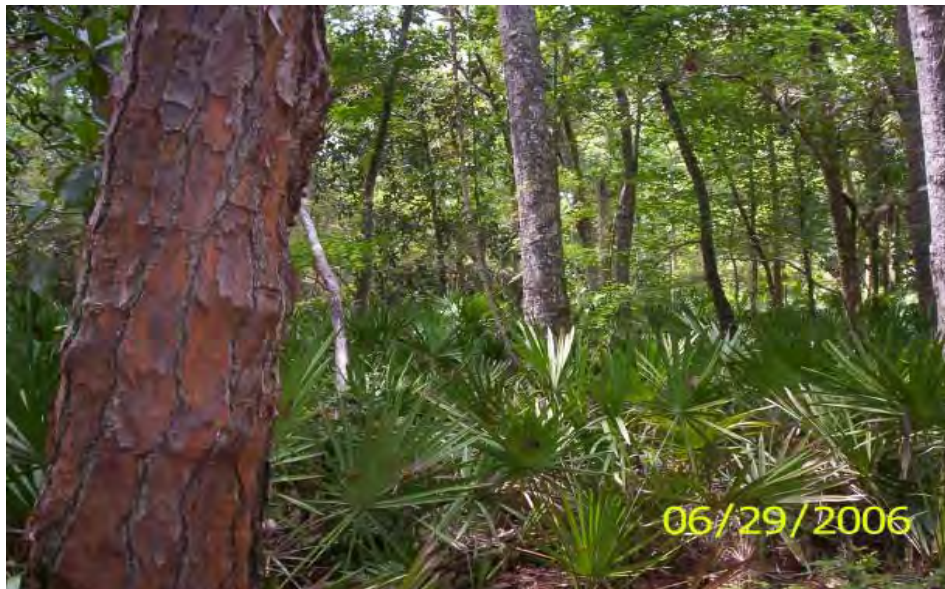
The hardwood-conifer mixed habitat is dominated by live oak and slash pine, with transitional species such as cabbage palm, cedar and magnolia. The understory has dense coverage of saw palmetto, with additional coverage provided by fetterbush, wax myrtle, and bracken fern.

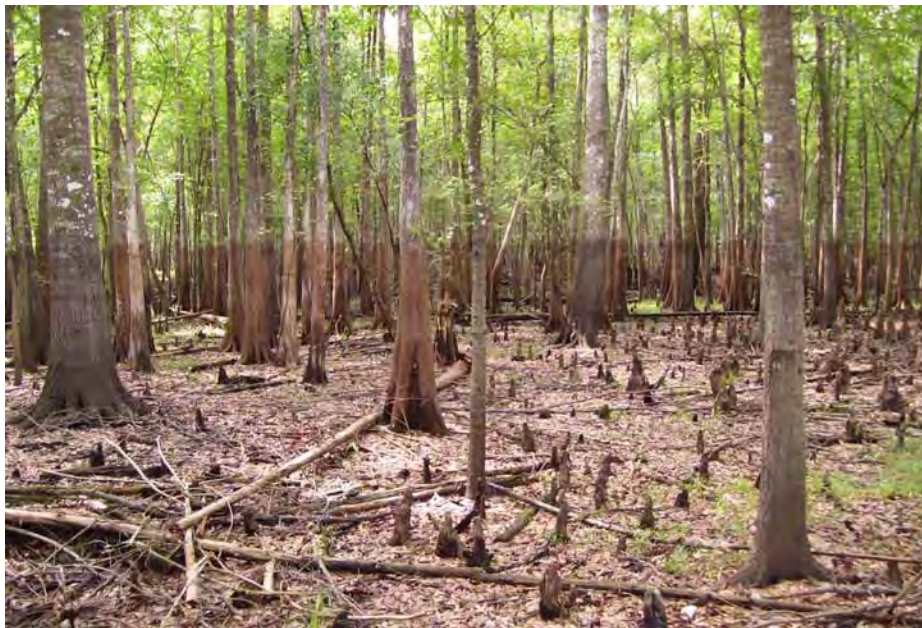
The obligate areas of the wetland floodplain have dominant coverage provided by bald cypress and hardwood species such as tupelo, pop ash, water hickory and red maple. The dark stains of the lower 6 ft. on the trees represent a flood water elevation from the river.

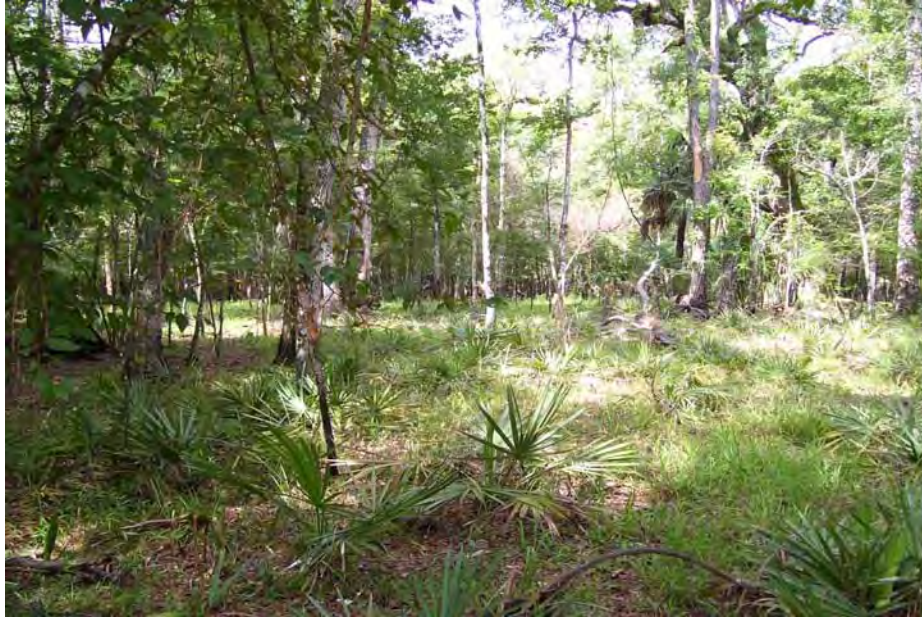
The wetland floodplain grade elevation rises and habitat conditions transition to include less cypress and more facultative species such as laurel oak, red maple, sweet gum, and American elm; as well as more ground coverage of low panicums and sedges where the canopy is more open than the obligate zone.

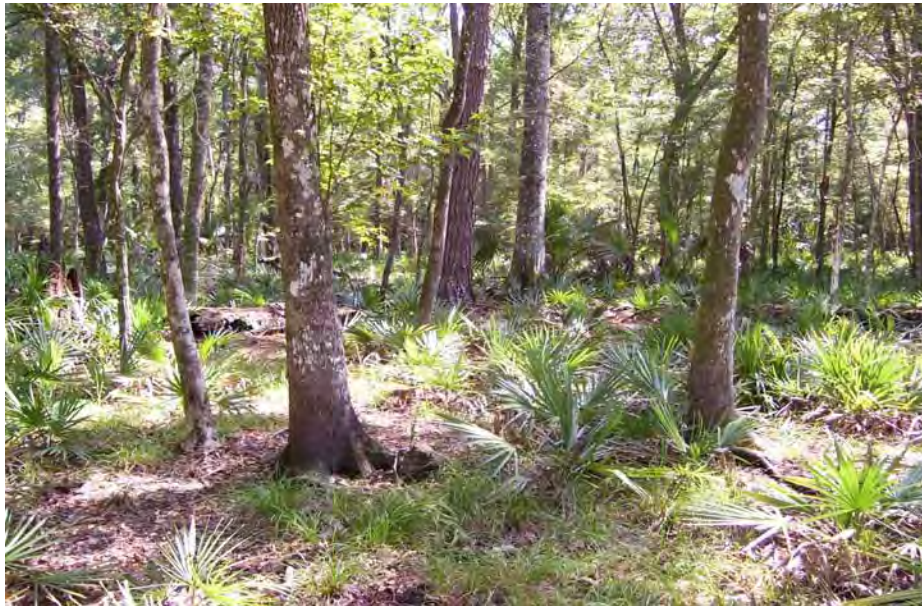
The highest grade elevations are within the southeast portion of the wetland; a hardwood hammock with water oak, cabbage palm, laurel oak, live oak, American elm, and ground coverage of dwarf palmetto and sedges. Flood water elevation indicators are evident within two feet of the surface grade.

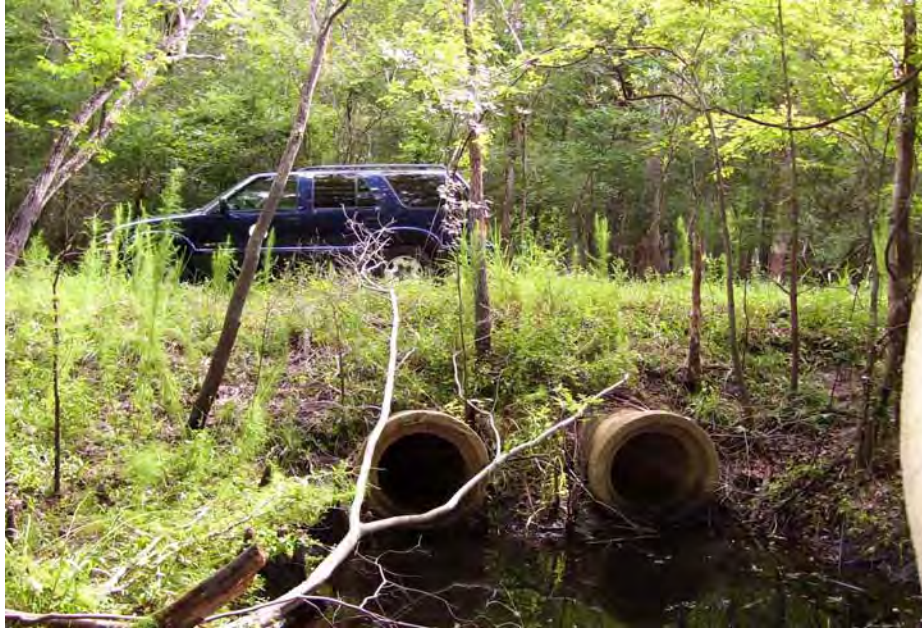
Downstream end of two culverts that discharge water into a creek channel. The culverts will be removed and replaced with rip-rap rubble that will allow gradual seepage into the channel; extending the hydroperiod and attenuation of surface water in the wetland portion on the upstream side of the berm.
