Southwest Florida
Water Management District

EDOT MITIGATION PLAN JANUARY 26, 2010

Southwest Florida Water Management District
Resource Regulation Division
Strategic Program Office
Brooksville, Florida 34604-6899

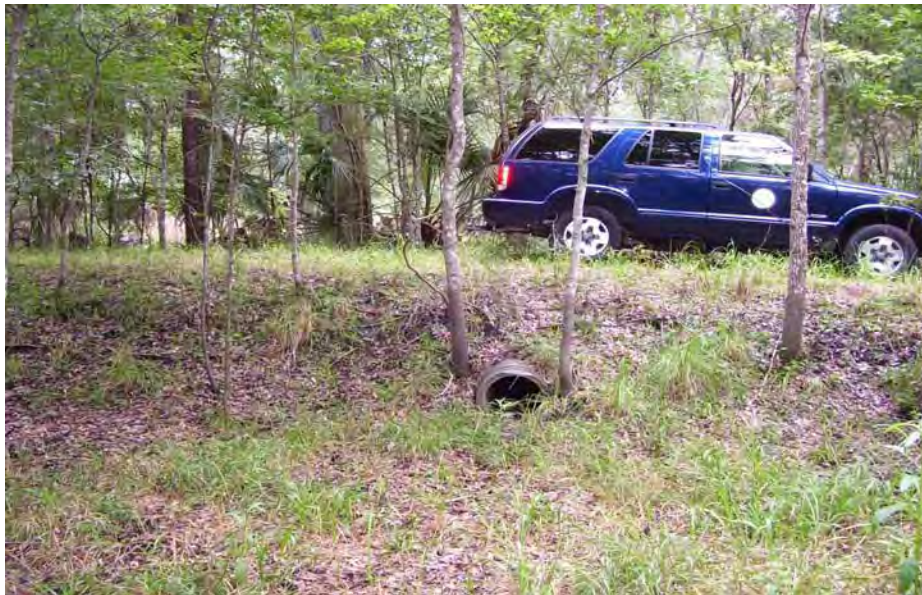
Four of the culverts will remain, however sumps and rip-rap will be placed at the culvert ends to aid in maintaining flow and minimize scouring and undermining of the culverts.

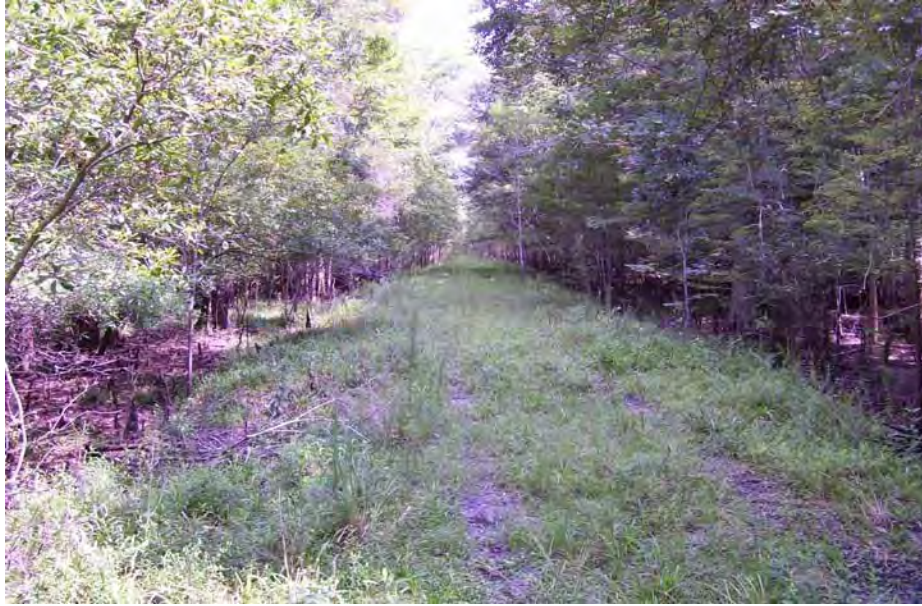
Portions of the access road berm will be removed and replaced with Geoweb material and small limerock to maintain a wet road crossing for vehicle access. The cleared path will also continue to provide a beneficial wildlife corridor connector through the forested wetland.

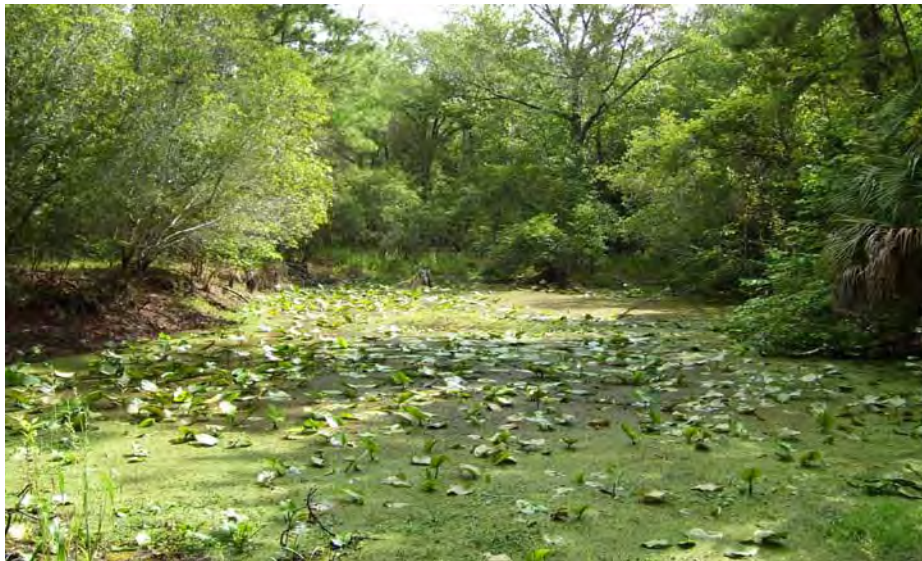
Small borrow ponds exist adjacent to the road; with dominant coverage of spatterdock and duckweed. The ponds provide a valuable water source for wildlife, particularly during the dry season. The proposed berm modifications will allow contributing flood waters to reach, recharge and flush the ponds more often than the current conditions.
