Facility: CR3 CRYSTAL RIVER PLANT NUCLEAR
 WR Originator: BATCH
 Unit : 3 Project :
 W/O Type: PM TSK PRI: 3 W/O Dspln: N
 Planner : BAKERJ02 BAKER J D
 W/O Title : E, SP0182, RB STRUCT INTEG TENDON SU
 W/O Task Title: E,Q,OW, RB ASME XI IWE / IWL VISUAL
 EXAMIS LINER / CONCRETE
 Task Dspln : N Due By: 09/01/06

00681043 08

*****PROBLEM DESCRIPTION*****
 THIS TASK WILL BE USED TO CAPTURE AND DOCUMENT THE VISUAL EXAMINATIONS OF
 REACTOR BUILDING CONCRETE CONTAINMENT AND LINER SURFACES.
 INSPECTIONS REQUIRED PER ASME XI, IWE (LINER) AND IWL (CONCRETE CONTAINMENT)

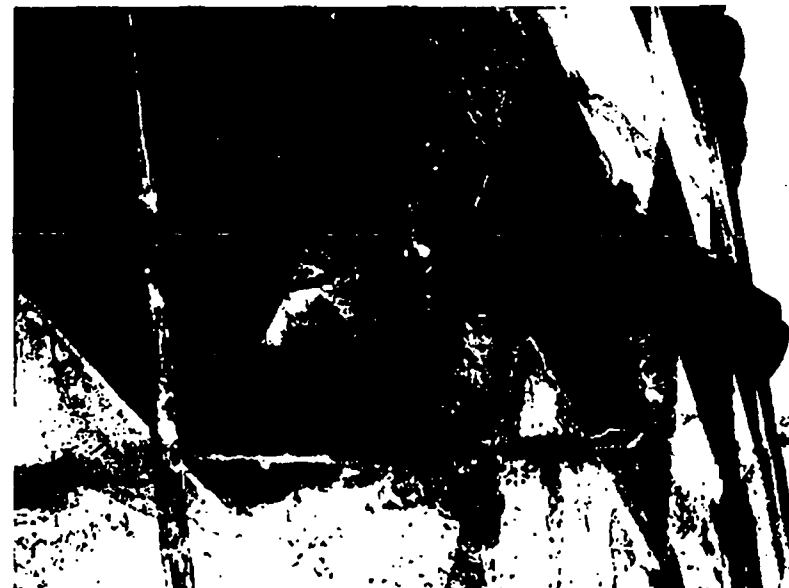
Comments: **PHOTOS FOR ITEM #9**

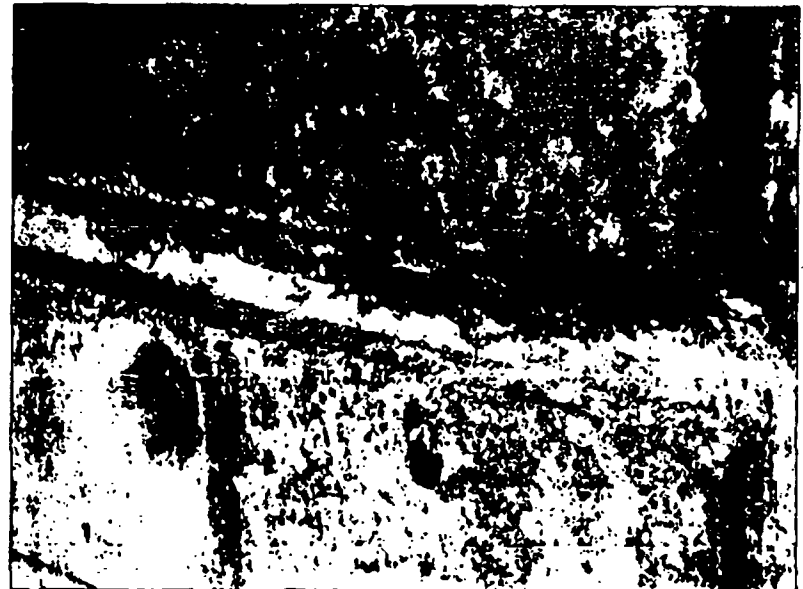
Comments: **PHOTOS FOR ITEM #10 (LEFT) AND ITEM #1 (RIGHT)**

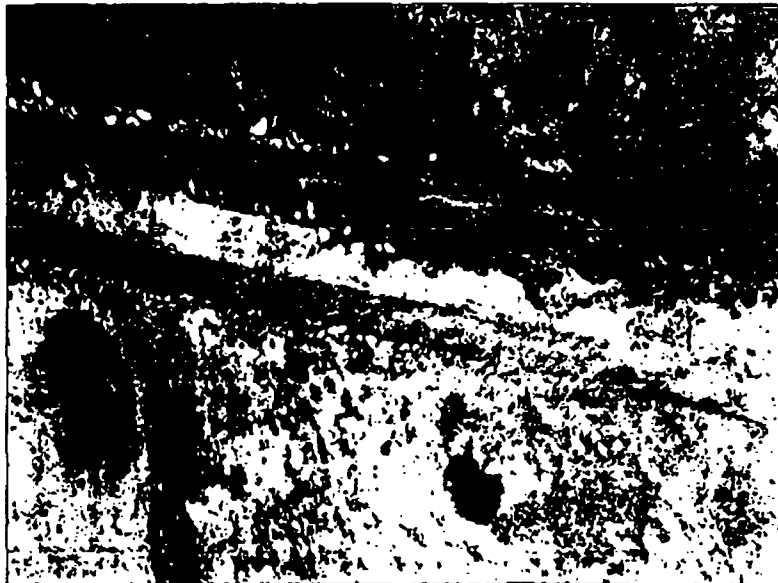
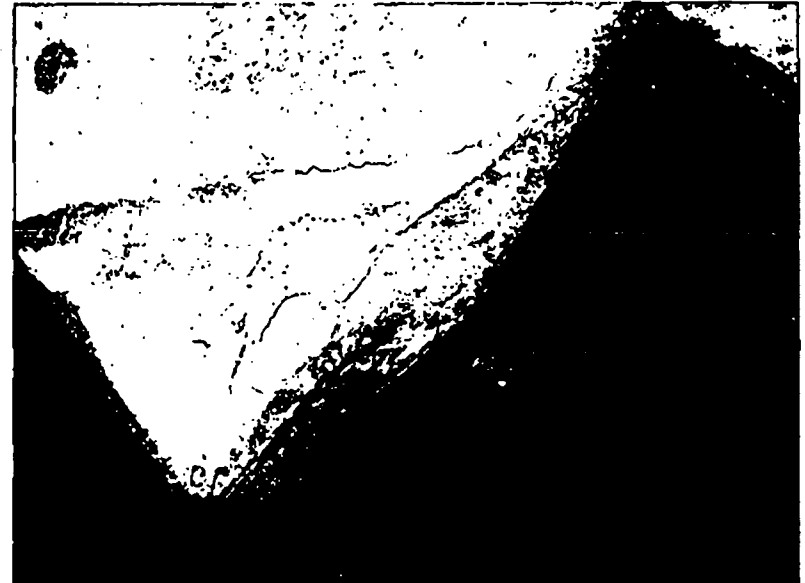
Comments: **PHOTOS FOR ITEM #1 (LEFT) AND ITEM #12 (RIGHT)**

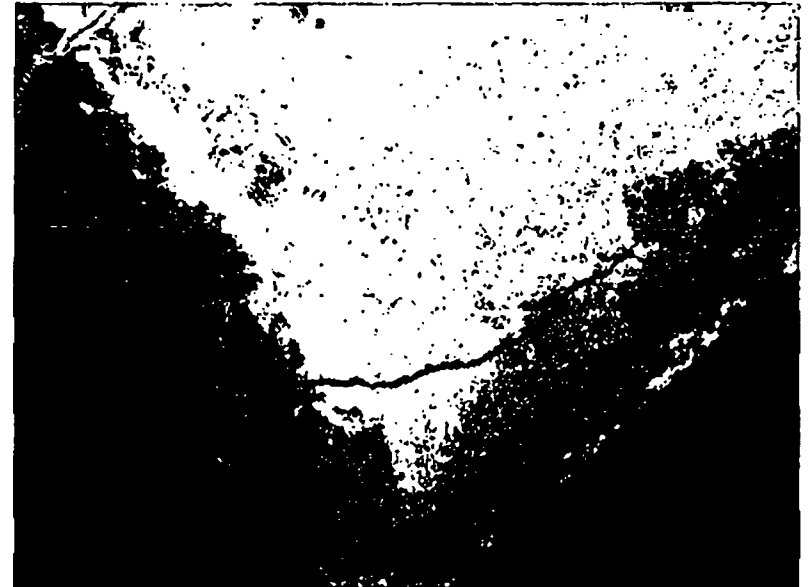
Comments: **PHOTOS FOR ITEM #12 (LEFT) AND ITEM #11 (RIGHT)**

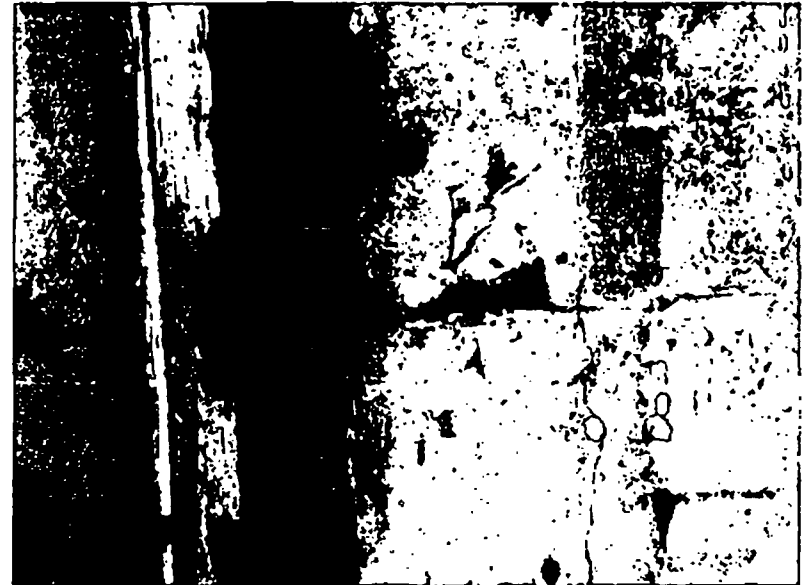
Comments: **PHOTOS FOR ITEM #11 (LEFT) AND ITEM #2 (RIGHT)**

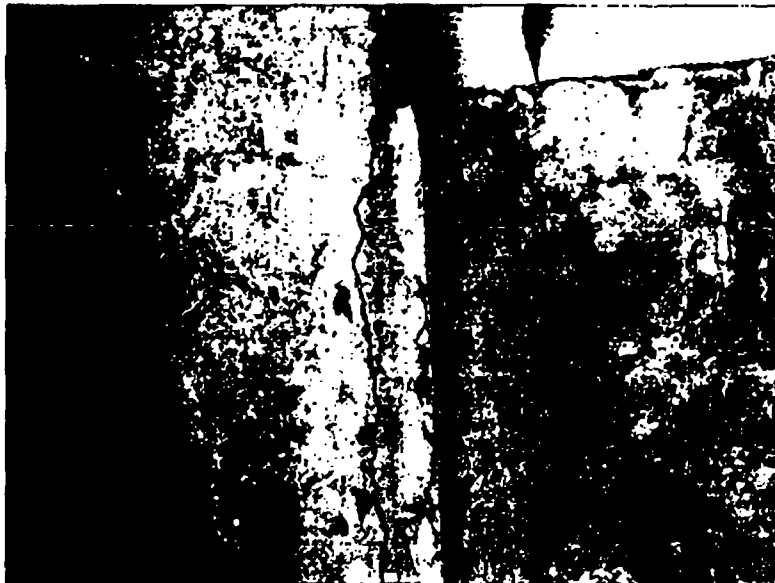
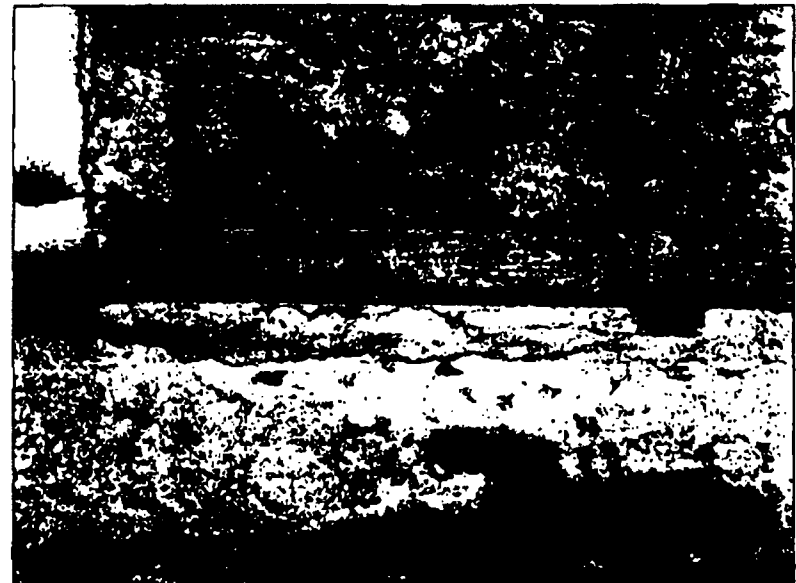
Comments: **PHOTOS FOR ITEM #4**

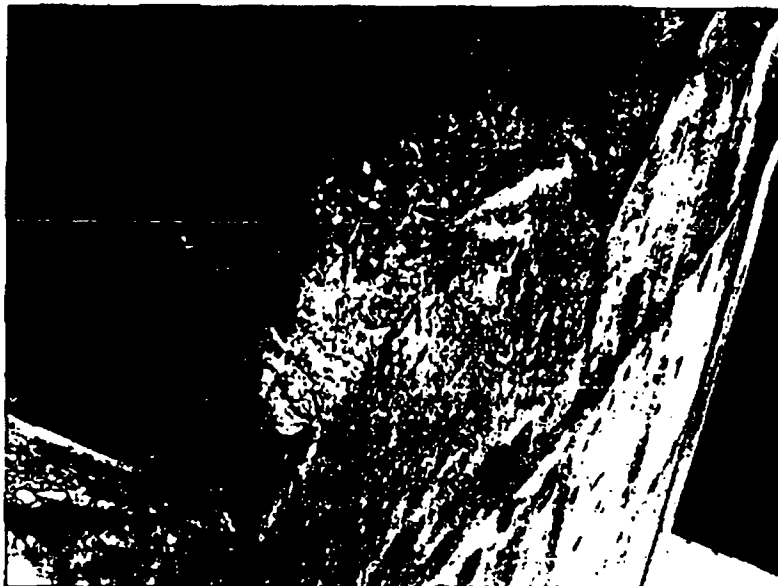
Comments: **PHOTOS ASSOCIATED WITH ITEM # 1 (LEFT) AND ITEM # 4 (RIGHT)**
